**Cultural Heritage Evaluation Report:  
Built Heritage Resources and Cultural Heritage Landscapes**

**3269 Dundas Street West  
Town of Oakville, Regional Municipality of Halton, Ontario**

ASI File 10SP-40

June 2010

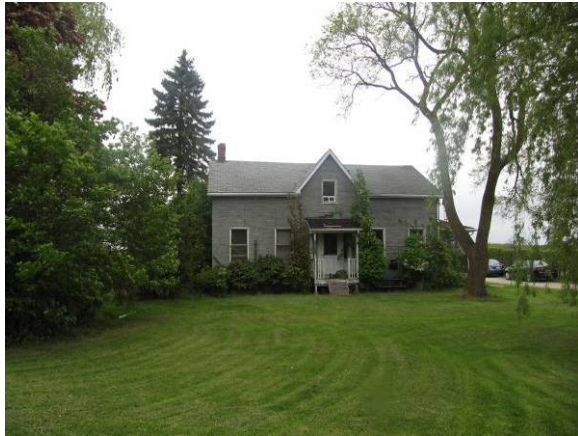
**Plate 1: Farmhouse at 3269 Dundas Street West**

The one and a half storey farmhouse features a gable roof, a single internal chimney with brick stack, concrete block foundations, and asphalt siding exterior (Plates 1-2). The gable roof is clad in asphalt shingles and bounded by aluminum eaves and soffits, and the single interior chimney with brick stack is located at the western gable end (Plate 3). The exterior of the dwelling is clad in asphalt siding, or InsulBrick, which was a popular type of siding during the 1930s to 1950s time period (Plates 4-5). The dwelling follows a rectangular floor plan with a central hall layout, and features entrances on the south, east and north elevations. The entrance on the south elevation is the main and original front entrance. The rear entrance is contained in an enclosed porch that likely dates to the first part of the twentieth century. The side entrance, located on the east façade, is accessed through a more recently built vestibule of glass and metal materials. Some of the windows in the dwelling have been replaced with modern glass in a one over two pane arrangement.

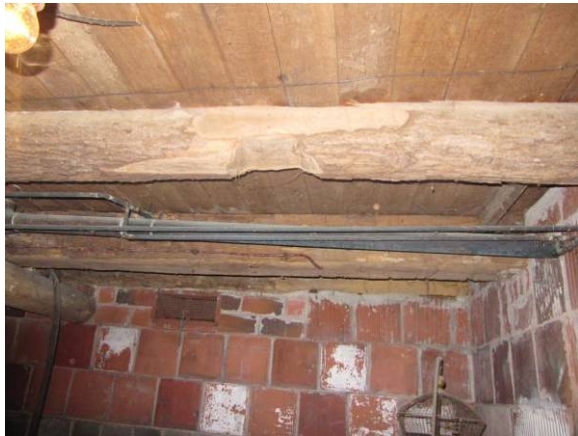
**Plate 19: View of the floor beams from the basement**

The basement (Plates 19-21) underlying the west half of the house provides a clear view of the concrete block foundation. The portion under part of the east half of the house, as seen from the staircase, has tiled walls. Large wooden floor beams underlie this section of the house, one of which is squared and exhibits

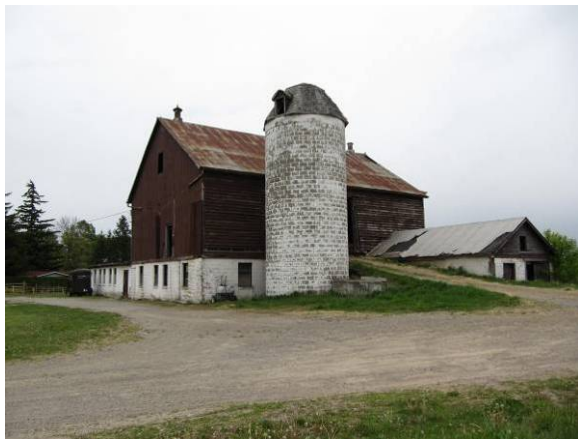
**Plate 23: Northeast elevation of the barn, view of silo and smaller, gable roof structure attached to the north elevation.**

The gable roof, hand-hewn beams, and type of framing/construction techniques indicate that the northern portion of the barn is of nineteenth century construction. The barn has undergone a number of alterations, however, including the addition of a gambrel roof extension, a lower flat roof section, and the introduction of concrete block foundations. A smaller gable roof shed structure was added to the north elevation of the barn, and a concrete block silo was built immediately northeast of the barn.
