**Phase I Environmental Site Assessment
Pigott Farm Land
Oakville, Ontario**

Trow Consulting Engineers Ltd.

BRGE0059627A
January 9, 2001

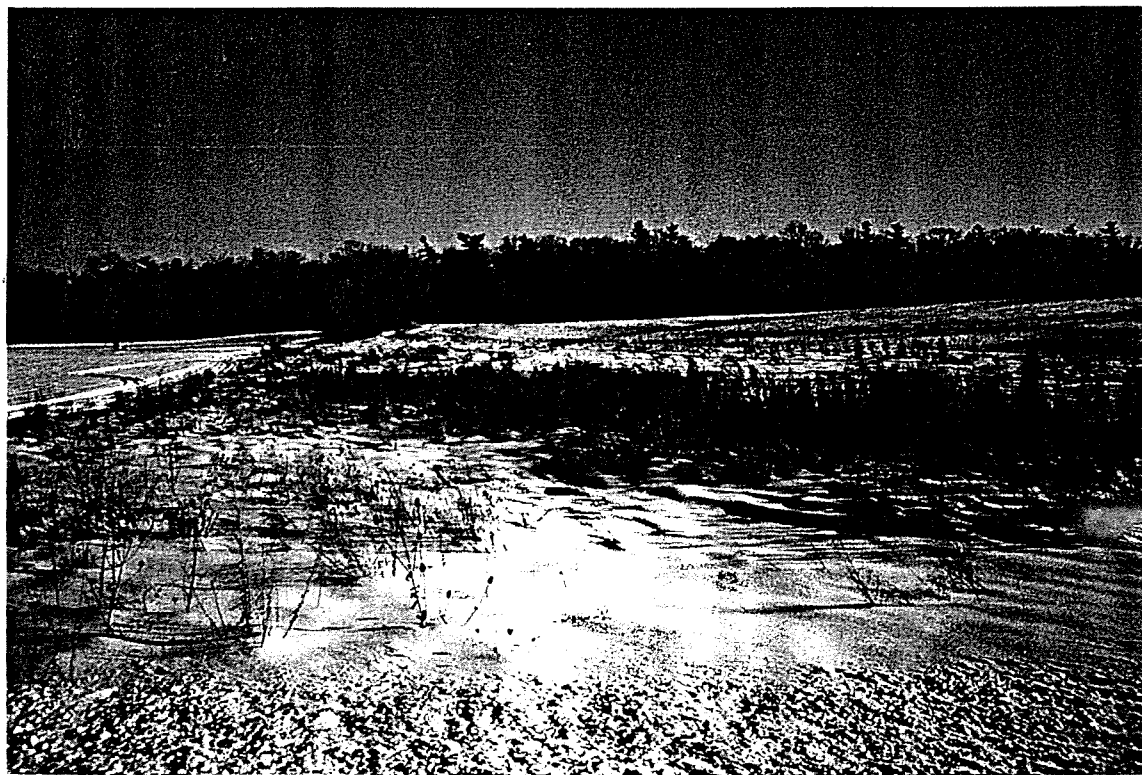
Photo 2: View of Site (Parcel B) looking south.

The Site is divided into two sections designated as Parcel A and Parcel B (Photos 1 and 2). Parcel A is approximately 75 hectares (186 acres) in size and is bound to the south by Dundas Street West and to the north by Highway 407 (under construction). Parcel B is approximately 23 hectares (57 acres) in size and is bound to the north by Burnhamthorpe Road West and to the south by Highway 407 (under construction).

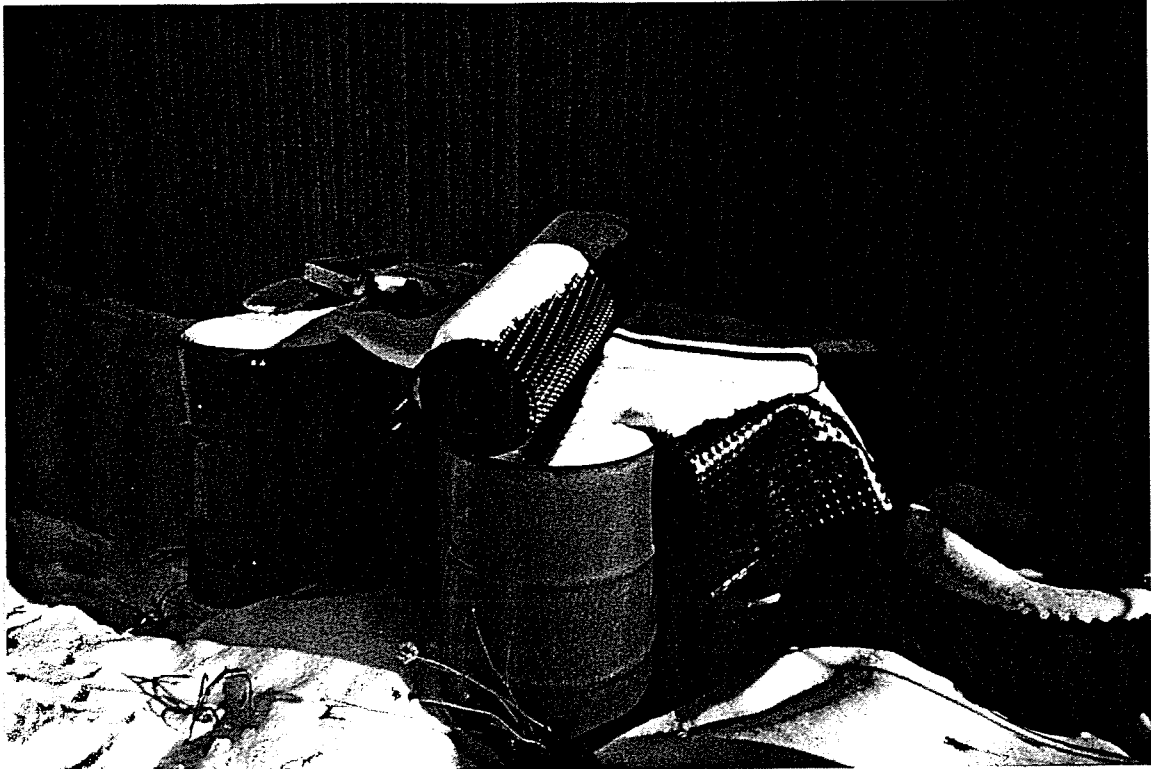
No significant staining was observed on the adjacent surfaces near items (i) through (iv). No significant staining or evidence of leakage was observed near the drums identified in item (v). However, Trow's visual assessment of the area was restricted due to snow cover present on Site.

Photo 3: View of eight 208 L steel drums labelled as containing 'chemical form release agent' located north of a shed in the southern portion of Parcel A.

- A Limited Phase II subsurface investigation should be undertaken to investigate the potential soil and/or groundwater contamination that may have resulted from the pig manure USTs, historic gasoline UST, the Site's existing and historic heating oil and diesel ASTs, the south adjacent property's diesel AST, the observed drums of 'chemical form release agent', and the historic emergency diesel generator.

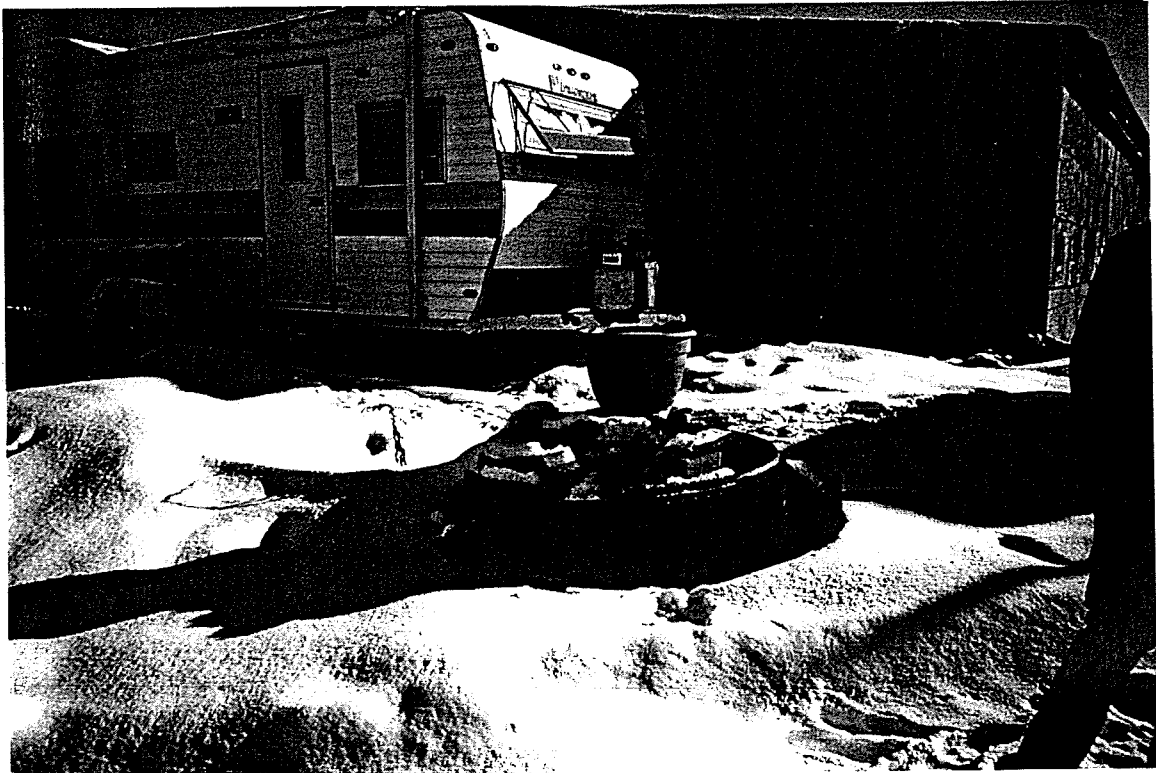
Four underground storage tanks (USTs) containing pig manure were observed on Site in the south portion of Parcel A. Three of the pig manure USTs are old railway cars approximately 45,000 L in size. Two are located north of a shed, on the west side of the Site's pond (Photo 4). One UST is located south of a barn located in the south central portion of Parcel A (Photo 5). The fourth UST is approximately 68,000 L in size and is located east of a concrete silo pad (Photo 6).

Photo 4: View of pig manure UST (old railway car) located north of a shed, on the west side of the Site's pond (~45,000 L).

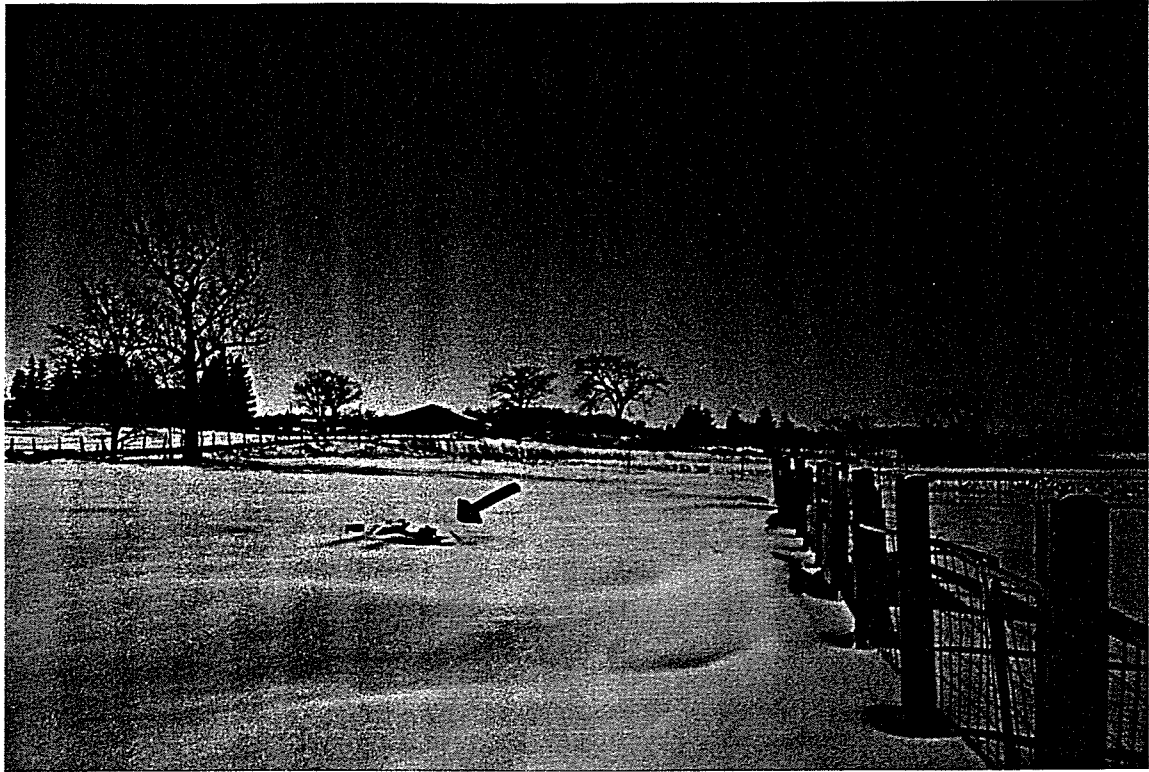
Photo 5: View of pig manure UST (old railway car) located south of a barn in the south central portion of Parcel A (~45,000 L).

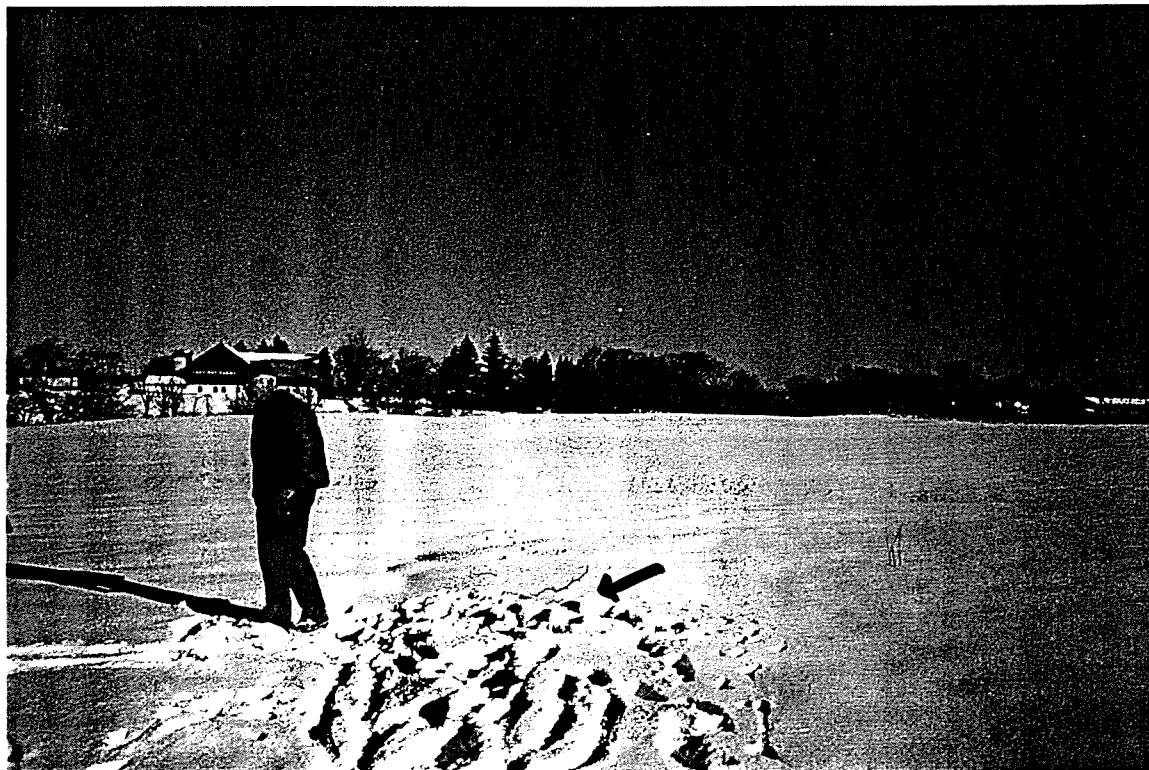
Photo 6: View of pig manure UST located east of a concrete silo pad in the south central portion of Parcel A (~68,000 L).

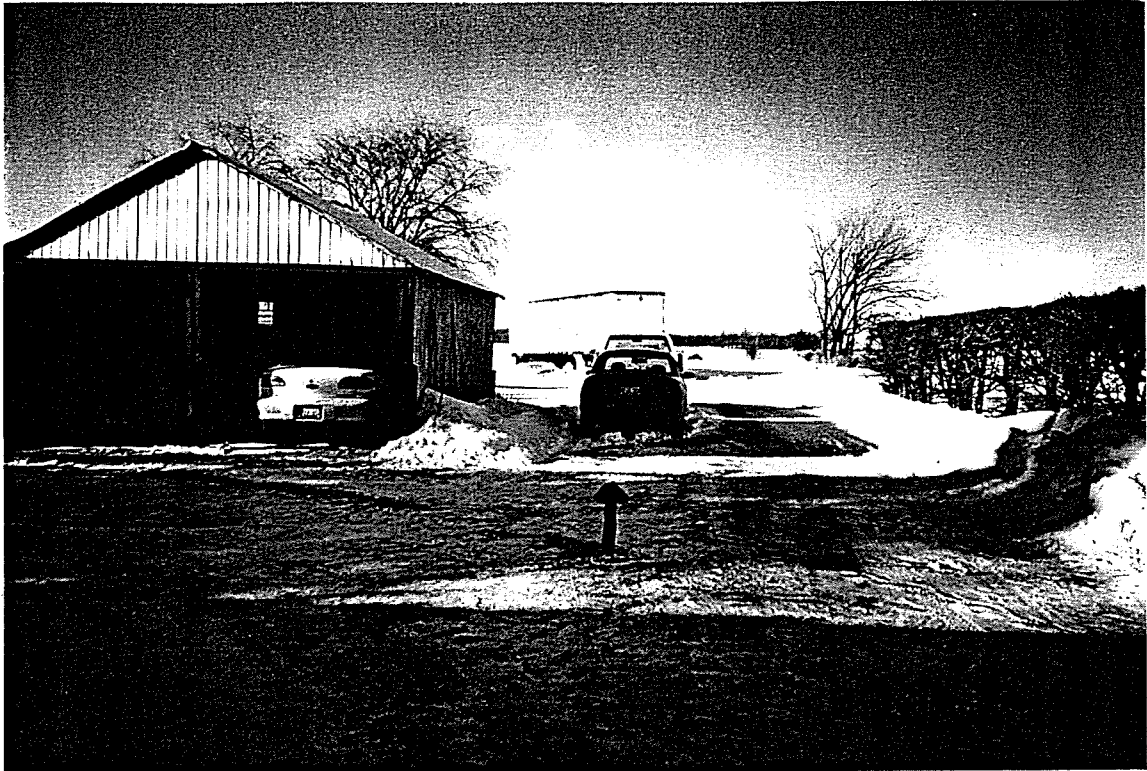
Photo 7: View of location where historic gasoline UST (~13,600 L) was previously located. UST was removed in ~1990.

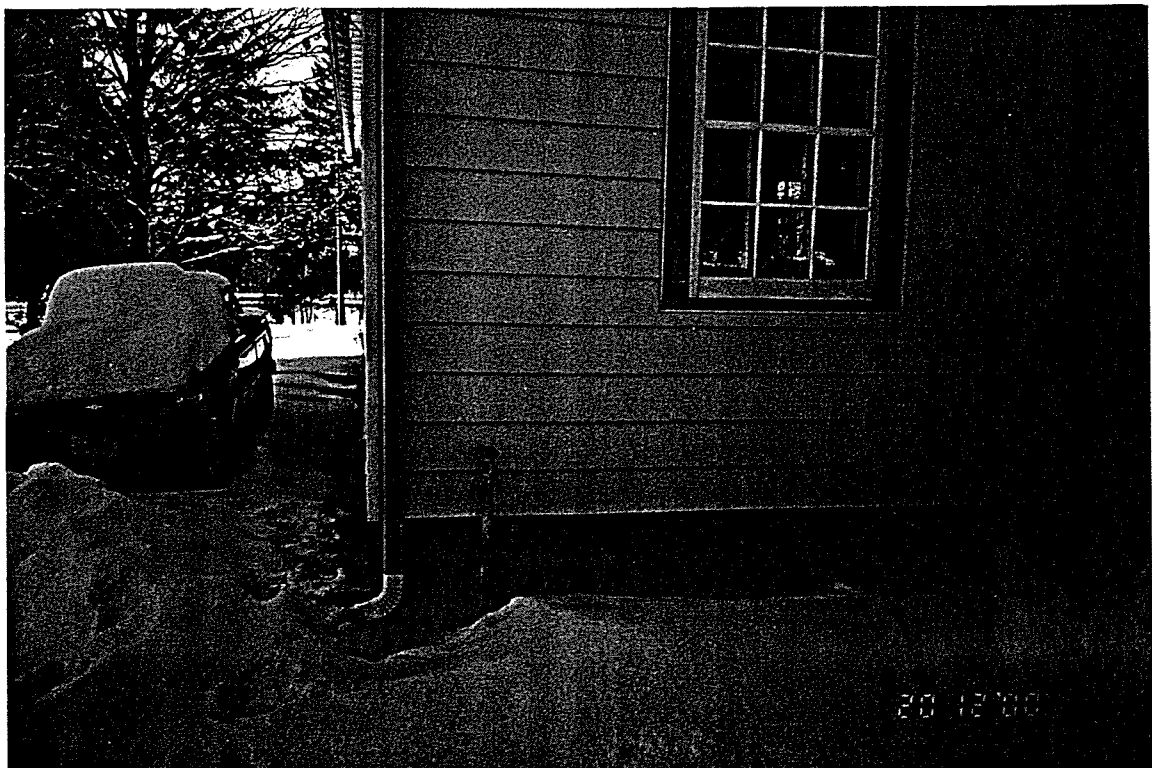
Two fill pipes were observed on the northeast corner of the residential house located at 3271 Dundas Street West (Photo 8). Mr. Pocock indicated to Trow that two heating oil ASTs, approximately 900 L in size were located in the basement of the residential house. No access to this house was made available during Trow's Site visit.

Photo 8: View of fill pipes for two heating oil ASTs (~900 L each). ASTs located in the basement of the 3271 Dundas St. W. residential house.

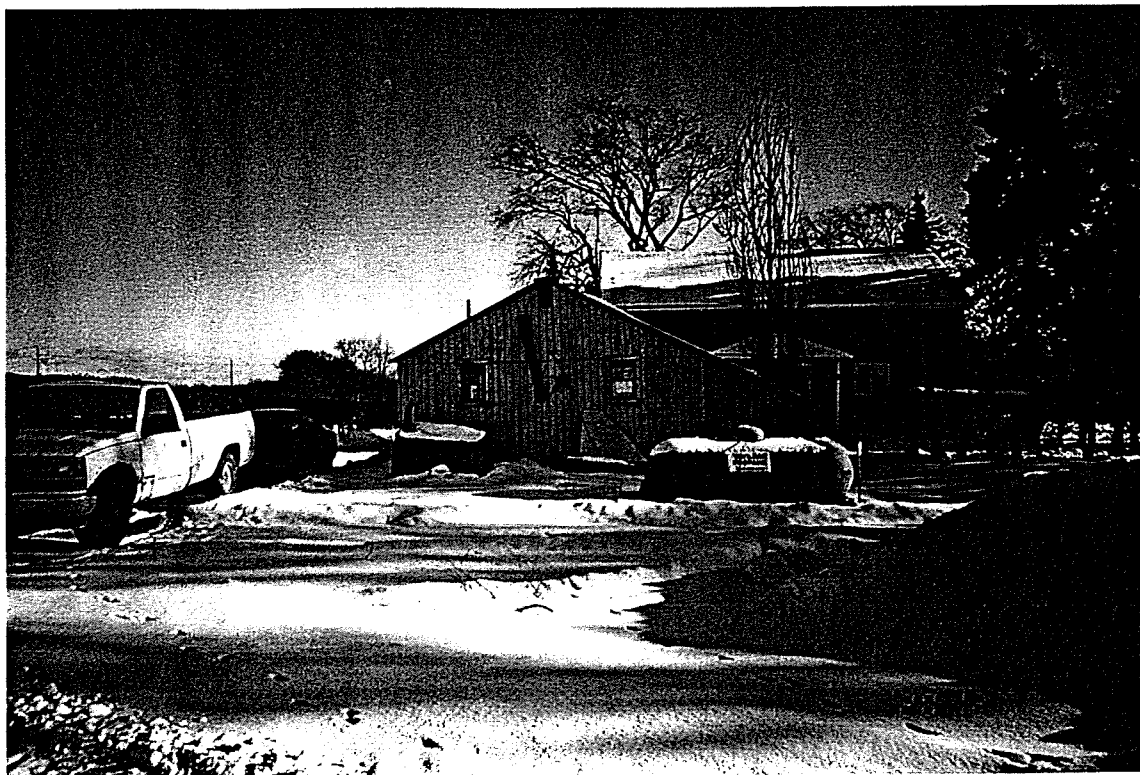
A diesel AST (~1,000 L) and a propane AST (~1,500 L) were observed north of the Site's garage (Photo 9). An empty chlorine AST was also observed underneath the Site's swimming pool.

Photo 9: View of ~1,000 L diesel AST and ~1,500 L propane AST located north of the Site's garage.

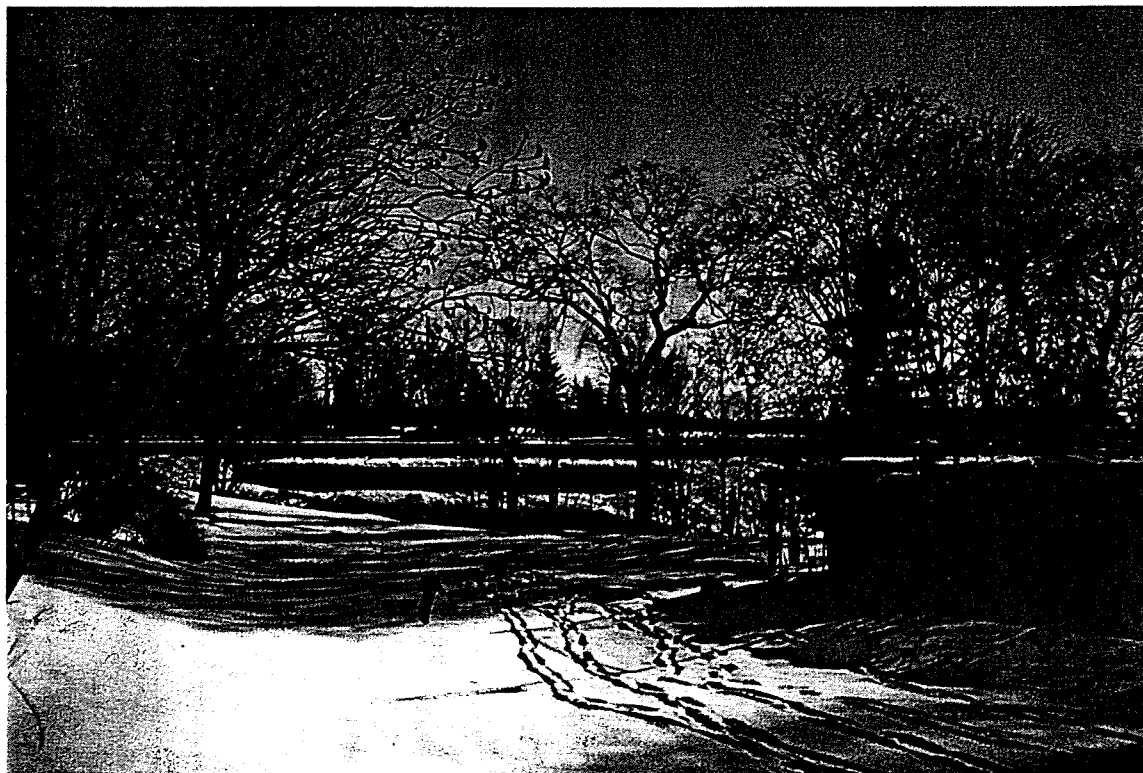
Photo 10: View of location where Site's concrete septic tank and septic bed are located (south/southeast of swimming pool).

The in-ground private sewage disposal system (located south of the swimming pool) may remain in place provided that it is not within the area of proposed construction. The concrete septic tank must be pumped out by a licensed hauler. After this is completed, the walls of the concrete septic tank can be collapsed and the voids filled. However, if the septic system is within the proposed area of construction and requires removal from the site, the concrete from the tank may be disposed at a concrete recycling facility or a licensed landfill. The stained or odorous soils associated with the septic beds may be disposed of as landscaping material at the site or a licensed landfill.

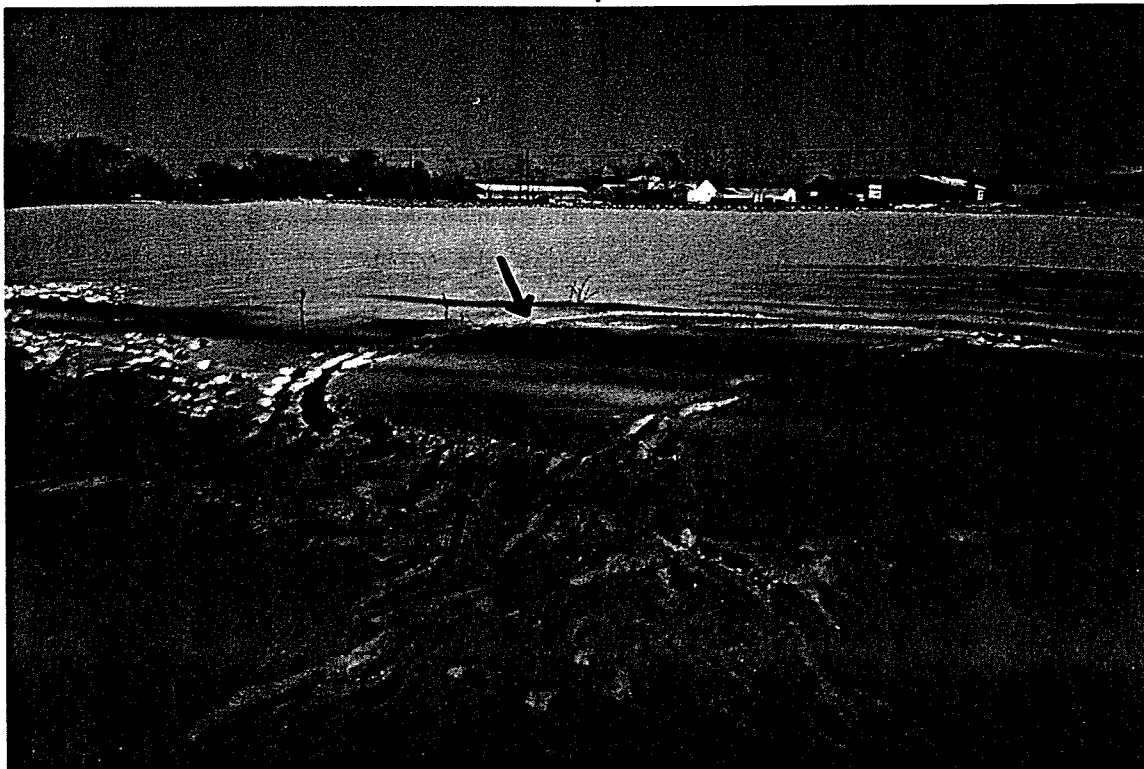
Mr. Pocock indicated to Trow that three additional houses and one barn were previously located near the south central portion of Parcel A. The structures have since been demolished. The foundation of two of the houses and the barn's concrete silo pad were observed during Trow's Site visit (Photos 11 and 12).

Photo 12: View of concrete silo foundation located in the south central portion of Parcel A - location of demolished barn.

- A Limited Phase II subsurface investigation should be undertaken to investigate the presence of fill material near the location of the historic houses, historic barn, observed concrete blocks and pile of debris (corrugated steel pipes and soil).
