Phase One Environmental Site Assessment

Part of Lot 31, Concession 1, Trafalgar NDS, S&E Parts 1, 3, 5,
7 & 10, 20R16040 and 3278 Regional Road 25
Oakville, Ontario

DS Project No : 19-323-100
Date: 2023-05-08

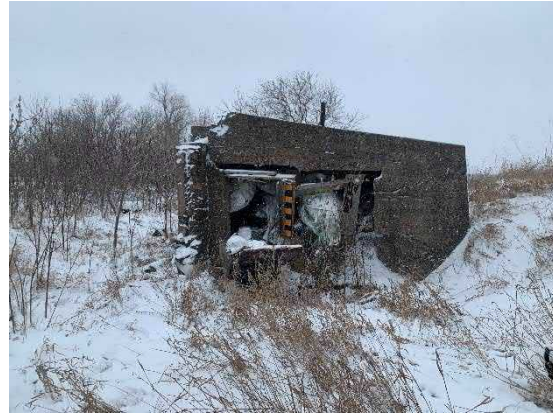
Picture 2: View of Site Building A on Phase One Property, facing west.

- During the Phase One site inspection, fill material and construction debris was observed to have been stockpiled within the interior of Site Building A. Historically, Site Building A extended further to the west, and this portion of the building was demolished in the 1990s. It is anticipated that fill material may have been utilised to infill the footprint of the demolished portion of the building **(PCA-13)**.

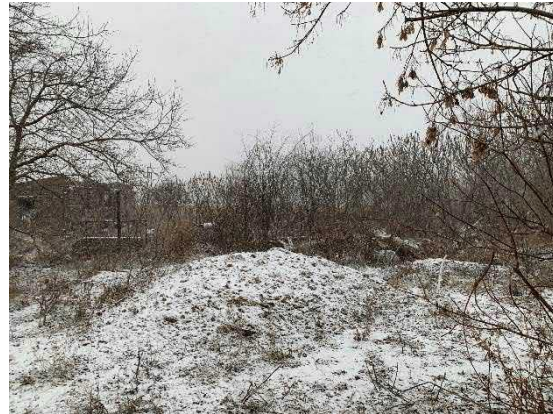
Picture 4: View of stockpiles of construction debris south of Building A, facing east.

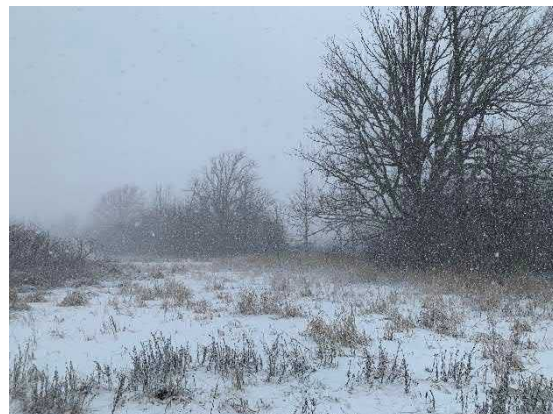
Picture 6: View of the small wetland present at the central portion of the Phase One Property, facing south.

During the site visit, standing water was observed at various points throughout the property. Small wetlands were observed within the central, northern and southwestern portions of the Property. The nearest body of water to the Phase One Property is Fourteen Mile Creek, which is located within the northwest portion of the Phase One Property and traverses the west adjacent property in a north-south orientation.

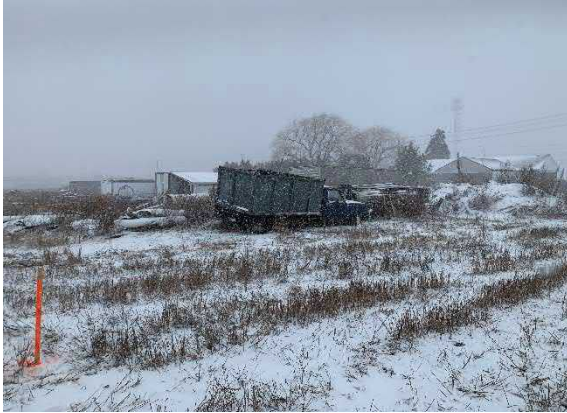
Picture 7: View of east adjacent property (3278 Regional Rd. 25) and several trucks, piping and stock piles on the Phase One Property, facing east.

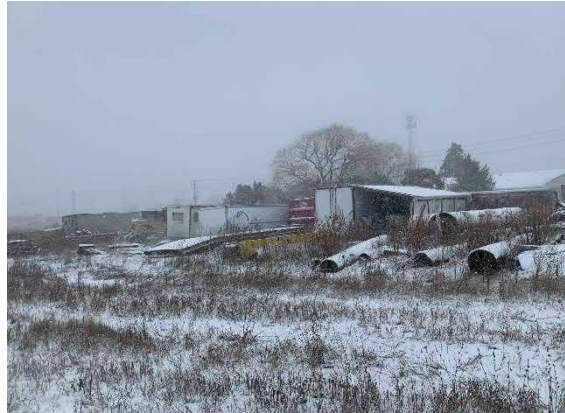
Picture 8: View of various truck trailers, piping, an excavator and refuse located at the east adjacent property (3278 Regional Rd. 25), facing east.

<p>xiv. Potentially contaminating activity</p>	<ul style="list-style-type: none"> ◆ Miscellaneous construction materials (lumber and metal piping), derelict vehicles and refuse were stored along the western side of 3278 Regional Road 25 and extended to west (PCA-9). ◆ Five (5) active ASTs were observed on-Site. Three (3) contained fuel oil and were used for heating purposes (PCA-4, 5 and 23). Two (2) contained diesel fuel and were used for vehicle re-fueling on-Site (PCA-19 and 20). ◆ At the time of the Site Visit, the interior of Site Building A was filled with miscellaneous construction debris (lumber, brick) and general refuse (PCA-13). ◆ A stockpile of construction debris (brick, lumber) and soil was observed to the south of the former extent of Site Building A and west adjacent to Site Building B (PCA-10). ◆ A soil stockpile of unknown origin was located on the Phase One Property adjacent to the property located at 3278 Regional Road 25 (PCA-15).

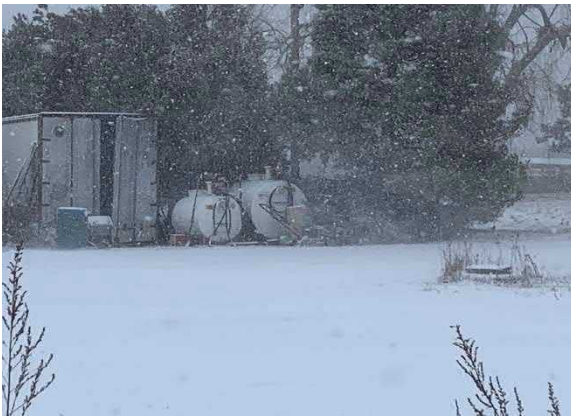
Picture 9: View of two (2) AST at the east adjacent property (3278 Regional Rd. 25), facing north.

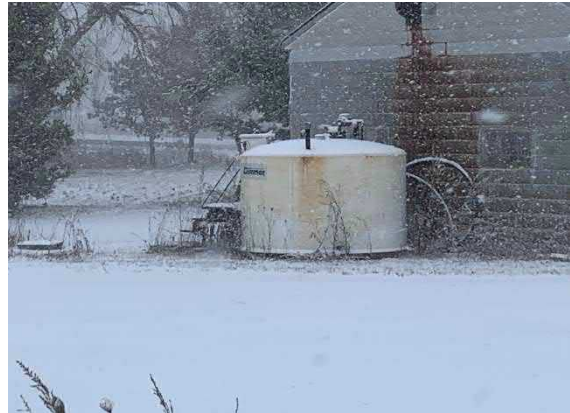
Picture 10: View of one cistern at the east adjacent property (3278 Regional Rd. 25), facing east.

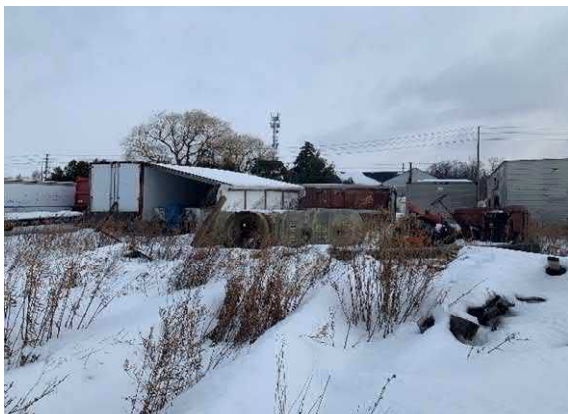
Picture 11: View of propane AST observed at the eastern border of the Phase One Property, adjacent to the property located at 3278 Regional Road 25.

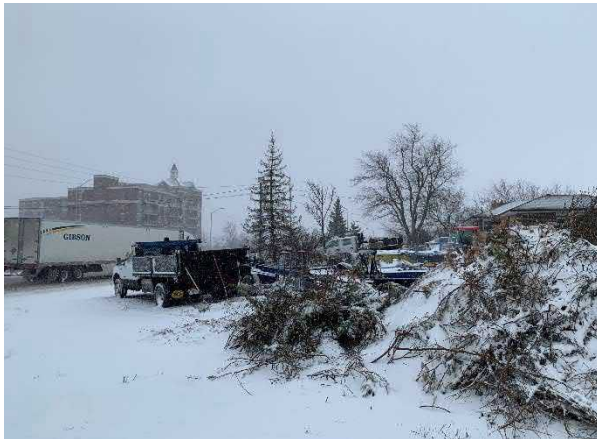
Picture 15: View of west adjacent property (3111 Dundas St. W.) and yard waste at the southwest corner of the Phase One Property, facing west.

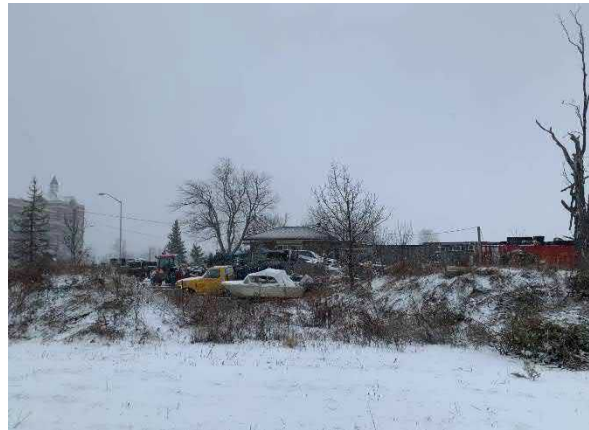
Picture 16: Yard waste, various trucks, and trailers, two (2) parked boats, and miscellaneous rubbish such as dis-used old cars and tires and containers at the southwest corner of the Phase One Property, facing west.

- During the Phase One site inspection, miscellaneous refuse and abandoned vehicles such as various trucks, and trailers, two (2) parked boats, dis-used cars, trailers, tires, shipping containers and smaller containers were observed at the southwest corner of the Phase One Property and on the southwest adjacent parcel with the municipal address of 3111 Dundas Street West **(PCA-11)**.
