4.0 Hydrogeology and Geology

4.1 Introduction

Environmental Implementation Report / Functional Servicing Study for 14 Mile Creek West and the Lazy Pat Farm Property

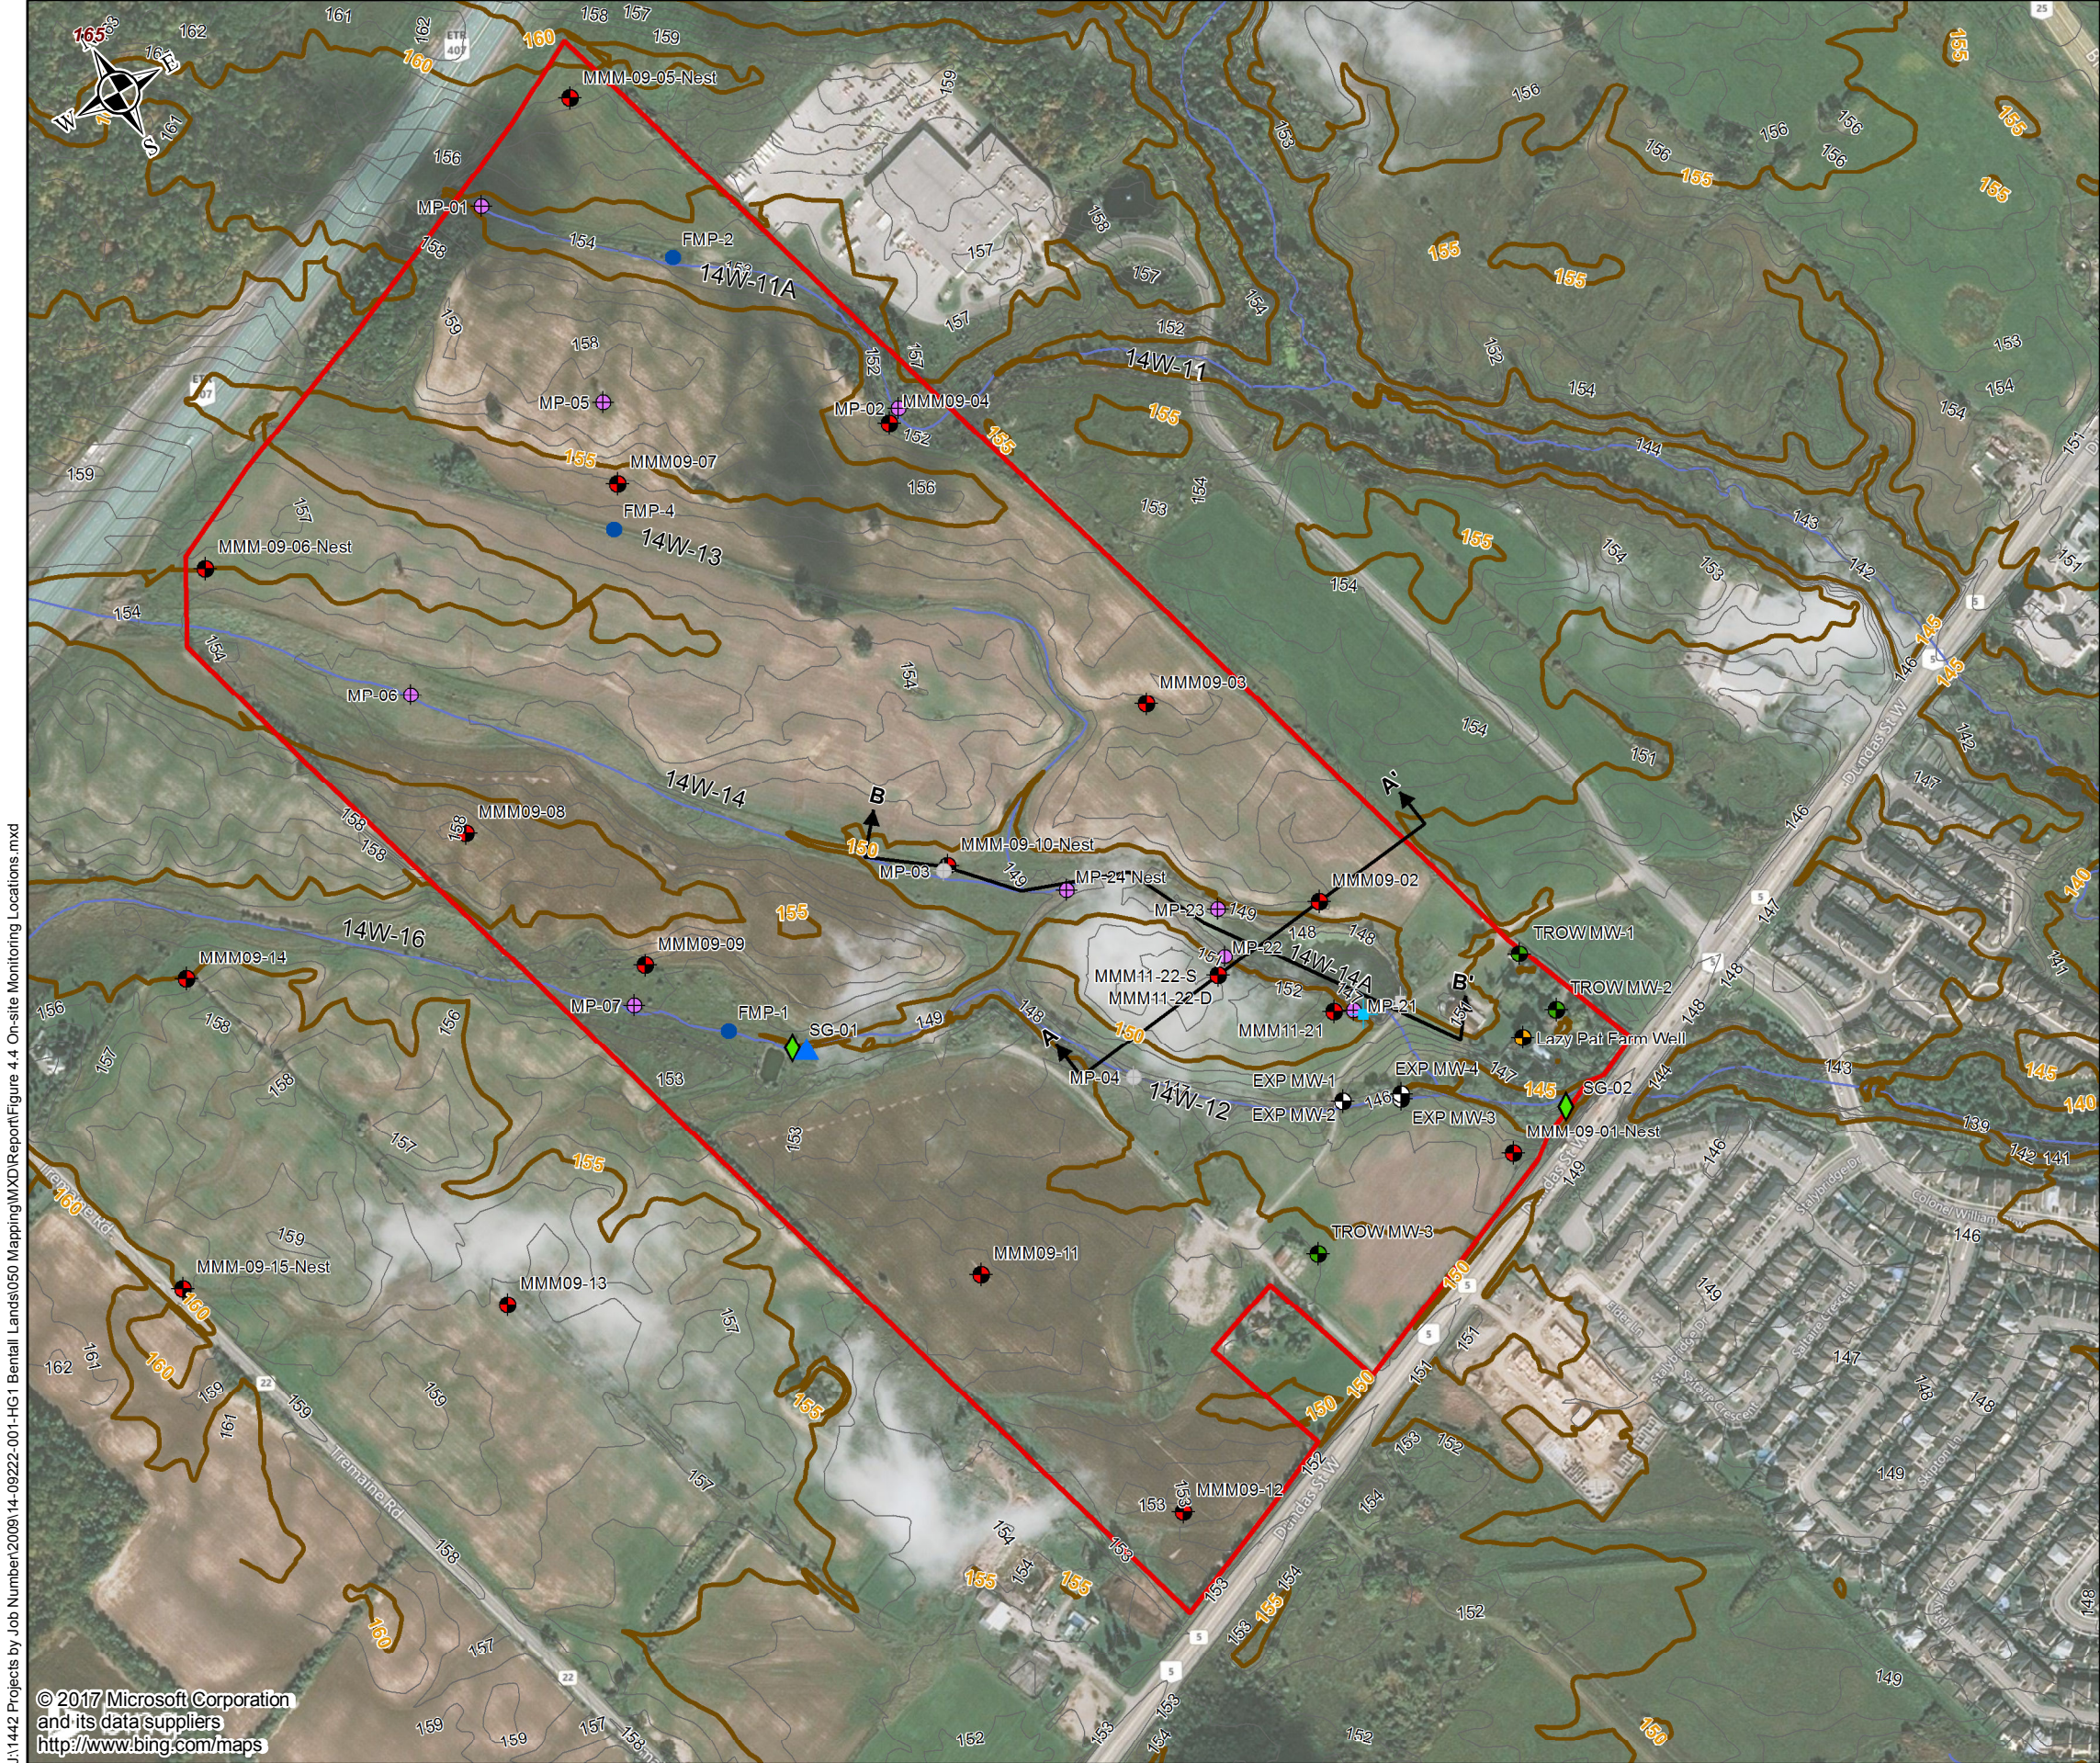
Date	Project No.
May 2019	09M-00013-01
Scale as Shown	Figure: 4.4
© Queen's Printer for Ontario

On-site Monitoring Locations

Groundwater level measurements at the monitoring wells and mini-piezometers have generally been carried out on a quarterly schedule since the installation of the on-site monitors in June 2009. On-site and off-site quarterly monitoring has been typically scheduled to occur roughly during the months of January, April, July and October¹¹. The complete results of groundwater level monitoring at the Subject Property are tabulated on Tables SWL-1 through SWL-2 found in Appendix 4-5. This table also includes water levels from the previously installed Trow monitors MW-1, MW-2 and MW-3, which are included in the WSP monitoring program.

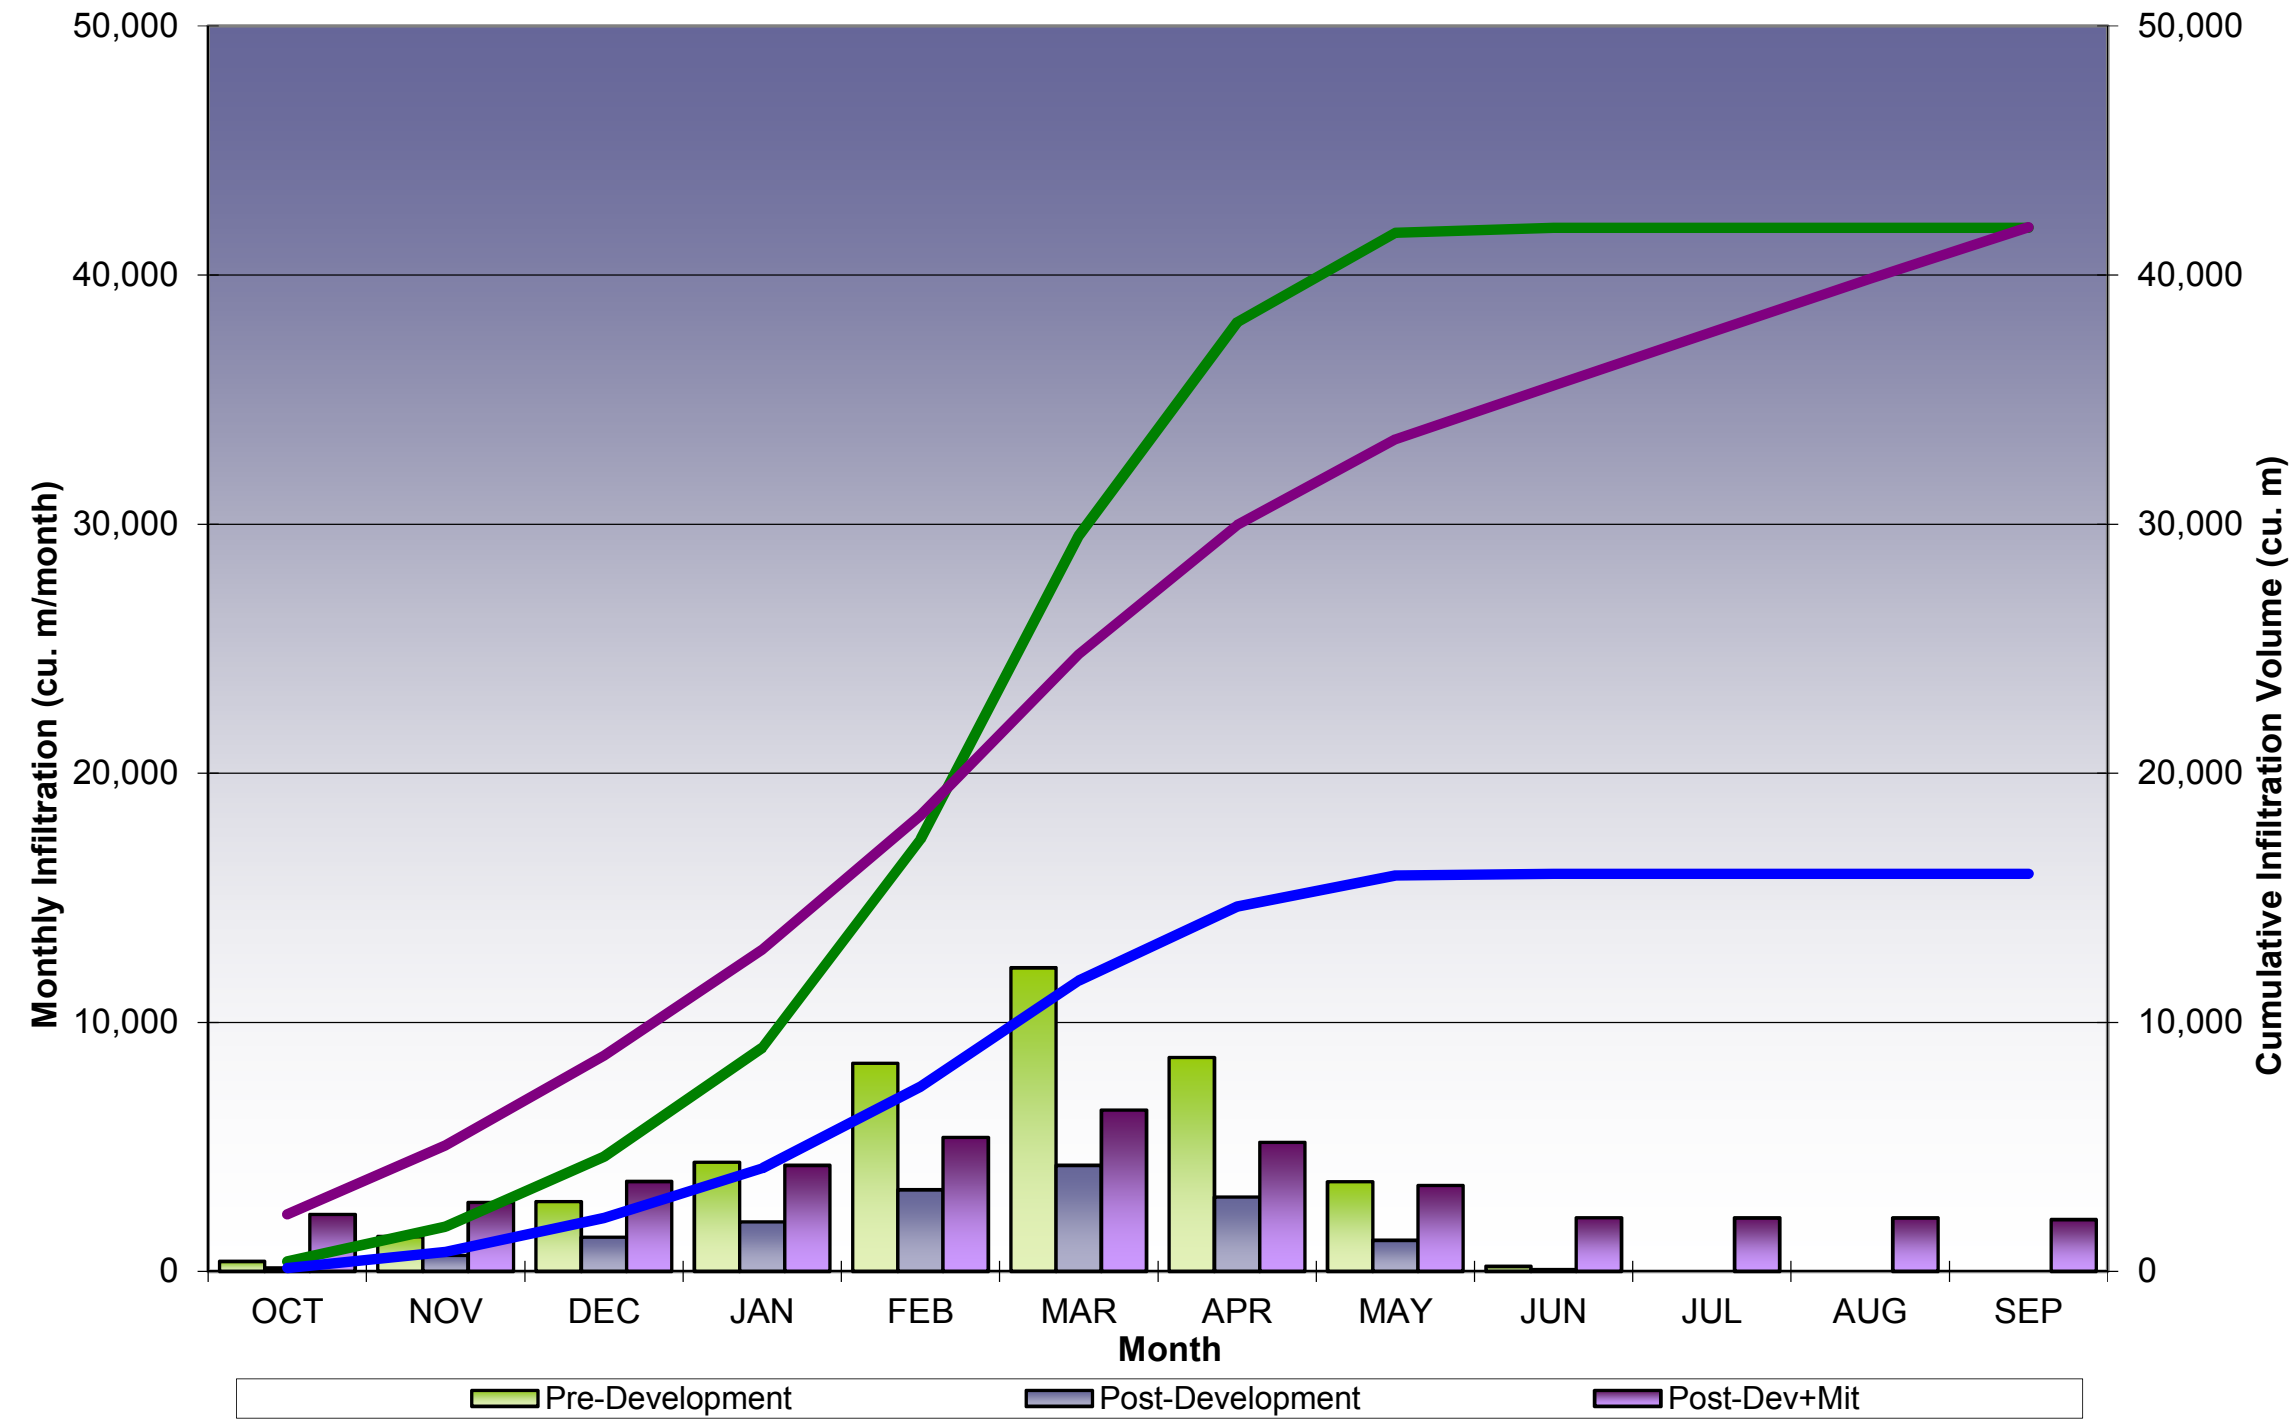
Figure 4.9: Monthly and Cumulative Infiltration - bclMC Lands within FM1001
Pre-Development and Post-Development
