Phase One Environmental Site Assessment

Part of Lot 31 Concession 1 Trafalgar, Parts 3, 5 & 10, 20R16040, Oakville, Ontario

DS Project No: 19-323-100

Date: 2023-05-08

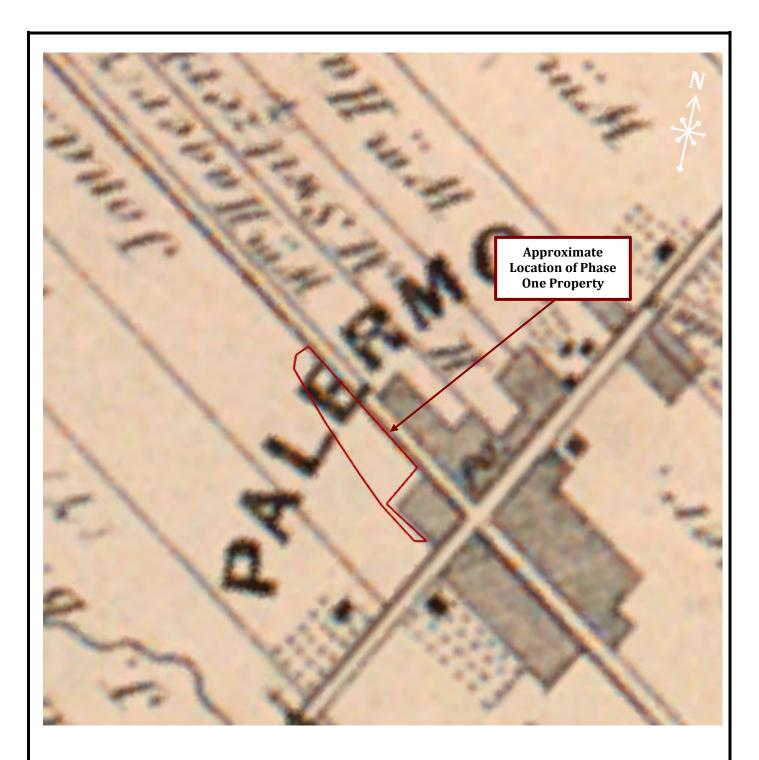
HALTON COUNTY ATLAS: 1877

Location	Observations	PCA ID No.	
	1877		
Phase One Property	According to the Halton County Atlas from 1877, the Phase One Property is owned by Jonathan Hager. The majority of the Property appears to be undeveloped.	No PCA	
North of the Site	The north adjacent properties appear to be undeveloped.	No PCA	
West of the Site	The west adjacent property appears to be undeveloped, and an orchard is observed approximately 180 m west of the Site.	PCA-3	
South of the Site	The south adjacent property appears to have been developed, and an orchard is observed approximately 100 m southwest of the Site.	PCA-4	
East of the Site	Developed parcels of land are visible at the intersection of Old Bronte Road and Dundas Street West, located to the southeast of the Site.	No PCA	
	1934		
Phase One Property	The Property appears to have been used for agricultural purposes.	No PCA	
North of the Site	The north adjacent property appears to be undeveloped and used for agricultural purposes.	No PCA
