## **Appendix H**

**Update to Traffic Operations Analysis/Safety Assessment (2018)**

**To:** Syed Rizvi – Town of Oakville  
**From:** Ravi Bhim and Behzad Rouhieh – Wood  
**Date:** October 2, 2018  
**File:** TPB166147  
**cc:** David Sinke – Wood, Bob Felker - Wood  
**Re:** **Update to Traffic Operations Analysis/Safety Assessment for Lakeshore Road West Improvements Class EA (Final Memorandum)**

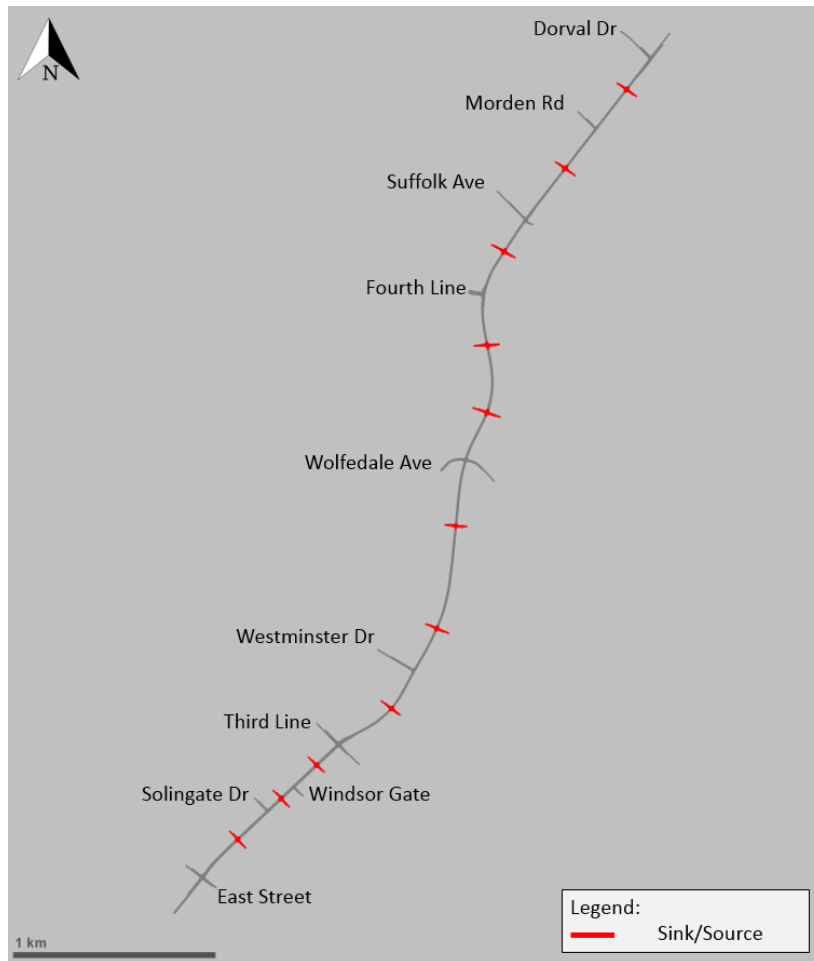
To capture the interaction between the vehicles entering and/or exiting to/from the local streets with through traffic along Lakeshore Road, side streets were aggregated and included as *sinks and sources* between key intersections within the model. The traffic demand for each sink and source location was calculated based on land use in accordance with the Trip Generation Manuals of the Institute of Transportation Engineers, 10<sup>th</sup> Edition (2017). The updated VISSIM model is illustrated in **Figure 1**.

Figure 1: Updated VISSIM model

The May 2017 study had reviewed existing conditions and future needs to year 2021 and year 2031 along the study corridor using VISSIM microsimulation software. For the analysis update, the same models were modified with the inclusion of a TWLTL between East Street and Dorval Drive. Subsequently, the segment between Mississaga Street and East Street was removed from the model.

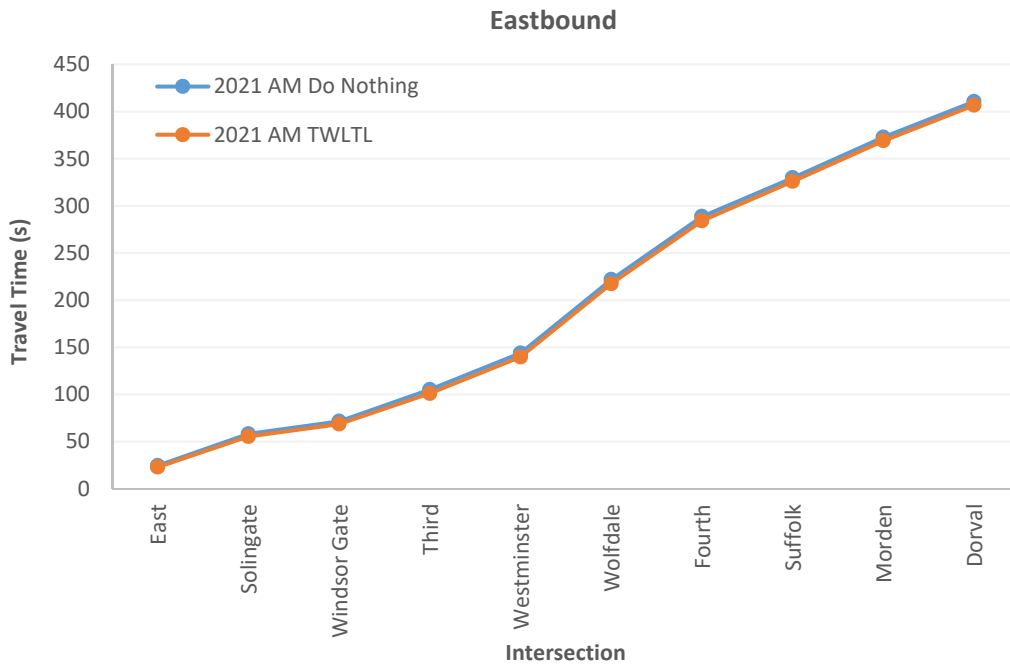
The analysis revealed the impact of the inclusion of a TWLTL on travel times is minimal. A comparison of travel times of the two scenarios are shown in **Figure 2** through **Figure 5**. The travel times are represented based on peak hour and direction.

As shown, the differences in travel times between the do-nothing scenario (existing configuration) and the inclusion of TWLTL are expected to be marginal.

Figure 2: Travel Time Plots - 2021 AM Peak Hour, Eastbound

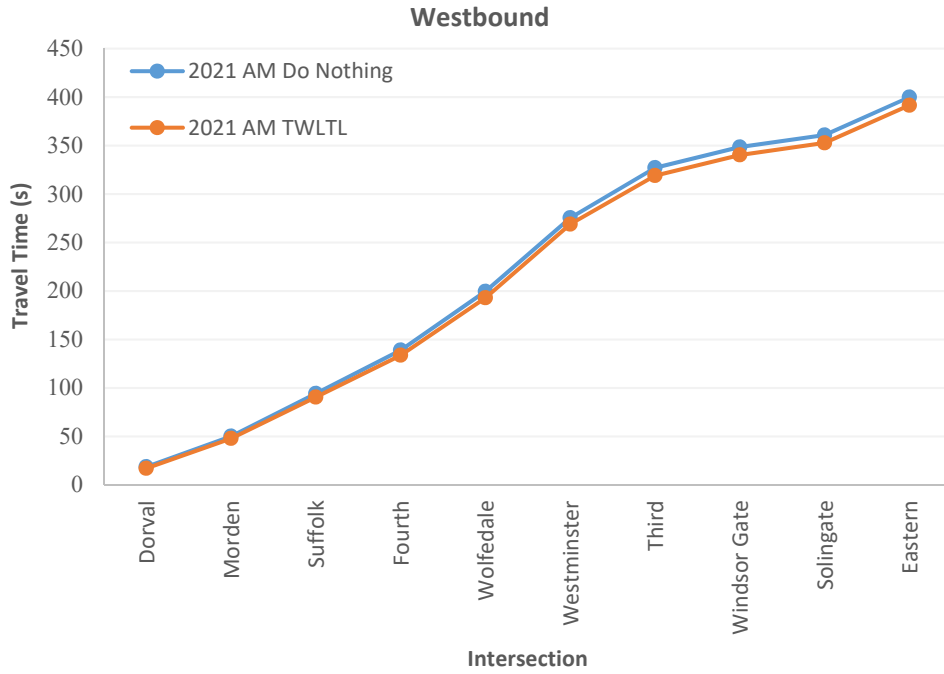
Figure 3: Travel Time Plots - 2021 AM Peak Hour, Westbound

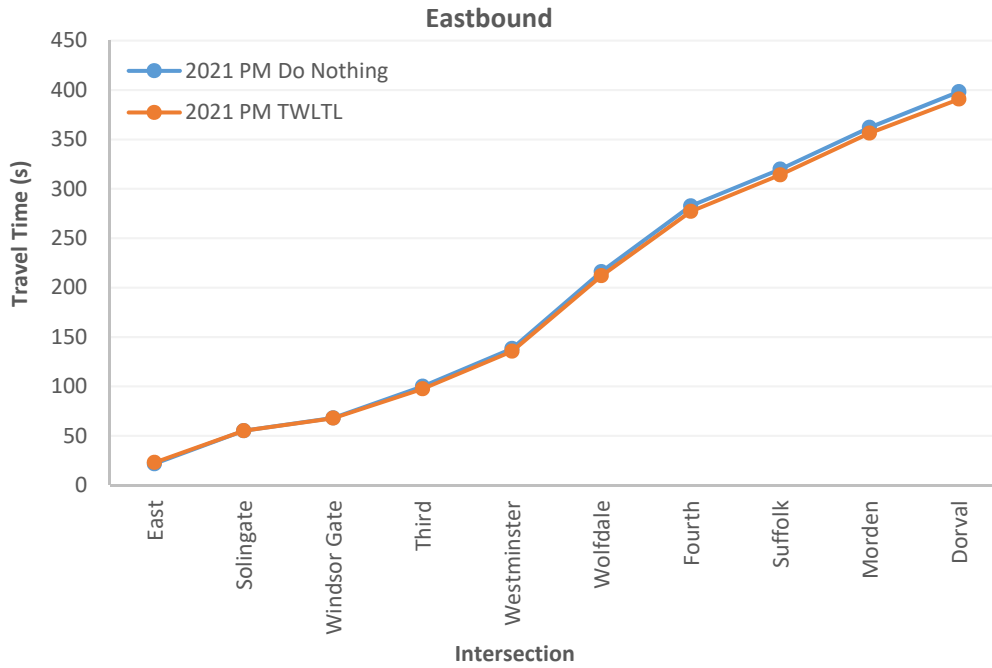
Figure 4: Travel Time Plots - 2021 PM Peak Hour, Eastbound

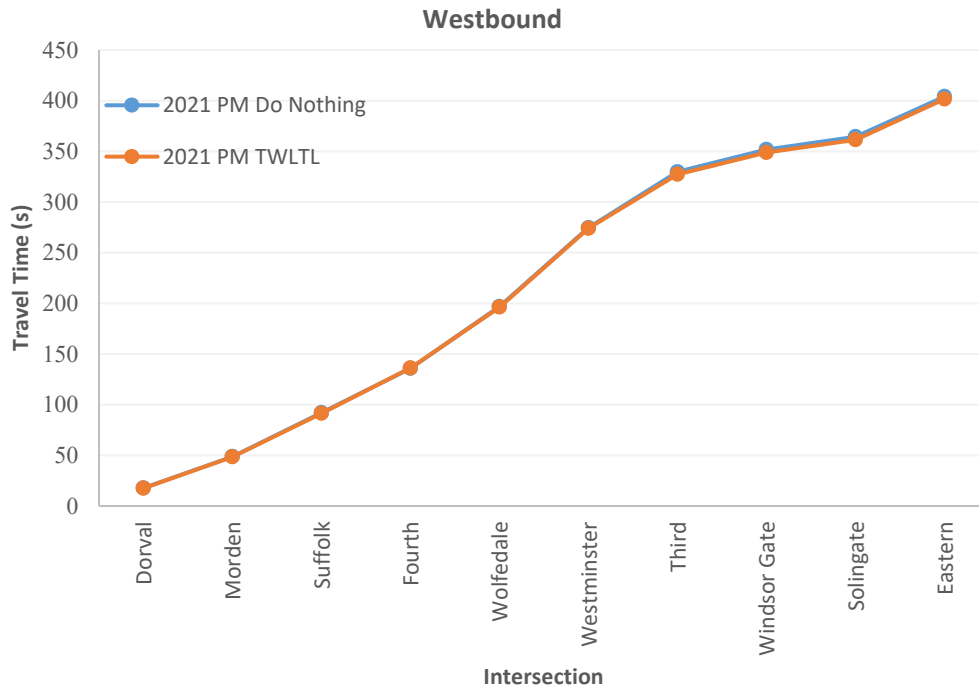
Figure 5: Travel Time Plots - 2021 PM Peak Hour, Westbound

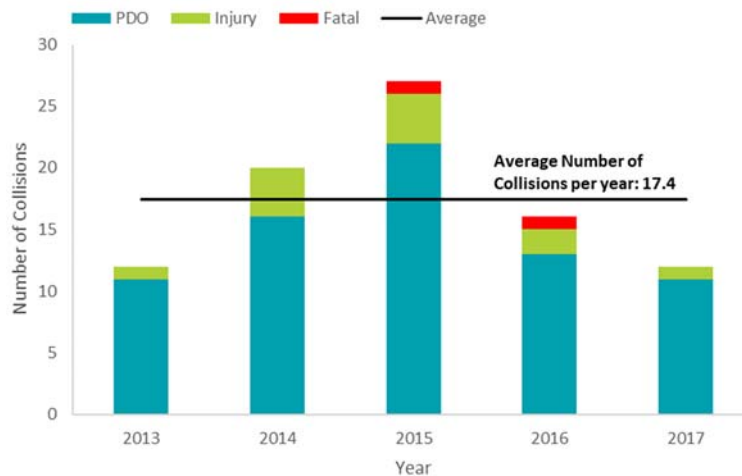
The most recent inclusive collision records from January 1, 2013 to December 31, 2017 were provided by The Town of Oakville, as presented in **Figure 10** and **Table 1**. In total, there are 87 collisions recorded within the study limits that resulted in 73 (or 84%) Property Damage Only (PDO), 12 (or 14%) non-fatal injuries and 2 (or 2%) in fatalities.

Figure 10: Collisions by Severity and Year (2013-2017)

As shown, there is a steady increase in the number of collisions from 2013 to 2015, followed by a decline in the subsequent years. On average, the study corridor experienced, 17.4 collisions annually within the analysis period as noted in **Figure 10**.

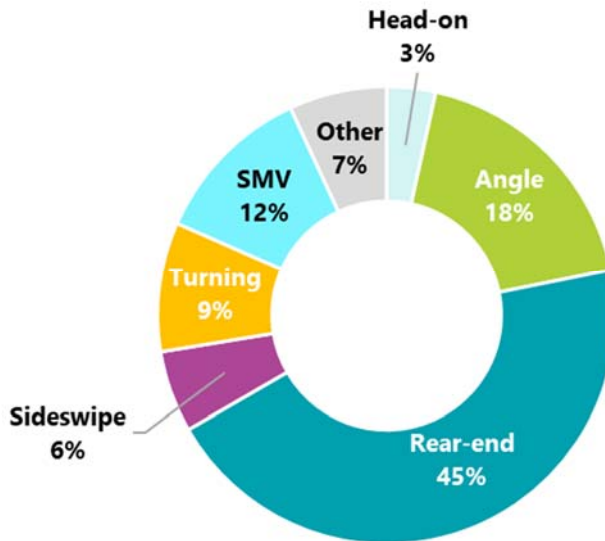
The collisions by impact type are presented in **Figure 11** and **Table 3**. The predominate impact type is rear-end collision (45% or 39 out of 87) followed by angle (18% or 16 out of 87) and single-motor-vehicle (SMV) collisions (12% or 10 out of 87). Due to limited resolution in the collision dataset, the team was not able to summarize the driver behaviours associated with these collisions. There is a higher likelihood for rear-end, angle and turning collisions to be attributable to vehicles making turning movements to access adjacent properties due to abrupt braking or insufficient traffic gaps.

Figure 11: Collisions by Impact Types

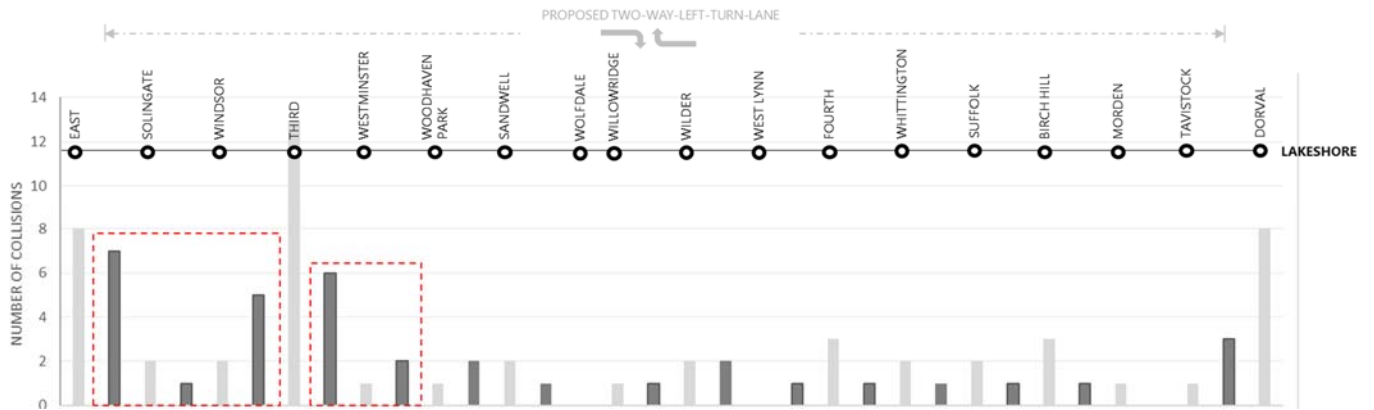
Collisions were further analyzed to understand the spatial relationships of the occurrences and impact types. As shown in **Figure 12**, Third Line intersection experienced the highest number of collisions (13) followed by East Street and Dorval Drive intersections. Segments that exhibited relatively higher number of collisions are between East Street and Woodhaven Park Drive with the highest occurrence of 7 collisions in the five-year analysis period (approximately 1.4 collision on average over the five-year analysis period).

Figure 12: Total Collisions Plot by Location

A more detailed analysis on collision locations was undertaken to understand whether the collisions are susceptible to the density of driveway accesses within the study limits. As summarized in **Table 4**, of the 87 incidents, approximately 40% (or 35 out of 87) are non-intersection related. These collisions occurred in mid-blocks, at/near private driveway or at underpass or tunnel, as summarized in **Table 4** and illustrated in **Figure 12**.

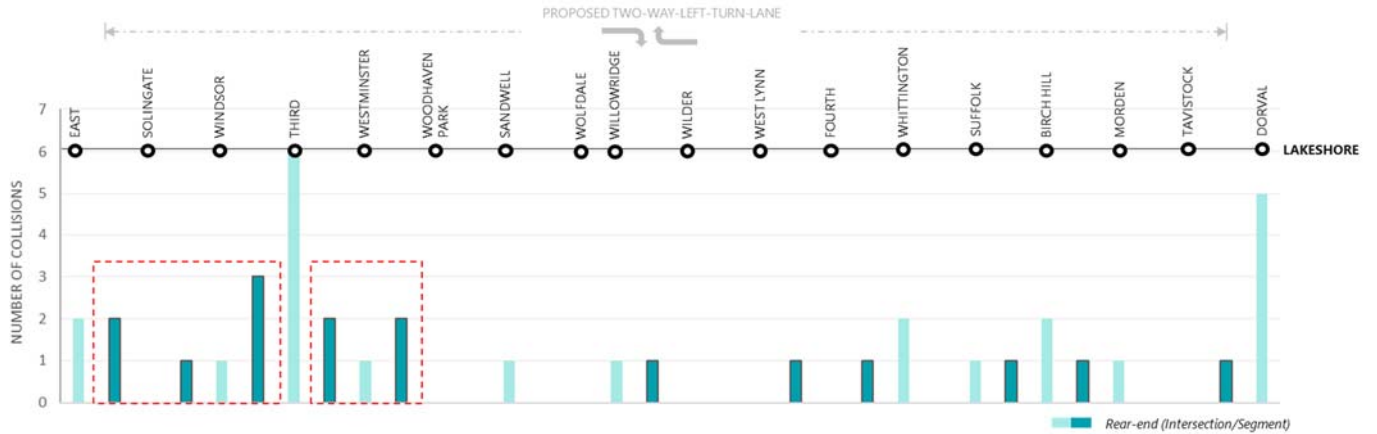
Rear-end collisions were isolated from the dataset and plotted along the corridor as shown in **Figure 13**. Segments between East Street and Woodhaven Park Drive exhibited higher number of rear-end collisions

compared to other locations along the Lakeshore corridor. Overall, historical collision data does not show an overrepresentation of rear-end collision along mid-block segments.

Figure 13: Rear-end Collisions by Locations

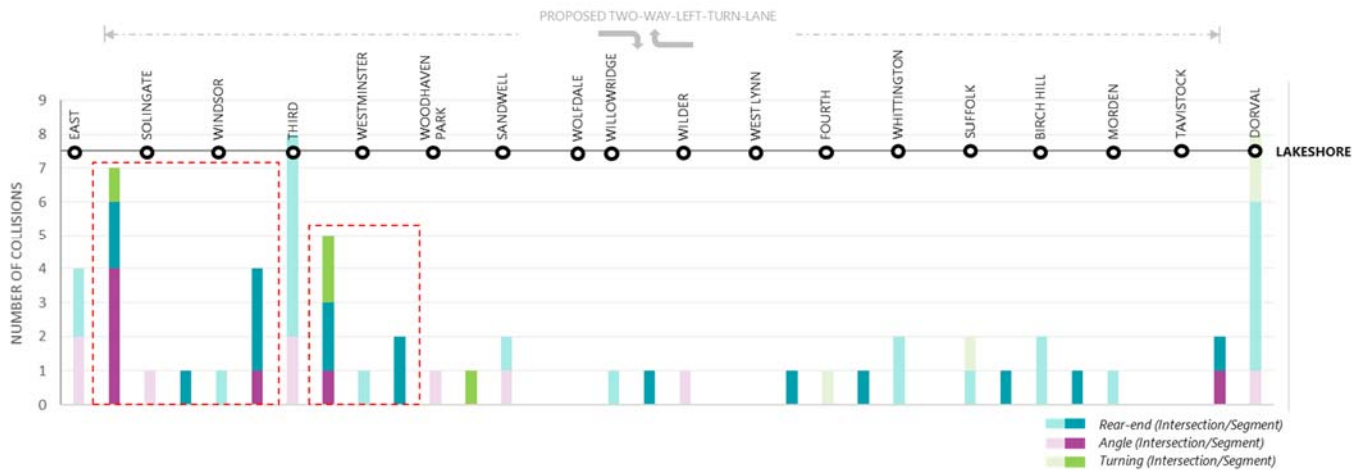
Moreover, access-related collisions (rear-end, angle and turning) were further examined as illustrated in **Figure 14**. Depicting similar patterns as rear-end collisions in **Figure 13**, segments between East Street and Woodhaven Park Drive exhibited relatively higher number of potential access-related collisions along the Lakeshore corridor. Overall, historical collision data does not show an overrepresentation of segment-related collisions.

Figure 14: Potential Access-Related Collisions

From the safety perspective, only segments between East Street and WoodHaven Park will likely benefit from a reduction in access-related collisions.

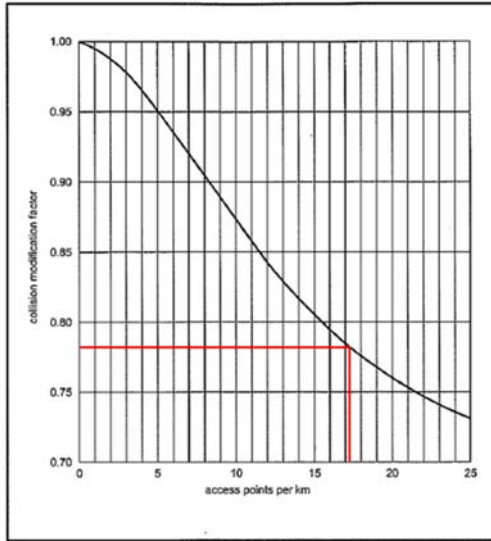
Figure 15: Collision Modification Factor vs. Access points per km for TWLTLs (source: TAC Guidelines 2017, Chapter 8, Figure 8.6.2)

According to TAC guidelines, the safety benefit for adding a TWLTL on the study corridor is estimated to be 23% potential reduction in collisions, predominantly in reducing the potential of conflicts involving left-turn maneuvers. This was derived based on CMF calculation as set out in TAC manual Chapter 8 (Access) Section 8.6.3.1, presented in **Figure 15**.

The CMF is determined to be 0.77;  $(1 - 0.77 \times 100) = 23\%$  reduction in overall collisions. Note that the number of accesses within the study limits were estimated during our desktop review using Google Streetview.

Based on industry standards and directives such as Transportation Association of Canada (TAC) guidelines, benefits can be realized with a TWLTL due to the frequency of accesses and by removing turning traffic from the through lanes. The addition of a TWLTL will also reduce overall corridor travel times by eliminating frequent stoppage for through traffic behind left turning vehicles. This improvement is typically implemented to improve traffic safety and capacity.

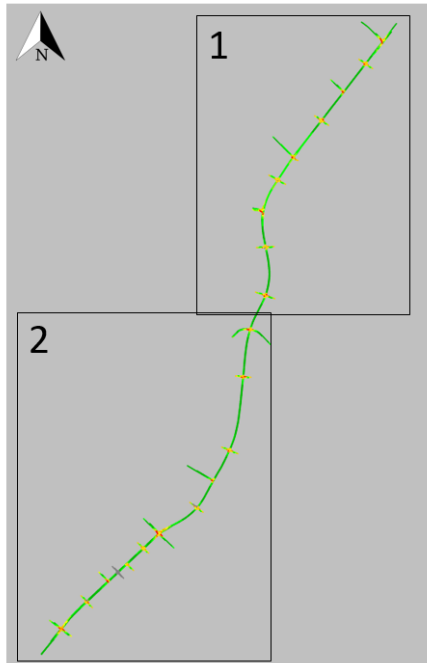
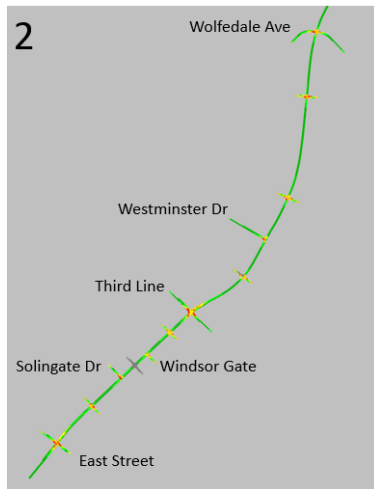
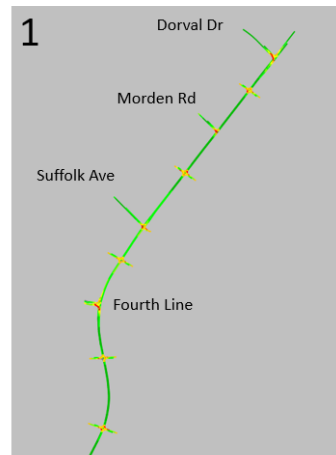
2021 PM – Do Nothing

Speed (km)		
0	10	Red
10	20	Orange
20	30	Yellow
30	40	Light Green
40	50	Green
50	60	Dark Green

The speed contour plots provided in **Appendix A** show speed reduction near intersections as expected. Similar speed reductions can be observed near the sink and source links (representing driveway accesses). Comparing the speed plots between existing and after the implementation of a TWLTL shows minimal improvement due to the inclusion of a TWLTL.

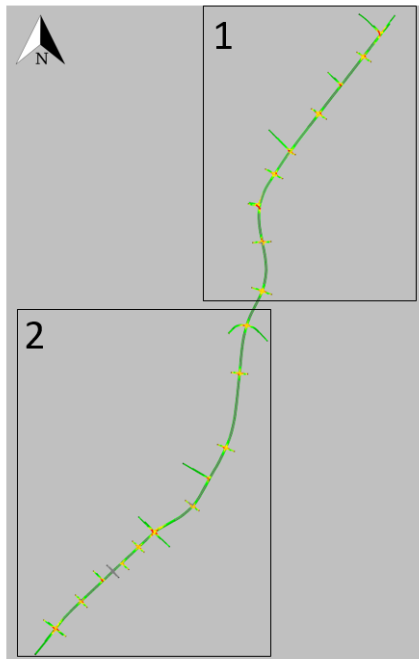
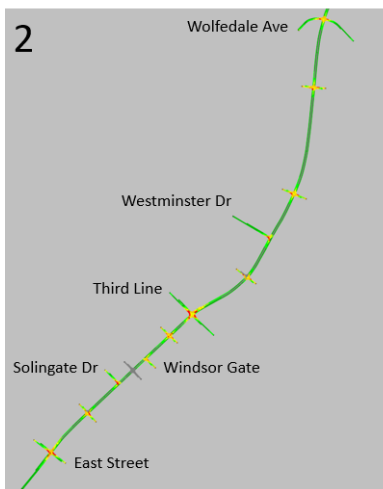
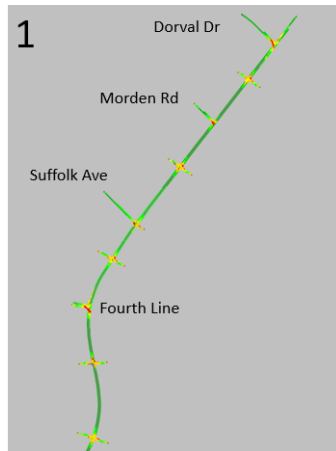
2021 PM – Two-Way Left Turn Lane (TWLTL)

Speed (km)		
0	10	Red
10	20	Orange
20	30	Yellow
30	40	Light Green
40	50	Green
50	60	Dark Green
