OAKVILLE HERITAGE INVENTORY SHEET

Address: 21 Dunn Street

Address: 30 Dunn Street

Address: 43 Dunn Street

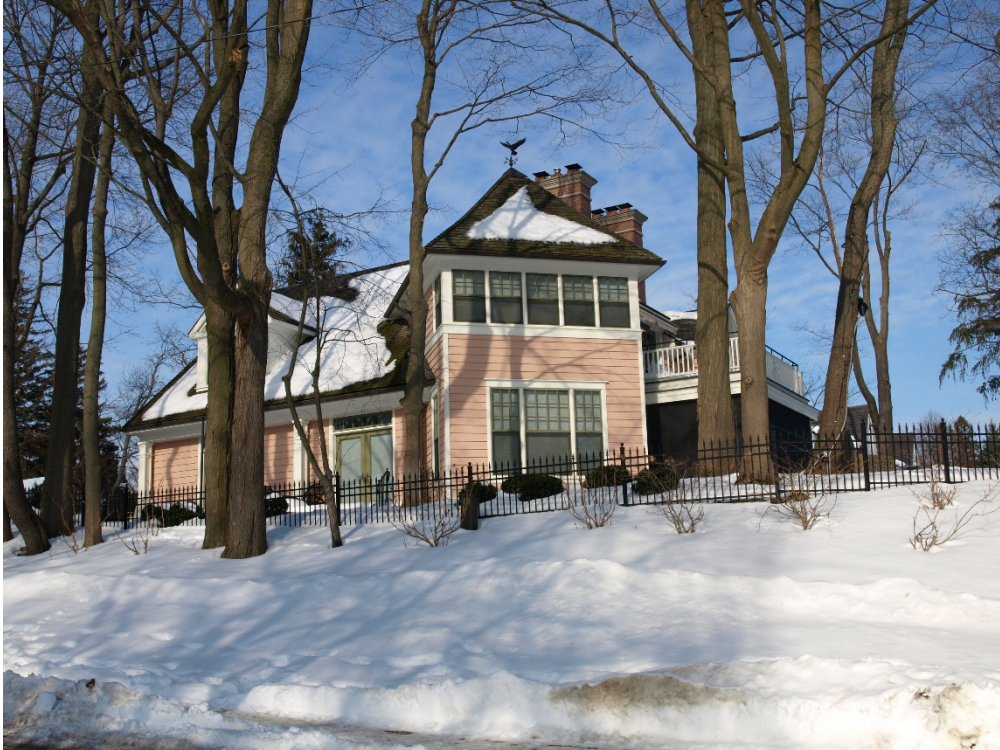
- Style: New Traditional
- Two storey
- Combination roof with hipped and multiple gable roof
- Two triple stack chimneys
- Clad in horizontal wood siding
- Contemporary fenestration
- French door
- Cedar shingle roof

- Wrought iron fencing
- Oakville lakeside trail system runs along lakeside
- Steep hill between house and lake
- Detached one storey garage accessed from Dunn Street
- Mature trees

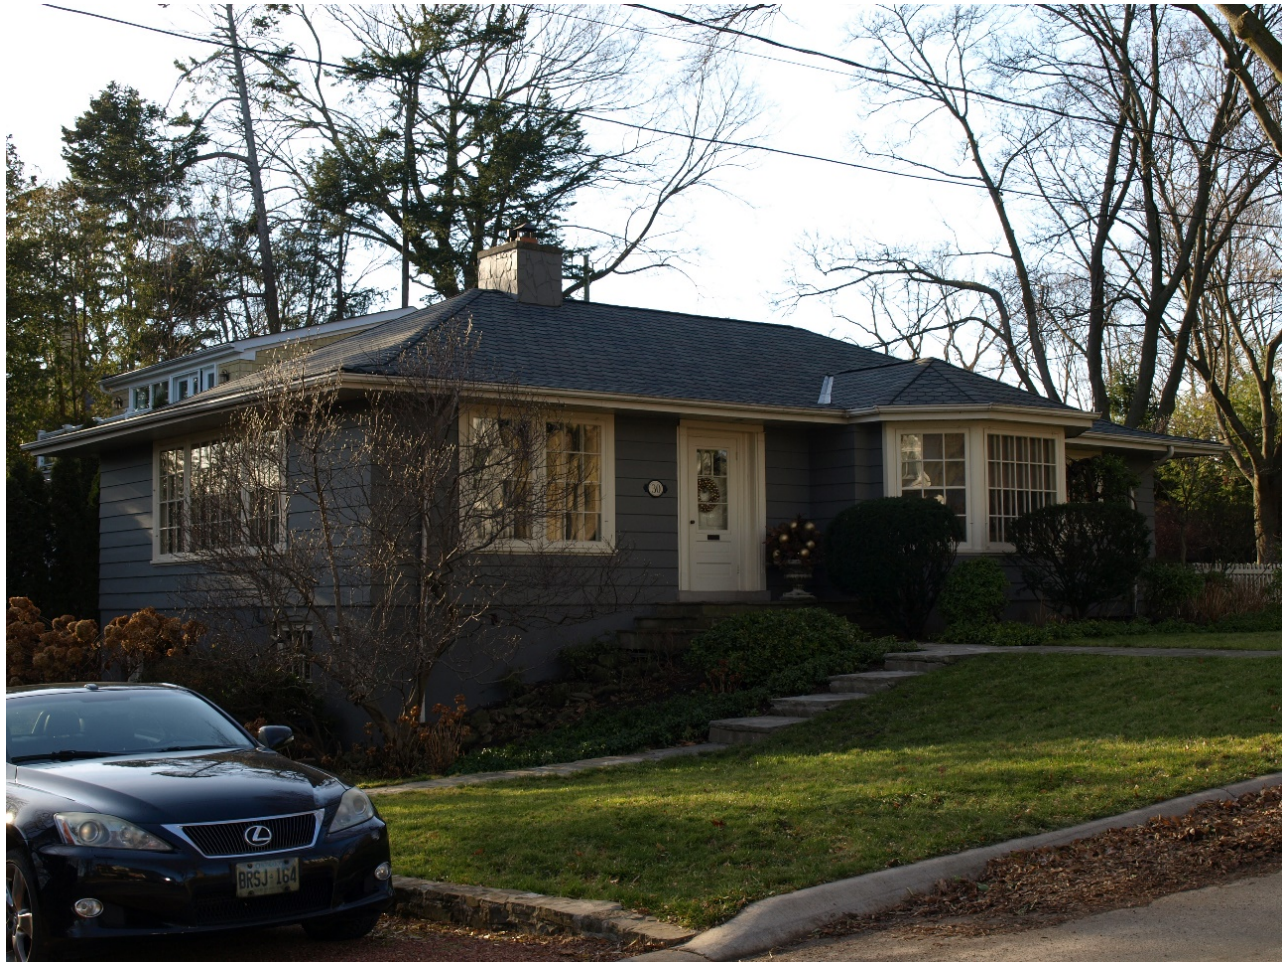
- Style: Mid 20th Century Vernacular
- Craftsman details
- One storey with full walkout basement
- Multi-paned wood windows
- Low hip roof with wide eaves
- Clad in horizontal wood siding
- Stone clad chimney

- Corner lot (King Street and Dunn Street)
- Siting of building on lot allows for views southwest views to Dingle Park and Lake Ontario originating at King Street
- Drastic grade change from top of King Street descending down Dunn Street

- Driveway off Dunn Street into integral garage at basement level
- White picket fence facing King Street
- Sunken patio area along King Street

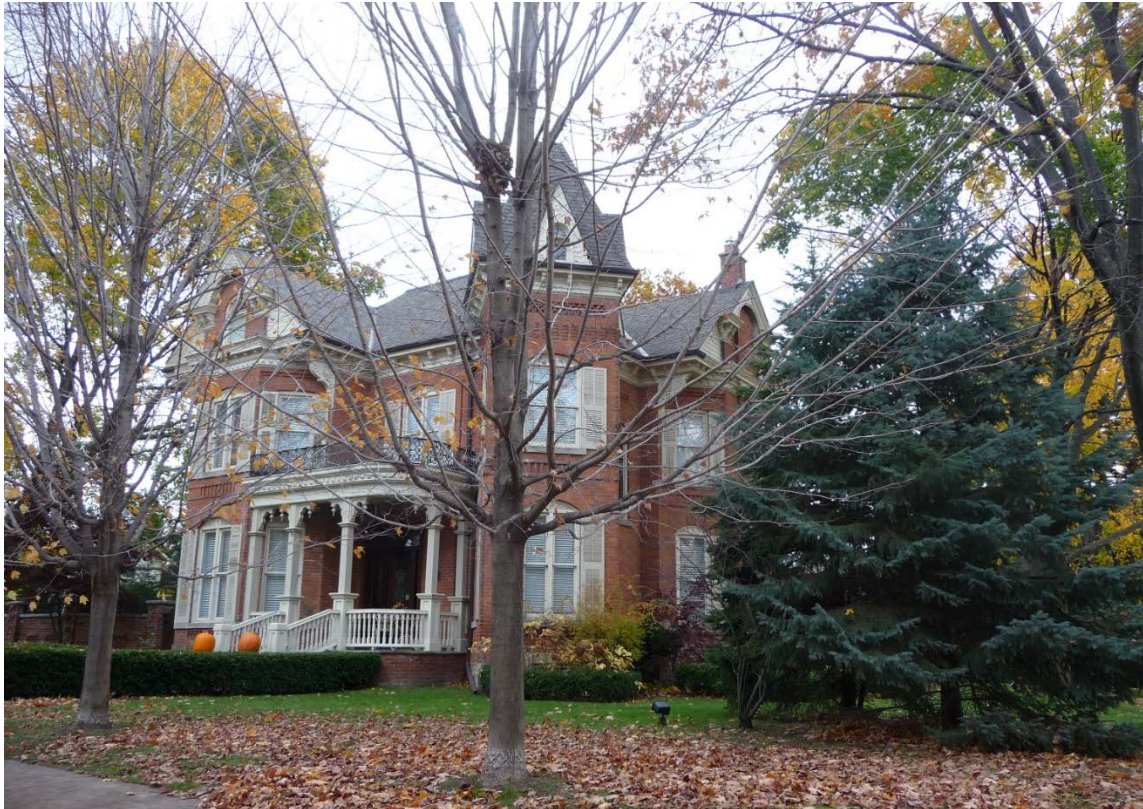
- Style: Italianate
- Two and a half storeys

- Large bays projecting from both westerly and southerly walls crowned with protruding gable, bargeboards and fish-scale shingles
- Steep gable end roof with tower, set at 45 degree angle to main block
- Clad in red brick – common bond brickwork with variety of brick pattern bands
- Ornate eaves, brackets, front porch
- Hipped roof
- Description of curving front veranda with turned spools and spindles
- Stained glass window by J. McCausland & Sons dated 1888
- Glass solarium added to north in 2008

- Corner lot (King Street and Dunn Street)
- Addition with double car garage
- Separate driveway off King Street
- Mature trees
- Garage addition (reminiscent of coach house design) to the east blends with design of historic residence and is ‘attached’ through use of garden wall

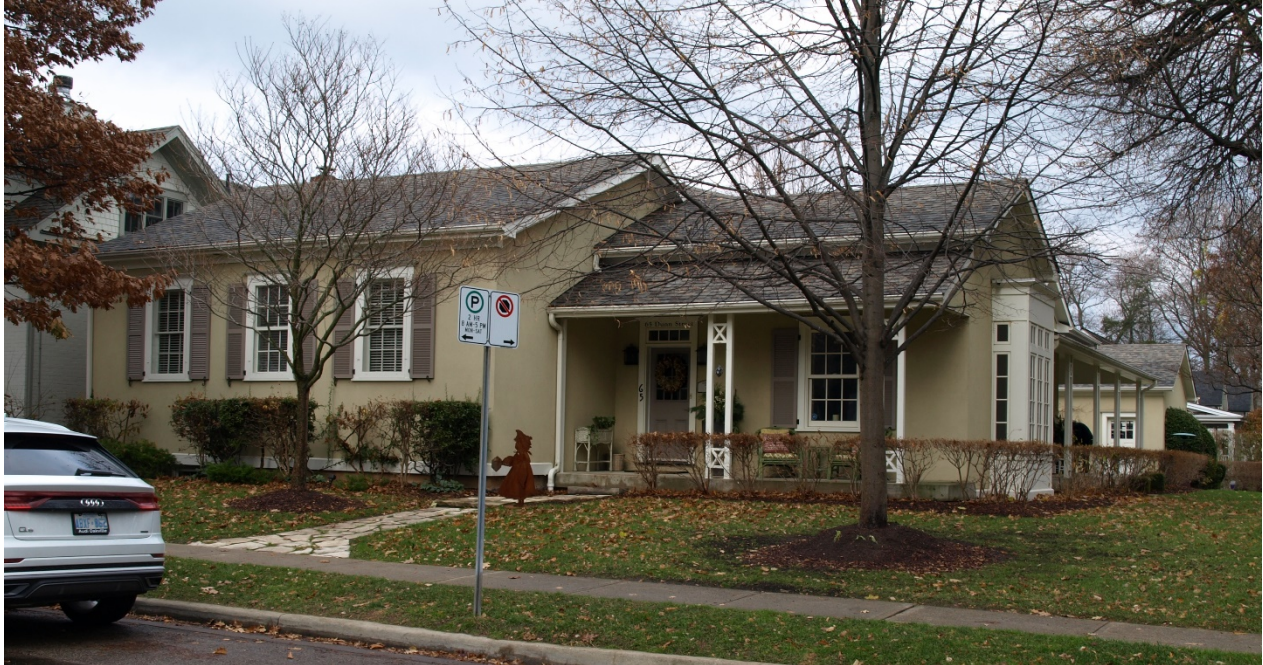
Address: 65 Dunn Street

- Style: 19th Century Vernacular with contemporary additions
- Low pitched side and end gable roofs
- One storey
- Original section, overlooking Dunn Street, was configured as a three bay façade, with the front door centrally located.
- Front entryway has been shifted to the small addition to the south, but it still overlooks Dunn Street.
- Multiple additions have been added to the structure over its history, including two covered porches.

- Variety of windows including: Six over six sash wood windows, some with non-functioning shutters, multi-paned windows in addition; bay windows; round attic window above side porch.
- Stucco cladding

- Corner lot (northeast corner of William Street and Dunn Street)
- Detached double car garage, driveway access and side entrance off William Street
- Mature trees

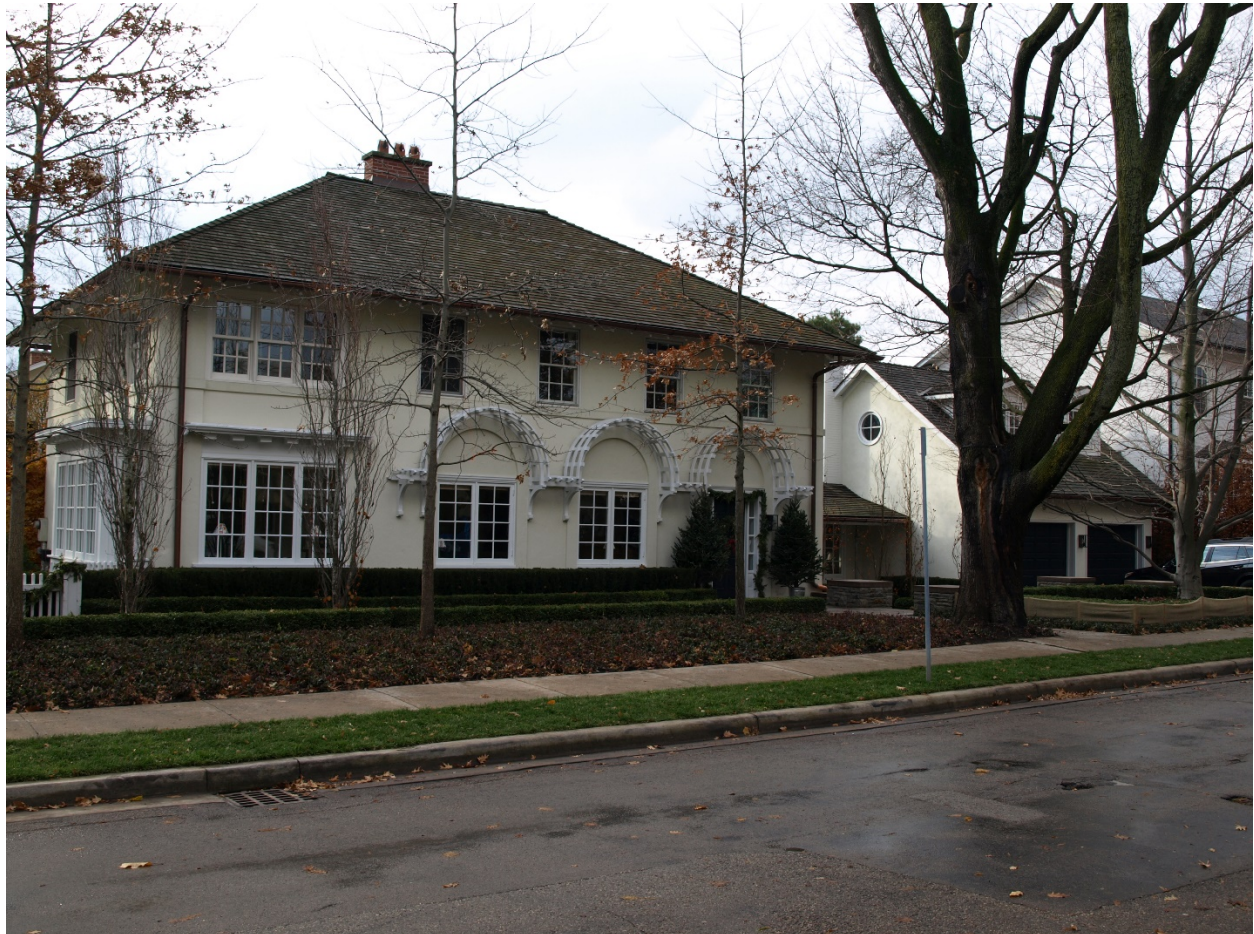
Address: 66 Dunn Street

- Style: Arts & Crafts

- Low hipped roof, cedar shingles, wide overhanging eaves with exposed rafter tails
- Two storeys
- Large structure with an asymmetrical four bay front façade. The predominant feature of the façade are the three arcades, two of which are blind, with the third housing the home's offset entryway. Single panel front door, flanked by sidelights and embellished with a simple surround.

- Between the two storey section and the attached garage is a one storey section with a second entryway, flanked by two large (floor to ceiling) windows, all of which are protected by a small covered porch.

- The south façade includes a square projecting bay window on the east side of the lower floor, with multiple, multi-pane windows.
- The west façade which was an addition in 2016 overlooks the property's garden and includes wall-to-wall windows on the lower level, topped by a wood clad second floor, with a Juliette balcony.

- Round arch with glazing, over large windows/door lies to the north.
- Replacement multi-sash, some double hung, some fixed and some that may be casements.

- Primarily stucco clad with wood shingles cladding west façade
- Large red brick chimney
- Stone garden walls, white picket fence and ornament shrubs that serve as a natural fence.

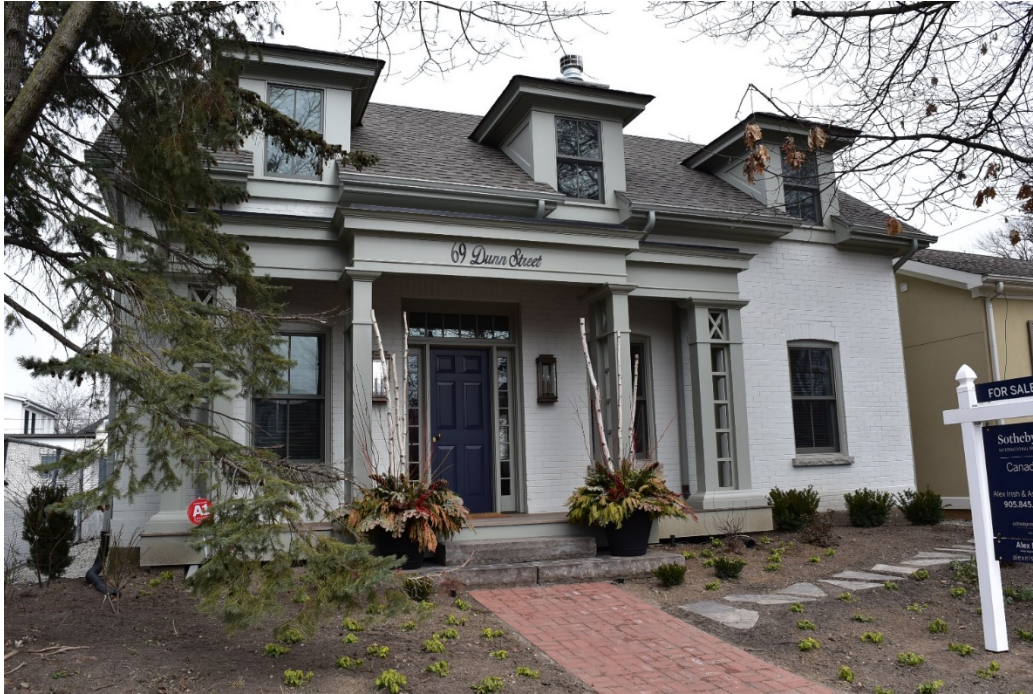
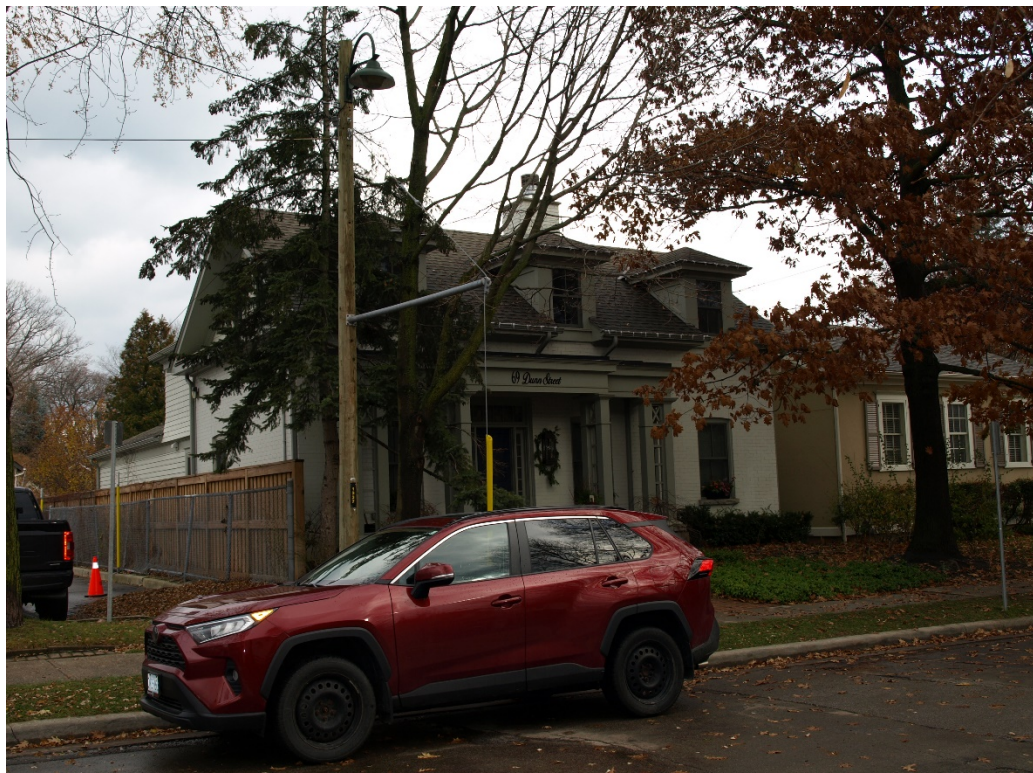
Address: 69 Dunn Street

- Style: 19th Century Vernacular (Cottage)
- One and a half storey
- Side gable roof broken by three hipped dormers
- Four bay façade. Front entryway is offset, and now protected with a recent front porch addition. Single panel front door, with sidelights and transom.
- Three oversized wall, hip dormers.
- Contemporary two-over-two windows
- Frame structure clad in brick, then covered in stucco

- Detached open garage at rear of property
- Driveway off William Street (laneway, flag lot access)

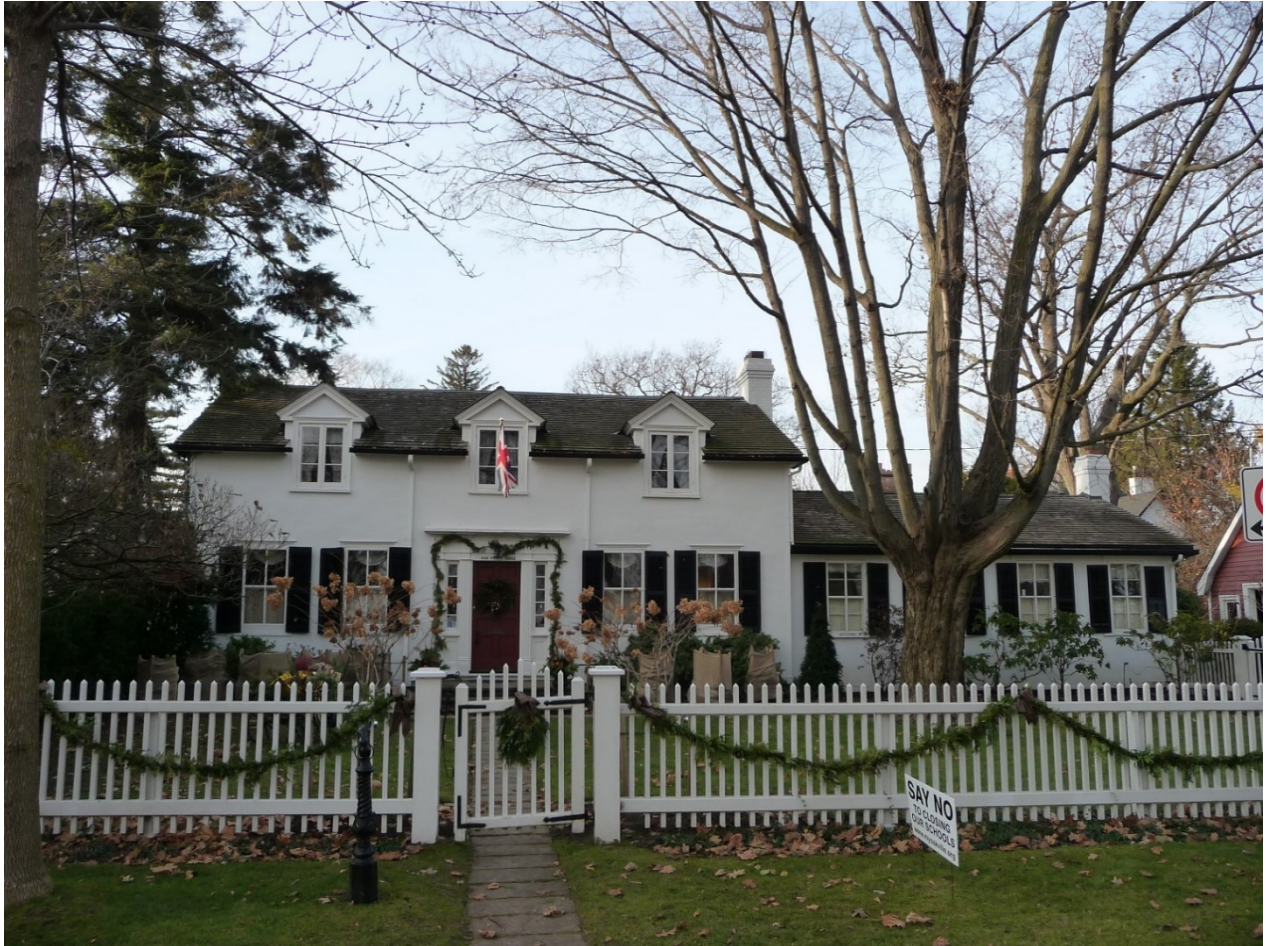
Address: 143 Front Street

- Style: Georgian Revival
- Cross gable roof, with five bay front façade section broken by three gable wall dormers (which were added in 1934), and a rear façade shed dormer window.
- One and one half storey
- Central doorcase entryway, with single eight panel door flanked by sidelights of five panes, and paired pilasters – bold projecting cornice and high frieze
- One storey additions constructed on the east and rear elevations
- Two-over-two, and four-over-four windows with functioning shutters, paired three-pane (or six-pane) casement windows in the gable wall dormers

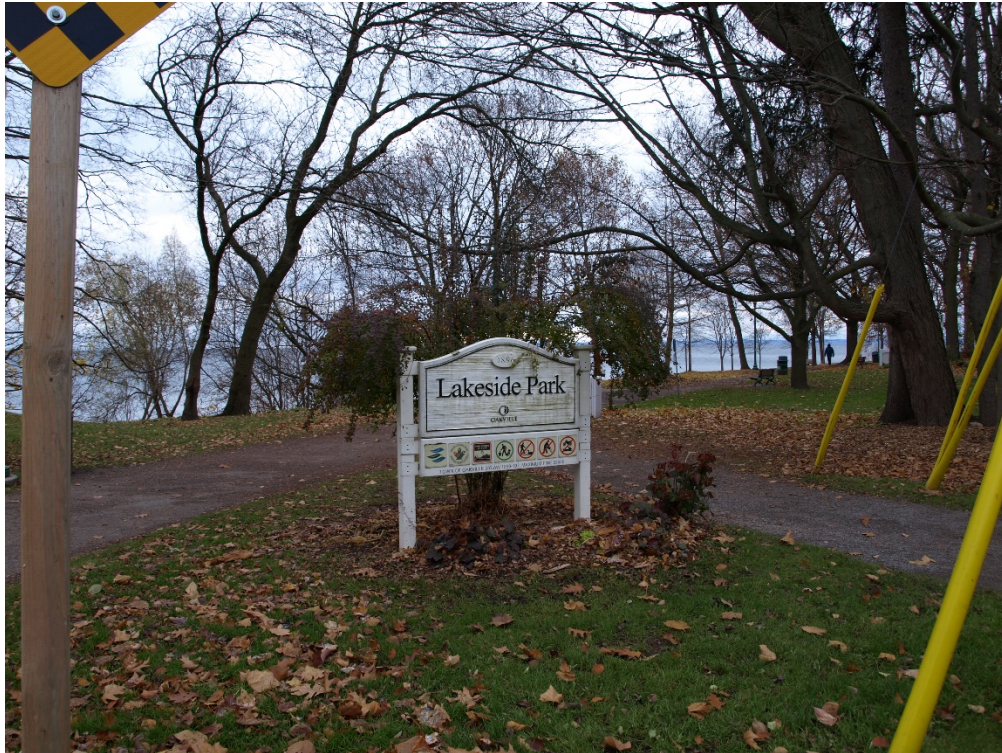
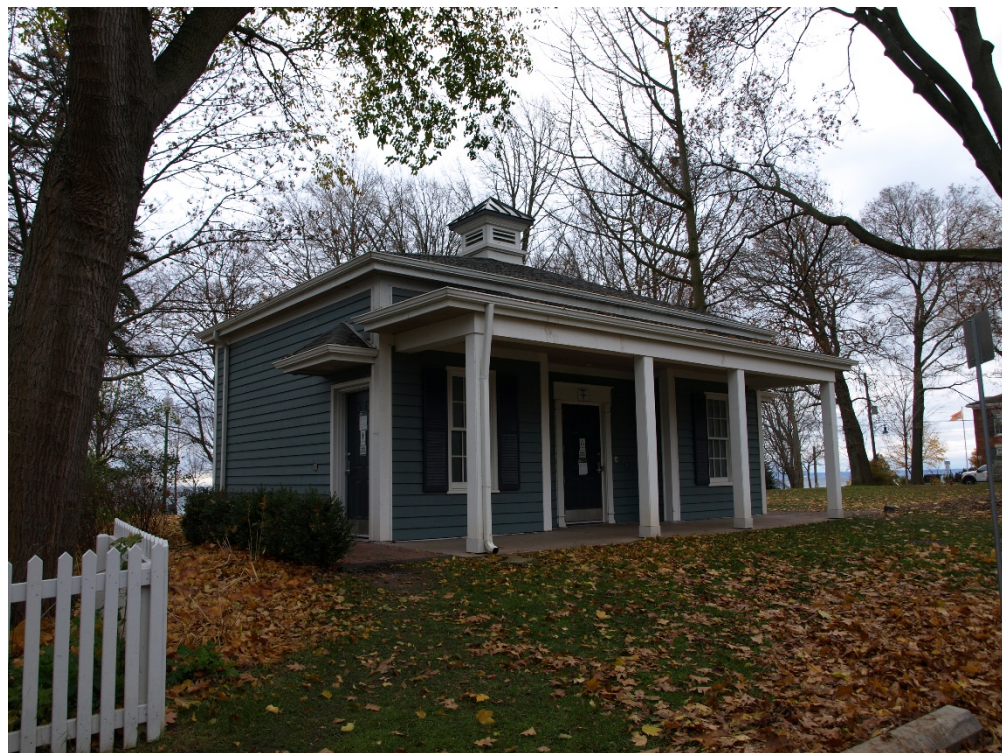
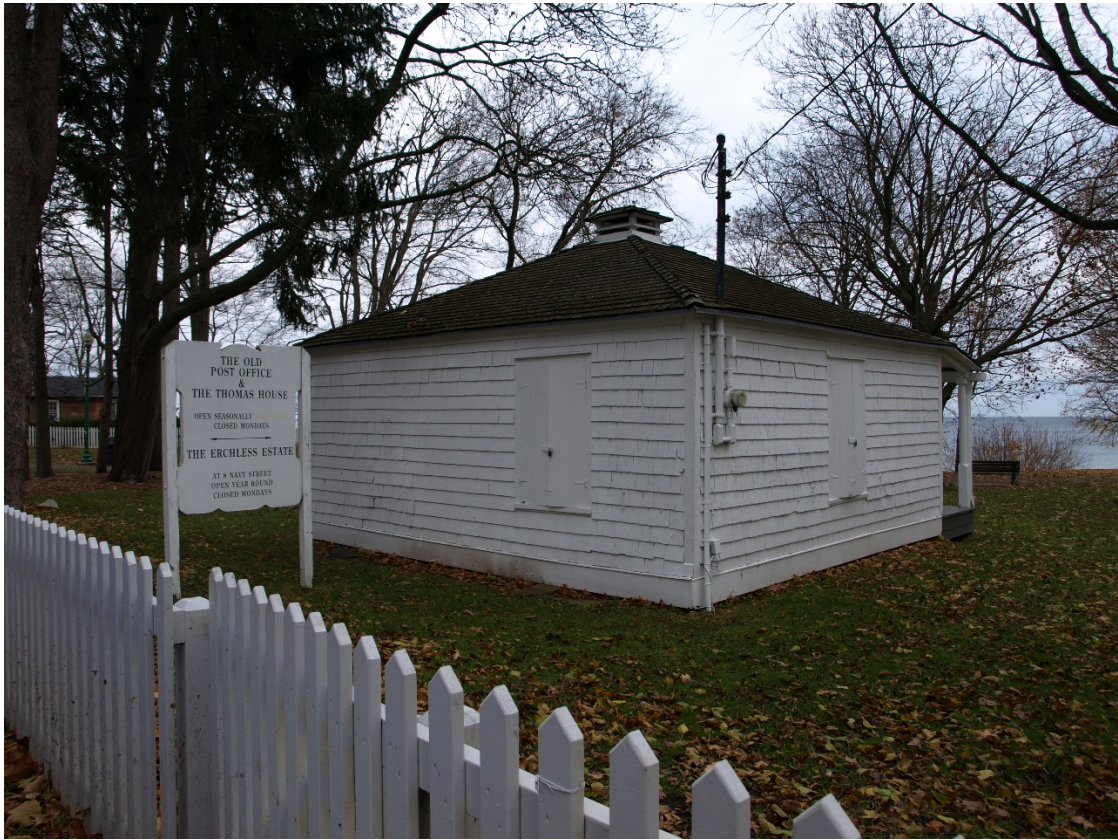
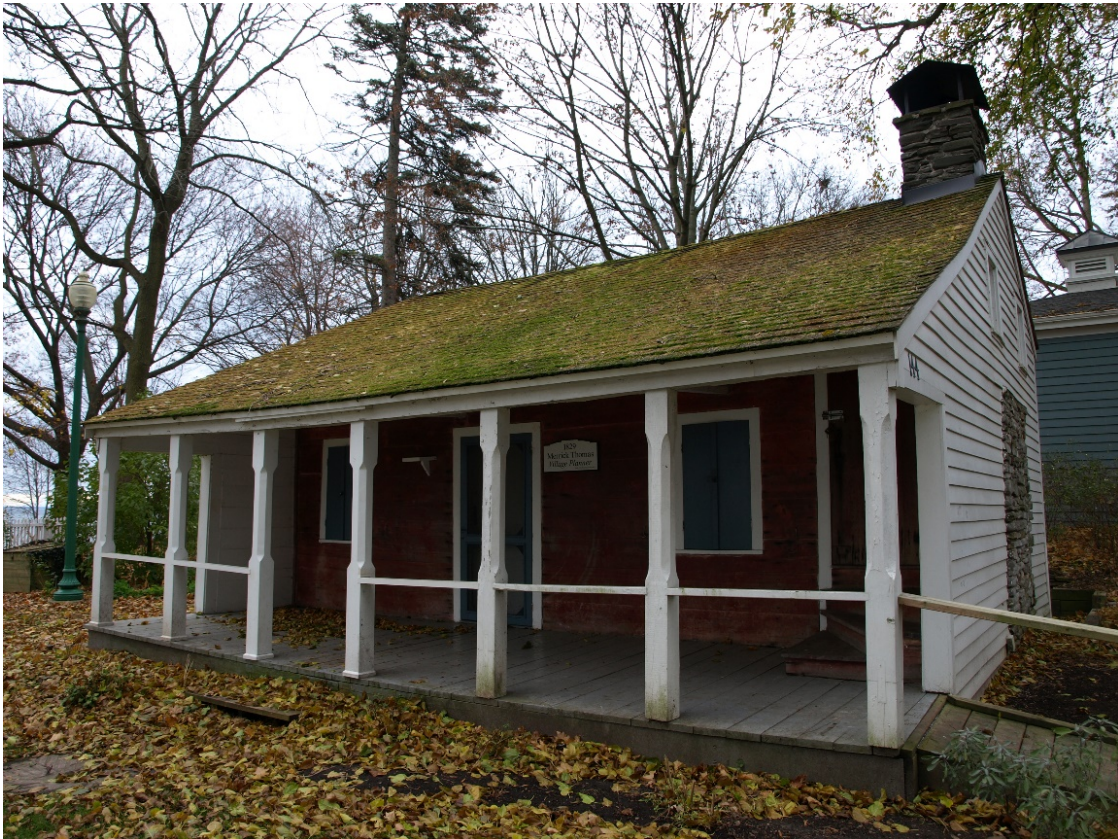
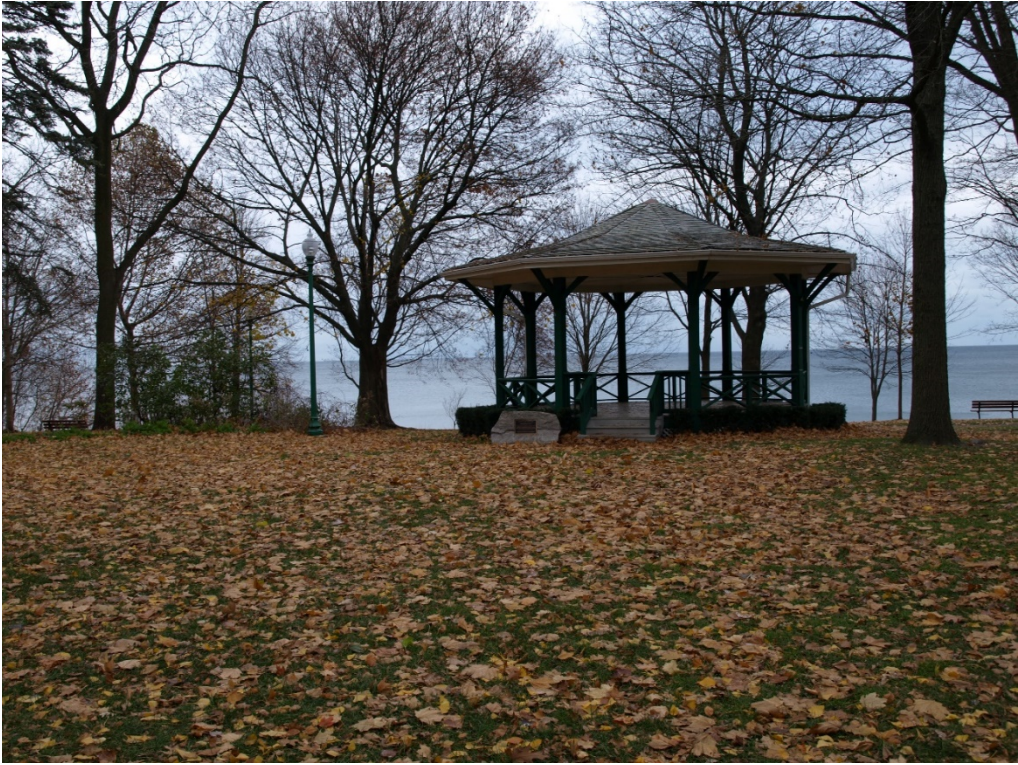
Name: Lakeside Park

- Includes two historic buildings: Post Office and Merrick Thomas House
- Includes contemporary structures: public washrooms, bandstand/gazebo, children's play equipment
- Includes landscape elements: trees, plantings, paths, benches, lamp standards, tables, fencing, commemoration carin/plaque
- Washroom building designed in 'New Traditional' style
- Post office: Hipped roof, cedar roof, one storey, cedar shake siding, simple porch
- Merrick Thomas House: Gable roof, Saltbox style, cedar roof, one and a half storey, clapboard siding

- Post Office: Built as Oakville's first post office. Was originally a 2- storey structure. Moved from Lakeshore Road East and Navy Street to Lakeside Park in 1950. A one storey wood frame building which typically replaced a crude log cabin. The building contains a small ventilator on the roof. Stone foundation comprised of large square timbers and iron spikes and bolts.

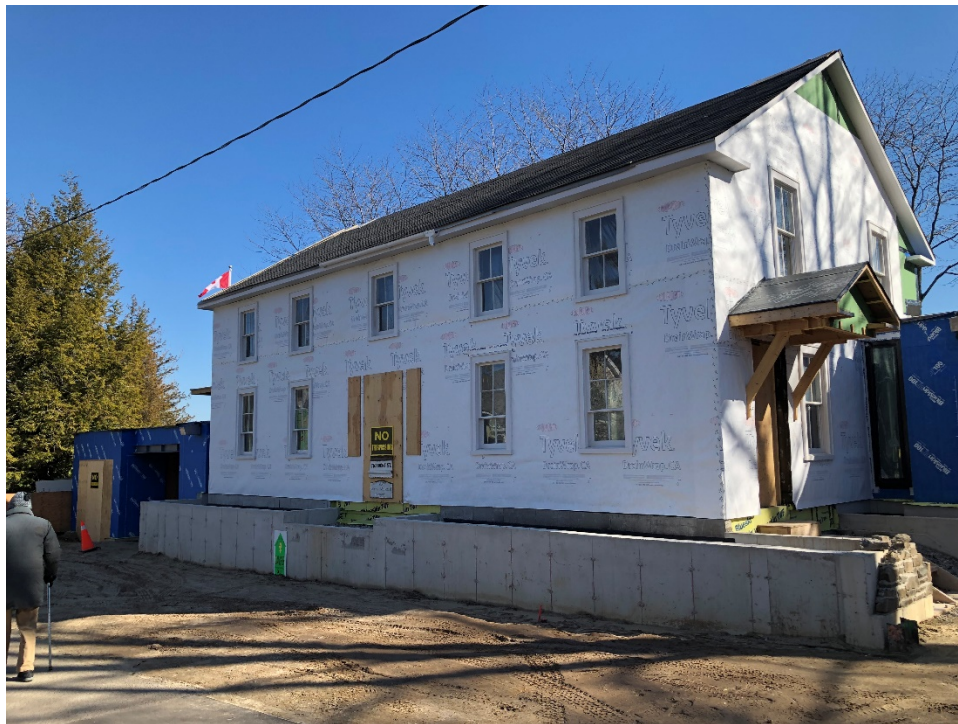
Name: James McDonald House

- Style: Georgian Revival
- Side gable roof
- Two storey
- Symmetrical, five bay façade, with centrally located front entryway. Single panel front door, with sidelights, all framed by a decorative surround. Frame structure. One storey addition demolished in 2021.
- New contemporary addition(s) approved by heritage permit and under construction in 2022-2023 including garage with flat roof
- Two-over-two windows on second storey, four-over-two windows on first storey. Shutters on front façade. Some storm windows.
- Stucco cladding

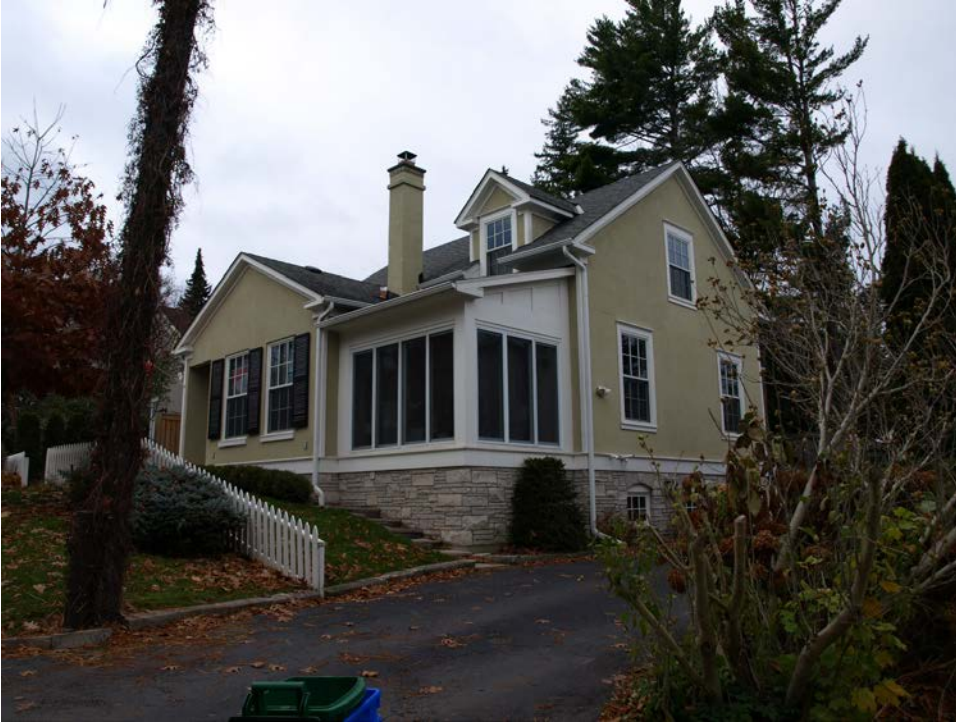
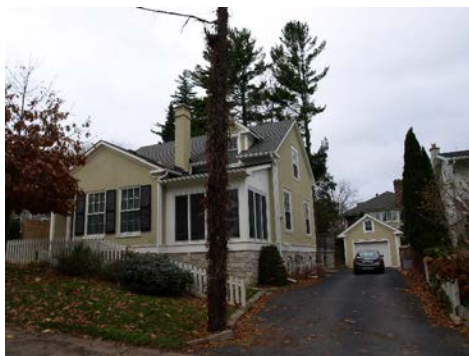
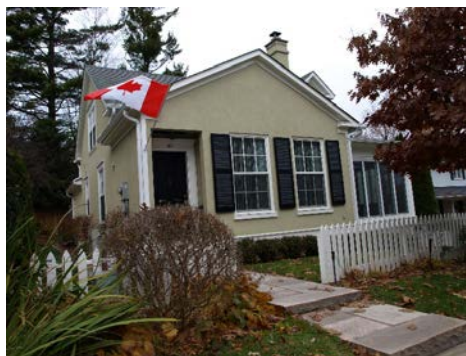
- Style: New Traditional (replica of historic vernacular cottage)
- Cross gable roofs with shed roof on front one-storey section. Front façade includes dormer, capped by a gable roof.
- One-and-a-half storey
- Asymmetrical three bay front façade, with an offset, recessed entryway. Small sunroom/enclosed porch on the east side of the front façade.
- Six over six replacement windows with non-functioning shutters; and six-pane windows topped by segmented stone lintels in basement
- Frame structure clad in stucco with veneer stone clad foundation
- Masonry chimney

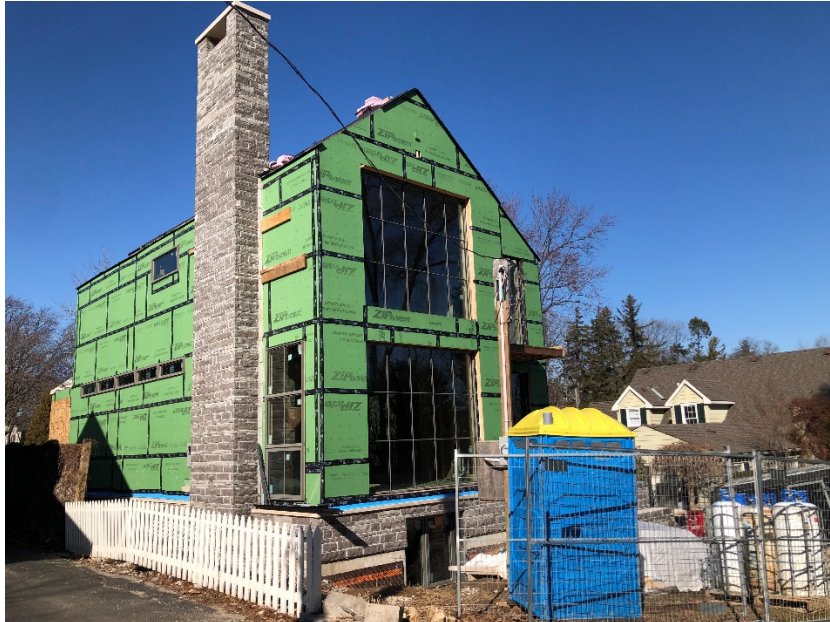
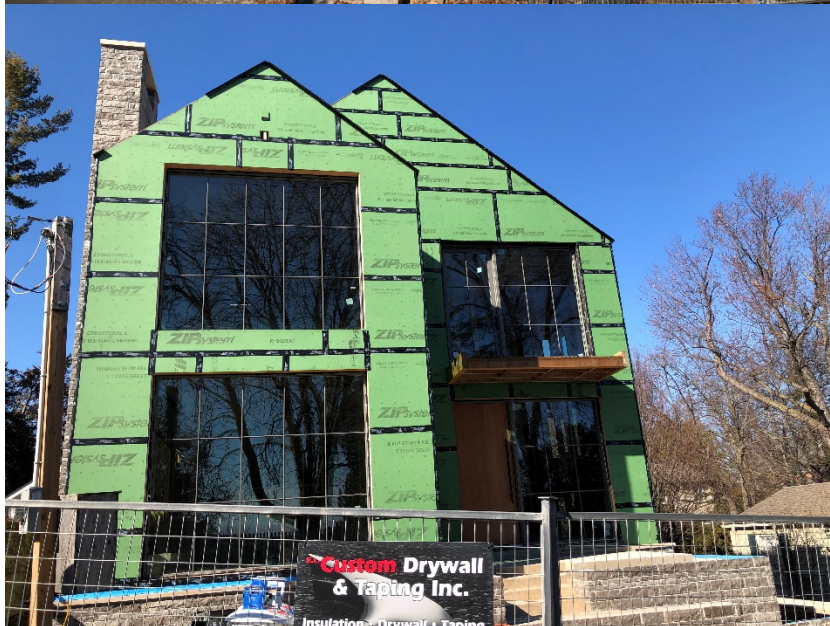
Photo:
2023

- Style: Contemporary
- Two-storey
- Bay window on first storey
- Low side gable roof with porch overhang
- Recessed entrance

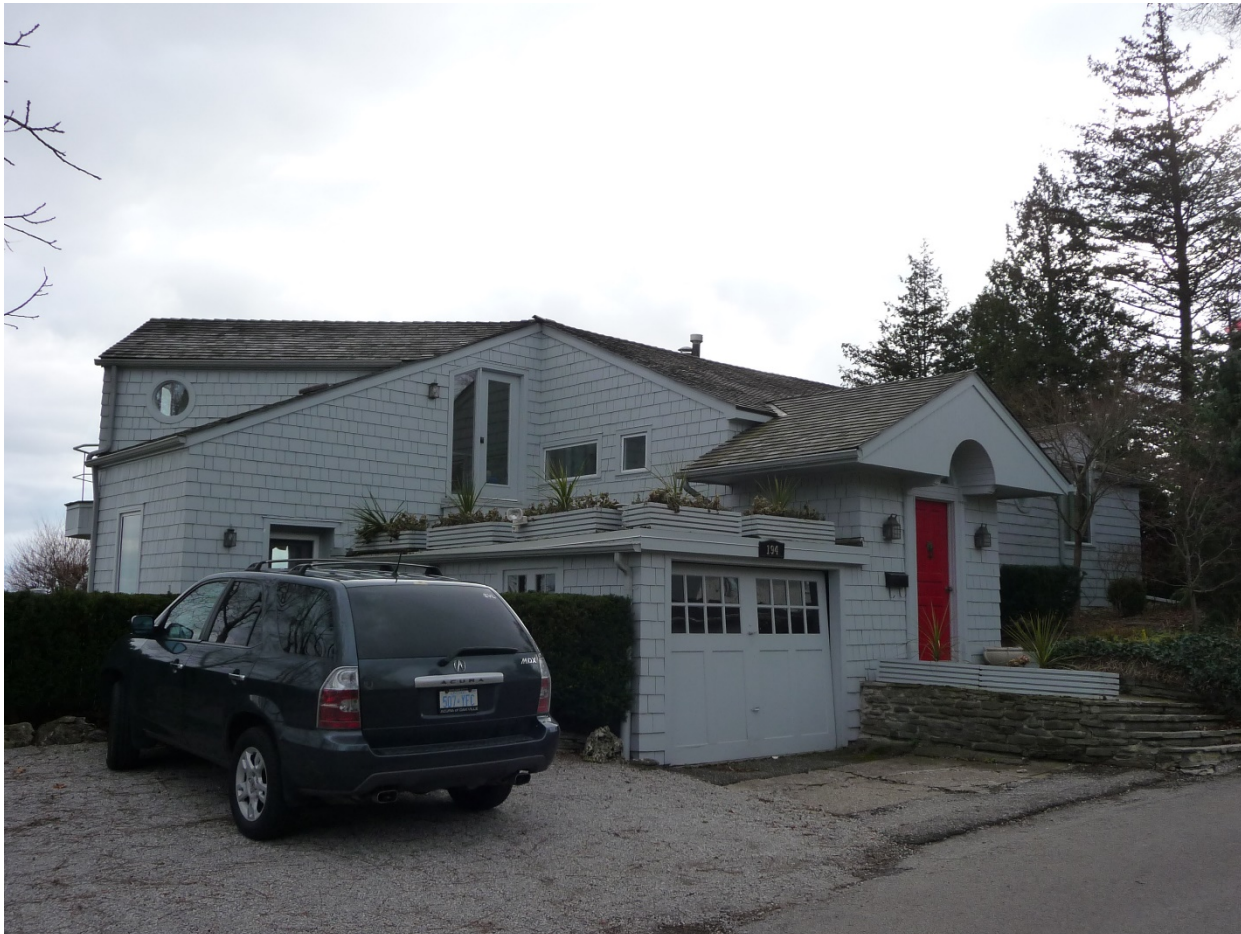
- Style: Late 20th century vernacular
- Two-storey
- Modern windows
- Combination roof – hipped, flat, gable
- Shake cladding
- Entrance under porch overhang

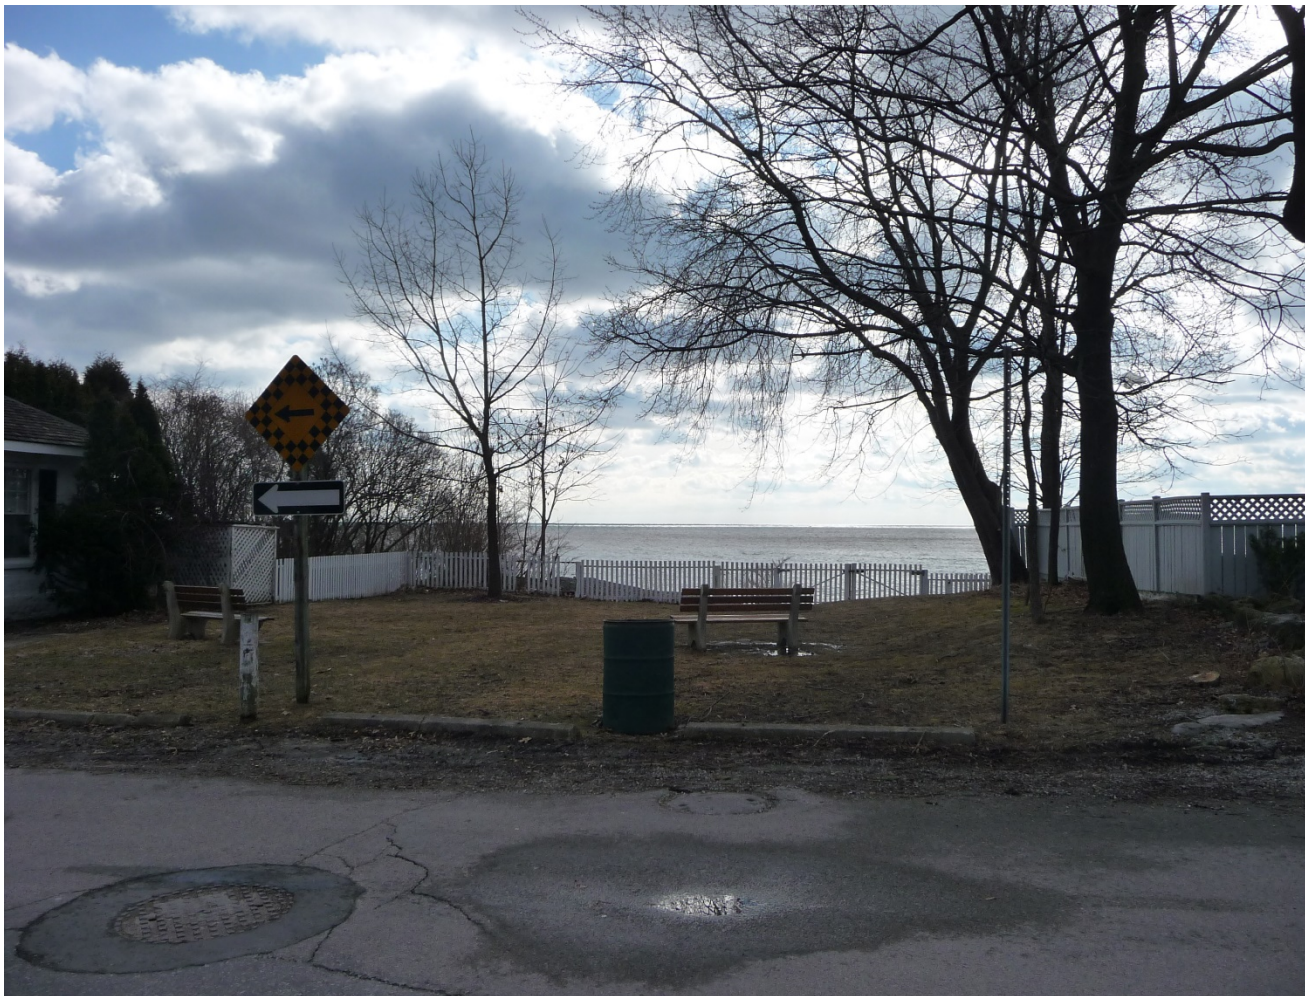
Address: 204 Front Street

- Parkette set between two residential structures at the foot of George Street
- Park benches, white picket fencing between parkette and Lake Ontario
- Mature trees along edge of parkette

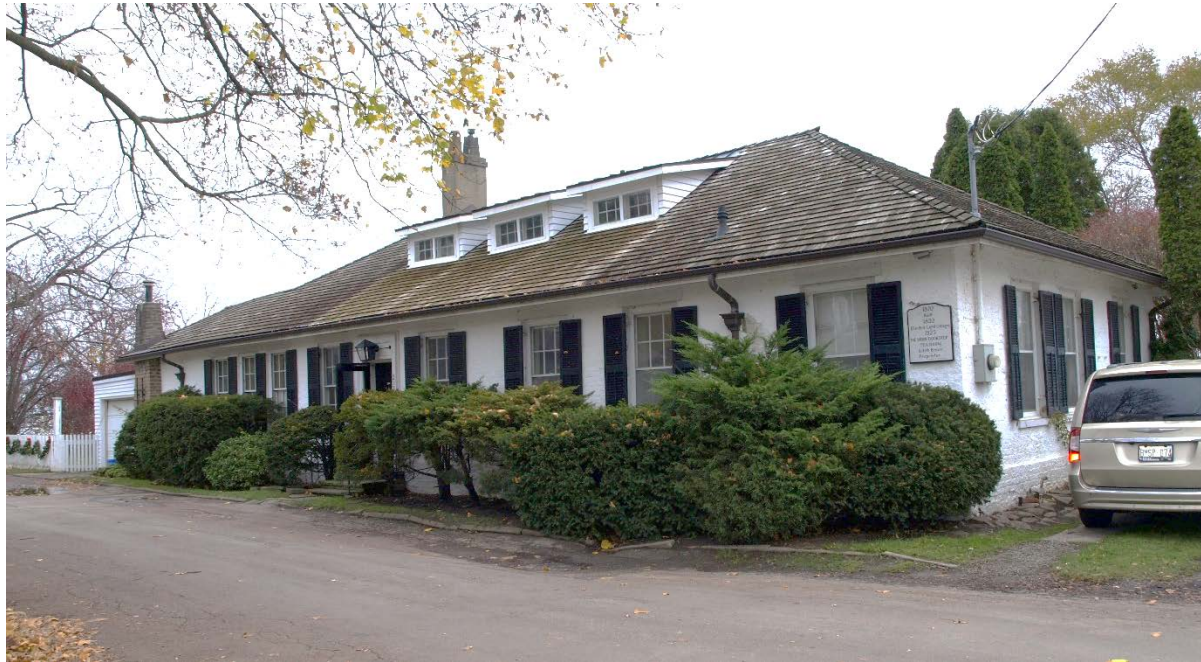
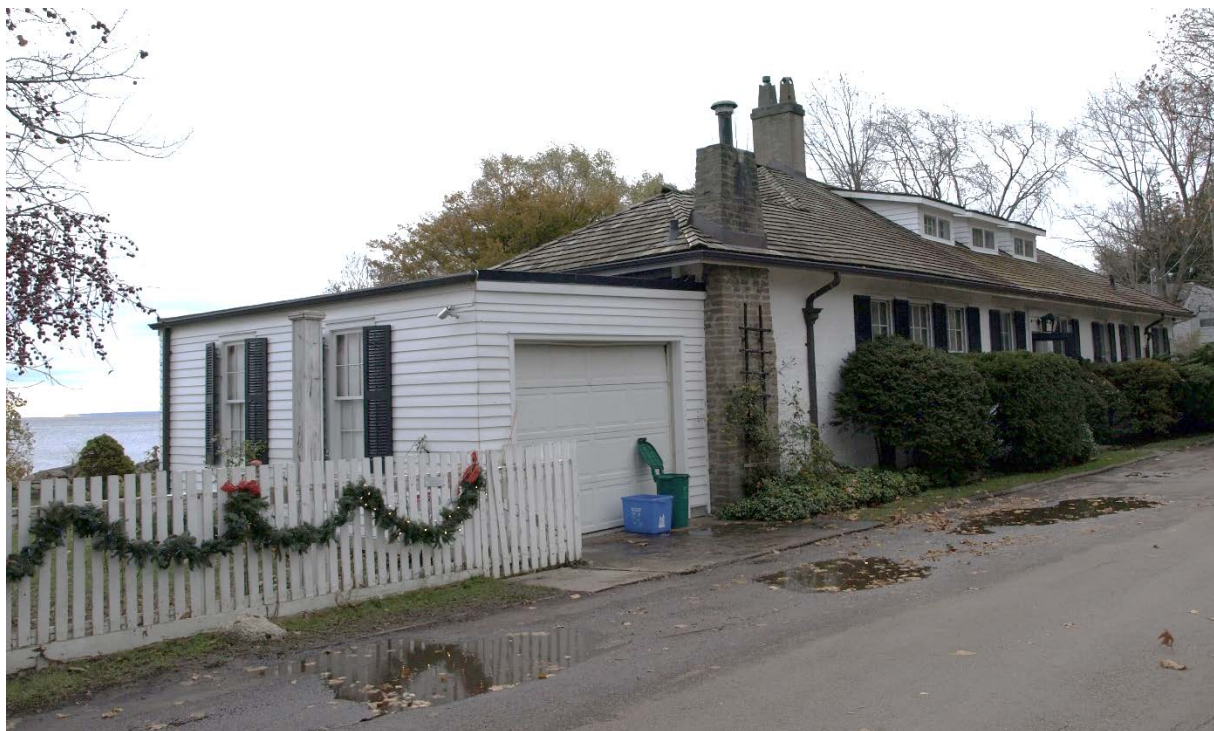
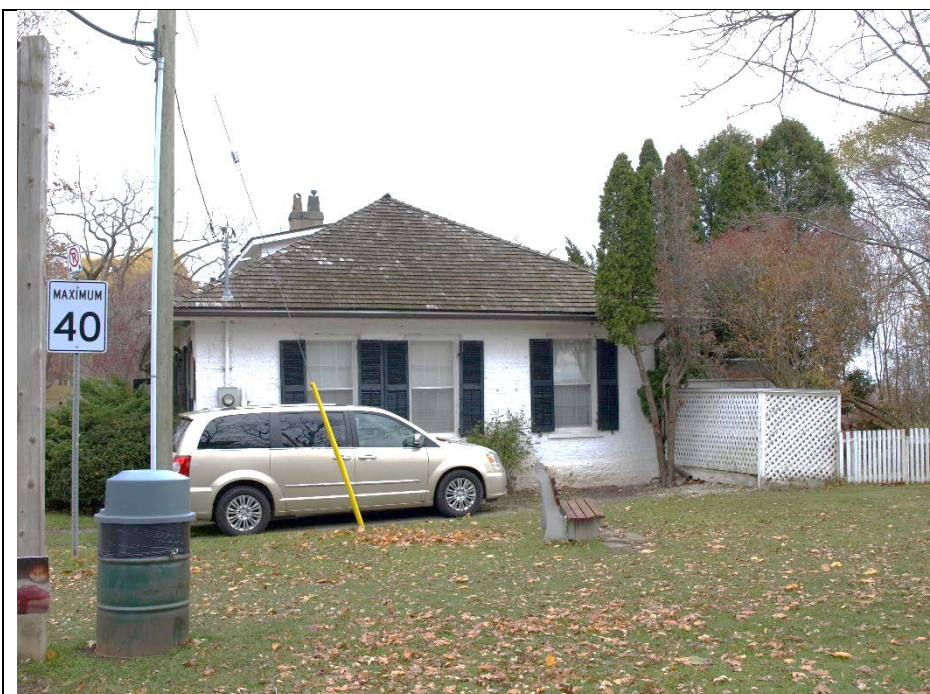
Name: Worn Doorstep

- Style: 19th Century Vernacular
- One and one half storey
- Low hipped roof clad in cedar shingles broken by three shed dormers
- Broad overhanging eaves
- Six over six sash windows with functioning shutters
- Double stack chimney at peak of hip roof
- Single stack lakestone chimney on east side of front facade
- Nine bays across the front elevation, irregular spacing
- Main entrance with simple surround
- Rough cast stucco cladding

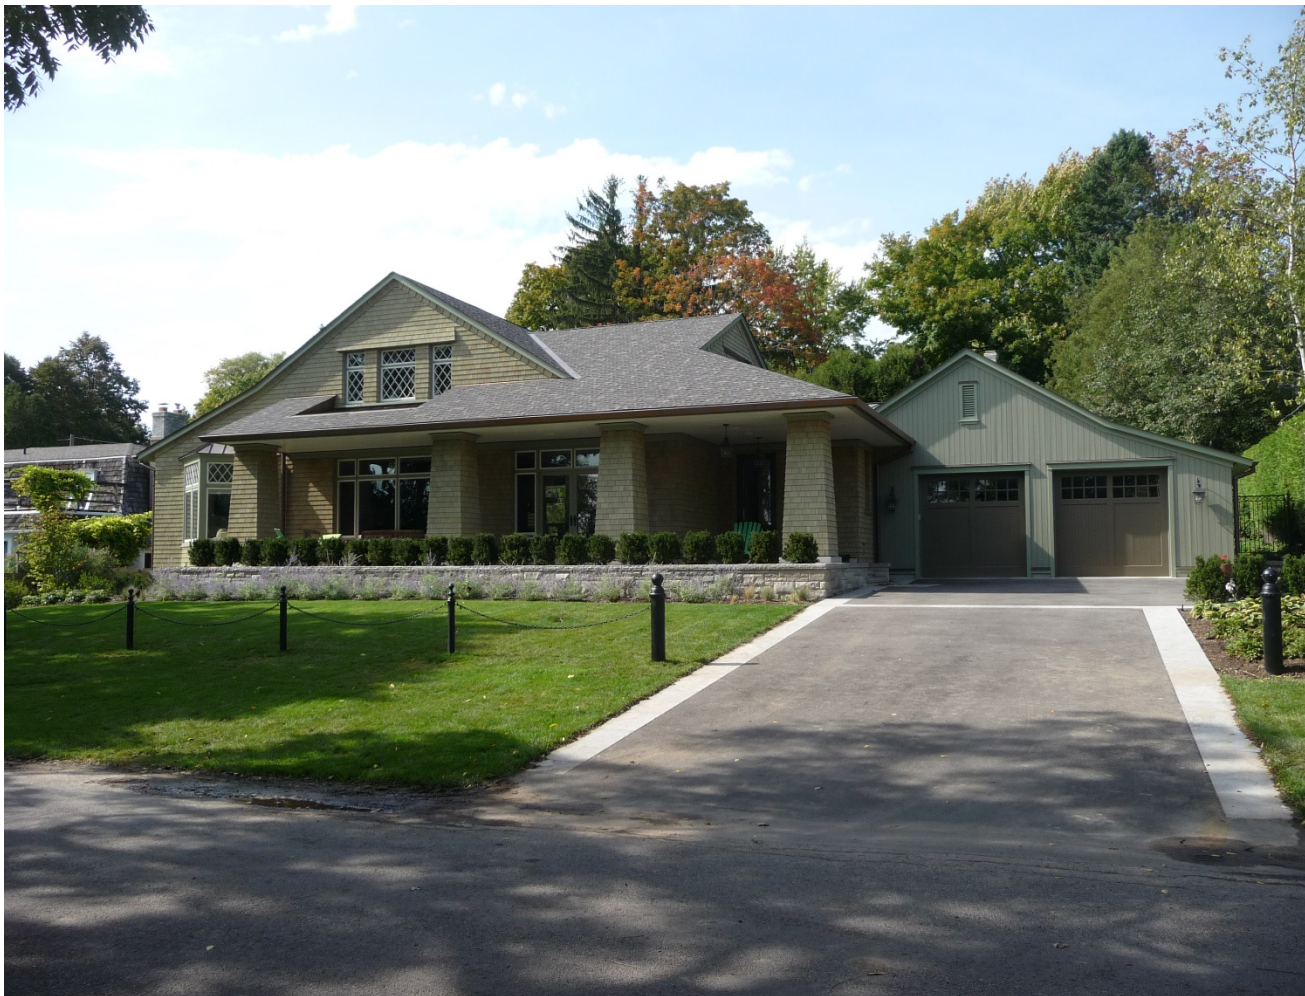
- Style: New Traditional
- One and a half storey
- Shingle clad exterior
- Diamond pane windows
- Medium pitch hipped roof with gable end
- Large front porch with shingle clad columns
