OAKVILLE HERITAGE INVENTORY SHEET

Address: 21 Dunn Street

Address: 30 Dunn Street

Address: 43 Dunn Street

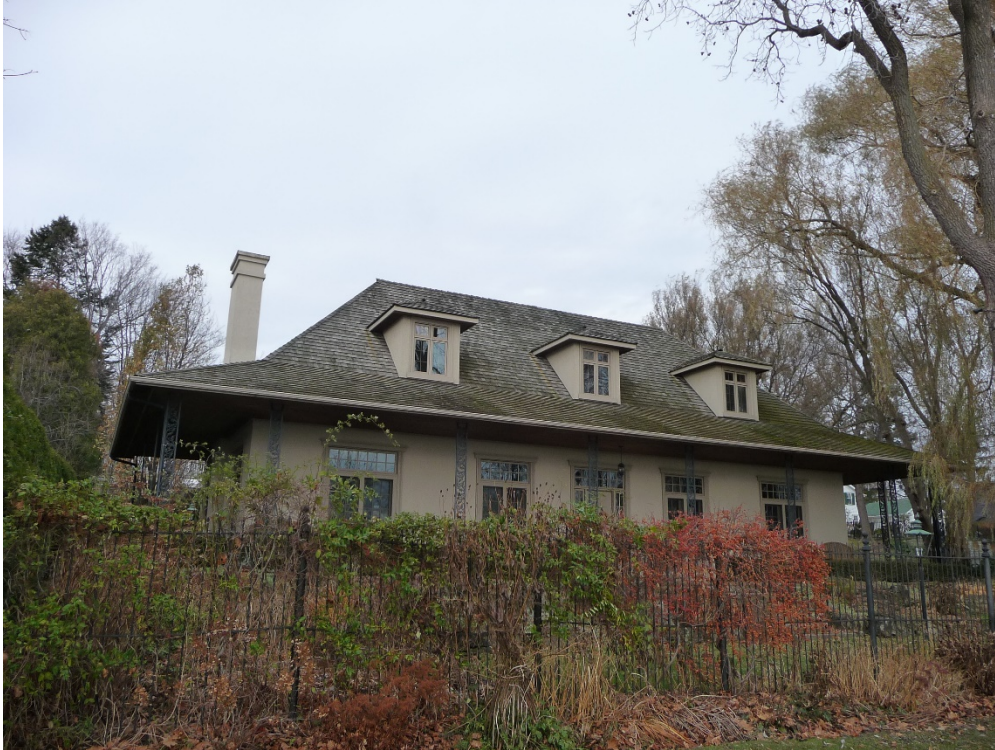
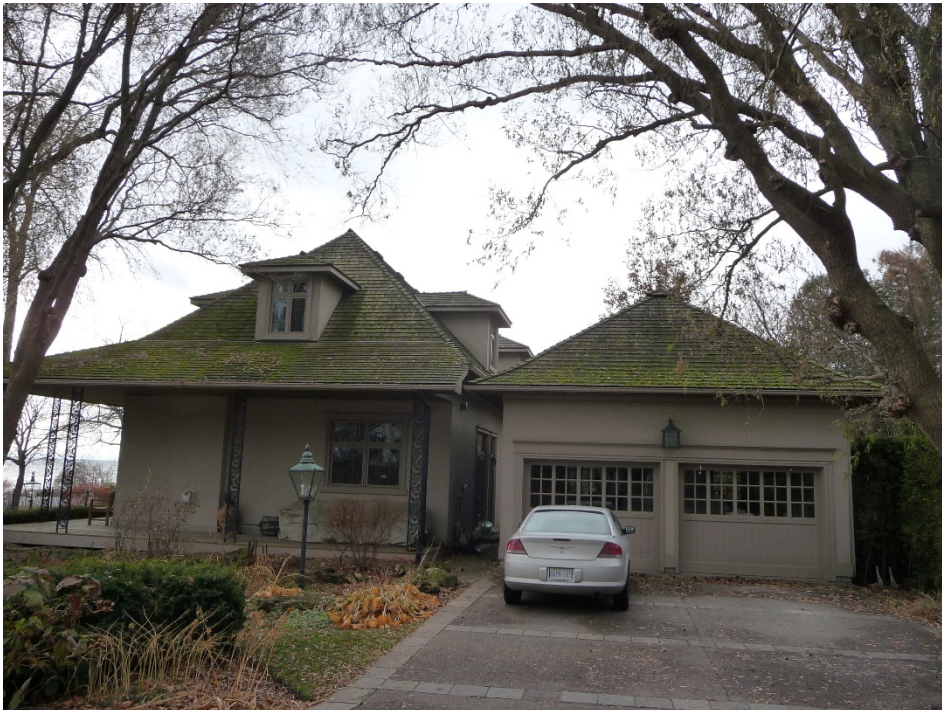
- Style: New Traditional
- One and a half storey
- Stucco clad exterior
- French doors on first storey
- Steeply pitch hipped cedar shingle roof with bellcast eaves that create a wraparound porch
- Wrought iron columns on porch
- Central entrance with transom and sidelights

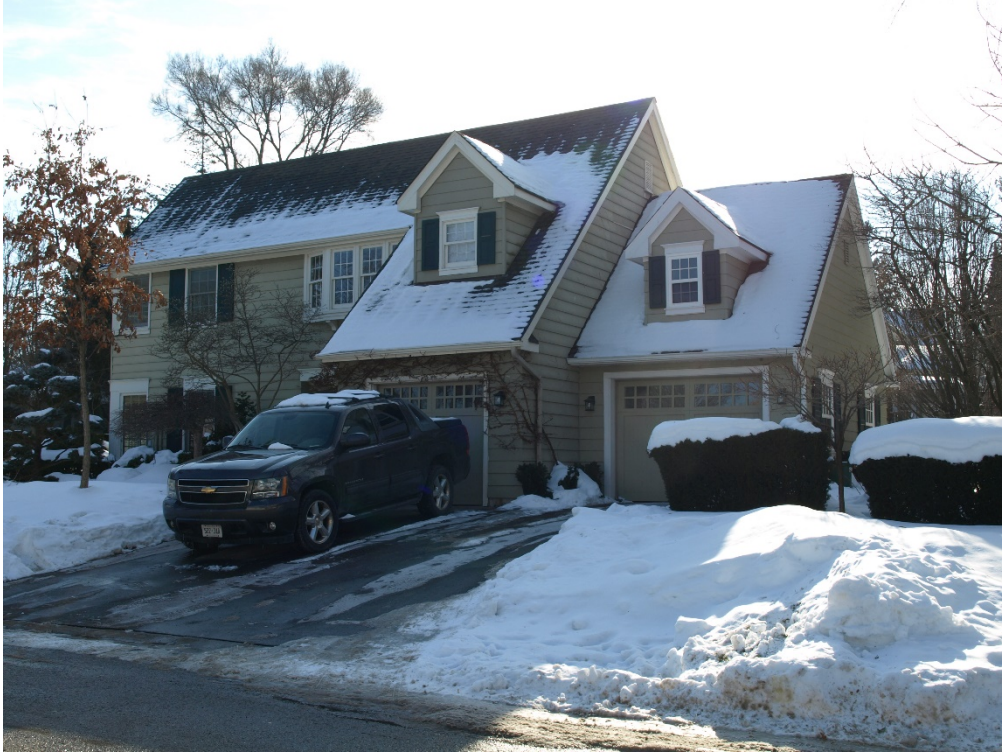
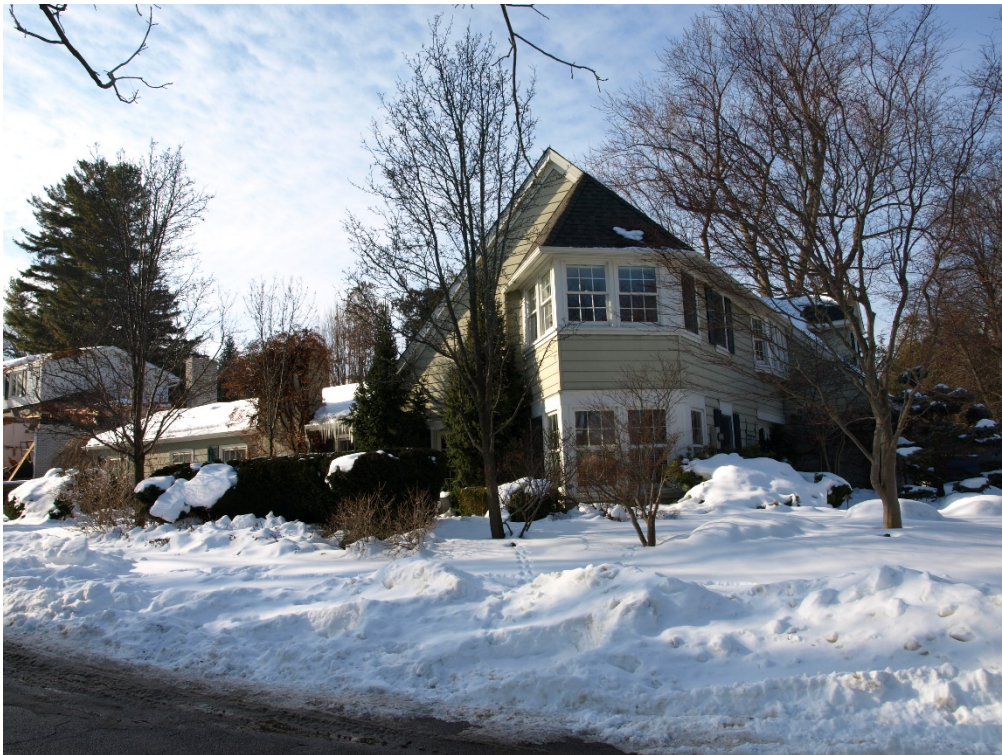
- Style: Late 20th Century Vernacular
- Two-storey along George Street
- One-storey extension along Front Street
- Six over six double hung system in contemporary materials some with non-functioning shutters
- High pitch gable roof
- Corner bay, two-storeys tall
- Recessed entrance off George Street next to garage
- Clad with wood horizontal siding

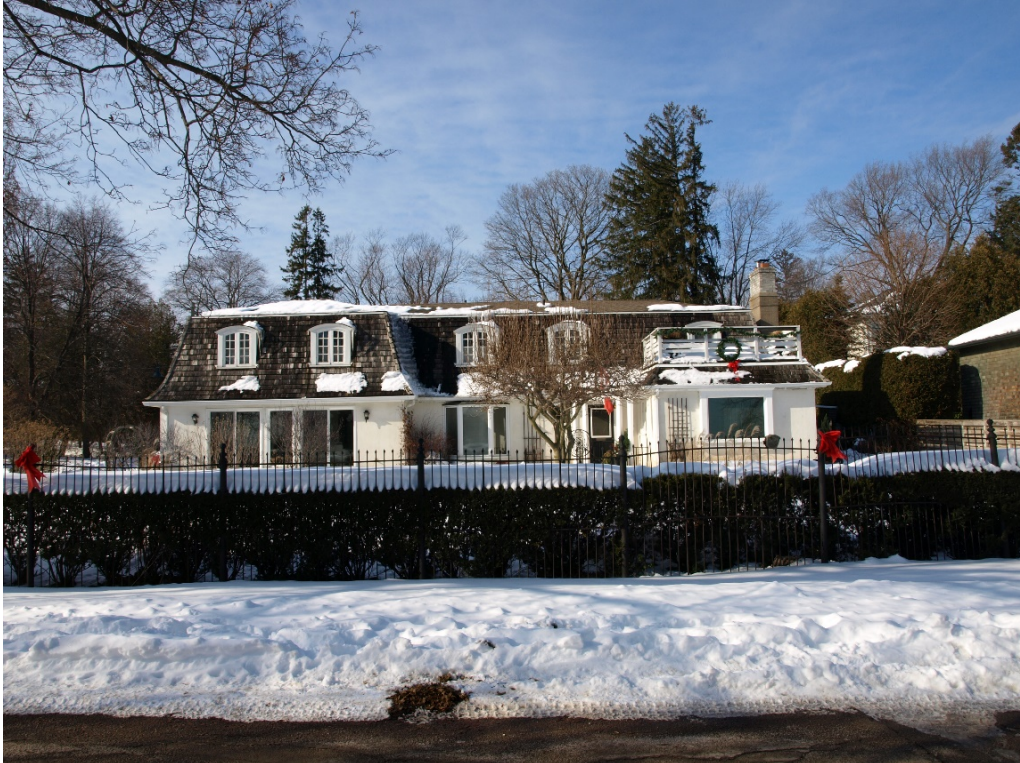
- Style: Early to Mid-20th Century Vernacular
- Two-storey
- Modern sliding French doors on first storey
- Rounded top eight pane casement windows on second storey
- Cedar shingle bellcast mansard roof
- Stucco cladding

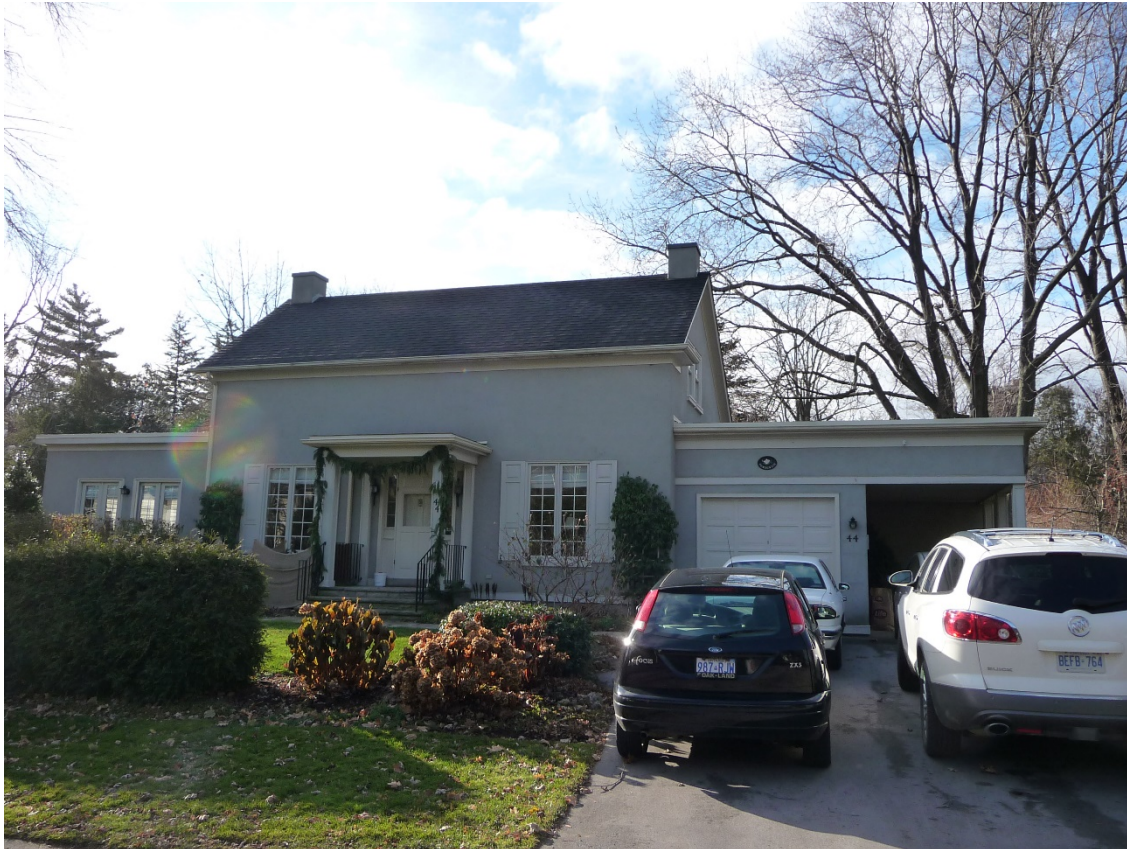
- Style: New Traditional (central portion of residence is a replica)
- One and a half storeys
- Large casement windows
- Side gable roof with cornice returns
- Stucco cladding
- Flanking one storey 'additions' (sunroom and garage)
- Front porch with columns over central entrance
- Attached garage with open carport and flat roof

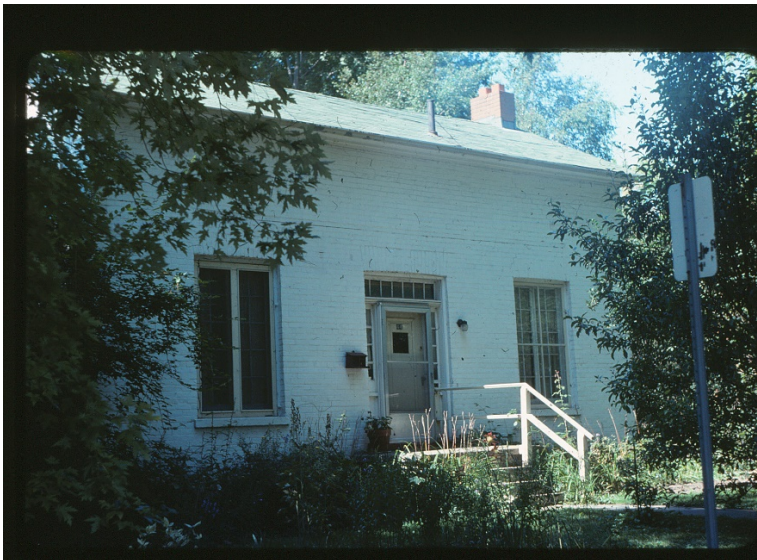
Captain Hiram Wilson House – one of the oldest brick houses in Oakville. Known for its large casement windows which were unusual for the period and probably originally opened onto a large porch.

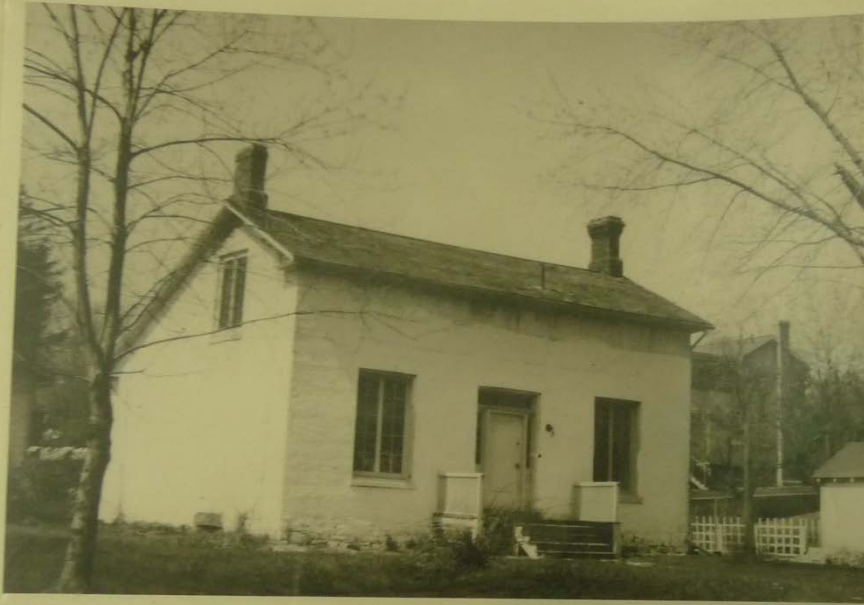
Williams was the commander of the Royal Tar and the Dauntless. Around 1850, he built a house on the north-west corner of King and George Streets. This building, pictured here, was considered one of the first brick structures in Oakville. The brick was originally used as ballast for a schooner returning to Oakville, a common practice to stabilize a vessel. The present address of this house is 44 George Street.

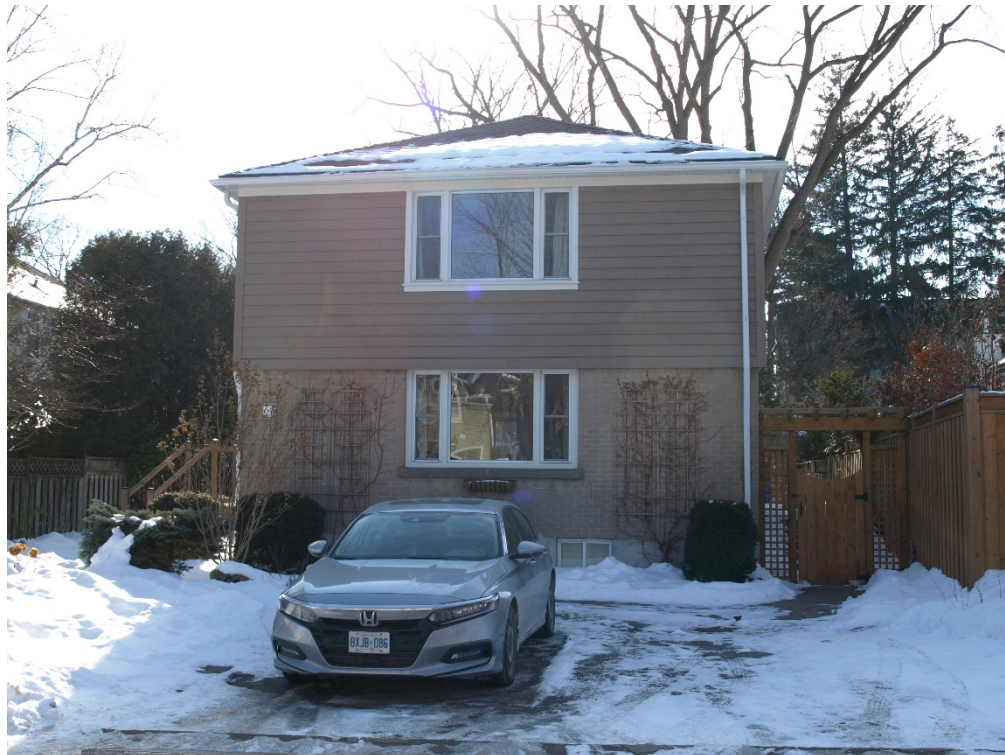
- Style: Mid 20th century vernacular
- Two storeys
- Large sliding windows
- Low hip roof
- Brick on first storey, horizontal siding on second storey
- Entrance at the side of the house
