OAKVILLE HERITAGE INVENTORY SHEET

Address: 56 Water Street

Name: Oakville Club/ Granger's Warehouse

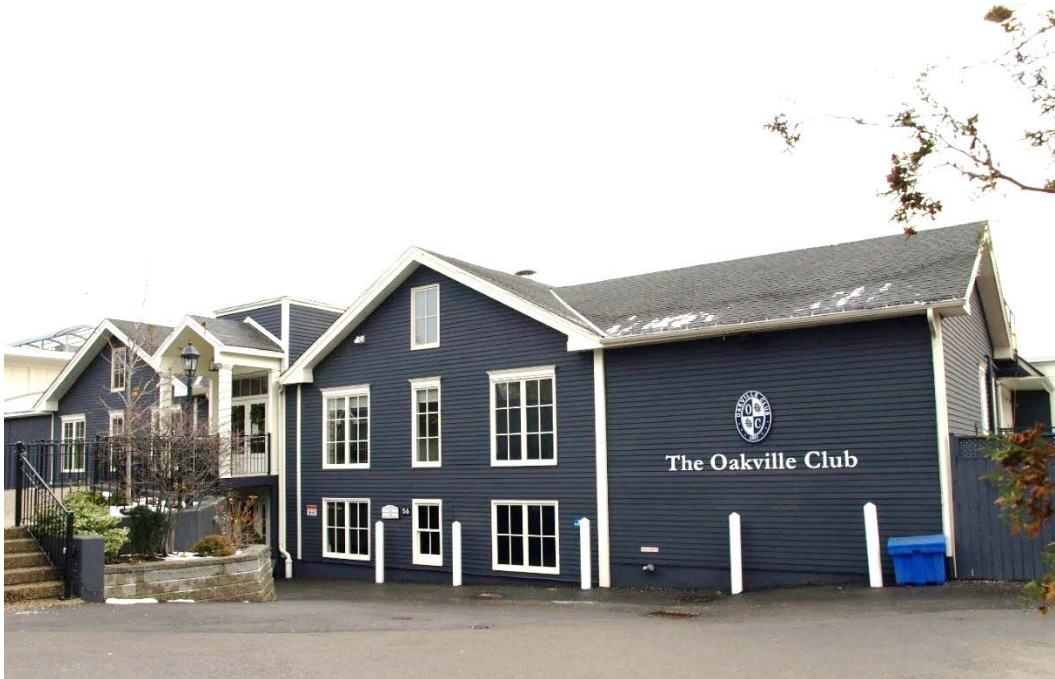
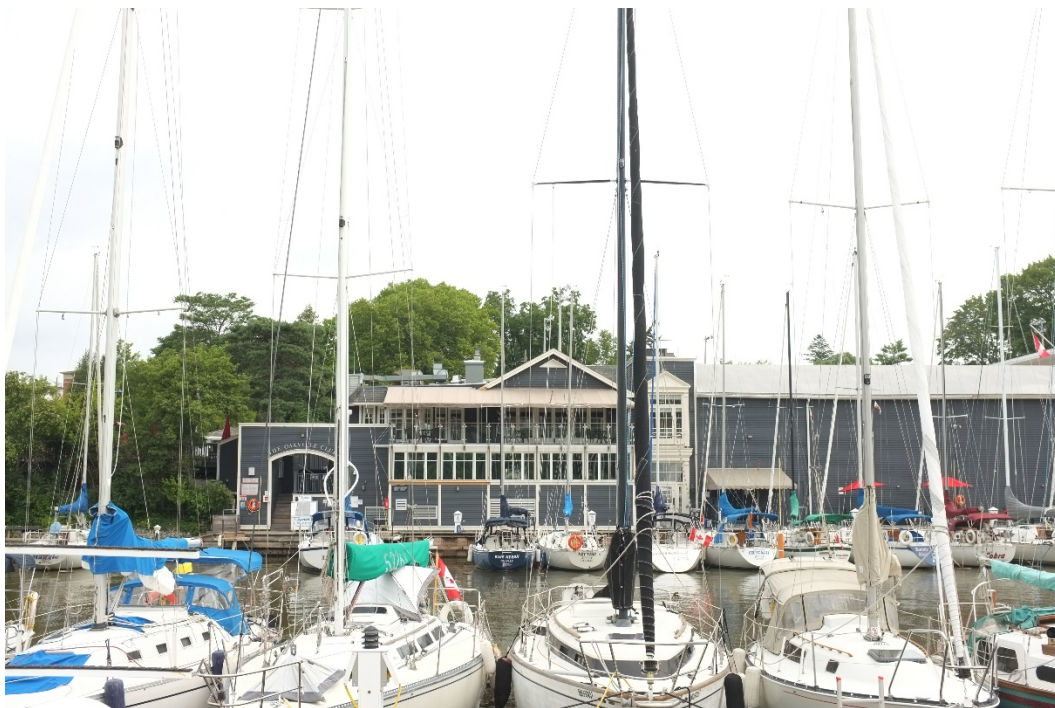
Photos:
2021:

- Style: 19th century vernacular (non-residential)
- While there have been a number of additions and changes to the Oakville Club building over the last several years, the warehouse from the mid 1800s and the airplane hangar from the 1920s remain
- Contemporary horizontal siding and consistent colour connect the various elements of this multi-component structure
- Medium pitched cross gable roof system with dispersed flat and semi-elliptical roof elements
- Most of the multi-component structure is two storeys in height
- Semi-elliptical roof element on the southern end housing a fitness facility built in DATE
- Primary entrance on second level with a double acting door with a transom
- Contemporary windows
- Asphalt shingle roof

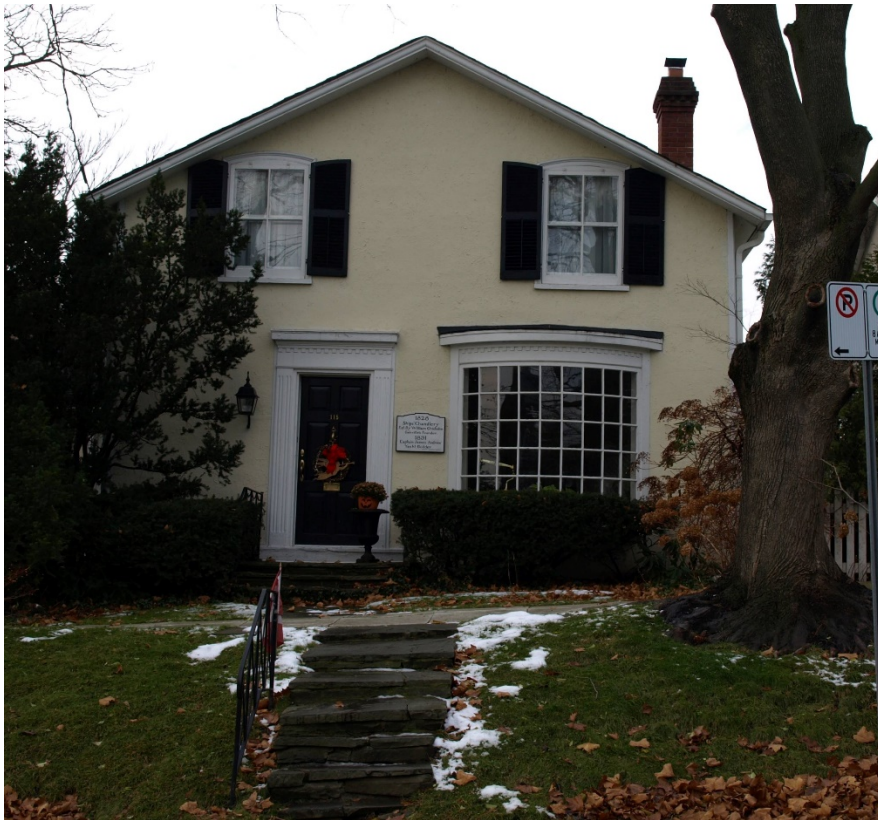
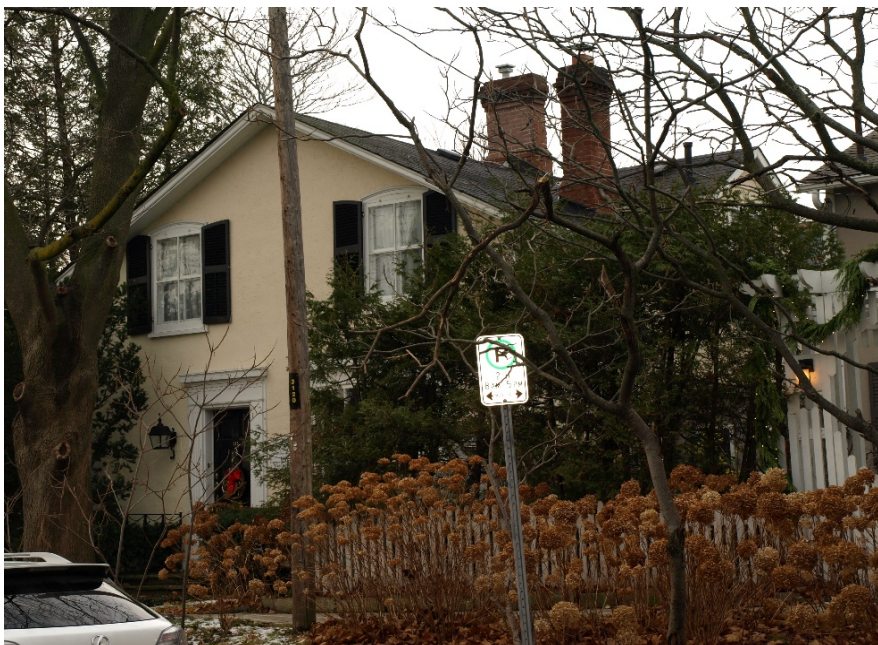
Photos:
2021

- Style: 19th century vernacular
- Low pitch open end gable roof with asphalt shingles
- Pair of brick chimneys with decorative crown
- One-and-a-half storey
- Asymmetrical two-bay, offset front entryway with decorative door surround.
- Two-over-two double hung windows, some with curved headers, flanked by functioning shutters.
- Multi-pane fixed semi-elliptical bay window (later addition)
- Rough cast stucco cladding
- Lakestone foundation

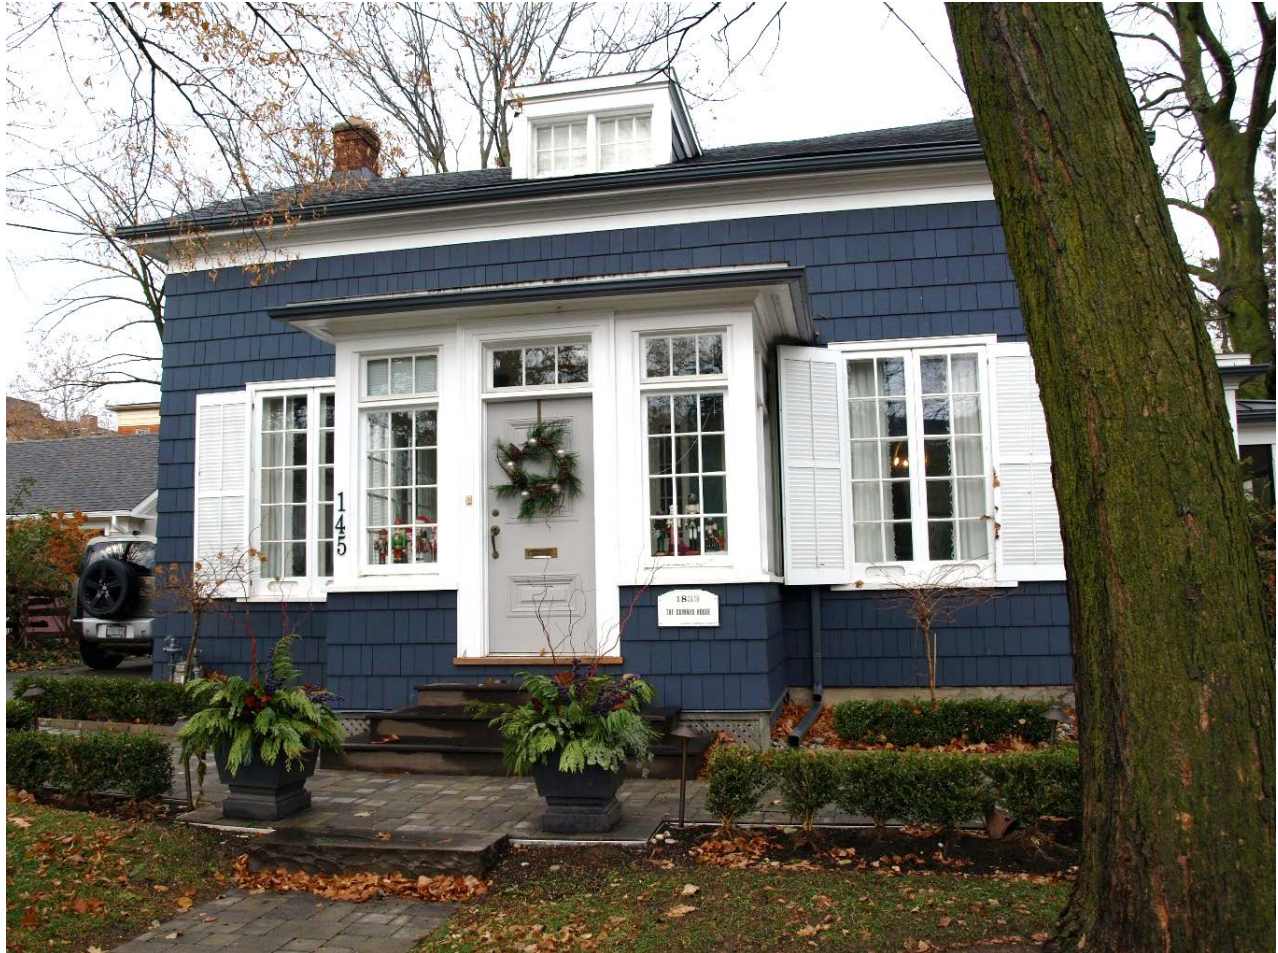
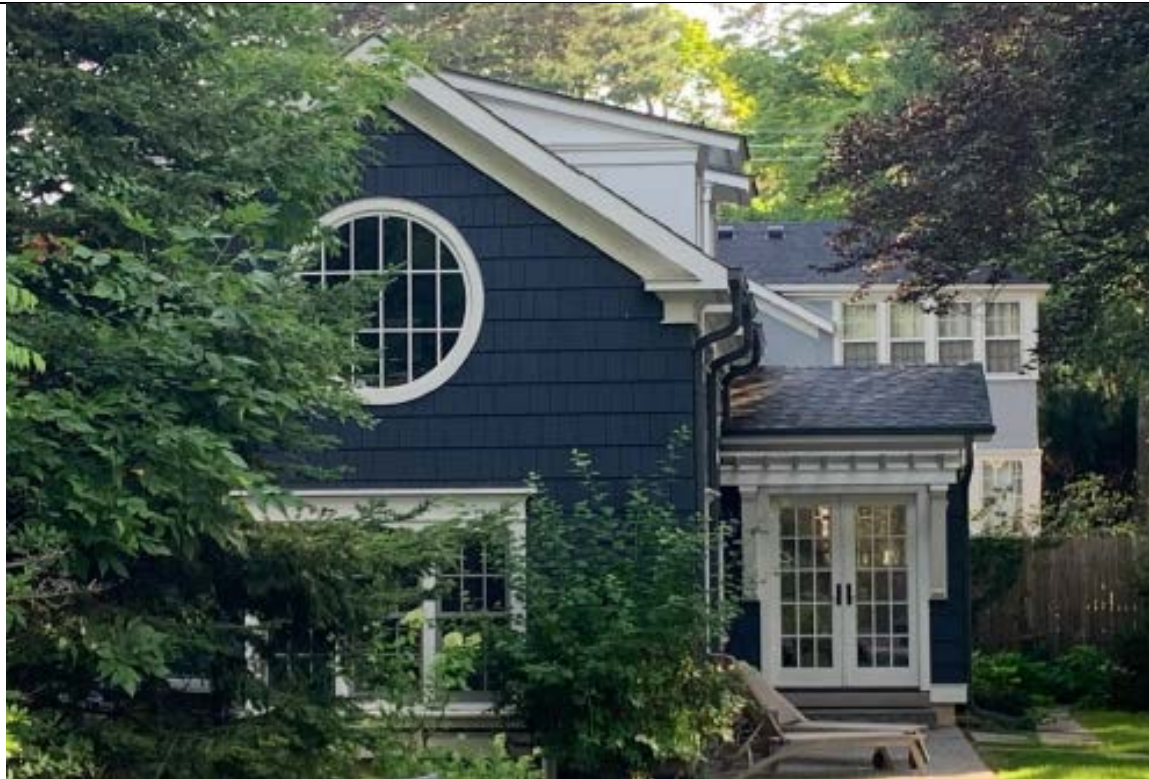
Photos:
2021

- Style: one-and-a-half storey Cottage (originally Neo-Classical, later additions have modified style)
- The first restoration of this home took place in the early 1920s by Walter Moorhouse, a recognized Toronto architect who moved to Oakville at that time and lived there until his death. The original “form” of the 1 ½ storey building was maintained while replacing the back summer kitchen with a 1 ½ storey addition and adding the front entryway and projecting bay and covered porch to the east

- Side gable, flat, and shed gable roofs. Gables have return eaves.
- One-and-a-half storey, with a one storey section at the rear (west) elevation
- Multiple sections, with a three-bay façade.

- Projecting front entryway with multiple windows and transoms. Shed roof dormer centred above the front entryway.
- West elevation includes a projecting bay window, and a second entryway, protected by an overhang. Beyond that lies the one storey shed roof section.

- East elevation includes a large projecting bay, and a sunroom.
- The structure includes windows in a variety of shapes and sizes. Ten-pane casements windows; 12-pane fixed (or casement) windows topped by three-pane transoms; paired, 6-pane fixed (or casement) windows in the roof dormer; and, six-over-six double hung windows.

- Most windows are flanked by functioning shutters.
- Clad in cedar shake
- Red brick chimney with corbelling
- Stone walkway and stoop to the front façade entryway

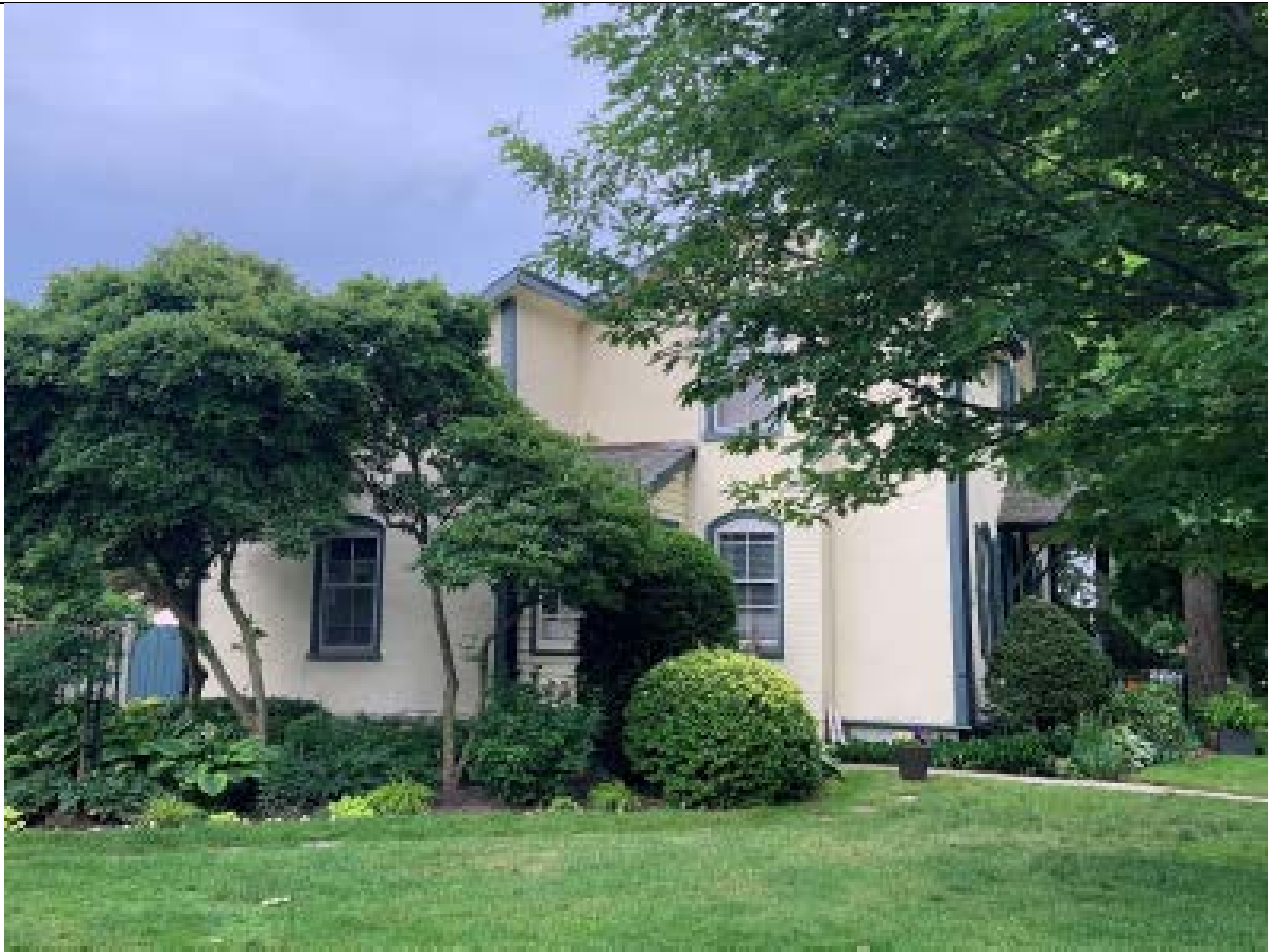
Photos:
2023

- Style: Gothic Revival Cottage
- Saltbox roof with center gable
- One and a half storey
- Three bay façade with central entryway; gable roof covering over main entryway; single window above main entryway
- Gently arched two over two windows with functioning shutters
- Clad in rough cast stucco
- Timber frame construction

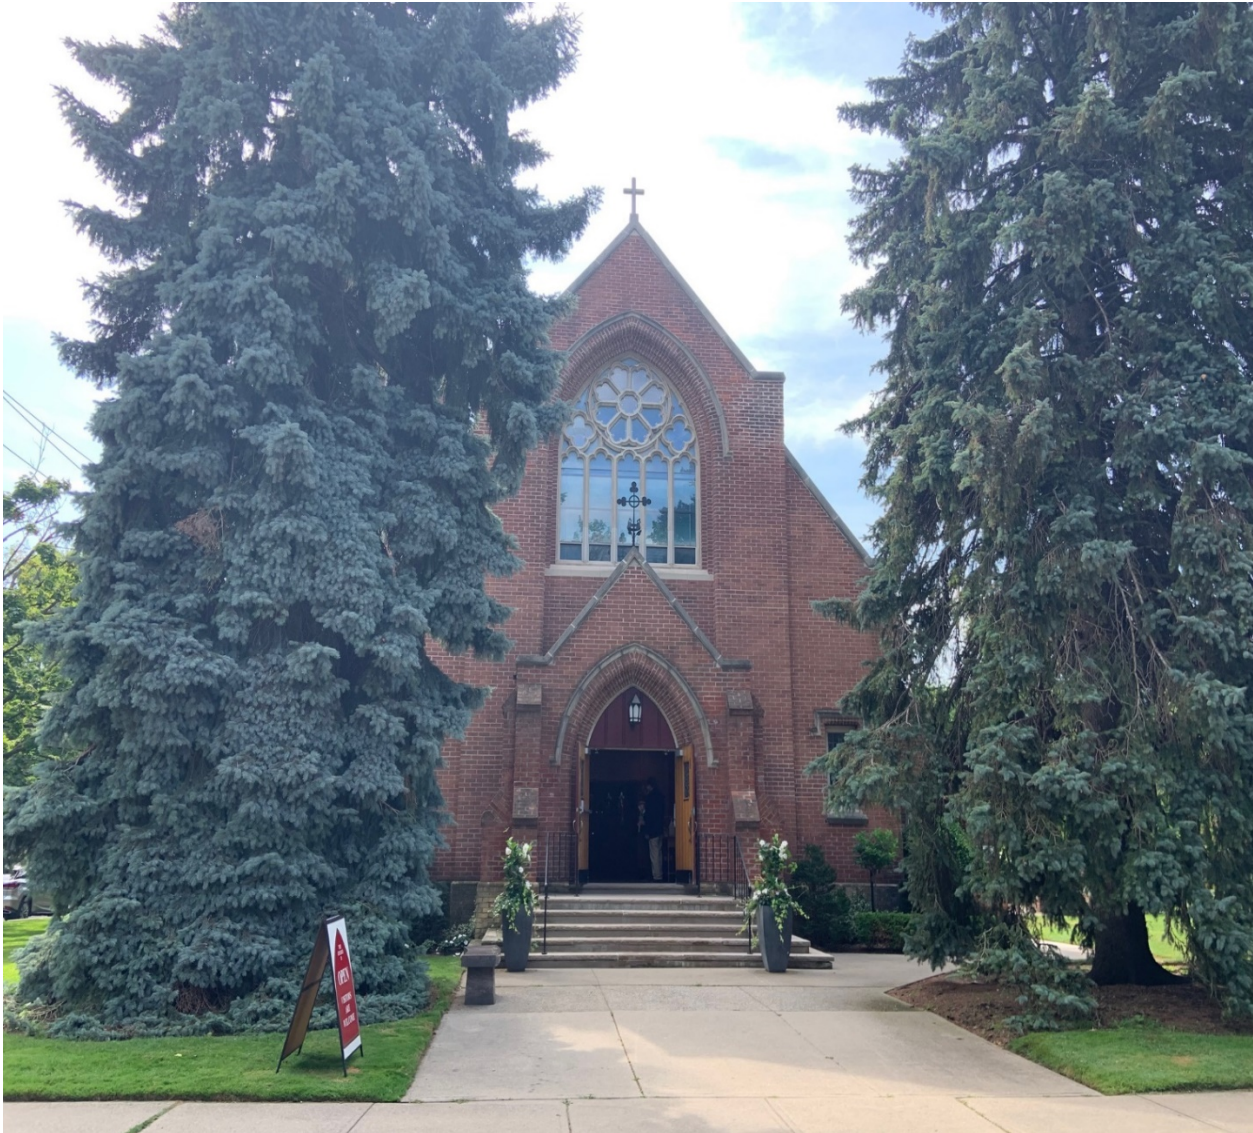
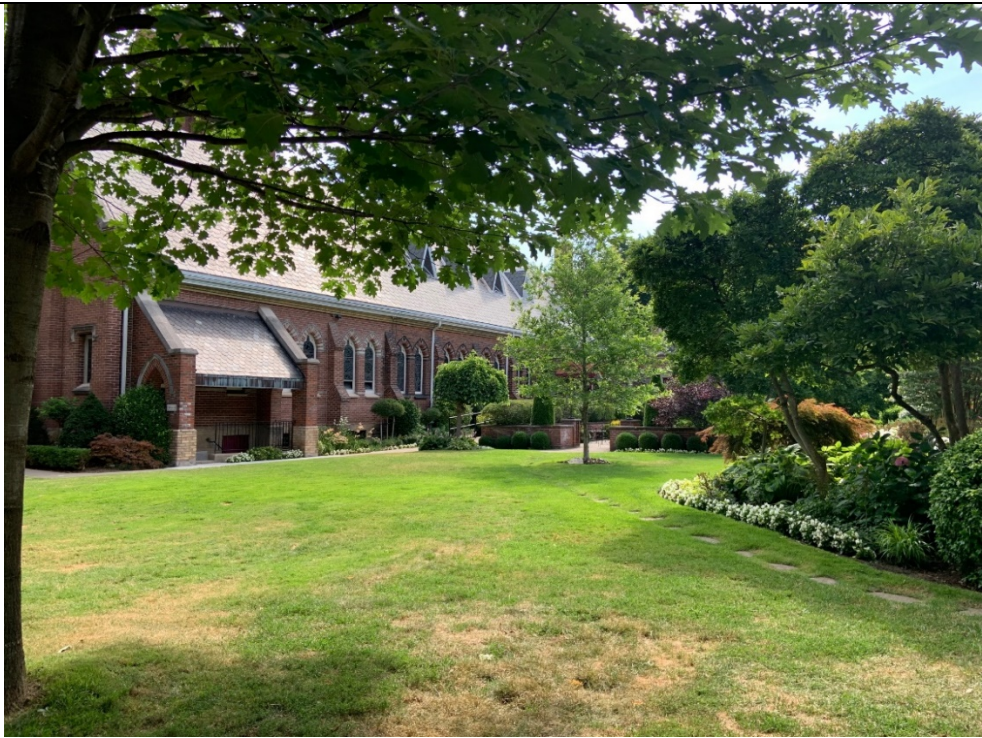
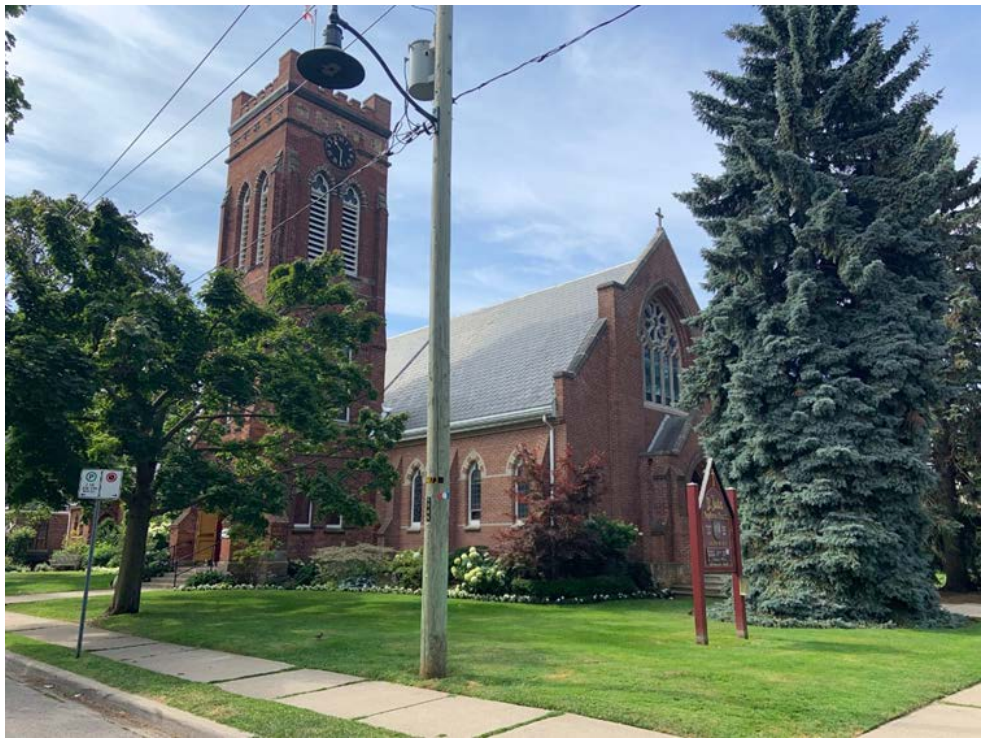
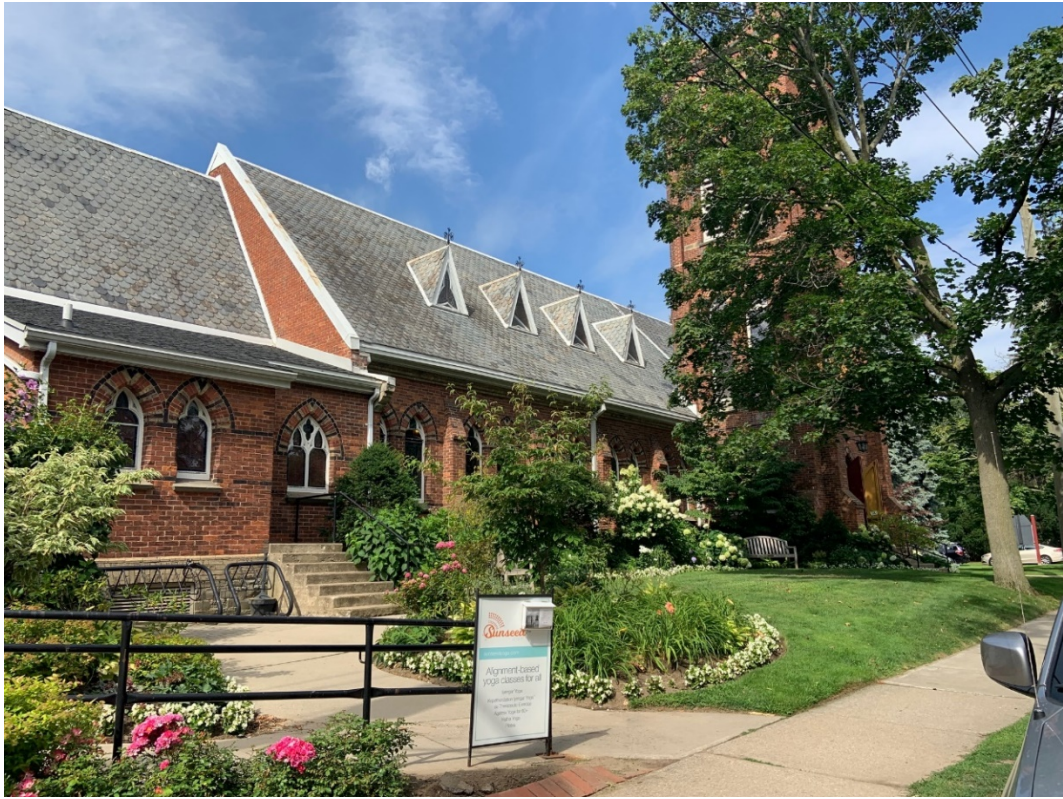
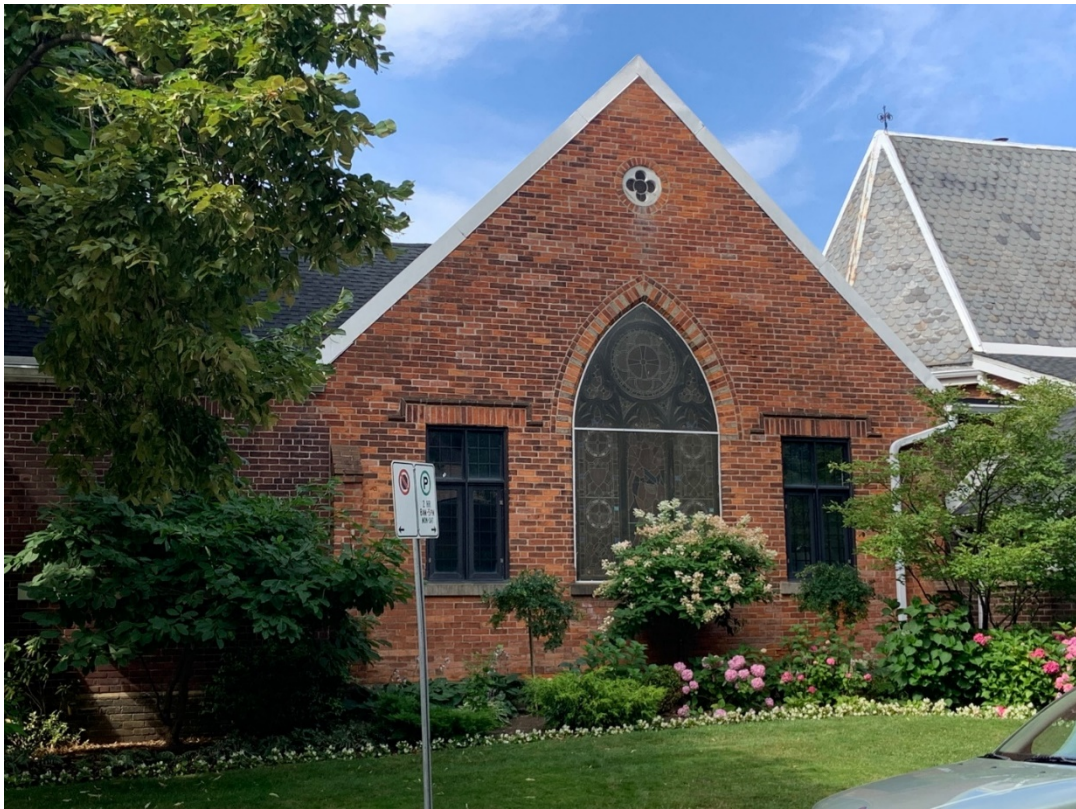
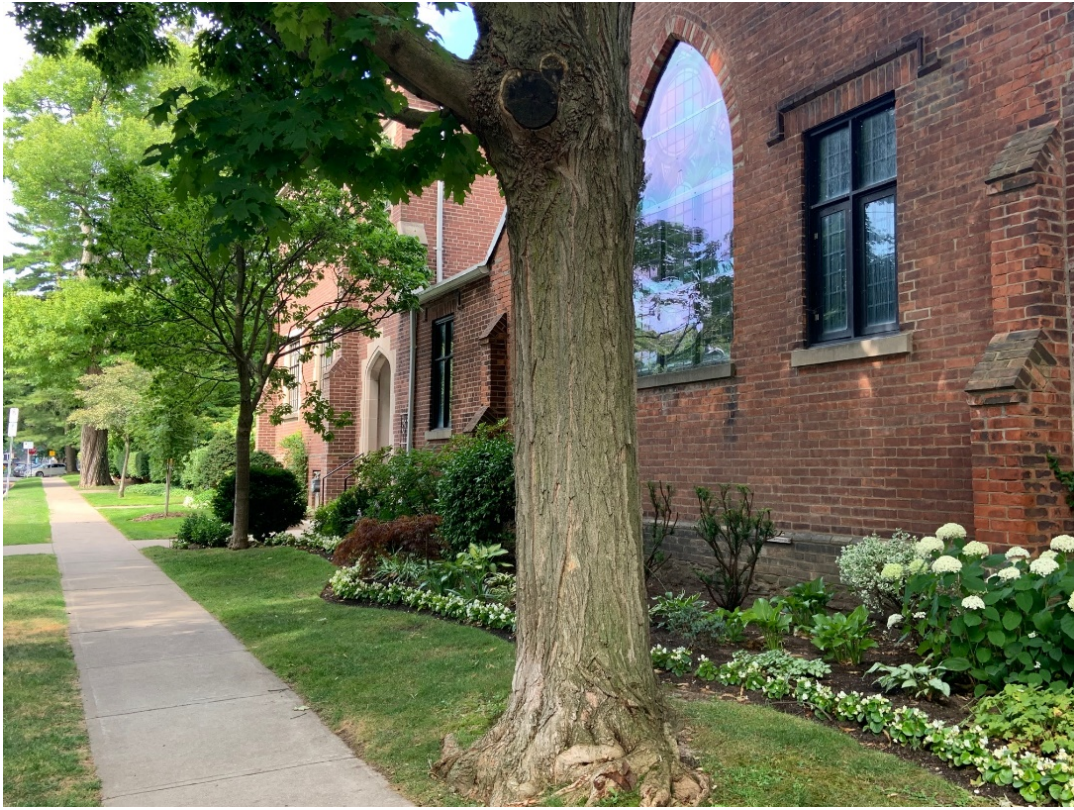
Photos:
2022

- St. Jude's church and its surrounding gardens are a landmark in the community
- Since its original building in 1883, several additions have been made over the years to accommodate the evolution of the church with the red brick used throughout to create a unifying appearance

- Style: Gothic Revival
- Steep pitched slate clad gable roof with steeply pitched gabled trefoil dormers
- Variety of window forms – paired lancet stained glass in the nave, narthex and tower, rose window in narthex above entrance
- Stone sills
- Polychromatic brick clad, including red brick with colored brick details and brick buttresses
- Square tower with lancet and trefoil stained glass windows

- Cross gable roof clad in asphalt shingles
- Large stained glass window facing Thomas Street commemorating Queen Victoria's Jubilee
- Polychromatic brick clad, including red brick with colored brick details and brick buttresses
- Paired windows with brick voussoirs or brick courses
- Quatrefoil windows
- Cast sills
- Covered porch with steep gable roof, exposed rafters, wood posts set into brick piers

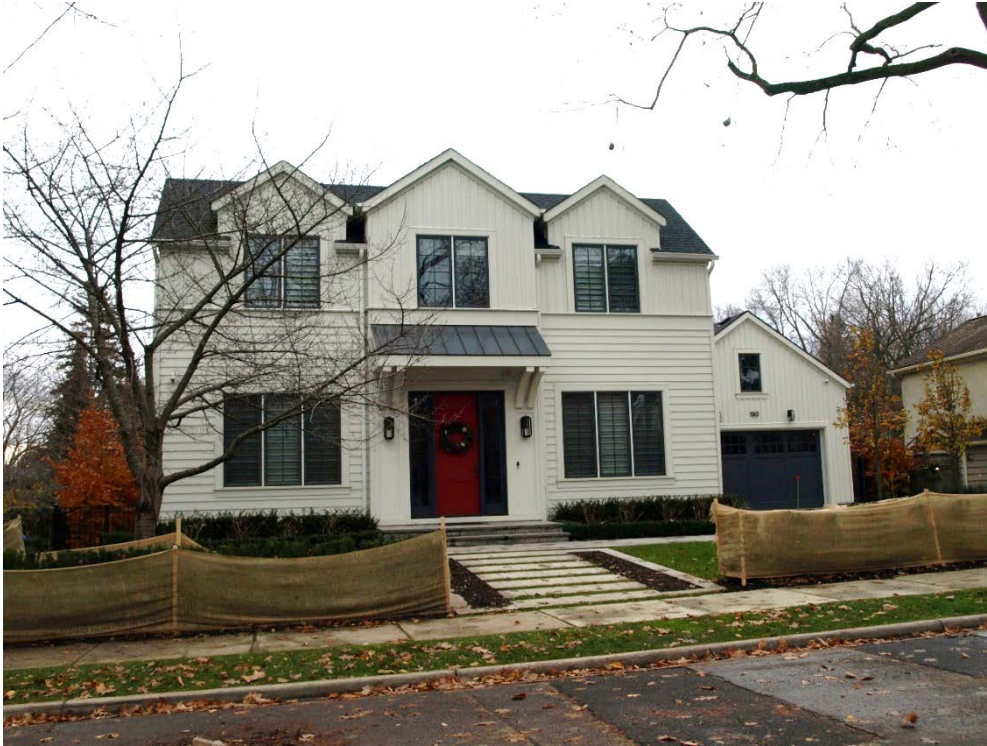
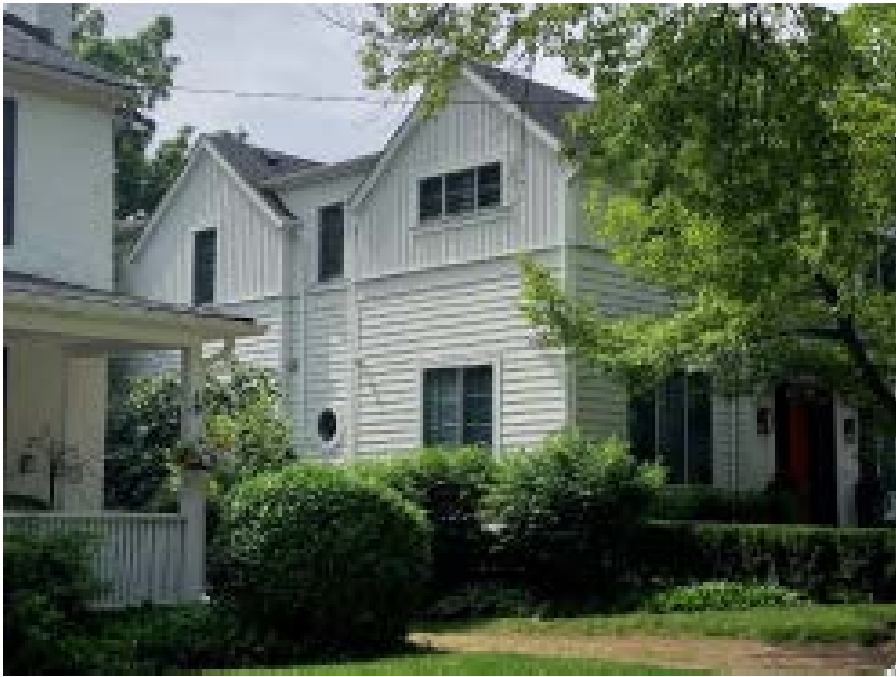
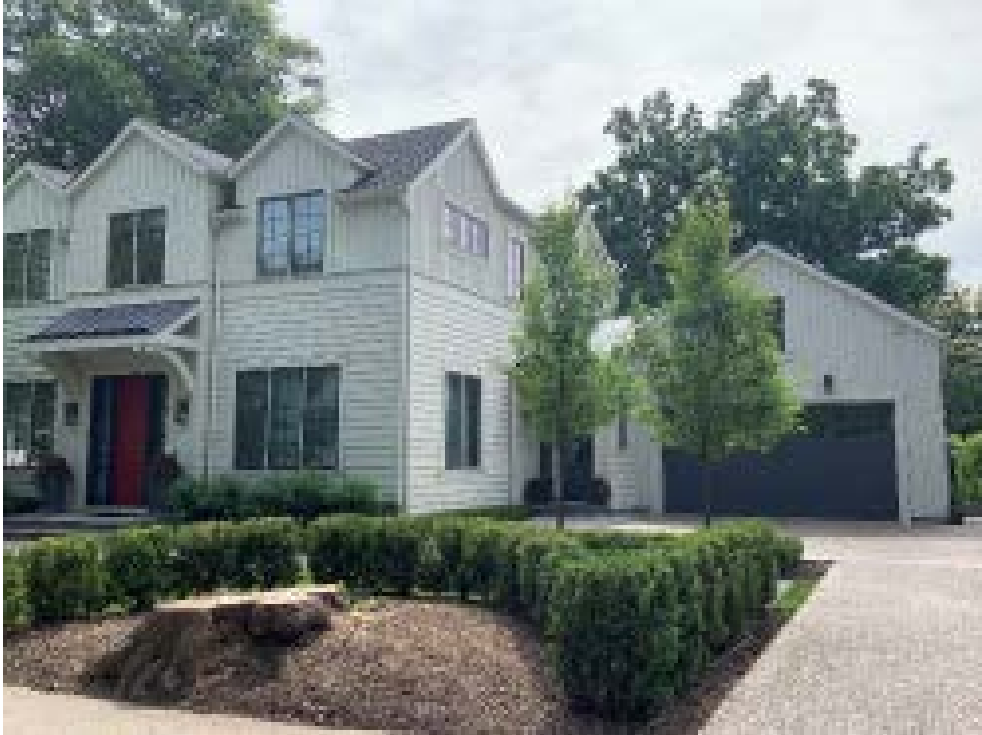
Photos:
2021

- Style: New Traditional
- Side gable roof with dormers
- Symmetrical three bay facade
- Two storeys
- Attached double car garage on west elevation set back from the residence
- Asphalt roof; metal roof on garage
- Horizontal wood siding on first storey, vertical wood siding on second storey
- Central entrance with shed (metal) roof porch overhang

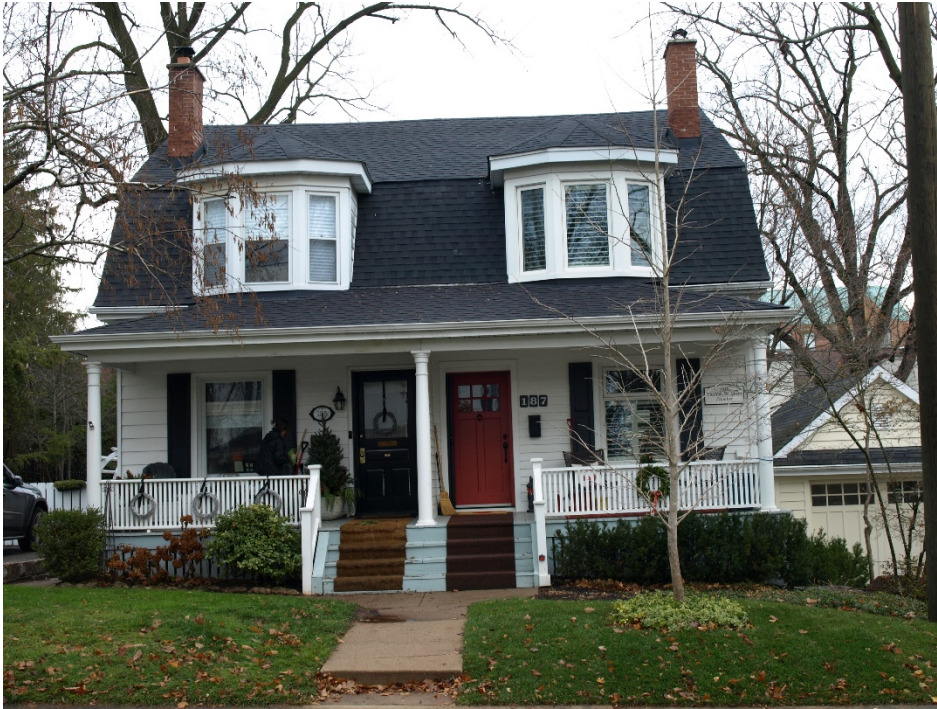
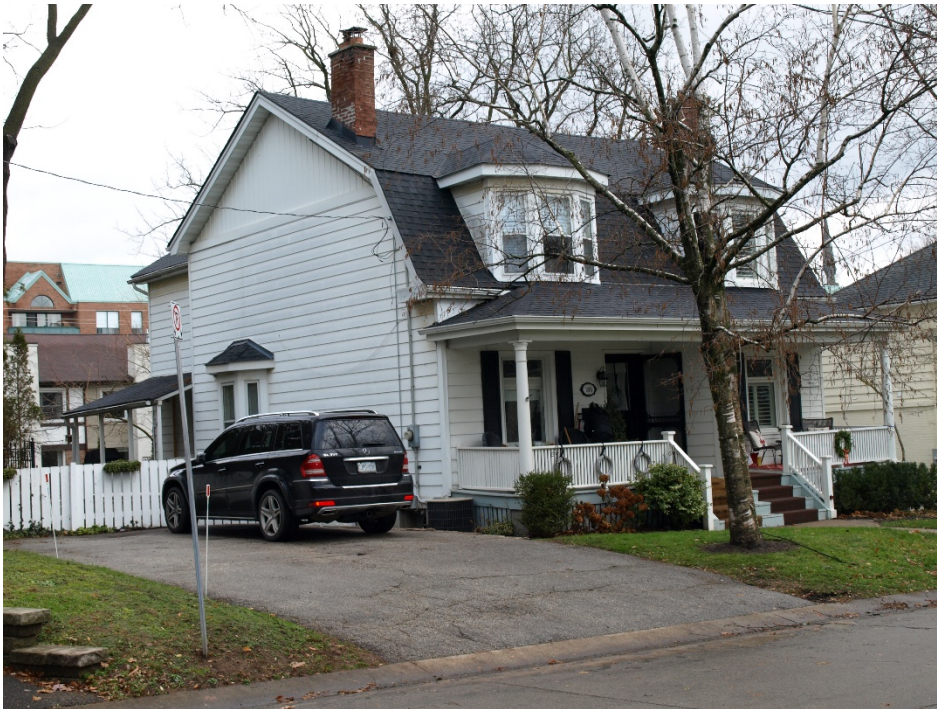
Photos:
2021

- Style: Early 20th century Vernacular
- Gambrel roof with projecting dormer
- One and a half storey
- Front porch facing William Street
- Side porch on west elevation
- Horizontal wood siding
- Contemporary windows

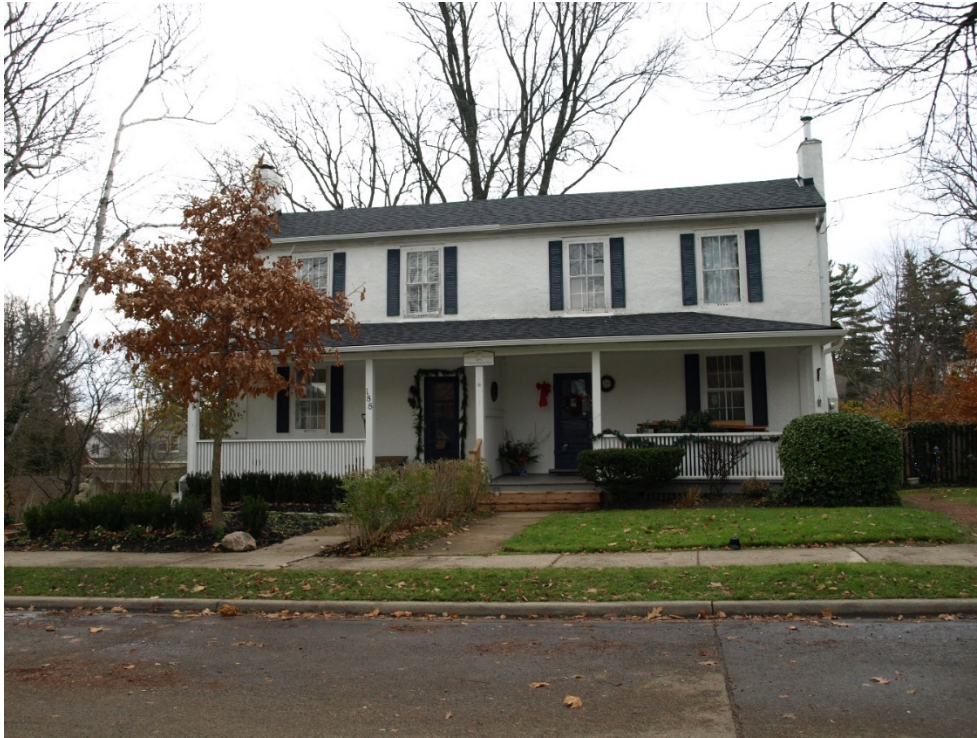
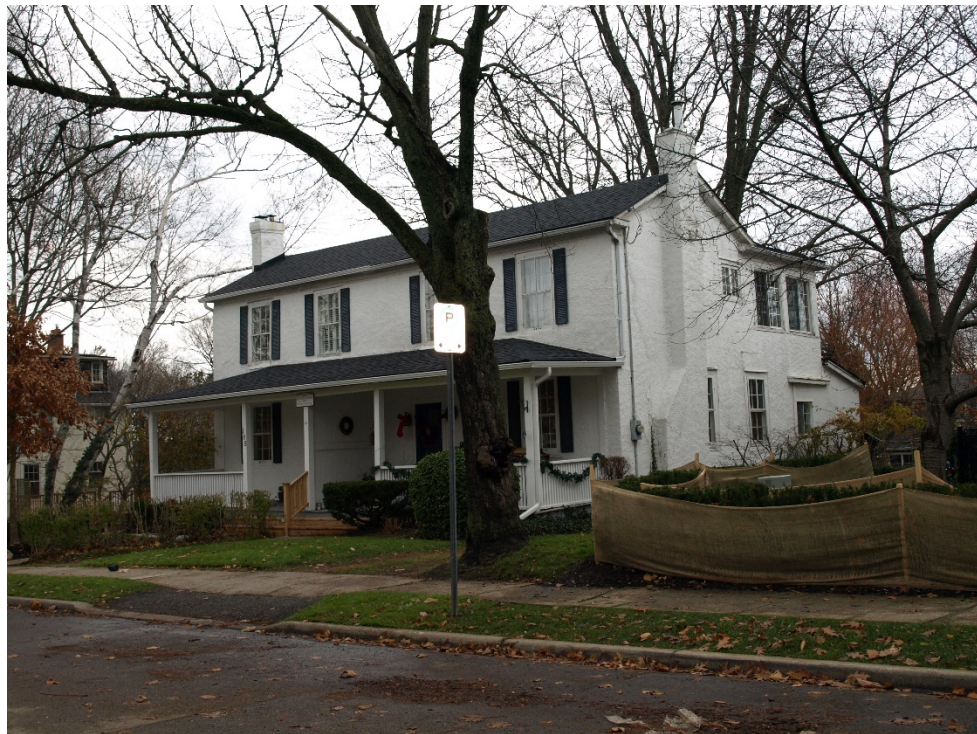
Photos:
2021

- Style: 19th century vernacular
- Medium pitch side gable roof
- Two-storey, multiple sections. Shared, one-storey open front porch, across the majority of the front façade of both 186 and 188 William Street.
- Four bay front façade, two bays per unit. Offset front entryway.
- Front façades of the two homes are symmetrically laid out, and as such references Georgian style architecture.
- Six-over-six windows, flanked by decorative wood shutters on the front façade. Four-over-four wood storm windows.
- Rough cast stucco clad
- Single stack brick chimney on the side façade clad in stucco

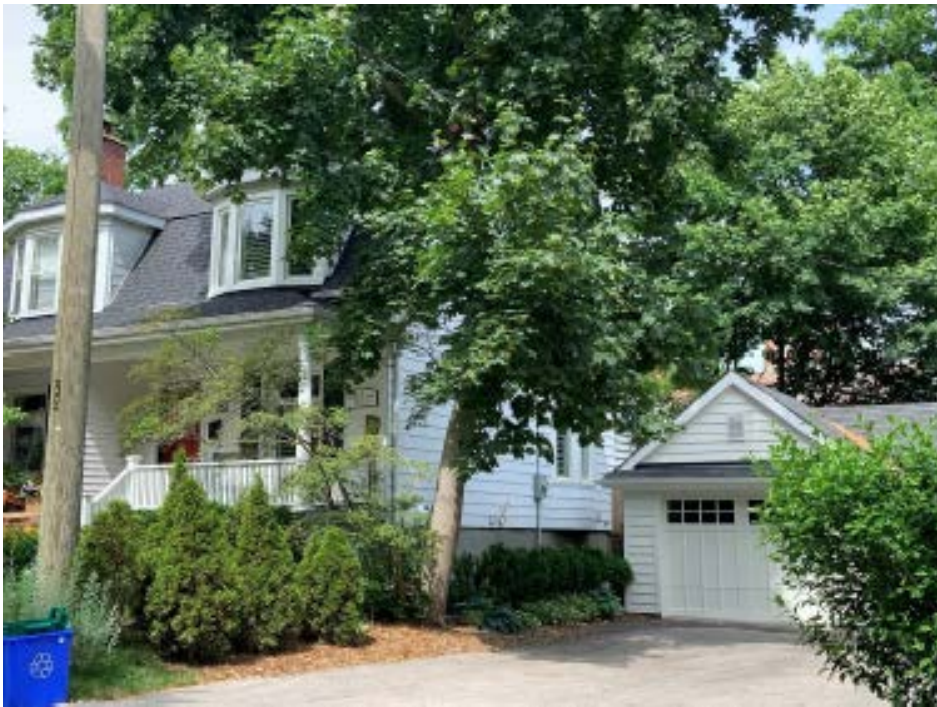
Photos:
2021

- Style: Early 20th century Vernacular
- Gambrel roof with projecting dormer
- One and a half storey
- Front porch facing William Street
- Side porch on west elevation
- Horizontal wood siding
- Contemporary windows

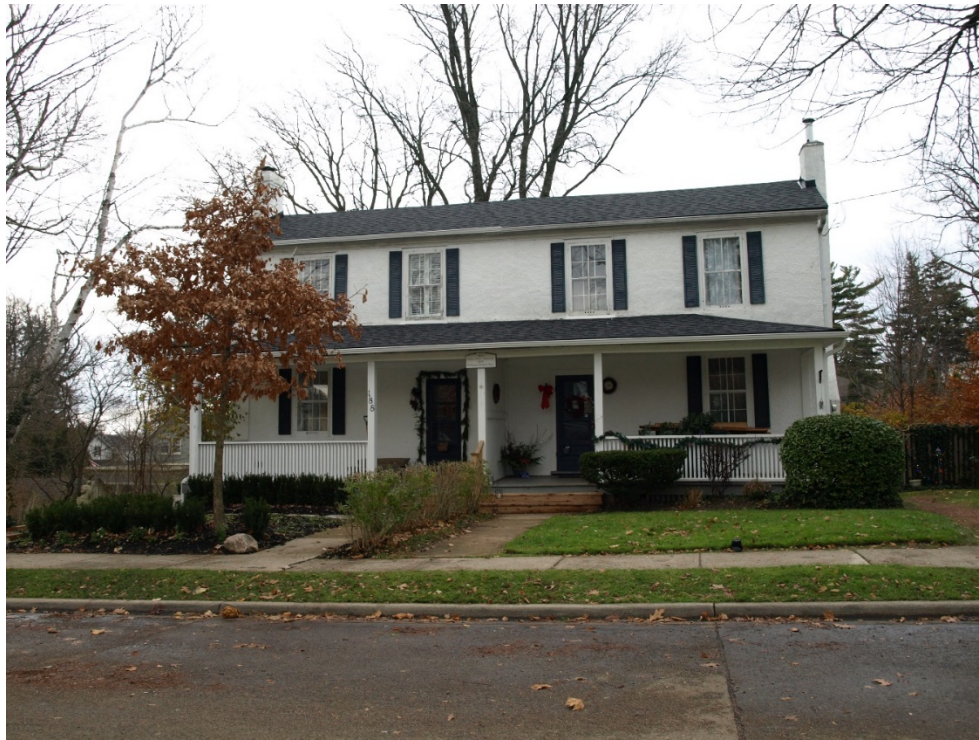
Photos:
2021

- Style: 19th century vernacular
- Medium pitch side gable roof
- Two-storey, multiple sections. Shared, one-storey open front porch, across the majority of the front façade of both 186 and 188 William Street.
- Four bay front façade, two bays per unit. Offset front entryway.
- Front façades of the two homes are symmetrically laid out, and as such references Georgian style architecture.
- Six-over-six windows, flanked by decorative wood shutters on the front façade. Four-over-four wood storm windows.
- Rough cast stucco clad
- Single stack brick chimney on the side façade clad in stucco

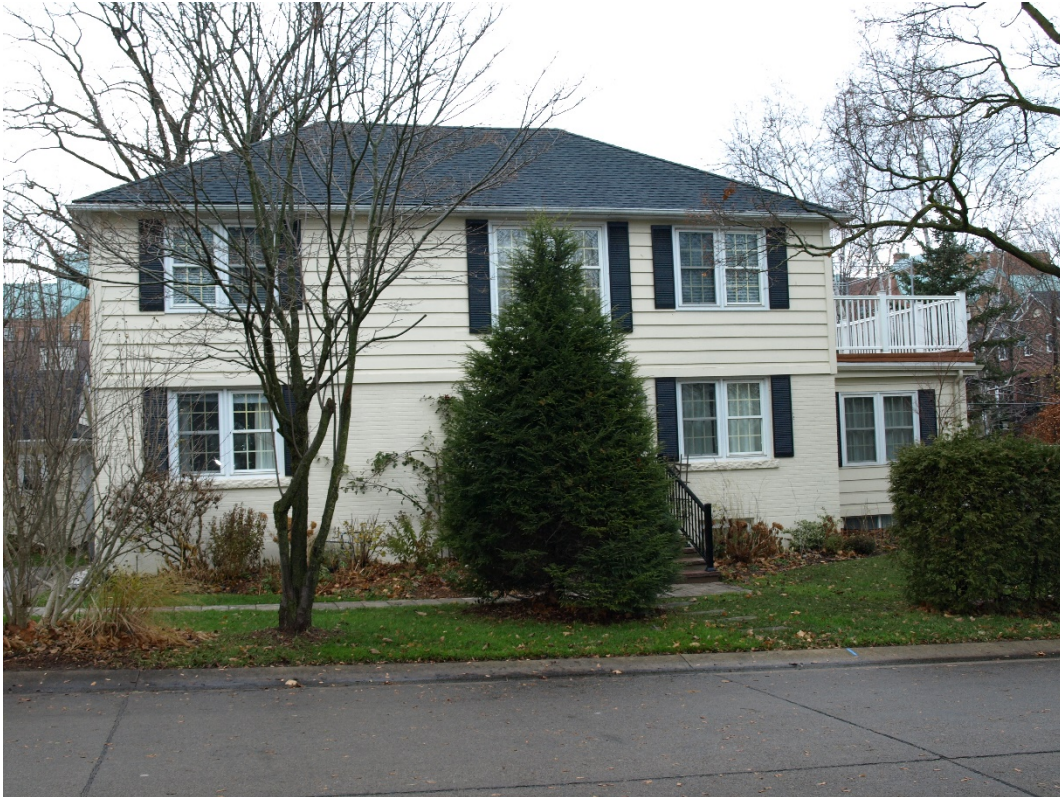
Photo:
2021

- Style: Late 20th century vernacular
- Two storey
- Painted brick first storey; horizontal wood siding second storey
- Hipped roof
- Six over six windows contemporary windows with non-functioning shutters
- One-storey flat roof addition to east with porch railing

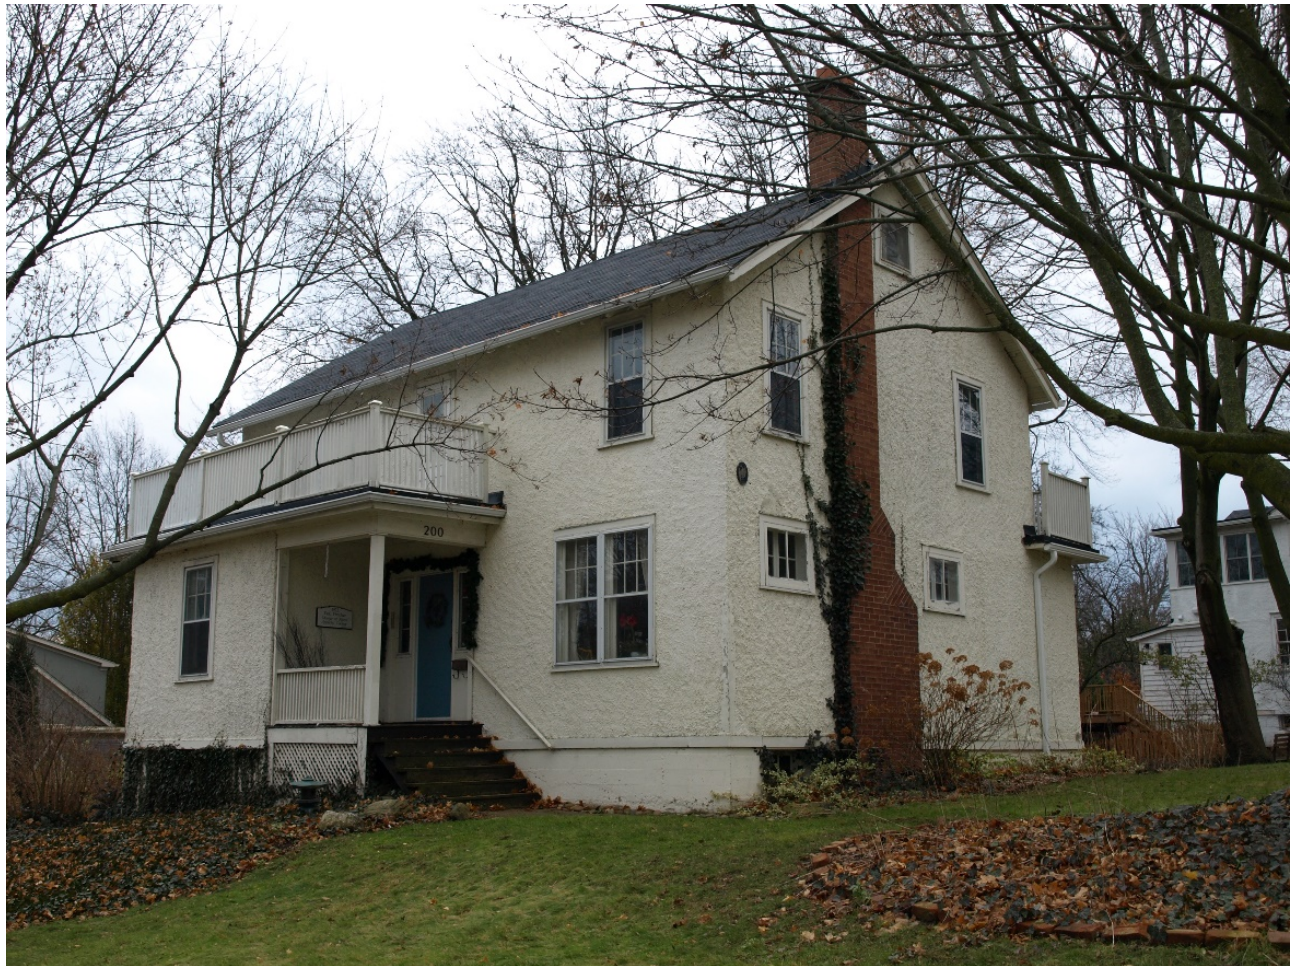
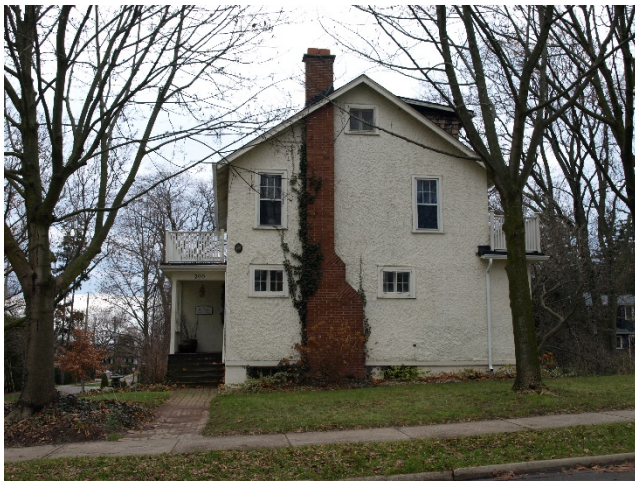
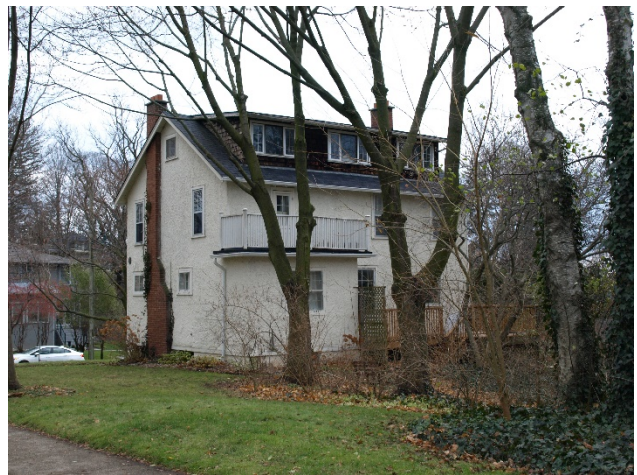
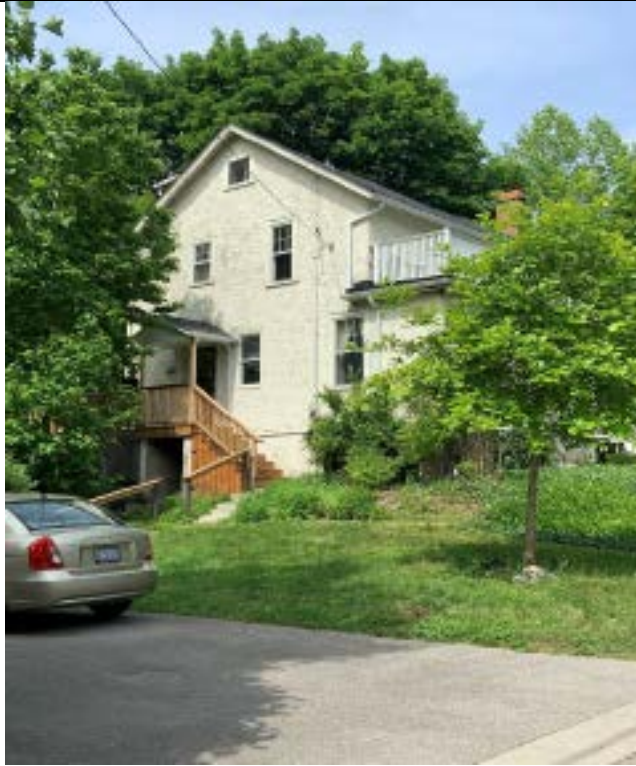
- Style: Early 20th Century Vernacular
- Side gable roof, with a large shed dormer, clad in wood shingles, at the back of the house (west elevation)
- Two-and-a-half storeys

- Symmetrical front façade, obscured by a one-storey front section leading to the front entryway.
- The roof of the one-storey addition serves as an open verandah accessed from a door on the second-storey.

- Centrally located front entryway, protected by the second storey verandah.
- Front door is a simple single panel with sidelights.
- Small one-storey section at the rear (west) façade, with another small open verandah accessed from a door on the second-storey.

- Rough cast stucco clad
- Red brick chimney with decorative brick work
