OAKVILLE HERITAGE INVENTORY SHEET

Address: 56 Water Street

Name: Oakville Club/ Granger's Warehouse

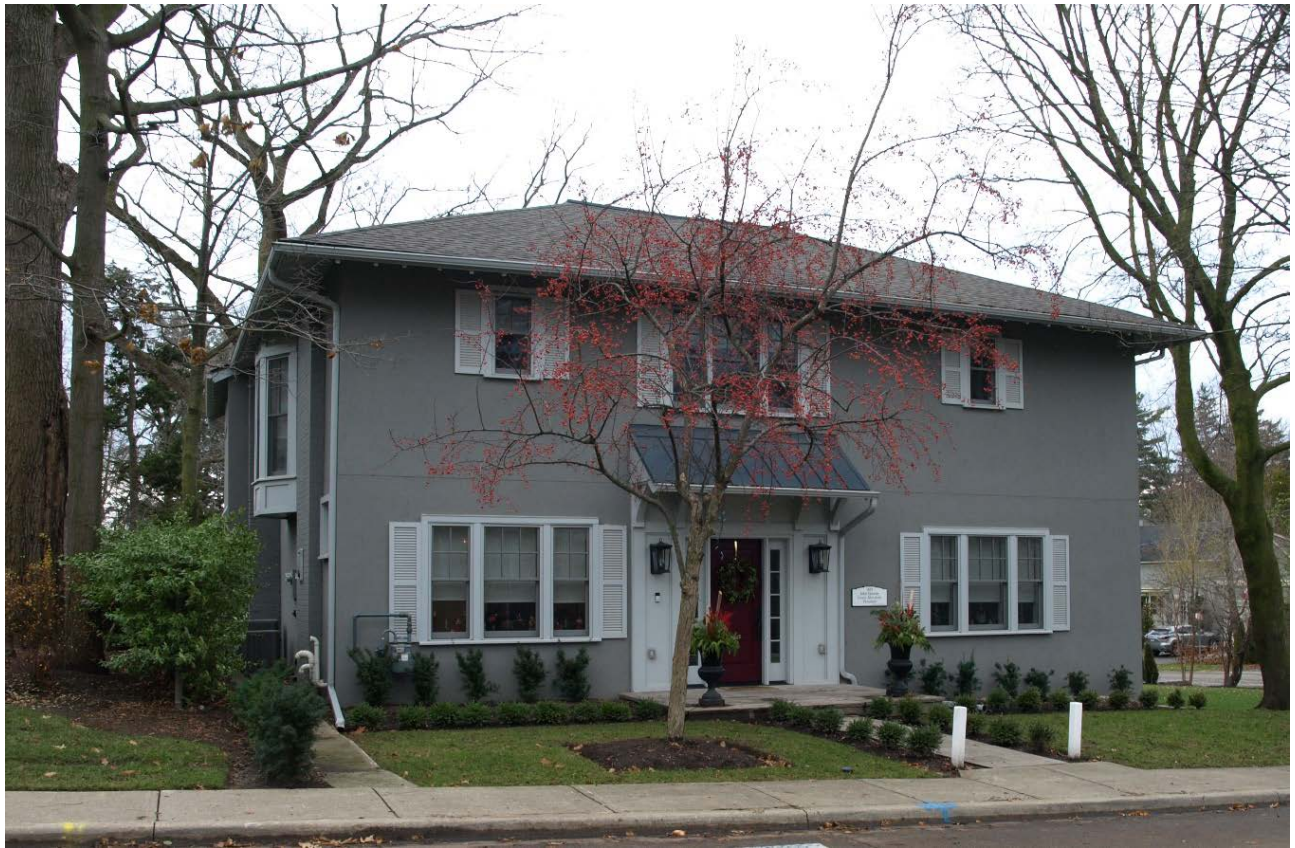
- Style: 19th century vernacular with multiple additions
- Hip roof, with hipped roof dormers.
- Two storey, predominantly square massing, with additions (one-storey to the west and one-and-a-half storeys to the south).
- Front facade is a 3-bay configuration, with the entryway centrally placed. Single pane front door with sidelights, protected by an overhang.

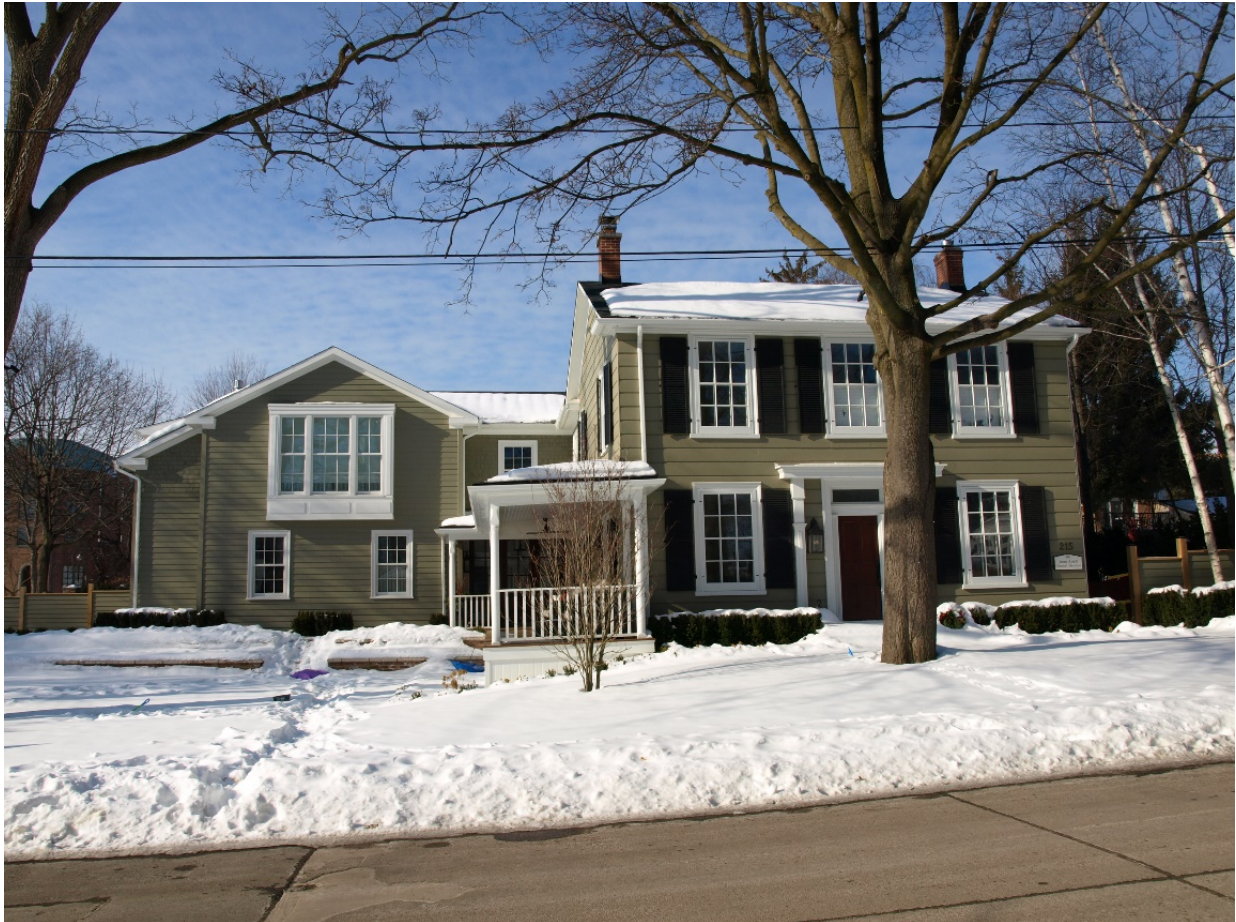
Photos:
2021

- Style: Georgian Revival with early 21st century additions
- Moderately pitched, side gable roof
- Two storeys

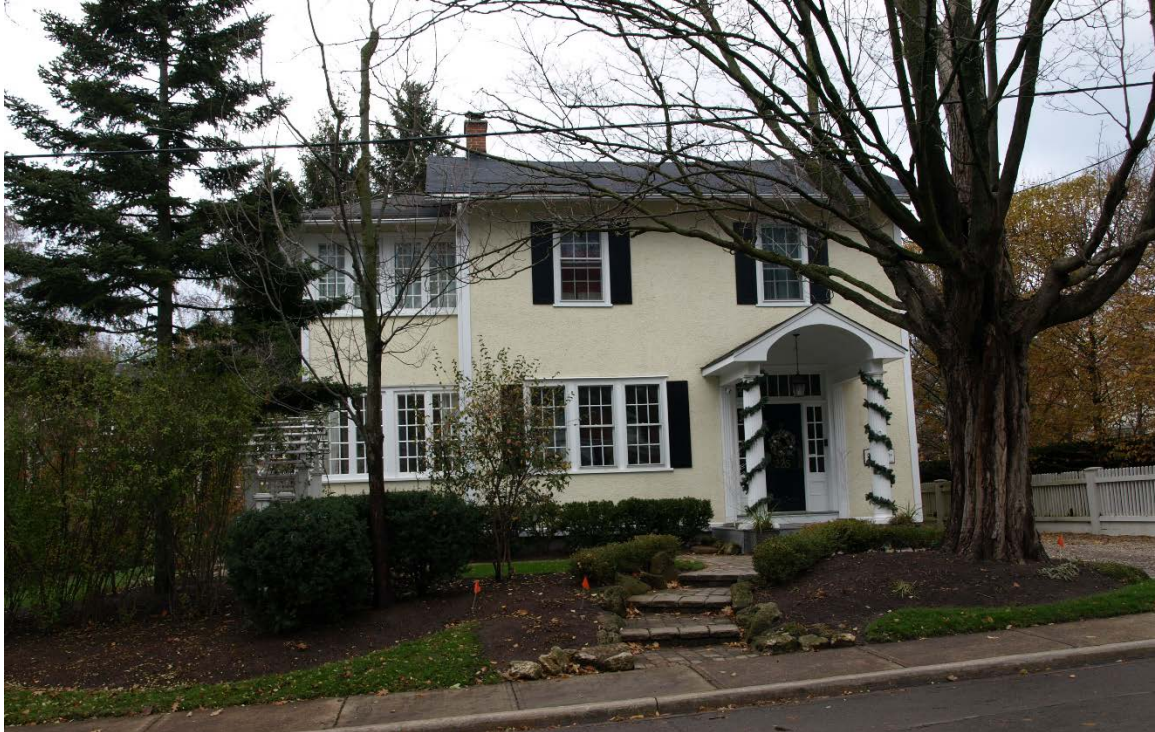
Photo:
2021

- Style: 19th Century Vernacular
- Gable roof
- Two storeys
- Six over six windows with non-functioning shutters
- Main entryway with sidelites and transom
- Portico over main entryway with columns
- Two-storey addition to the west (pre 1982 District Plan) with contemporary fenestration and cladding

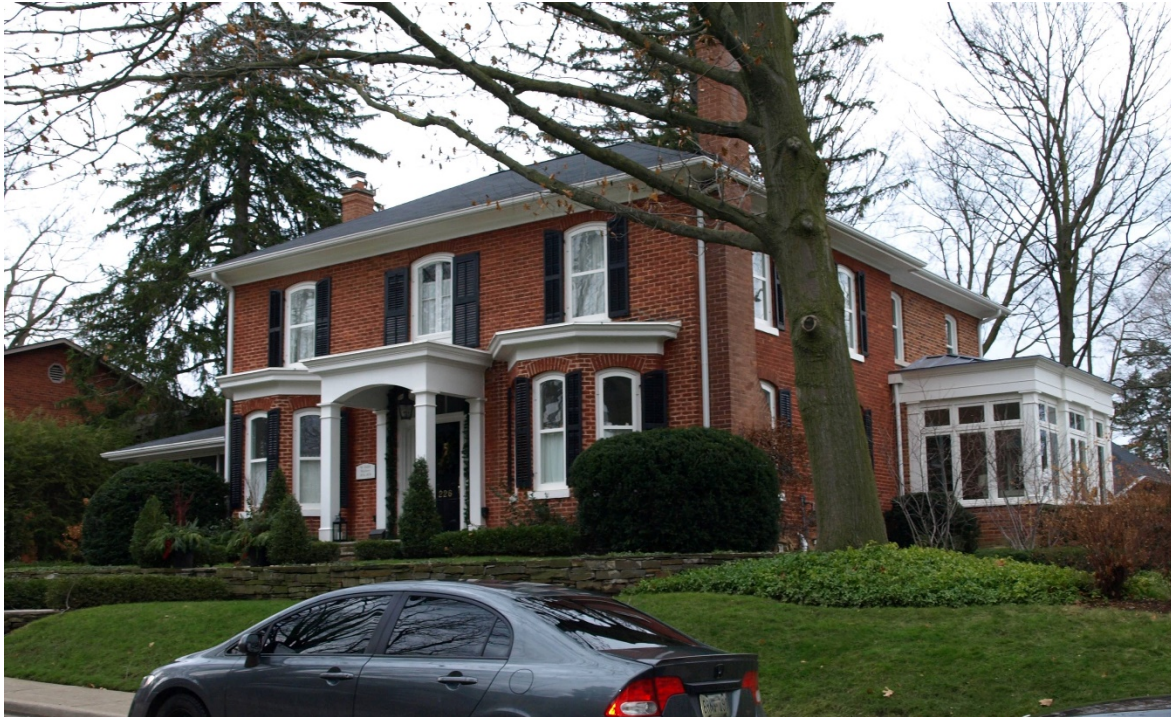
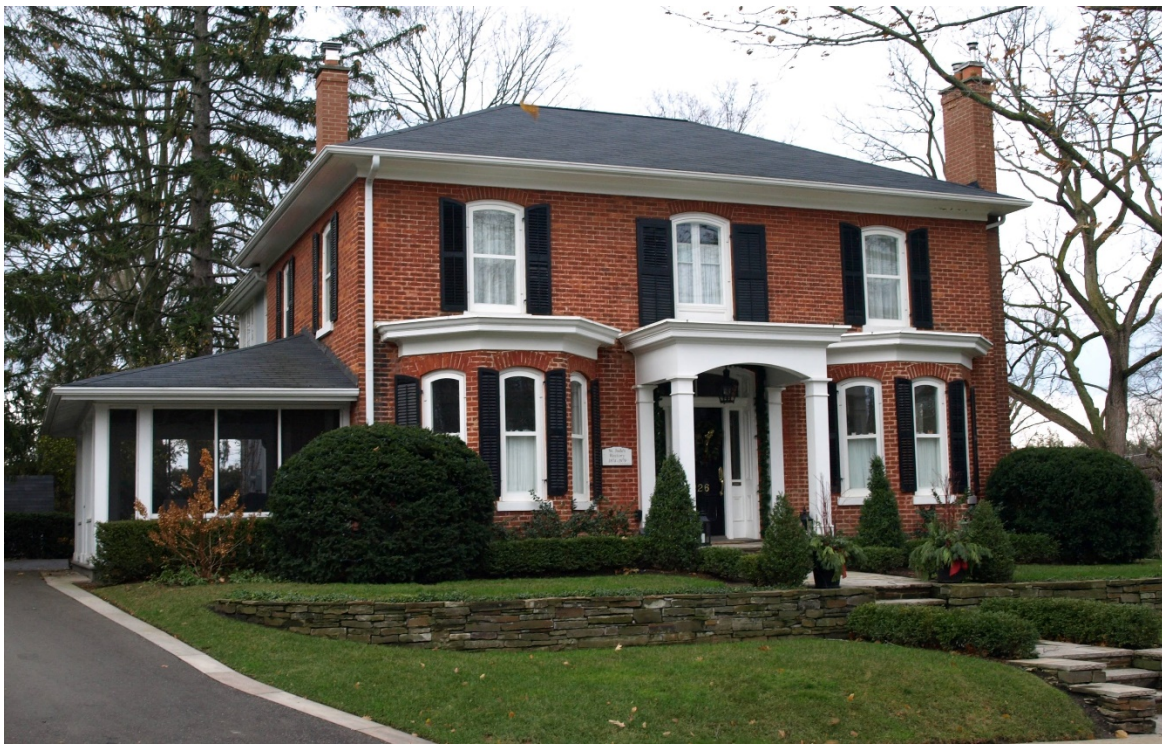
Photos:
2021

- Style: Classical Revival
- Hip roof
- Two storey
- Large, three-bay structure, with centrally located front entryway, flanked by two projecting bay windows. Front entryway is a restoration that was completed in 2016.

- It was restored to its original condition, based on photographic evidence, removing an enclosed porch which was built in the 1940s.
- The single panel front door is embellished by a segmented transom and sidelights, all of which is topped by a segmental arch brick header. The entryway is accessed by a stone pathway and stairs. The front door is sheltered by a small, flat roofed porch, and supported by square pilasters and columns.

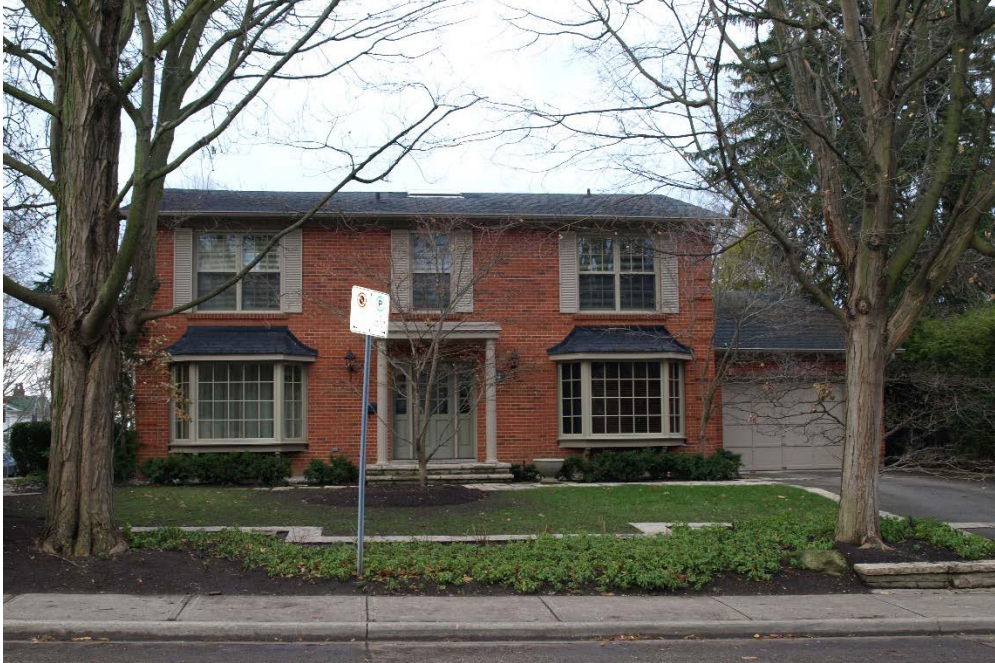
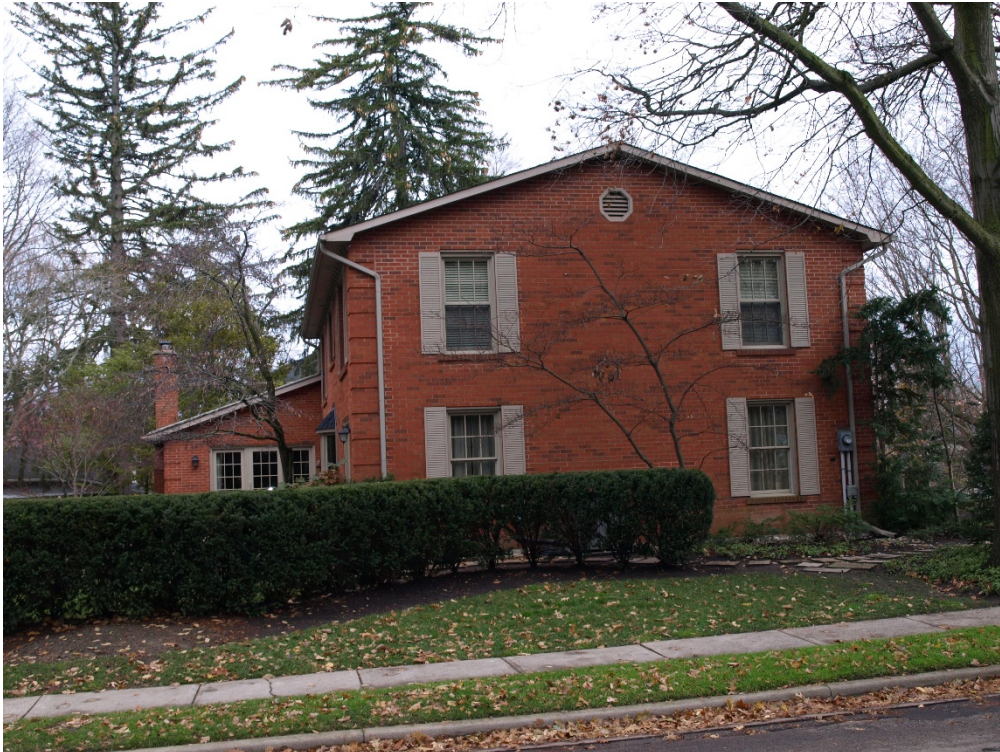
Photos:
2021

- Style: New Traditional
- Gable roof
- Two storey
- Three bay with central entryway with pediment
- Symmetrical bay windows on the first floor
- Double hung six-over-six windows
- One storey addition on rear elevation
- Brick cladding

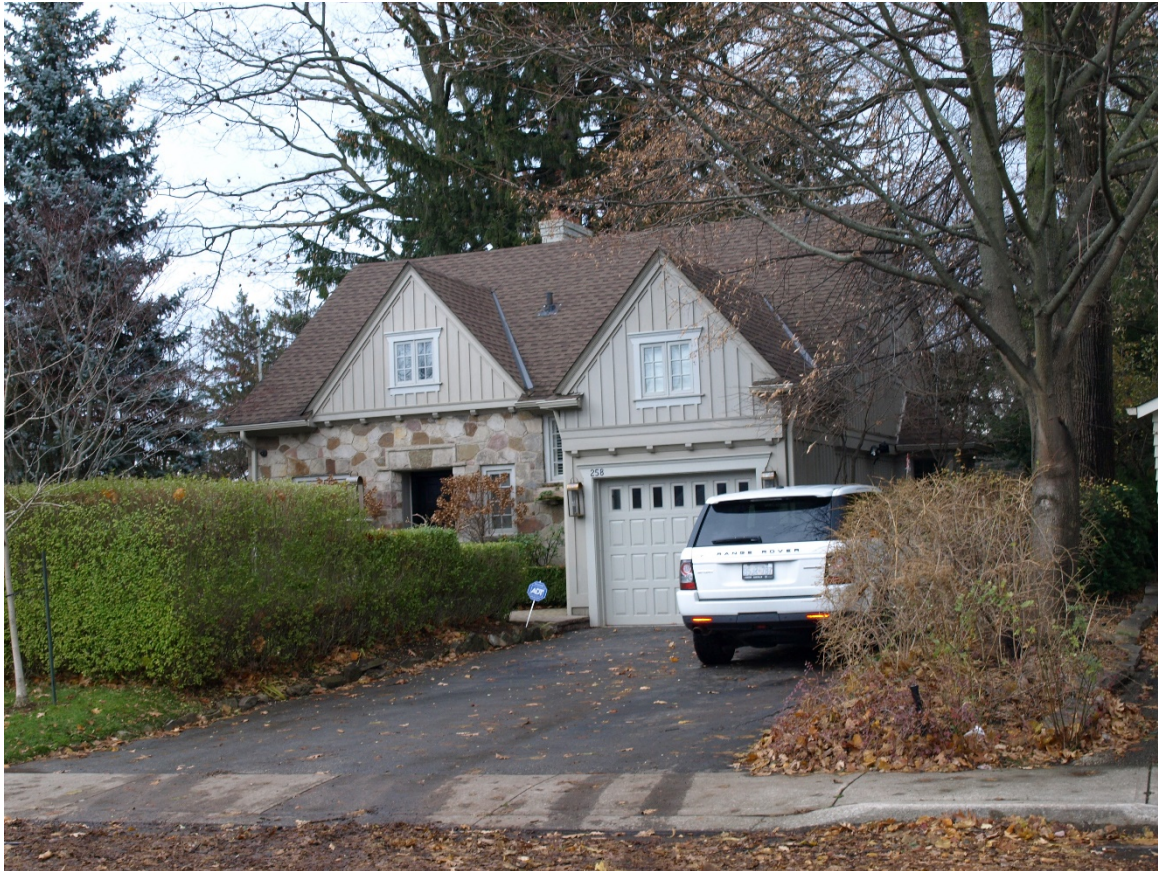
Photos:
2021

- Style: Mid-20th century vernacular
- Gable roof with asphalt shingles
- One and a half storey
- Stone veneer cladding on first storey
- Two gable wall dormers clad in board and batten siding
- Attached single car garage projects forward slightly

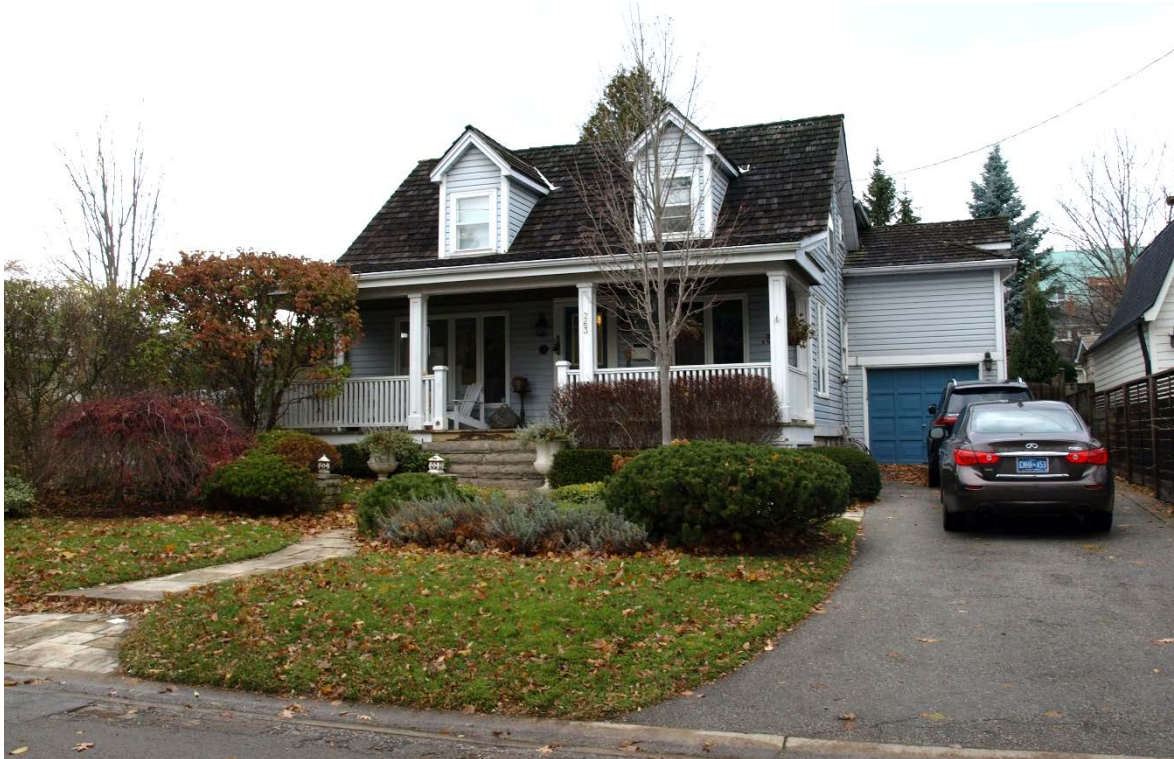
Photos:
2021

- Style: Cape Cod Revival
- Cedar shake side gable roof with symmetrical dormers
- One and a half storey
- Horizontal wood siding
- Dormers have one-over-one sash windows
- Main windows are contemporary large pane
- Covered porch with simple railing
- Attached one and a half storey single car garage

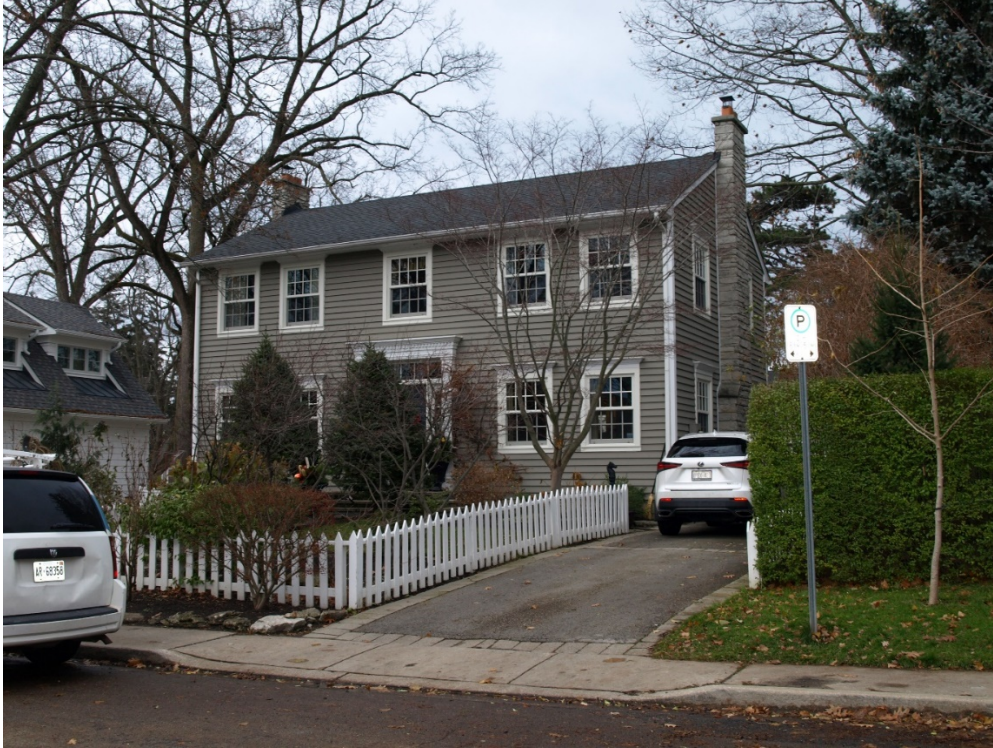
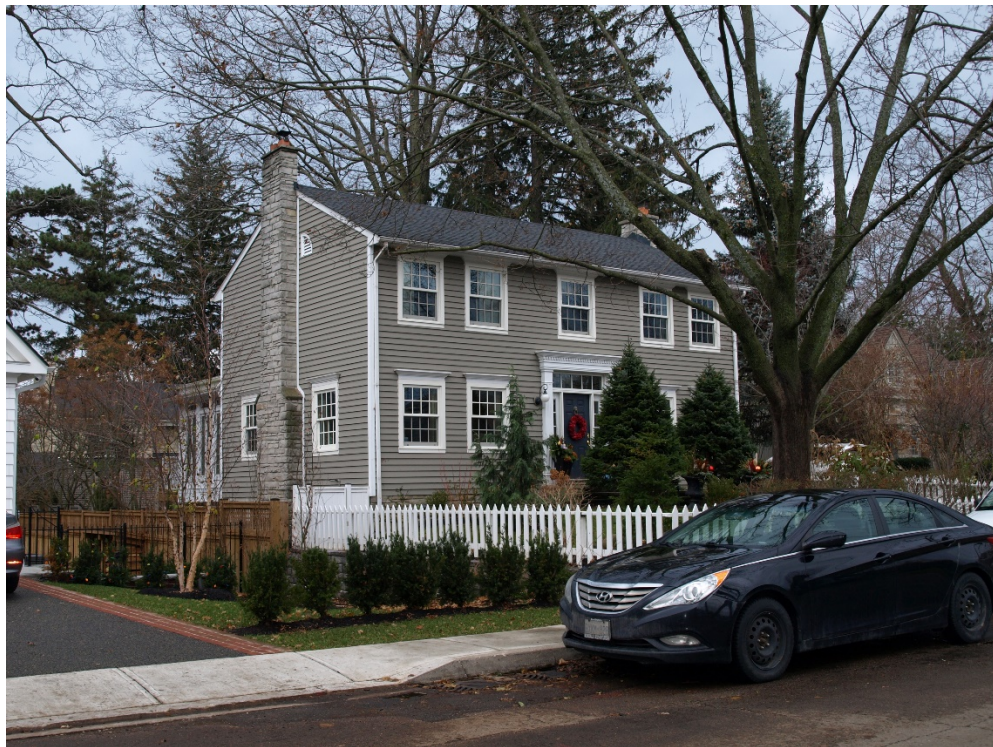
Photos:
2021

- Style: New Traditional
- Side gable roof
- Two storey with one storey rear section
- Symmetrical, five bay front façade
- Centrally located front entryway with decorative door surround with dentil moulding and pilasters
- Single pane door topped by a multi-pane transom window, flanked by multi-pane sidelights
- Eight-over-eight double hung windows
- Wood clapboard siding
- Two stone clad chimneys
- White picket fence fronting on William Street

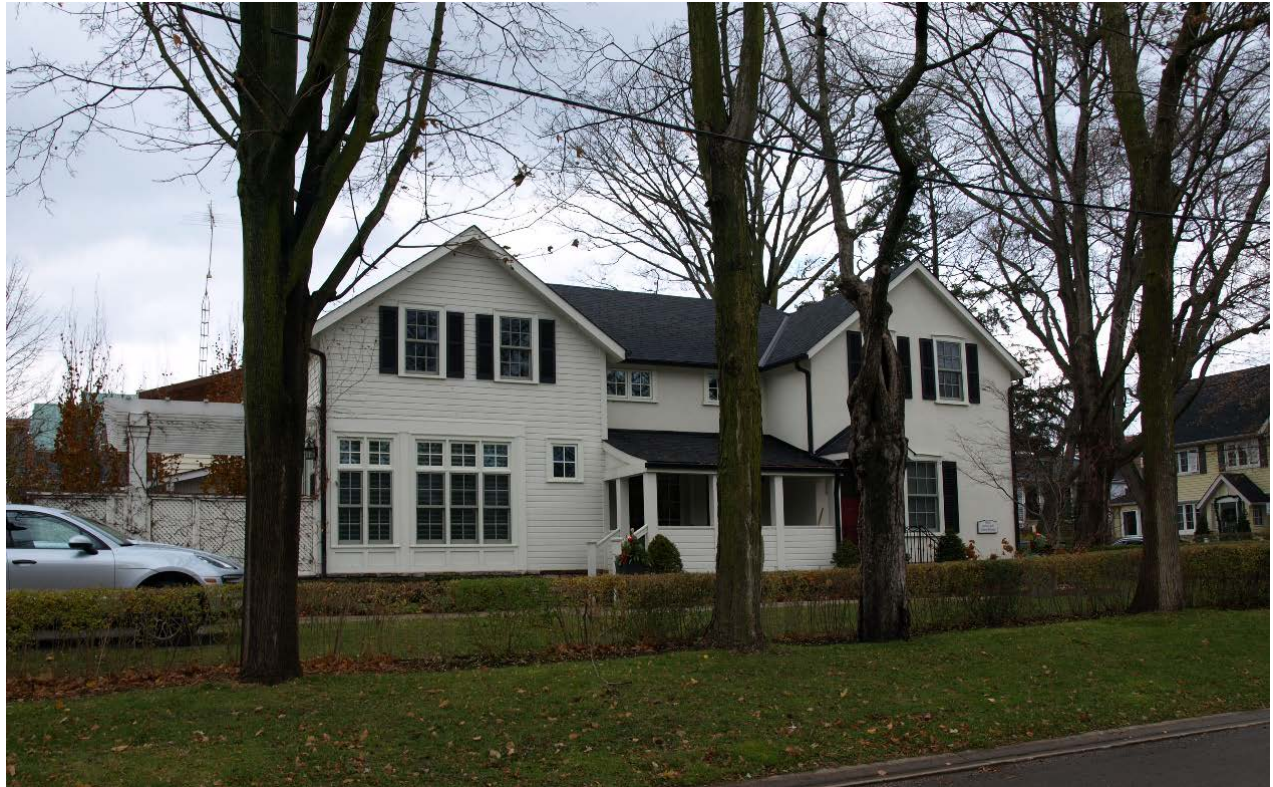
Photos:
2021

- Style: 19th century vernacular
- Medium pitch cross gable roof with asphalt shingles
- One-and-a-half storey
- Large, multiple section building with a small open verandah between the earlier section and the 21st century addition
- Off-centre entryway on William Street protected by a small porch.
- West addition constructed in 2010s.

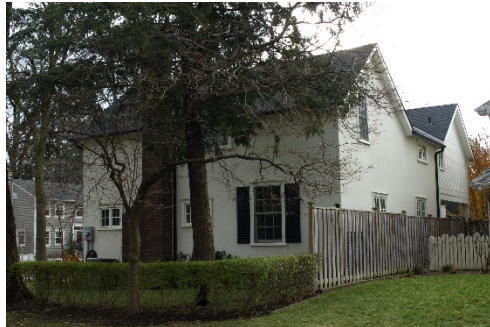
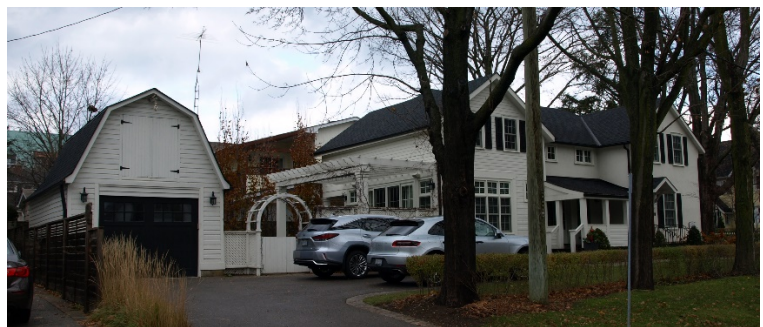
- A combination of windows including six-over-six sash, four pane casements, and four-over-four sash, capped by 4 four pane transom lights. None appear original. Six-over-six windows include shutters
- Rough cast stucco cladding on historic portion and horizontal shiplap wood cladding on west addition
- Red brick chimney on east elevation
- Historic gambrel roof barn located to the west of the residence, converted into garage.

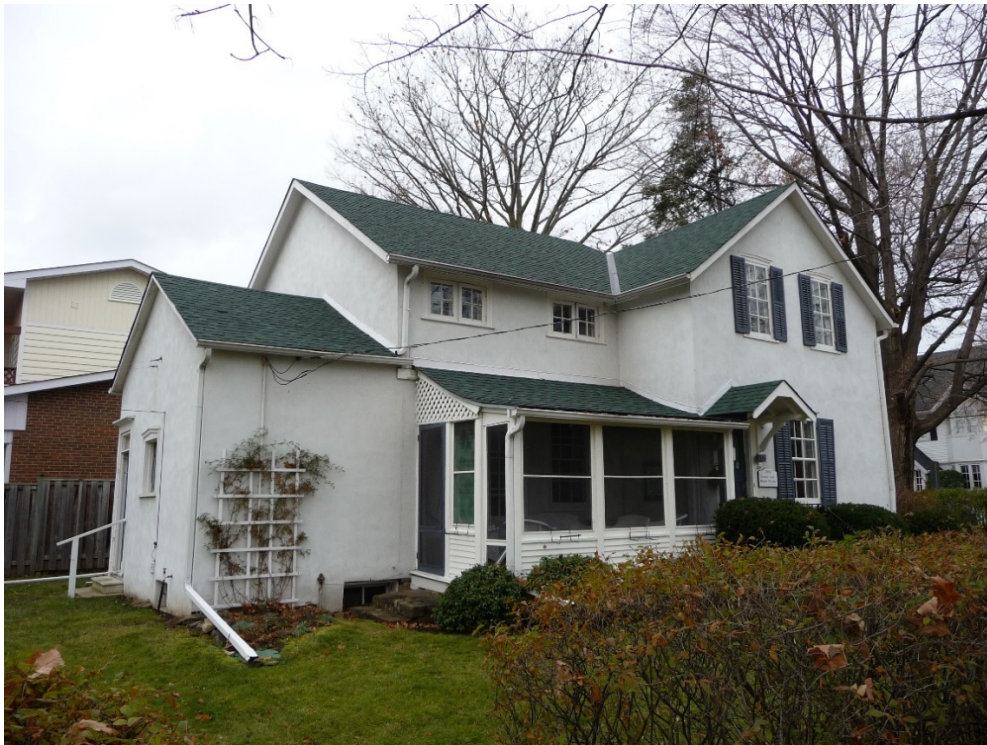
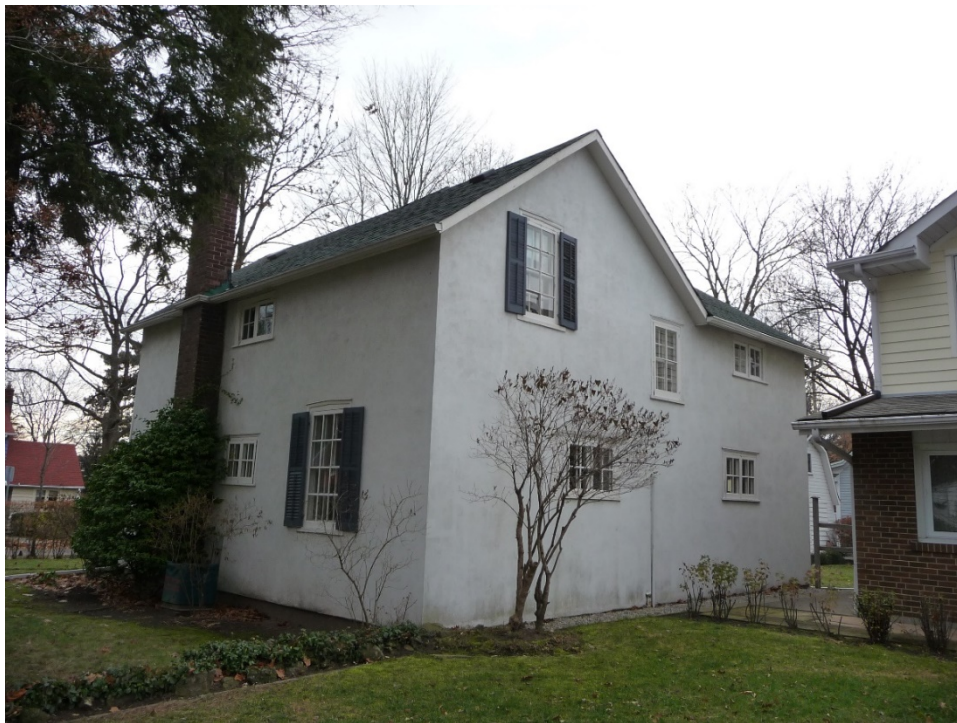
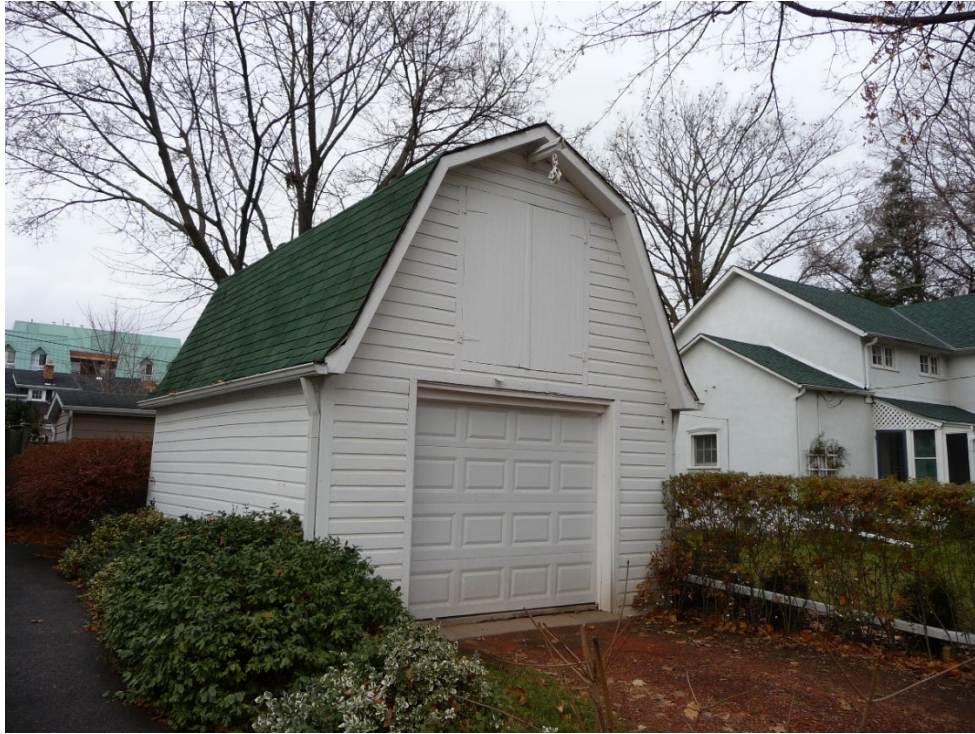
2008

The veranda set in the corner of this asymmetrically planned house has been enclosed but otherwise the building maintains the essence of its original character

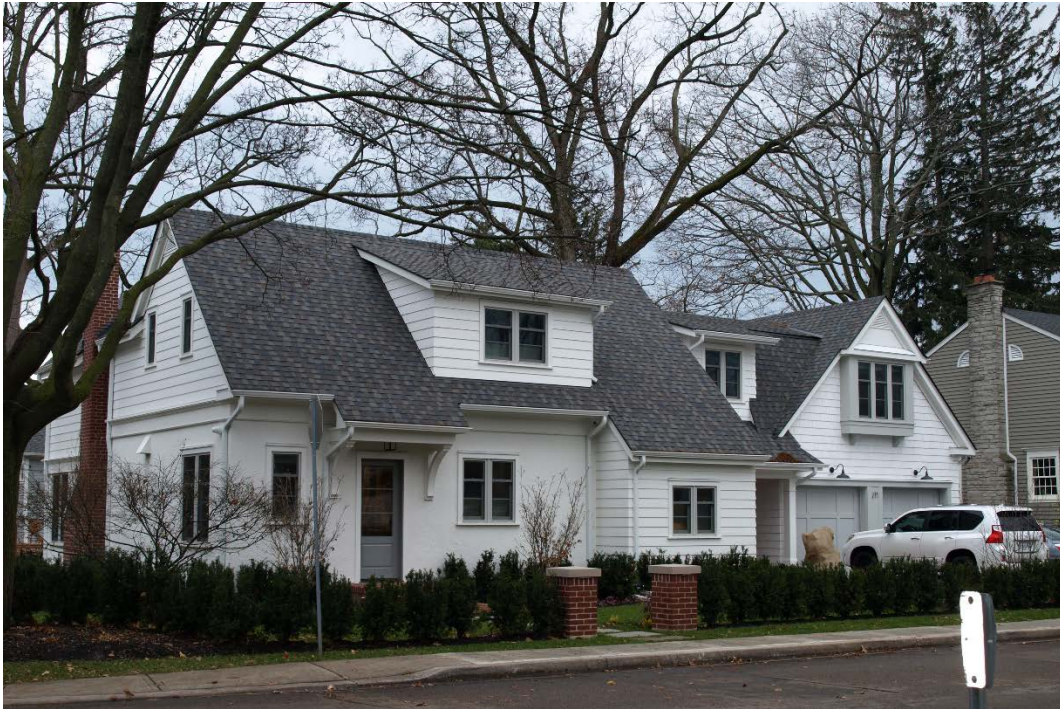
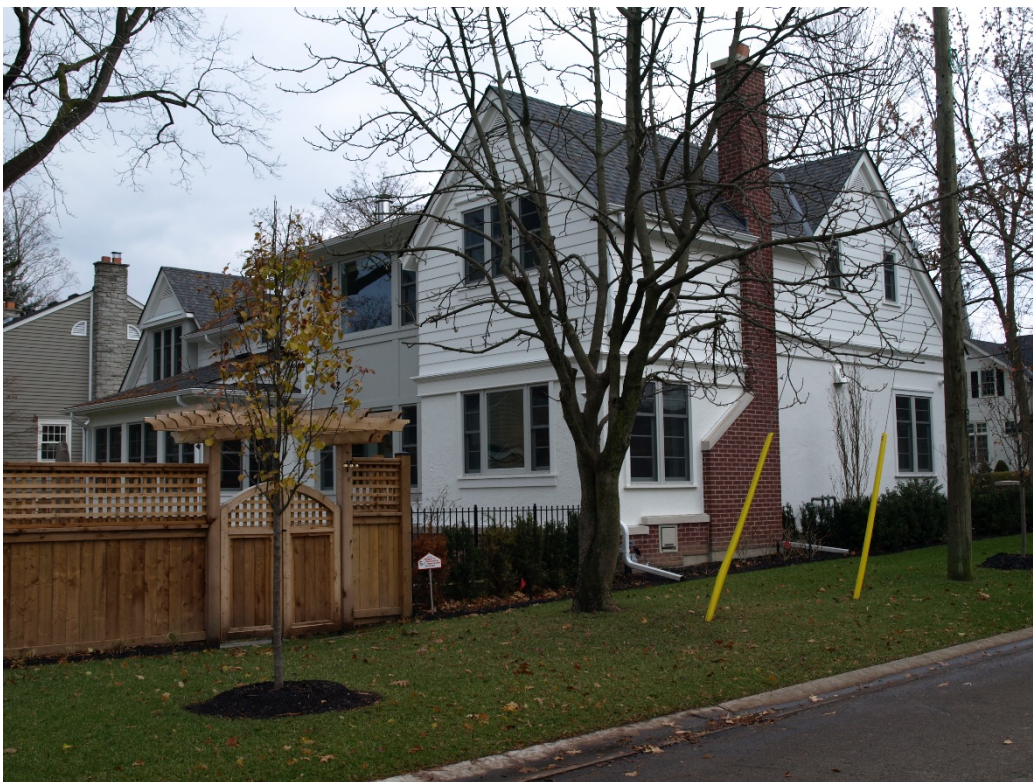
Photos:
2021

- Style: New Traditional
- Eastern portion of home is a replica of earlier building on property
- Gable roof with shed dormers
- One and a half storeys
- Stucco and horizontal wood siding
- Attached two car garage
- Red brick chimney

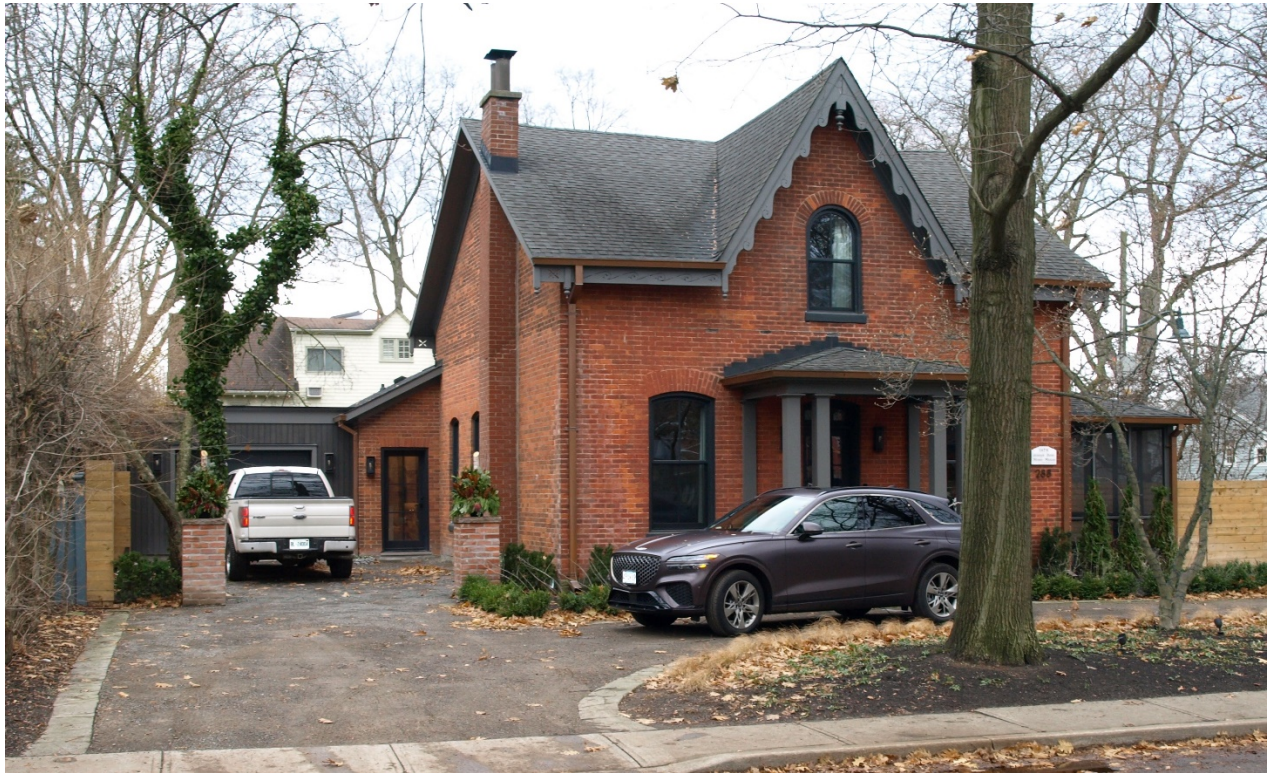
2021

- Style: Gothic Revival
- Steeply pitched side gable asphalt roof
- One-and-a-half storey, with one-storey sections
- Symmetrical three bay front façade with centrally located entrance
- Doors are topped by segmentally arched door openings
- Small front porch supported by square posts and pilasters

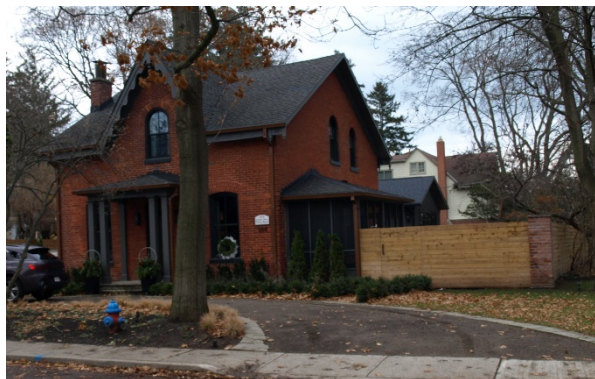
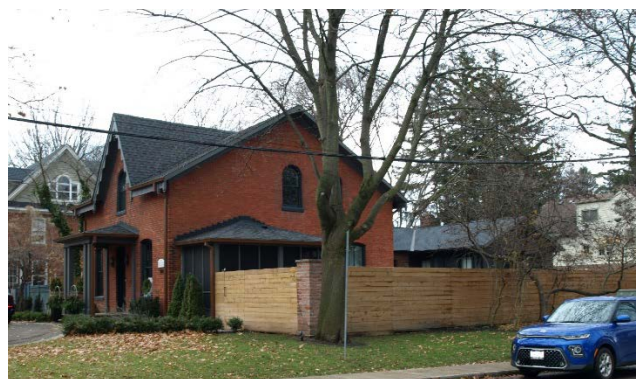
- Decorative fretwork bargeboard and drop pendants.
- Small, lean-to style side door entryway located at back of the building
- Flat roof single car garage with board and batten siding is attached to the lean-to entryway
- Two-over-two round-headed gable windows, topped by segmentally arched brick headers.
- One storey screened porch on west elevation
- Brick cladding with vertical wood siding on rear additions
- Brick chimney

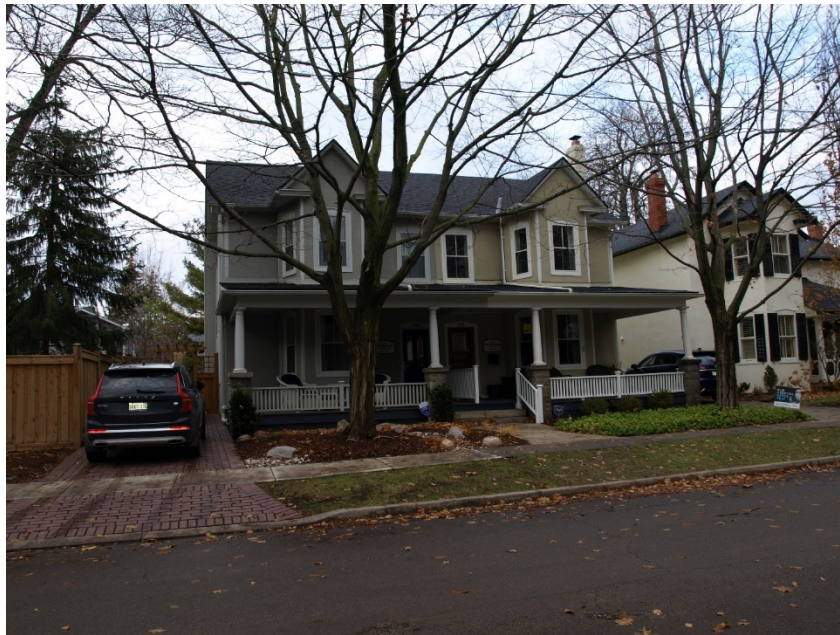
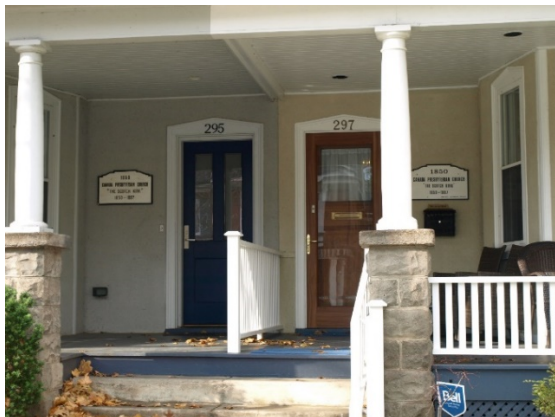
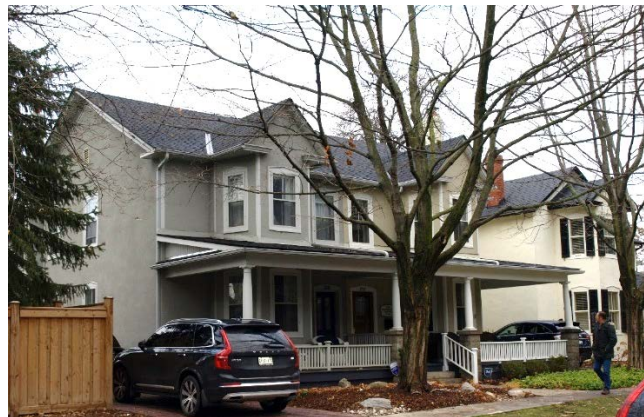
- Style: 19th century vernacular
- Side gable roof clad in asphalt shingles broken by a front facing gabled wall dormer
- Two storey
- Semi-detached building. Two bay front façade, with offset front entryway.
- Mirrored in 297 William Street.
- Covered front porch with deep balcony.
- Front façade includes two-storey projecting bay windows.
- Later two storey addition to the rear
- Stucco clad

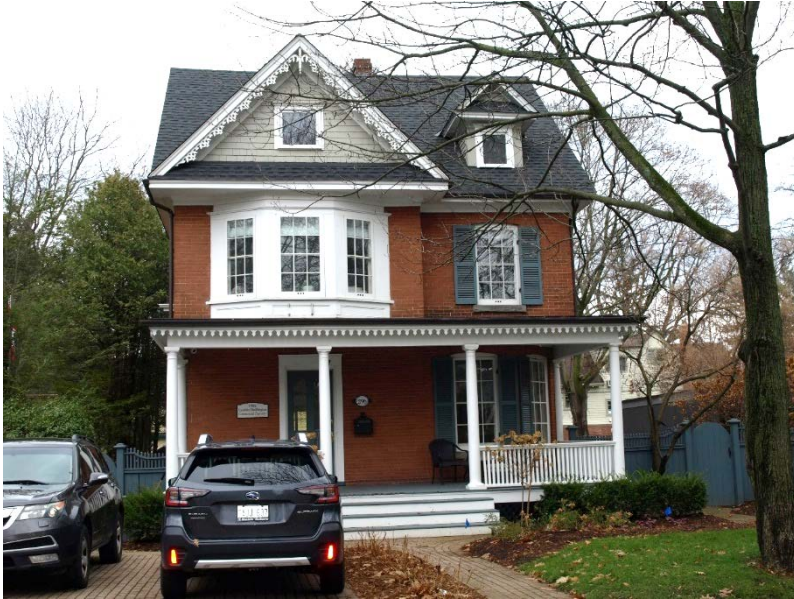
Photo:
2021

- Style: Early 20th Century Vernacular with Queen Anne details
- Side gable asphalt shingle roof with front facing wall gable
- Two and a half storeys
- Six over six windows with functioning shutters
- Second storey bay window projecting over front porch
- Contemporary windows in dormers
- Front door offset to left
- Front porch with dentils and columns wraps around to west elevation
- Masonry brick walls
- Pediment with bargeboard
- Rear two storey addition circa 2000- clad in horizontal wood siding

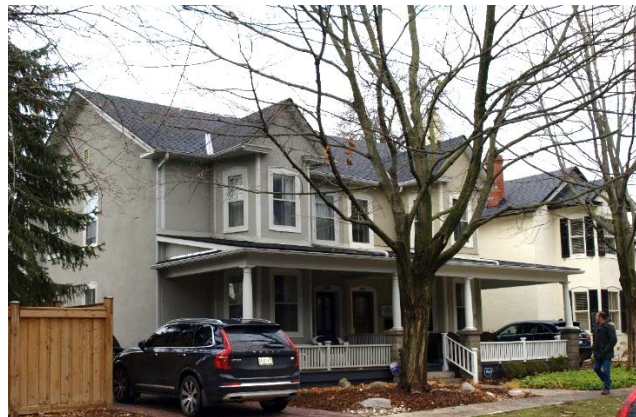
- Style: 19th century vernacular
- Side gable roof clad in asphalt shingles broken by a front facing gabled wall dormer
- Two storey
- Semi-detached building. Two bay front façade, with offset front entryway.
- Mirrored in 295 William Street.
- Covered front porch with deep balcony.
- Front façade includes two-storey projecting bay windows.
- Later one storey addition to the rear
- Stucco clad

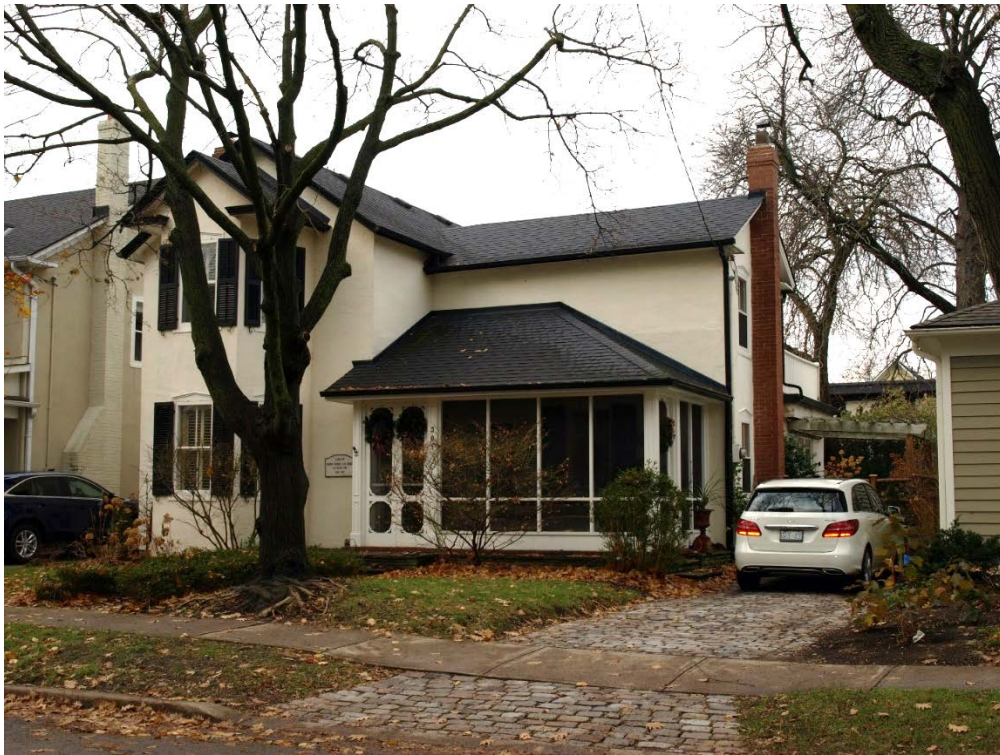
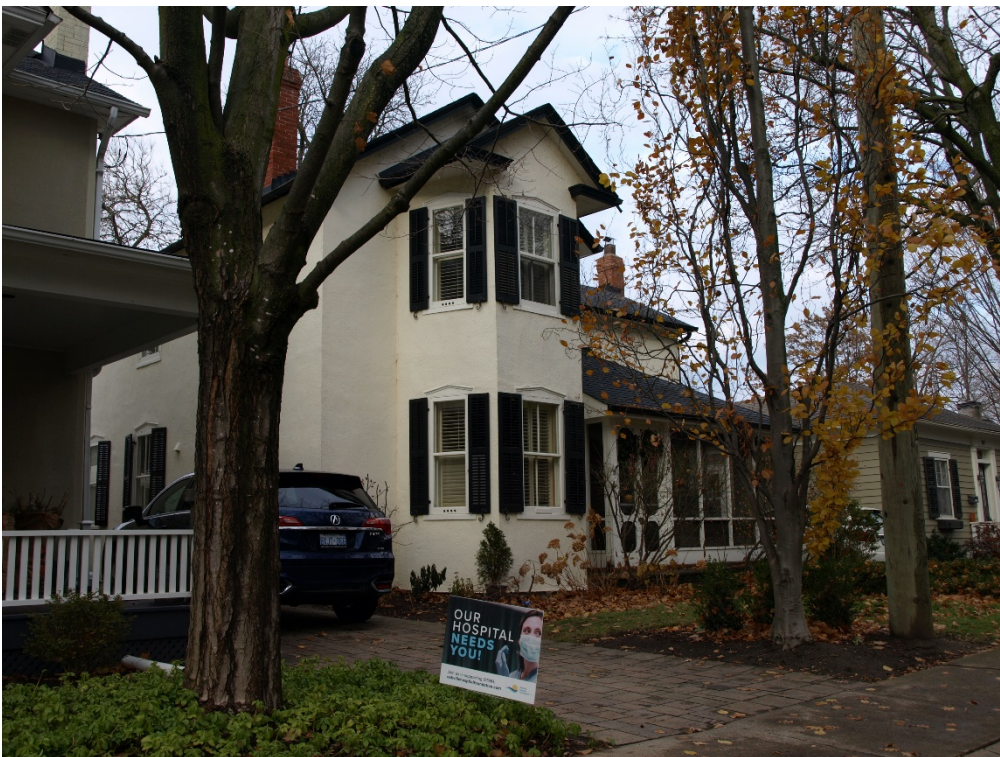
- Style: 19th century vernacular
- Cross gable roof with asphalt shingles
- Two storey
- Multiple sections, two storey projecting bay section with gabled roof and cornice returns
- Enclosed front porch is an addition pre-1960s
- Two-over-two windows, with decorative headers. Some windows have functioning shutters.
- Stucco clad
- Red brick chimneys
- One storey later rear addition with flat roof and wooden railing

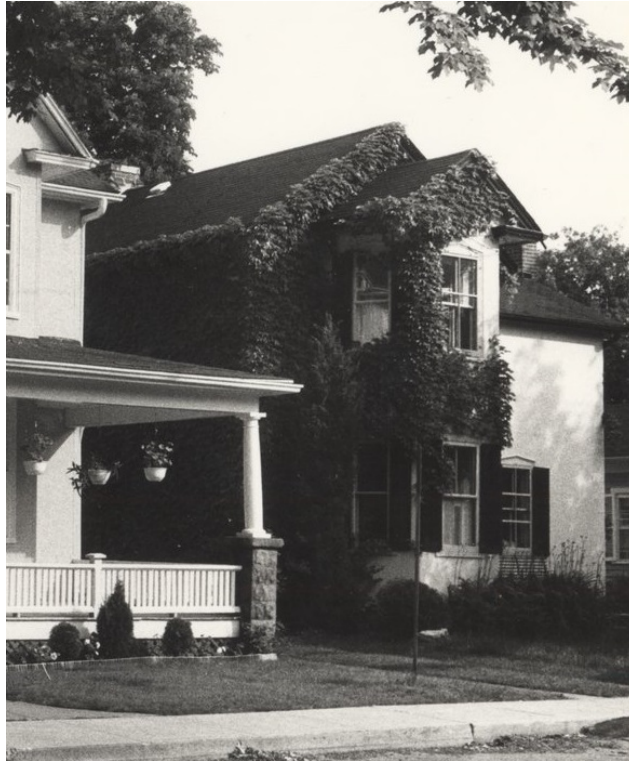
Pre 1960 (no porch addition)

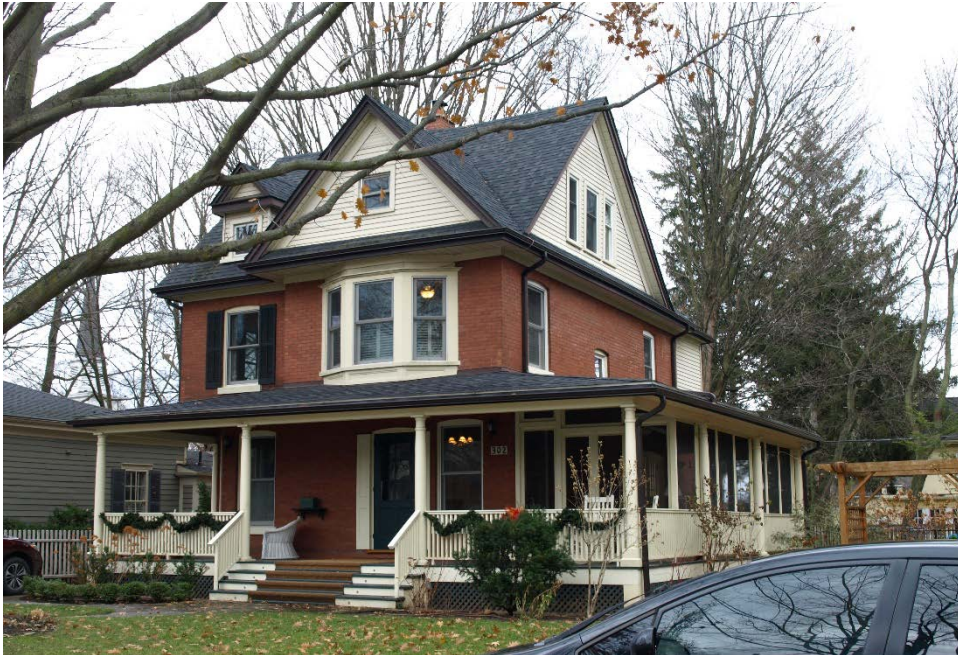
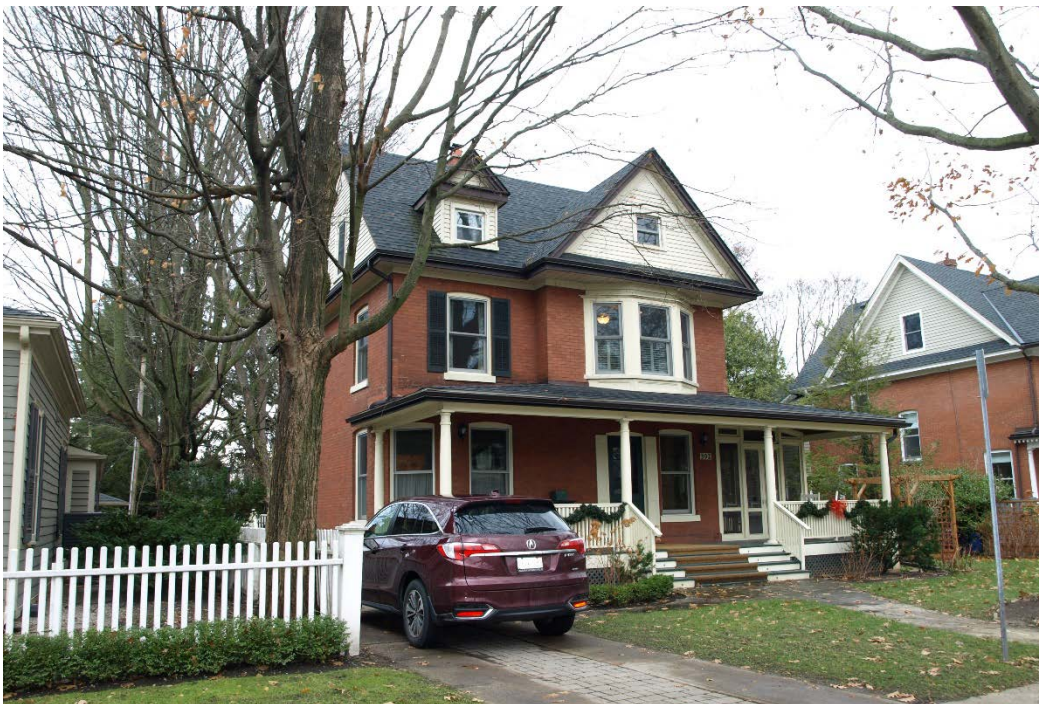
Photo:
2021

- Style: Early 20th Century Vernacular with Queen Anne details
- Cross gable roof with asphalt shingles
- Two and a half storeys
- Front door offset to the left
- One over one windows likely a contemporary alteration
- Masonry brick walls
- Wrap-around porch on front and partially enclosed verandah on west façade with columns
- Second storey bay window projecting over front porch
