OAKVILLE HERITAGE INVENTORY SHEET

Address: 56 Water Street

Name: Oakville Club/ Granger's Warehouse

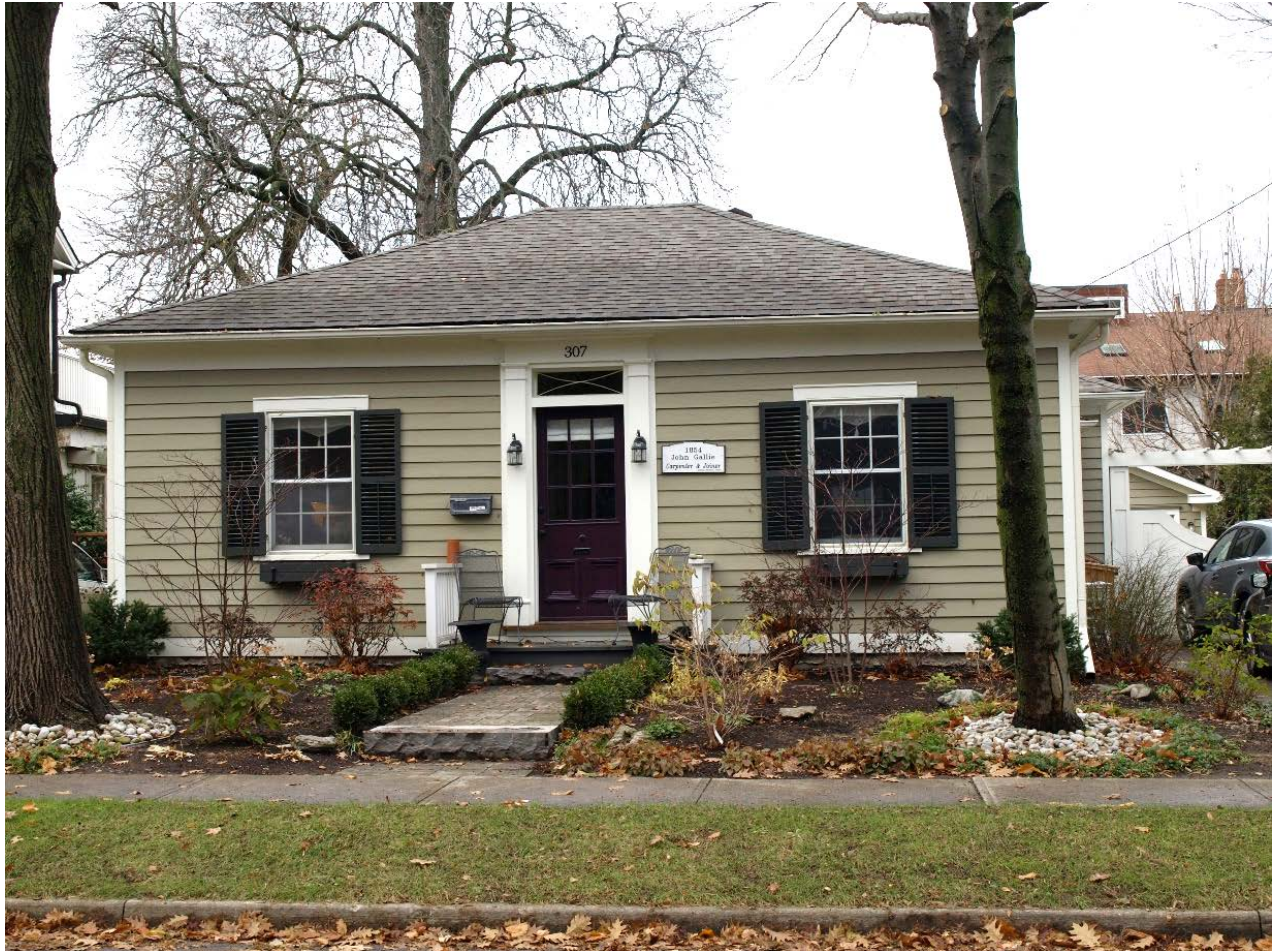
Photo:
2021

- Style: Regency Cottage
- Hipped roof
- One storey
- Small, square building laid out in a central hall plan.
- The symmetrical three-bay front façade houses a centrally located, single panel, wood and glass door with a transom, and a decorative surround containing matching gas lantern style lights.
- A stone pathway leads to a small door stoop with paired railings.
- A second entrance lies toward the back of this section, on the east façade. It is protected by a door overhang supported by simple brackets.
- There is a one storey rear addition on the east side of the house.
- Six-over-six windows with functioning shutters
- Horizontal wood cladding

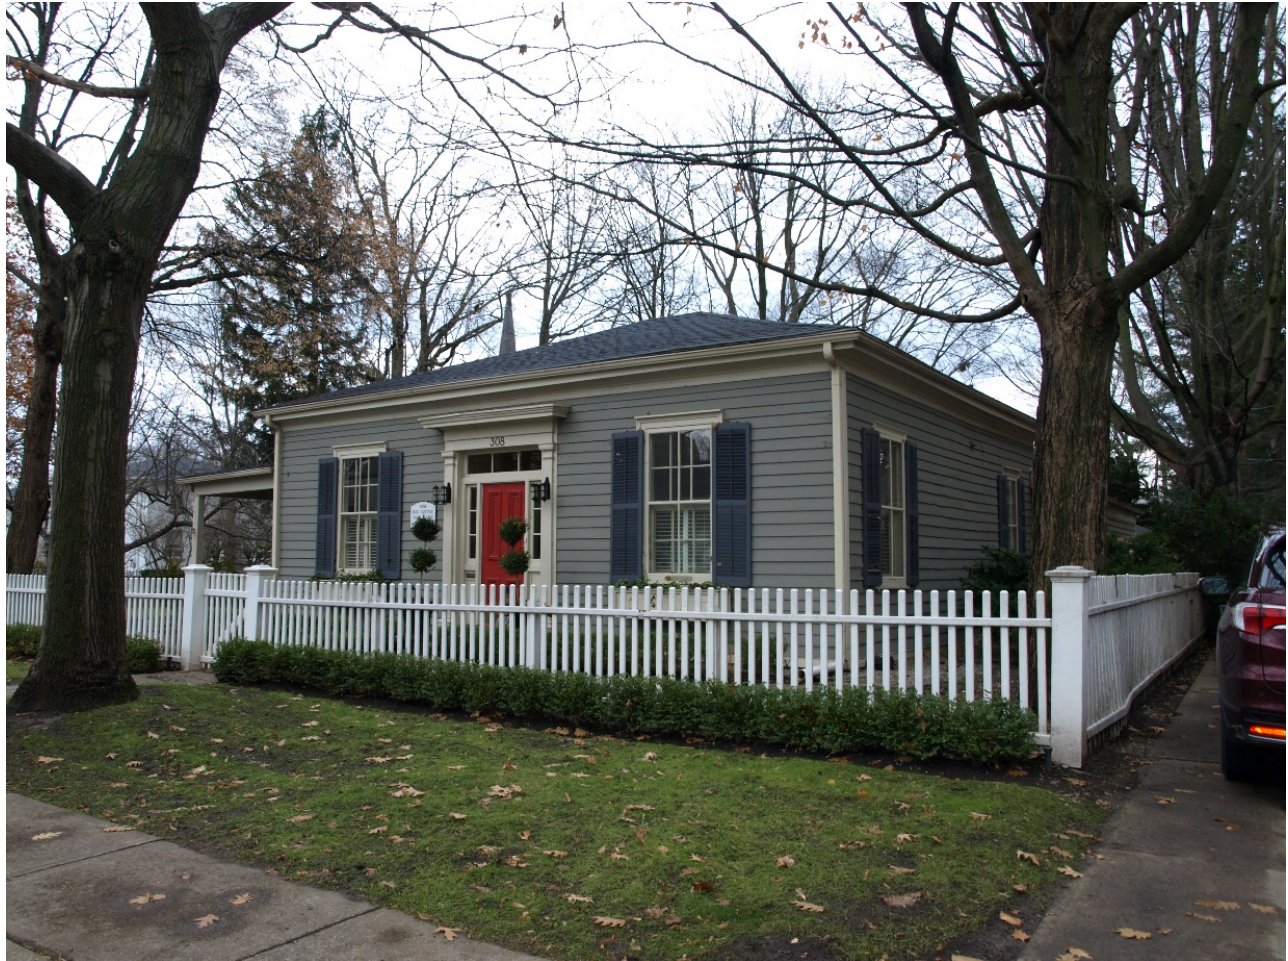
Photos:
2021

- Style: Regency Cottage
- Hipped roof
- One storey
- The symmetrical three-bay front façade houses a centrally located, four panel door with a large transom light and side lights
- The doorcasing has a projecting cornice, deep frieze and pilasters
- A small open porch on the east side of the front section includes a secondary entrance. The remainder of this east section is enclosed.
- Six-over-six windows with four-over-four storms. Some windows have functioning shutters.
- One storey hip roof addition to the rear of the house was constructed circa 1990, roof line aligned with original cottage
- Horizontal wood cladding
- French doors on rear addition facing east lead on to back patio
- Contemporary chimney at rear

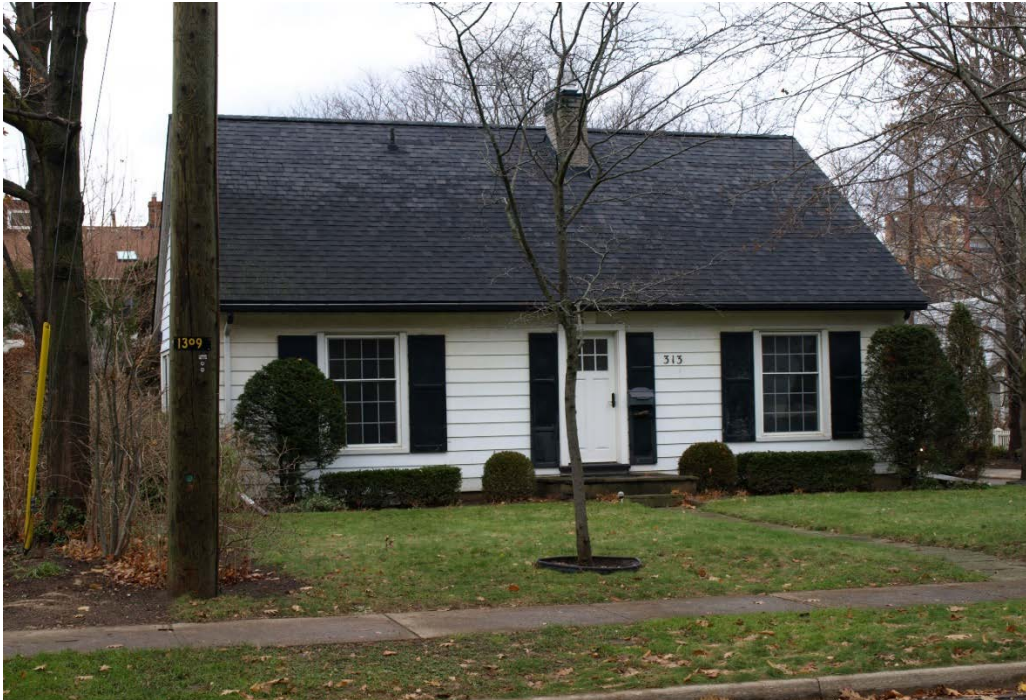
Photo:
2021

- Style: Mid-20th century vernacular
- One and half storey
- Gable roof with asphalt shingles
- Six over twelve windows with non-functioning shutters
- Three bay with central entryway
- Horizontal wood cladding
- Brick chimney almost centred over front entrance
- Victory housing features – frame construction, modest in scale and simple in design

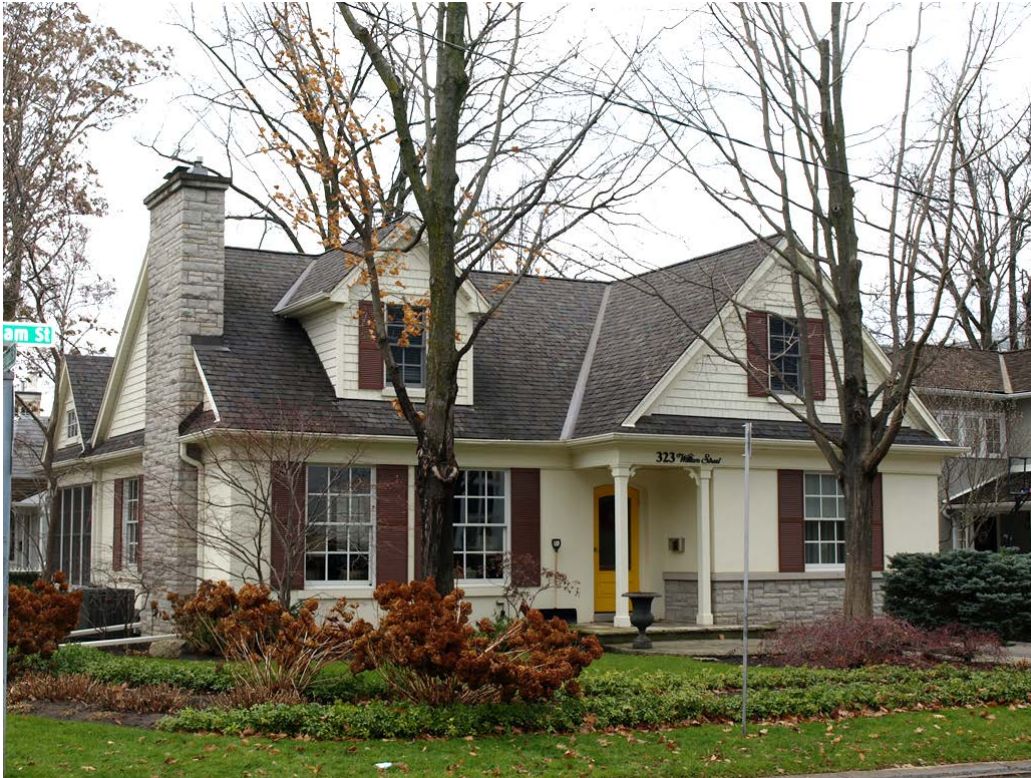
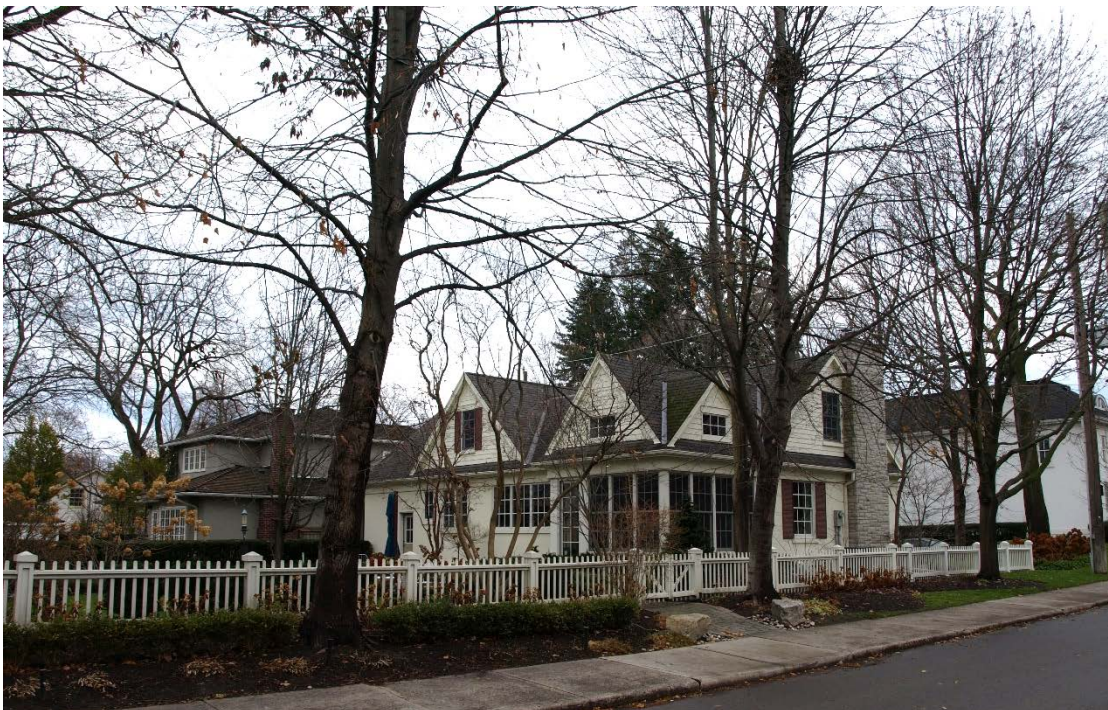
Photos:
2021

- Style: Mid-20th Century Vernacular with traditional details
- Cross gable roof with asphalt shingles
- One and a half storey
- Large six-over-six windows with decorative shutters on first storey
- Four over four windows and one over three windows in gables of half storey
- First storey clad in stucco (and stone on south east façade) with half storey clad in horizontal wood siding
- Brick chimney clad in stone

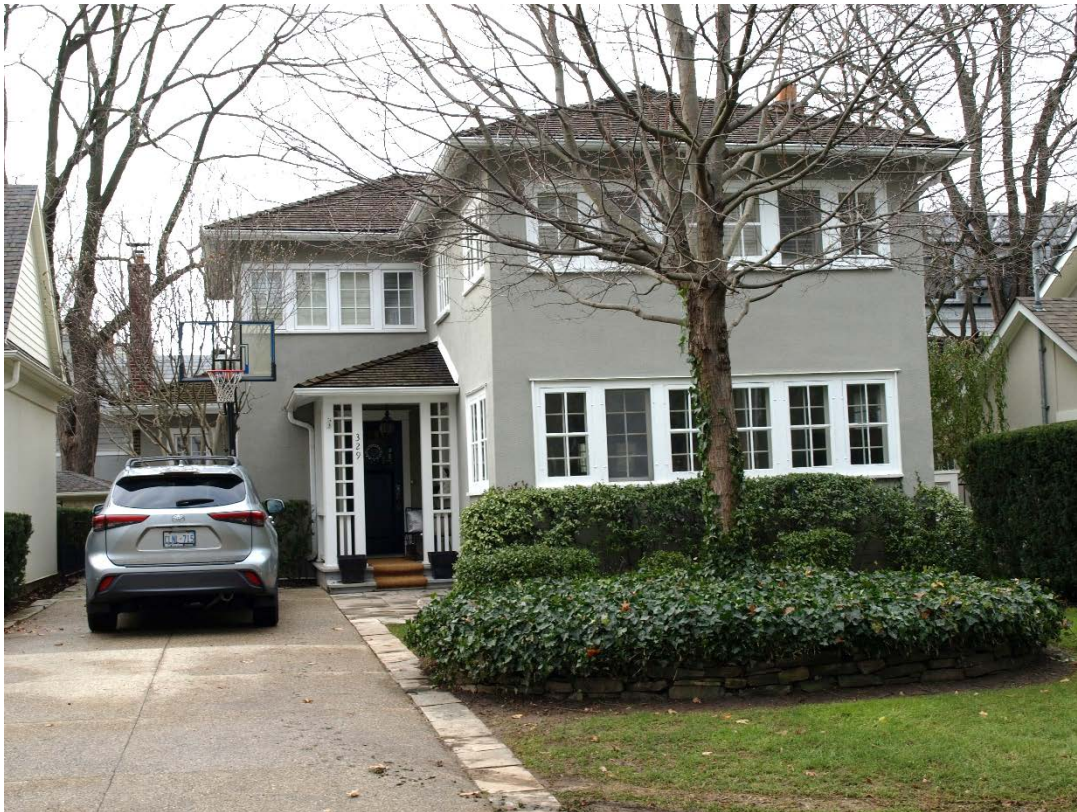
Photo:
2021

- Style: Arts and Crafts
- Hipped roof with cedar shakes
- Fenestration on both floors forms a wide opening allowing a lot of light to enter. Configured in four-over-four
- Open porch with lean-to-roof protects front door entrance
- Two storeys
- Stucco cladding
- Two storey addition to the west and rear of the structure circa 2000s

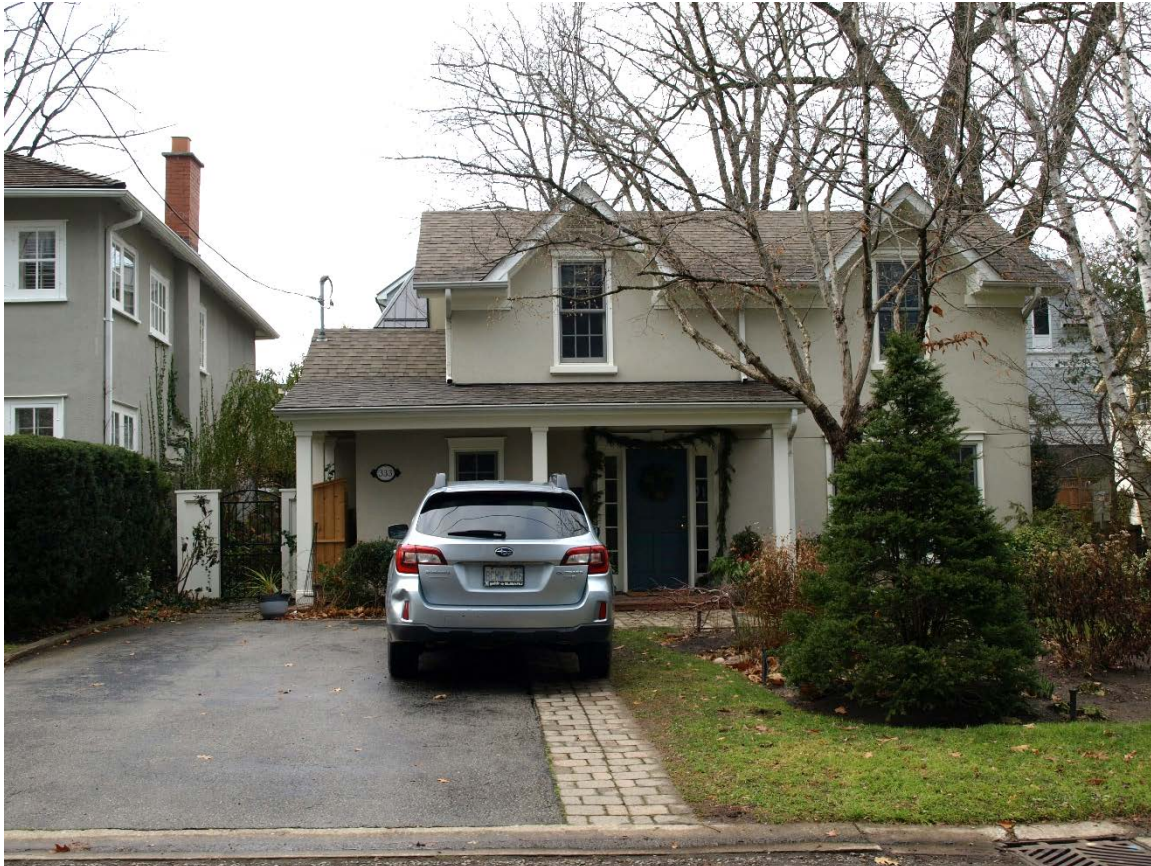
Photo:
2021

- Style: Late 20th Century Vernacular
- Side gable roof with asphalt shingles
- One and a half storey
- Front porch covering main entrance
- Main entrance with sidelites
- Stucco cladding
- Six over six double hung contemporary windows
- Bay window on first storey

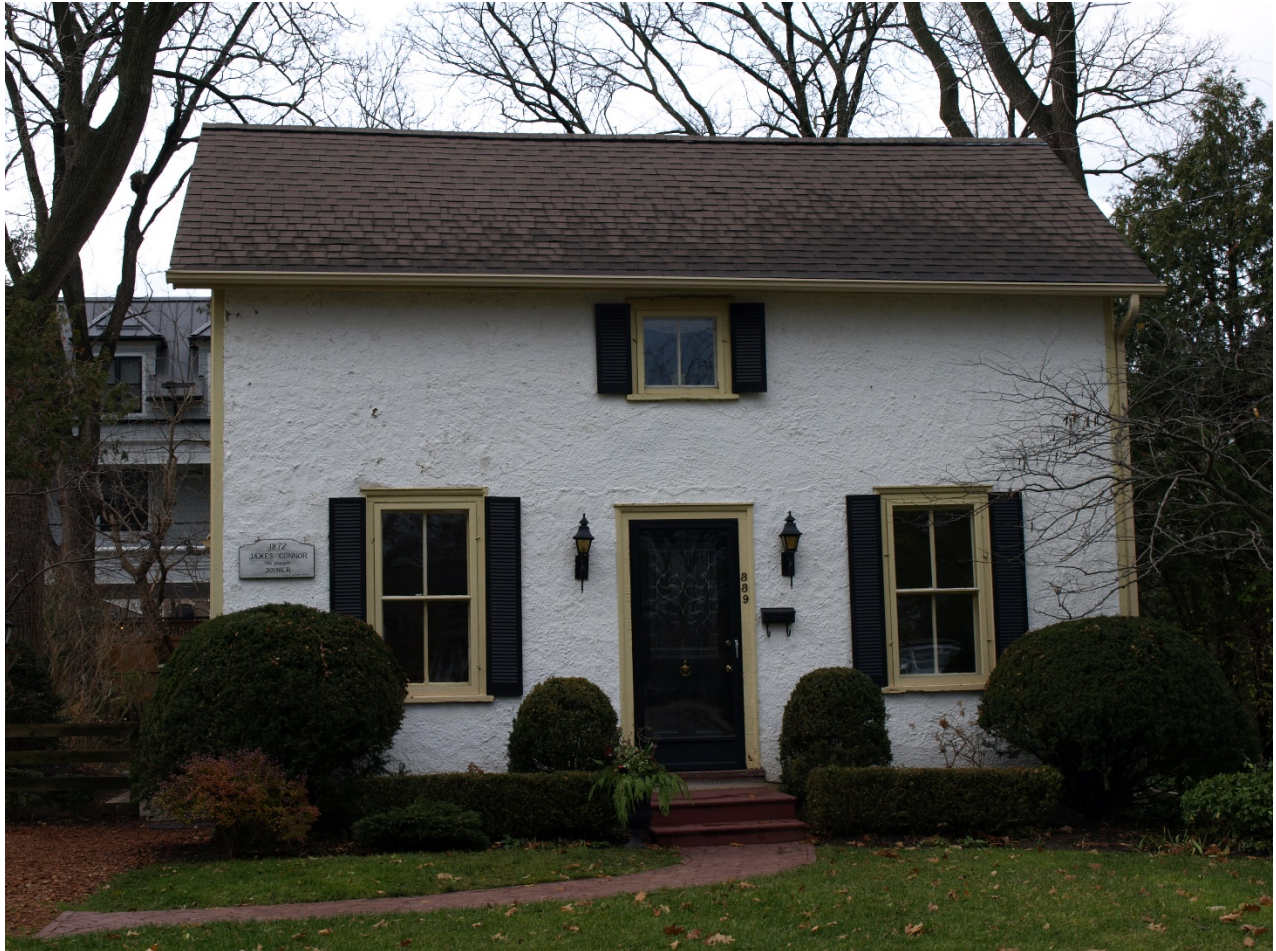
Photos:
2021

- Style: 19th Century Vernacular
- Medium pitch cross gable roof with asphalt shingles
- One-and-a-half storey, multiple sections
- One-storey covered porch at rear of front section leads to second side entrance on west side.
- Symmetrical 3 bay front façade, with central doorway, referencing Georgian style architecture. Minimal decoration.
- Two-over-two wood windows with modest pediment surrounds and decorative window shutters.
- Rough cast stucco cladding
- Rear addition matching front of the building in size, shape, window layout and cladding completed in late 1970s/early 1980s

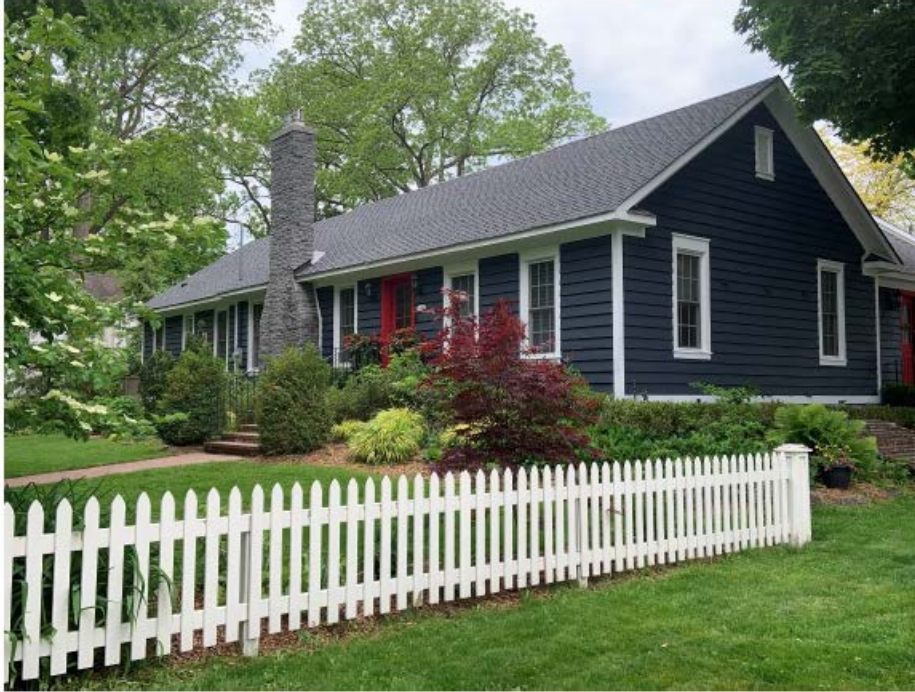
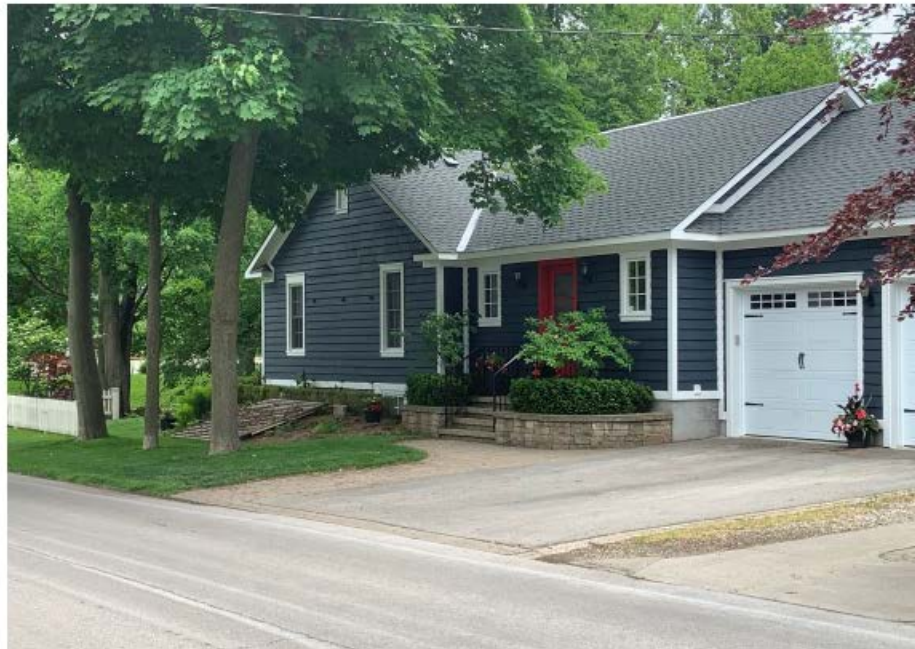
Photos:
2023

- Style: Mid 20th Century Vernacular
- Cross gable asphalt shingle roof with return eaves
- One storey
- Horizontal wood siding
- Double car attached garage with single car garage doors
- Large stone chimney centred on the front façade facing William Street
