## **Appendix B: Stage 1 Archaeological Assessment (2017)**

**STAGE 1 ARCHAEOLOGICAL ASSESSMENT FOR A SECTION OF  
LAKESHORE ROAD WEST, FROM MISSISSAGA STREET TO DORVAL  
DRIVE LOCATED ON PART OF LOTS 17 TO 31 BROKEN FRONT  
TRAFALGAR, AND PART OF LOTS 17 TO 20, CONCESSION III SOUTH IN  
THE FORMER TOWNSHIP OF TRAFALGAR, HALTON COUNTY, NOW IN  
THE TOWN OF OAKVILLE, ONTARIO**

**Archaeological Consulting License # P141 (Austin)  
P.I.F. # P141-0265-2017  
Amec Foster Wheeler Project # TPB166147.3000.1  
29 May 2017**

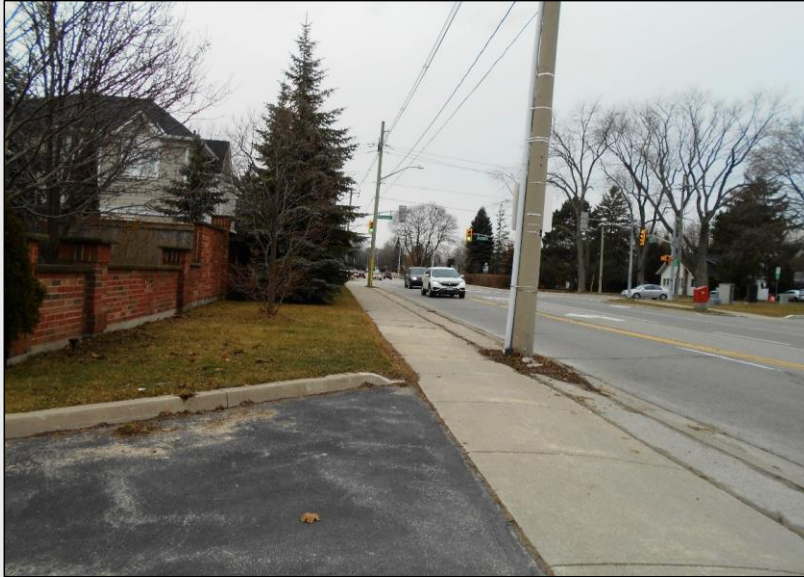
<b>PHOTOGRAPH</b>	<b>1</b>
-------------------	----------

Description
Facing south along Lakeshore Road West towards Mississaga Street. The manicured lawn retains archaeological potential, intensive testing required.

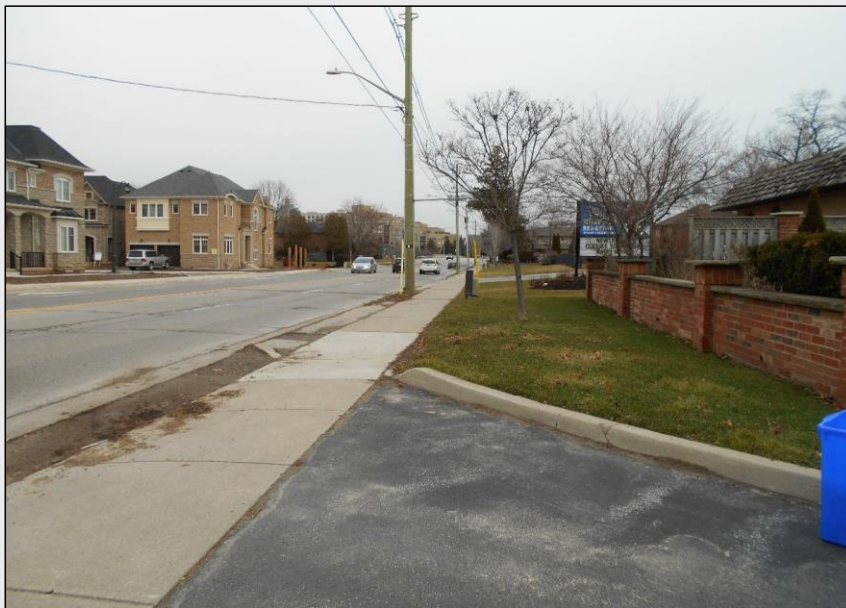
<b>PHOTOGRAPH</b>	<b>2</b>
-------------------	----------

Description
Facing north along Lakeshore Road West. The manicured lawn retains archaeological potential, intensive testing required.

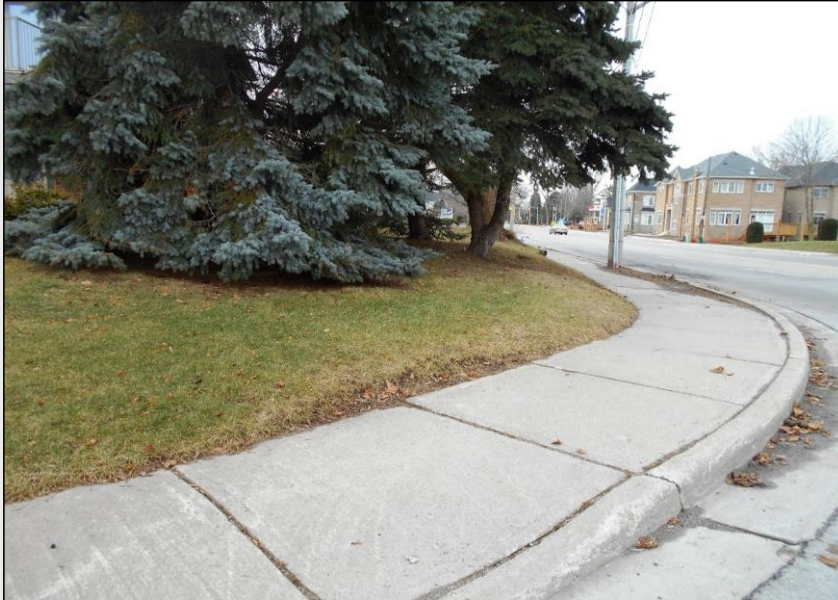
3

Facing south along Lakeshore Road West. The manicured lawn retains archaeological potential, intensive testing required.

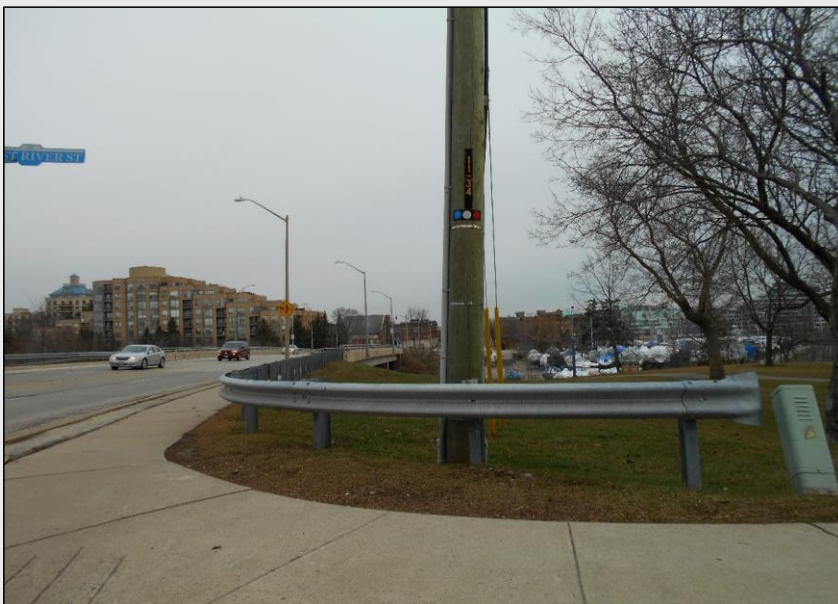
4

Facing south along Lakeshore Road West. Area of low archaeological potential due to paved sidewalk and road.

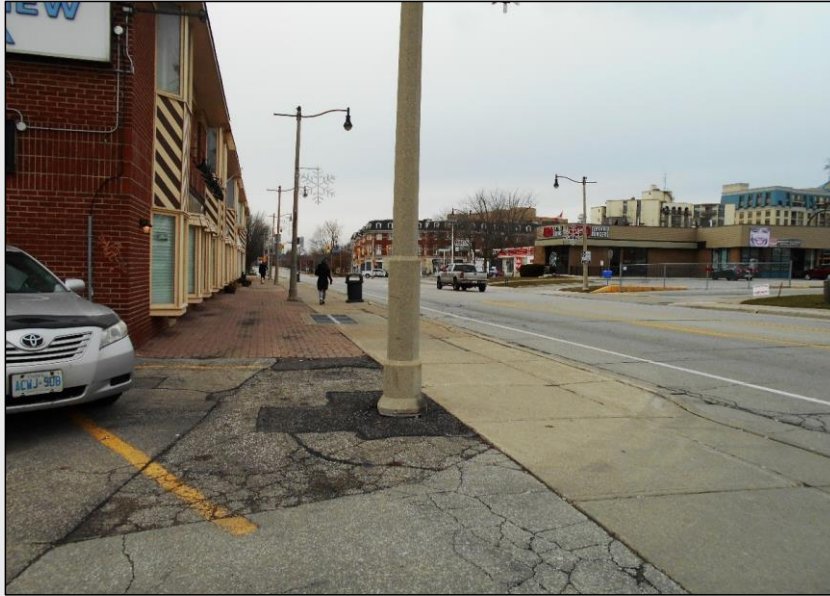
<b>PHOTOGRAPH</b>	<b>7</b>
-------------------	----------

Description
Facing southwest along Lakeshore Road West as the study area passes through Bronte. Area of low archaeological potential due to paved sidewalk and road.

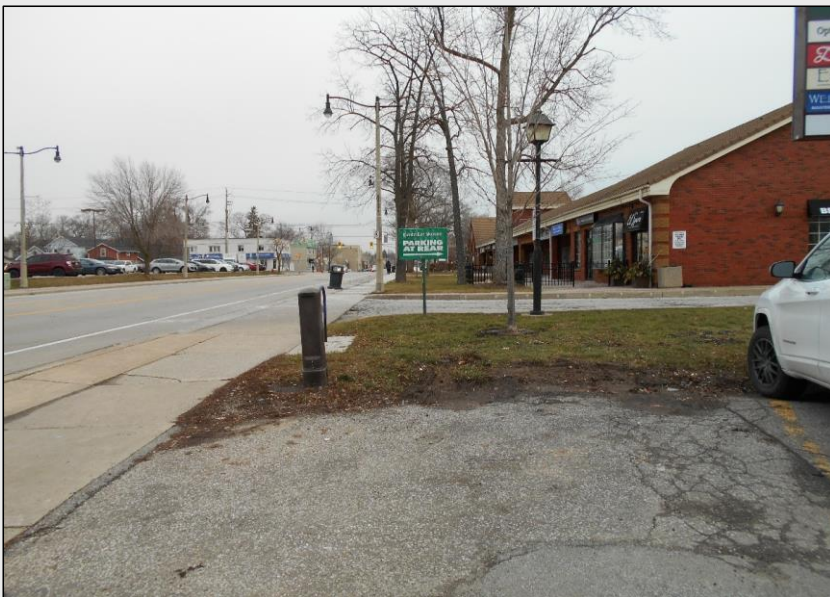
<b>PHOTOGRAPH</b>	<b>8</b>
-------------------	----------

Description
Facing northeast along Lakeshore Road West as the study area passes through Bronte. Area of low archaeological potential due to paved sidewalk and road.

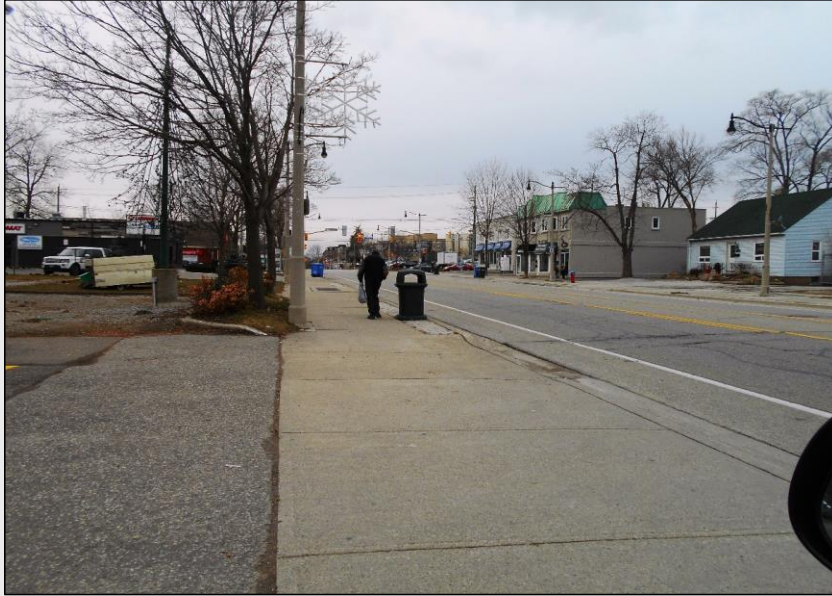
<b>PHOTOGRAPH</b>	<b>9</b>
-------------------	----------

Description
Facing southwest along Lakeshore Road West. Area of low archaeological potential due to paved sidewalk and road.

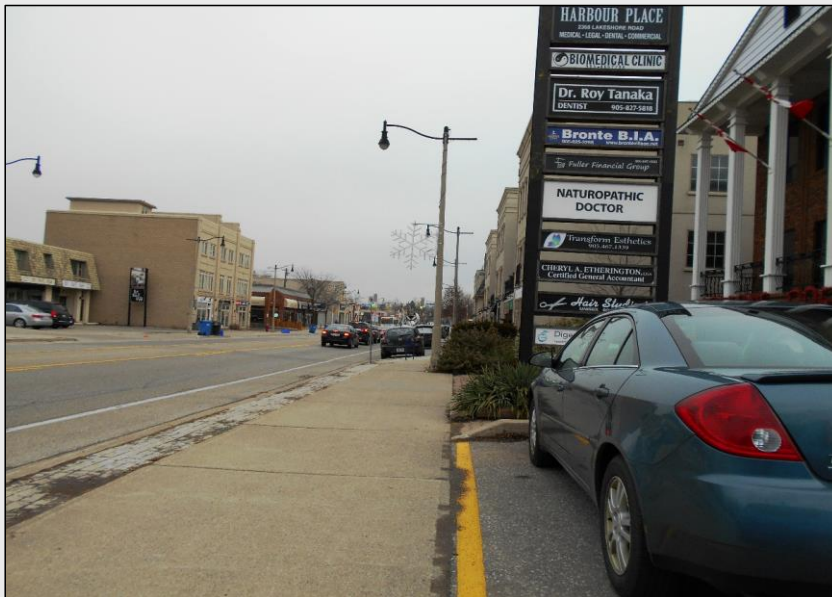
<b>PHOTOGRAPH</b>	<b>10</b>
-------------------	-----------

Description
Facing northeast along Lakeshore Road West. Area of low archaeological potential due to paved sidewalk and road.

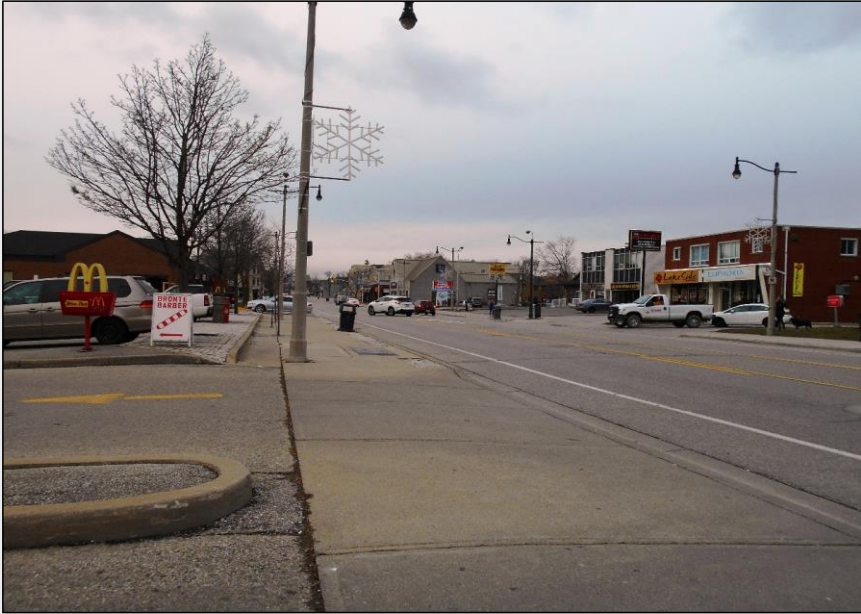
<b>PHOTOGRAPH</b>	<b>11</b>
	<b>Description</b> Facing southwest along Lakeshore Road West. Area of low archaeological potential due to paved sidewalk and road.

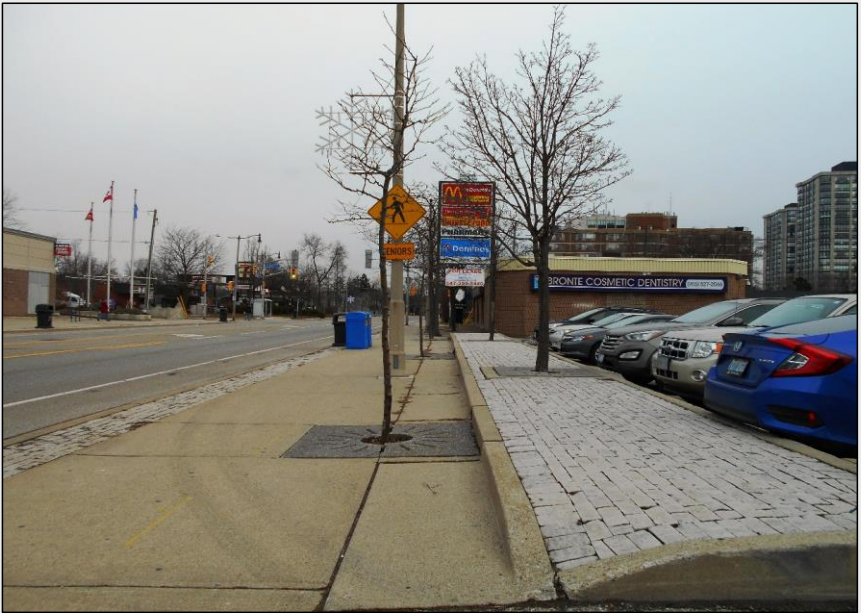
<b>PHOTOGRAPH</b>	<b>12</b>
	<b>Description</b> Facing northeast along Lakeshore Road West. Area of low archaeological potential due to paved sidewalk and road.

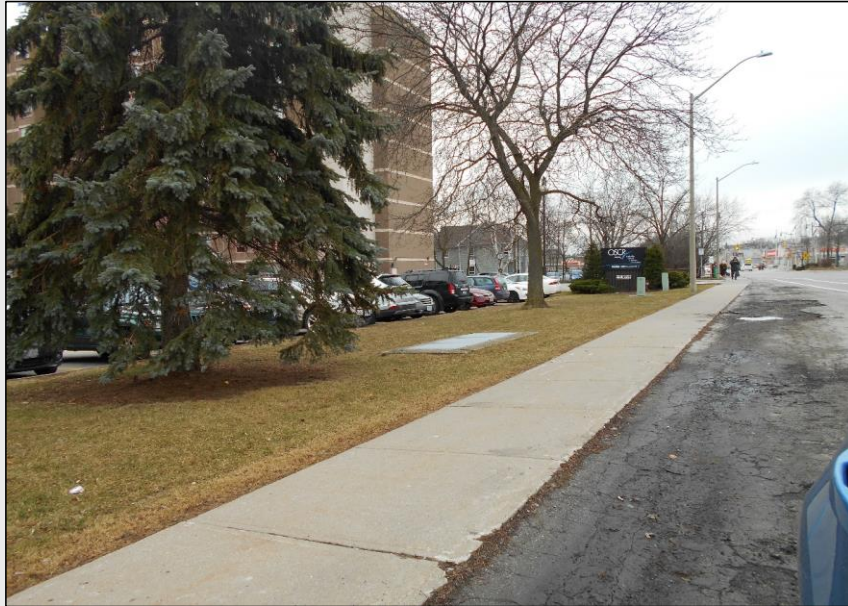
13

Facing southwest along Lakeshore Road West. The manicured lawn retains archaeological potential, intensive testing required.

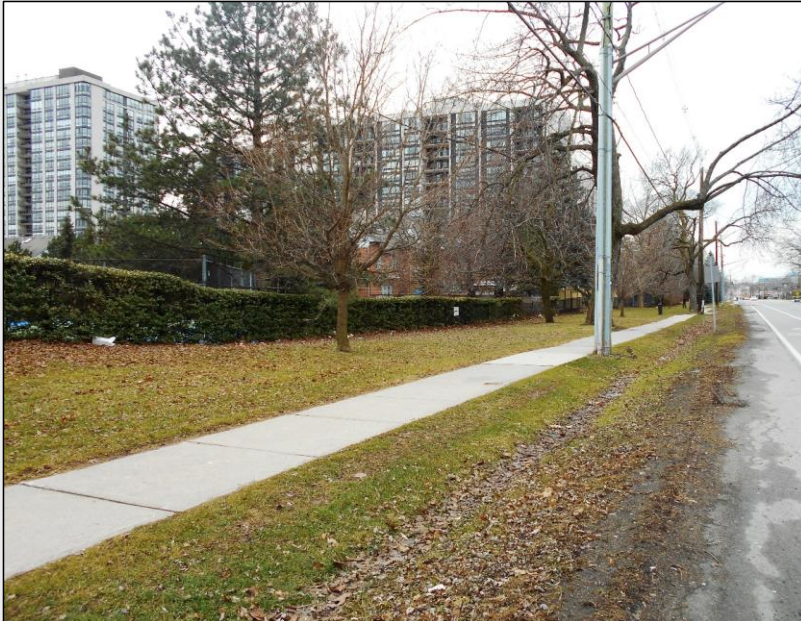
**15**

Facing southwest along Lakeshore Road West. The manicured lawn retains archaeological potential, intensive testing required.

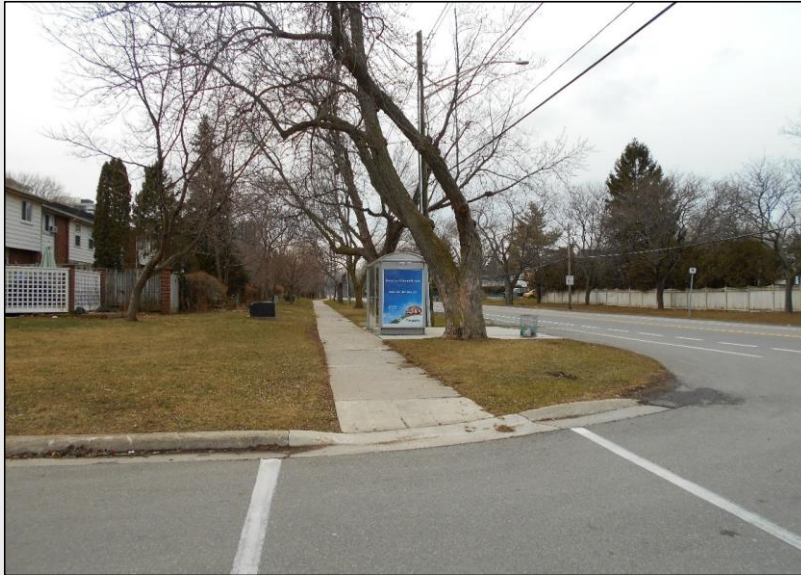
**17**

Facing southwest along Lakeshore Road West. The manicured lawn retains archaeological potential, intensive testing required.

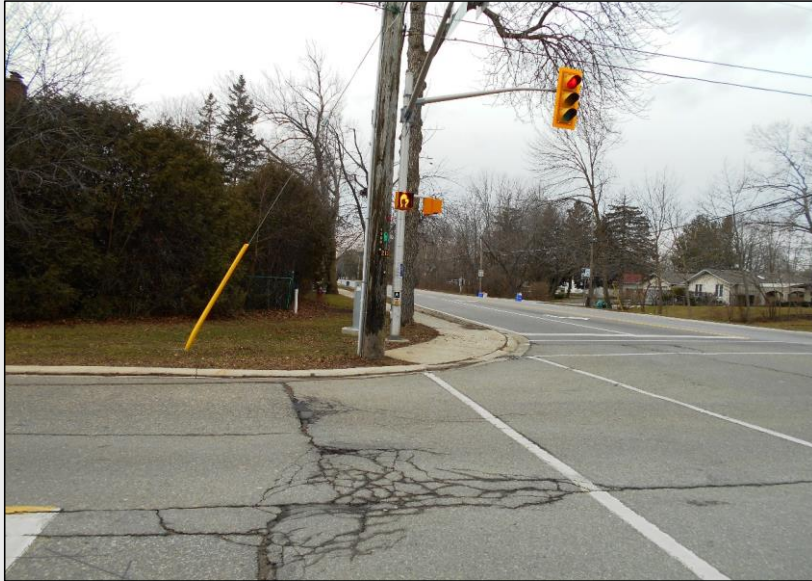
<b>PHOTOGRAPH</b>	<b>19</b>
-------------------	-----------

Description
Facing south along Lakeshore Road West. The manicured lawn in the foreground retains archaeological potential, intensive testing required.

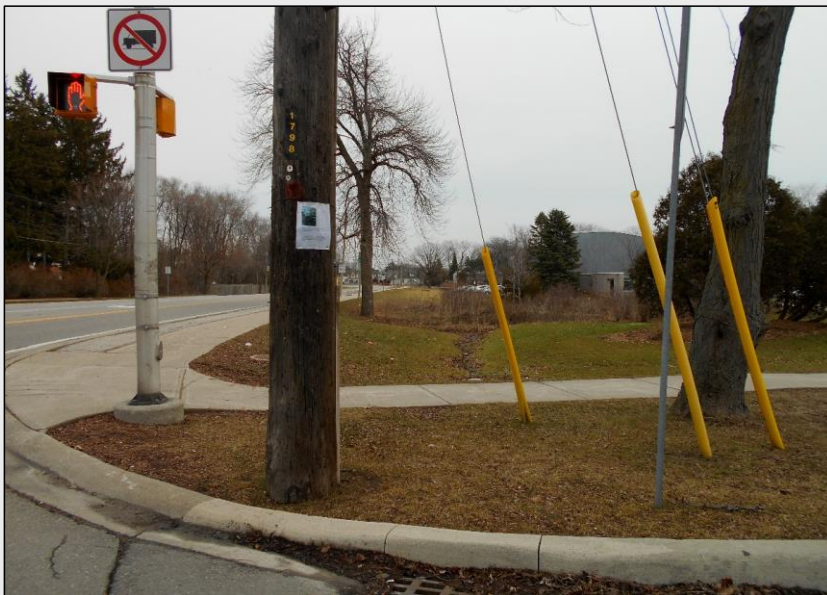
<b>PHOTOGRAPH</b>	<b>20</b>
-------------------	-----------

Description
Facing northeast along Lakeshore Road West. The manicured lawn in the foreground retains archaeological potential, intensive testing required.

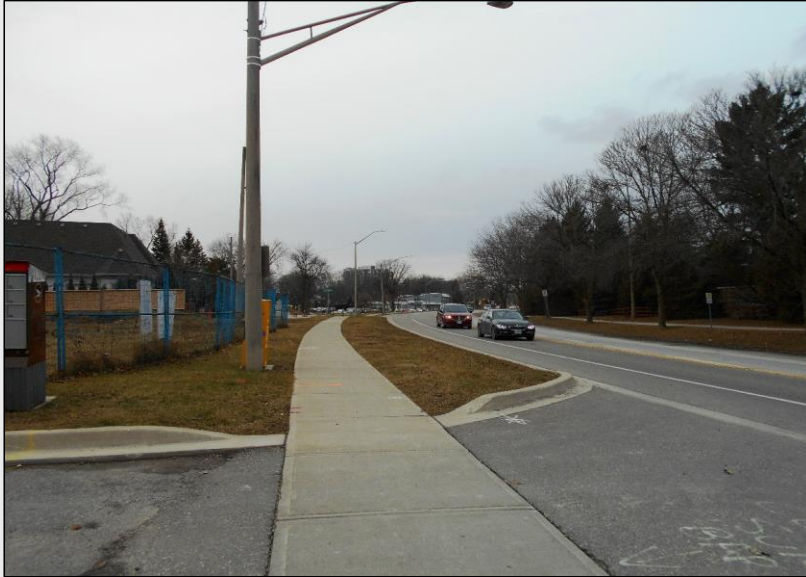
**21**

Facing south along Lakeshore Road West. The study area in this location falls between the road and the paved sidewalk. Area of low archaeological potential due to boulevard and paved sidewalk.

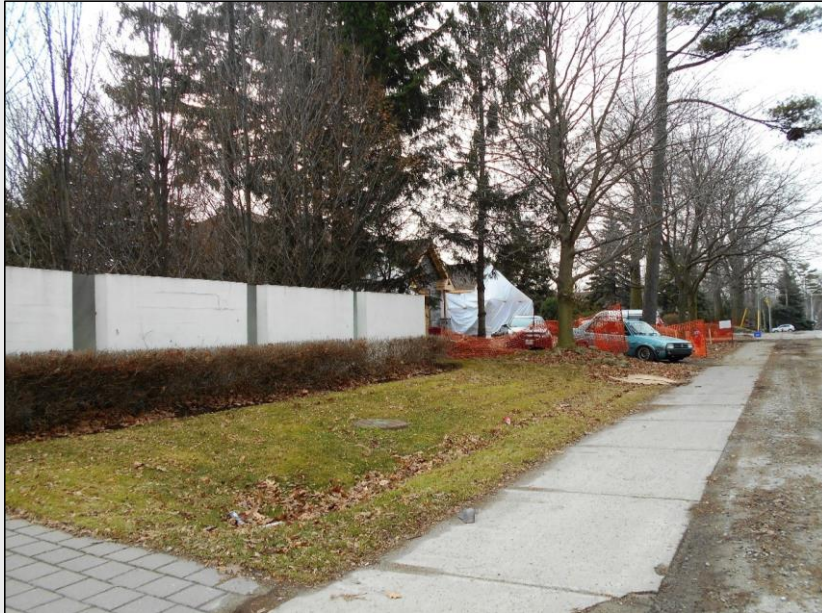
**25**

Facing south along Lakeshore Road West. Area of low archaeological potential due to paved sidewalk and road.

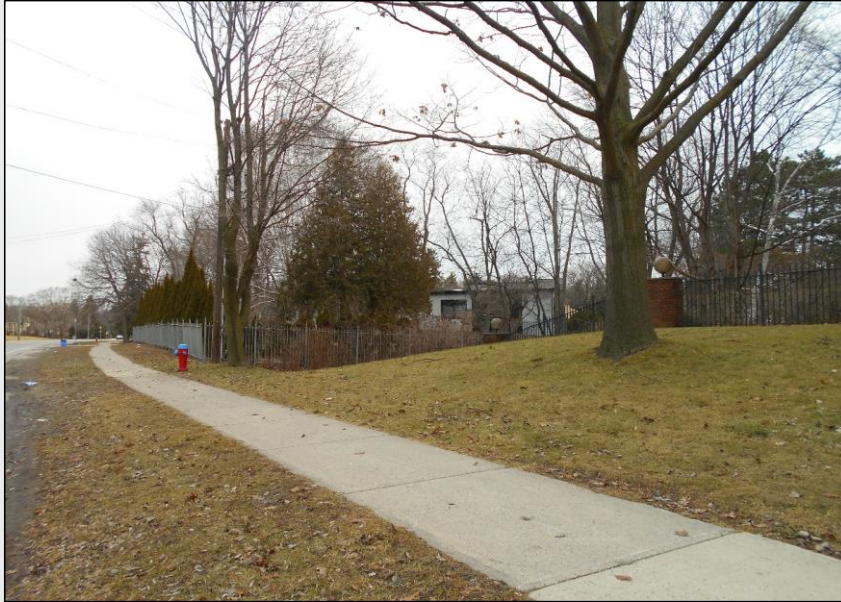
**27**

Facing north along Lakeshore Road West. Area of low archaeological potential due to paved sidewalk and road.

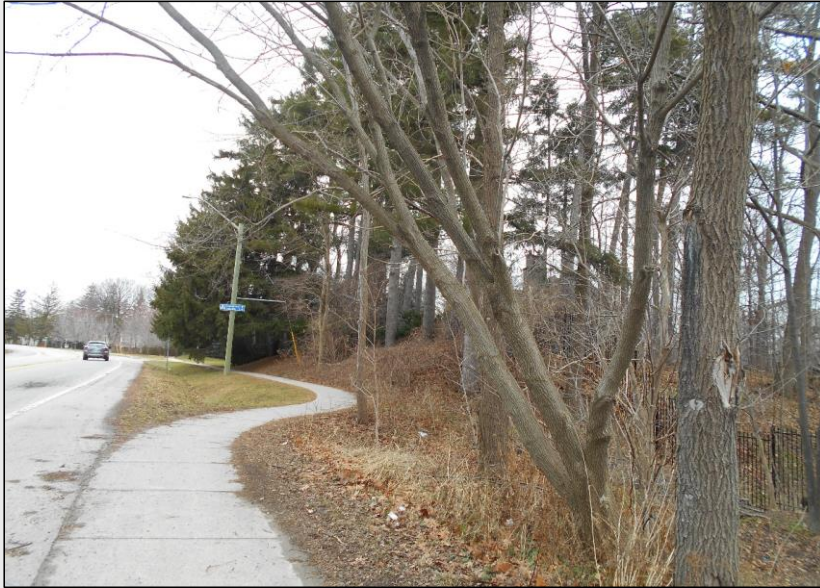
**29**

Facing northeast along Lakeshore Road West. Area of low archaeological potential due to paved sidewalk and road.

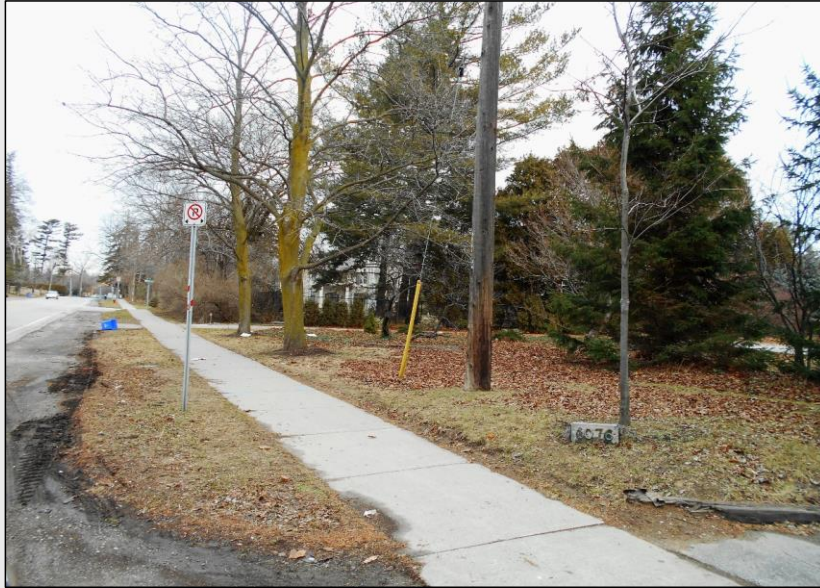
31

Facing northeast along Lakeshore Road West. The manicured lawn retains archaeological potential, intensive testing required.

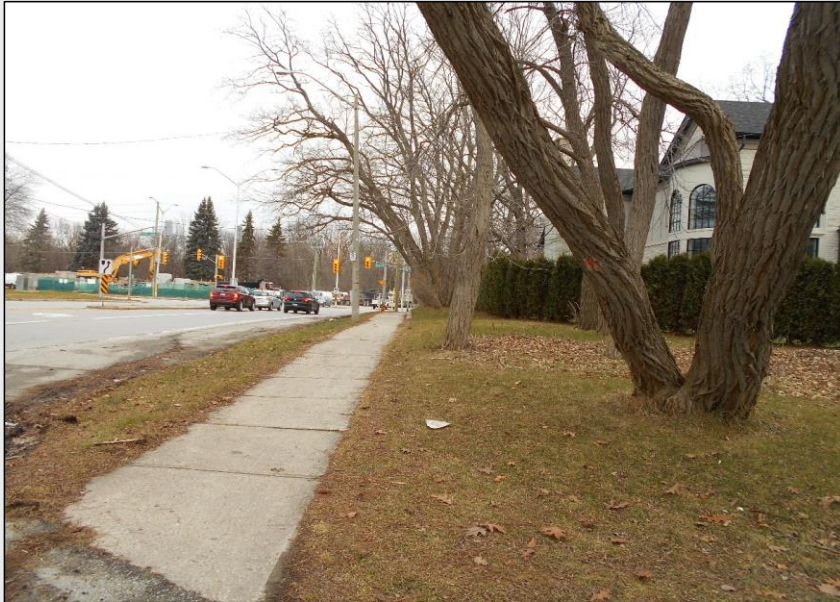
33

Facing north along Lakeshore Road West. The study area ends at the east side of the paved sidewalk. Area of low archaeological potential due to paved sidewalk and road.

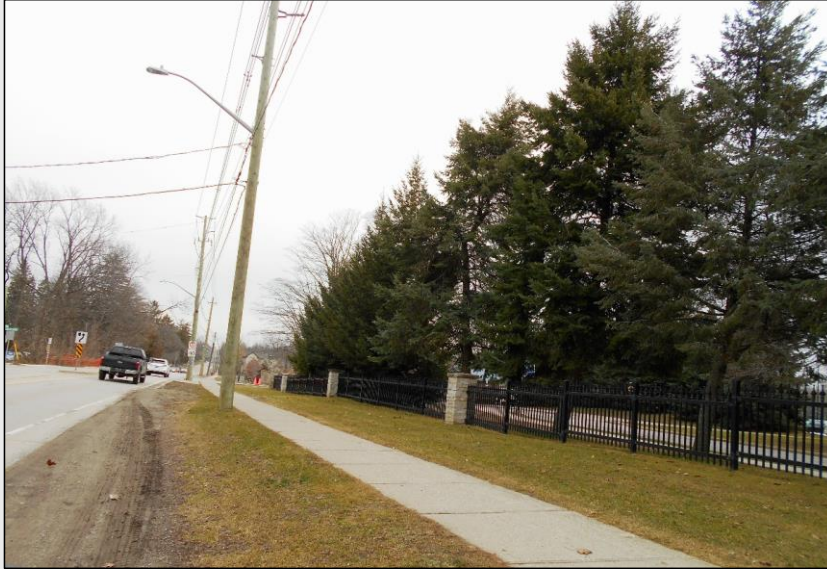
PHOTOGRAPH	35
------------	----

Description
Facing north along Lakeshore Road West. Area of low archaeological potential due to paved sidewalk, road, driveway and boulevard.

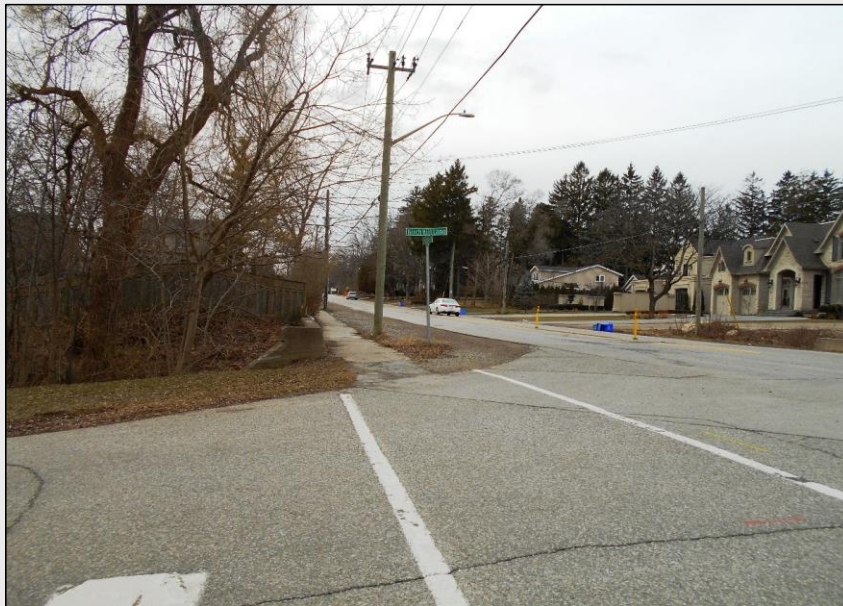
PHOTOGRAPH	36
------------	----

Description
Facing south along Lakeshore Road West. Area of low archaeological potential due to paved sidewalk and road.

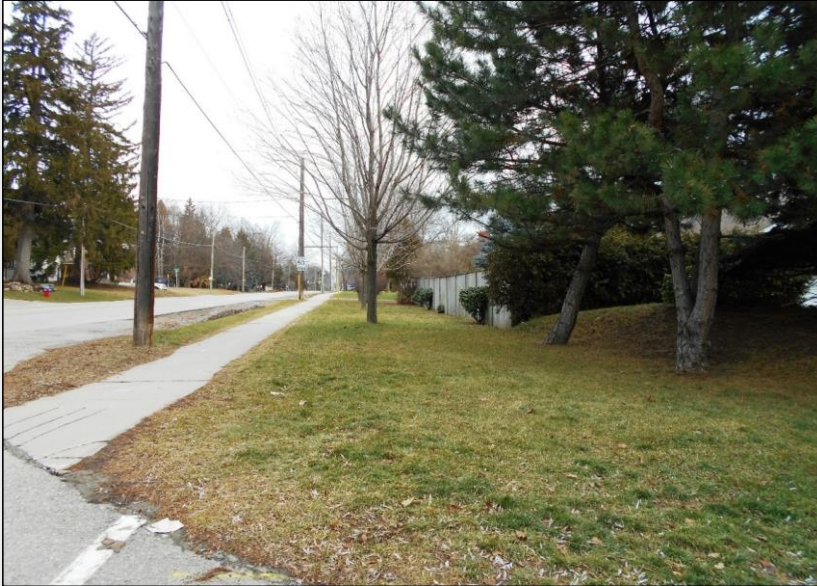
**37**

Facing northwest along Lakeshore Road West. The study area ends at the east side of the paved sidewalk. Area of low archaeological potential due to paved sidewalk and road.

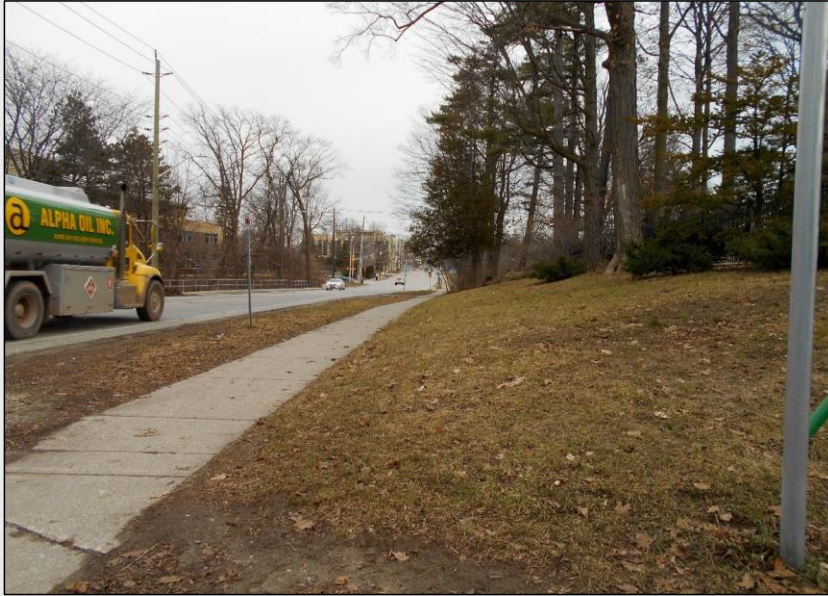
PHOTOGRAPH	41
------------	----

Description
Facing northeast along Lakeshore Road West. Area of low archaeological potential due to paved sidewalk and road.

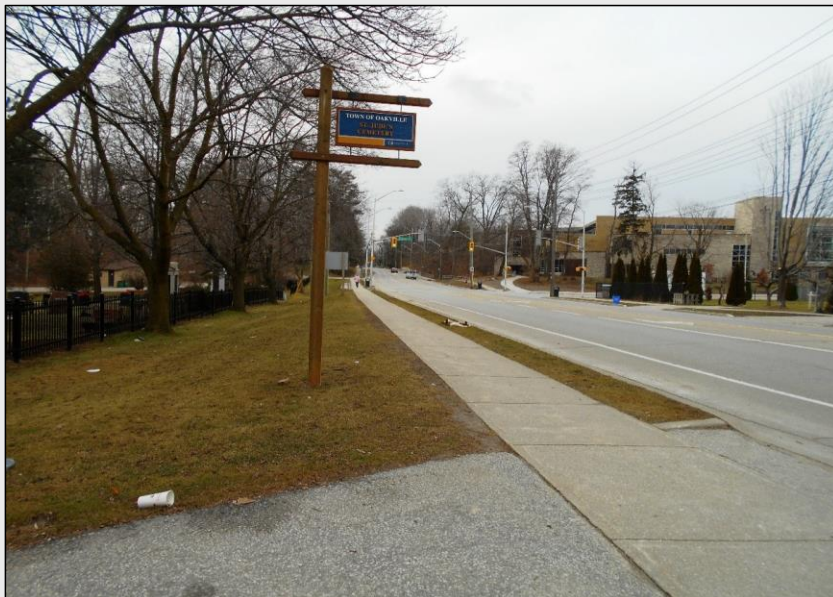
PHOTOGRAPH	42
------------	----

Description
Facing southwest along Lakeshore Road West. The study area extends to the east of the sidewalk. Area of low archaeological potential due to paved sidewalk and road.

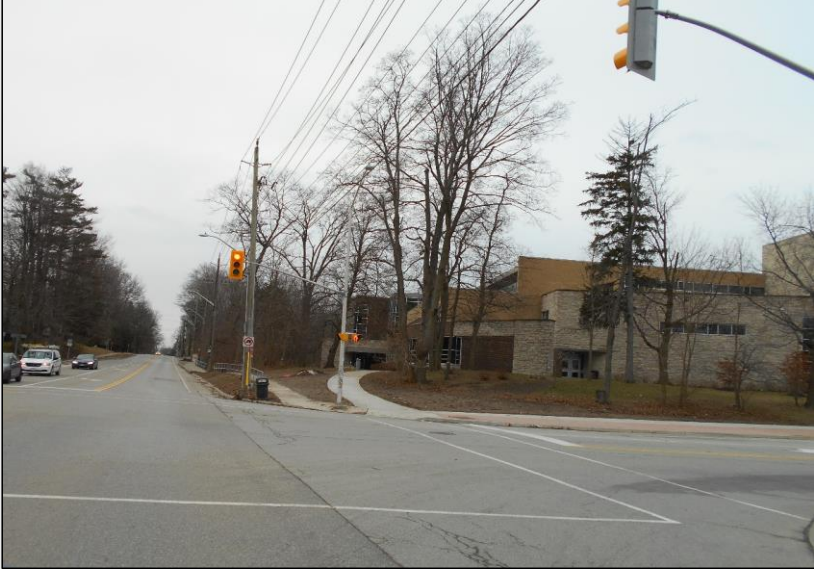
<b>PHOTOGRAPH</b>	<b>43</b>
	<b>Description</b> Facing southwest along Lakeshore Road West from Dorval Drive. Area of low archaeological potential due to paved sidewalk and road.

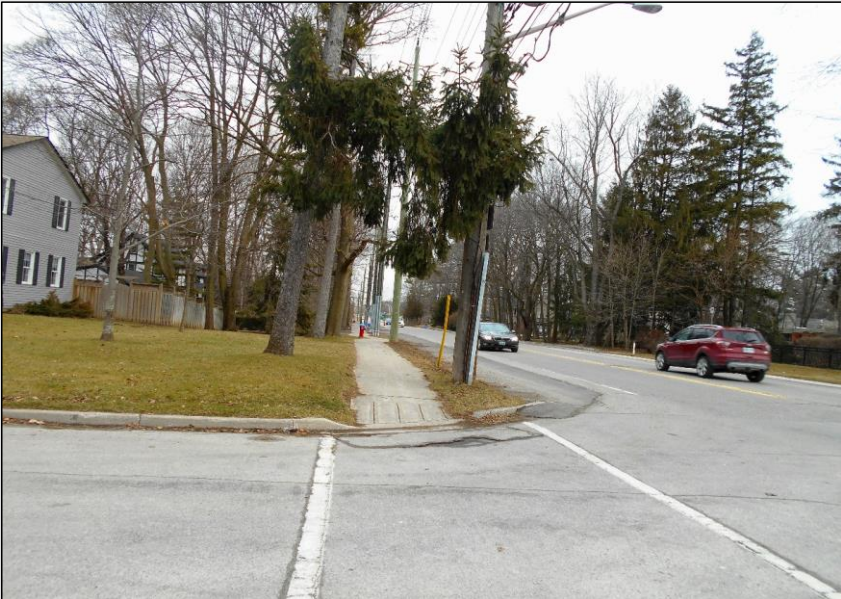
<b>PHOTOGRAPH</b>	<b>44</b>
	<b>Description</b> Facing northeast along Lakeshore Road West. Area of low archaeological potential due to paved sidewalk and road.

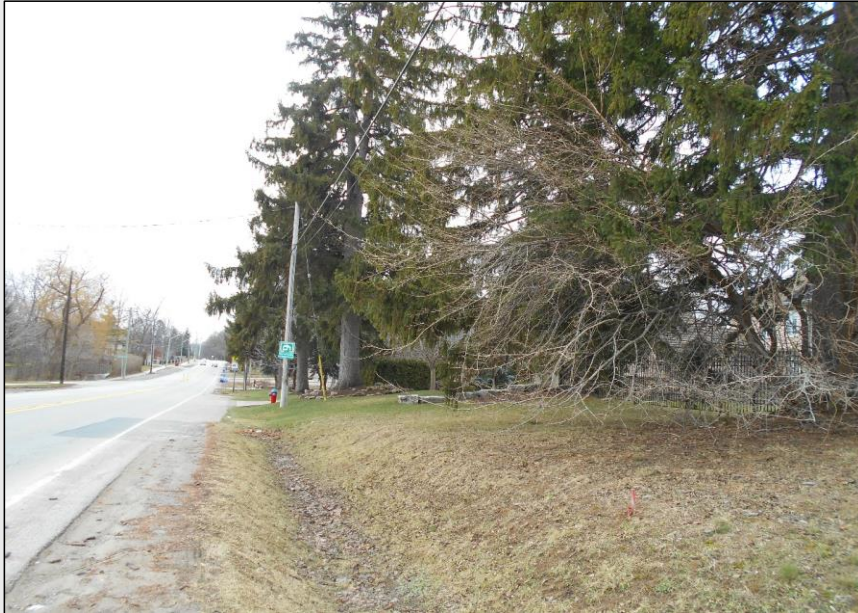
47

Facing southwest along Lakeshore Road West. The manicured lawn retains archaeological potential, intensive testing required.

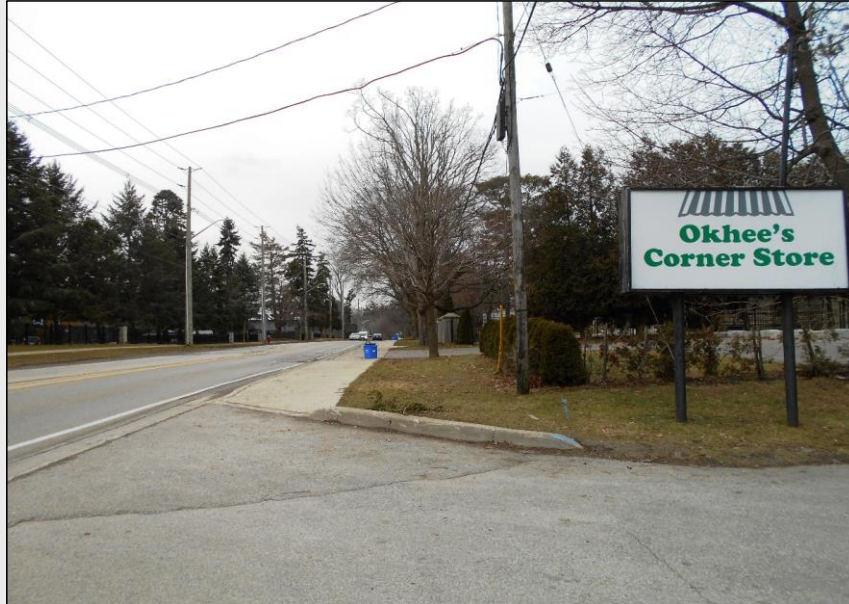
49

Facing southwest along Lakeshore Road West. Area of low archaeological potential due to paved sidewalk and road and driveway.

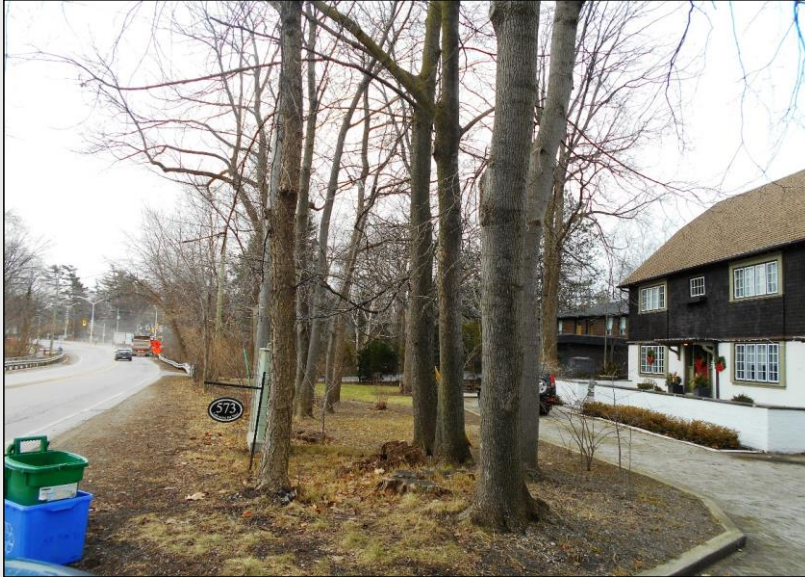
51

Facing southwest along Lakeshore Road West. Area of low archaeological potential due to paved road and driveway and boulevard.

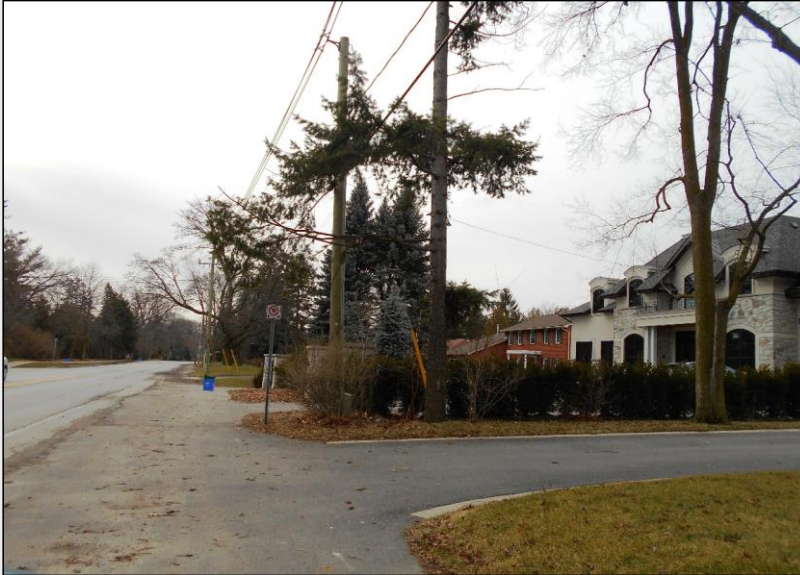
**PHOTOGRAPH** 53

Facing south along Lakeshore Road West. Area of low archaeological potential due to paved road, paved shoulder and driveway.

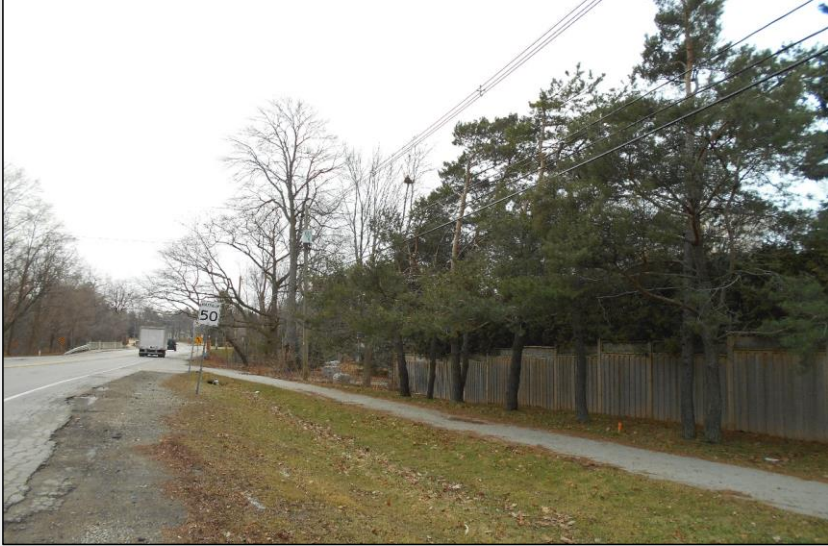
<b>PHOTOGRAPH</b>	<b>55</b>
	<b>Description</b> Facing south along Lakeshore Road West. Area of low archaeological potential due to paved road, gravel sloped shoulder and paved sidewalk.

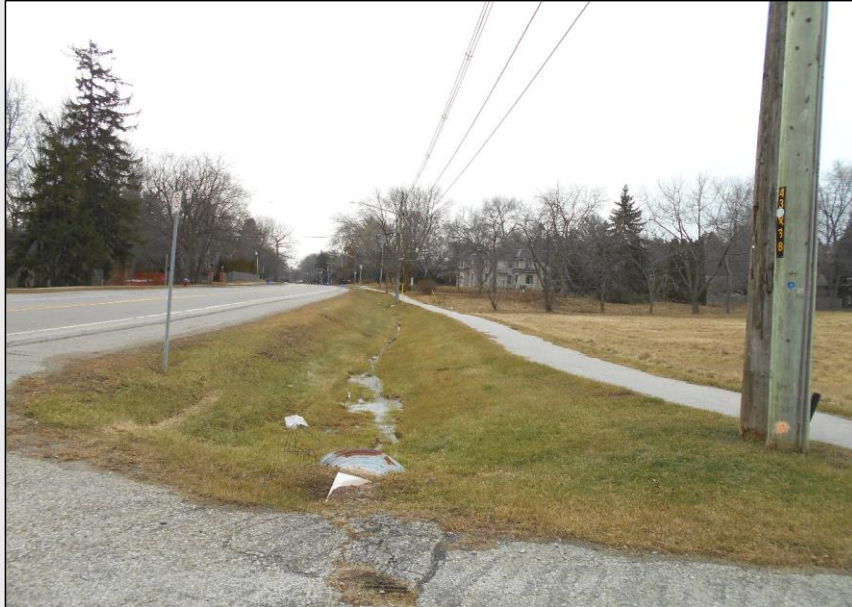
**PHOTOGRAPH** 57

Facing south along Lakeshore Road West. Area of low archaeological potential due to paved road, gravel sloped shoulder / ditch and paved sidewalk.

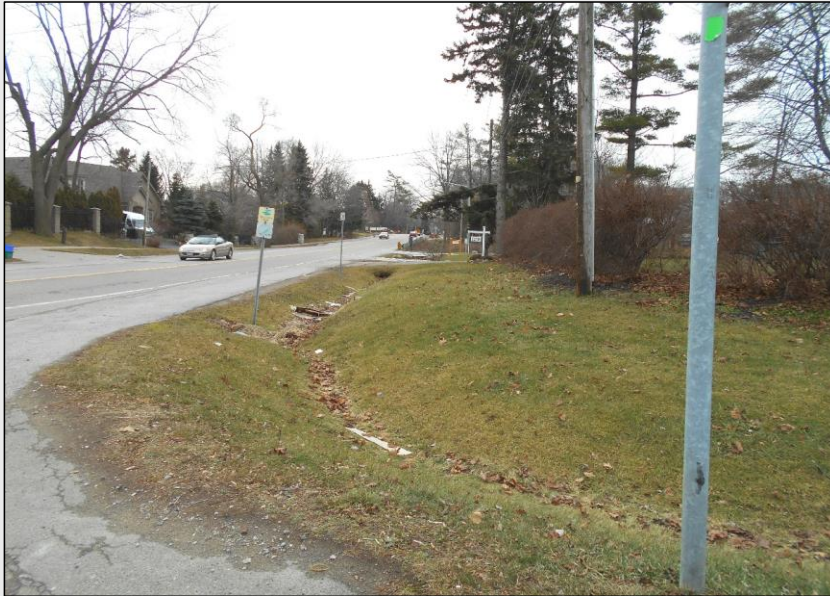
59

Facing south along Lakeshore Road West. Area of low archaeological potential due to paved road, disturbed shoulder and ditch.

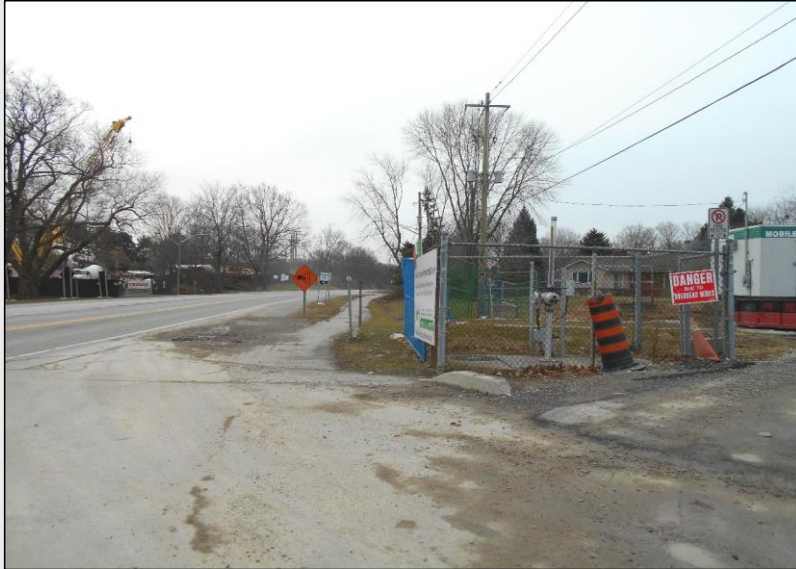
PHOTOGRAPH	61
------------	----

Description
Facing south along Lakeshore Road West. Area of low archaeological potential due to paved road, driveway and paved shoulder.

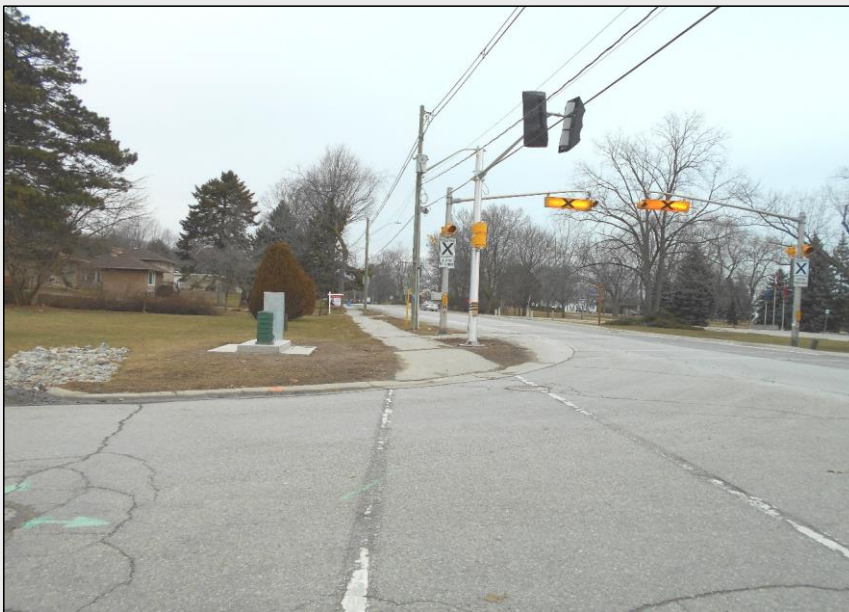
PHOTOGRAPH	62
------------	----

Description
Facing northeast along Lakeshore Road West. Area of low archaeological potential due to paved road, and sidewalk.

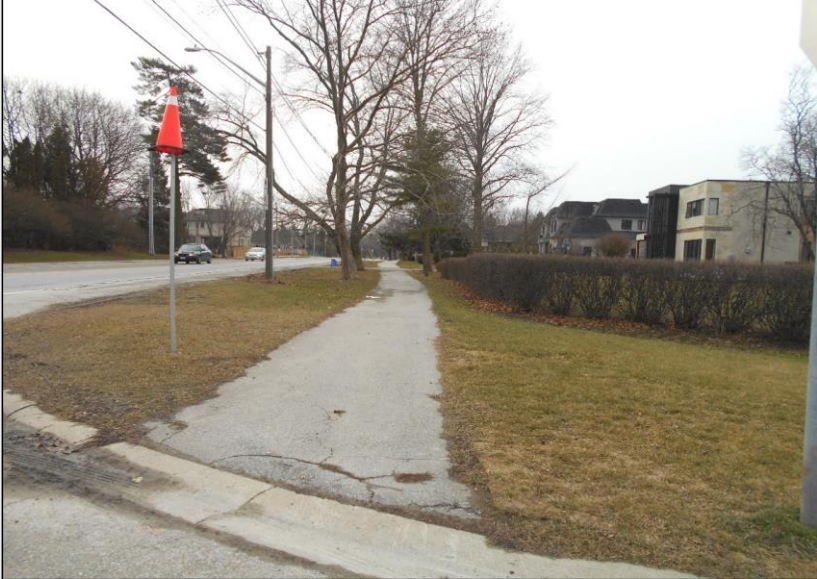
<b>PHOTOGRAPH</b>	<b>63</b>
	<b>Description</b> Facing southwest along Lakeshore Road West. Area of low archaeological potential due to paved road and disturbed boulevard to edge of paved sidewalk.

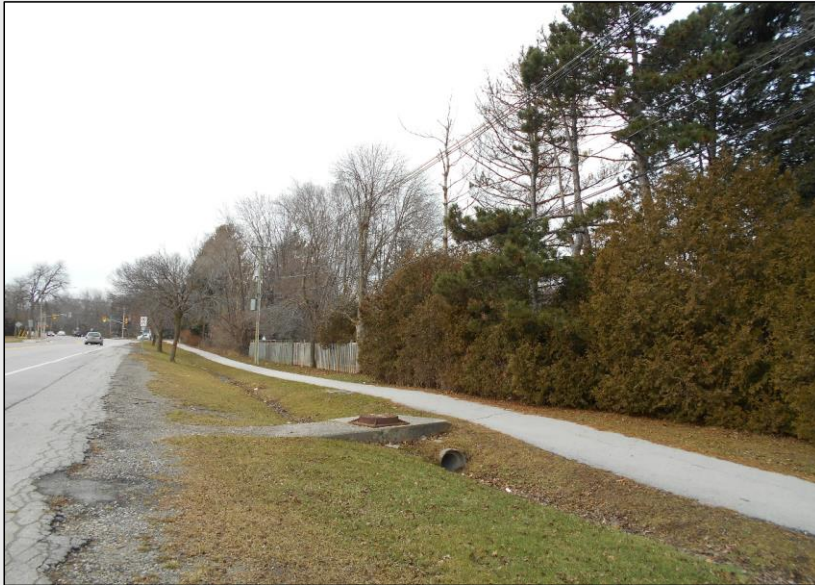
**65**

65 Facing west along Lakeshore Road West. Area of low archaeological potential due to paved road, gravel sloped shoulder to ditch, from the ditch to the edge of paved sidewalk.

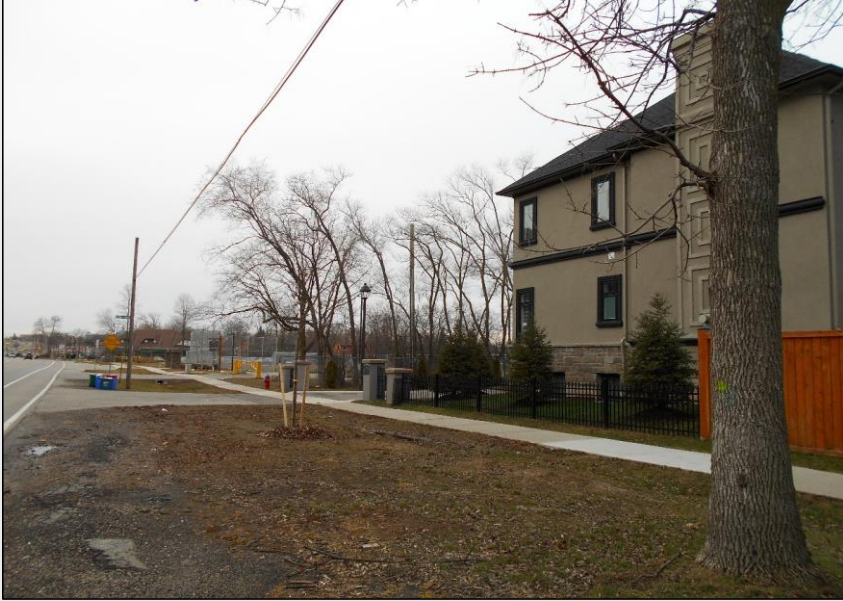
<b>PHOTOGRAPH</b>	<b>69</b>
	<b>Description</b> Facing southwest along Lakeshore Road West. Area of low archaeological potential due to paved road and disturbed shoulder to edge paved sidewalk.

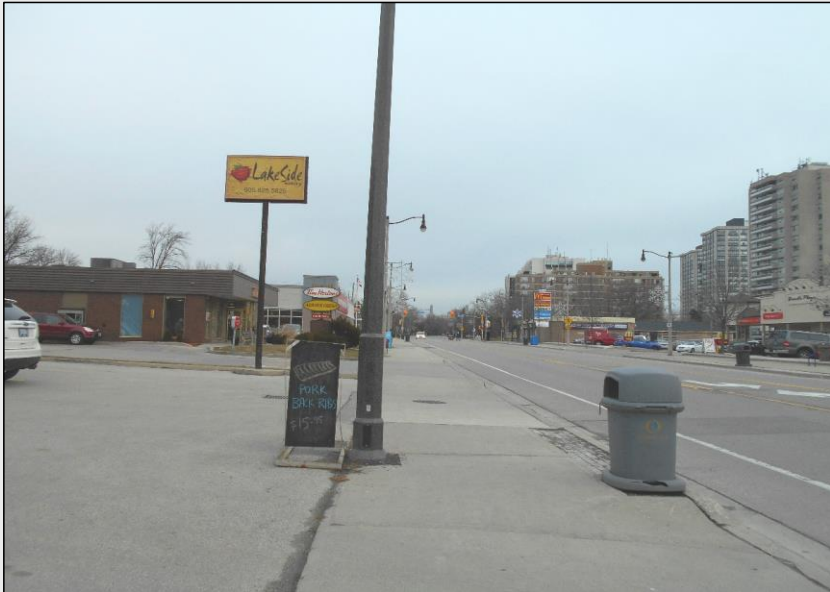
<b>PHOTOGRAPH</b>	<b>70</b>
	<b>Description</b> Facing northeast along Lakeshore Road West. Area of low archaeological potential due to paved road, sidewalk and driveway.

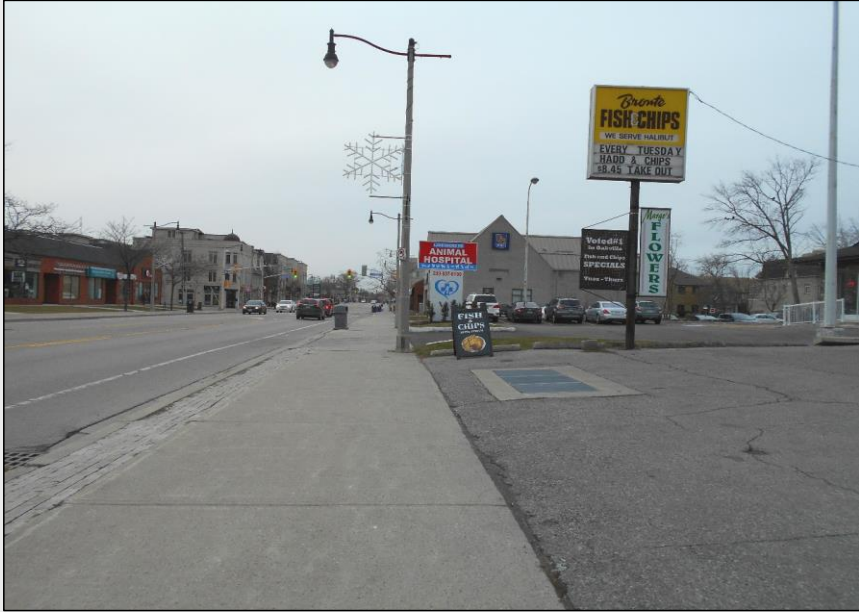
<b>PHOTOGRAPH</b>	<b>71</b>
	<b>Description</b>	
<p>Facing southwest along Lakeshore Road West. Area of low archaeological potential due to paved road, sidewalk and driveway.</p>
