## **Appendix B: Stage 1 Archaeological Assessment (2017)**

**STAGE 1 ARCHAEOLOGICAL ASSESSMENT FOR A SECTION OF  
LAKESHORE ROAD WEST, FROM MISSISSAGA STREET TO DORVAL  
DRIVE LOCATED ON PART OF LOTS 17 TO 31 BROKEN FRONT  
TRAFALGAR, AND PART OF LOTS 17 TO 20, CONCESSION III SOUTH IN  
THE FORMER TOWNSHIP OF TRAFALGAR, HALTON COUNTY, NOW IN  
THE TOWN OF OAKVILLE, ONTARIO**

**Archaeological Consulting License # P141 (Austin)  
P.I.F. # P141-0265-2017  
Amec Foster Wheeler Project # TPB166147.3000.1  
29 May 2017**

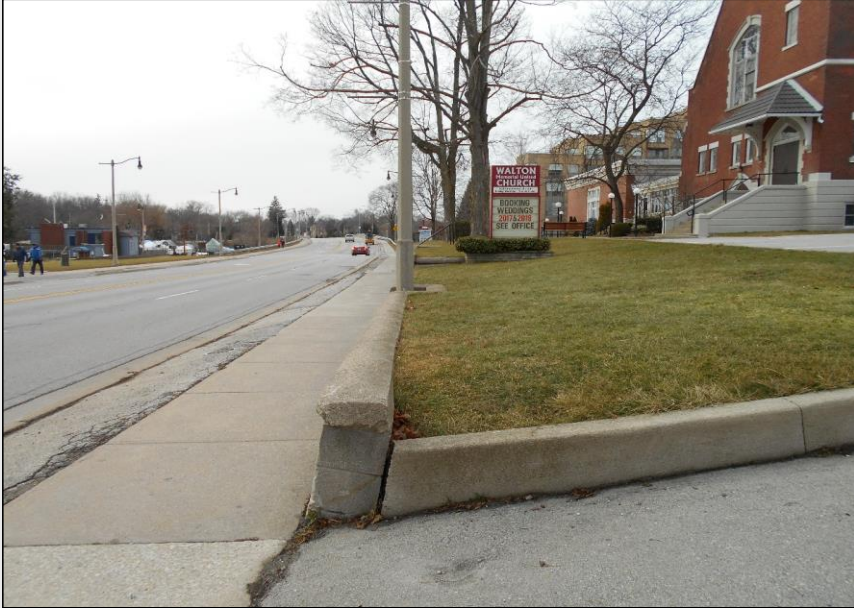
<b>PHOTOGRAPH</b>	<b>75</b>
	<b>Description</b>	
<p>Facing northeast along Lakeshore Road West. The study area does not extend past the east edge of the sidewalk. No potential.</p>

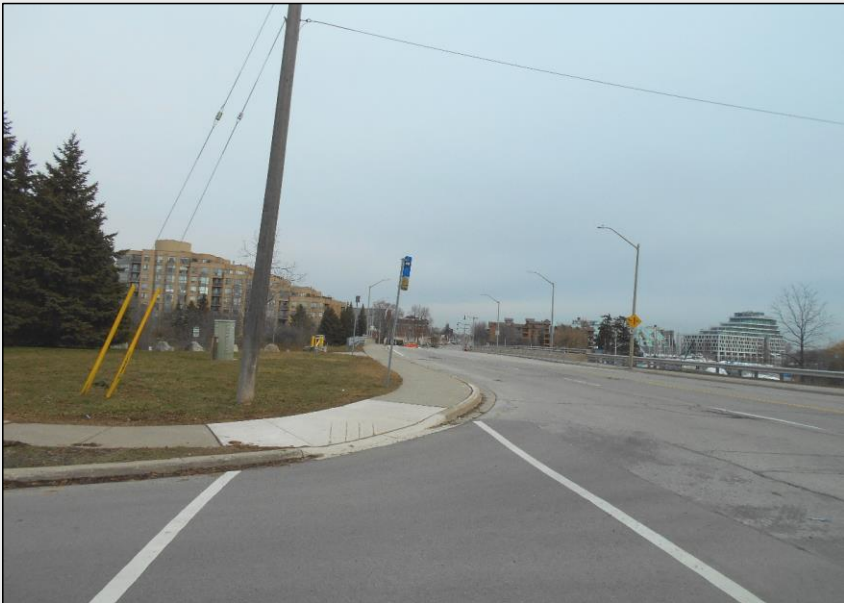
<b>PHOTOGRAPH</b>	<b>76</b>
	<b>Description</b>	
<p>Facing northeast along Lakeshore Road West. The manicured lawn retains archaeological potential, intensive testing required.</p>
