OAKVILLE

North Oakville Creeks Subwatershed Study

APPENDICES

August 2006

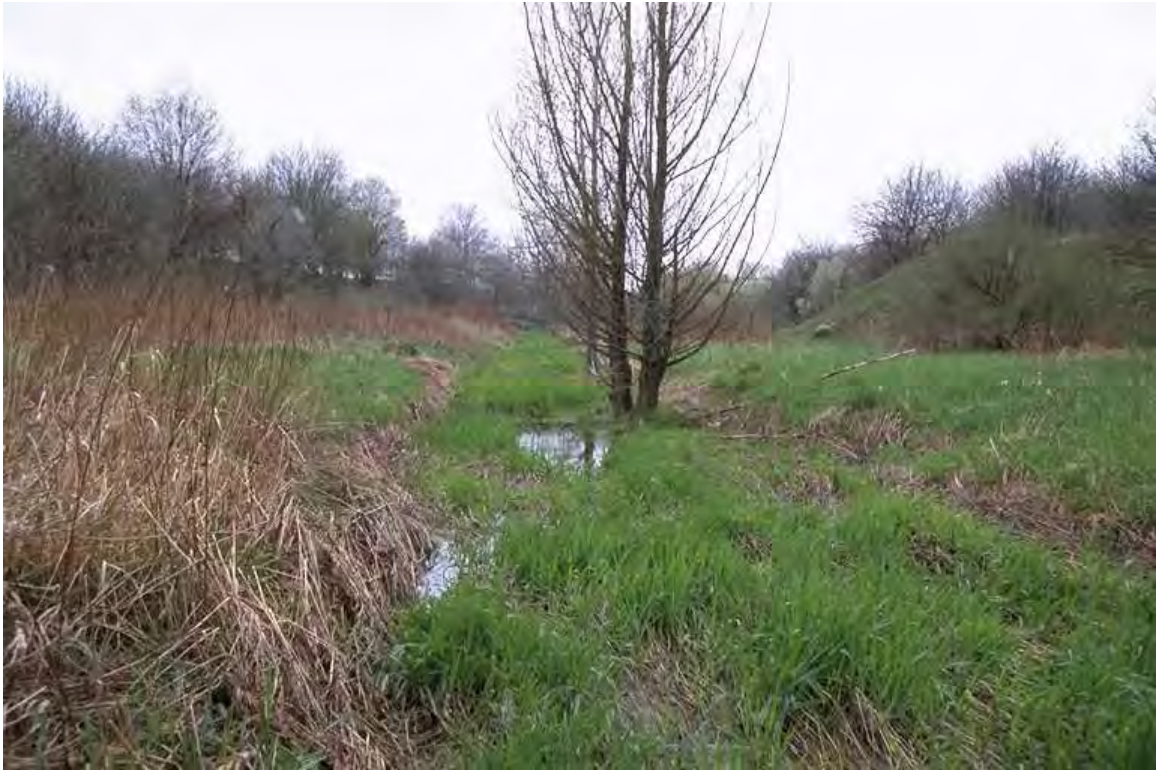
Photo 1. Reach JC-6 with formation of chutes.

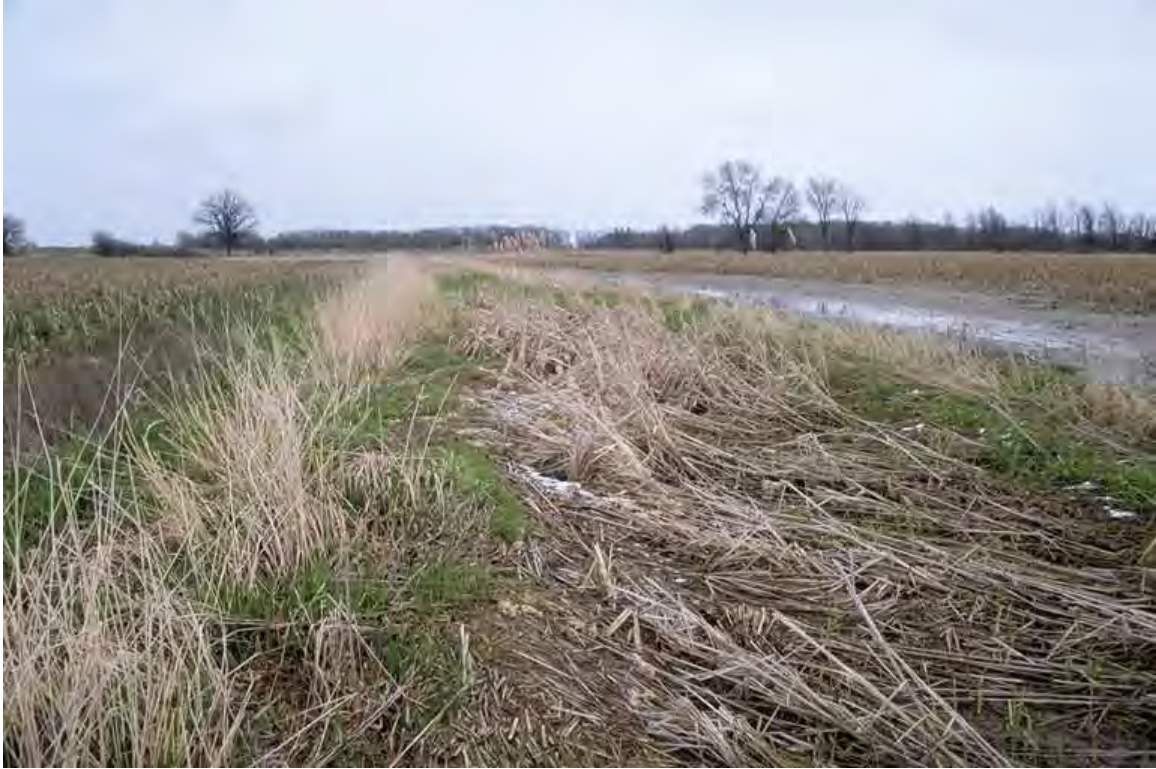
Photo 1. Reach JC-7 general channel conditions.

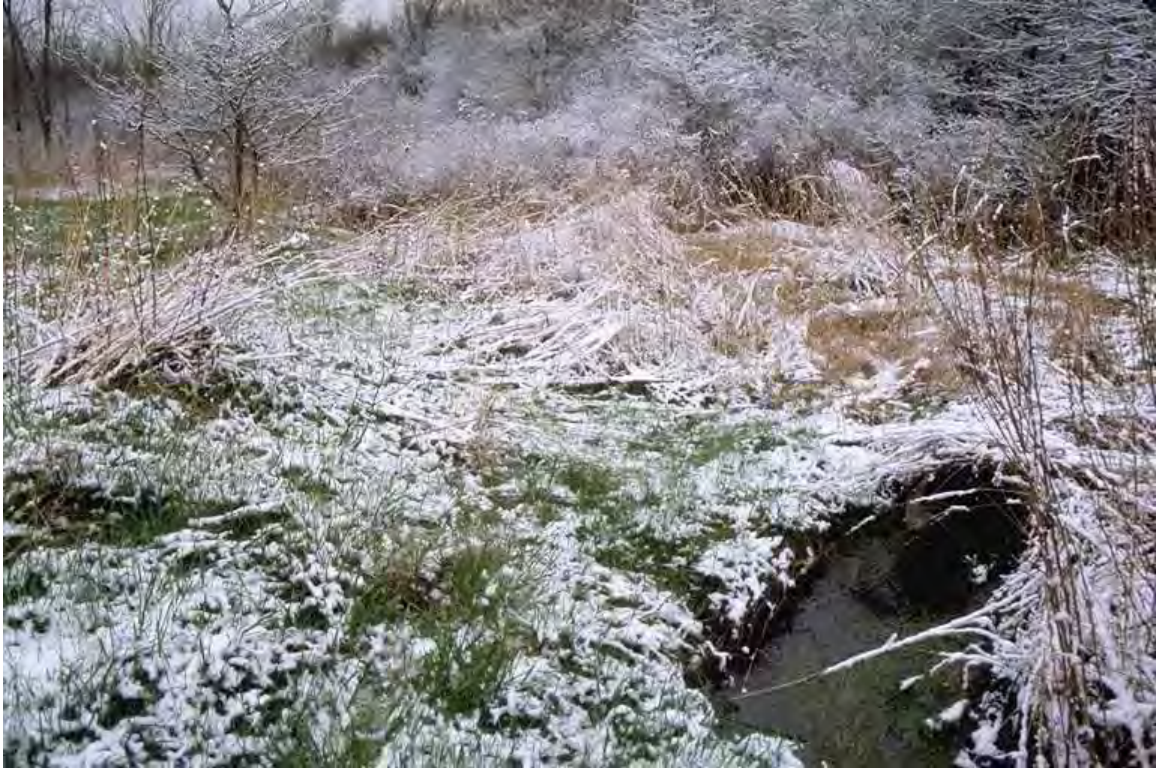
Photo 1. Reach JC-21 – dry, grassed channel.

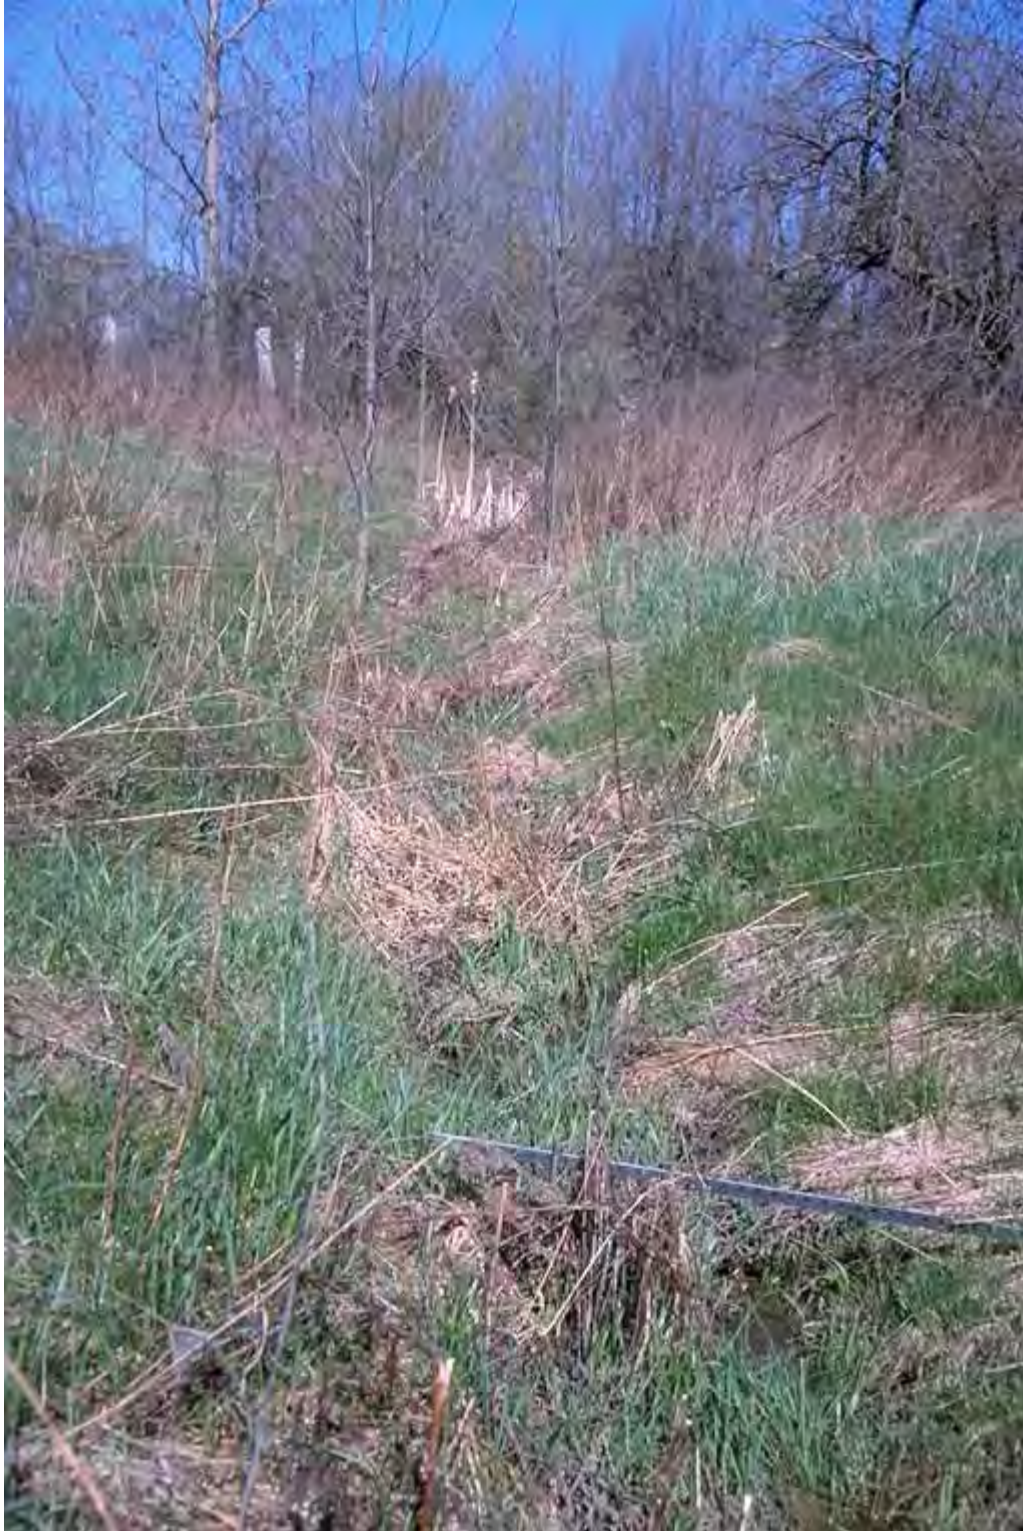
Photo 1. Reach JC-22 general channel conditions.

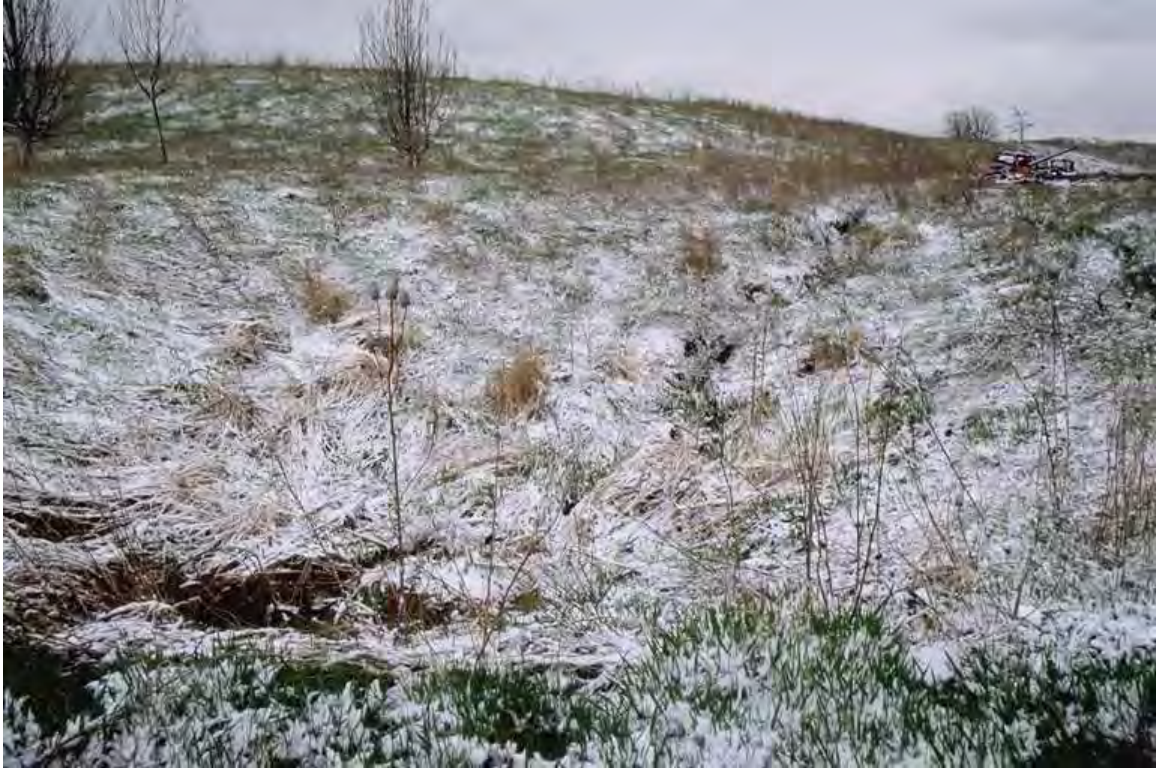
Photo 1. Reach JC-25 vegetated swale.

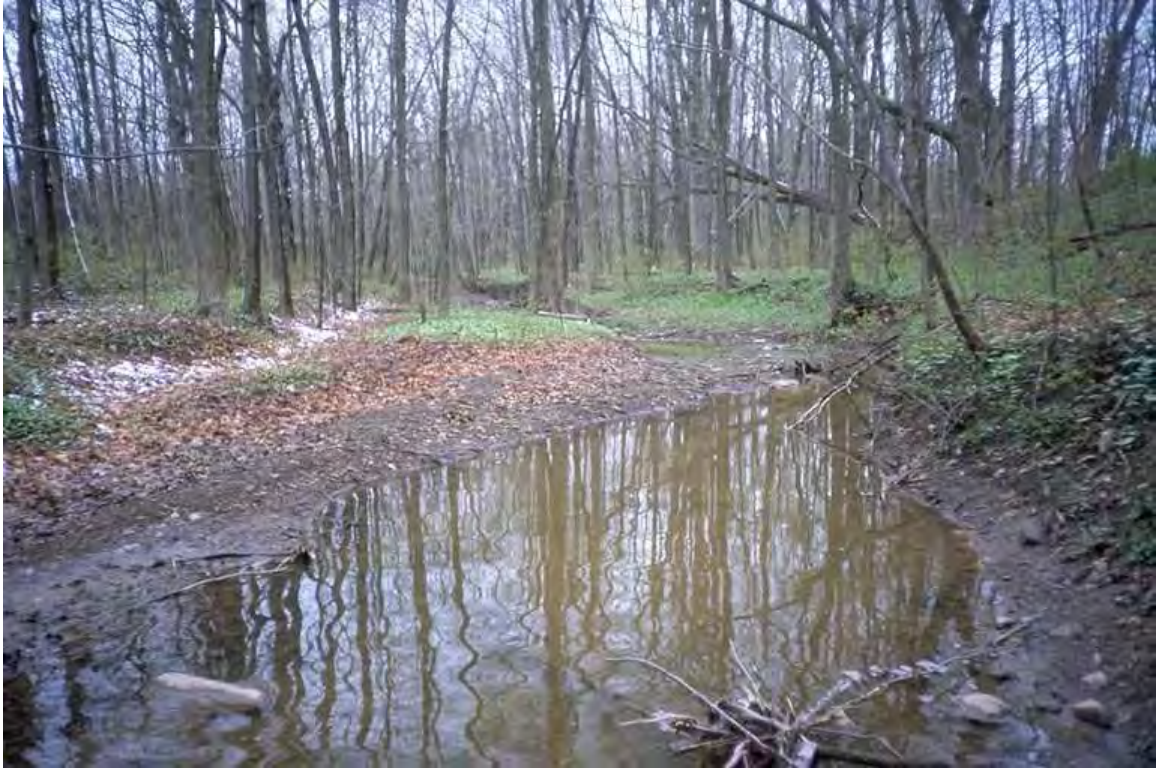
Photo 2. Reach SMA-1 valley wall contact.

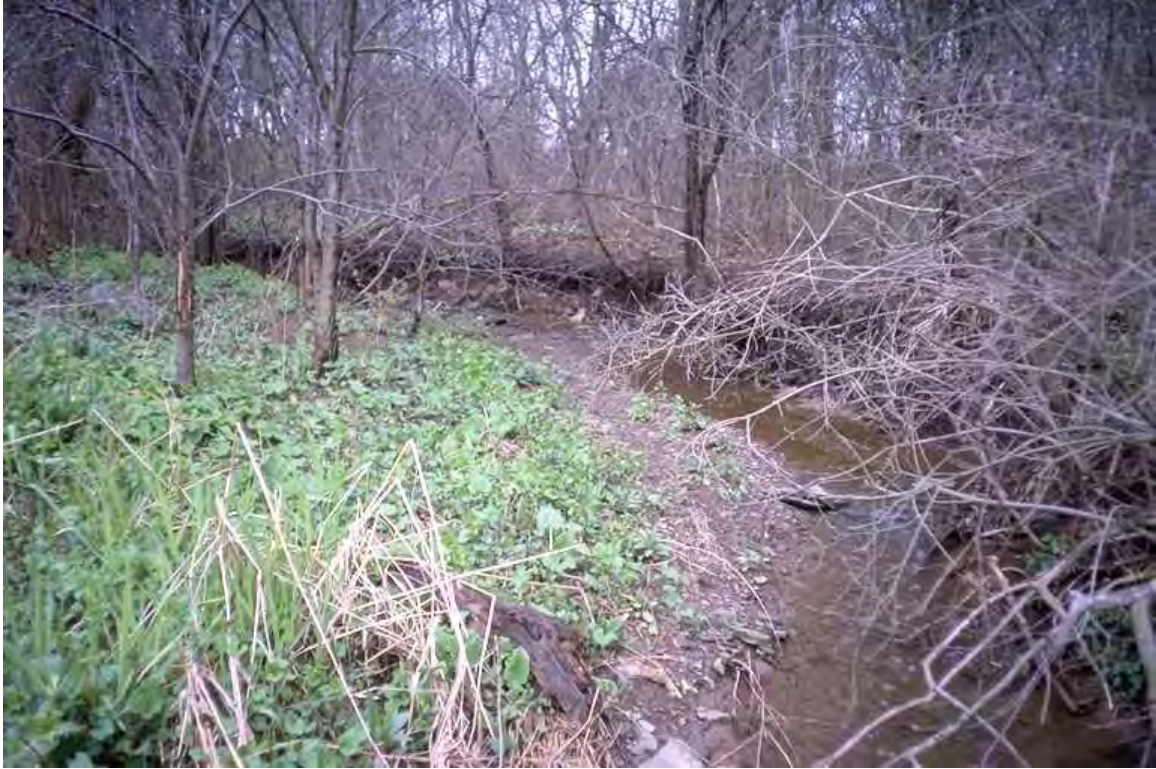
Photo 3. Reach SMA-2 at culvert.

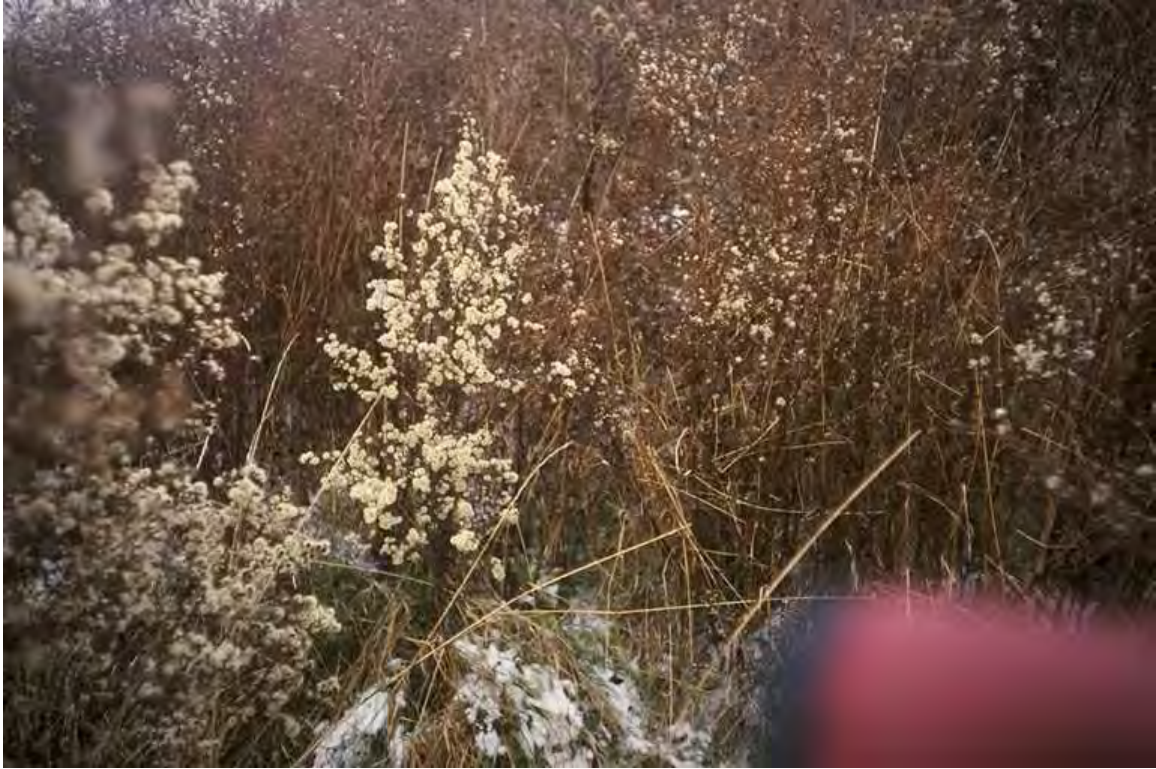
Photo 1. Reach MC-3 general conditions - swale.

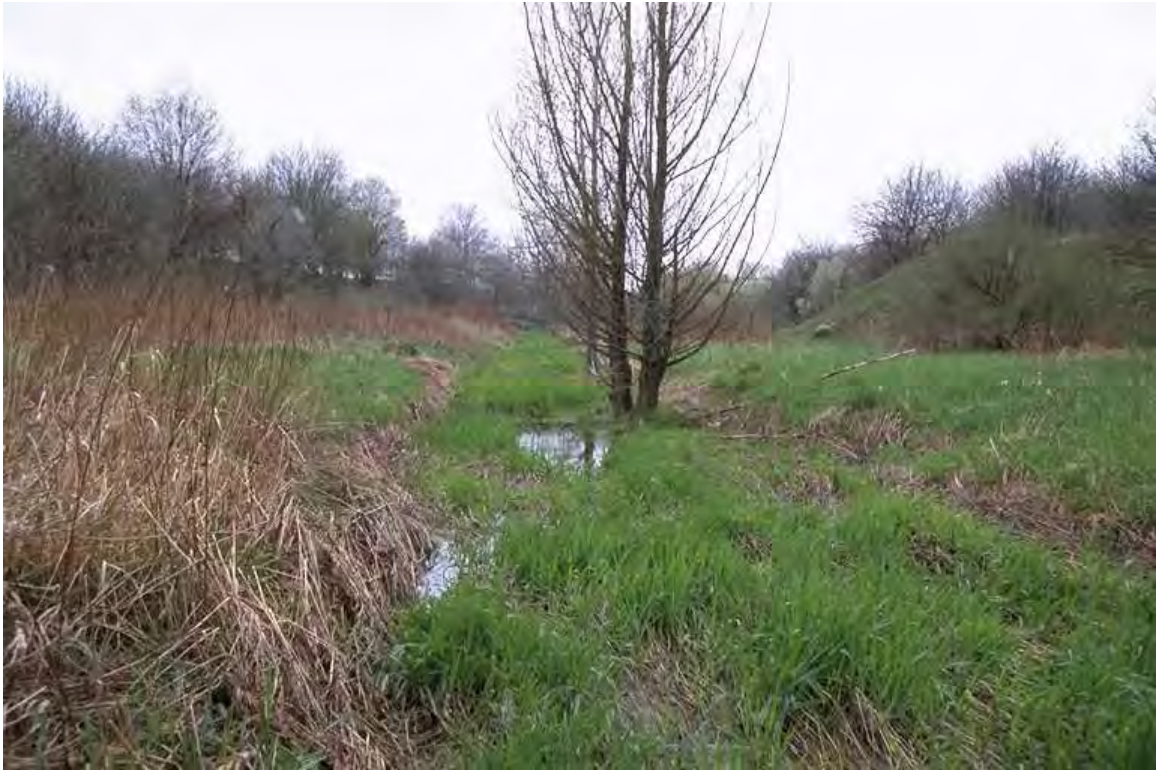
Photo 1. Reach JC-6 with formation of chutes.

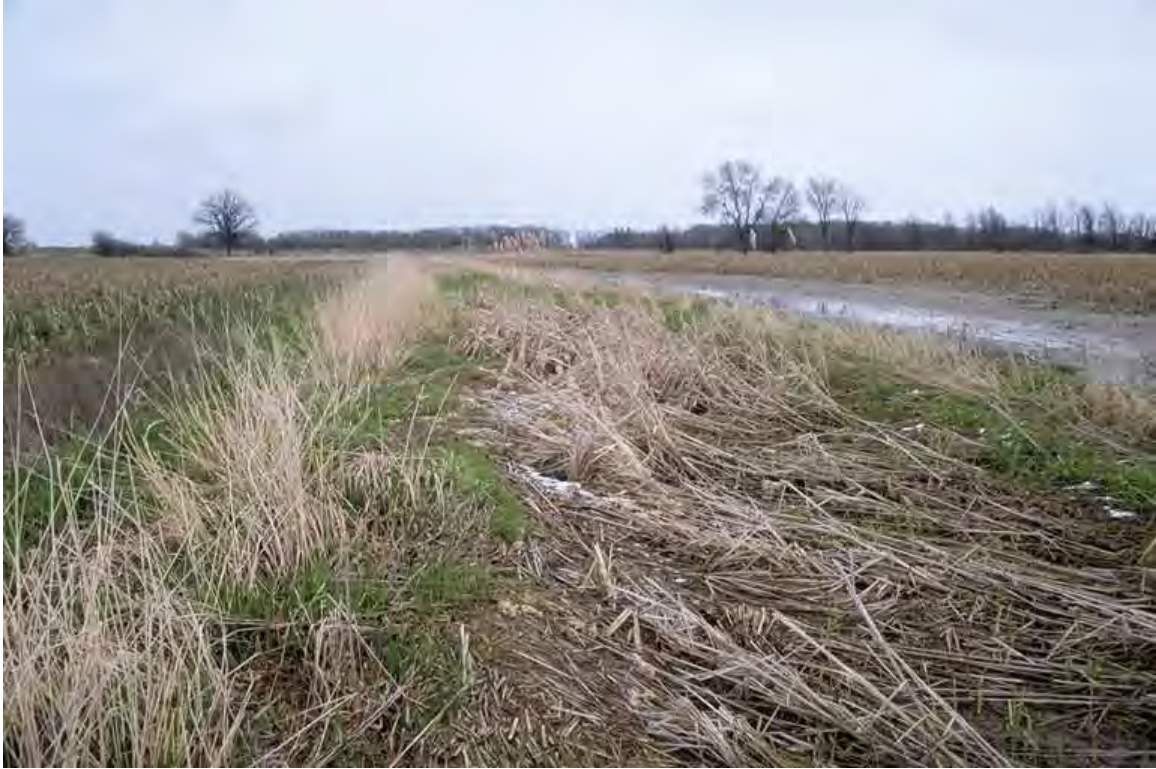
Photo 1. Reach JC-7 general channel conditions.

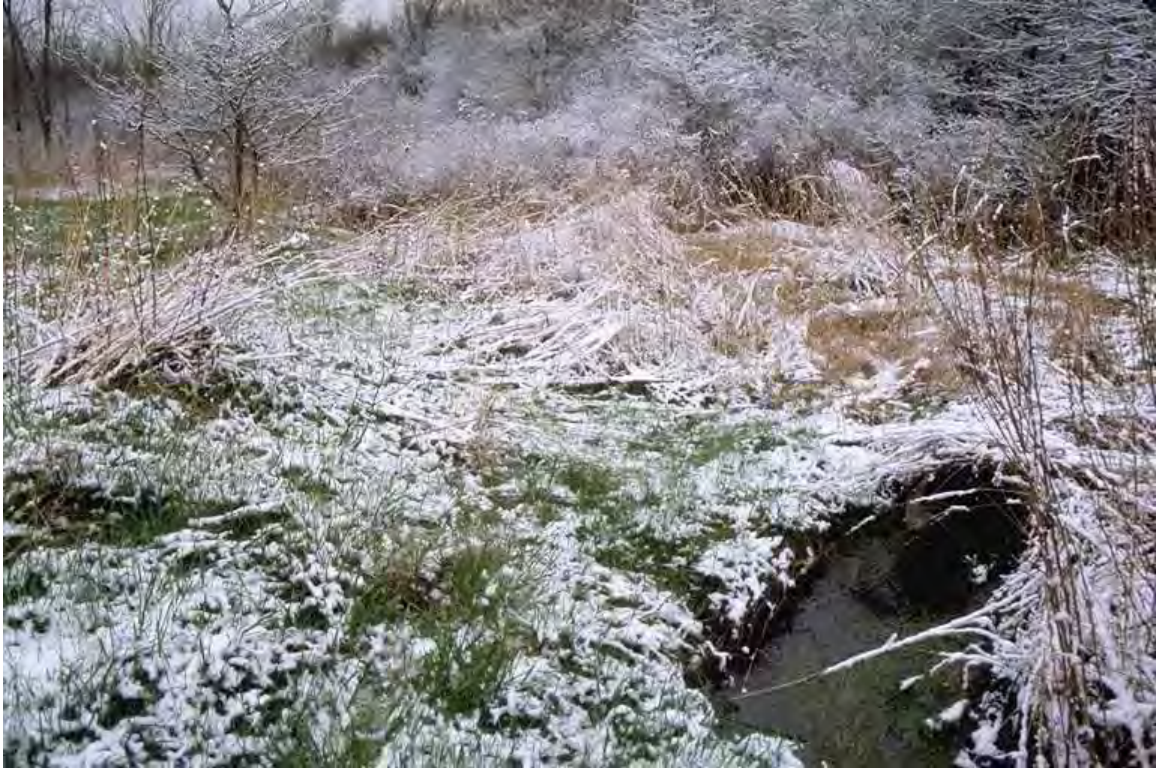
Photo 1. Reach JC-21 – dry, grassed channel.

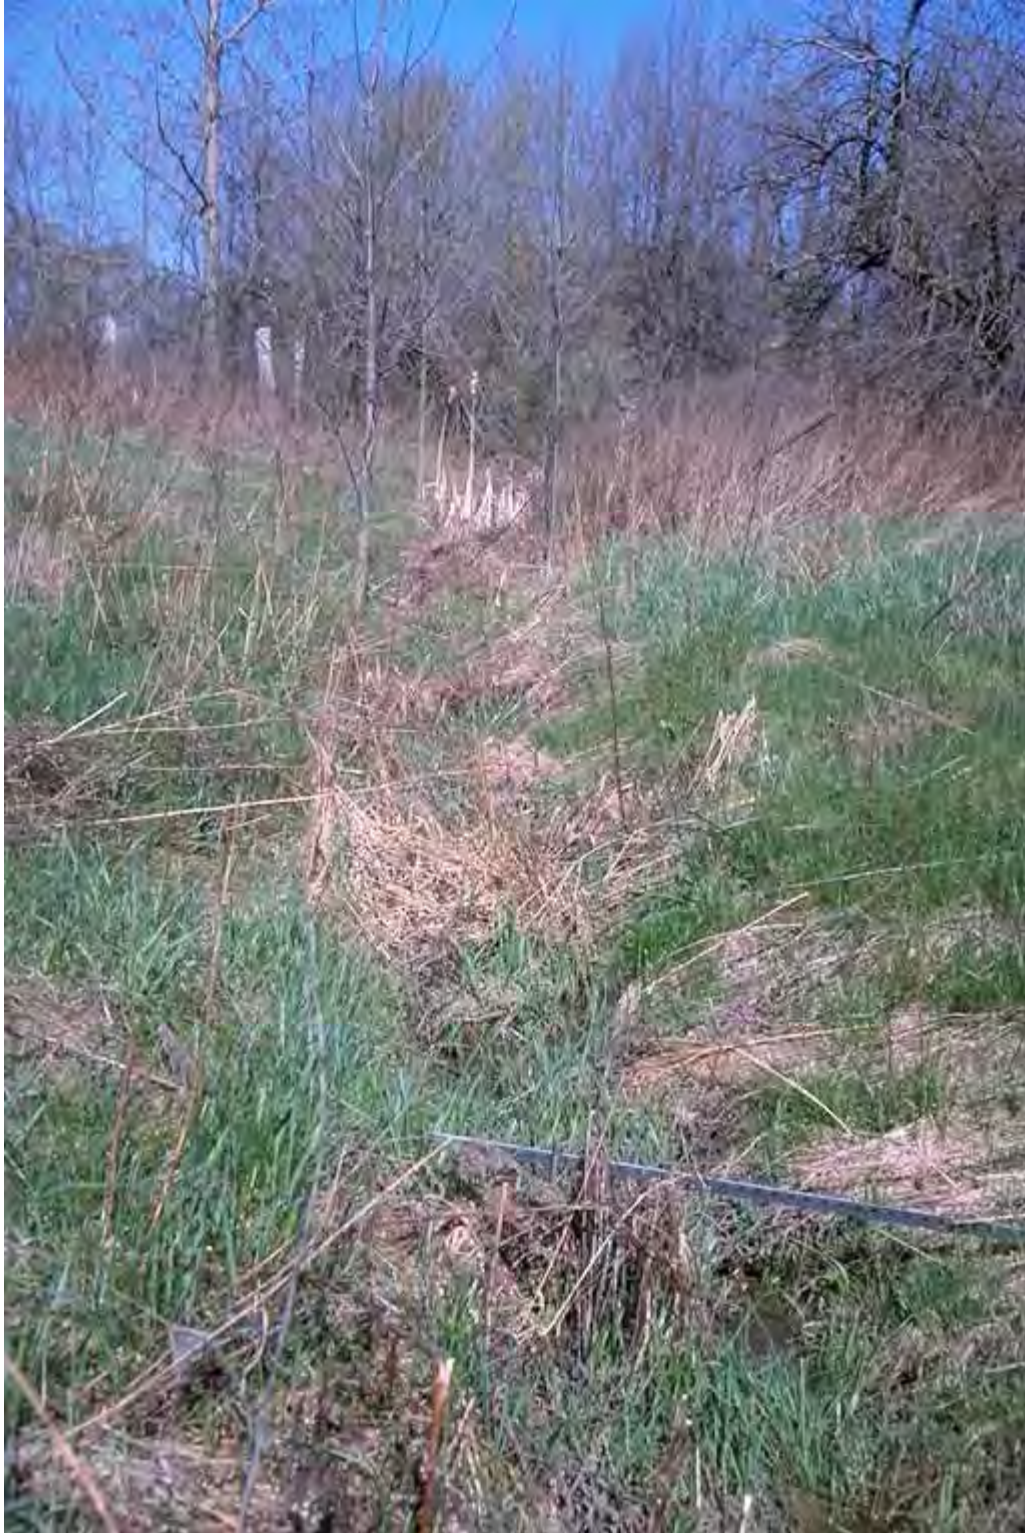
Photo 1. Reach JC-22 general channel conditions.
