APPENDIX C
NATURAL ENVIRONMENT REVIEW

MEMORANDUM

RE: Kerr Street at CNR Grade Separation Class Environmental Assessment Study (File: 3355)

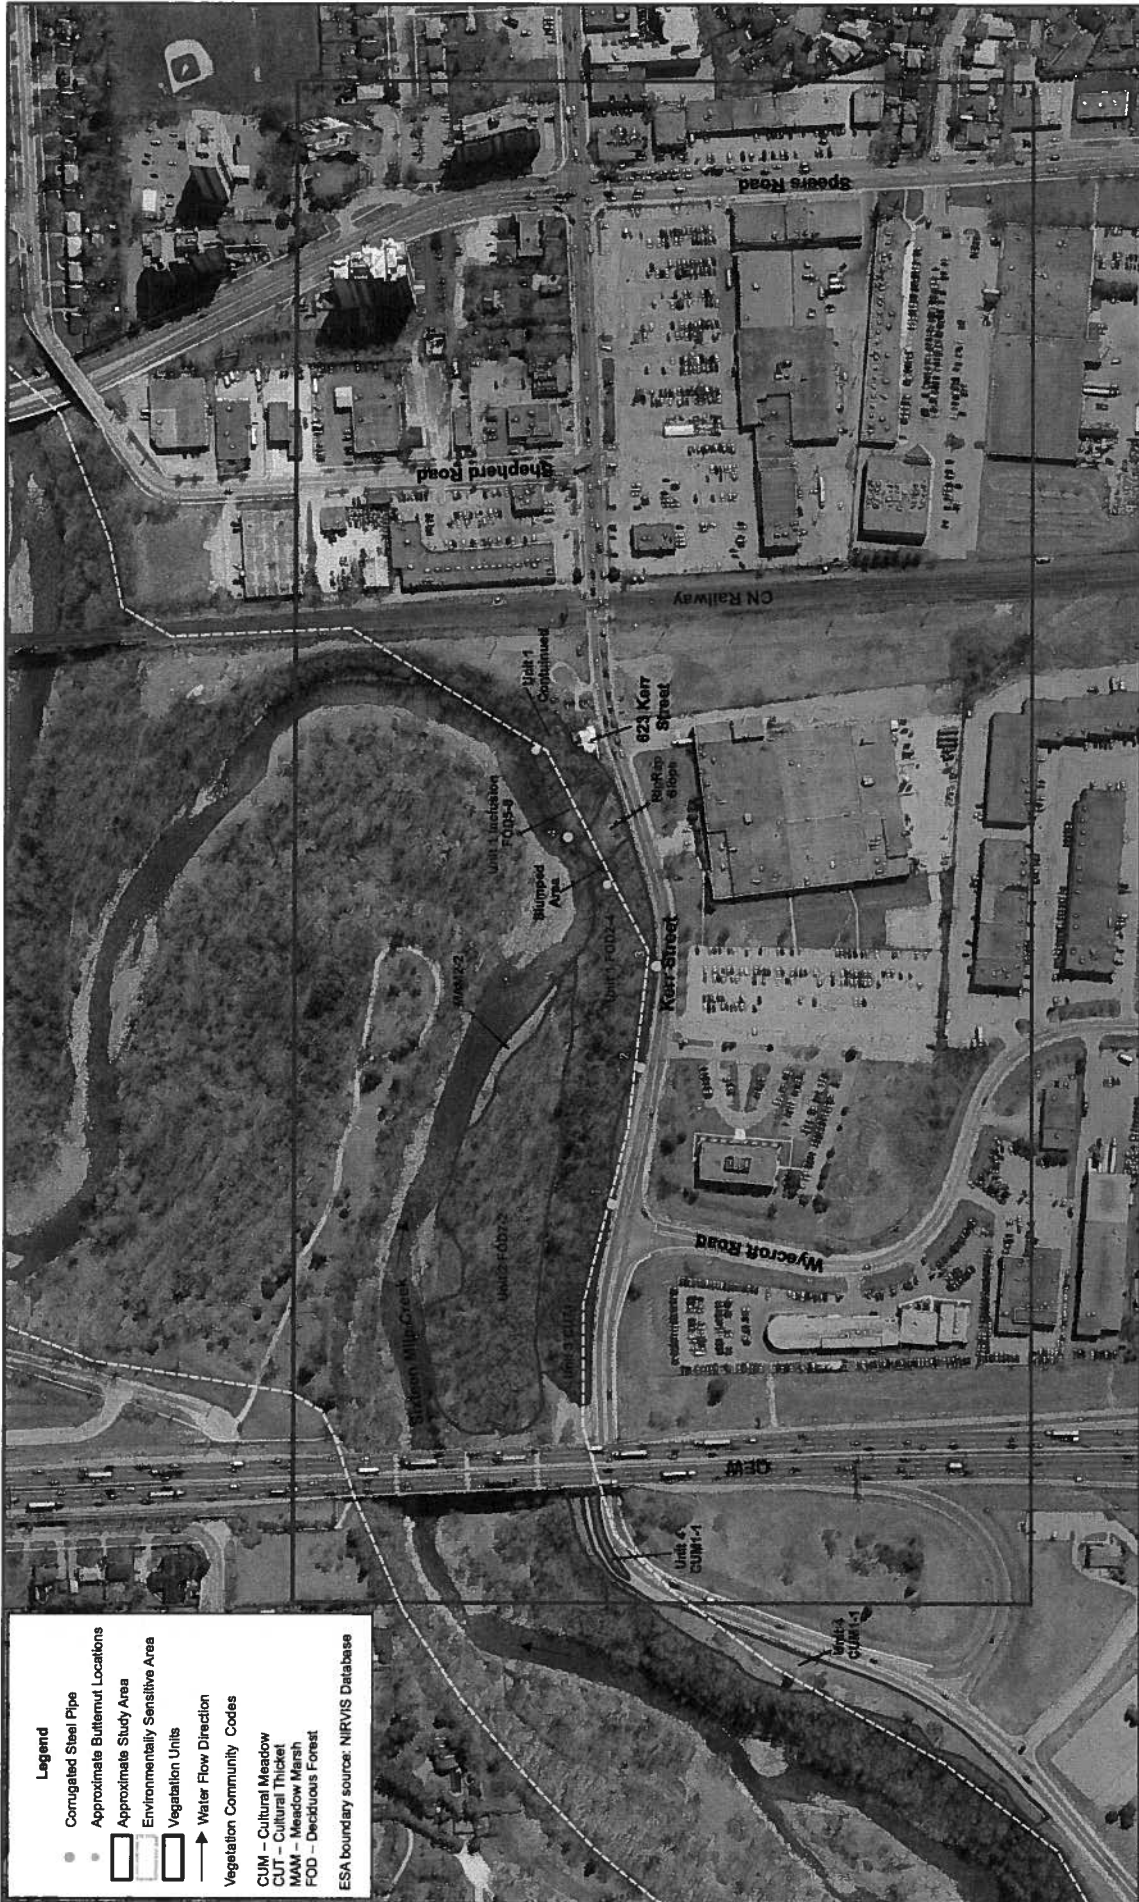
Date: Jan. 2009
 Project No: 50-3355
 Figure No: 1

A small portion of the Sixteen Mile Creek Valley Environmentally Sensitive Area (ESA #16) abuts the northeast side of Kerr Street in the northern half of the study area (Figure 1). The ESA encompasses the deeply incised valley of Sixteen Mile Creek, which cuts through the Queenston and Georgian Bay formation shales and supports a wide variety of bottomland, slope and tableland vegetation communities (Halton Region and North South Environmental Inc. 2005, Dwyer 2006).

A fourth CSP (CSP4, Figure 1) discharges stormwater directly into Sixteen Mile Creek at the outside bank of a 180° bend in the river. Replacement of CSP4 is required as part of the proposed improvements to Kerr Street. The existing CSP4 will be left in place to avoid additional disturbance to the valley slope. This is the only component of the proposed works that may have direct impacts to fisheries and aquatic habitat, and thus a description of the aquatic habitat features of the Sixteen Mile Creek is limited to the reaches immediately upstream and downstream of the proposed stormwater outlet and a general description of this portion of the Sixteen Mile Creek.

Kerr Street at CNR Grade Separation
Town of Oakville
Natural Environment Setting and Features

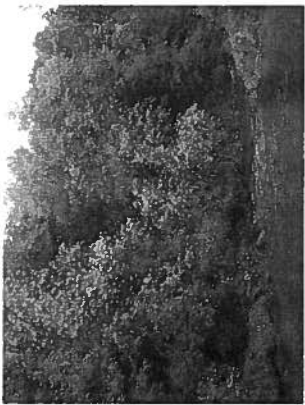
Channel banks are approximately 0.5 m to 1 m high on the east and west banks surrounding CSP4, exhibiting some moderate bank erosion and scouring on the west bank which has caused failure of the Gabion baskets supporting the bank at CSP4 and slumping of the valley slope just north of the rip rap slope. Large woody debris was observed within the channel just upstream of CSP4.

Substrates are mostly shale and cobble, with some pockets of gravel and silt. Large concrete blocks were observed at the CSP4 outlet. This portion of the channel is partially shaded by overhanging branches and trees along the west bank of the creek. Channel morphology includes a riffle zone upstream of CSP4 that transitions to a long flat section just downstream of CSP4. No seepage along the banks was observed (although seepage was observed along the west valley slope).

Photo 1: West bank of the Sixteen Mile Creek showing CSP4, Unit 1 inclusion (foreground) and Unit 1 (Background)

- The stormwater outlet will be designed to outlet in close proximity to, but outside of the main Sixteen Mile Creek channel and flow into the creek along a designed 'channel' with rock protection (scour protection) extending into the base of the creek. This will be an improvement over current conditions where the outlet plunges directly into the creek. This outfall will be designed by a qualified geomorphologist during detail design.

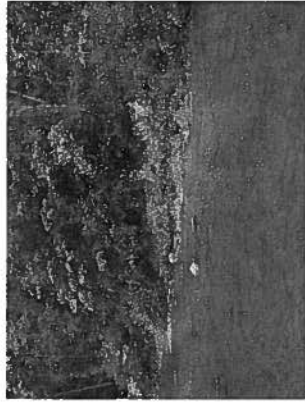
Photo 2: West bank of the Sixteen Mile Creek south of CSP4

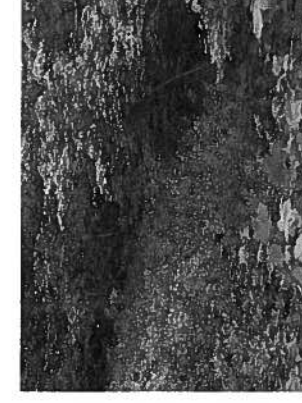
Two butternut specimens were observed in Unit 1, northeast of the residence at 623 Kerr Street, and north of the slumped area. Butternut is endangered provincially and federally and is discussed further in the Species of Conservation Concern section of this report. No other species at risk (SAR) were observed. Two species uncommon in Halton Region according to Varga et al. (1999) were observed: Jerusalem Artichoke and Virginia Stickseed. Jerusalem Artichoke is a provincially common exotic species (ranked SE5) observed along the banks of the Sixteen Mile Creek outside of the potential works zone in the MAM2-2 portion of Unit 2. Virginia Stickseed, ranked S5 (secure in Ontario) was occasionally present along the upper portions of the forested valley slope in Unit 1.

In addition to the species discussed above, two Butternut trees were observed in Unit 1. A 30 cm DBH Butternut infected with Butternut Canker was observed northeast of the residence at 623 Kerr Street (approximate location illustrated on Figure 1). Another smaller specimen infected with Butternut Canker and with substantial crown dieback was observed on the north edge of the slumped area on the lower third of the slope (Figure 1). This species is listed as endangered by COSSARO and COSEWIC due to recent population declines caused by the Butternut Canker. While both specimens are outside of the anticipated area of direct impacts, some mitigation strategies may be applicable to ensure that they are not accidentally harmed during construction. These strategies are discussed further in section 7.0 of this report.

Photo 8: Slumped area vegetation community from the west bank of the Sixteen Mile Creek showing one of the Butternut specimens

- While the Butternut observed northeast of the residence at 623 Kerr Street in Unit 1 is outside of the anticipated construction footprint, its location and status should be confirmed during detail design, identified on Contract Drawings, and flagged on site prior to the initiation of construction activities to limit the potential for accidental disturbance of this specimen. No impacts are anticipated to the Butternut located north of the slump area.

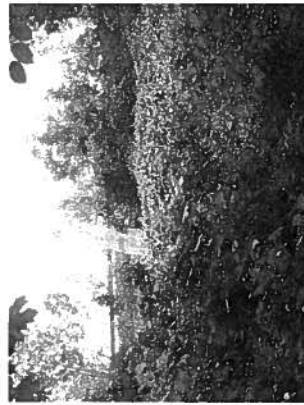
barren with the exception of a few young saplings and disturbance tolerant old-field species (see area labelled as 'Riprap Slope' on Figure 1).

Photo 9: Rip rap slope from the west bank of the Sixteen Mile Creek

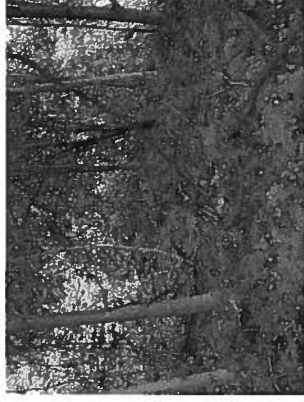
Unit 1 inclusion - Dry Fresh Sugar Maple-White Ash Deciduous Forest Type (FOD5-8) – The area surrounding the proposed location of the new storm water CSP outlet to Kerr Street was previously cleared for placement of the existing CSP. The area is currently occupied by a young partially closed

Photo 10: Unit 1 inclusion understorey at the base of the rip rap slope, facing north west
