3437 TRAFALGAR ROAD & 340
BURNHAMTHORPE ROAD EAST
Cultural Heritage Evaluation Report

March 19, 2026

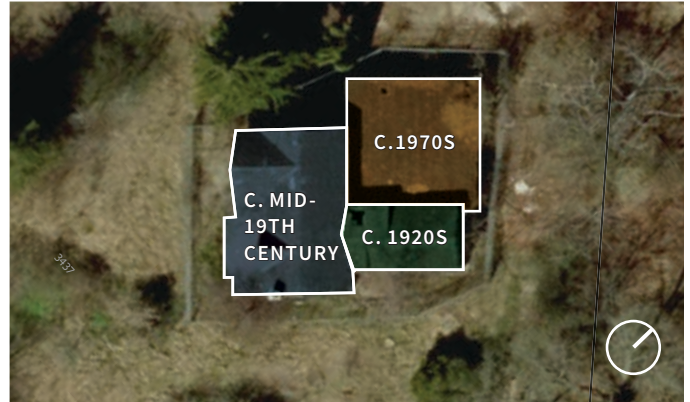
Aerial image indicating evolution of 3437 Trafalgar Road, with the approximate dates of each portion of the structure indicated (Town of Oakville, 2025; annotated by ERA).

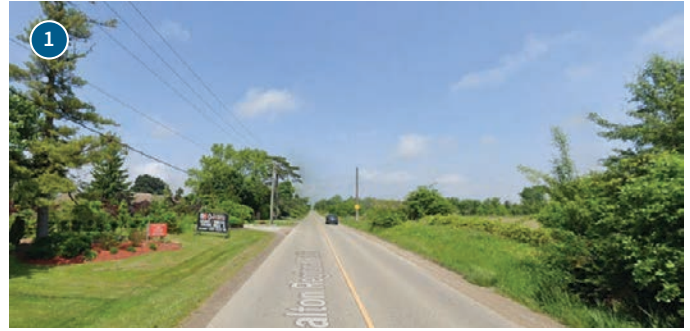
Rural stretch of Burnhamthorpe Road East to the northeast of the Site (Google, 2025).

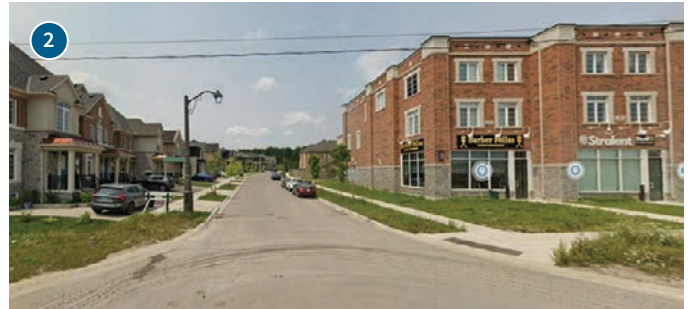
New residential subdivision with a mixed-use building fronting onto Burnhamthorpe Road East (Google, 2025).

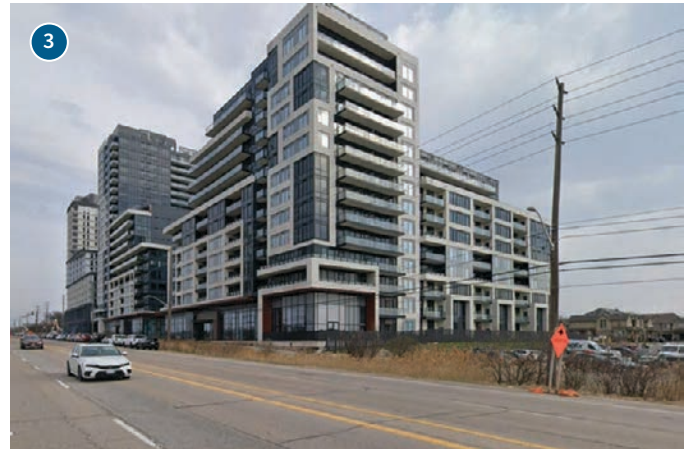
Recently-completed mid-rise building along Trafalgar Road, with low-scale residential beyond (Google, 2025).

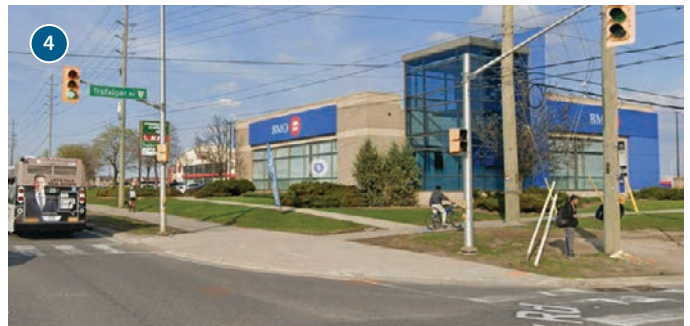
Southeast corner of Trafalgar and Burnhamthorpe Roads (Google, 2025).

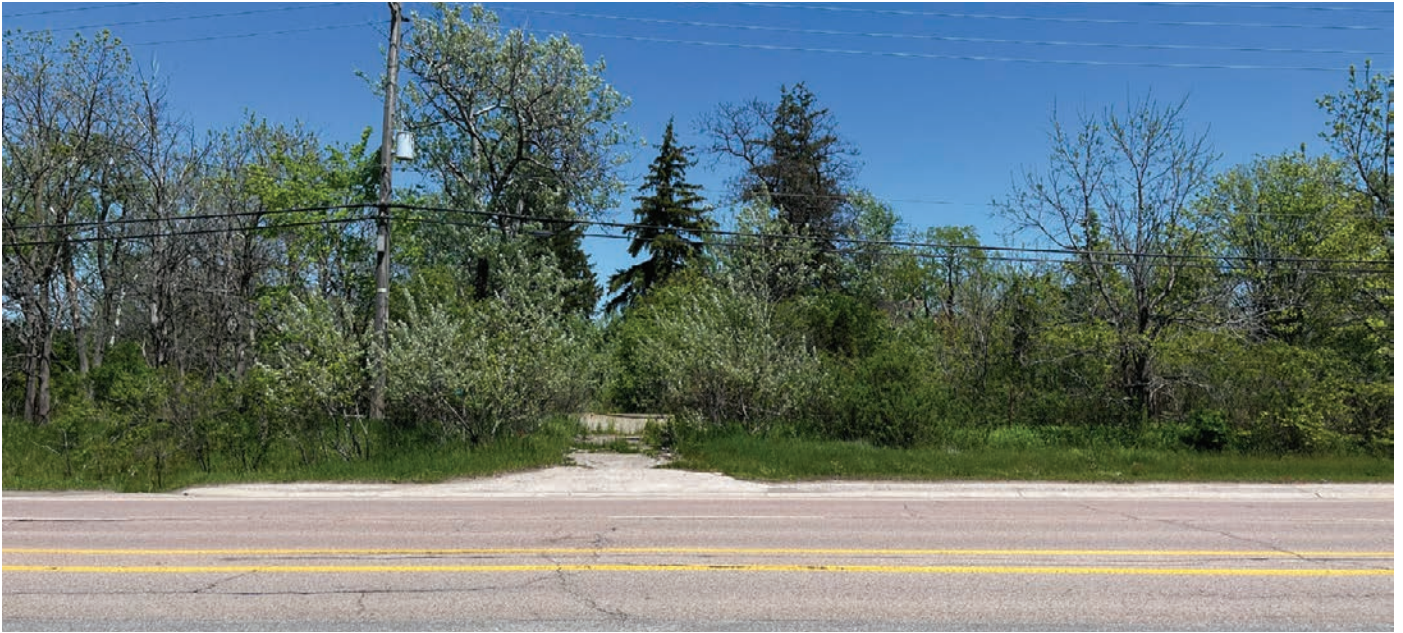
Looking east from Trafalgar Road towards 3437 Trafalgar Road. The building on the property is obscured by vegetation and is not visible (ERA, 2025).

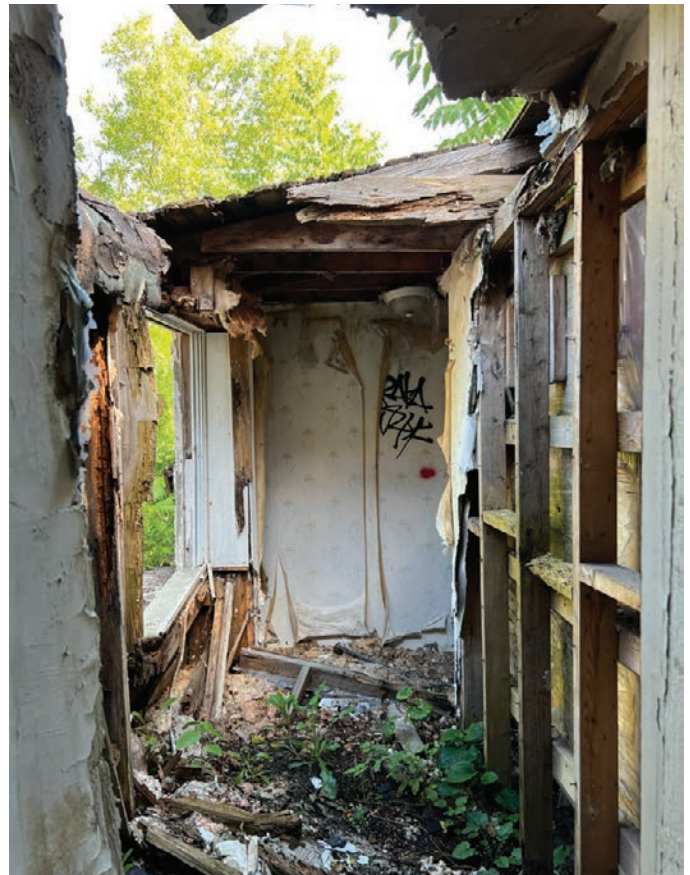
The roof in the 20th-century two-storey addition has failed (ERA, 2025).

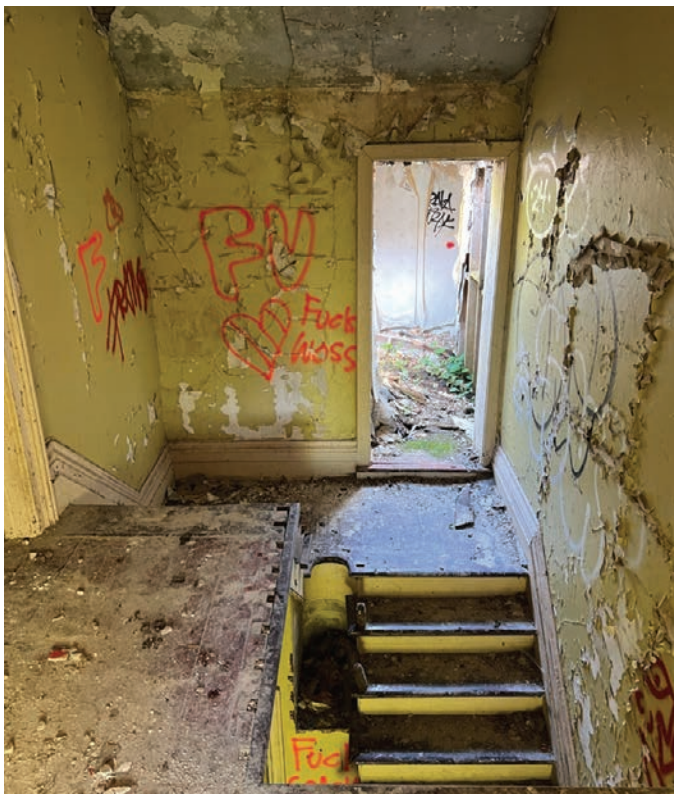
Looking towards the 20th-century rear addition from the second storey. Note the balustrade has been removed (ERA, 2025).

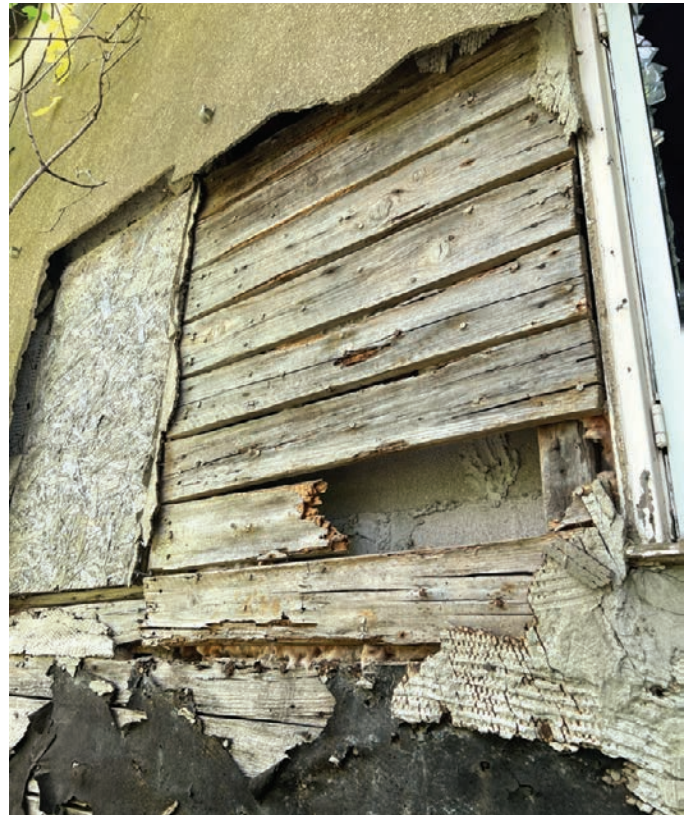
Concrete block structure visible underneath stucco at the two-storey rear addition (ERA, 2025).

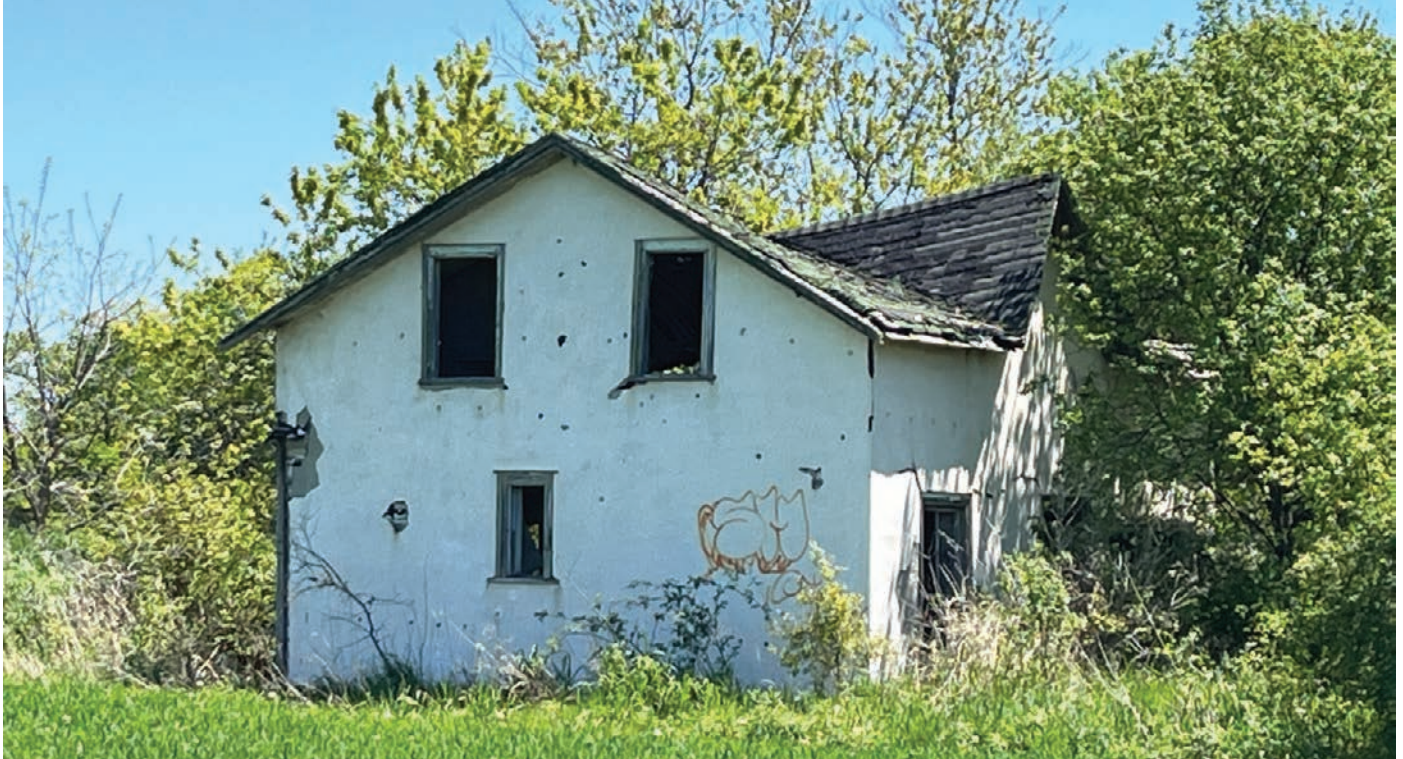
Principal (west) and side (north) elevations of the circa 1840s building at 340 Burnhamthorpe Road (ERA, 2025).

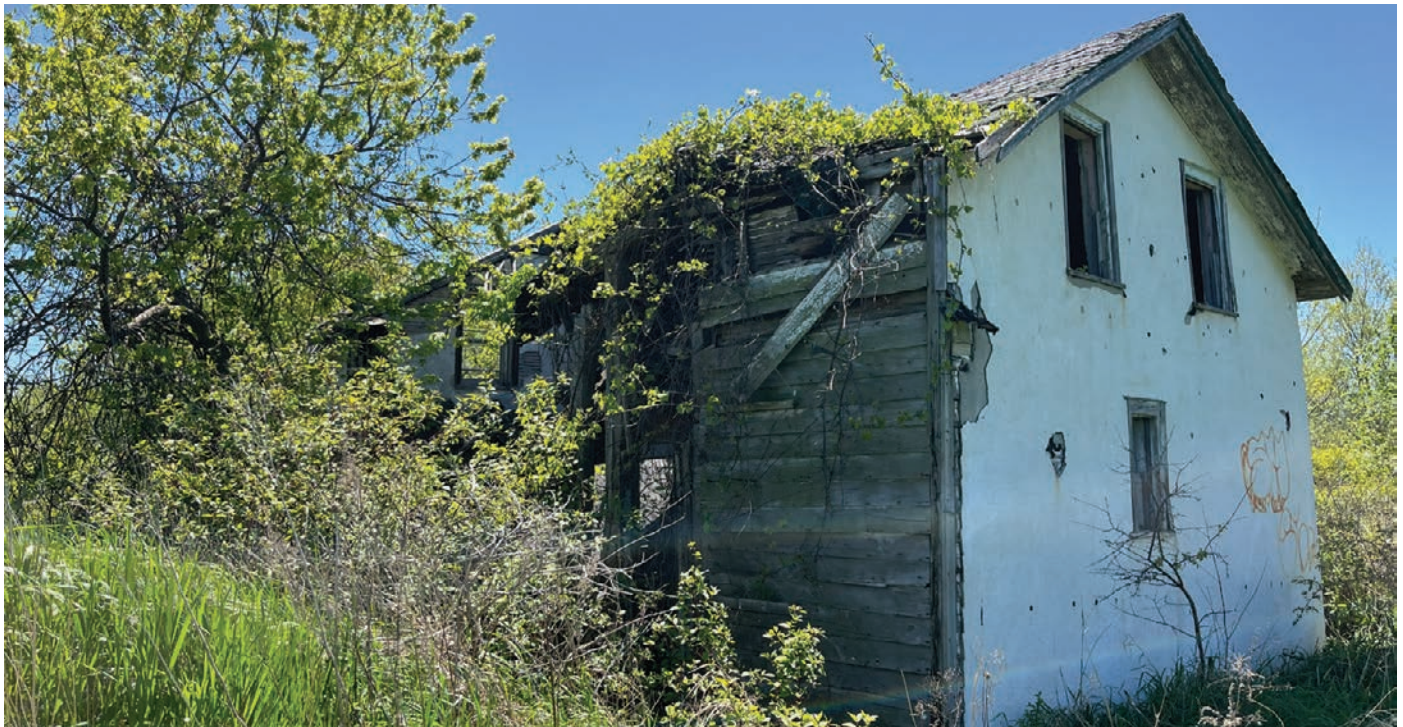
Side (south) and rear (east) elevations of the circa 1840s building at 340 Burnhamthorpe Road. Note the failure and collapse of the rear wall (ERA, 2025).

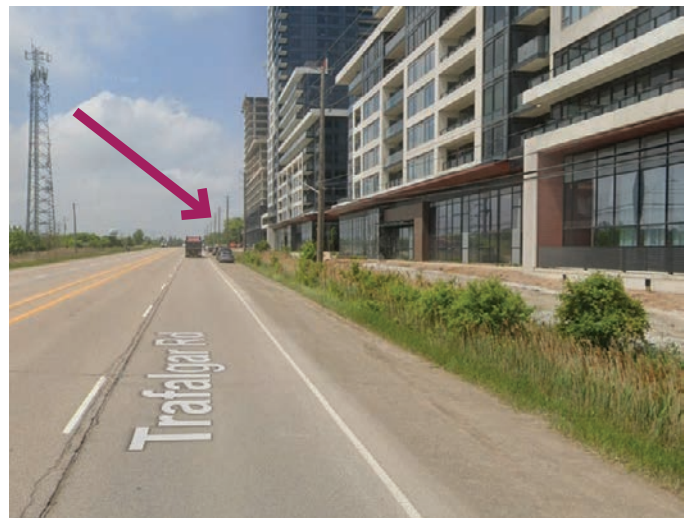
Looking north along Trafalgar Road, with the Site (indicated by an arrow) obscured by high-rise construction (Google, 2025).

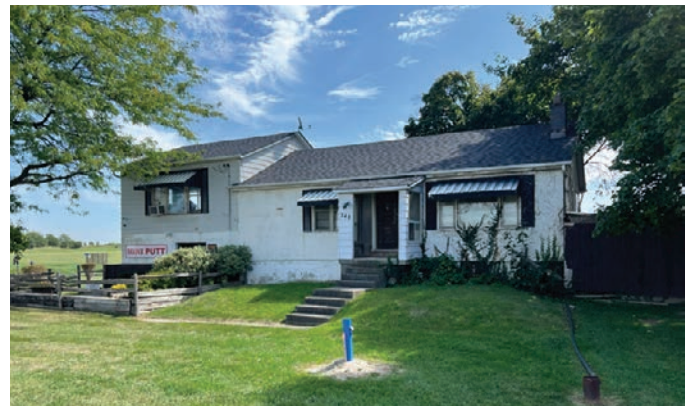
Mid 20th-century house-form building, constructed between 1954-1978 (ERA, 2025).

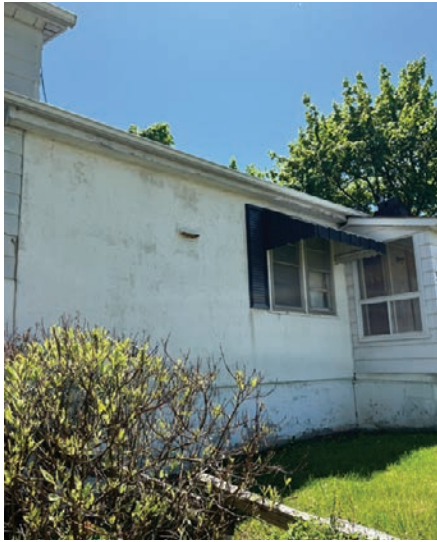
Stucco in poor condition (ERA, 2025).

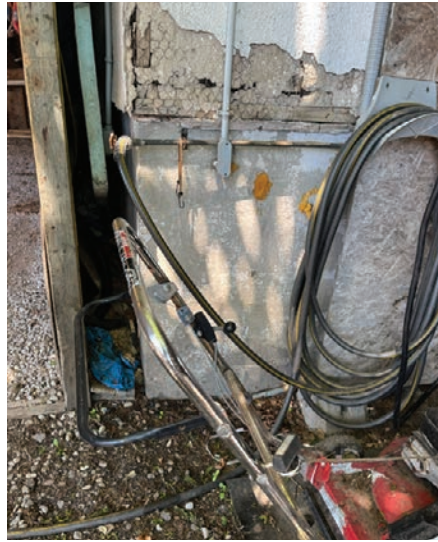
Stucco in poor condition, showing delamination (ERA, 2025).

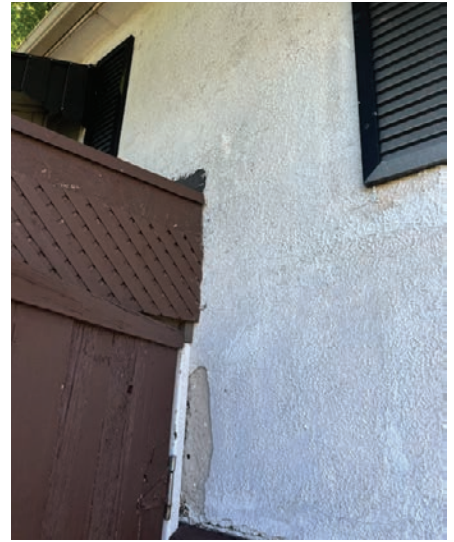
Stucco in poor condition, showing cracking and delamination (ERA, 2025).

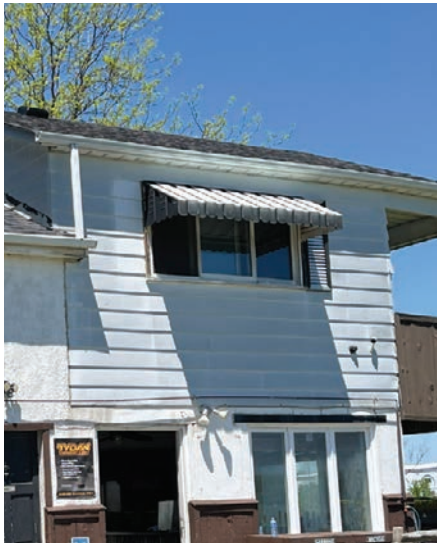
Metal siding in fair condition, with areas of poor condition (ERA, 2025).

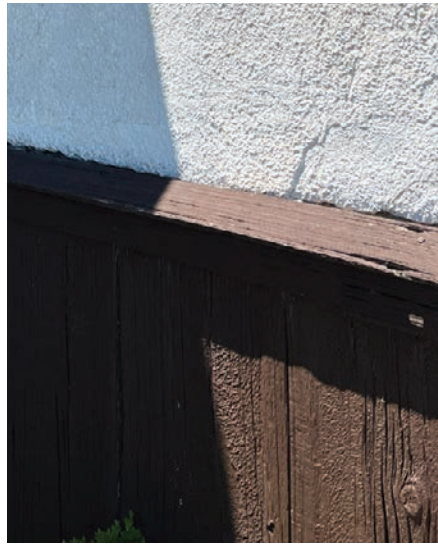
Wood siding in fair condition, with areas of poor condition (ERA, 2025).

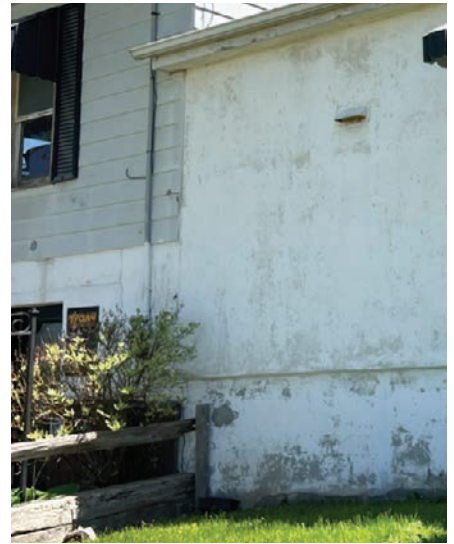
Concrete block wall mostly in fair condition despite defects (ERA, 2025).

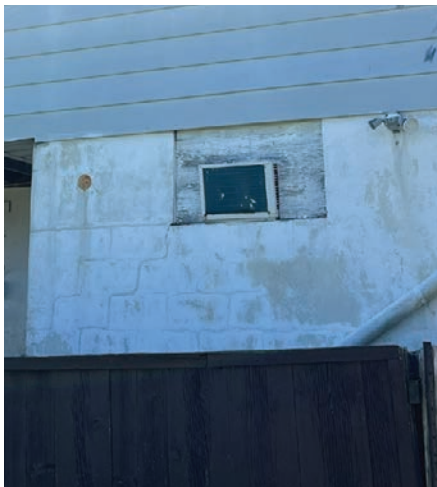
Concrete block wall with areas of poor condition, including step cracking (ERA, 2025).

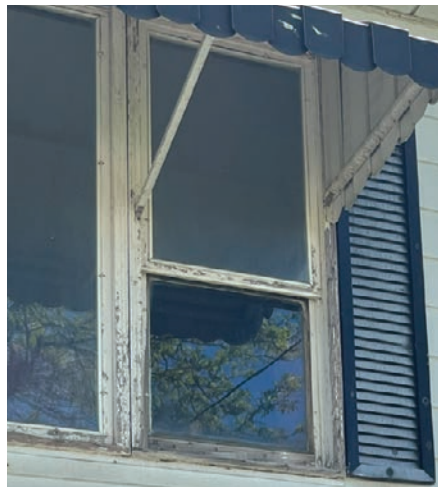
Wood windows in poor condition, with areas of wood rot (ERA, 2025).

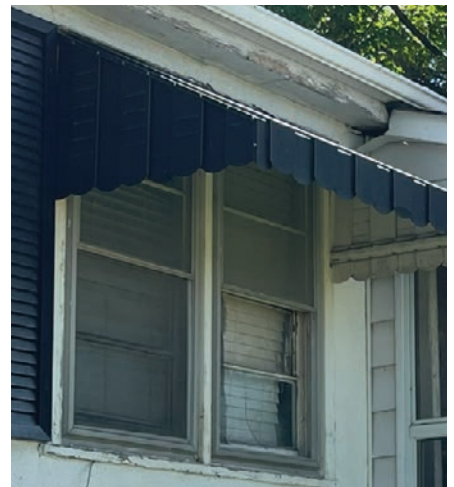
Metal windows in fair condition (ERA, 2025).

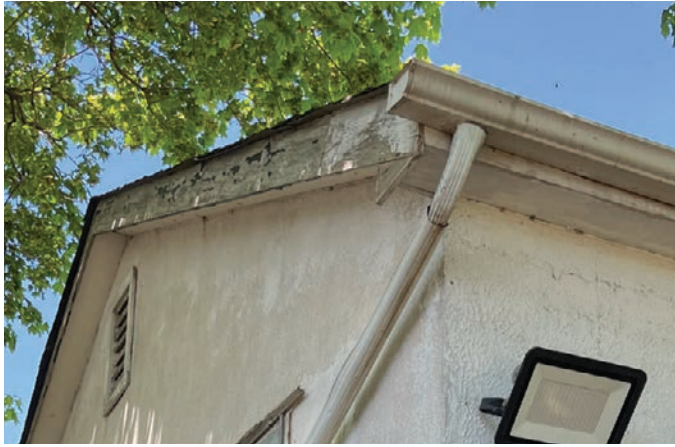
Bargeboard, fascia and soffit show paint flaking, wood rot and cracking (ERA, 2025).

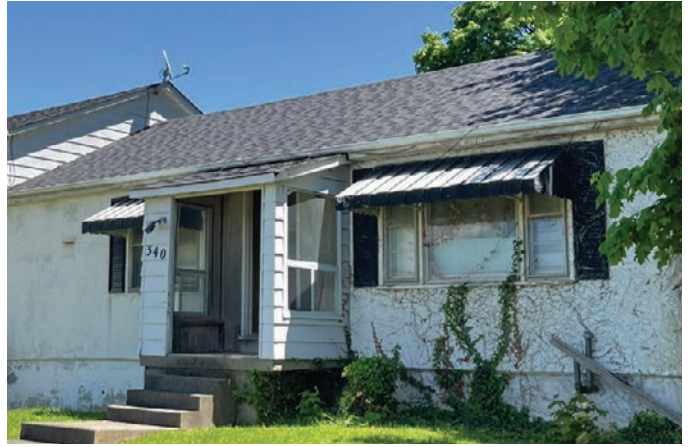
Asphalt roof shingles in good condition (ERA, 2025).

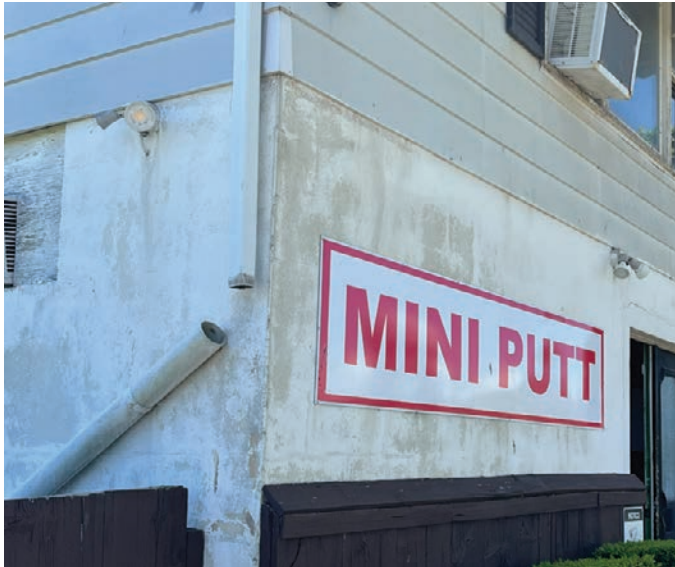
Metal eavestrough and downspouts in fair condition with an area of poor condition, with a missing downspout elbow (ERA, 2025).

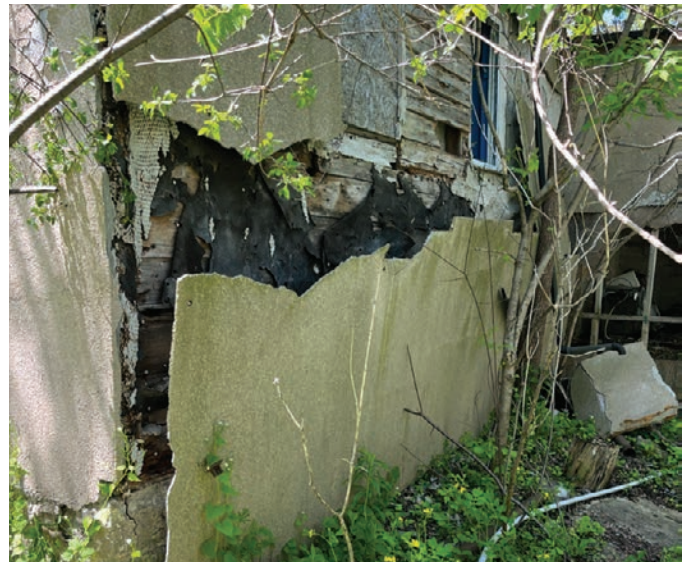
Areas of stucco in defective condition (ERA, 2025).

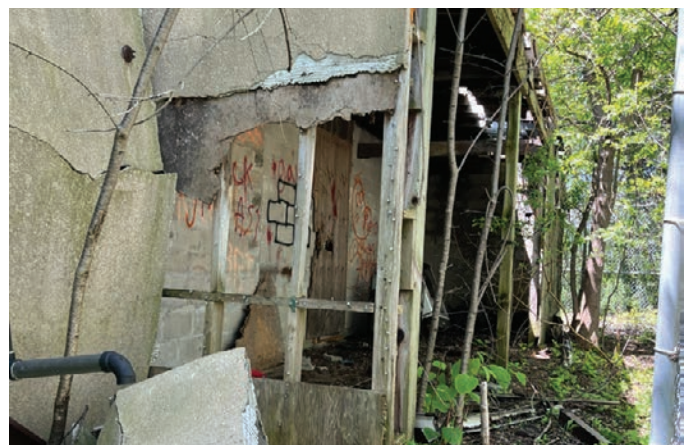
Concrete block wall in fair condition, with sections of graffiti (ERA, 2025).

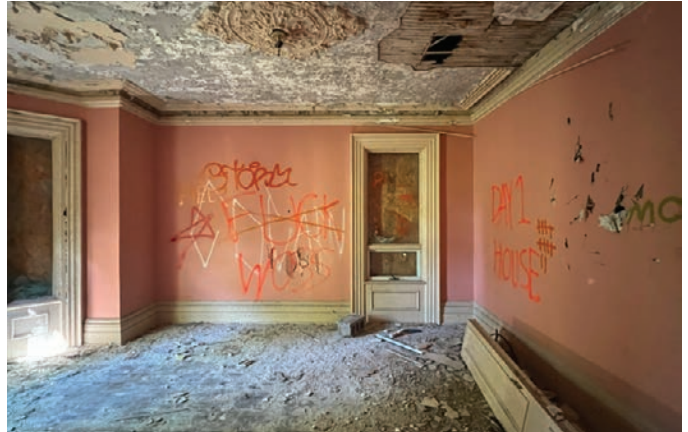
Interior spaces generally in defective condition (ERA, 2025).

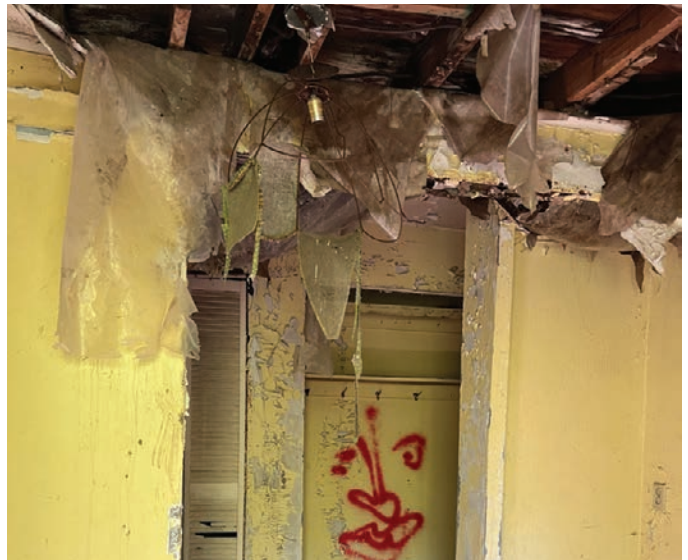
Interior spaces showing missing and damaged finished, revealing materials underneath (ERA, 2025).

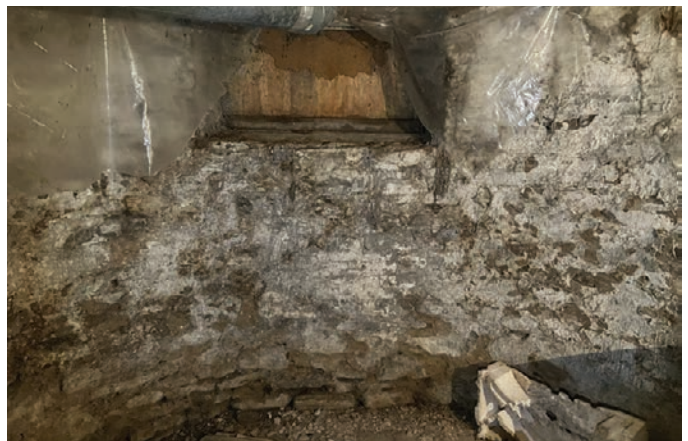
Fieldstone foundations, viewed from the basement, in poor condition (ERA, 2025).

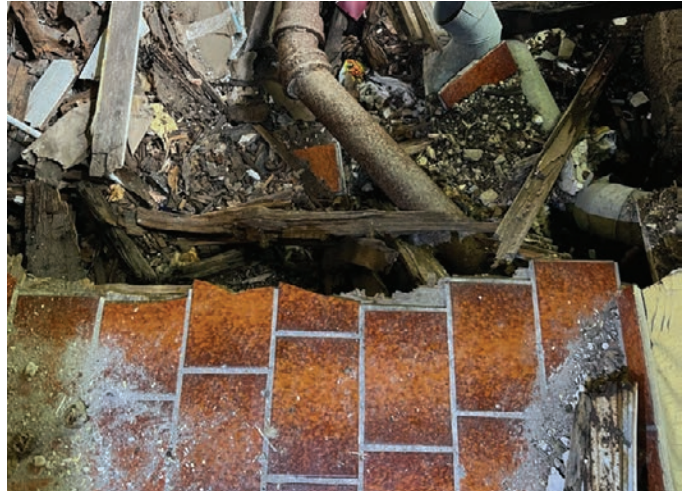
Tile floors at the later addition in defective condition (ERA, 2025).

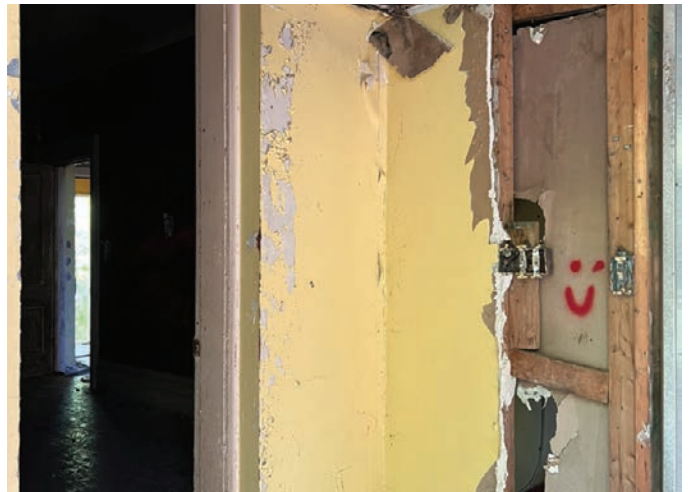
Drywall at the later addition in poor to defective condition (ERA, 2025).

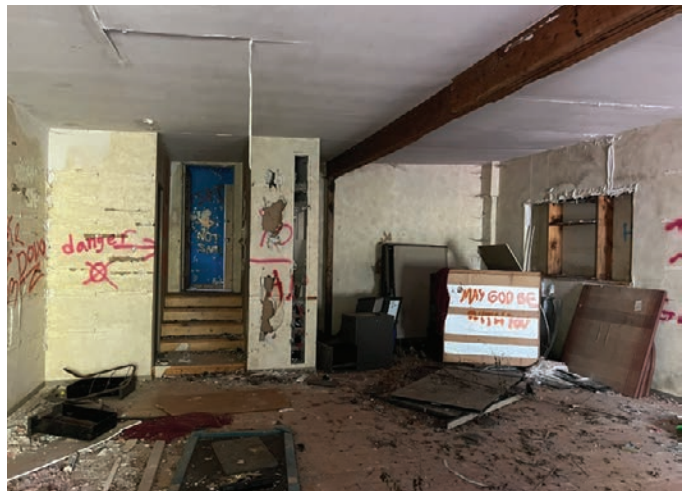
Ceiling at the north part of the later addition in poor condition (ERA, 2025).

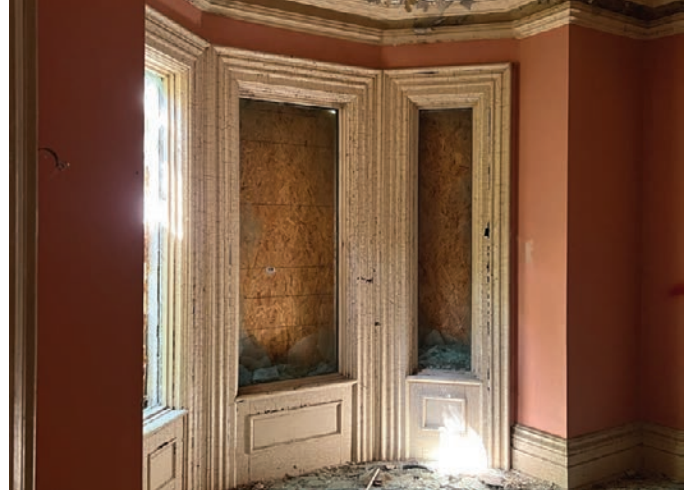
Window surrounds in fair condition (ERA, 2025).

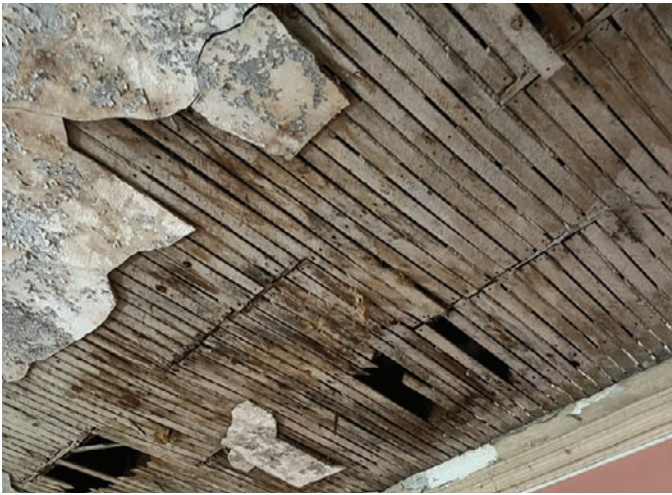
Plaster ceiling at original portion of building in poor to defective condition, showing large areas of missing material (ERA, 2025).

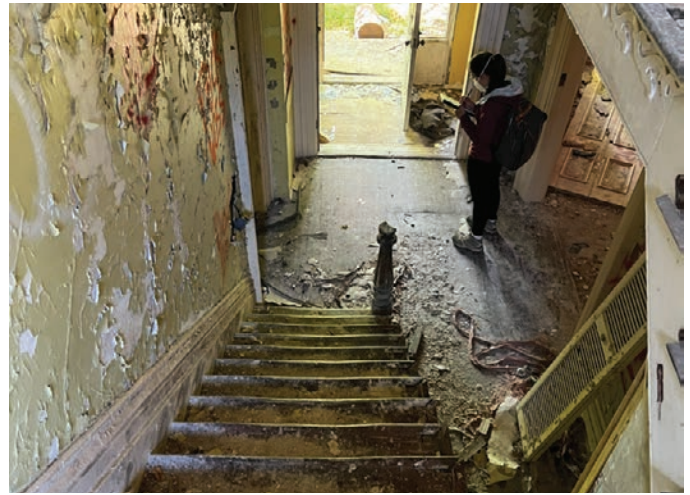
Staircase at original portion of building in defective condition, with significant damaged and missing sections (ERA, 2025).

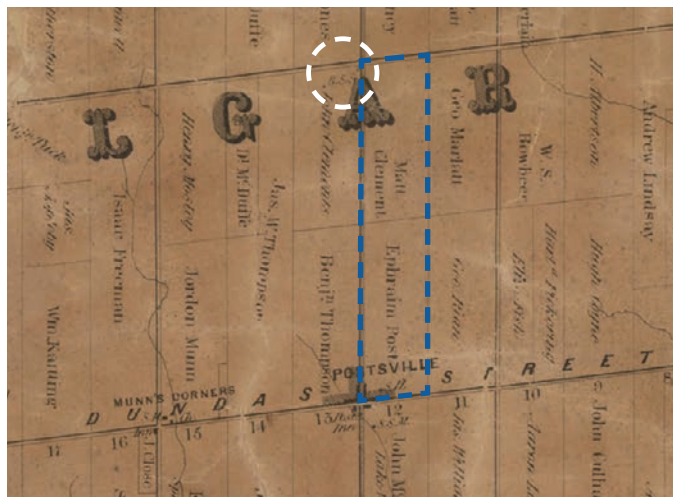
1860 Tremaine Map of York County showing Lot 12, Concession 1 NDS, dashed in blue, which includes the Site. Note the "B.S.S." at the southwest corner of Trafalgar and Burnhamthorpe Roads, denoting a blacksmith shop, circled in white (annotated by ERA).

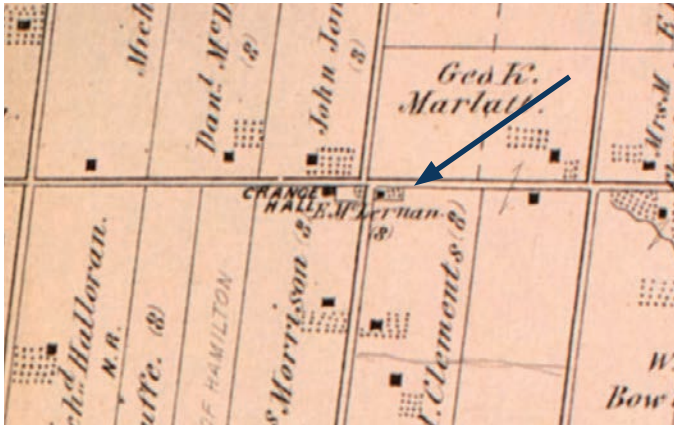
1877 County Atlas showing Edward McLernan at the southeast corner of Trafalgar and Burnhamthorpe Roads (McGill University Library; annotated by ERA).

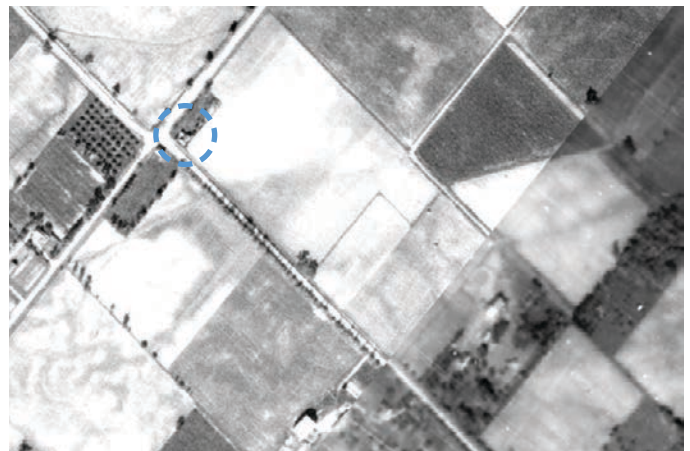
1934 aerial of the Site prior to the relocation of the mid-19th century farmhouse at 340 Burnhamthorpe Road East (Town of Oakville; annotated by ERA).

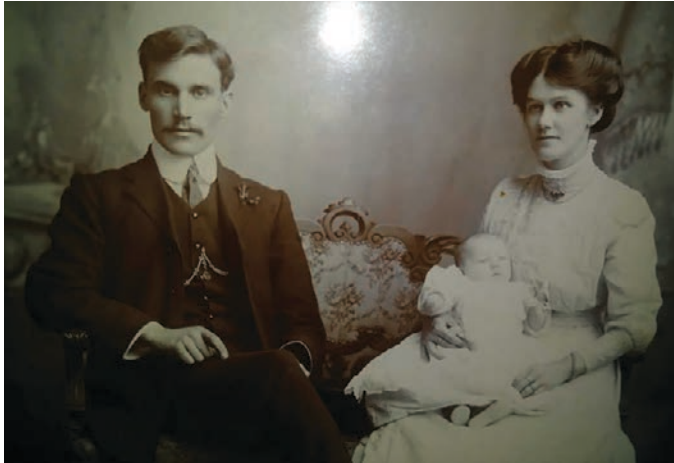
Undated photograph of Agnes and Isaac Watson, taken shortly after the birth of daughter Noel (ancestry.ca, Julie Hadfield family tree).

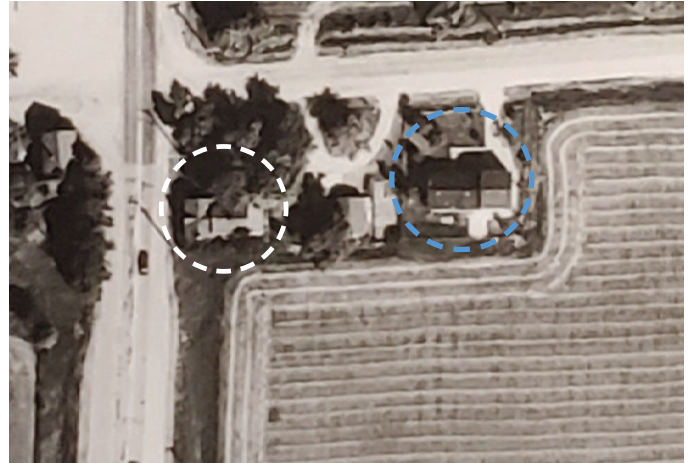
1978 aerial of the corner of Trafalgar and Burnhamthorpe Roads prior to the relocation of the mid-19th century dwelling (circled in white). The extant mid-20th century building is circled in blue (York University; annotated by ERA).

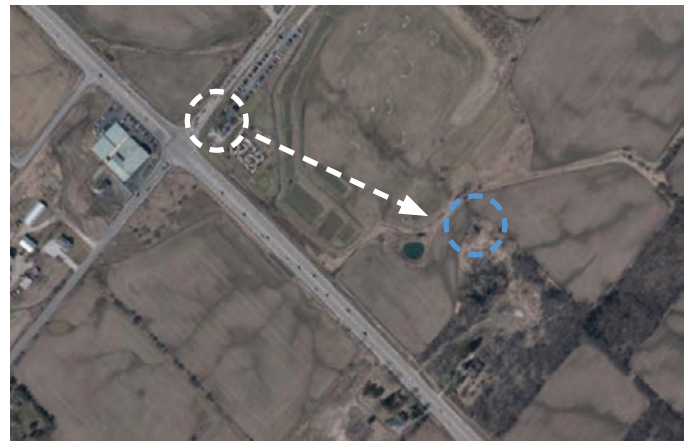
2015 aerial of the Site following the relocation of the mid-19th century farmhouse (Town of Oakville; annotated by ERA).

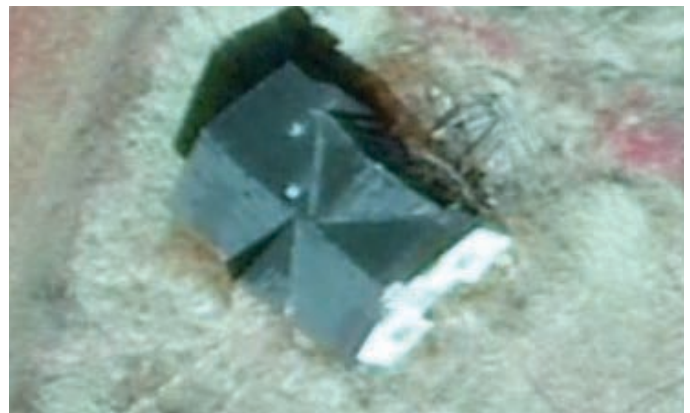
2006 close-up aerial photo of the farmhouse at 340 Burnhamthorpe Road East. Note the two openings on the east and south elevations where the fireplace and rear addition would have been prior to the relocation of the building (Town of Oakville).

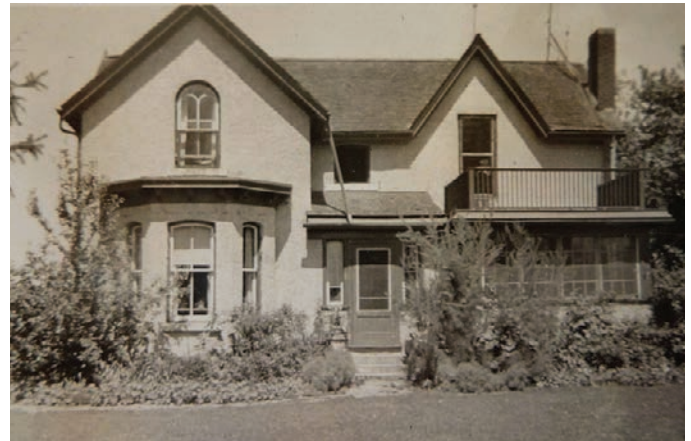
Principal (west) elevation of 3437 Trafalgar Road (Town of Oakville, courtesy of Sybil Rampen).

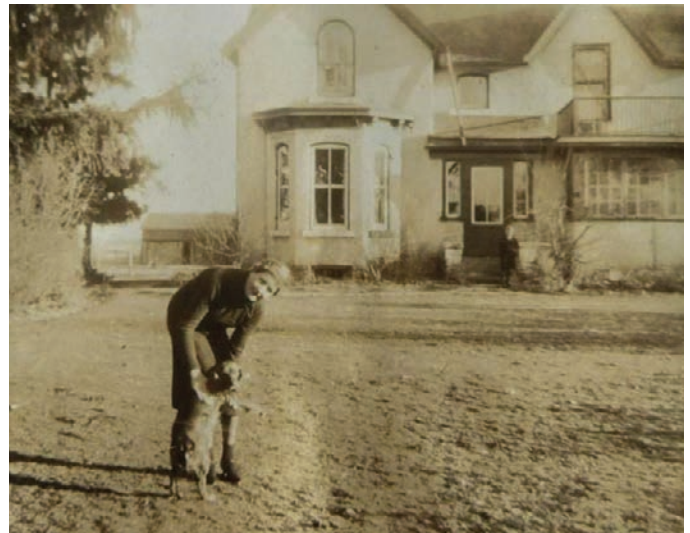
Undated photo of Amice Calverley in front of 3437 Trafalgar Road (Town of Oakville, courtesy of Sybil Rampen).

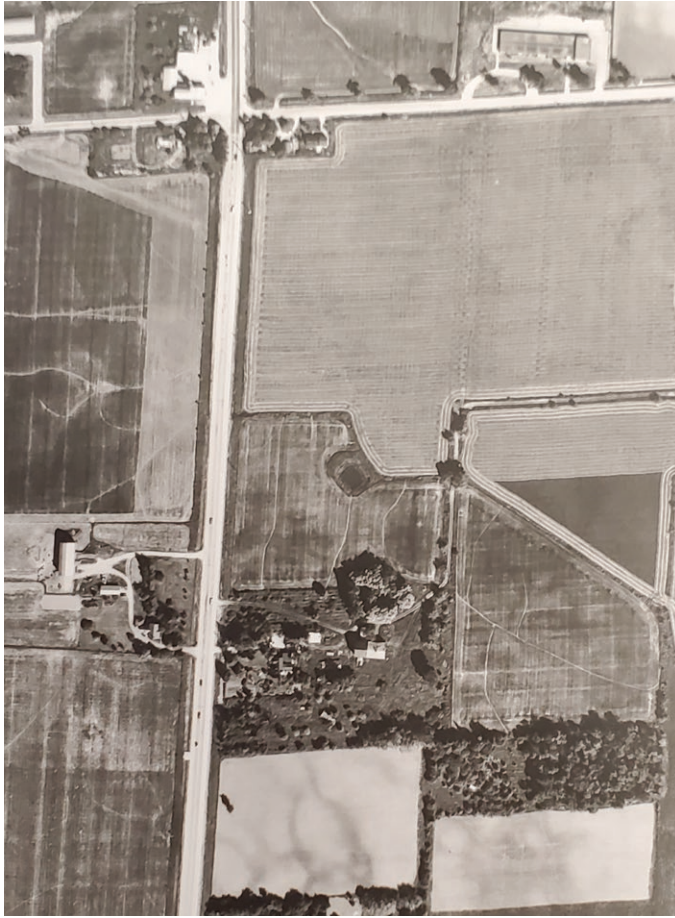
1978 aerial of the Site prior to the relocation of the mid-19th century dwelling at 340 Burnhamthorpe Road and establishment of the golf centre (York University).

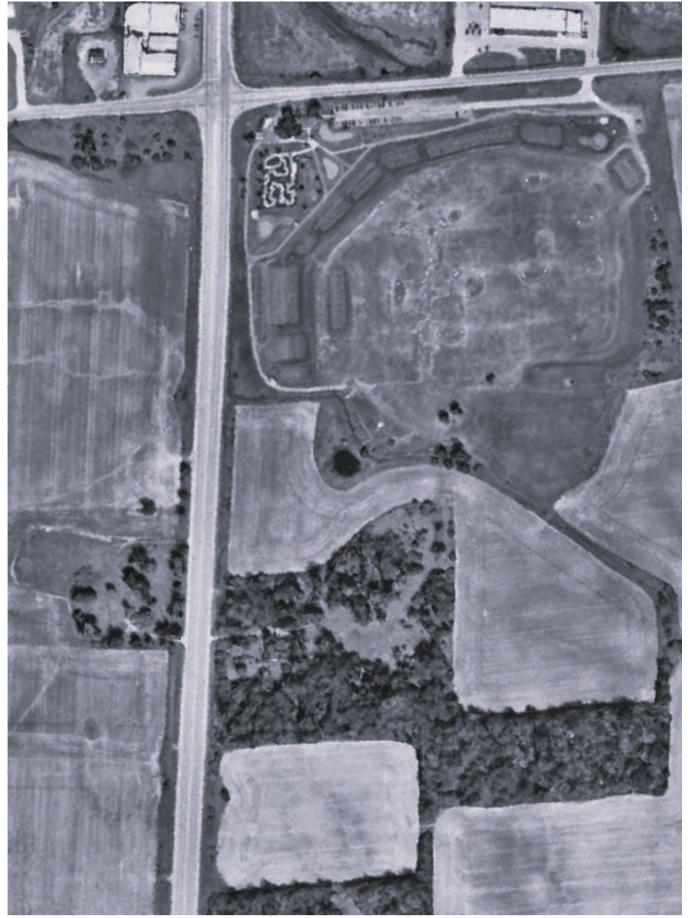
Circa 2024 aerial of the Site following the relocation of the mid-19th century dwelling at 340 Burnhamthorpe Road and widening of the intersection (Google).
