## APPENDIX A-11

## Mattamy Joshua's Creek Phase 3 EIR/FSS Addendum

Geotechnical Investigation Report, Proposed Culvert Crossing, Joshua's Creek Properties South of Burnhamthorpe Road East & West of 9<sup>th</sup> Line

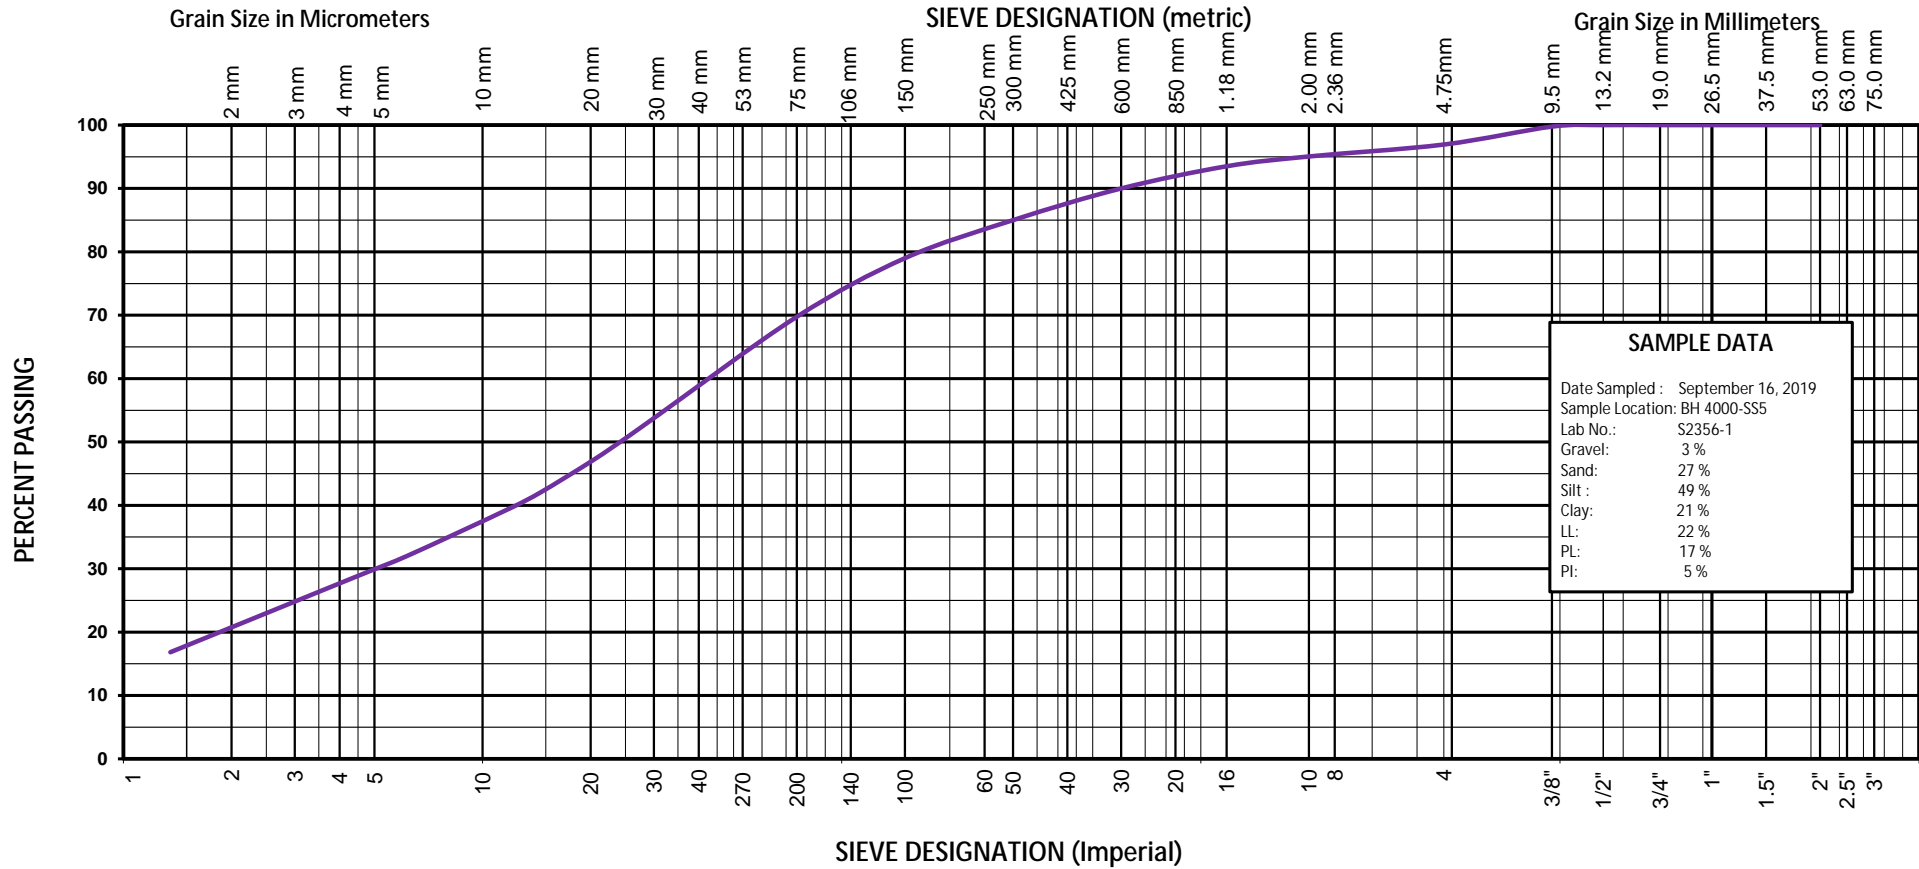
SAMPLE DATA	
Date Sampled :	September 16, 2019
Sample Location:	BH 4000-SS5
Lab No.:	S2356-1
Gravel:	3 %
Sand:	27 %
Silt :	49 %
Clay:	21 %
LL:	22 %
PL:	17 %
PI:	5 %

Upon completion of boreholes, the soil and rock samples were transported to our Soil Laboratory for further examination and laboratory testing. Soil laboratory testing consisting of moisture content determination and gradation analysis were performed on representative soil samples. The results of the in-situ and laboratory tests are presented on the corresponding Record of Borehole Sheets. The Gradation Analysis curves are shown in Enclosure A.

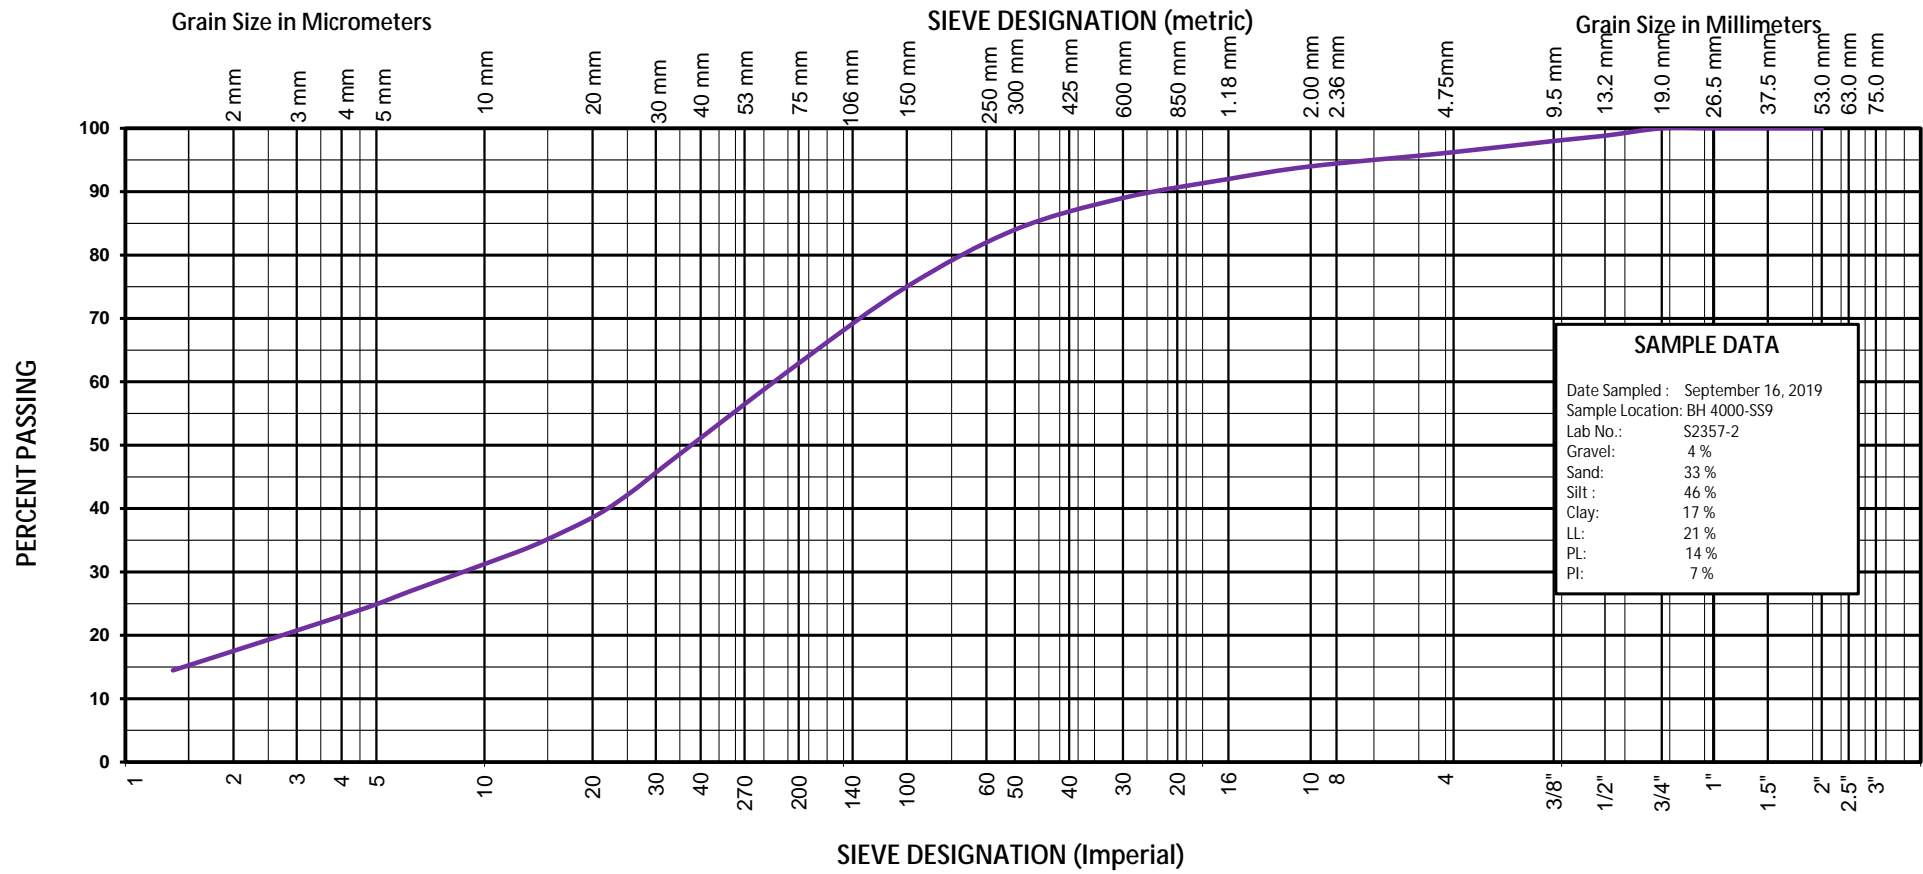
**GRAIN SIZE ANALYSIS**

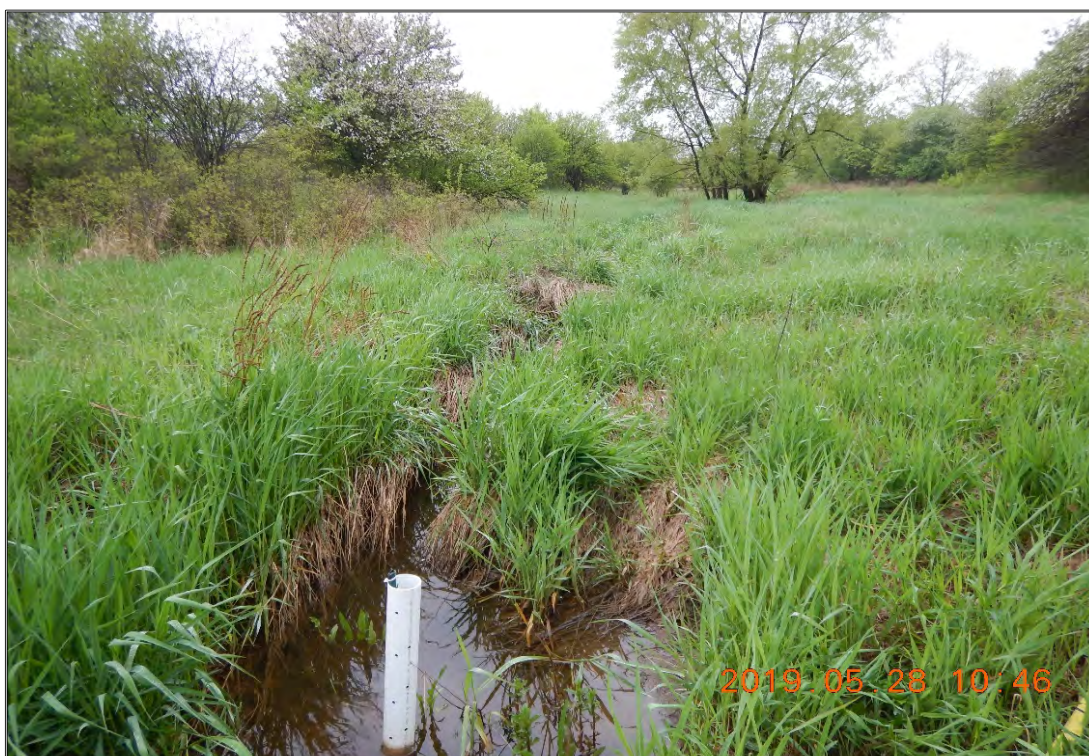
**Figure 7.8 – Representative Photo of PSW45 and Stream Reach JC-13**

Stream Reach JC-13 flows through PSW 45. The watercourse is a low-gradient and slightly meandering channel that sits within a wide and densely vegetated floodplain. Riparian vegetation beyond the limit of PSW45 consists primarily of various grasses, shrubs, and tree species. In the summer months, there is extensive encroachment of riparian wetland vegetation (graminoids) within the channel; vegetation also becomes well established on mid-channel deposits. Channel substrate ranges from fine sand to small gravels. Morphological variability is poor with limited riffle or pool development along the reach. Given the local vegetation control, the channel is characteristic of a low-energy and depositional environment.

A representative ground photo of PSW 45 is shown in **Figure 7.8**.
