## Bell Zone 3 W0034

### 4243 Sixth Line Oakville, ON

Final  
Phase I ESA Report

June 10, 2020

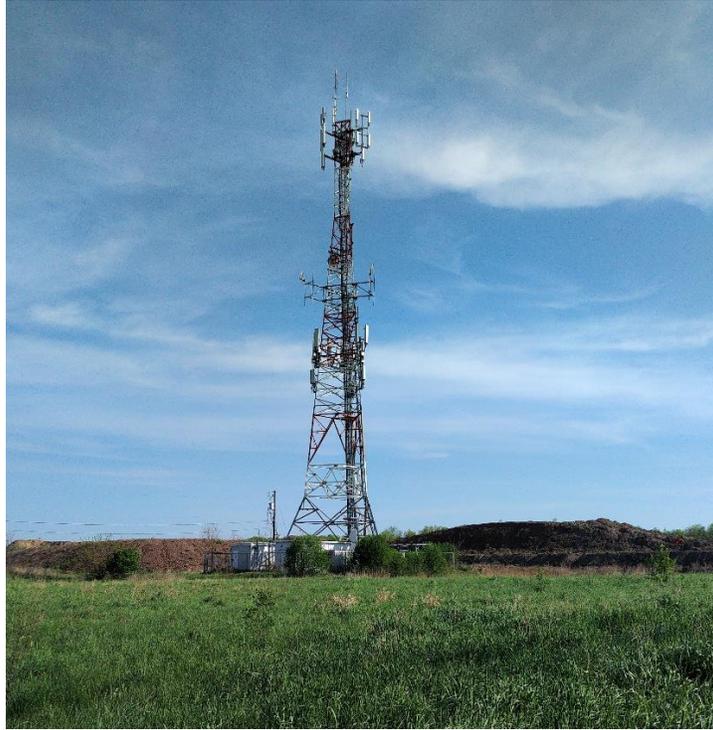
**Photograph No. 3** – East facing view of the Site from the southwest corner, including the telecommunications tower and compound.

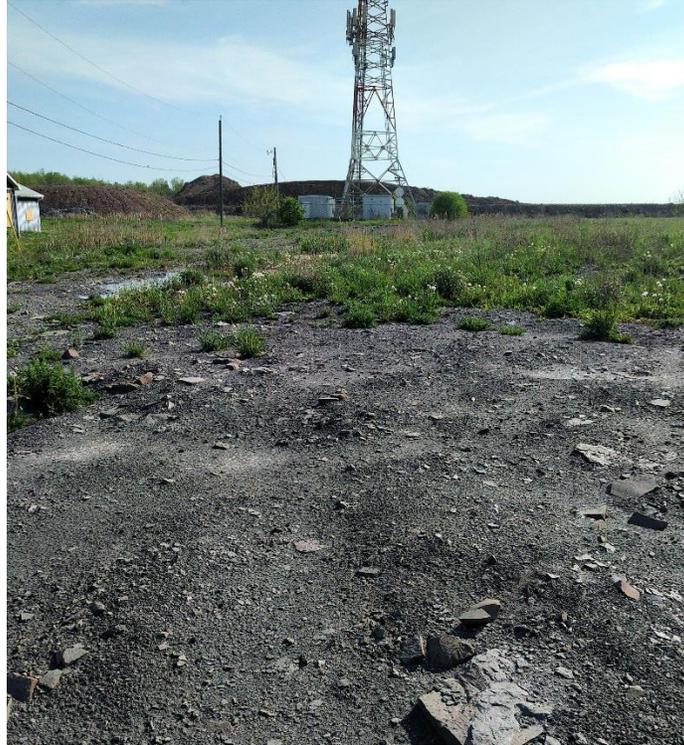
**Photograph No. 5** – East facing view of an area of soil dumping located in the central portion of the Site.

Based on the inherent environmental risks associated with the actual and potential concerns noted above, a Phase II ESA for the Site was recommended to assess soil and groundwater quality at the Site.

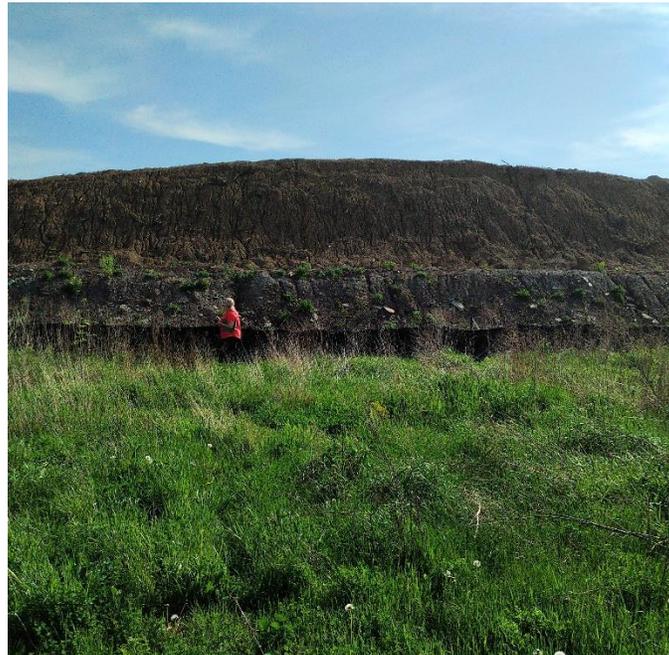
**Photograph No. 6** – East facing view of the large soil stockpile located on the adjacent property east of the Site.

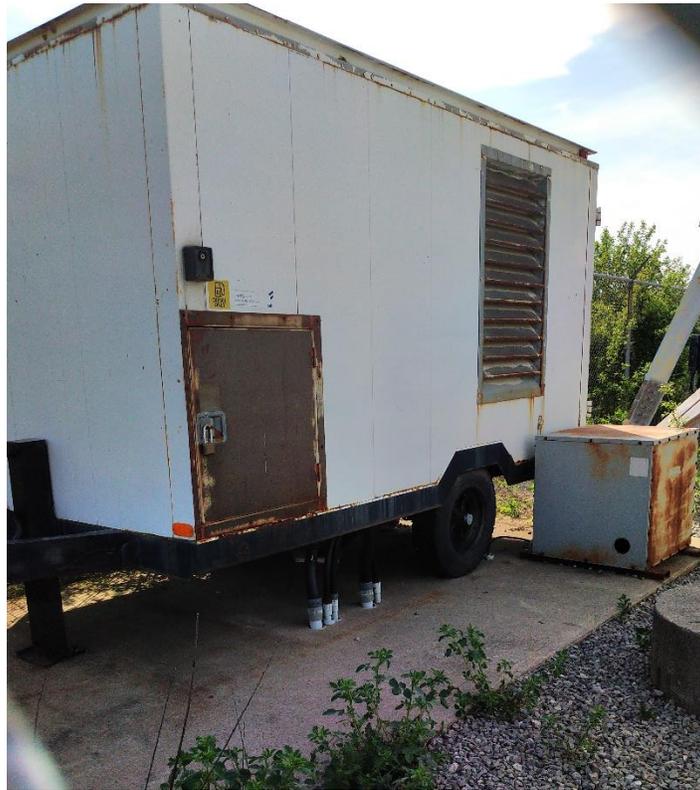
- Mr. Anderson was unsure of the current and former heating systems used on the Site.
- Mr. Anderson indicated that the tower compound contains an air conditioning unit, a self contained, trailer mounted back-up diesel generator and a battery rack located within a shelter (short term back-up for equipment).

**Photograph No. 7** – View of the trailer mounted, self-contained standby diesel generator located within the tower compound.

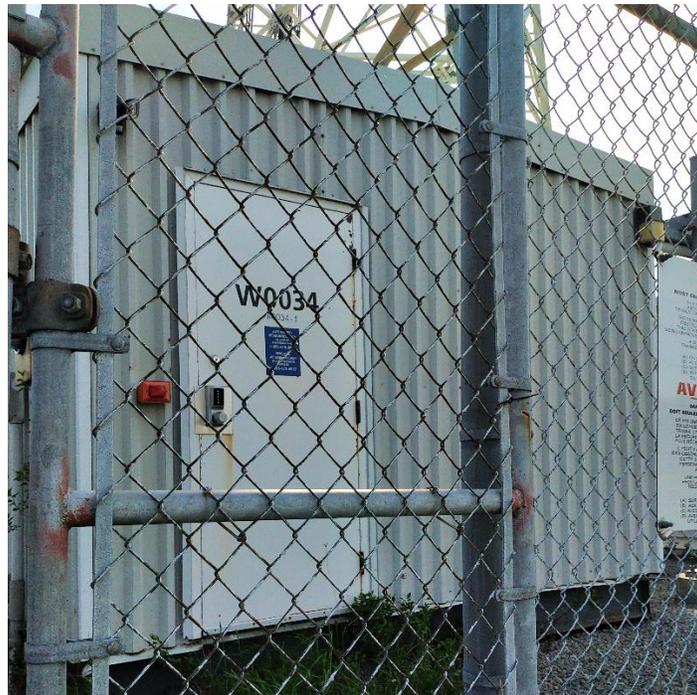
**Photograph No. 8** – View of one of the shelters located within the tower compound.

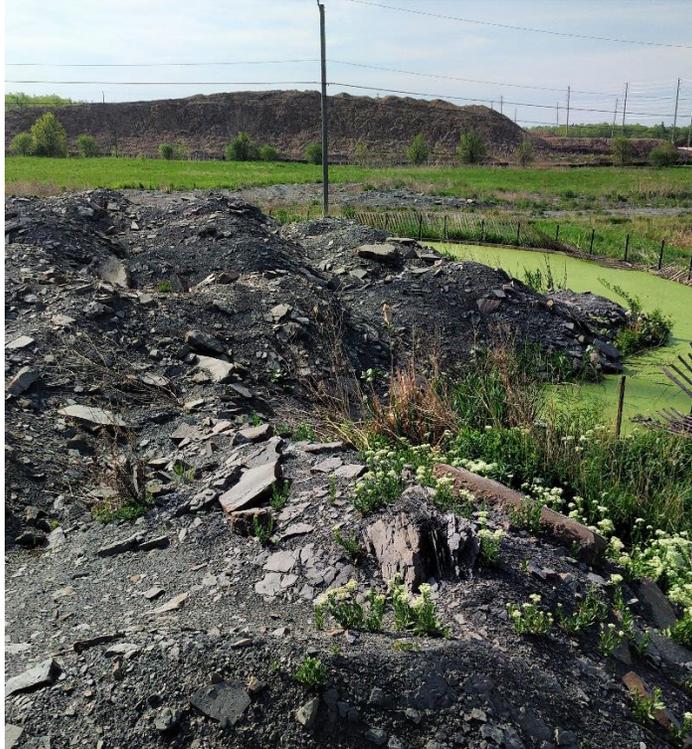
**Photograph No. 9** –South facing view of fill material dumped on the east portion of the Site, including on top of the manure pit. Note the large soil stockpile in the background, located on the adjacent property to the south.

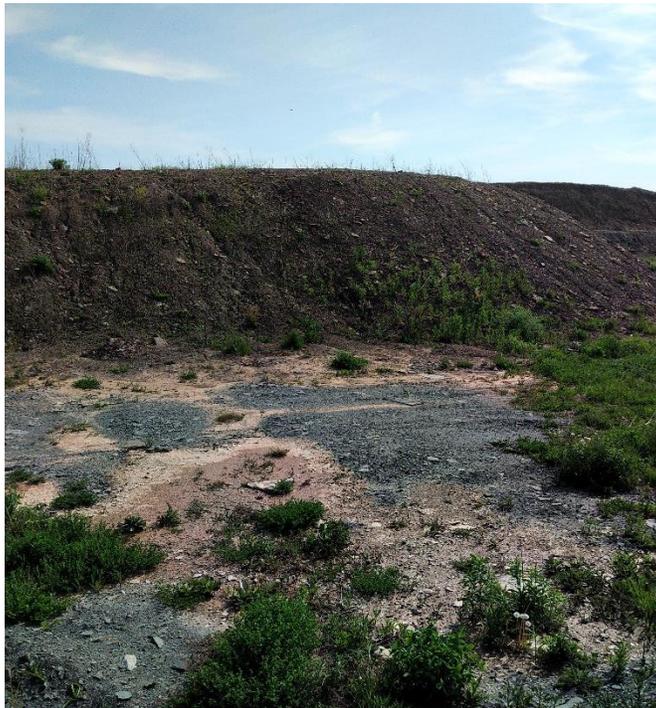
**Photograph No. 10** – East facing view of the soil pile located on the northeast portion of the Site.

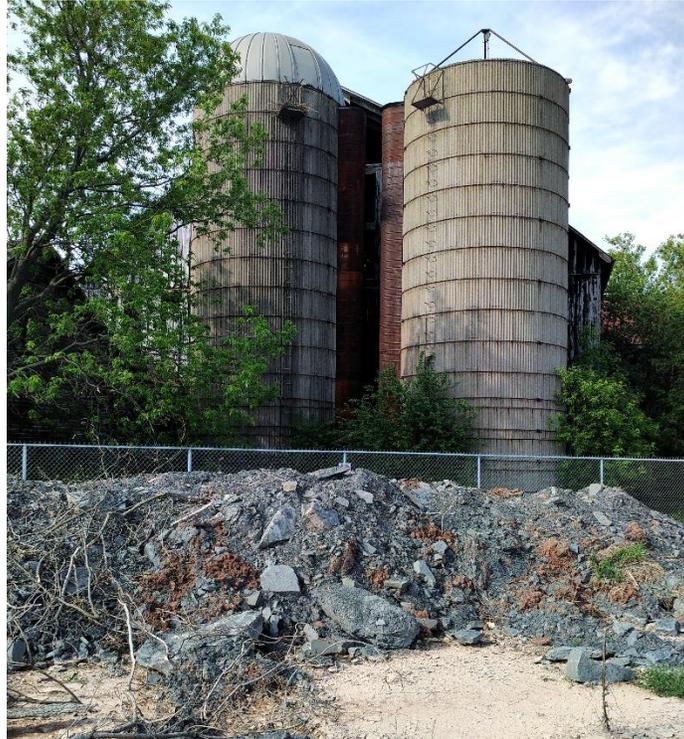
**Photograph No. 11** – West facing view of soil dumped east of the silos and bank barn on the northeast portion of the Site.

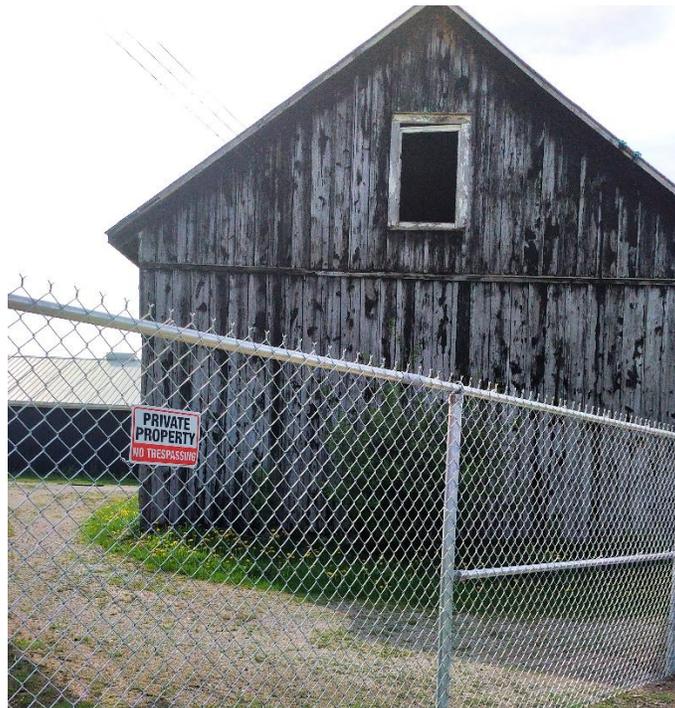
**Photograph No. 12** – South facing view of the drive shed. A former fuel tank was reportedly located on the northern exterior of the drive shed.

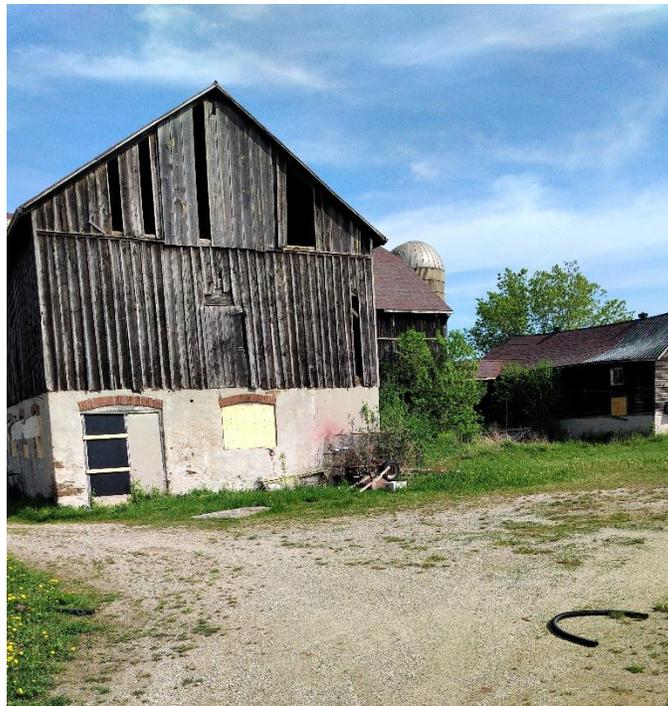
It is noted that MTE did not have access to the buildings on-Site, as they have been boarded up and secured. Furthermore, a locked, chain-link fence was present around the bank barn, drive shed, and aluminum sided barn, therefore MTE could not walk around the entirety of each building. The exteriors of the aforementioned buildings were observed from a distance. These limitations represent an uncertainty in the forming of report conclusions.

**Photograph No. 14** – Northeast facing view of the bank barn. Note that this area is located within a locked, chain link fence surrounding the bank barn, drive shed and aluminum siding barn. MTE did not walk though this area of the Site.

Furthermore, a Designated Substances Audit (DSA) and hazardous building materials survey is recommended prior to any alterations or demolitions of any Site buildings or structures due to the potential presence of asbestos containing materials, lead based materials, polychlorinated biphenyls and ozone depleting substances. Also, on-Site septic systems and/or connections to existing water supply wells should be maintained or properly decommissioned.

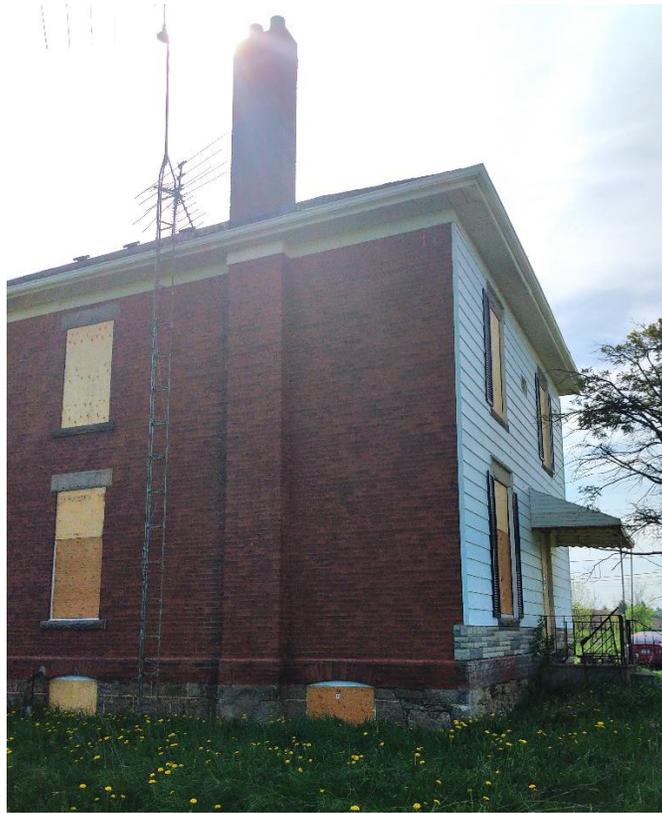
- The basement of the residential dwelling has water damage, and presumably mould issues.
- Based on the age of the buildings, there may be designated substances present. Bell has no record of any removal activities.

**Photograph No. 15** – South facing view of the residence on the west central portion of the Site.

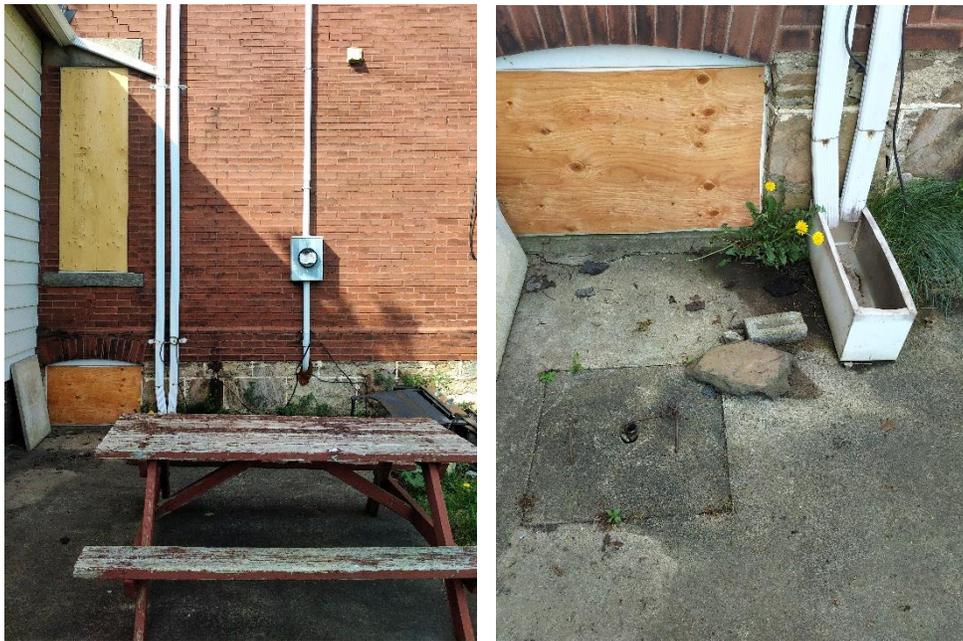
MTE observed what may have been a septic system servicing the residential dwelling on Site.

**Photograph No. 16** – Left: View of the northeast corner of the residence. Right: Close up view of possible septic system lid located at the northeast corner of the residence.
