ENVIRONMENTAL IMPLEMENTATION REPORT / FUNCTIONAL SERVICING STUDY – MAIN REPORT (SUBMISSION)

May 2011

14 Mile Creek West and the Lazy Pat Farm Property
(3269 Dundas Street West), North Oakville West

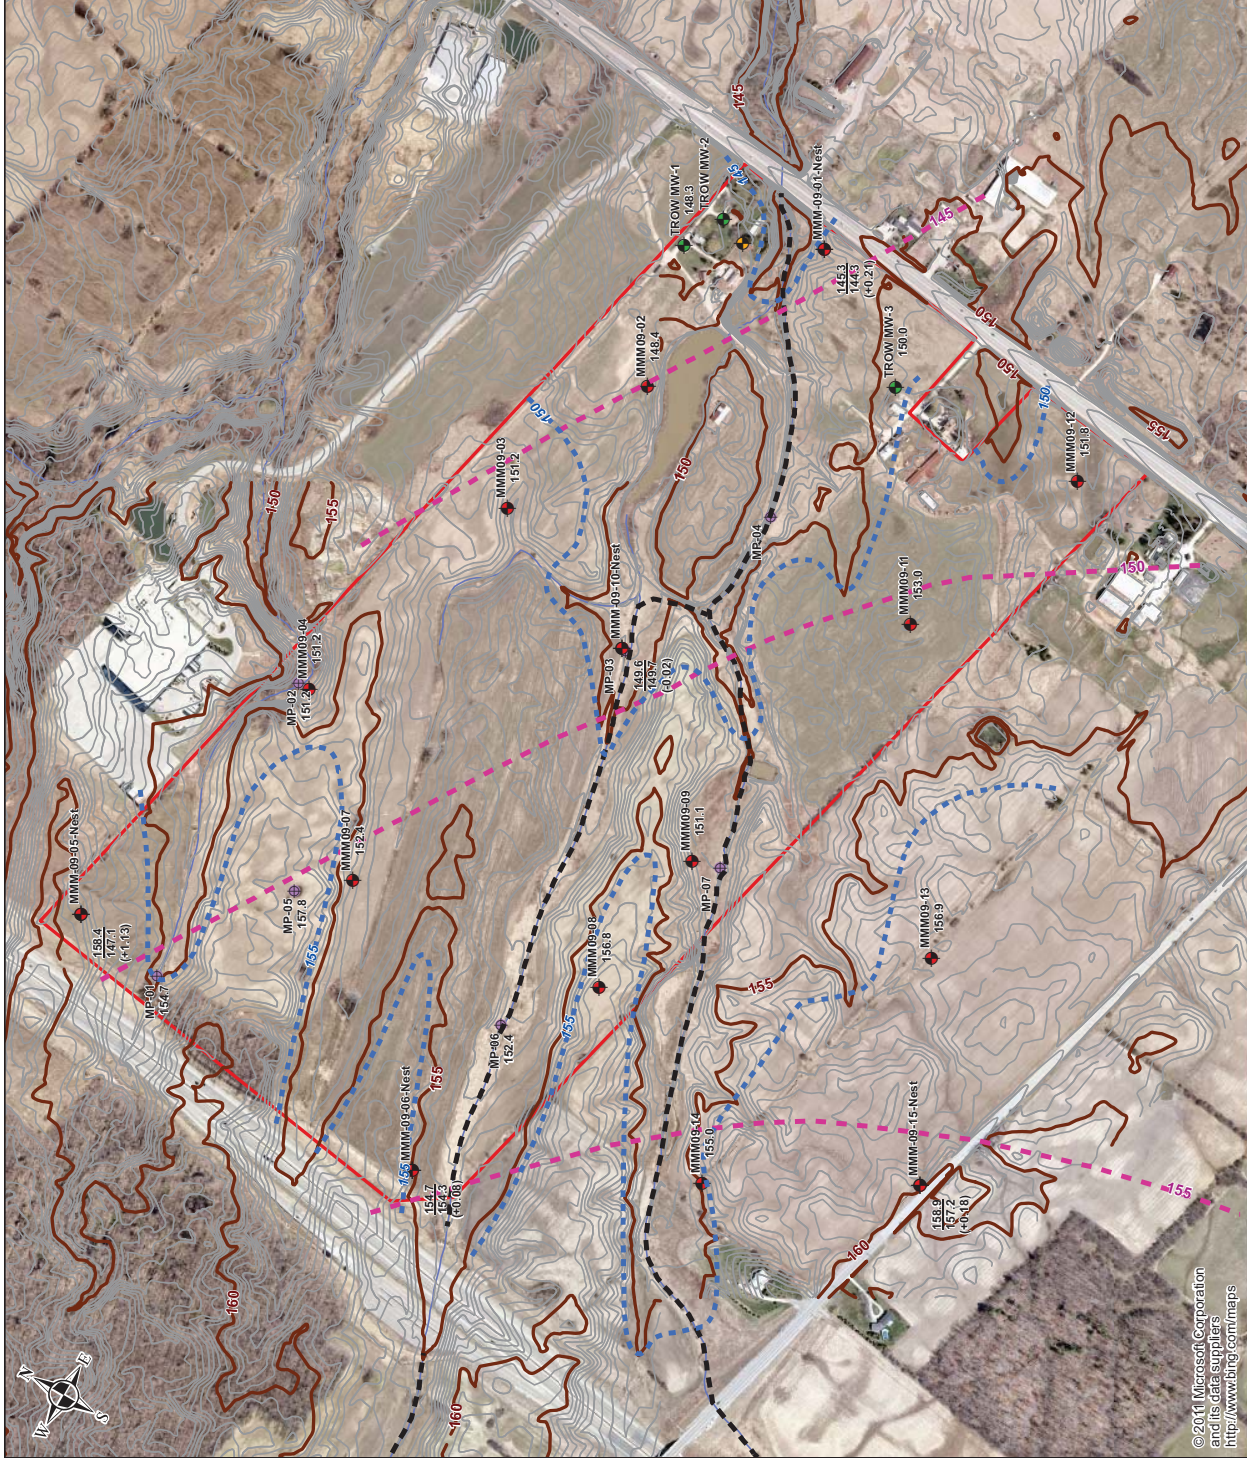
Figure: 4.5

Static Water Levels - Summer

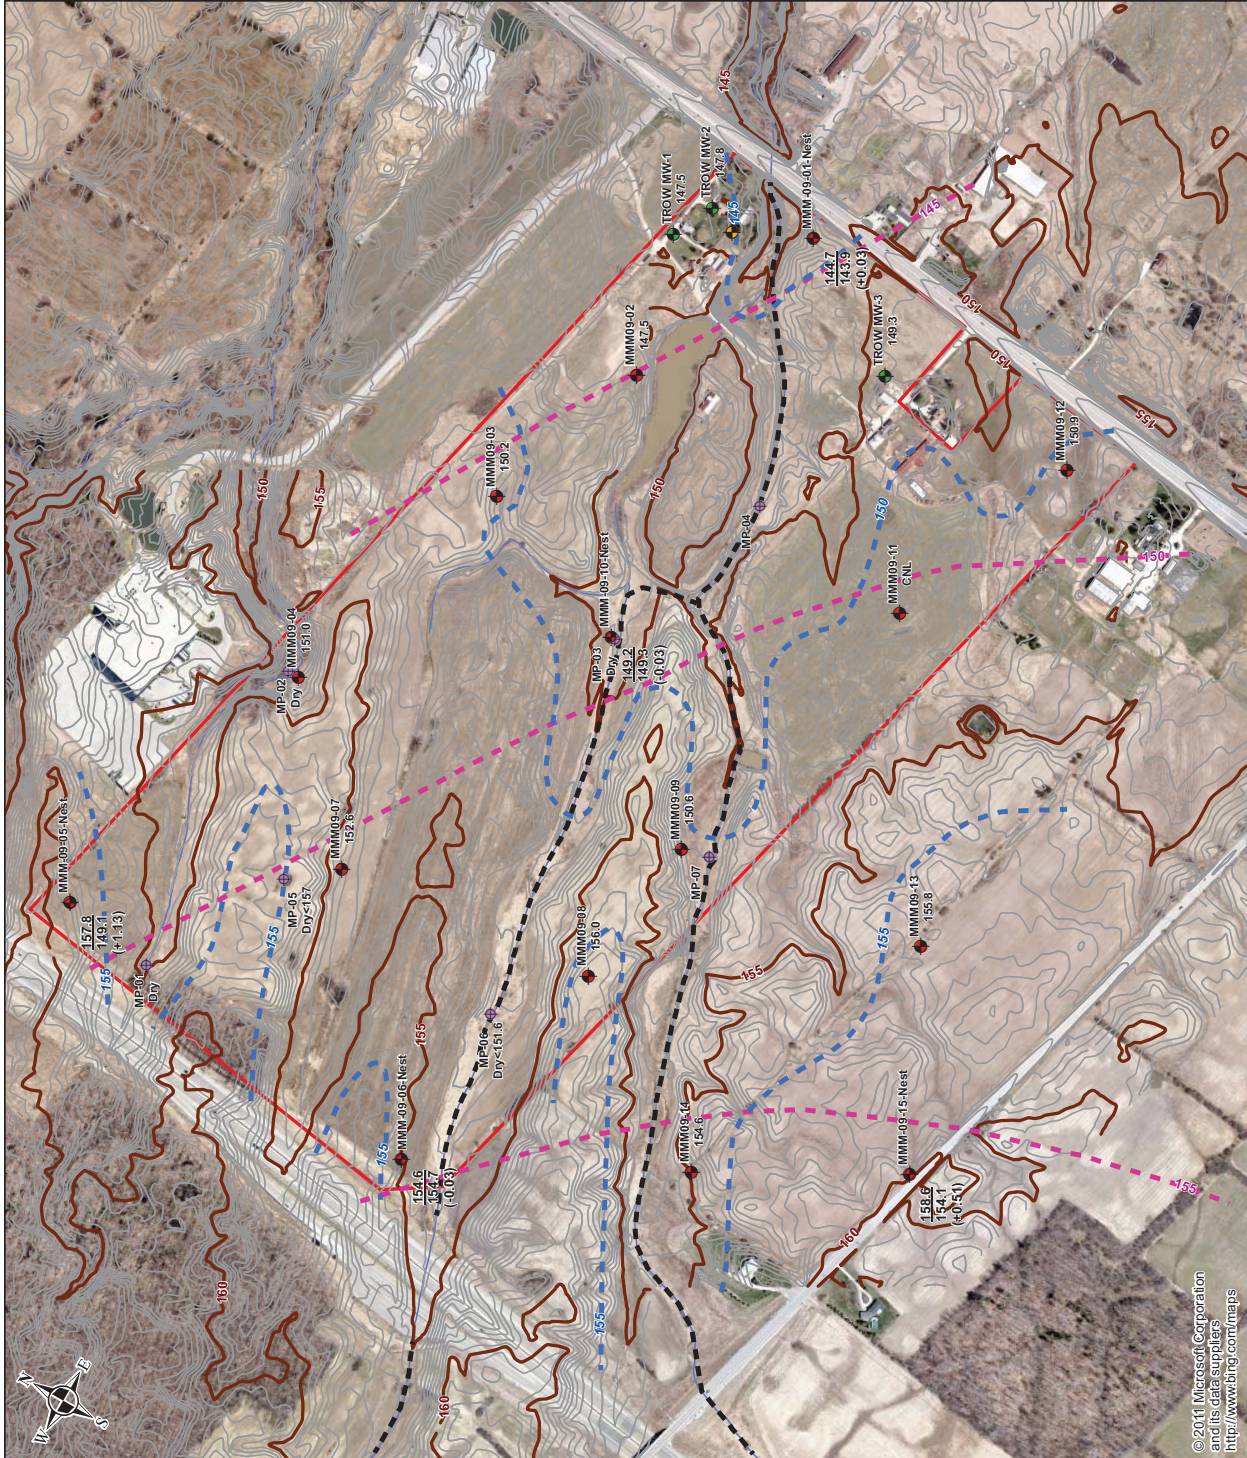
Figure: 4.6

Concept Plan and
Mitigation Opportunities

The greatest opportunity for mitigating against infiltration losses at the Subject Property is along the edge of the existing valley lands where the naturally weathered and fractured surficial till soils will remain undisturbed by construction and will retain their ability to convey water laterally towards the watercourses. It is along these lands that infiltration swales receiving clean roof runoff are proposed, and such infiltration measures are calculated to reduce the post-development on-site infiltration deficits from approximately 70% (with no mitigation proposed) to about 50%. On a total subwatershed basis, post-development base flow during the period between November and May is predicted to remain within 78% to 92% of the existing base flow contributions, whereas in dry periods, a slight increase in infiltration is provided to the groundwater system from the proposed mitigation measures.

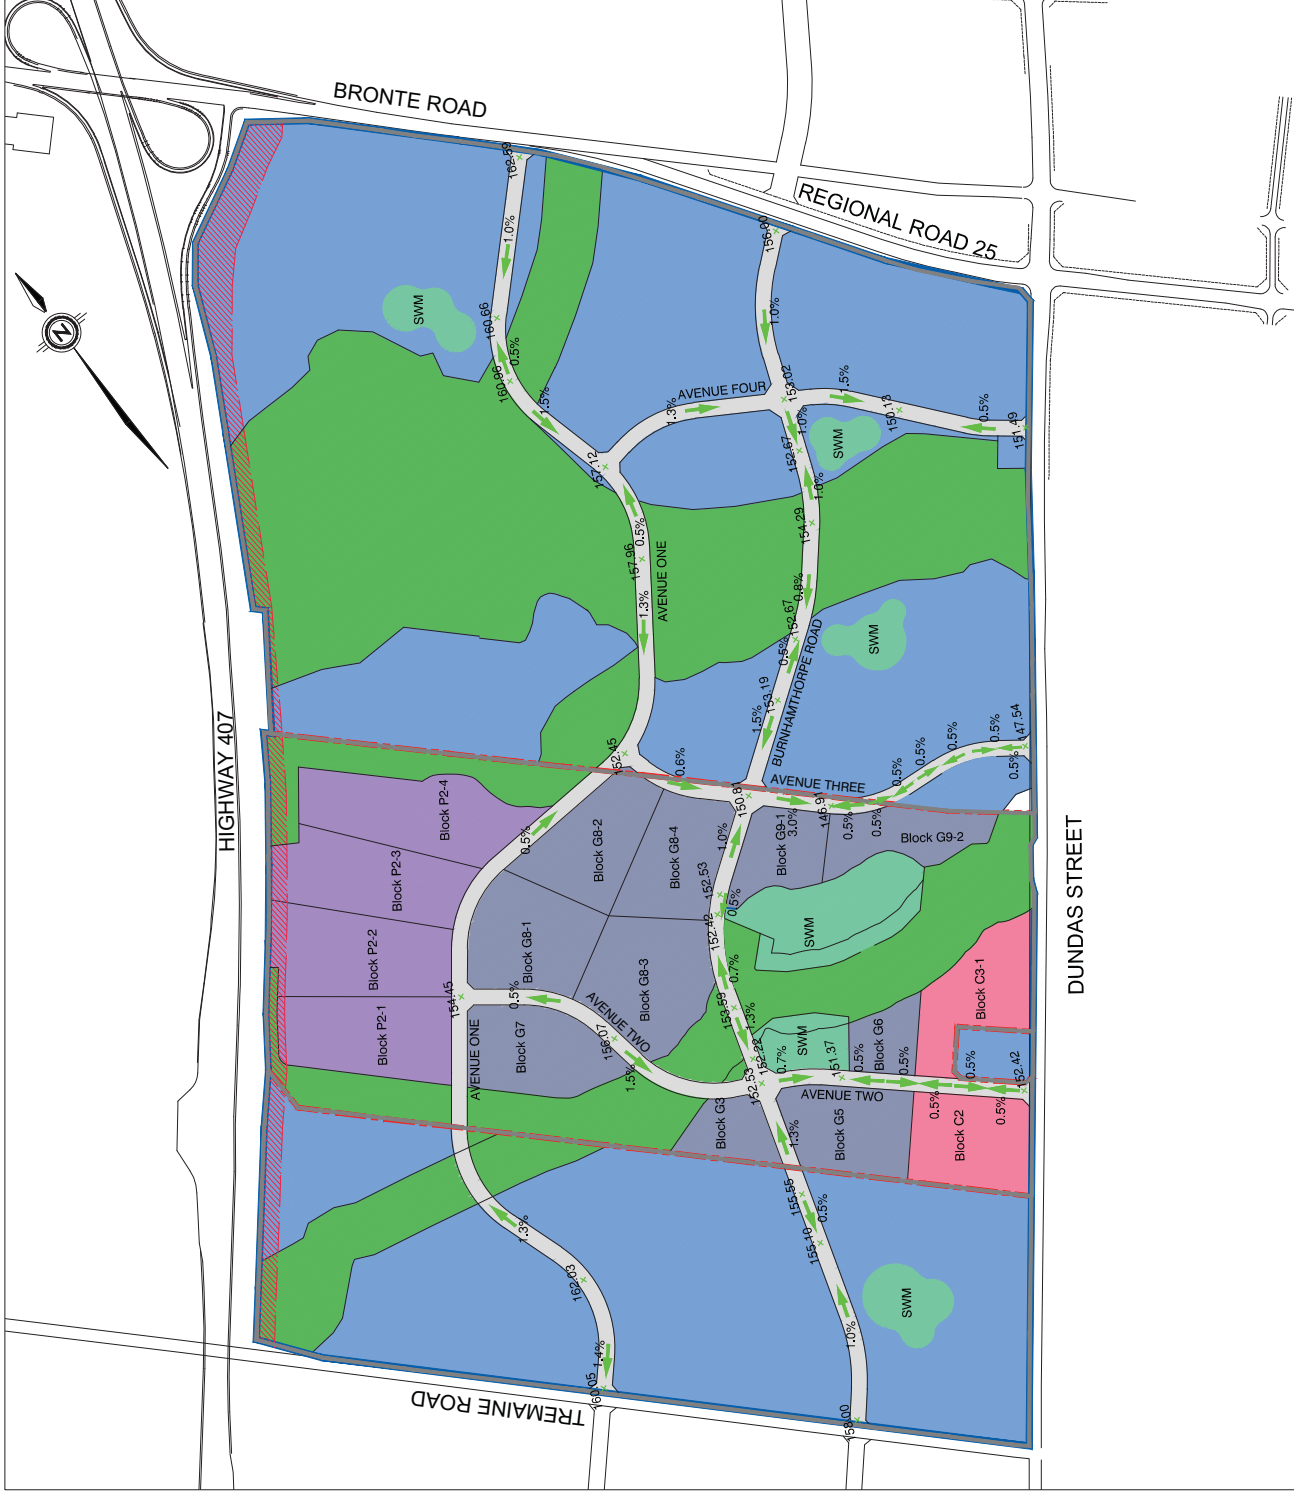
FIGURE 8.6

GRADING PLAN

The conceptual road and lot grading was designed with the intention of matching existing grades as closely as possible while still maintaining necessary elements of the Stormwater Management Plan detailed in Section 7.0. The conceptual grading plan is illustrated on Figure 8.6.
