ENVIRONMENTAL SITE ASSESSMENT

**3005 DUNDAS STREET WEST
OAKVILLE, ONTARIO**

Fisher Project No. FE-P 21-11715

December 30, 2021

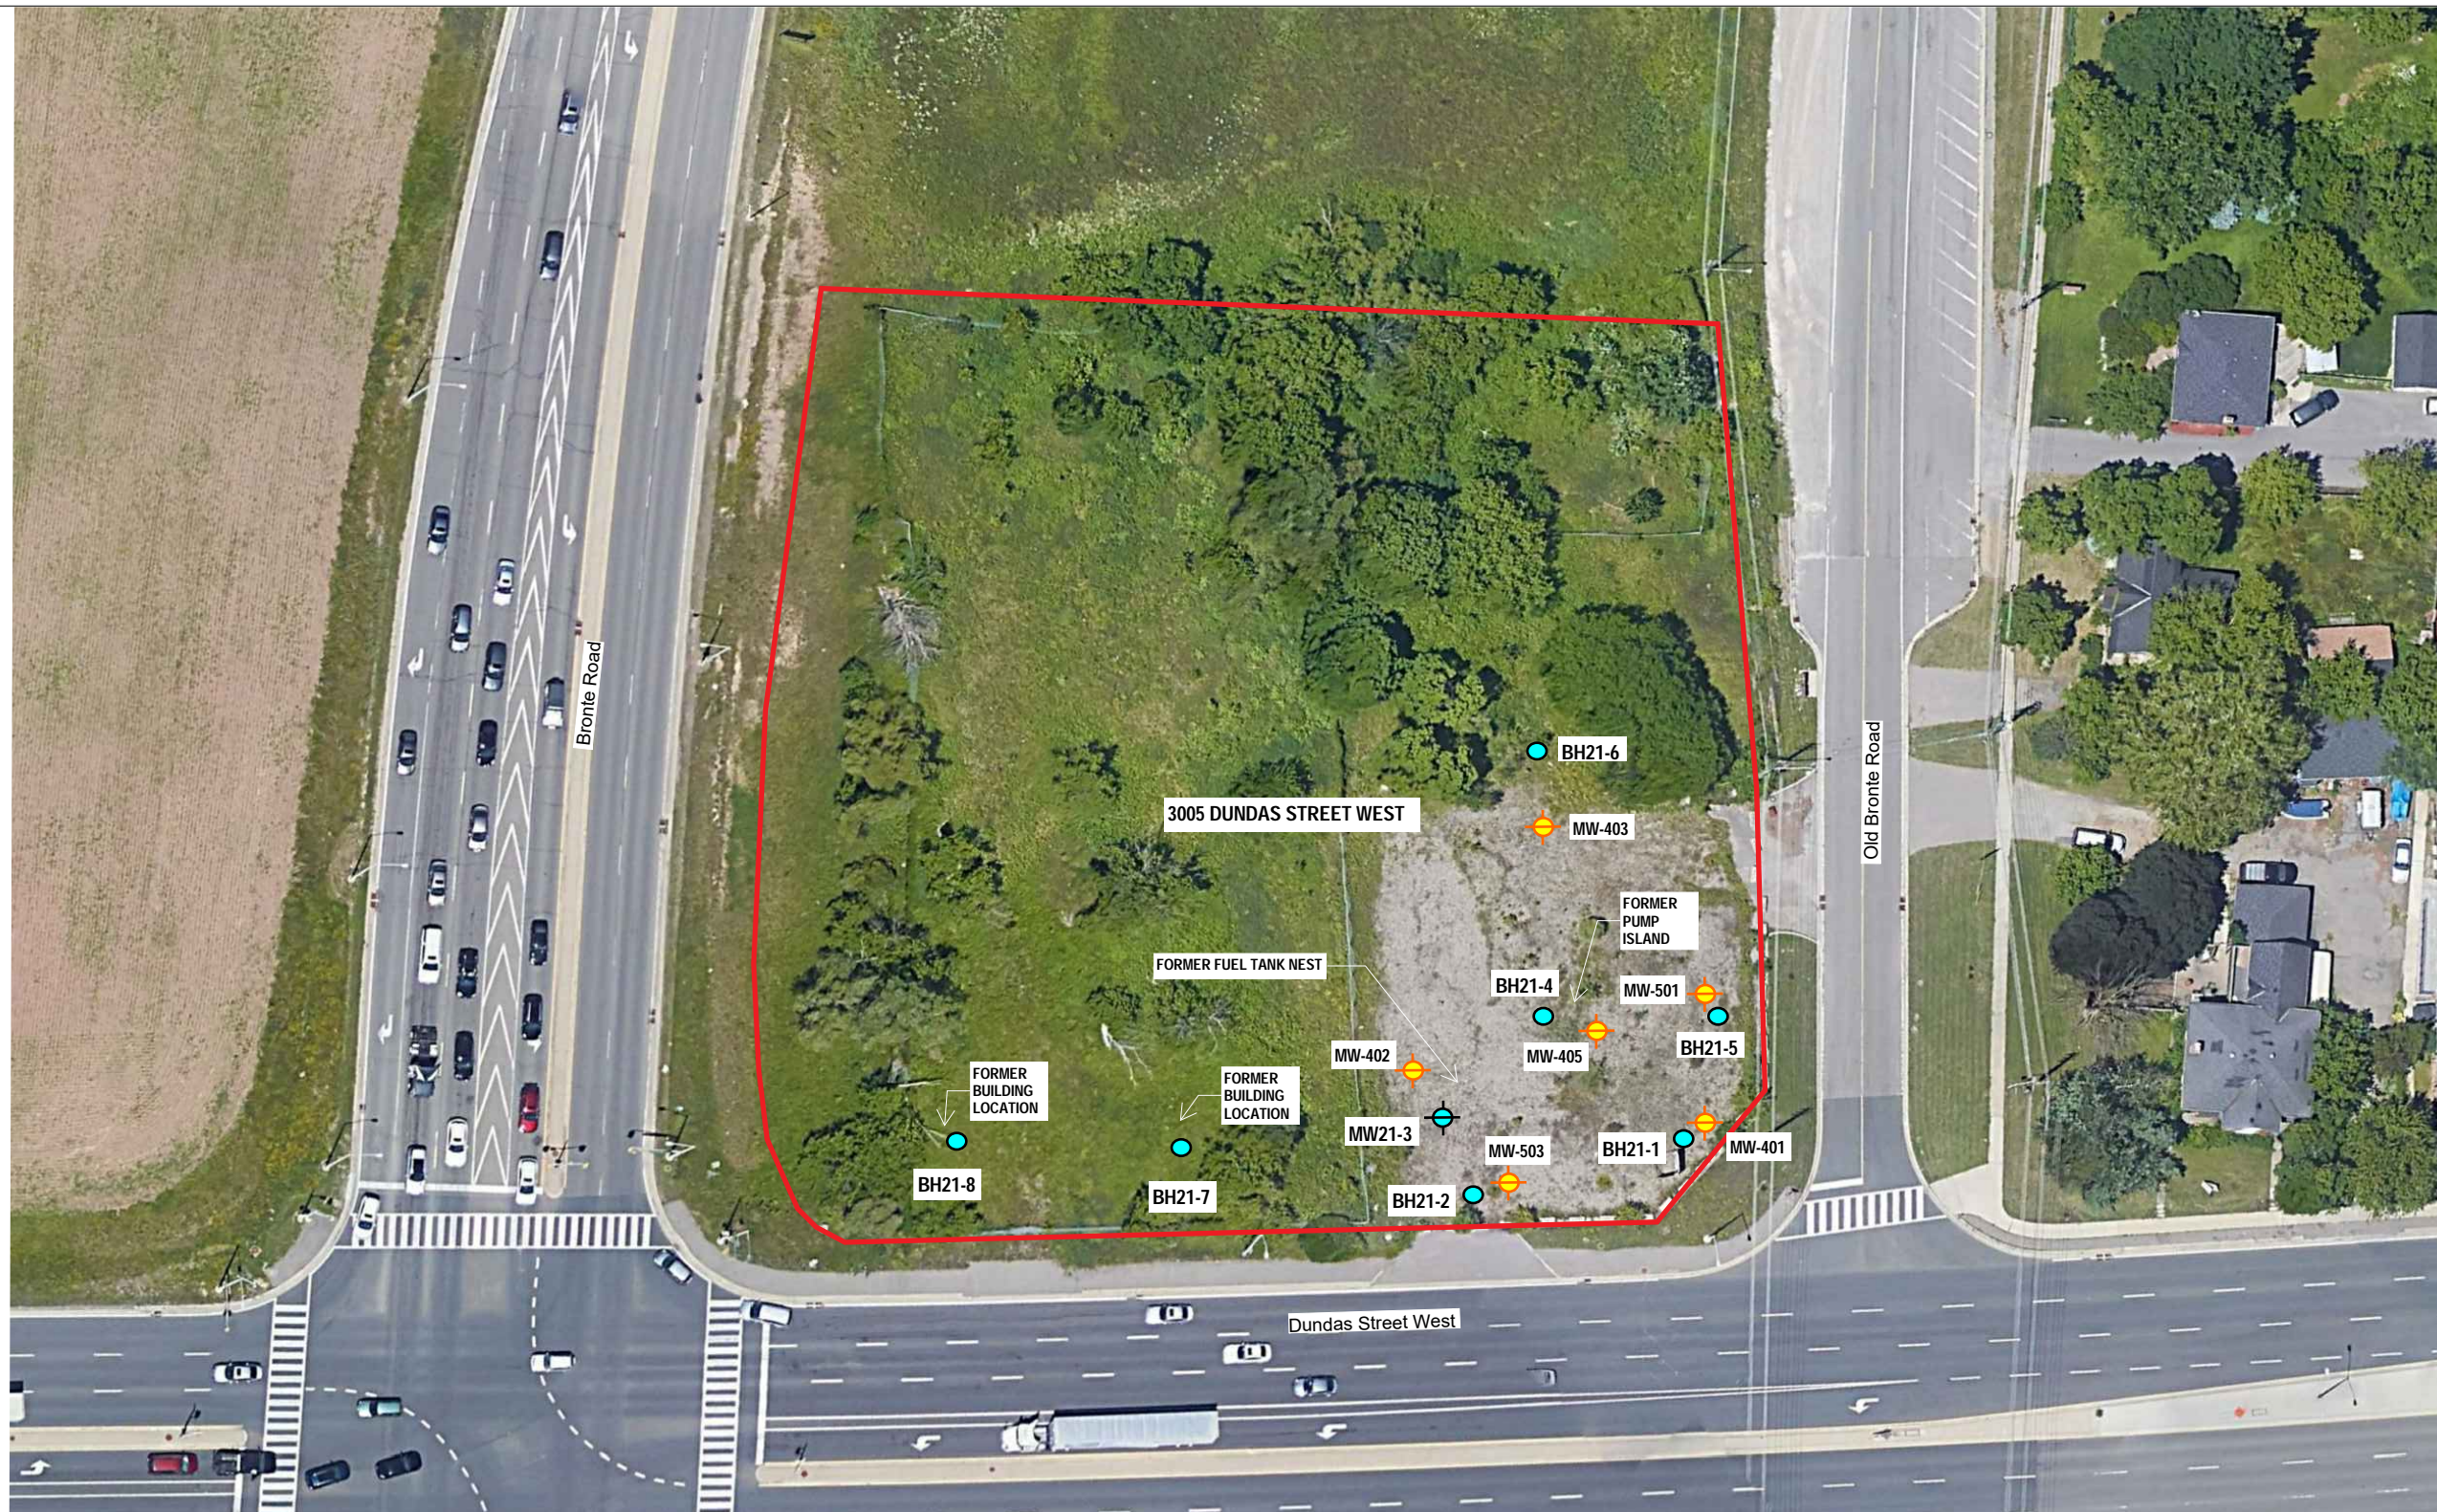
The borehole locations were selected by an initial rationale as being the most likely locations of contamination. Refer to the attached Site Plan with Borehole and Monitoring Well Locations (Figure 1 in Appendix A) and Table 2 for description of borehole locations rationale.
