DOWNTOWN OAKVILLE HERITAGE CONSERVATION DISTRICT REVIEW

November 2025

Downtown Oakville Heritage Conservation District Review Data Analysis Assessment 2025

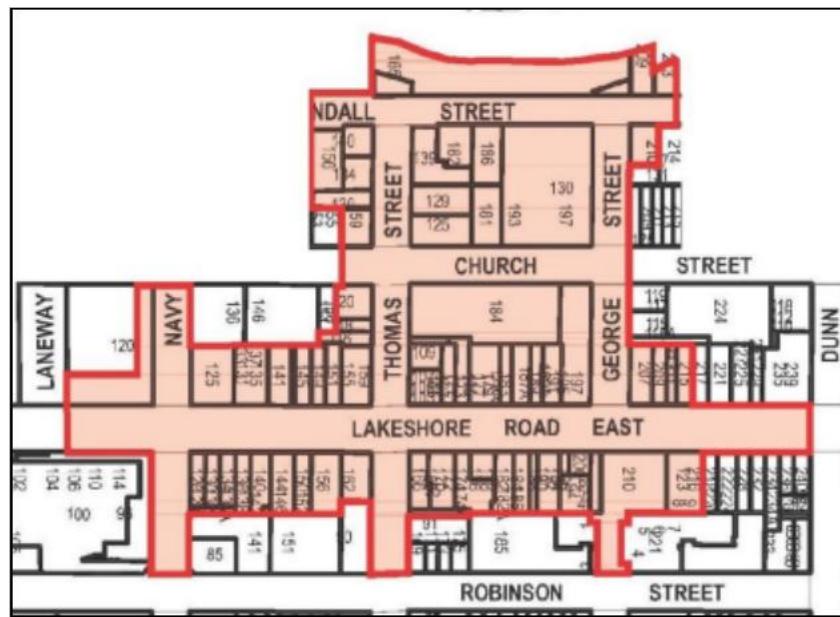
The HCD has an irregular boundary as shown below. The character of the area is defined by its wealth of 19th and 20th century building stock, the commercial streetscape of Lakeshore Road East, and its proximity to the Sixteen Mile Creek and Oakville Harbour.

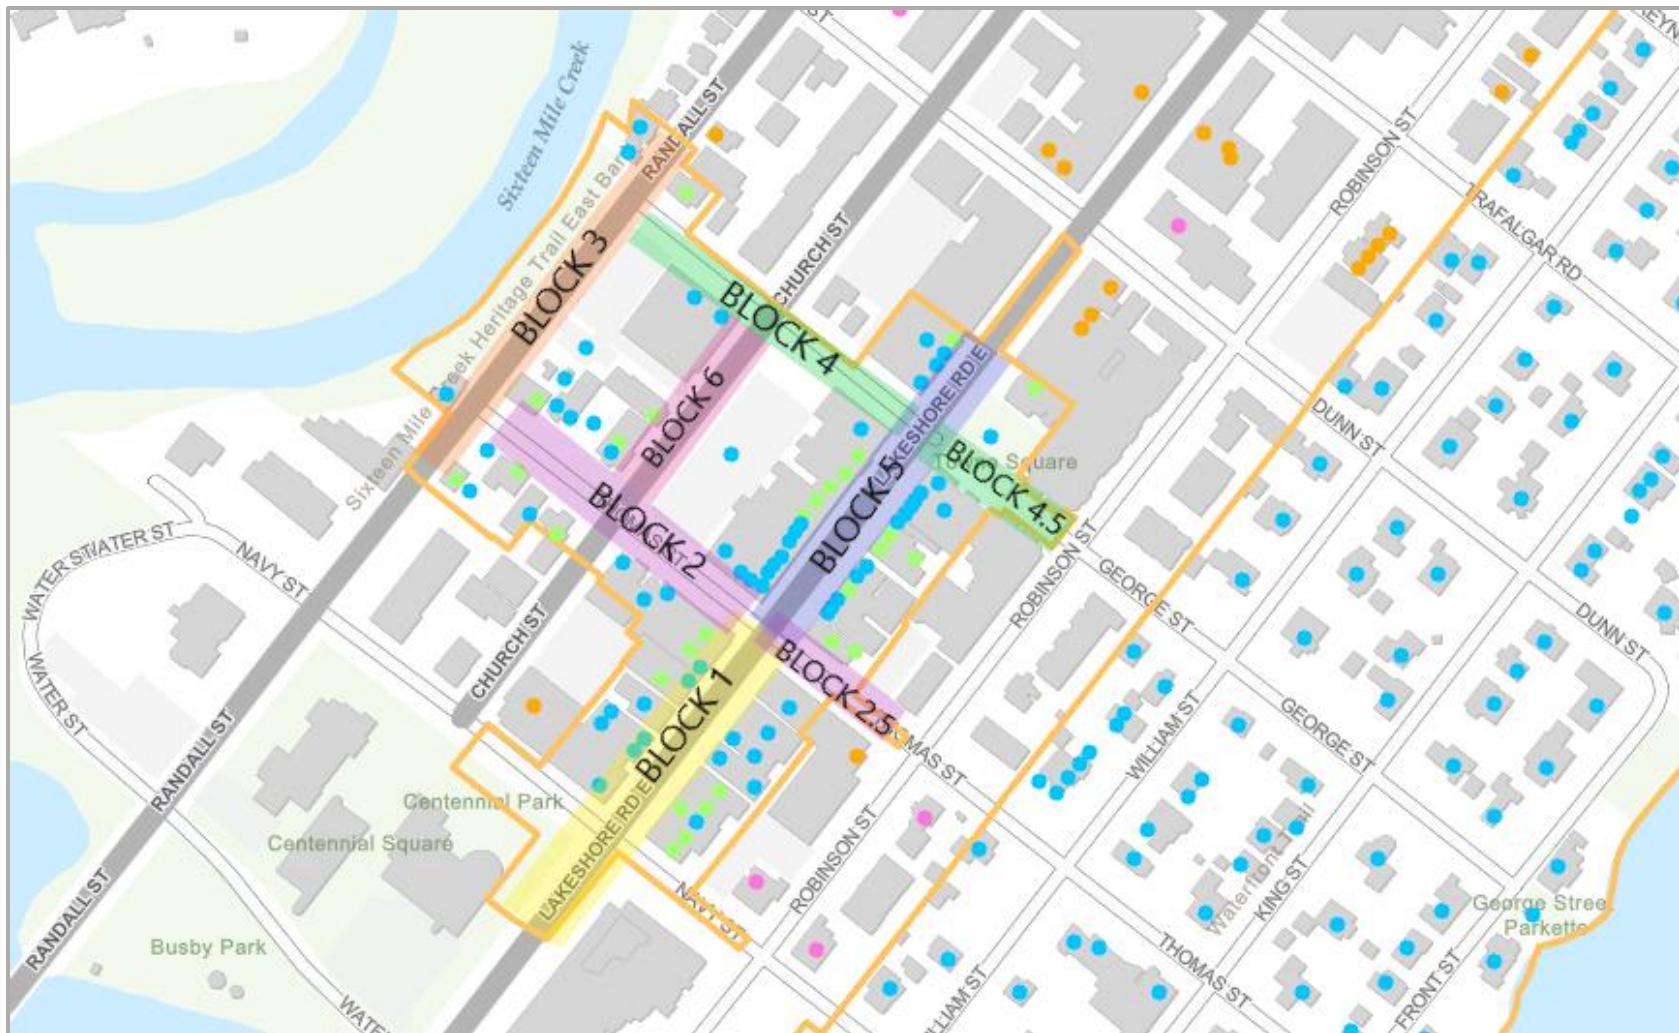
To conduct these site visits, a block analysis was created, as seen on the map below. Staff walked these routes and made notes on the following:

- Heritage attribute conditions
- Streetscape integrity
- Condition and presence of greenery/trees
- Evidence of recent changes
- Maintenance issues or deterioration
- Visible impact from public works projects

BLOCK 1	
Condition of exterior (facades, signage, windows and doors), maintenance or deterioration noted	<ul style="list-style-type: none"> • In general, facades, signs, exteriors in good shape • Most windows are updated (not historic) • Masonic block shows signs of brick and millwork deterioration
Streetscape integrity (height consistency, rhythm of buildings, setbacks)	<ul style="list-style-type: none"> • Heights consistent with Plan and Guidelines • “Street wall” for commercial district in place, no gaps, setback consistent • Cladding materials consistent with Plan and Guidelines
Condition and presence of vegetation/trees contributing to character	<ul style="list-style-type: none"> • Trees are small- to medium-sized as part of 2019 streetscape project • Contributes to the outdoor patio/pedestrian feel
Evidence of recent changes (repairs, alterations, demos, new builds)	<ul style="list-style-type: none"> • Some recent changes to cladding, signage and storefronts

BLOCK 2	
Condition of exterior (facades, signage, windows and doors), maintenance or deterioration noted	<ul style="list-style-type: none"> • Facades: some have been painted but are in good shape • Claddings of contributing buildings generally good: Radial Station and 156 (now 158) Randall updated as part of development • Masonic Hall brick in good shape, but some wooden windows on façade are deteriorated
Streetscape integrity (height consistency, rhythm of buildings, setbacks)	<ul style="list-style-type: none"> • New developments at north end on Randall on east and west sides • Heights consistent with zoning by-law, visible due to Thomas and Randall Street’s lower elevations • The residential history of Thomas Street evident, with homes converted to commercial
Condition and presence of vegetation/trees contributing to character	<ul style="list-style-type: none"> • Trees at northeast corner, not many anywhere else on the block

BLOCK 3	
Condition of exterior (facades, signage, windows and doors), maintenance or deterioration noted	<ul style="list-style-type: none"> Good exteriors in general Scout Hall needs maintenance (exterior painting) As noted, Radial Station restored as part of development Rear of Post Office has some exterior maintenance ongoing Some stucco work on some older buildings; historic windows when present are in good condition
Streetscape integrity (height consistency, rhythm of buildings, setbacks)	<ul style="list-style-type: none"> Still a generally low-elevation street (1.5 storeys in the Plan and Guidelines) aside from development at 158 Randall
Condition and presence of vegetation/trees contributing to character	<ul style="list-style-type: none"> View of Sixteen Mile Creek still present, with trees in the river valley Large trees on north residential lots North side has more vegetation
Evidence of recent changes (repairs, alterations, demos, new builds)	<ul style="list-style-type: none"> New development at 158 Randall; 133-135 Thomas Street

BLOCK 4	
Condition of exterior (facades, signage, windows and doors), maintenance or deterioration noted	<ul style="list-style-type: none"> Some work needed on post office exterior (missing stone, glass in windows and doors) Stone wall at the parking lot needs some repair at the rear

BLOCK 6	
Condition of exterior (facades, signage, windows and doors), maintenance or deterioration noted	<ul style="list-style-type: none"> Post Office: some work needed to be done on stone façade and windows Masonic Hall: wood windows somewhat deteriorated, some covered (but historic pieces still present) Fire Hall: some window and stucco work needed
Streetscape integrity (height consistency, rhythm of buildings, setbacks)	<ul style="list-style-type: none"> South side all parking lot North side: three historic buildings that maintain their historic heights, setbacks, and rhythm
Condition and presence of vegetation/trees contributing to character	<ul style="list-style-type: none"> Not a lot of trees, since south is all parking lot
Evidence of recent changes (repairs, alterations, demos, new builds)	<ul style="list-style-type: none"> Some temporary measures on Post Office
Visible impacts from public work projects	<ul style="list-style-type: none"> Lights updated as part of streetscape project
