PHASE ONE ENVIRONMENTAL SITE ASSESSMENT

DUNDAS STREET EAST, EAST OF
EIGHTH LINE, OAKVILLE, ONTARIO

Project No. 161-03293-00

Prepared for:
National Homes Inc.

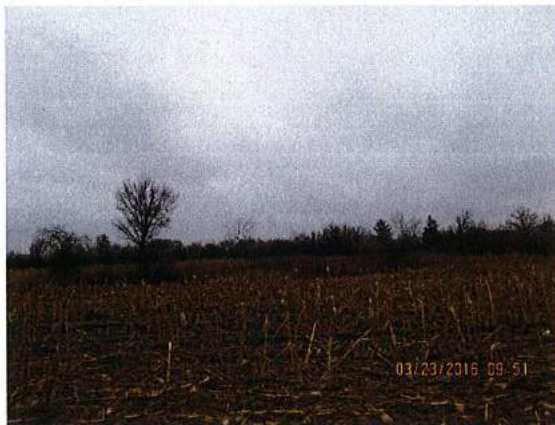
5. Area of the provincially significant wetland on the Subject Property (as designated by the Ministry of Natural Resources); facing north

Water Bodies	A tributary of the Joshua Creek was observed on the within the vicinity of the PSWs within northern wooded area of the Subject Property during the site reconnaissance.
Areas of Natural Significance	During the site reconnaissance, the suspected area of PSWs (as designated by the Ministry of Natural Resources) was located on the Subject Property. As such, ANSIs exist in the area of the PSWs, and the Subject Property is considered to be environmentally sensitive.

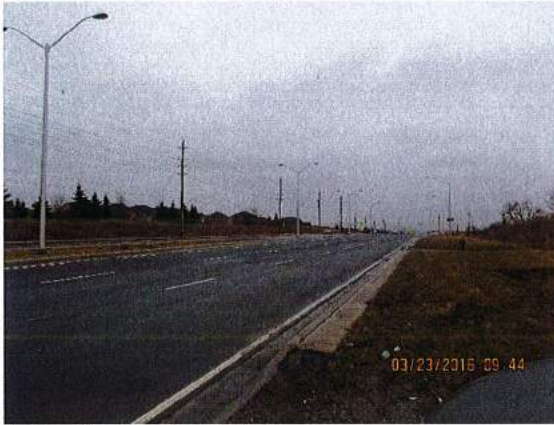
7. Dundas Street East; facing west

6. **Adjacent roadway:** The southern boundary of the Subject Property is adjacent to Dundas Street East, which is a municipal roadway. This municipal roadway may have been subjected to seasonal de-icing activities. However, any potential contamination caused by the use of de-icing substances for the purpose of keeping a municipal roadway safe for traffic under conditions of ice and snow is not considered an exceedance under O.Reg.153/04, s.48 (3). As a result, these impacts to the soil (i.e., EC and SAR) and groundwater (i.e., chloride and sodium) do not need to be delineated or remediated. However, if during redevelopment-related construction activities, these impacted soil and/or groundwater need to be disposed of off-Property, they would need to be managed appropriately as waste.

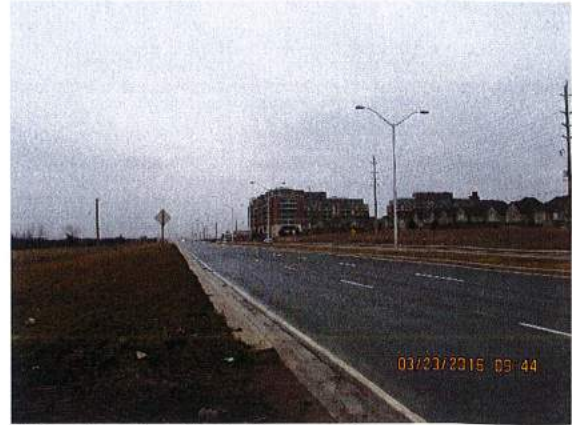
8. Dundas Street East; facing east

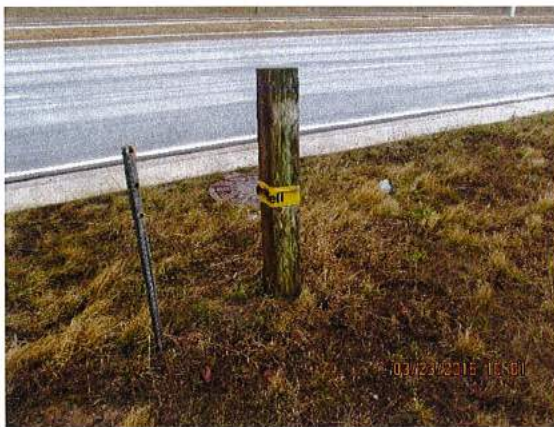
9. Evidence of underground bell communication and sanitary sewer lines between Dundas Street East and the southern boundary of the Subject Property

i. Wells	No monitoring wells were observed on the Subject Property.
ii. Sewage Works	No sewage works were observed on the Subject Property. However, as previously discussed, a potential underground sanitary sewer corridor borders the southern boundary of the Subject Property.
iii. Ground Surface	The ground surface on the Subject property was observed to be relatively flat.
iv. Railway Lines and Spurs	No evidence of railway lines or spurs was observed on the Subject Property.
Other Observations

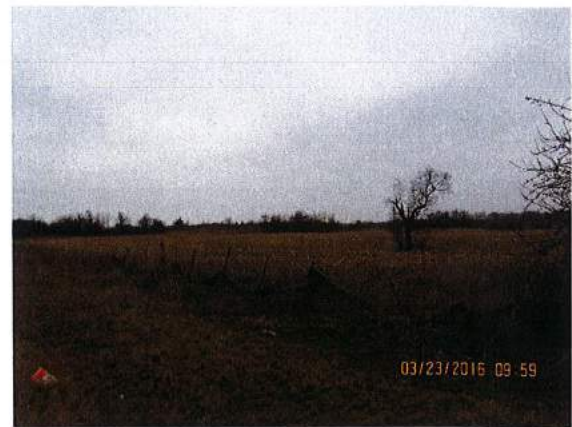
10. Swales on the southern boundary of the Subject Property; facing northwest

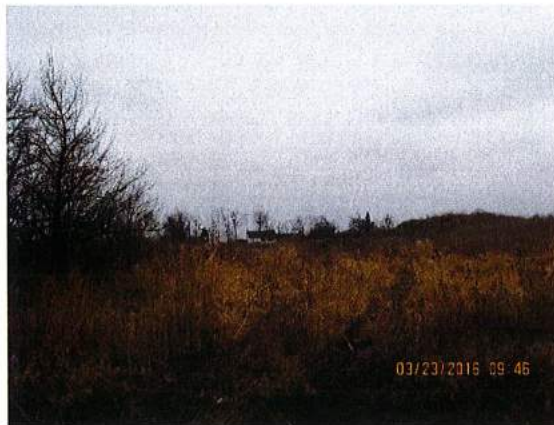
11. Soil berms observed on a southwestern adjacent property near the western boundary of the Subject Property; facing west

30. Importation of Fill Material of Unknown Quality	Phase One Study Area: Based on observations made during the site reconnaissance, soil berms were found to be located on a southwestern adjacent property from the Subject Property, near the property boundary with the Subject Property. As no documentation was available on the source or chemical characterization of these soil materials, these soil berms are conservatively considered to be fill material of unknown environmental quality. Given their close proximity with and their up-gradient locations from the Subject Property, these PCAs are considered to contribute to APEC-2.

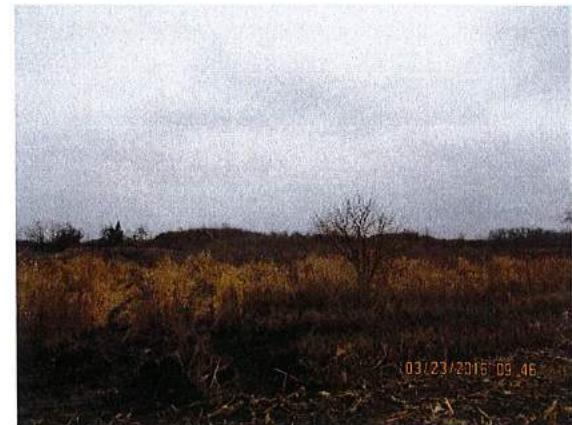
12. Another view of the soil berms on a southwestern adjacent property near the western boundary of the Subject Property

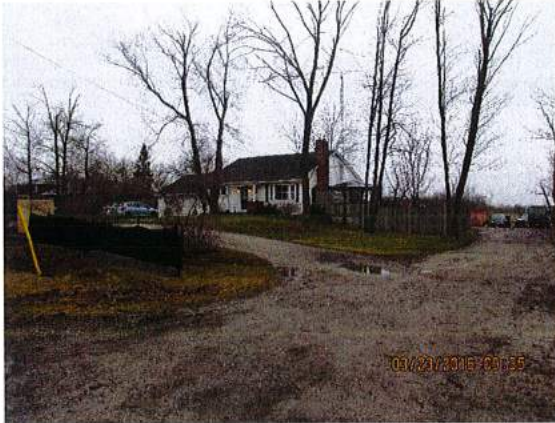
13. 3033 Eighth Line, a southwestern adjacent property; location of the suspected commercial storage of mechanized equipment

52. Storage, maintenance, fuelling and repair of equipment, vehicles, and material used to maintain transportation systems	Phase One Study Area: Based on a review of the 2005 and 2015 satellite images as well as observations made from the site reconnaissance, a suspected commercial property used for the storage of mechanized equipment was located at 3033 Eighth Line, which is a southwestern adjacent property to the Subject Property. Given its close proximity with and its up-gradient location from the Subject Property, these PCAs are considered to contribute to APEC-2.

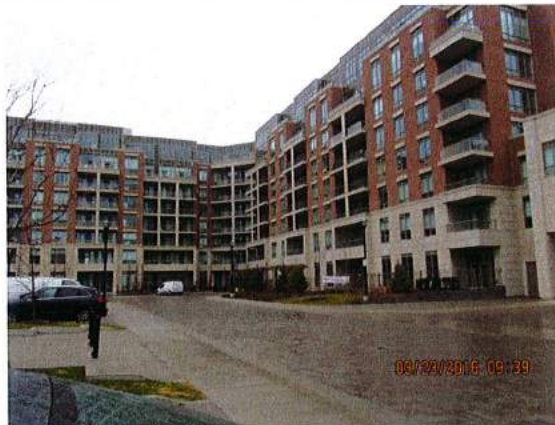
15. Location of the O. Reg. 347 HWIS record at 2470 Prince Michael Drive, approximately 230 m east of the Subject Property

Phase One Study Area: Based on a review of the Ontario Regulation 347 HWIS database, one (1) property registered as Ontario Waste Generators were found at an eastern neighbouring location from the Subject Property for the aliphatic solvents waste class. This HWIS records is located at 2470 Prince Michael Drive, approximately 230 m east of the Subject Property. Given the distance of this PCA from the Subject Property, its down-gradient location and the anticipated fine-grained soils within the Phase One Study Area, there is a low potential for adverse environmental impacts to the Subject Property; this PCA is not considered to contribute to an APEC.
