Environmental Study Report

Wycroft Road Improvements from Bronte Road to Kerr Street

Appendix B: Natural Environment

NATURAL ENVIRONMENT REPORT – IMPACT ASSESSMENT

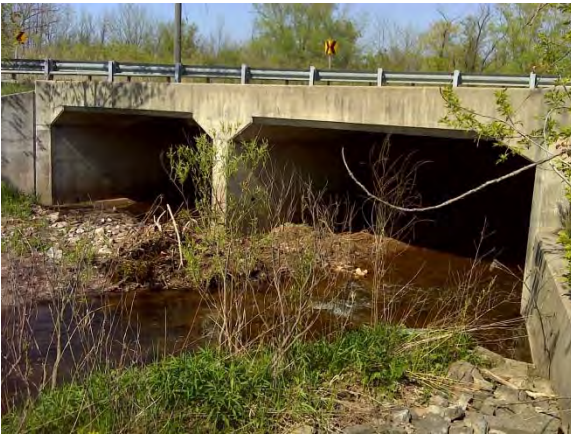
Photo 1: Structure inlet, view from southwest bank (May 17/2018).

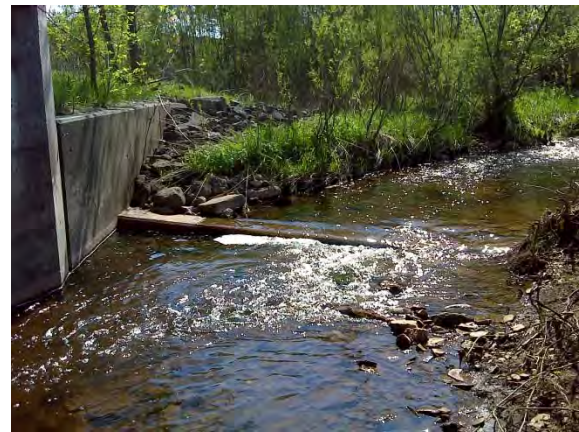
Photo 4: Concrete lip located at structure inlet; partially exposed above the water at the time of survey (May 17, 2018).

There is a low concrete lip that extends between the culvert inlet wingwall and crosses the channel within 1 m of the culvert inlet (Photo 4). This lip appears to represent a partial barrier to fish movement during low flow conditions (approximately 1/3 of lip is exposed). Where water travels over the lip, depth was only 5 cm (Photo 11). A small scour pool (24 cm deep in spring) is present immediately downstream of this lip and the water travels along the west wall of the culvert. A large gravel and cobble point bar extends into the north cell and a portion of the south cell, immediately upstream of the culvert inlet.

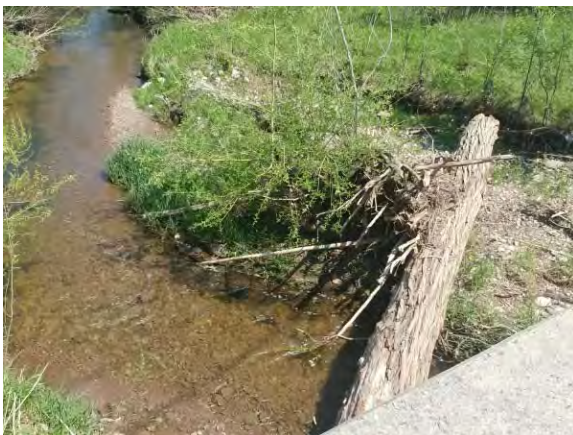
Photo 5: View from on top of the structure outlet, showing large log across channel.

Downstream of South Service Road West, a large log is located instream within 65 cm of the structure outlet (Photo 5) causing some flow to be directed into the north cell, in turn causing a backwater area (Photo 6, 12). This log was not present (appeared to have been removed by maintenance) at the time of the summer survey. Inside the south cell, exposed substrates are present near the upstream end, again on the north side of the structure. Spring water depth is 25 cm deep at the upstream end and an average of 13 cm deep at the downstream end over gravel and cobble substrates. Water depth upstream of the log measures 40 cm deep, as some scour is occurring here as water travels underneath the log. The stream bends slightly north downstream of the double cell structure, with point bar material (cobble, gravel) extending along the south side, supporting some terrestrial vegetation growth here (cultural meadow species, young tree saplings) (Photo 7).

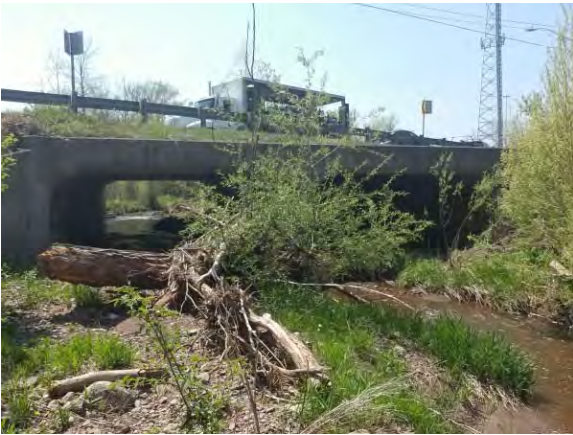
Photo 7: Upstream view of the structure outlet, showing large log and dry vegetated point bar.

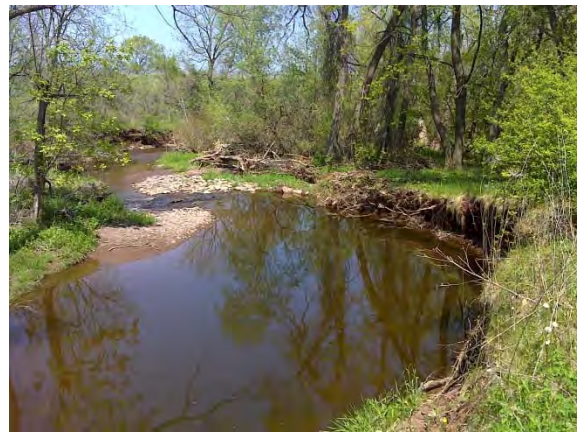
Photo 10: Downstream view of large pool at bend and presence of eroding banks (within 115m downstream of Wycroft Road).

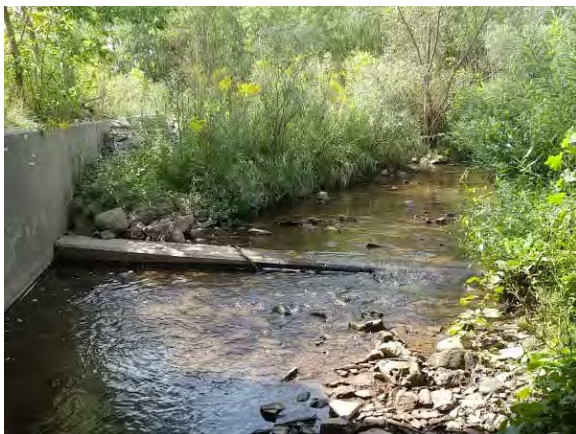
Photo 11: Upstream view of concrete lip at the inlet of the culvert (September 7, 2018).

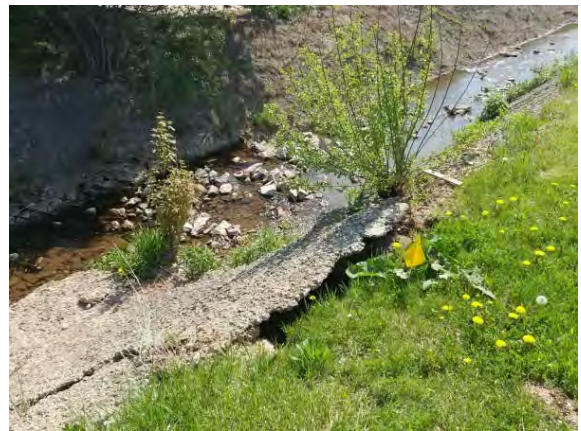
Photo 14: Eroding concrete channel banks near the culvert outlet.

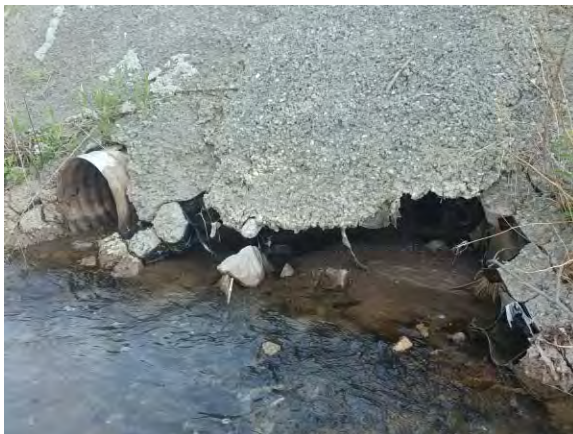
Photo 15: Eroding channel banks (up to 90 cm undercut), located within 6m downstream of the Wyecroft Rd. culvert.

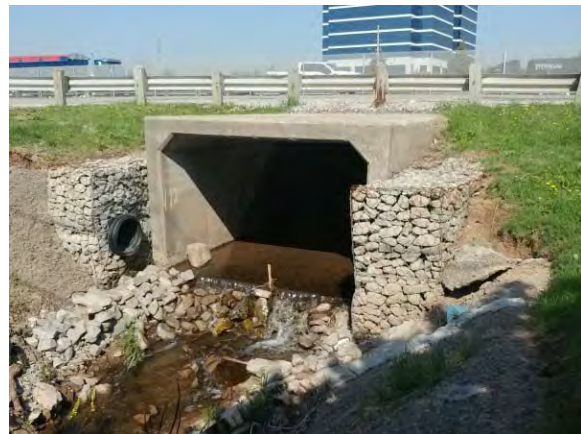
Photo 16: Upstream view of the culvert outlet, highlighting perch (May 17, 2018).

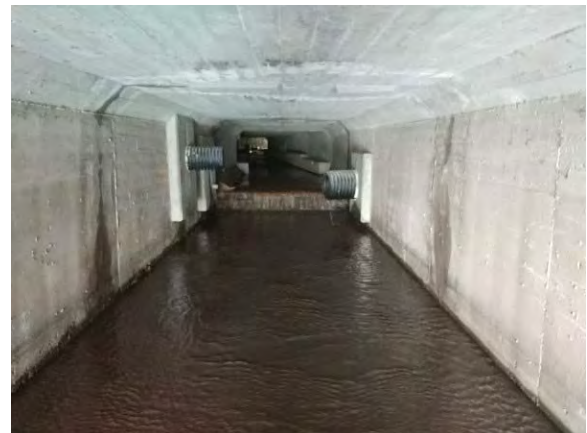
Photo 18: Inside culvert, upstream view of perch.

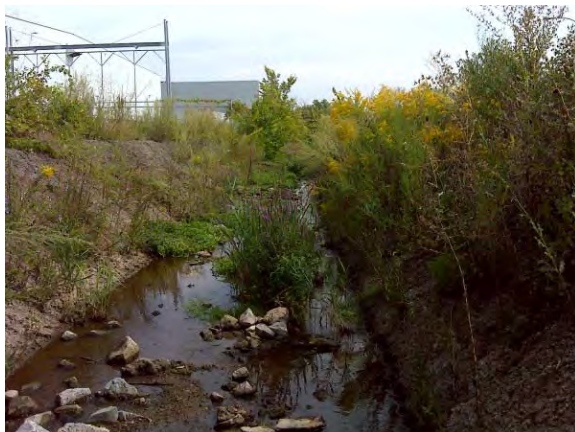
Photo 21: Deeper water and increase instream and overhanging cover approximately 130m downstream of Wycroft Road.

The channel appeared to support deeper water depths approximately 130 m downstream, where access was not possible (area fenced off) (Photo 21). Stagnant or slower flowing water was noted here, with estimated water depth measuring between 20 cm to 30 cm deep. Forage fish were observed and instream and overhead vegetative cover (overhanging willows) increases within this reach.

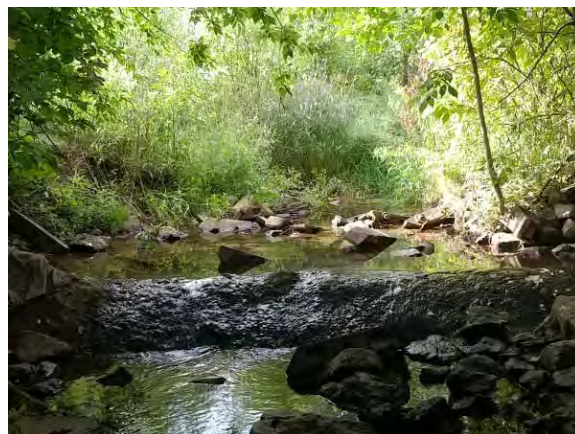
Photo 23: Channel reach upstream of the QEW showing instream barrier (September 7, 2018).

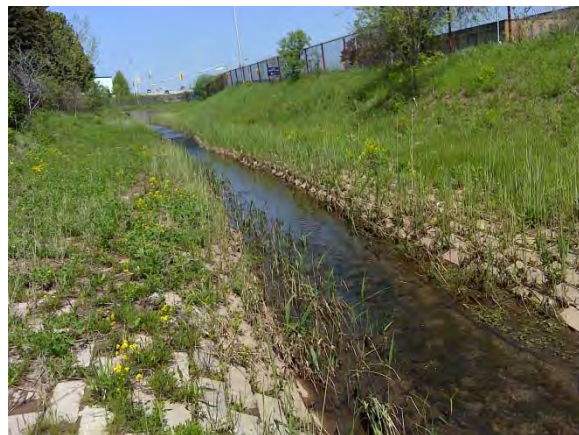
Photo 29: Upstream view of downstream channel reach (concrete blocks on bank and in channel visible); some instream vegetation present.

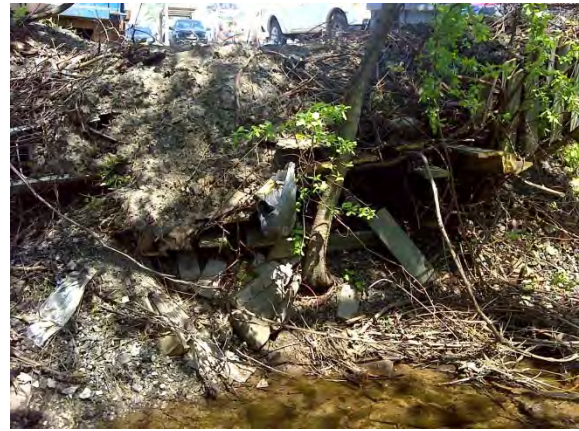
Photo 31: Example of dumping occurring along the bank edges, notable upstream of Wyecroft Road.

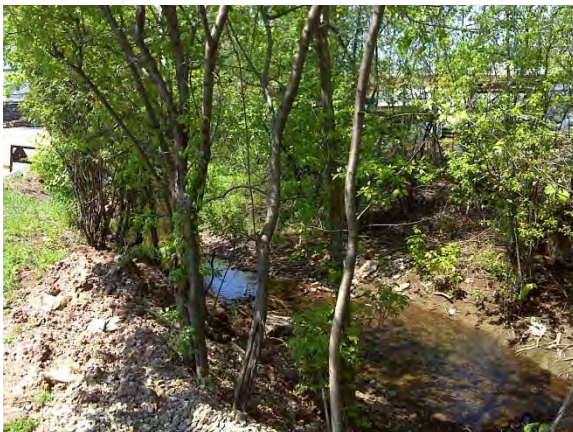
Photo 32: Upstream view of channel showing narrow riparian and soil dumping along the west bank.
