OAKVILLE HERITAGE INVENTORY SHEET

Address: 143 Front Street

Name: Peter McCorquodale House

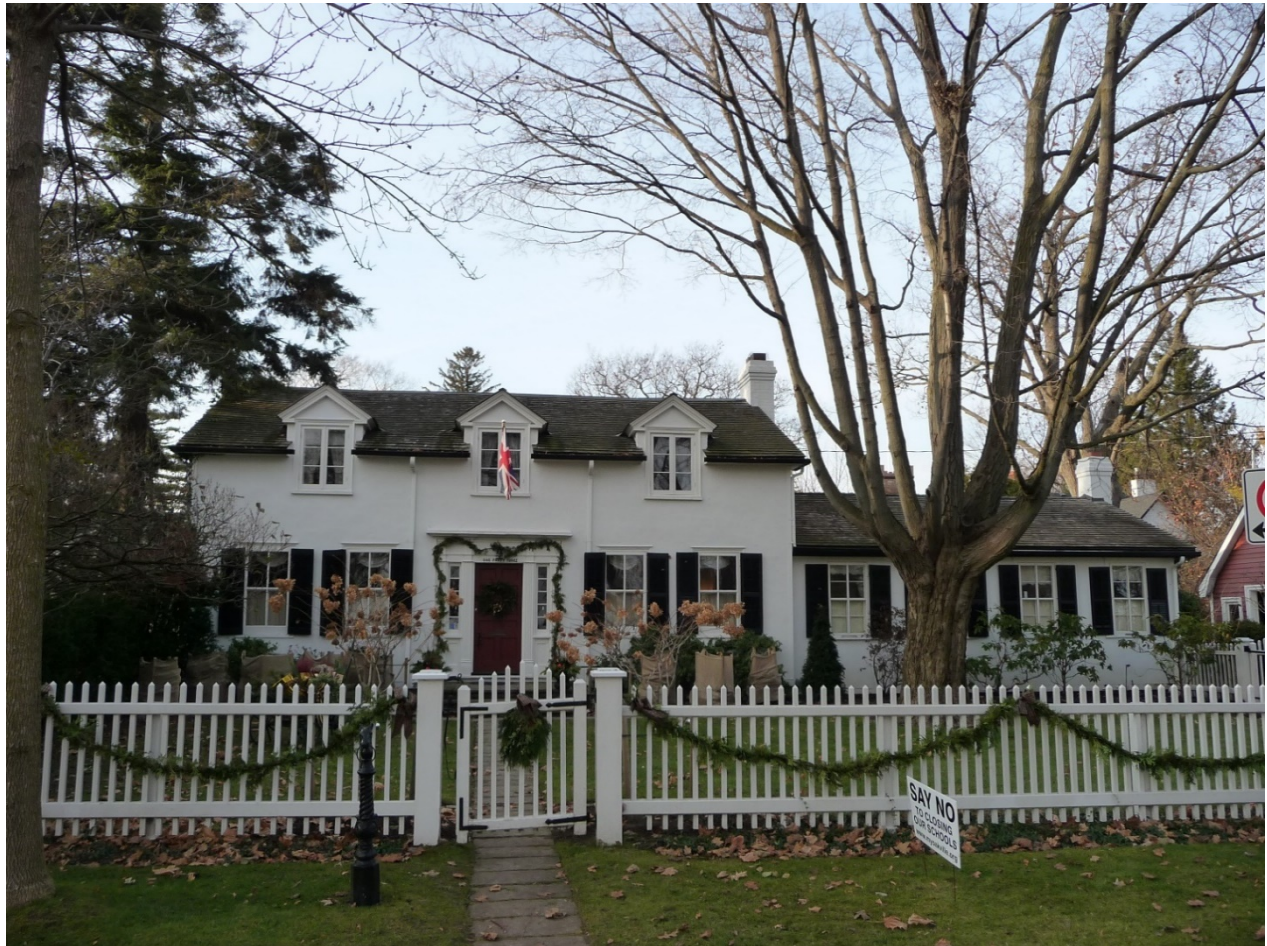
- Style: Georgian Revival
- Cross gable roof, with five bay front façade section broken by three gable wall dormers (which were added in 1934), and a rear façade shed dormer window.
- One and one half storey
- Central doorcase entryway, with single eight panel door flanked by sidelights of five panes, and paired pilasters – bold projecting cornice and high frieze
- One storey additions constructed on the east and rear elevations
- Two-over-two, and four-over-four windows with functioning shutters, paired three-pane (or six-pane) casement windows in the gable wall dormers

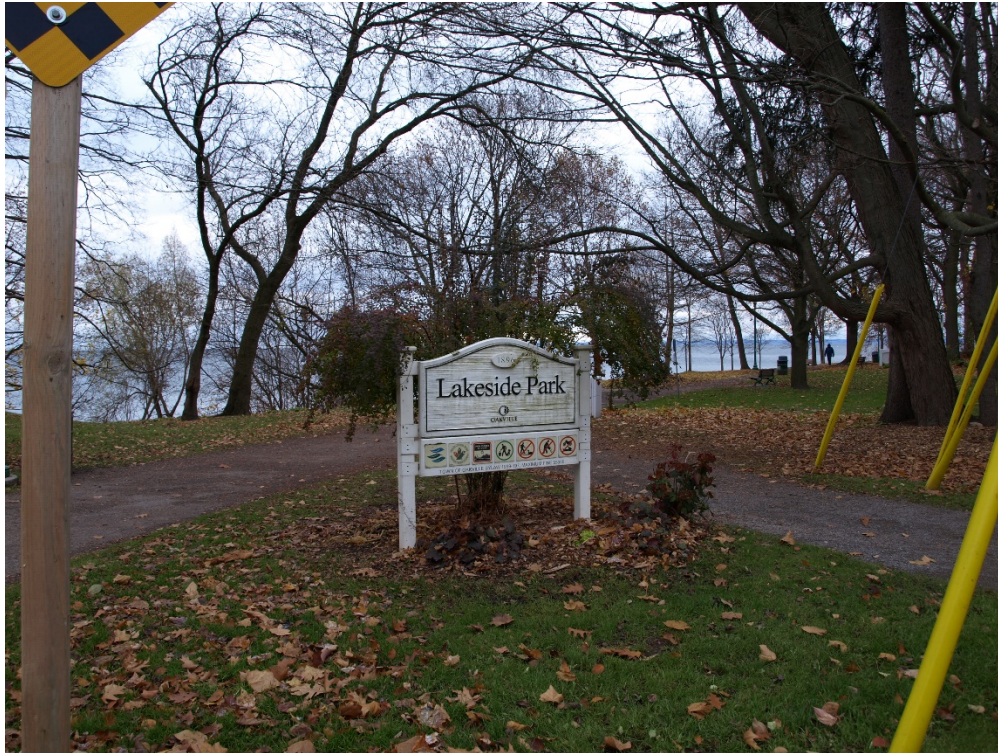
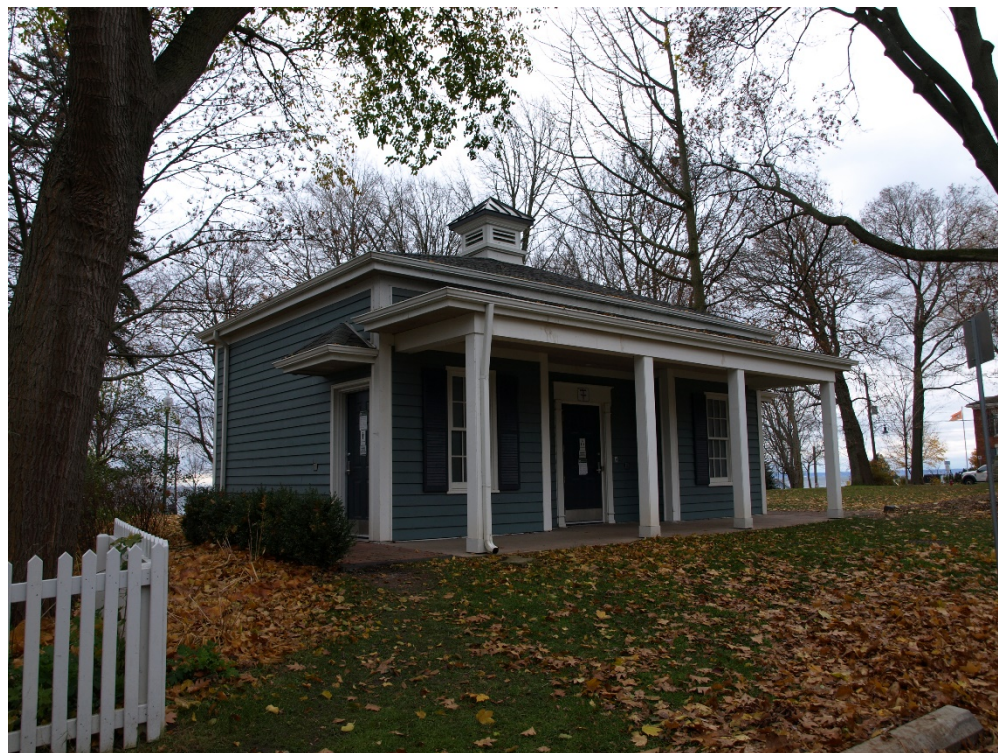
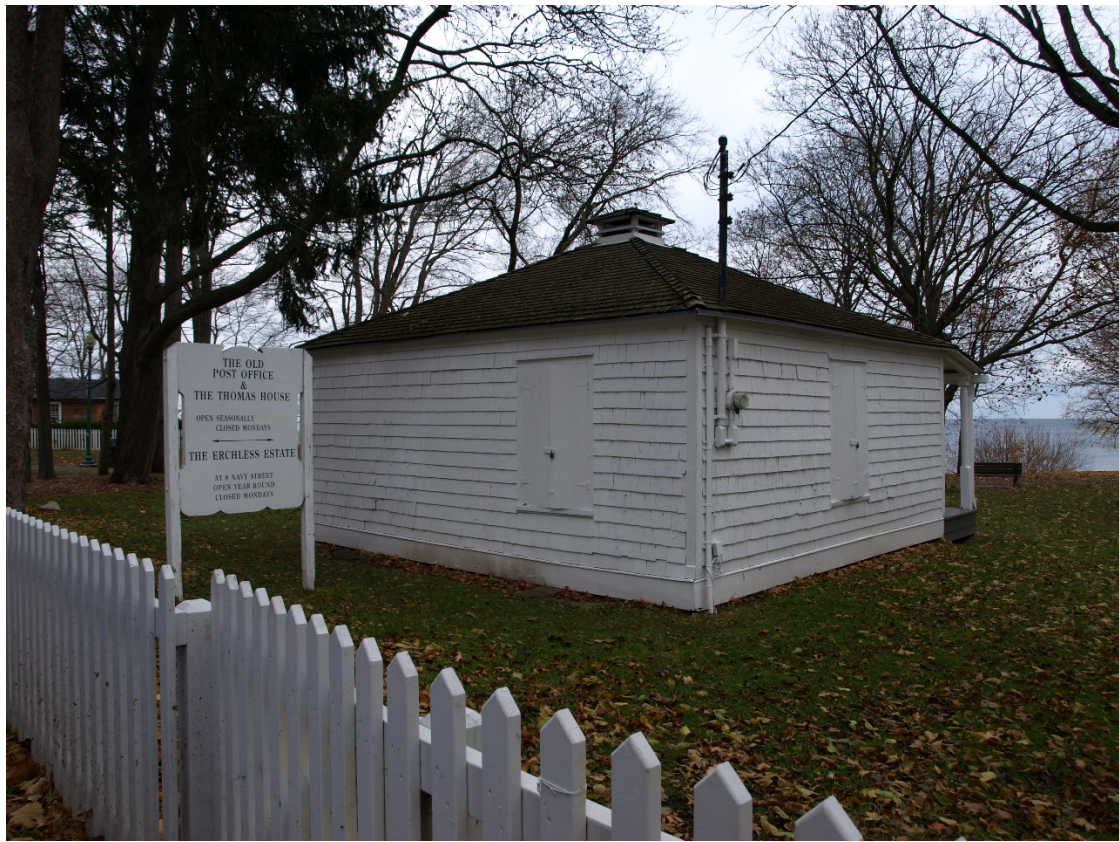
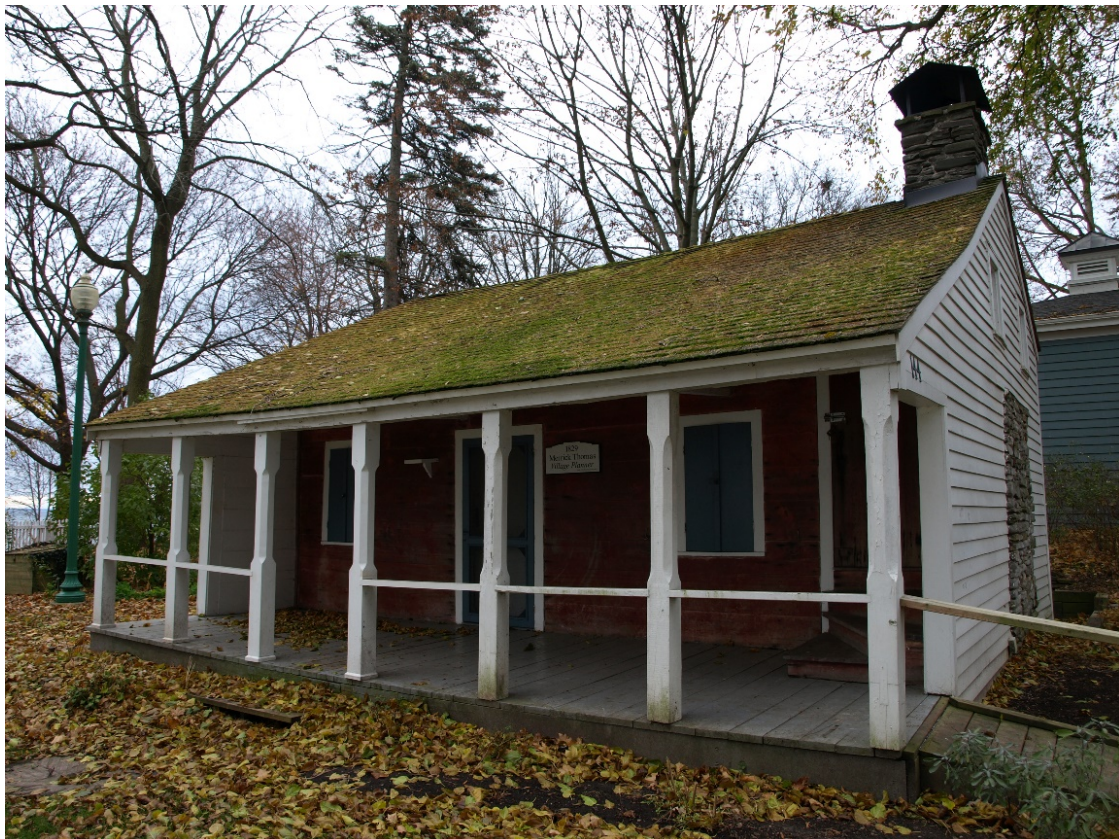
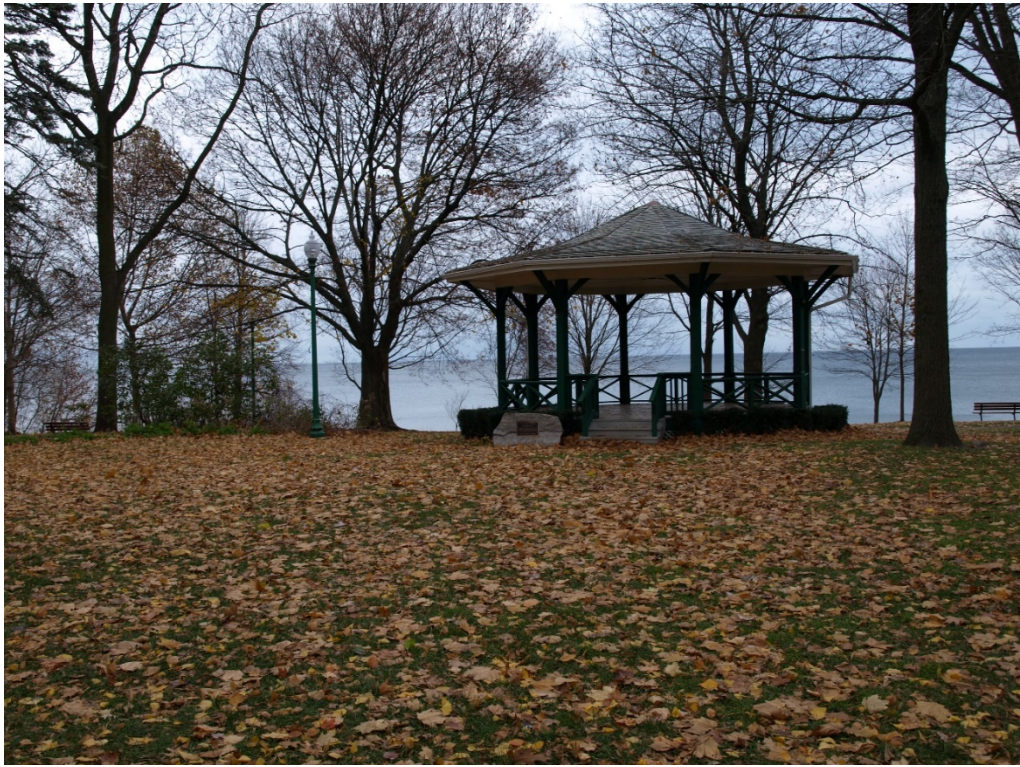
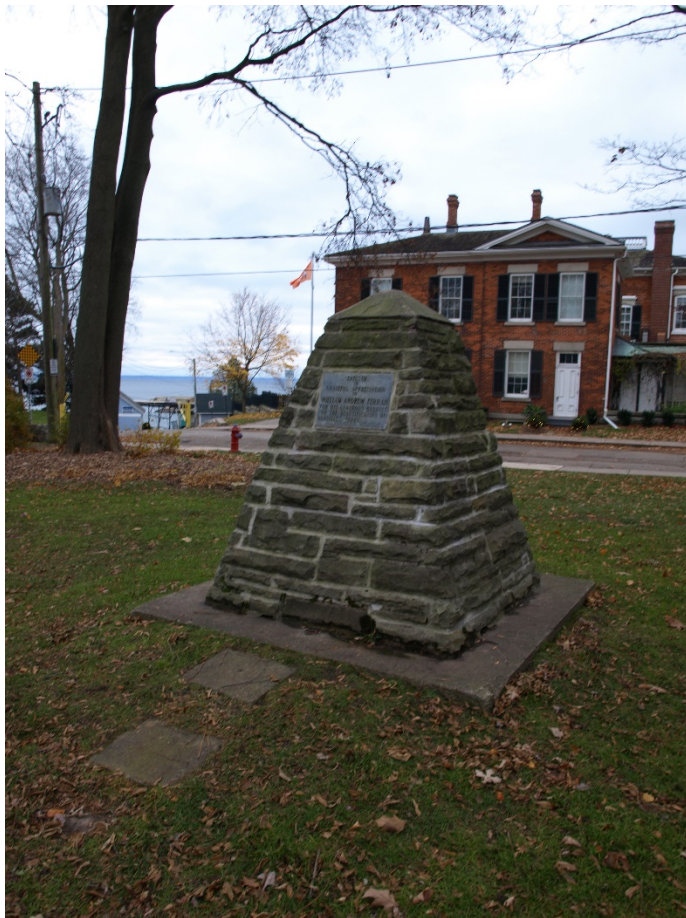
Photos:
2021

- Includes two historic buildings: Post Office and Merrick Thomas House
- Includes contemporary structures: public washrooms, bandstand/gazebo, children's play equipment
- Includes landscape elements: trees, plantings, paths, benches, lamp standards, tables, fencing, commemoration carin/plaque
- Washroom building designed in 'New Traditional' style
- Post office: Hipped roof, cedar roof, one storey, cedar shake siding, simple porch
- Merrick Thomas House: Gable roof, Saltbox style, cedar roof, one and a half storey, clapboard siding

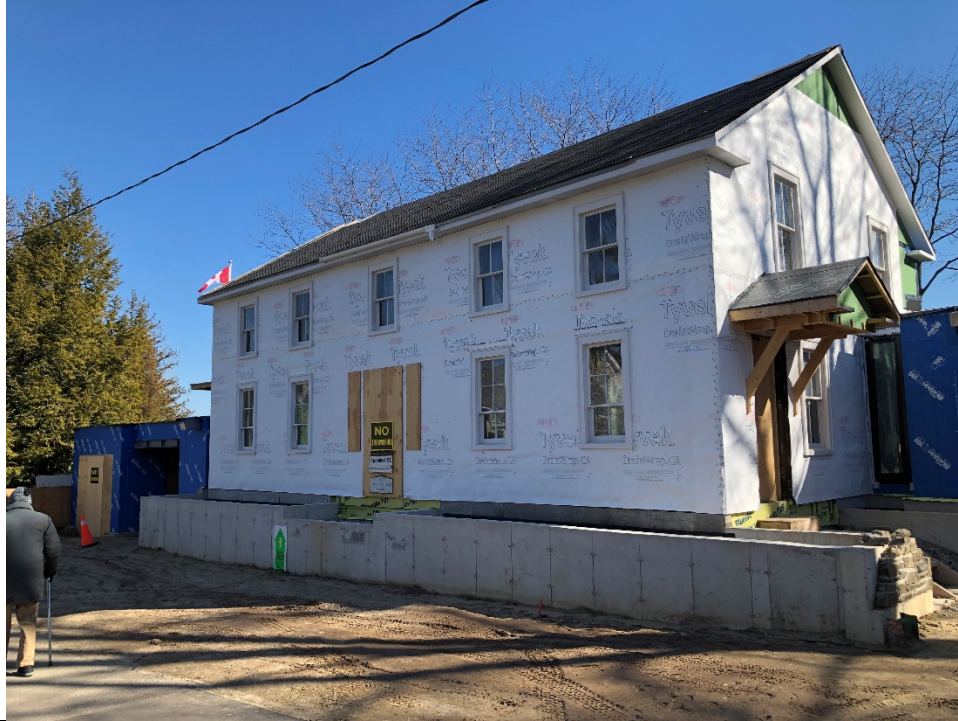
Photos:
2023

- Style: Georgian Revival
- Side gable roof
- Two storey
- Symmetrical, five bay façade, with centrally located front entryway. Single panel front door, with sidelights, all framed by a decorative surround. Frame structure. One storey addition demolished in 2021.
- New contemporary addition(s) approved by heritage permit and under construction in 2022-2023 including garage with flat roof
- Two-over-two windows on second storey, four-over-two windows on first storey. Shutters on front façade. Some storm windows.
- Stucco cladding

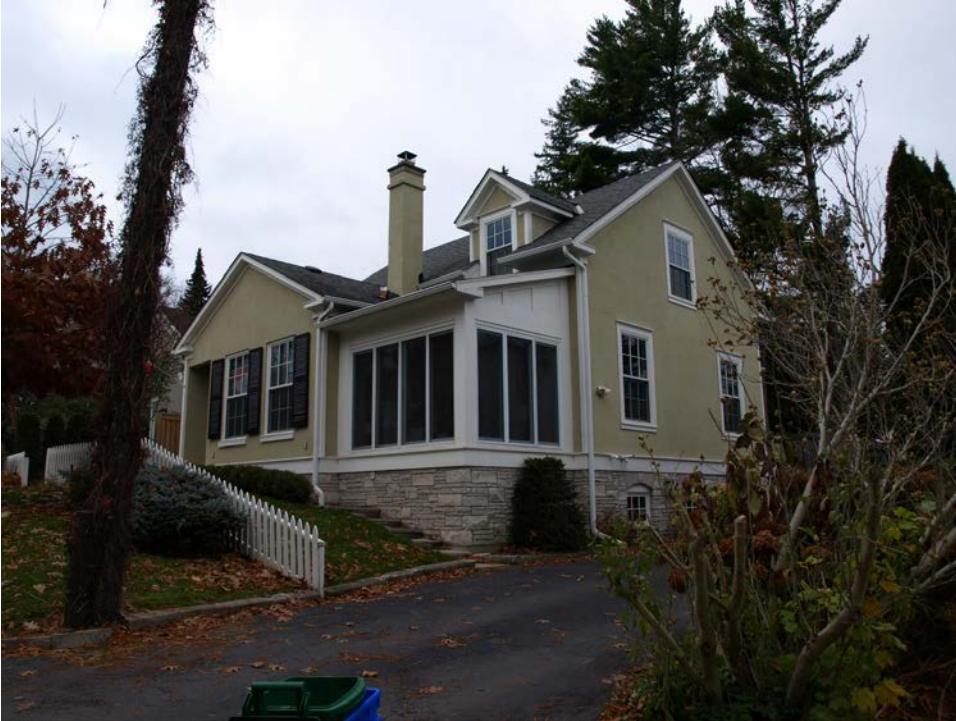
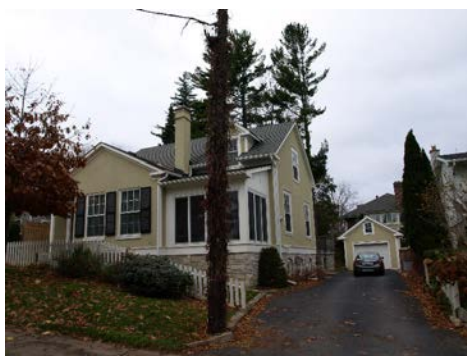
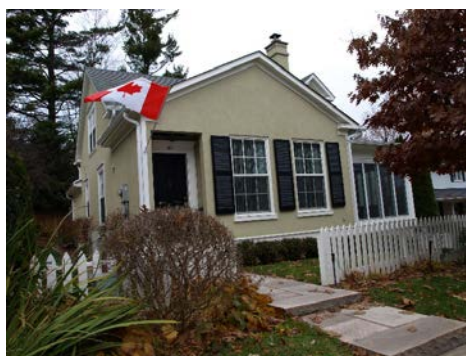
Photos:
2021:

- Style: New Traditional (replica of historic vernacular cottage)
- Cross gable roofs with shed roof on front one-storey section. Front façade includes dormer, capped by a gable roof.
- One-and-a-half storey
- Asymmetrical three bay front façade, with an offset, recessed entryway. Small sunroom/enclosed porch on the east side of the front façade.
- Six over six replacement windows with non-functioning shutters; and six-pane windows topped by segmented stone lintels in basement
- Frame structure clad in stucco with veneer stone clad foundation
- Masonry chimney

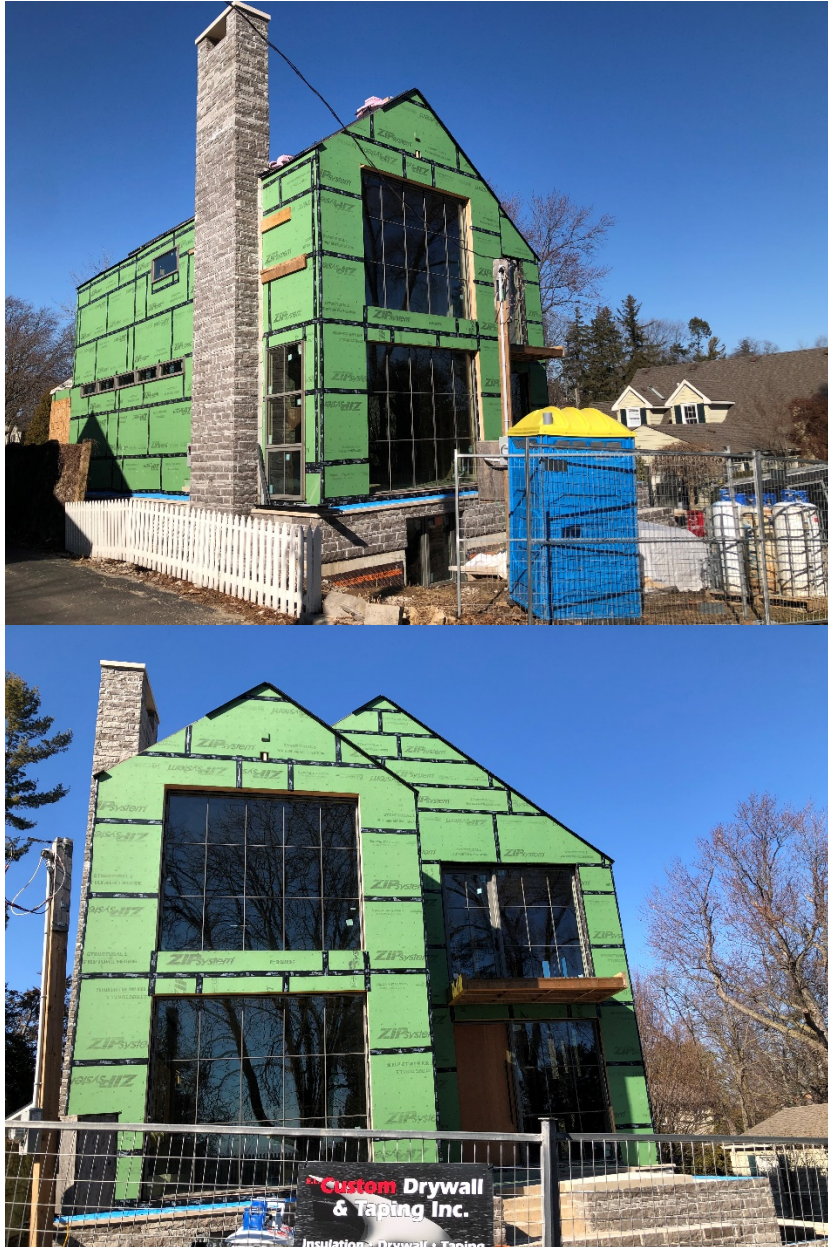
Photo:
2023

- Style: Contemporary
- Two-storey
- Bay window on first storey
- Low side gable roof with porch overhang
- Recessed entrance

- Construction is ongoing

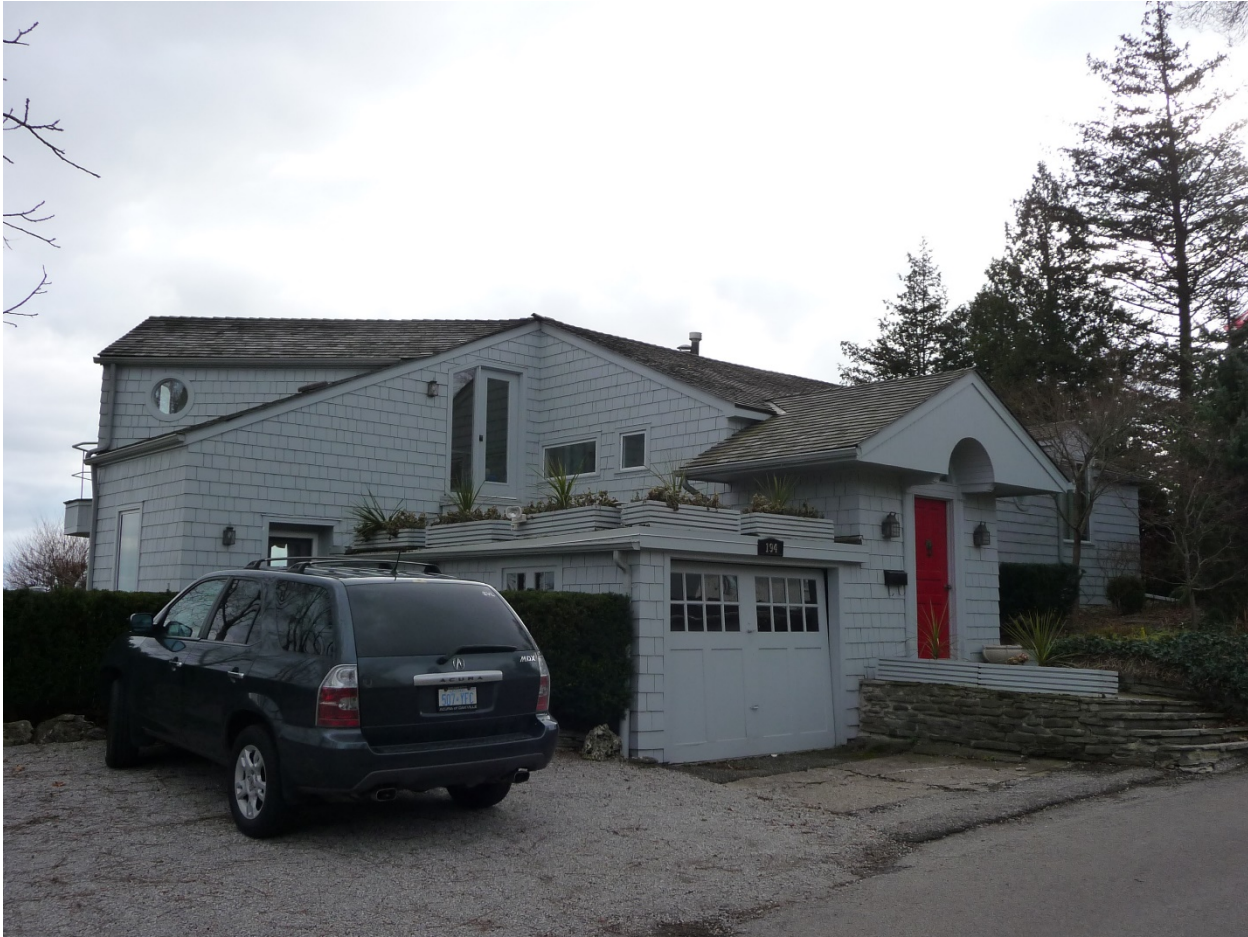
Property approved for demolition in July 2023
2021

- Style: Late 20th century vernacular
- Two-storey
- Modern windows
- Combination roof – hipped, flat, gable
- Shake cladding
- Entrance under porch overhang

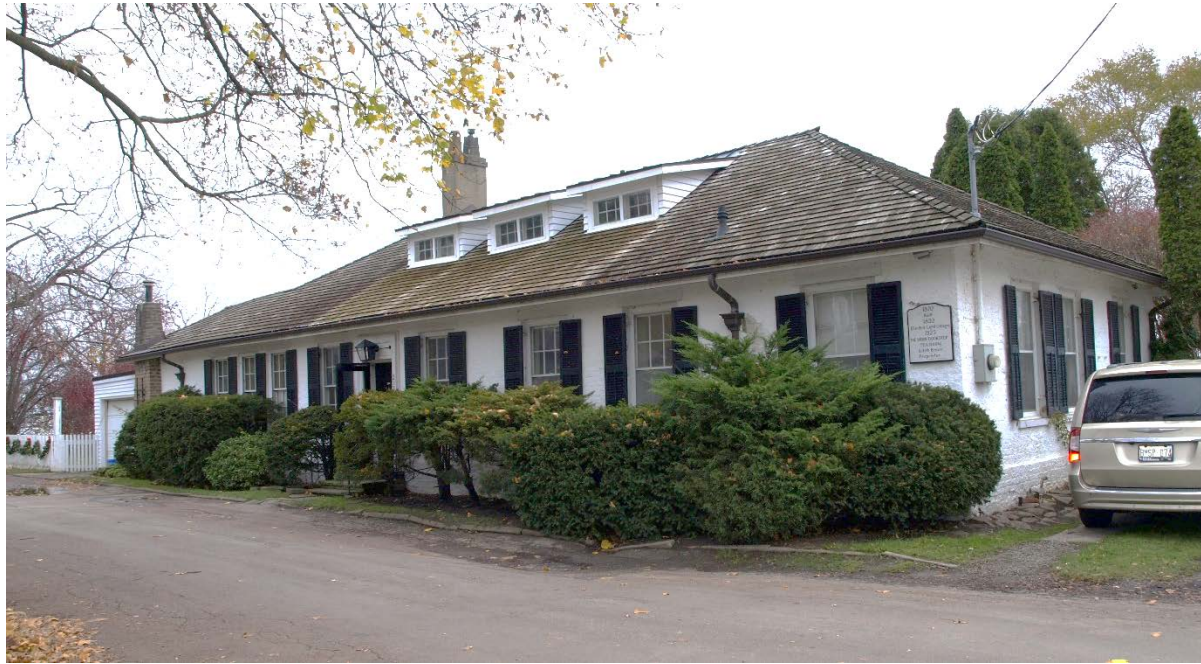
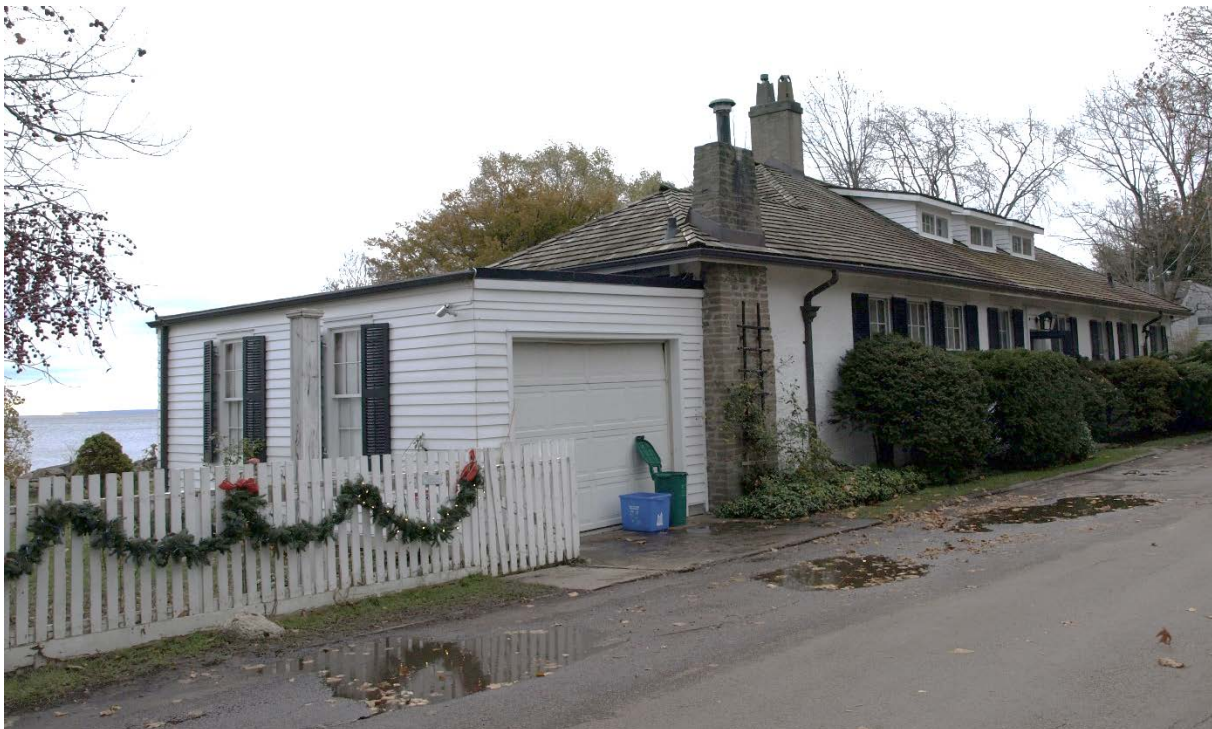
Photos:

- Style: 19th Century Vernacular
- One and one half storey
- Low hipped roof clad in cedar shingles broken by three shed dormers
- Broad overhanging eaves
- Six over six sash windows with functioning shutters
- Double stack chimney at peak of hip roof
- Single stack lakestone chimney on east side of front facade
- Nine bays across the front elevation, irregular spacing
- Main entrance with simple surround
- Rough cast stucco cladding

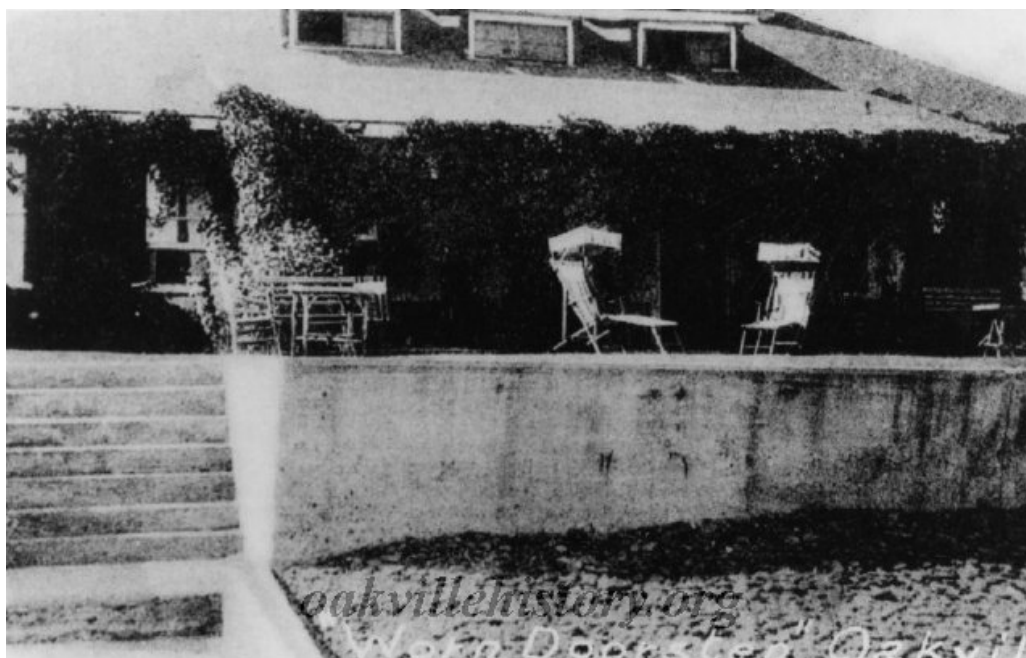
1930 – Rear of building facing Lake Ontario when it operated as a tea house

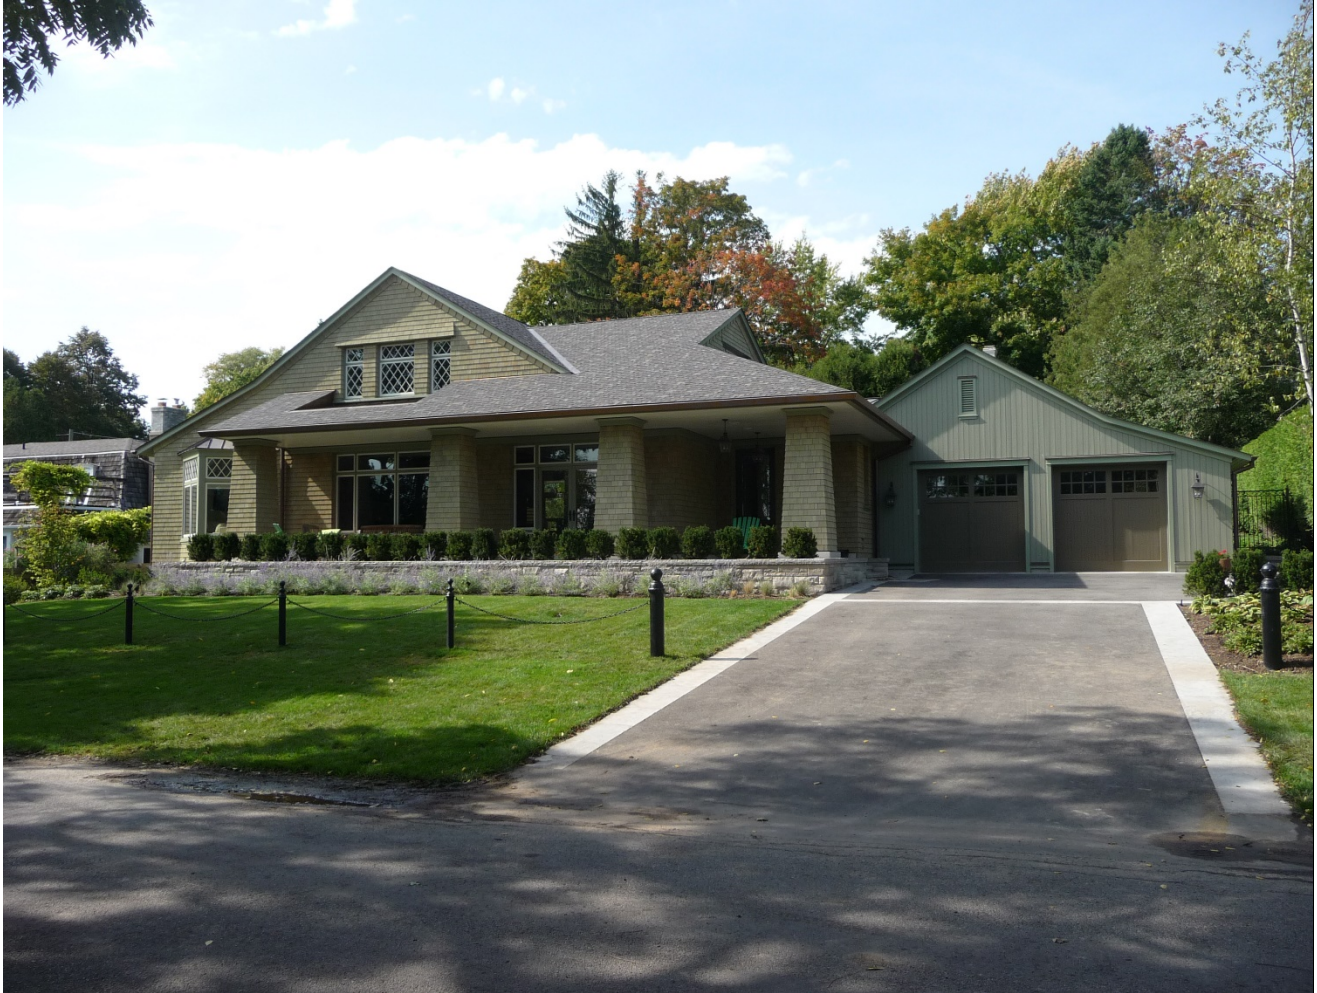
Photos:
2021

- Style: New Traditional
- One and a half storey
- Shingle clad exterior
- Diamond pane windows
- Medium pitch hipped roof with gable end
- Large front porch with shingle clad columns
