# 193 Nautical Boulevard, Oakville

#### **Phase II Environmental Site Assessment**

193 Nautical Boulevard, Oakville, ON

August 26, 2021

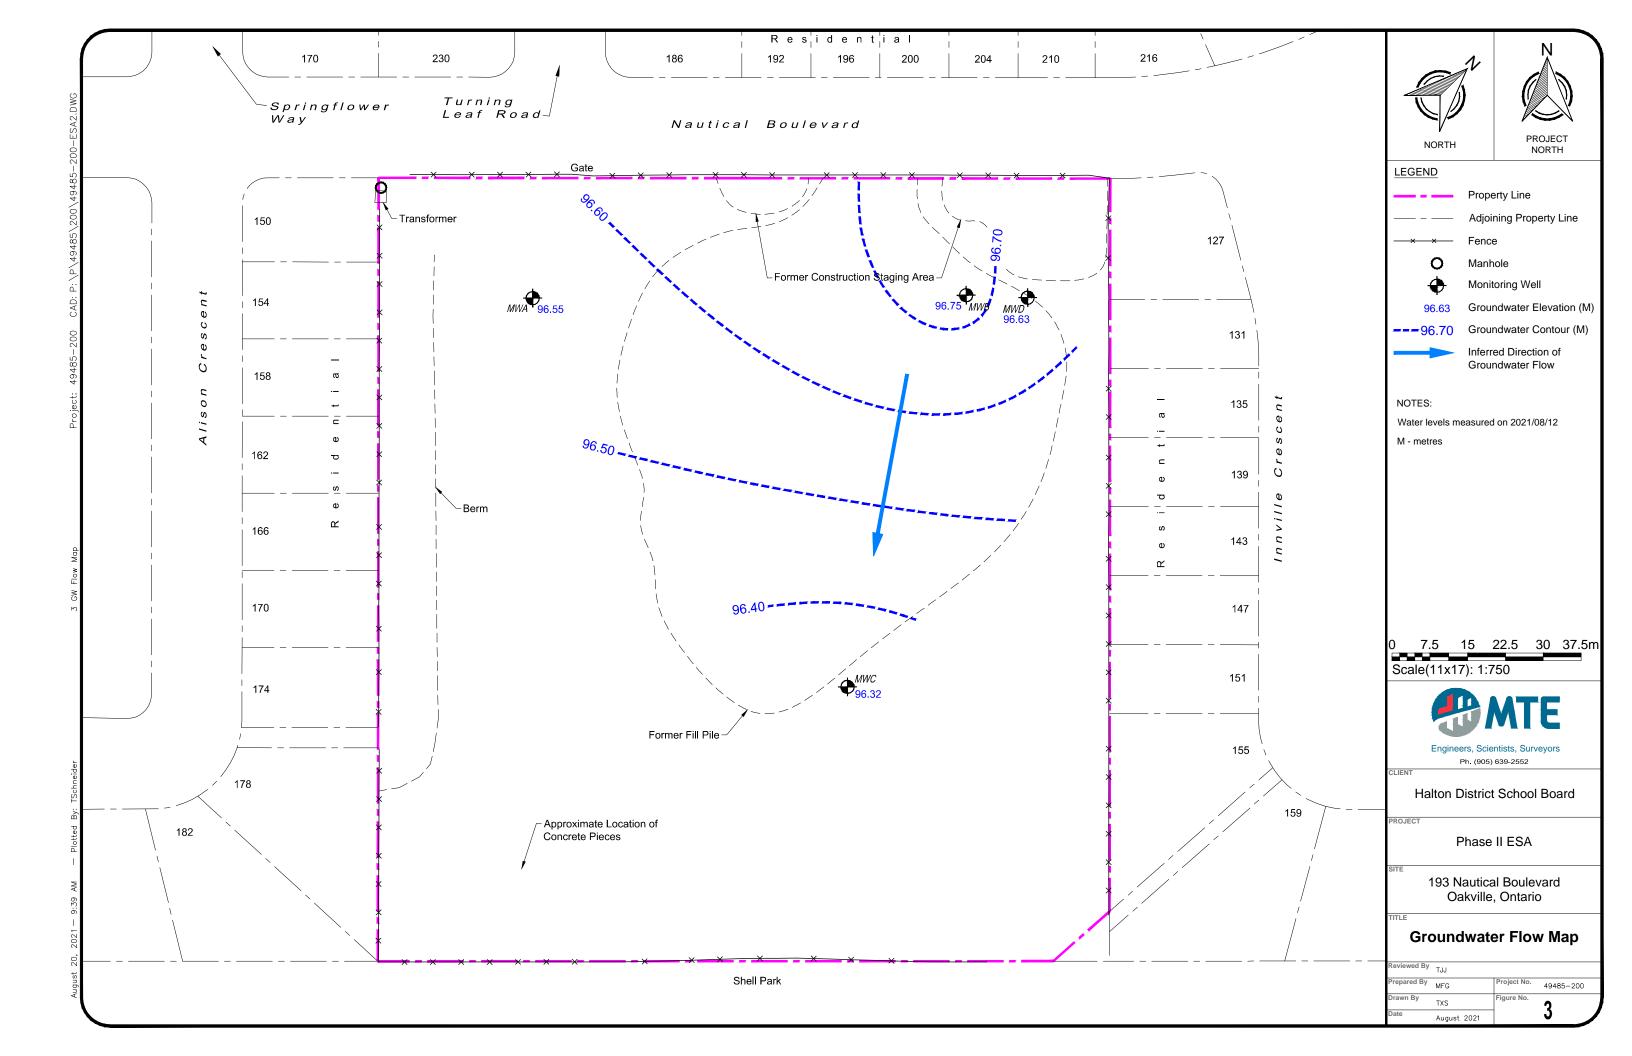
Figure 3 - Groundwater Flow Map

The measured depth to groundwater in the monitoring wells was between 2.59m and 3.27m bgs and the water table occurs in the bedrock. The inferred groundwater flow direction was south-southwesterly. No evidence to suggest groundwater contamination was observed during the sampling activities and the groundwater analytical results were below the 2011 Table 3 RPI SCSs and the 2011 Table 7 RPI SCSs.

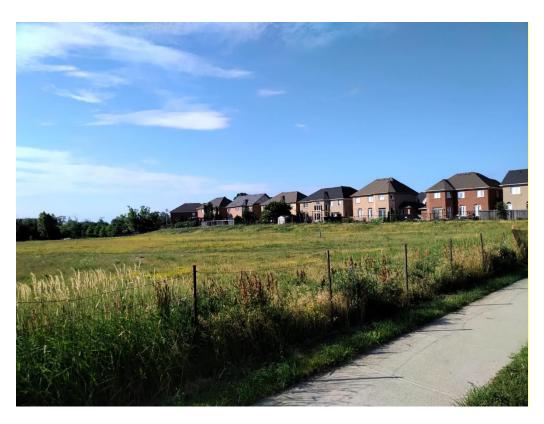
Photograph No. 1 – Southwest facing view of the Site from the sidewalk along Nautical Boulevard. Including the berm along the western boundary.

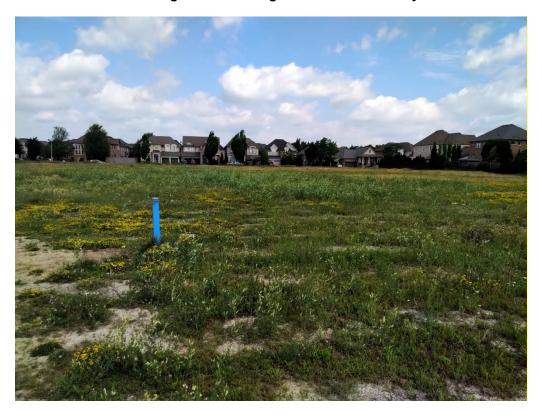
Photograph No. 2 – Northeast facing view of the Site, including monitoring well MWC.

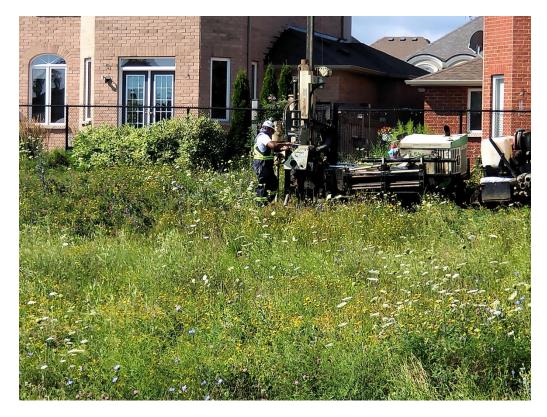
Photograph No. 3 – View of the advancement of borehole BH102-21 within the western soil berm.

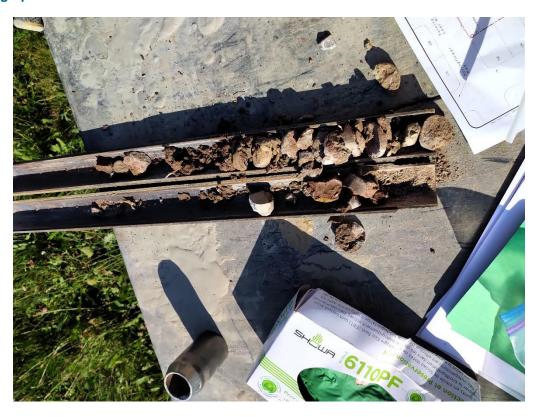
The subsurface stratigraphy on the Site generally consisted of 0.6m to 2.1m of clayey silt fill, overlying native clayey silt till to refusal on inferred bedrock at depths ranging from 2.3m to 3.0m below ground surface (bgs). Non-soil material including glass, was observed in one borehole (BH102-21).

Photograph No. 4 – View of the fill material at borehole BH102-21.

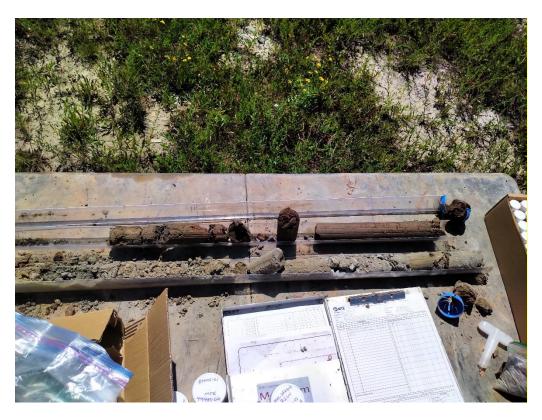
Photograph No. 5 – View of the general soil stratigraphy observed on the Site, including a clayey silt fill over a native clayey silt.

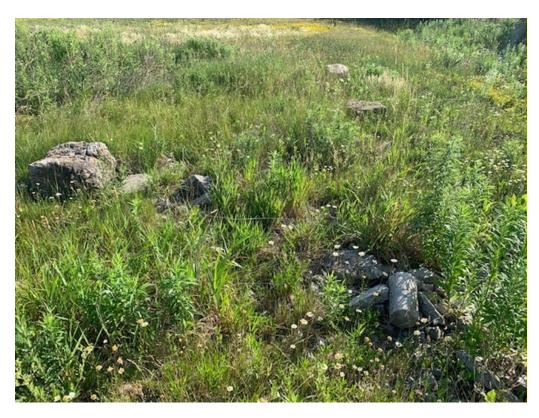
Photograph No. 6- View of the concrete debris in the southern portion of the Site and the location of borehole BH105-21.
