Phase Two Environmental Site Assessment
Concession 1, Part Lot 8, North of Dundas Street
Oakville, Ontario

Prepared For:
Argo (Joshua Creek) Limited
2173 Turnberry Road
Burlington, ON, L7M 4P8

DS Project No: 18-518-20
Date: July 25, 2018

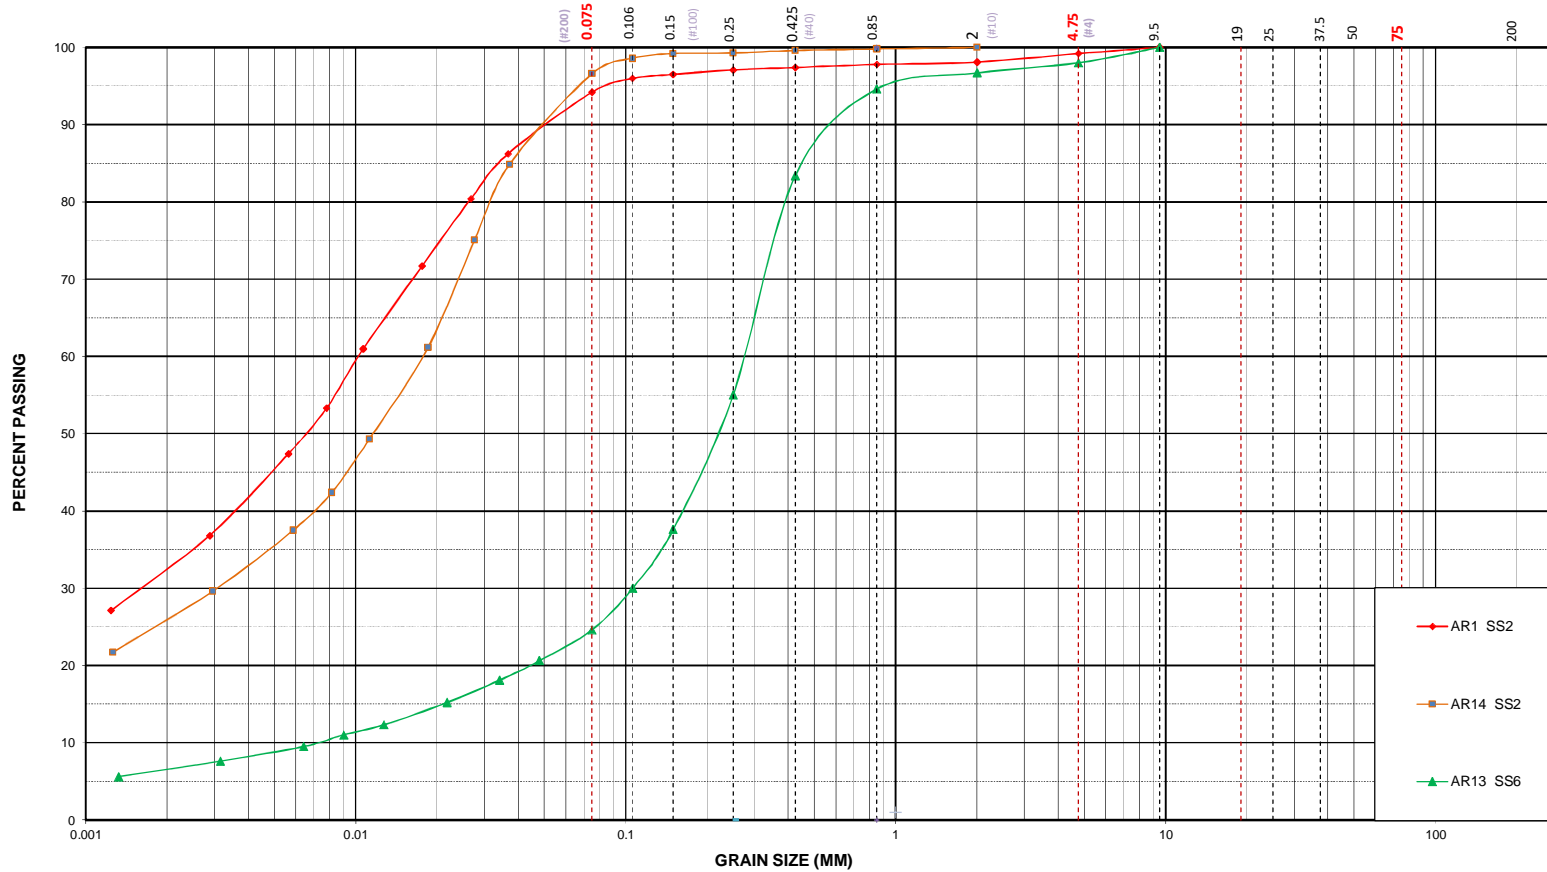
Particle Size Distribution (ASTM-D421/D422)

Silt and Clay		Sand			Gravel		Cobble +
Clay	Silt	Fine	Medium	Coarse	Fine	Coarse	
Specification and Comments:							
 Geotechnical • Environmental • Materials • Hydrogeology		Project: Diam Property ,Oakville			Project No.: 18-518-10		
		Client: ARGO			Date: March-19-2018		
		Location: Oakville, ON.			Figure No.: 1/1
