PHASE ONE **ENVIRONMENTAL SITE** **ASSESSMENT**

**217, 227 Cross Avenue and 571 Argus Road,
Oakville, Ontario**

BIGC-ENV-349B

February 17, 2021

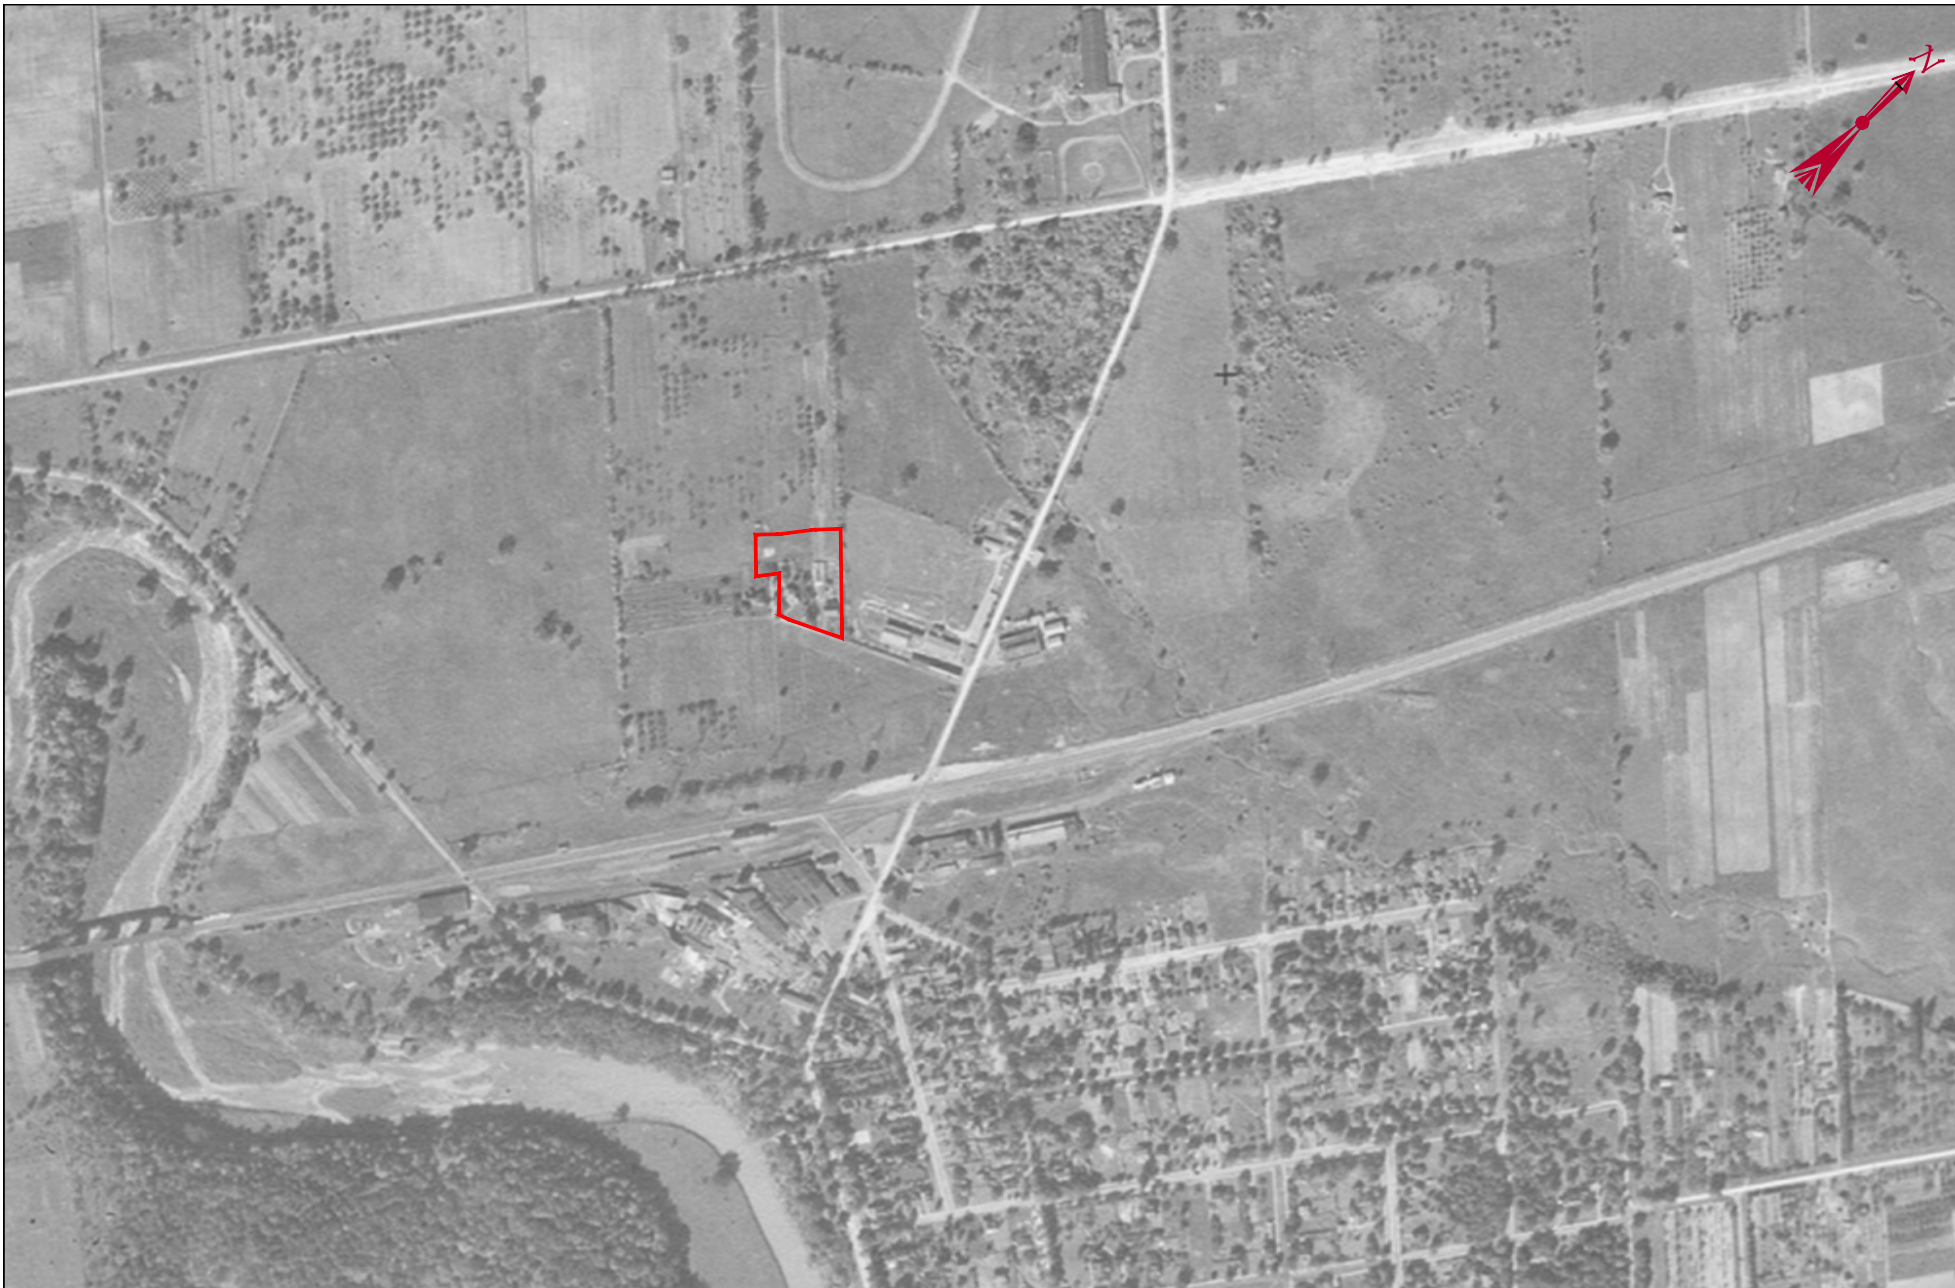
PROJECT NO. BIGC-ENV-349B	DWN. S.M.
SCALE N.T.S	CK. A.B.
DATE FEBRUARY 2021	FIG NO. F-1

**1934 AERIAL PHOTO
 PHASE ONE ESA
 217,227 CROSS AVENUE
 AND 571 ARGUS ROAD,
 OAKVILLE, ONTARIO**

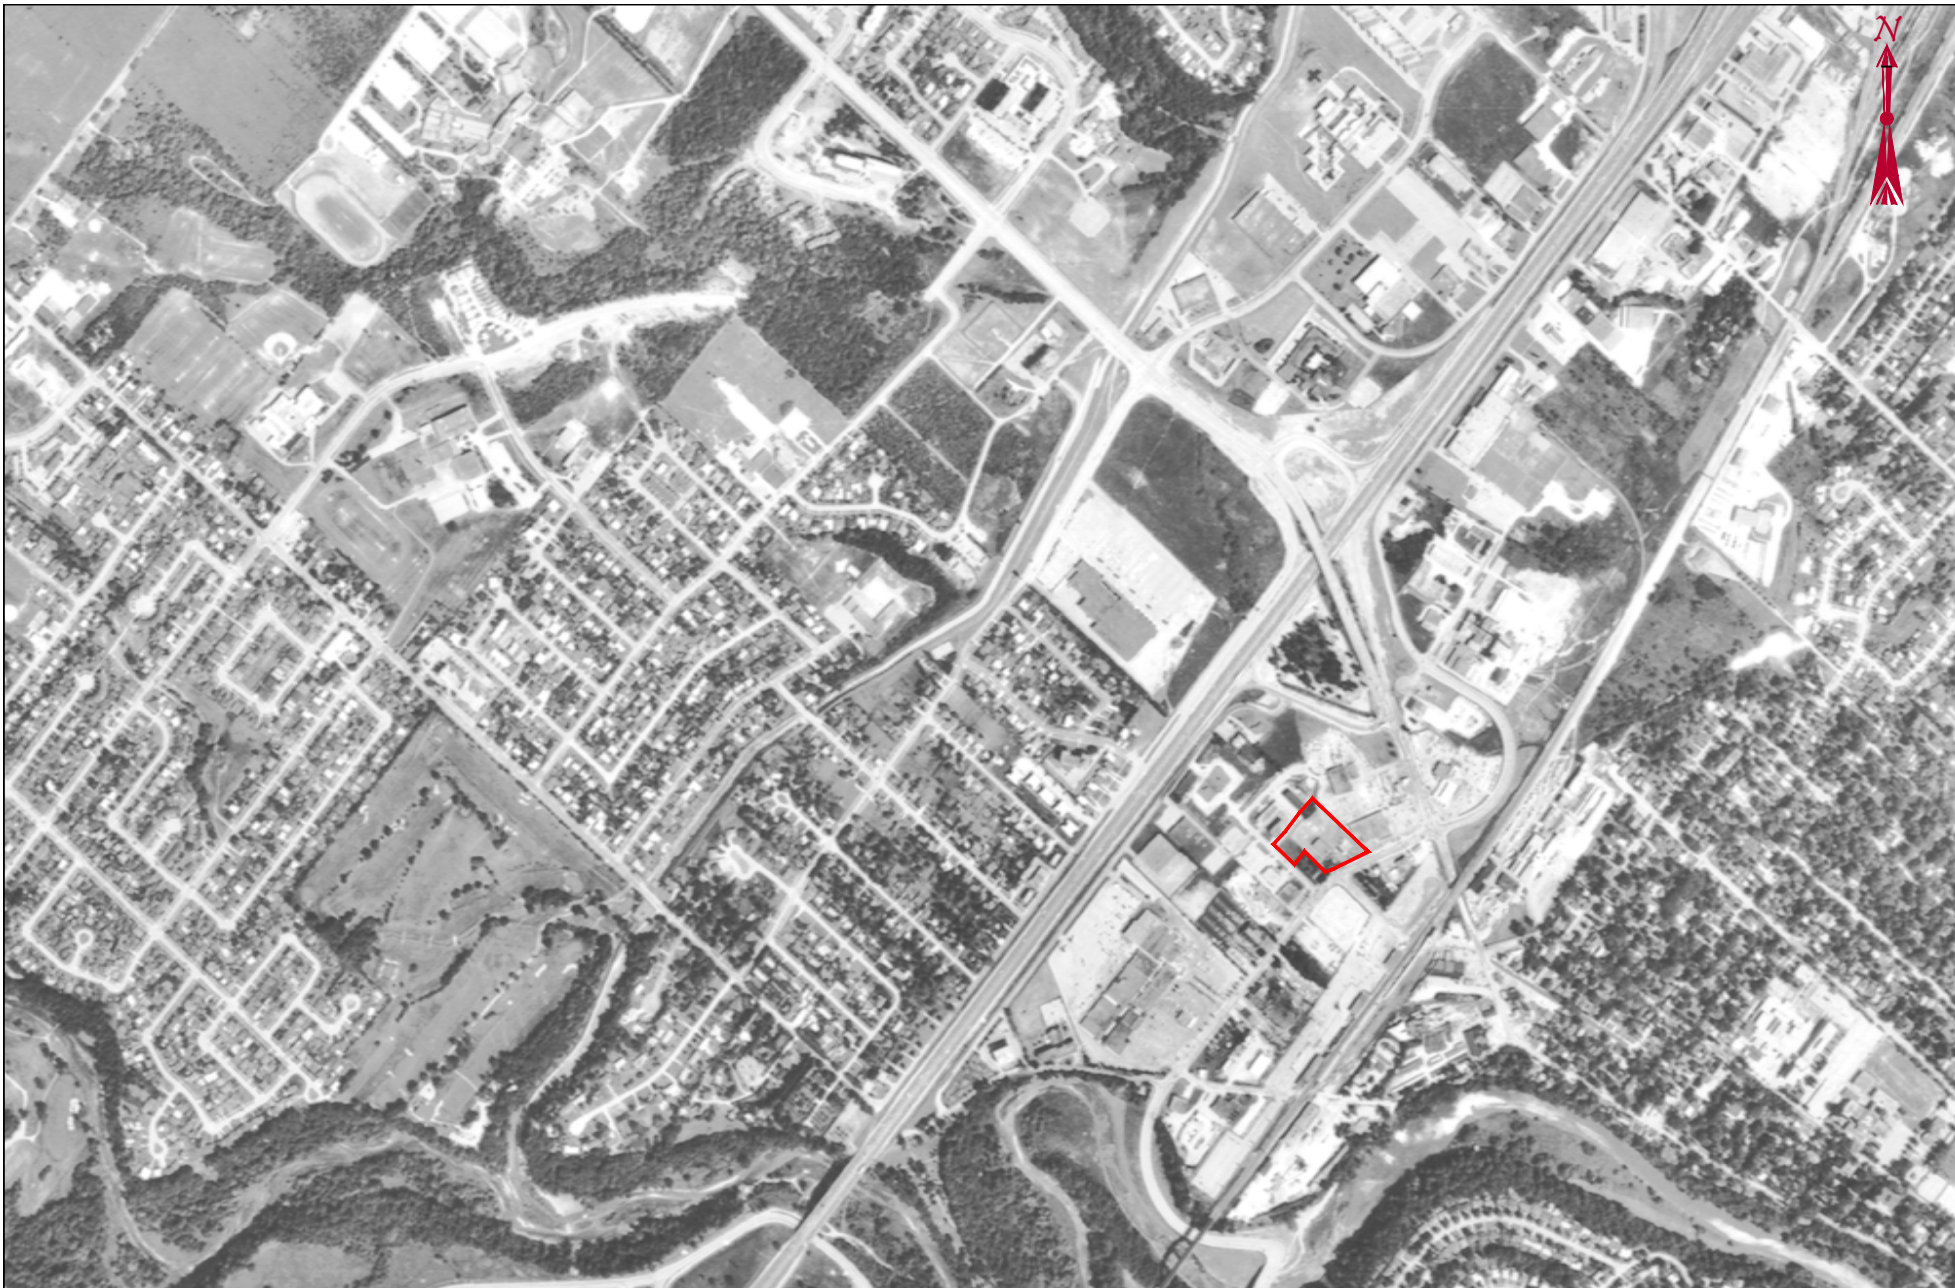
PROJECT NO. BIGC-ENV-349B	DWN. S.M.
SCALE N.T.S.	CK. A.B
DATE FEBRUARY 2021	FIG NO. F-3

**1979 AERIAL PHOTO
 PHASE ONE ESA
 217,227 CROSS AVENUE
 AND 571 ARGUS ROAD,
 OAKVILLE, ONTARIO**

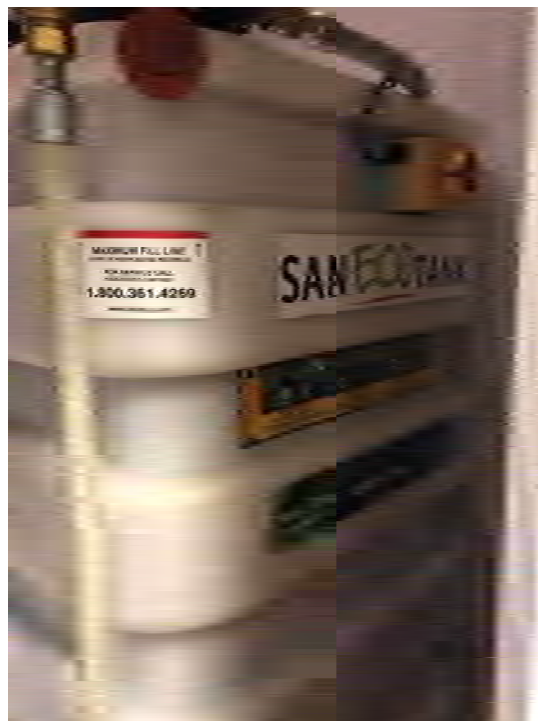
Photo 6: Grease container located on the north portion of the Site building.

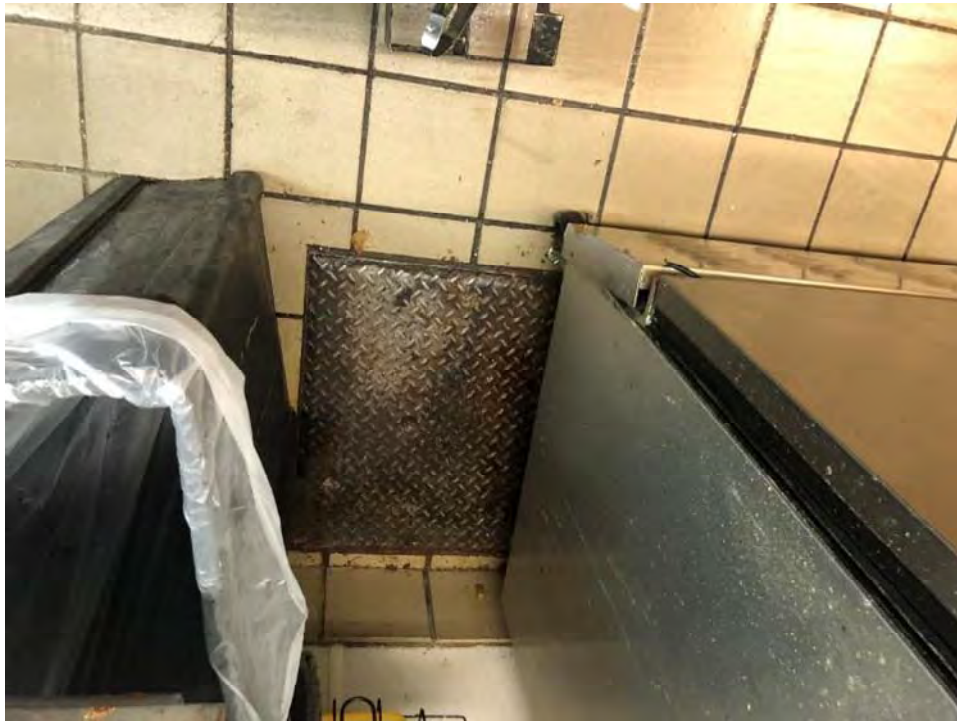
Based on the Site representative, a floor drain is located in the kitchen. On-Site at 227 Cross Avenue there was one (1) grease pit based in the northern portion of the Site building. No staining or overflow was observed. The excess oil was stored in an aboveground storage tank and disposed of weekly by an appropriate contractor. No PCAs were identified.

Photo 7: Grease trap located at the north portion of the Site building.

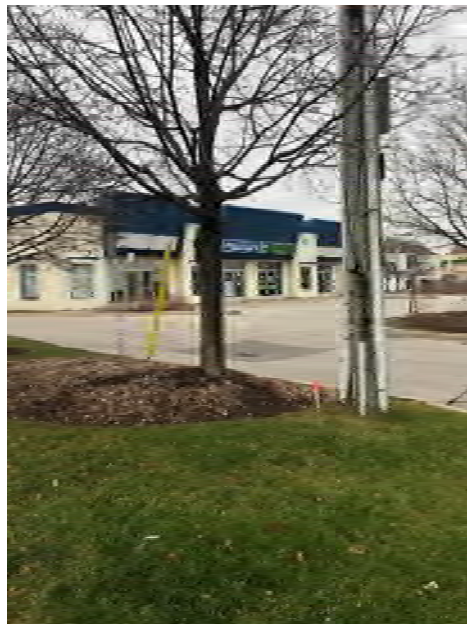
Photo 8: East adjacent commercial property (drycleaner).

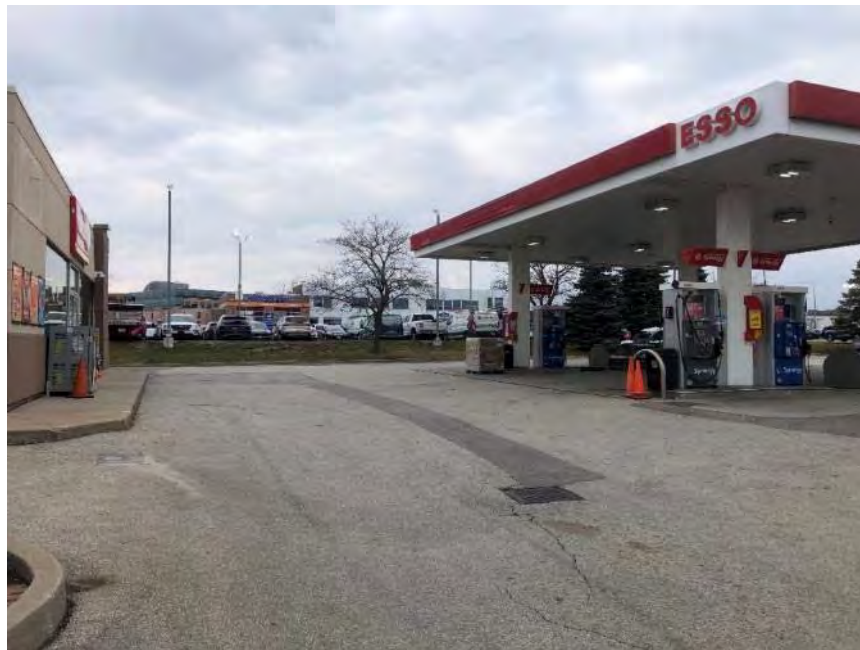
Photo 12: Gas station located 95 m northeast of the Site.
