PHASE TWO ENVIRONMENTAL SITE ASSESSMENT UPDATE

**4243 SIXTH LINE
OAKVILLE, ONTARIO**

Report AR104-23

Phase Two Environmental Site Assessment Update
4243 Sixth Line
Oakville, Ontario

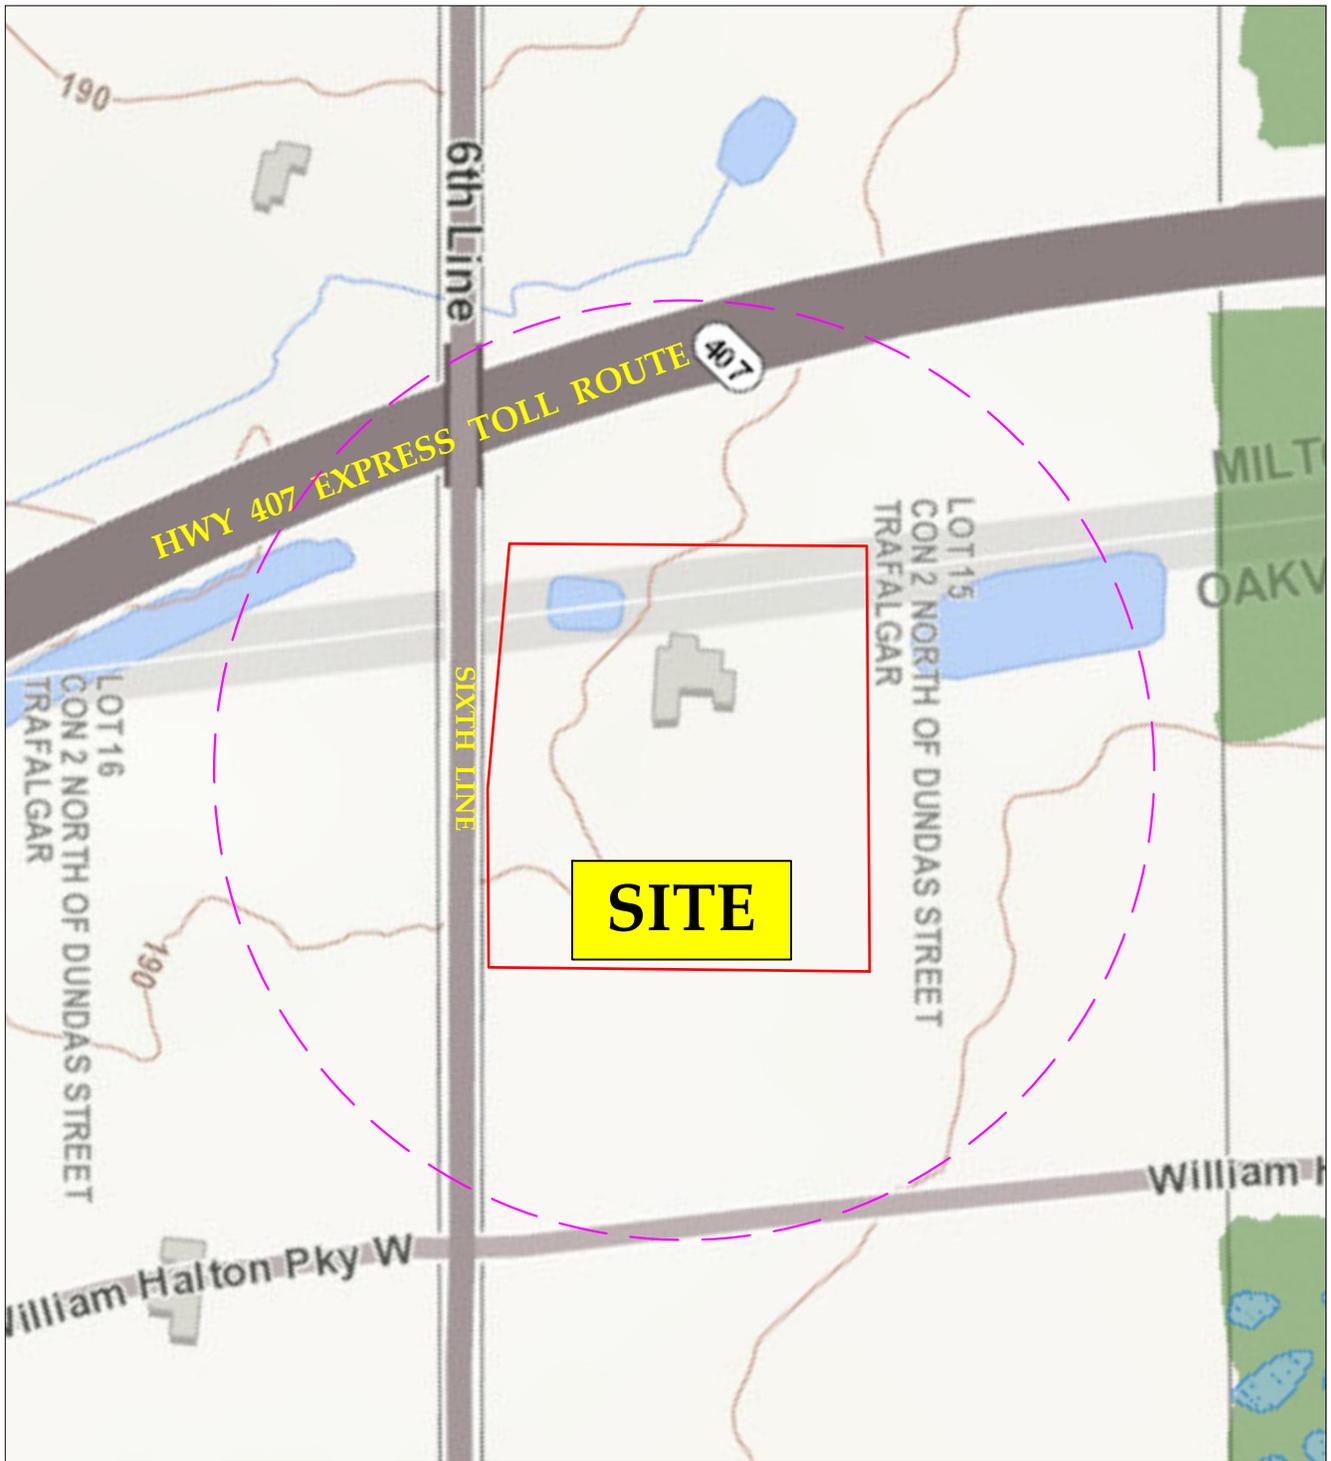
Drawing Title:	ANSI AND WATER BODIES		Scale:	 1 : 4000		
	Address:	4243 Sixth Line Oakville, Ontario		Paper Size:	8.5 x 11 in	Completed by:	EX
File Name:	AR104-23 D002	Project No.:	AR104-23	Date:	2023/06/22	Reviewed by:	MJ
						Drawing No.:	2

LEGEND		
Phase Two Property	Phase Two Study Area	Creek
Woodland	Provincially Significant Life Science ANSI	Provincially Significant Wetland Evaluated
Conservation Reserve	Provincially Significant Earth Science ANSI	Non - Provincially Significant Wetland Evaluated
Provincial Park	Unevaluated Wetland

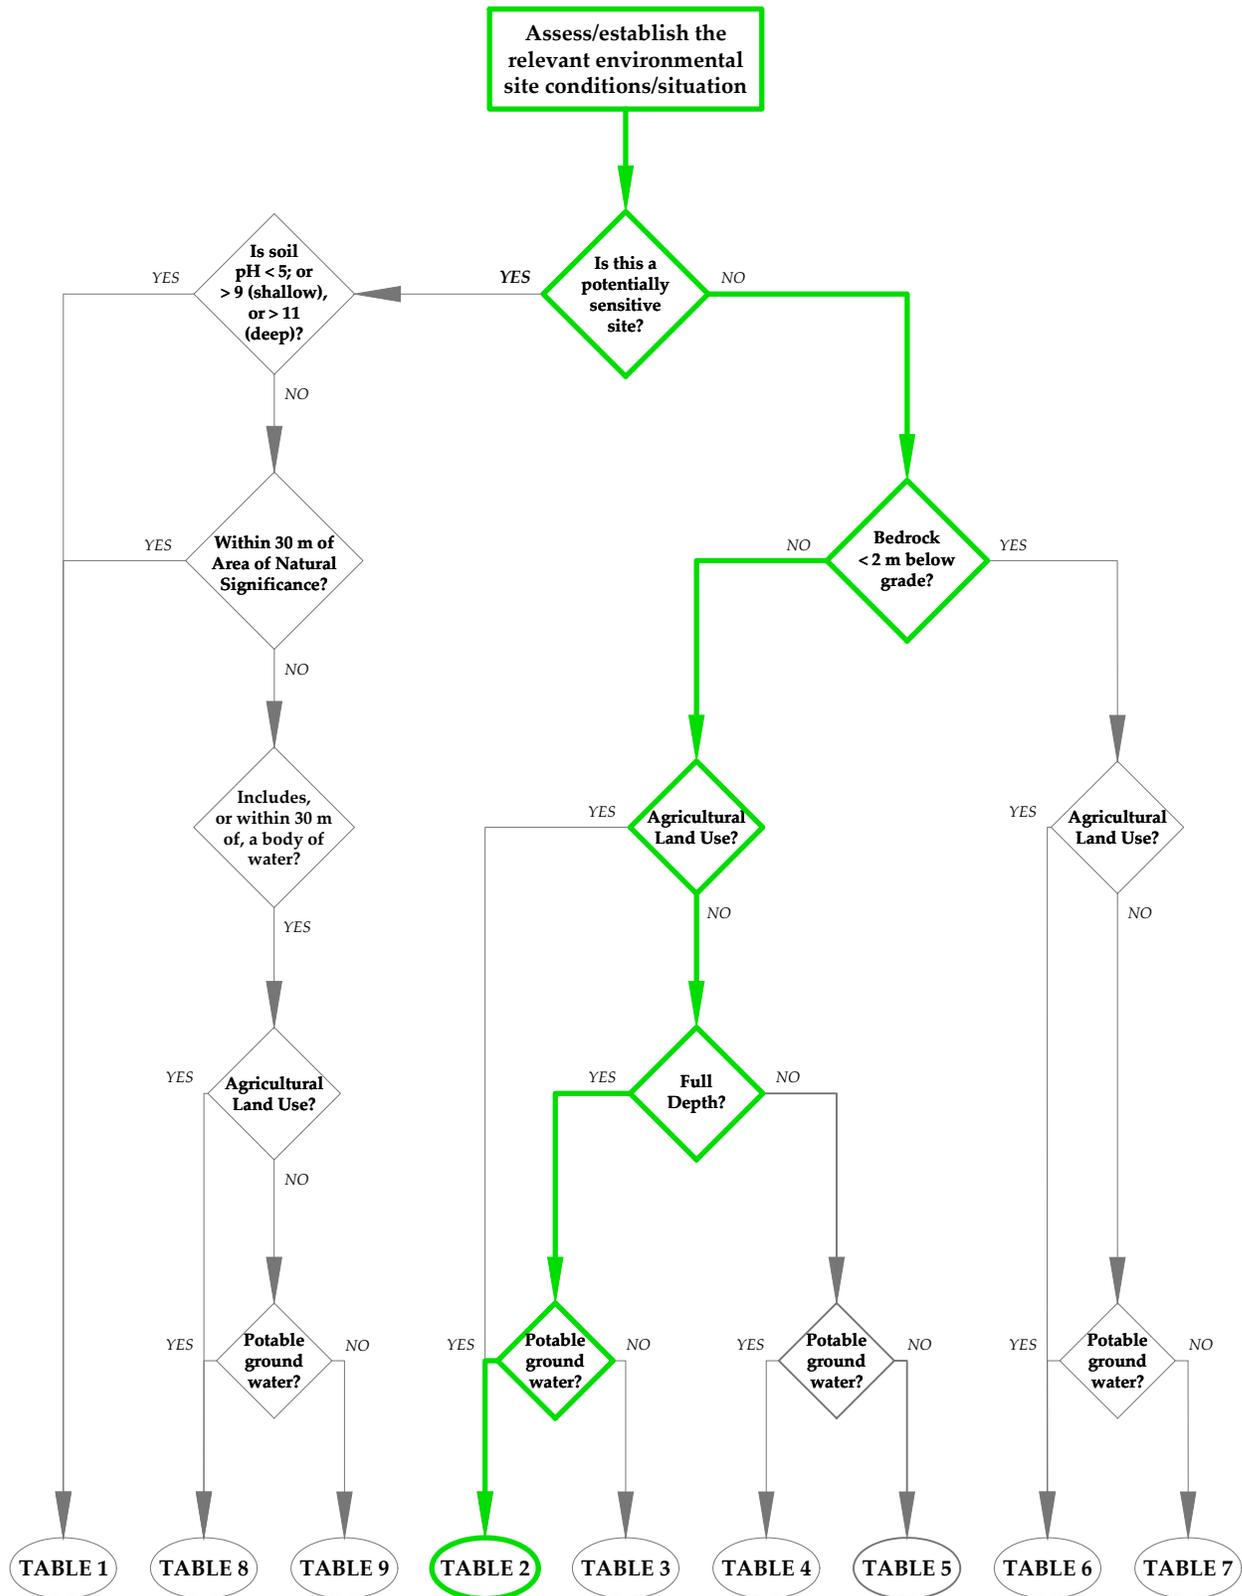
Drawing Title: SITE CONDITION STANDARDS		Scale: NOT TO SCALE		
	Address: 4243 Sixth Line Oakville, Ontario		Paper Size: 8.5 x 11 in	Completed by: EX	Figure No.: 3
	File Name: AR104-23 D003	Project No.: AR104-23	Date: 2023/06/27	Reviewed by: MJ

In accordance with Part IX, Sections 34 to 43.1, of Ontario Regulation 153/04 (as amended) under the Environmental Protection Act

<p style="text-align: center;">2.4 APPLICABLE SITE CONDITION STANDARDS</p> <p>Provide identification of and rationale for the choice of the applicable site condition standard for the phase two property, based on consideration of matters relevant to the choice, including sections 35, 41 and 43.1 of the regulation, the current and proposed use of the property, soil texture of the property and proposed grading of the property following adoption of the proposed use.</p>	<p>The Phase Two Property was assessed using the 2011 Ontario Table 2 Generic Site Condition Standards (SCS) for community/commercial/industrial (CCI) land uses in a potable groundwater condition from the MECP document <i>Soil, Groundwater and Sediment Standards for Use Under Part XV.1</i> of the 2011 EPA based on the following site-specific information:</p> <ul style="list-style-type: none"> • The site does not include, nor is within 30 m of, an area of natural significance; and there are no water bodies within 30 m of the subject site, as shown in <i>Drawing 2</i>. • The Phase Two Property was serviced by private drinking water supply derived from potable well. • Soils beneath the Site are near neutral in pH. • The depth of the soil exceeds 2 meters beneath the property. • A representative soil grain size analysis completed by <i>Bureau Veritas Laboratories</i> classified the native clayey silt till (loam) stratum underlying the site as fine-textured, and based on field observations of the subsurface stratigraphy, the QP has inferred that more than two-thirds of the soils investigated at the site were fine-textured. <p>Selection of the applicable SCS is also shown on <i>Drawing 3</i>.</p>

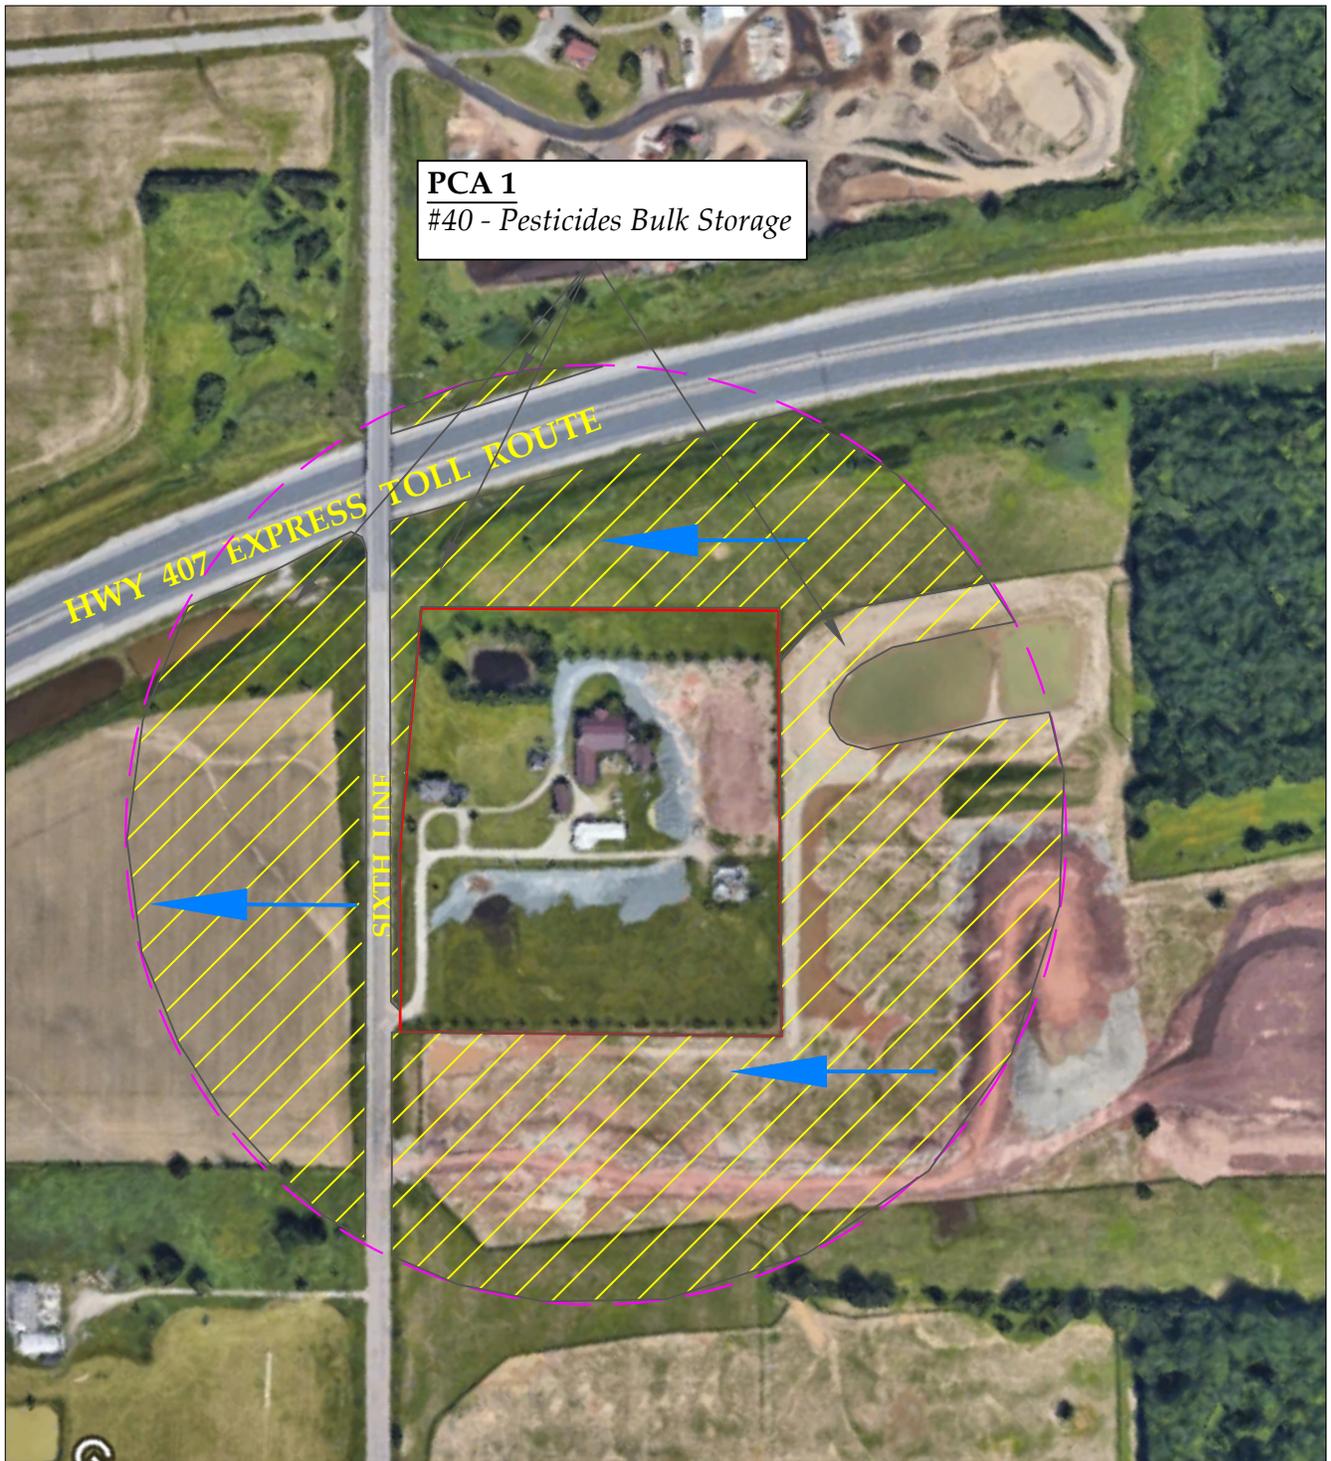
PCA 1
#40 - Pesticides Bulk Storage

<p>ii. an overview of the field investigation of each medium for which sampling and analysis were done.</p>	<p>Locations of representative samples of soil and groundwater media were based on the APECs identified in the previous Phase I ESA. The subsurface geological conditions were established from visual observations and soil samples collected during the borehole drilling program. Soil and groundwater quality data was obtained from visual and olfactory observations, field screening methods, and laboratory analytical data.</p>
<p>4.3 PHASE ONE CONCEPTUAL SITE MODEL</p> <p>Provide a description of the phase one conceptual site model prepared as part of the phase one environmental site assessment report and of relevant subsequently acquired information.</p>	<p>The Phase One Conceptual Site Model (CSM) was prepared based on historical records review, site reconnaissance, building inspection, and interviews with knowledgeable persons collected as part of the preliminary Phase I ESA.</p> <p>There were five on-site PCAs identified on the Phase Two Property of note within the Phase One Study Area. All five of the PCAs (PCAs 1 through 5) had corresponding APECs that could potentially affect the soil and groundwater of the Phase Two Property. Details of the PCAs and APECs are shown on <i>Drawings 4 and 5</i>.</p>

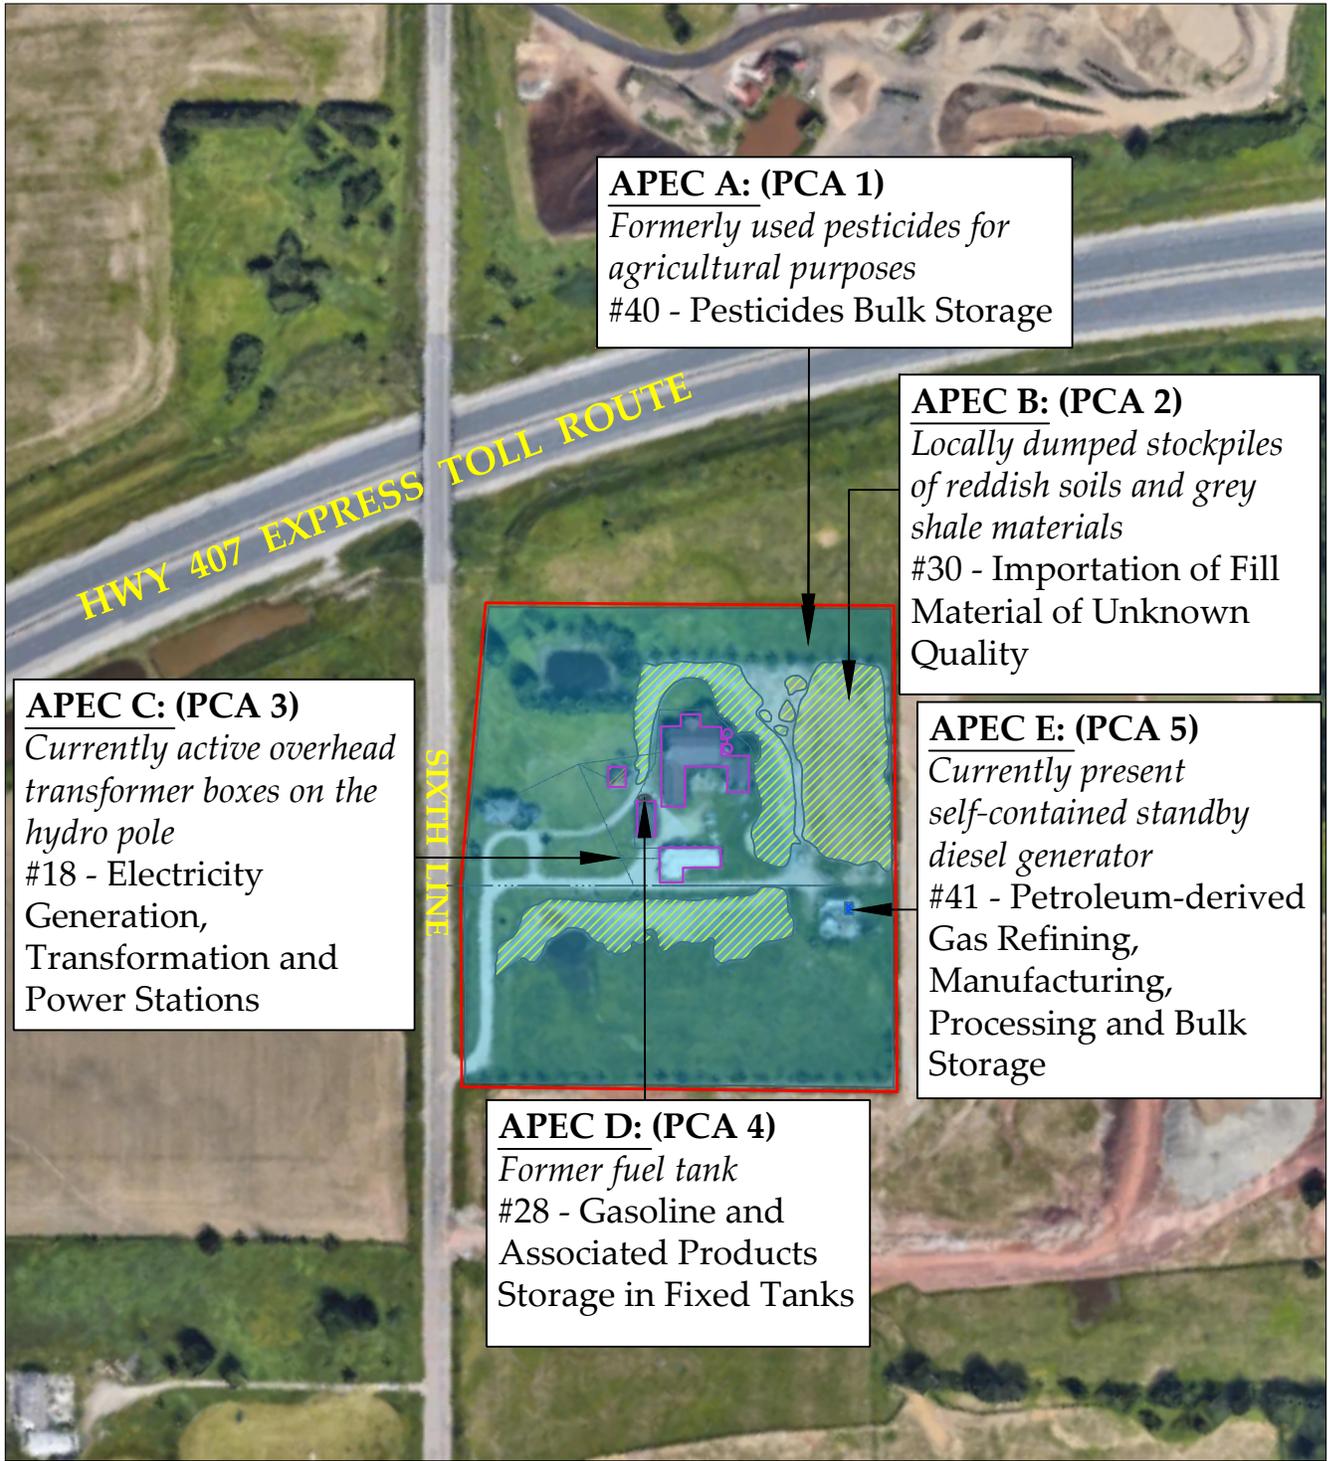
Drawing No.:
5

APEC A: (PCA 1)
Formerly used pesticides for agricultural purposes
 #40 - Pesticides Bulk Storage

APEC B: (PCA 2)
Locally dumped stockpiles of reddish soils and grey shale materials
 #30 - Importation of Fill Material of Unknown Quality

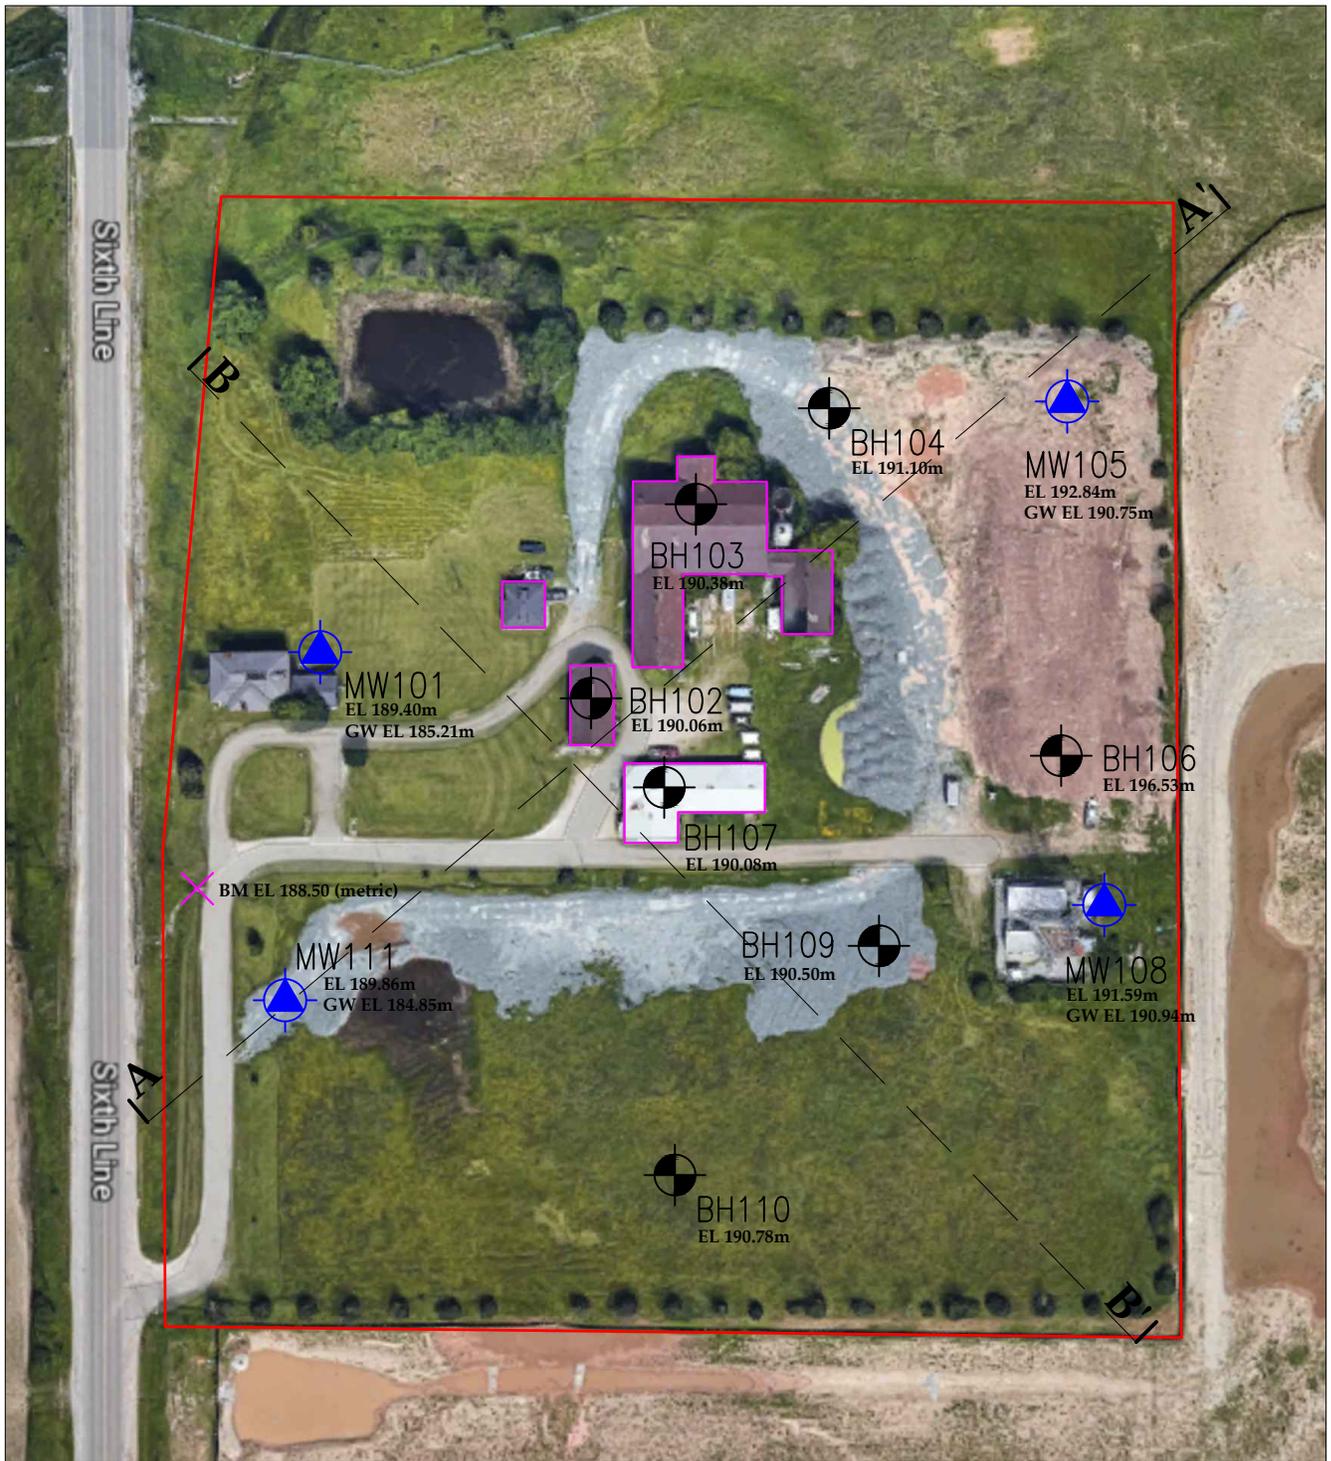
6

- Phase Two Property
- Demolished Buildings
- Sampled Borehole
- Groundwater Monitoring Well

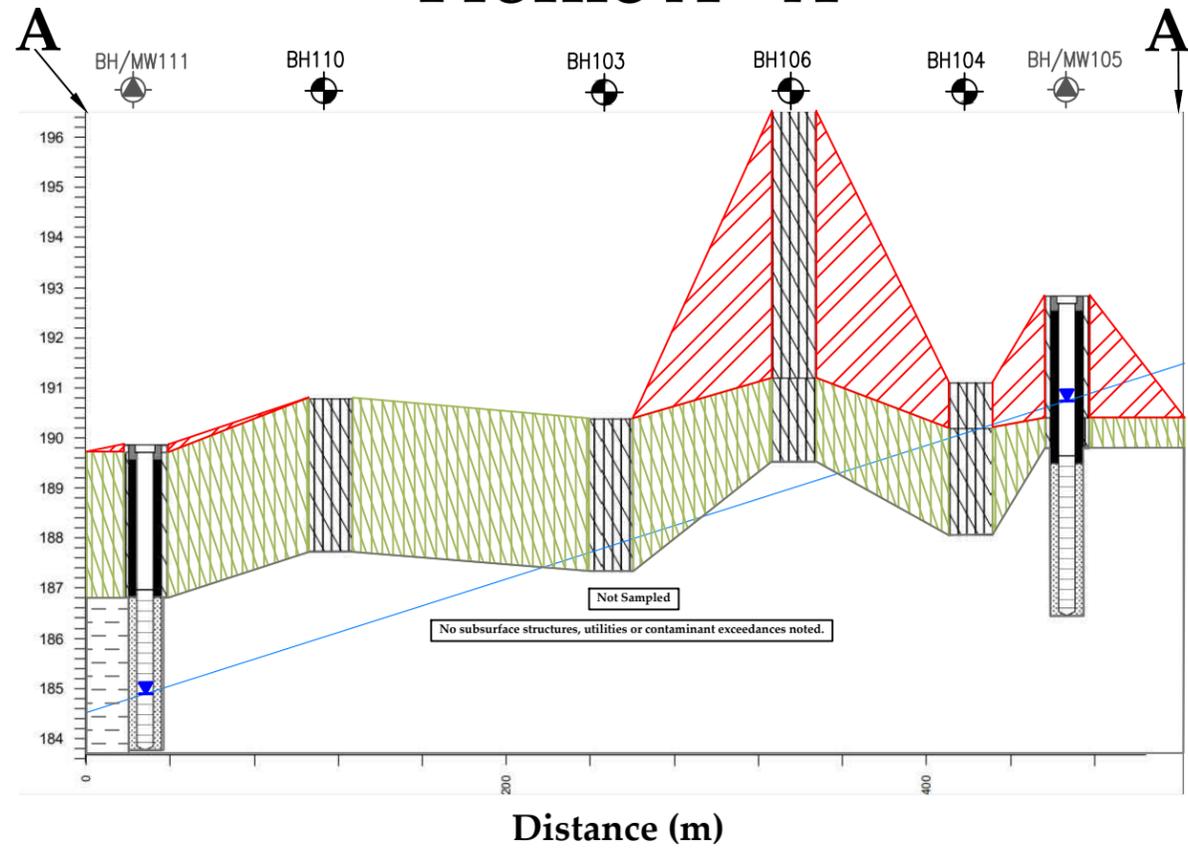
Profile A - A'

- Property Limits
- Demolished Buildings
- Sampled Borehole
- Sampled Borehole with Monitoring Well
- Locally Dumped Stockpile of Reddish Soil and Shale
- Topsoil
- Clayey Silt Till
- Inferred Groundwater Level
- ▼ Measured Groundwater Level
- Monitoring Well Construction

<p>to collect soil samples, and</p>	<p>moisture content, colour, and visual and olfactory evidence of impact (if any, including hydrocarbon staining and odours), and were split into portions that were divided for field logging in separate clear plastic bags or laboratory analysis. The selected soil samples were then placed in laboratory-prepared containers, including glass vials pre-charged with methanol preservative where appropriate, and kept cool prior to delivery to the laboratory.</p>
<p>ii. a geological description of soil and sediment cores and samples, based on the finalized field logs for each monitoring well, test hole or intrusive investigation point.</p>	<p>The observed stratigraphy from the ground surface to the deepest aquifer investigated during the Phase Two ESA generally comprised clayey silt fill (0 m to 5.3 m), which were underlain by clayey silt till (0 m to 7.0 m). Details of the soil stratigraphy are noted on the <i>Borehole Logs in Appendix B</i> and the Cross-Section Profiles in <i>Drawing 7</i>. Based upon a representative soil grain size analysis completed by <i>Bureau Veritas Laboratories</i> that classified the clayey silt till/loam stratum as fine-textured, as well as field observations, more than two-thirds of the soils investigated at the site were fine-textured.</p> <p>Please refer to <i>Drawing 7</i> and <i>Borehole Logs in Appendix B</i>.</p>

C. subsurface utilities.	
<p>4. Provide, where contaminants on, in or under the phase two property are present at concentrations greater than the applicable site condition standard, one or more cross-sections showing,</p> <p>i. the lateral and vertical distribution of a contaminant in each area where the contaminant is present at a concentration greater than the applicable site condition standard in soil, ground water and sediment,</p>	Not applicable.
<p>ii. approximate depth to water table in each area referred to in subparagraph i,</p>	Please refer to <i>Drawings 7 and 8</i> .
<p>iii. stratigraphy from ground surface to the deepest aquifer or aquitard investigated, and</p>	<p>The observed stratigraphy from the ground surface to the deepest aquifer investigated during the Phase Two ESA generally comprised clayey silt fill with some shale (0 m to 5.3 m), which were underlain by sandy silt till (0 m to 7.0 m). Details of the soil stratigraphy are noted on the <i>Borehole Logs</i> in <i>Appendix B</i> and the Cross-Section Profiles in <i>Drawing 7</i>.</p>

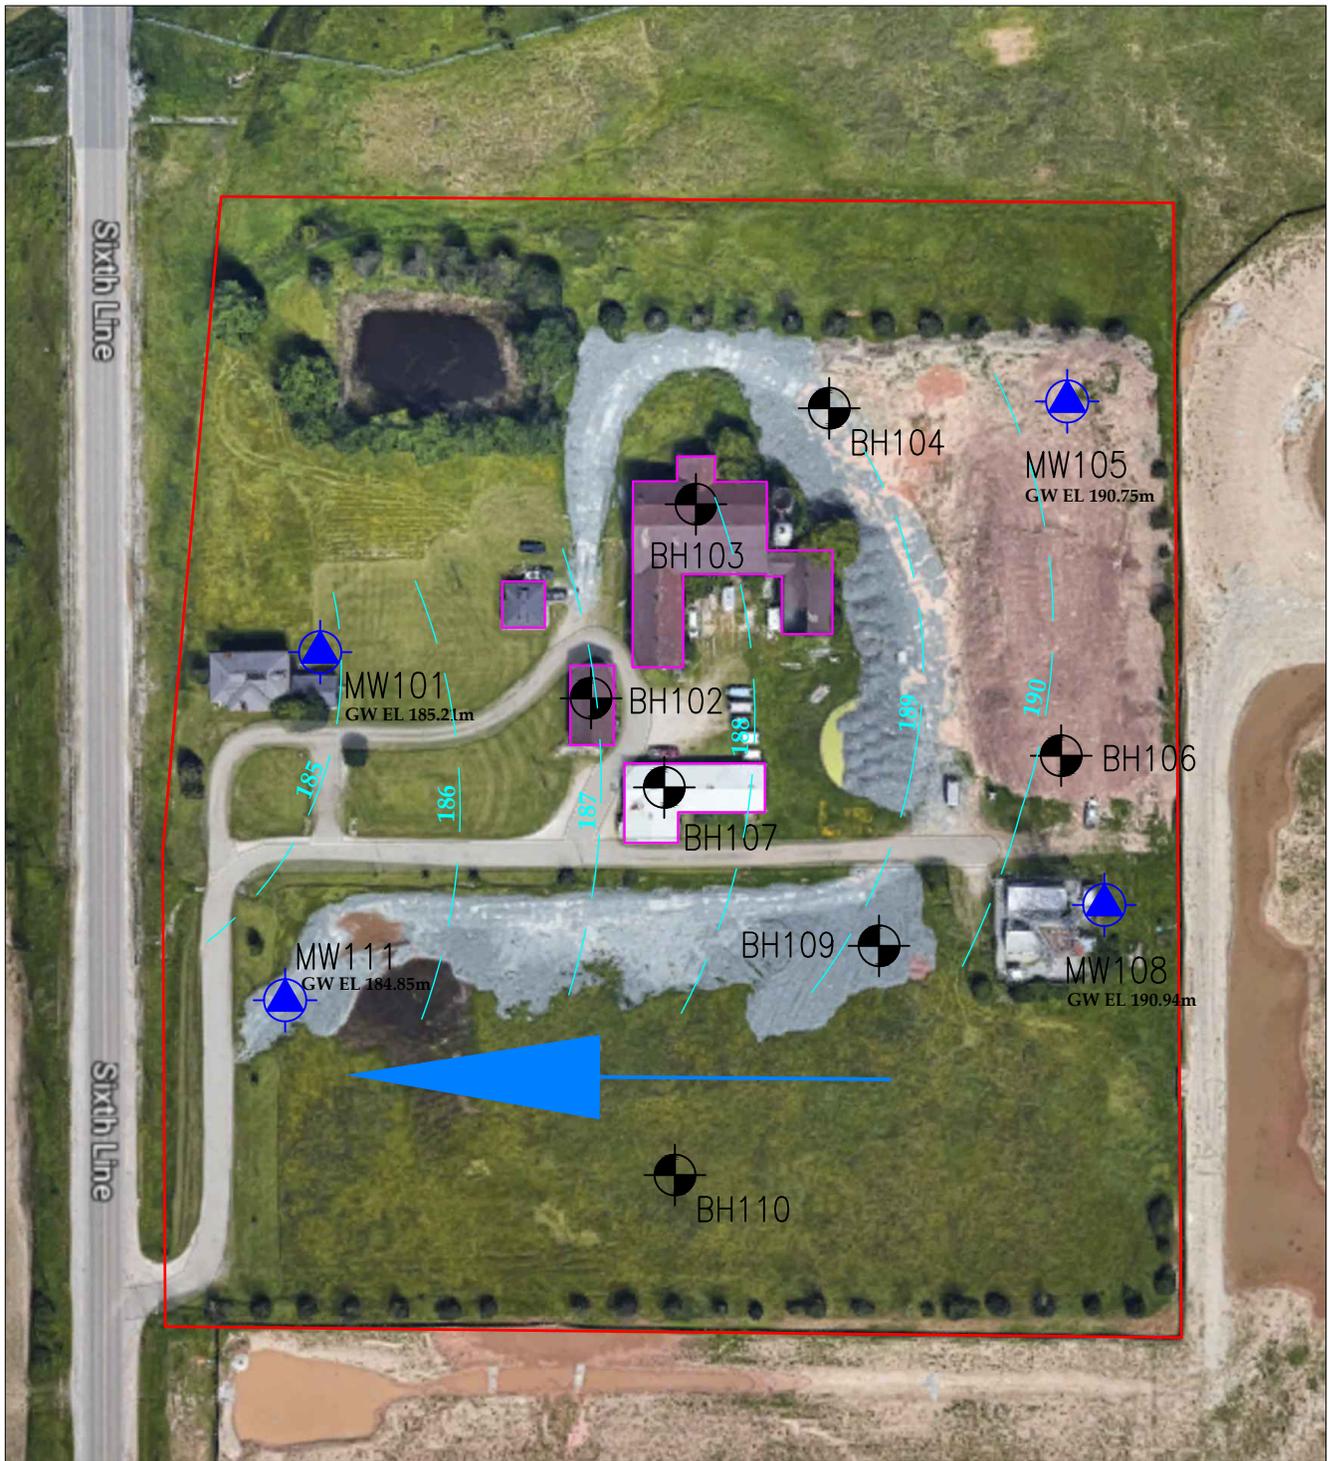
8

- Phase Two Property
- Demolished Buildings
- - - Ground Water Elevation Contours
- Groundwater Elevation (MASL)

<p>6.3 GROUNDWATER HYDRAULIC GRADIENTS</p> <p>i. a description of the horizontal hydraulic gradient for each aquifer investigated, including minimum, maximum and average horizontal hydraulic gradients, and</p>	<p>The results of the ground water monitoring indicated that the primary near surface water table resides within the clayey silt till/loam stratum.</p> <p>Please refer to <i>Drawings 7 and 8</i>.</p> <p>No visual, olfactory or analytical evidence of impact was noted in the ground water, therefore only the shallow aquifer warranted investigation.</p> <p>The average lateral hydraulic gradient is 0.035 m/m. Based on grain size analyses, the hydraulic conductivity of the native loam soil in which the water table resides is estimated to be of the order of 10^{-6} m/s.</p>
<p>ii. a description of vertical hydraulic gradients in aquifers where a contaminant is present at a concentration greater than the applicable site condition standard for the contaminant, including minimum, maximum and average vertical hydraulic gradients.</p>	<p>Not applicable – no groundwater impact was noted.</p>

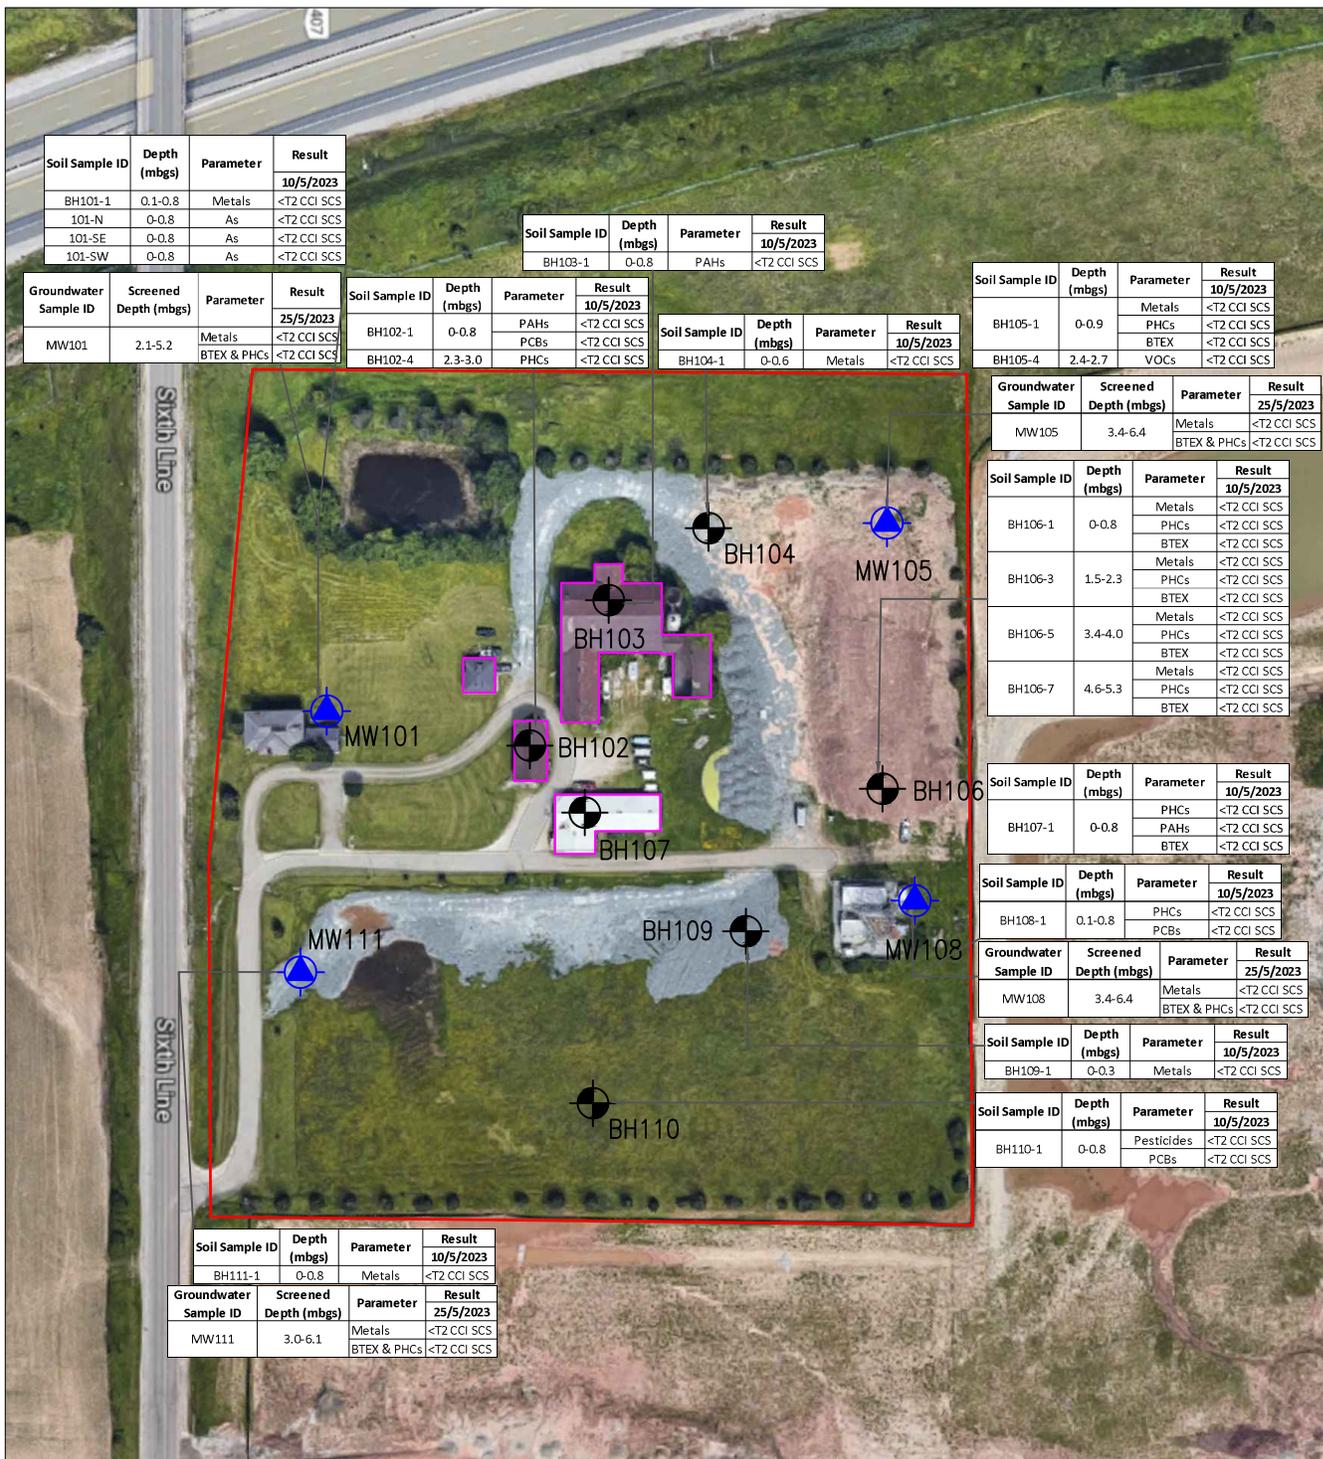
Soil Sample ID	Depth (mbgs)	Parameter	Result
BH101-1	0.1-0.8	Metals	<T2 CCI SCS 10/5/2023
101-N	0-0.8	As	<T2 CCI SCS
101-SE	0-0.8	As	<T2 CCI SCS
101-SW	0-0.8	As	<T2 CCI SCS

Soil Sample ID	Depth (mbgs)	Parameter	Result
BH103-1	0-0.8	PAHs	<T2 CCI SCS

<p>7.0 CONCLUSIONS</p> <p>Provide a summary of the information about the following:</p> <p>i. the location and concentration of contaminants in the land or water on, in or under the phase two property,</p>	<p>In summary, the measured contaminant concentrations in the soil and groundwater samples analyzed complied with applicable <i>Ontario Regulation 153/04</i> Table 2 site condition standards (SCS) for commercial lands having fine-textured soils in a potable groundwater condition.</p> <p>Based on these findings, no further environmental investigation is presently warranted. However, we note that there is a stockpile of locally dumped fill materials on the premises which will require testing and documentation in accordance with <i>Ontario Regulation 406/19</i> if the material is to be moved off the premises for reuse or disposal offsite.</p> <p>Finally, if the monitoring wells are not required for further testing, they should be decommissioned in accordance with <i>Ontario Regulation 903</i> provisions.</p>
