**PHASE ONE**  
**ENVIRONMENTAL SITE**  
**ASSESSMENT**

**1280 Dundas Street West, Oakville, Ontario**

BIGC-ENV-185F

January 12, 2022

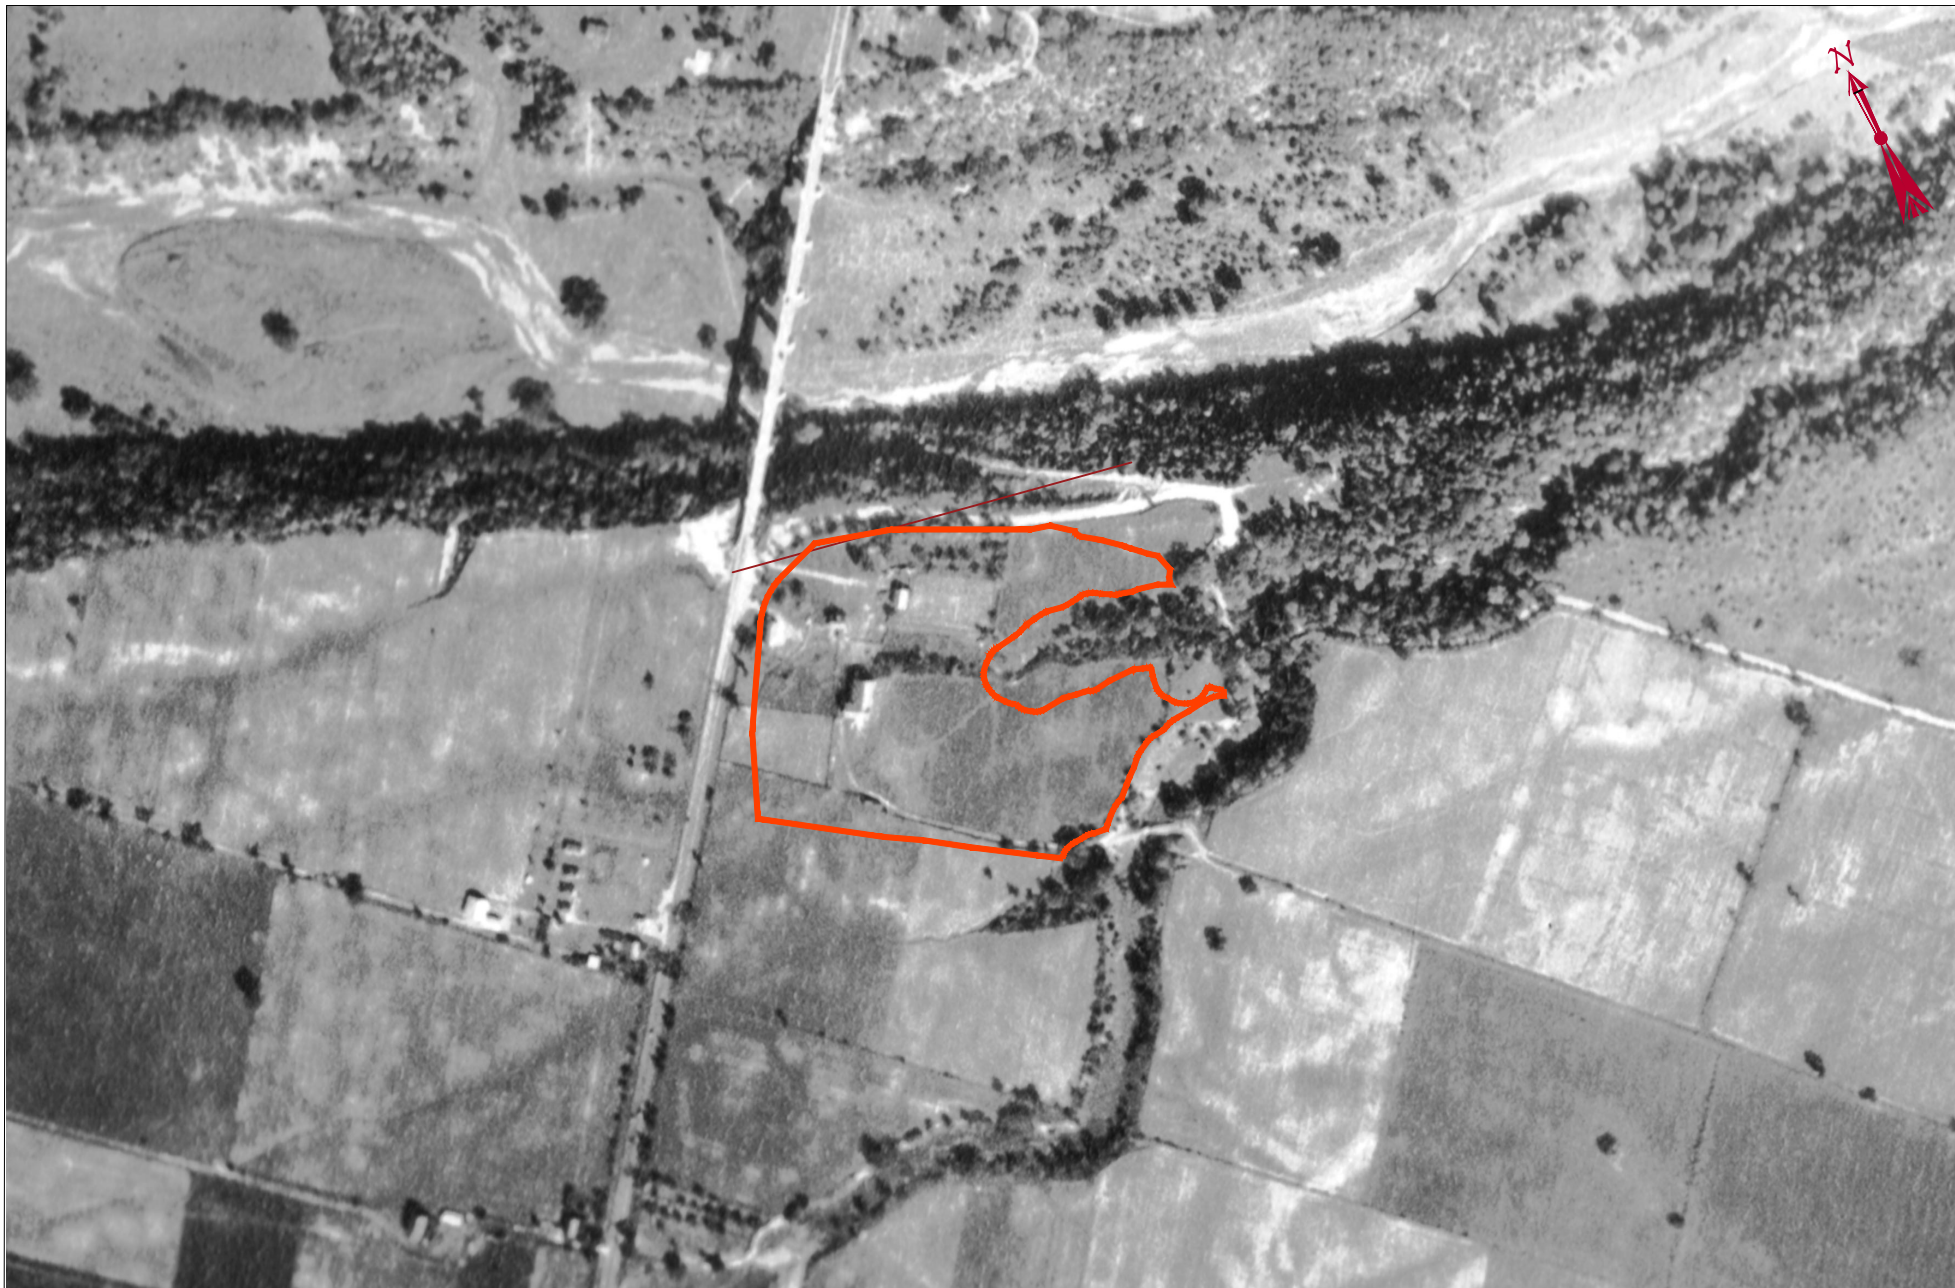
<b>PROJECT NO.</b> BIGC-ENV-185F	<b>DWN.</b> L.C.K.
<b>SCALE</b> NOT TO SCALE	<b>CK.</b> E.L.
<b>DATE</b> DECEMBER 2021	<b>FIG NO.</b> H-1

IMAGERY SOURCED FROM LGI COPY SERVICES, DATED 1934

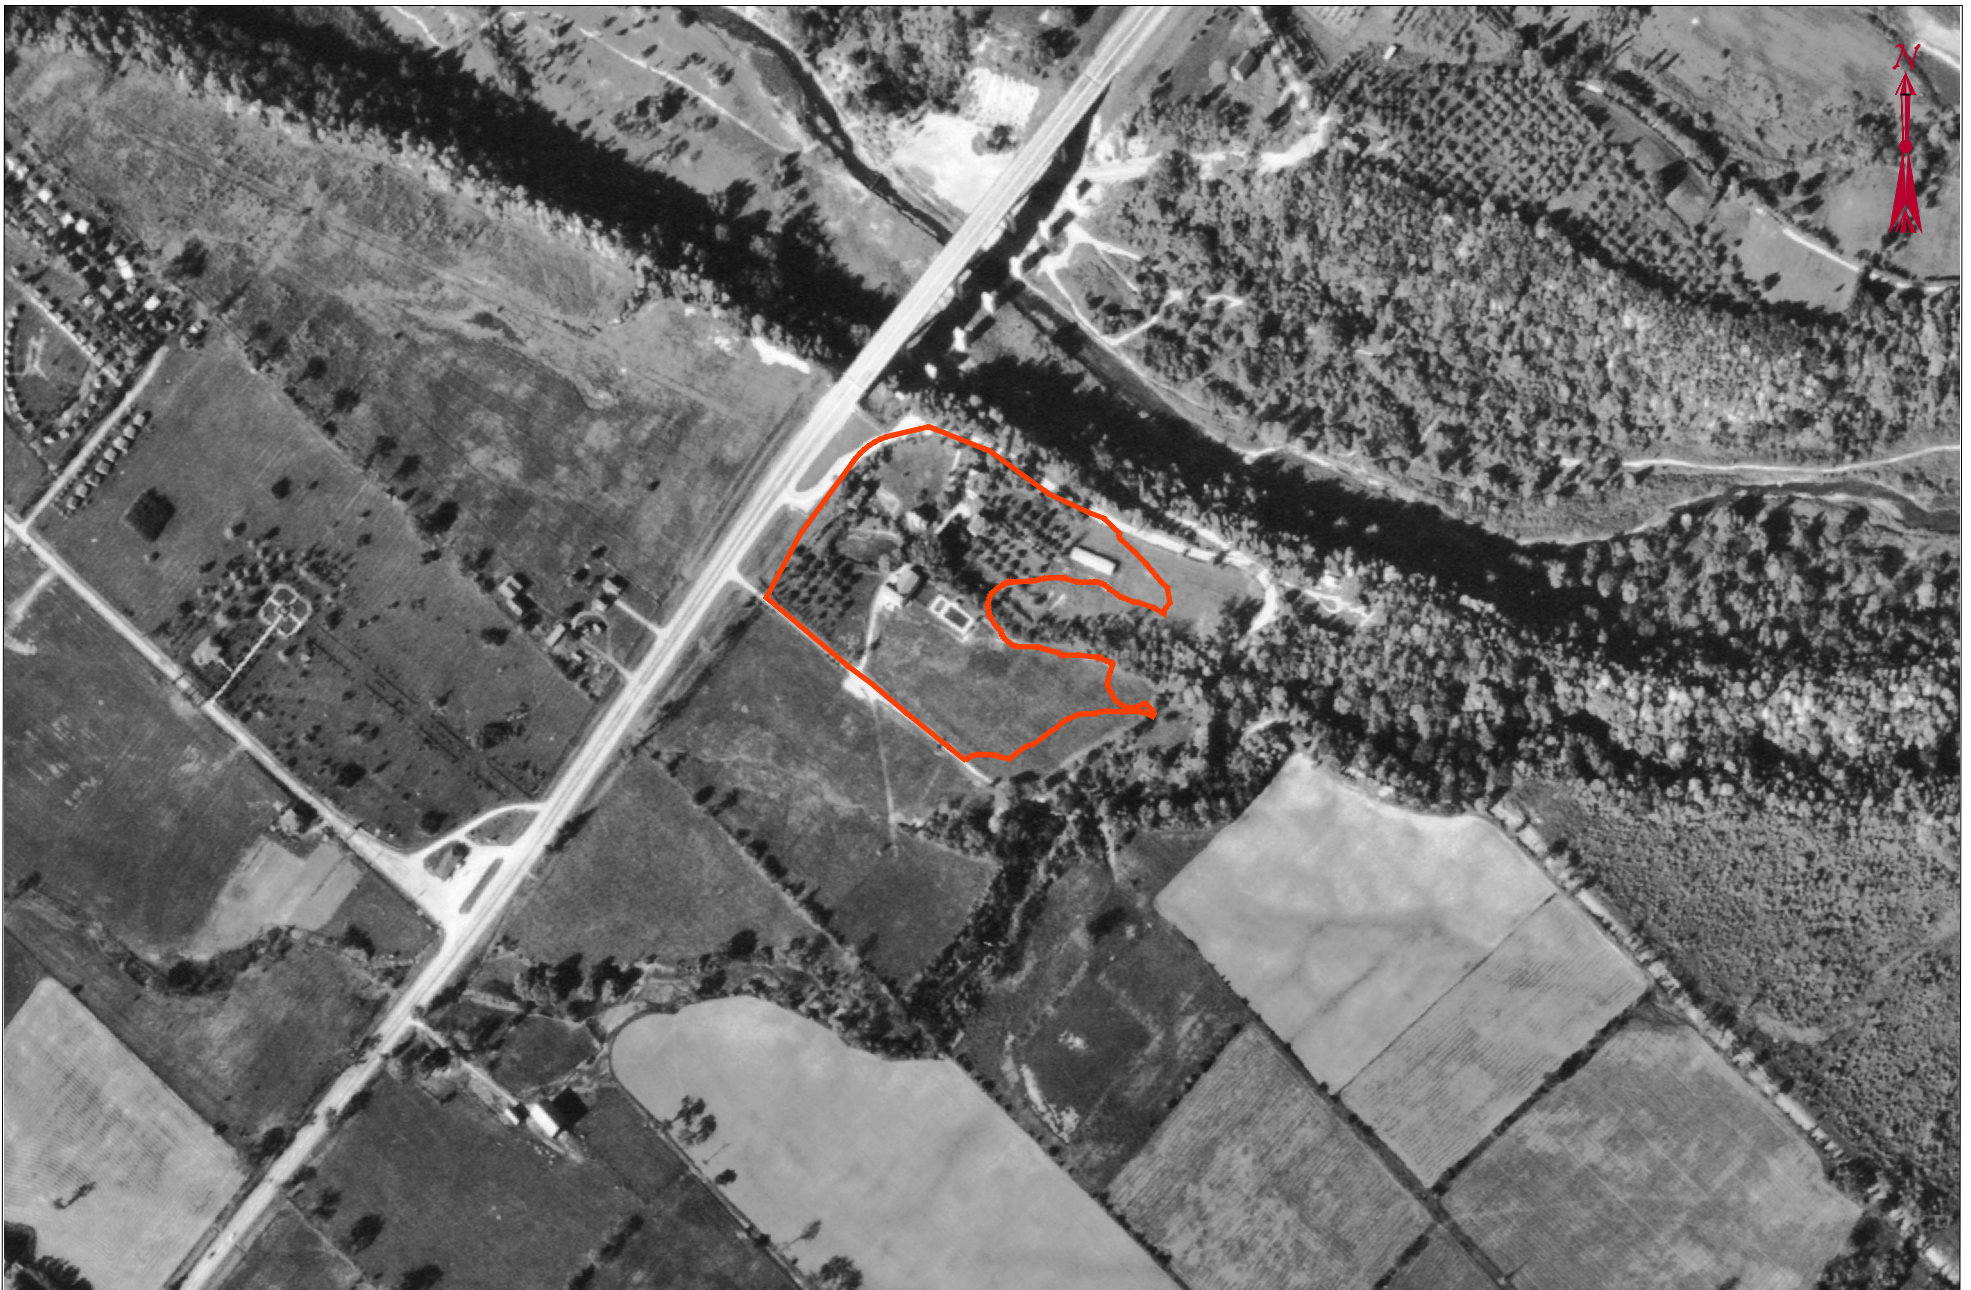
PROJECT NO. BIGC-ENV-185F	DWN. L.C.K.
SCALE NOT TO SCALE	CK. E.L.
DATE DECEMBER 2021	FIG NO. H-2

IMAGERY SOURCED FROM LGI COPY SERVICES, DATED 1965

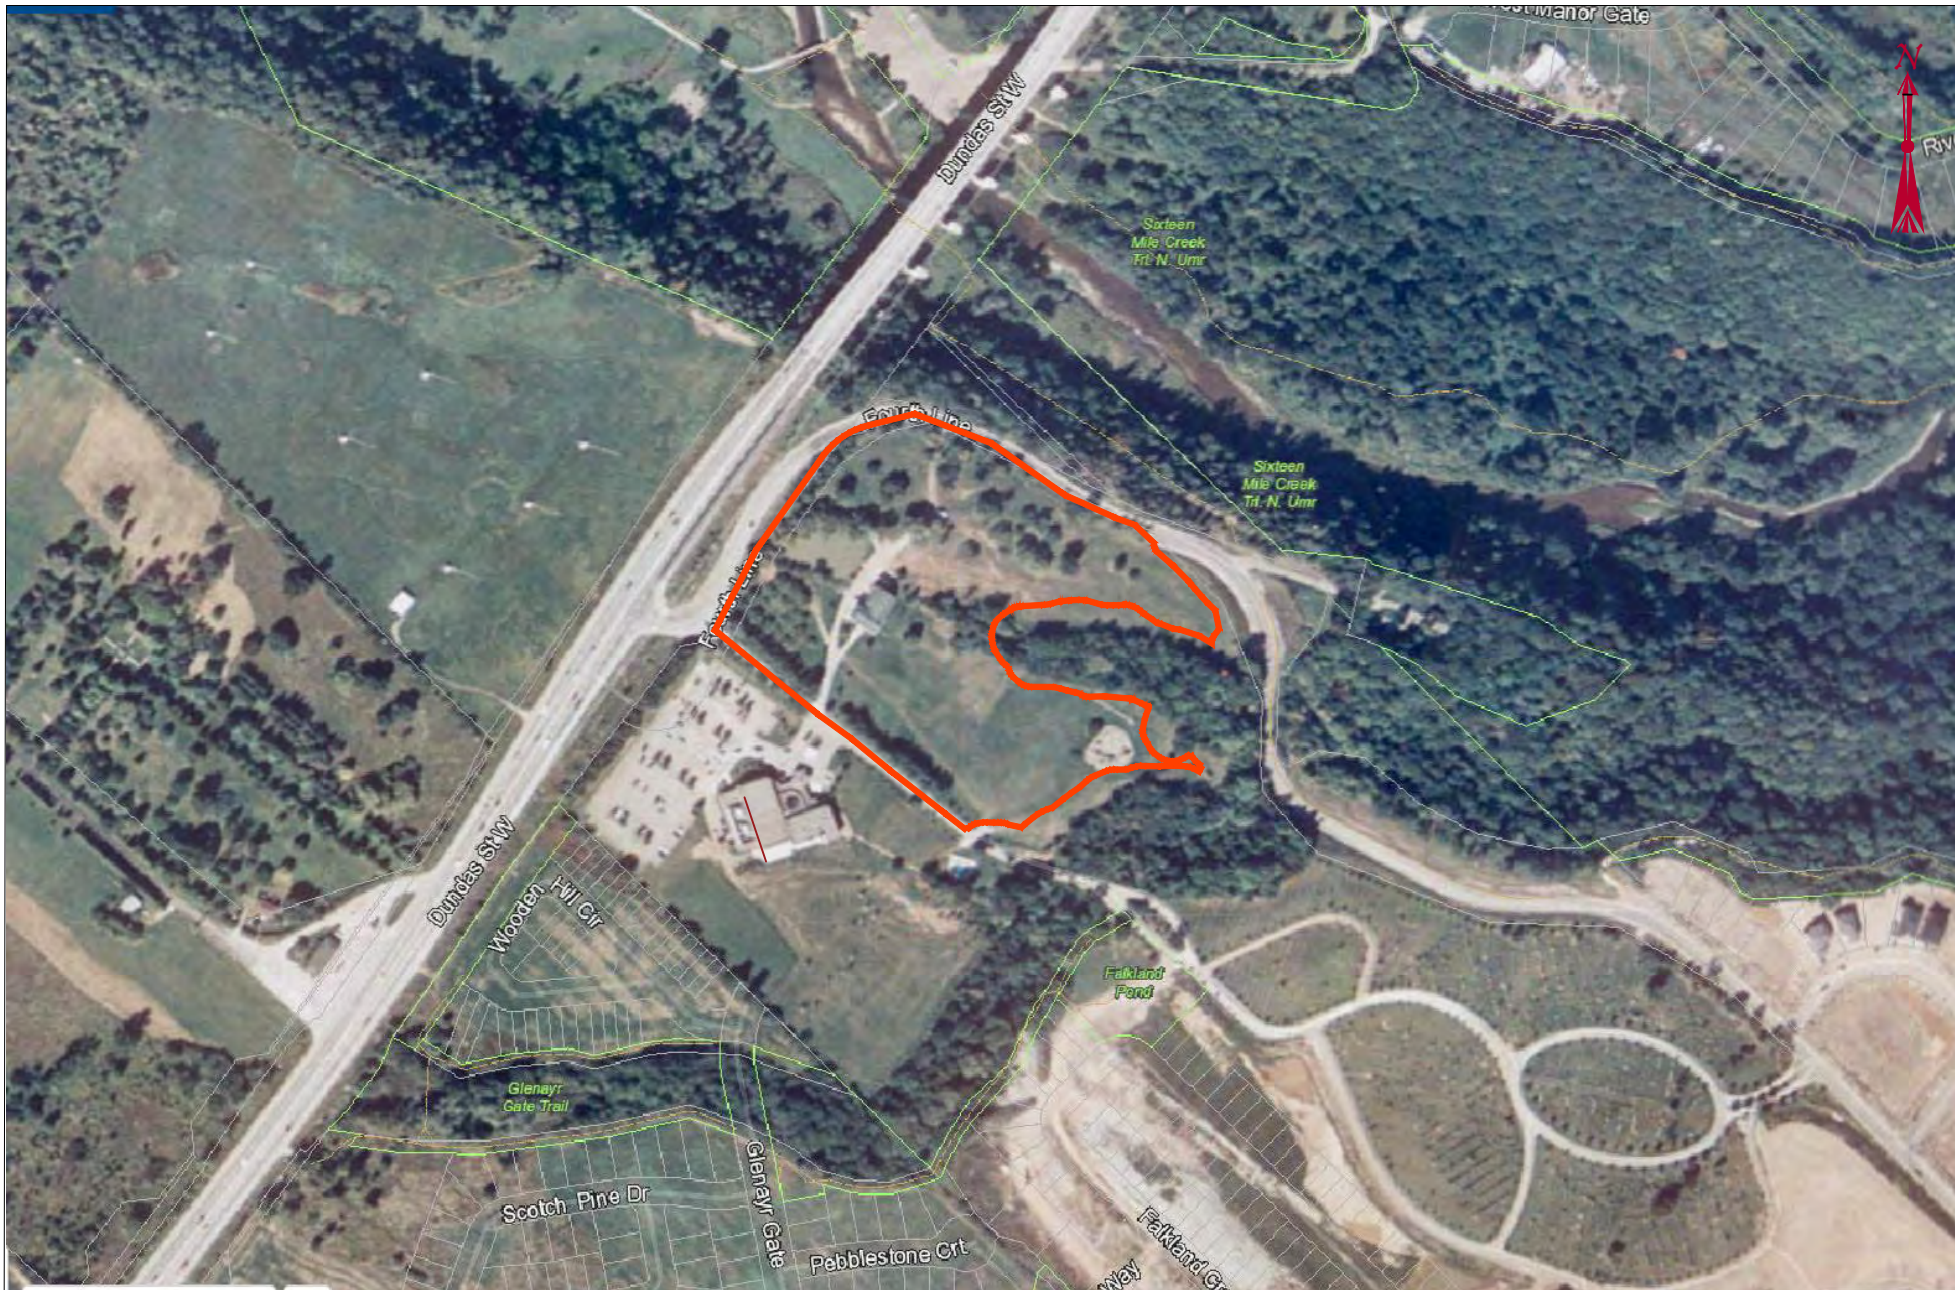
PROJECT NO. BIGC-ENV-185F	DWN. L.C.K.
SCALE NOT TO SCALE	CK. E.L.
DATE DECEMBER 2021	FIG NO. H-4

IMAGERY SOURCED FROM TOWN OF OAKVILLE, DATED 1995

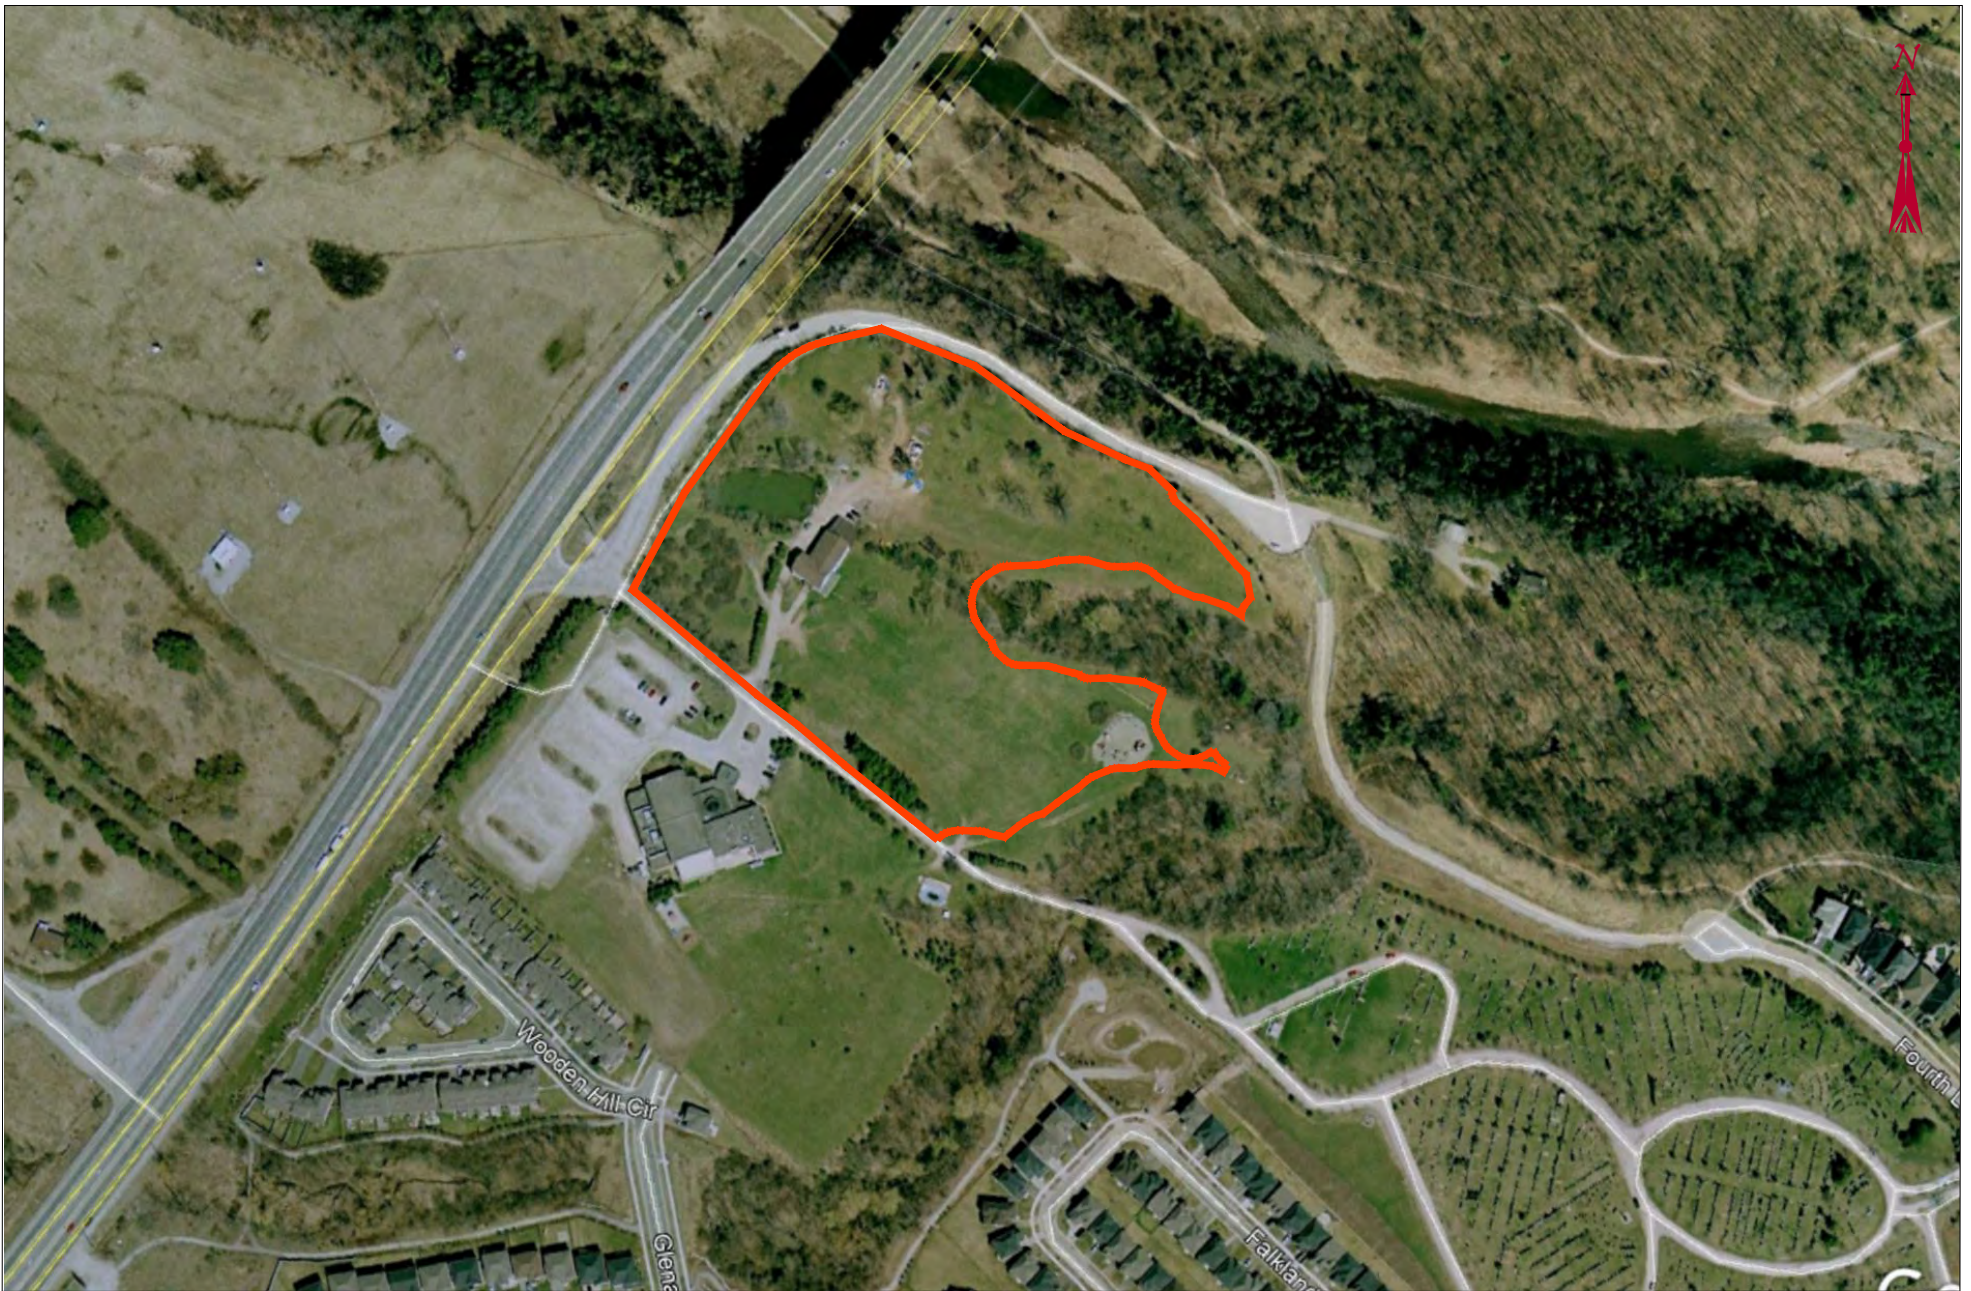
PROJECT NO. BIGC-ENV-185F	DWN. L.C.K.
SCALE NOT TO SCALE	CK. E.L.
DATE DECEMBER 2021	FIG NO. H-5

IMAGERY SOURCED FROM GOOGLE EARTH ONLINE IMAGERY, DATED 2005

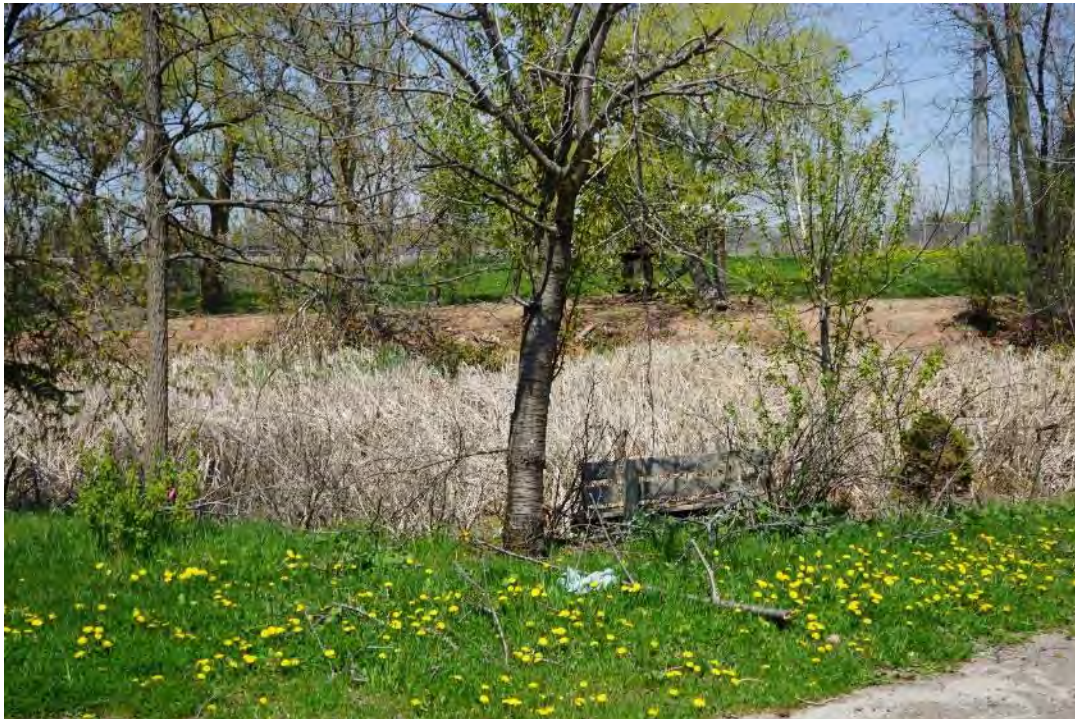
Photo 1: A pond located on northwestern portion of the Site.

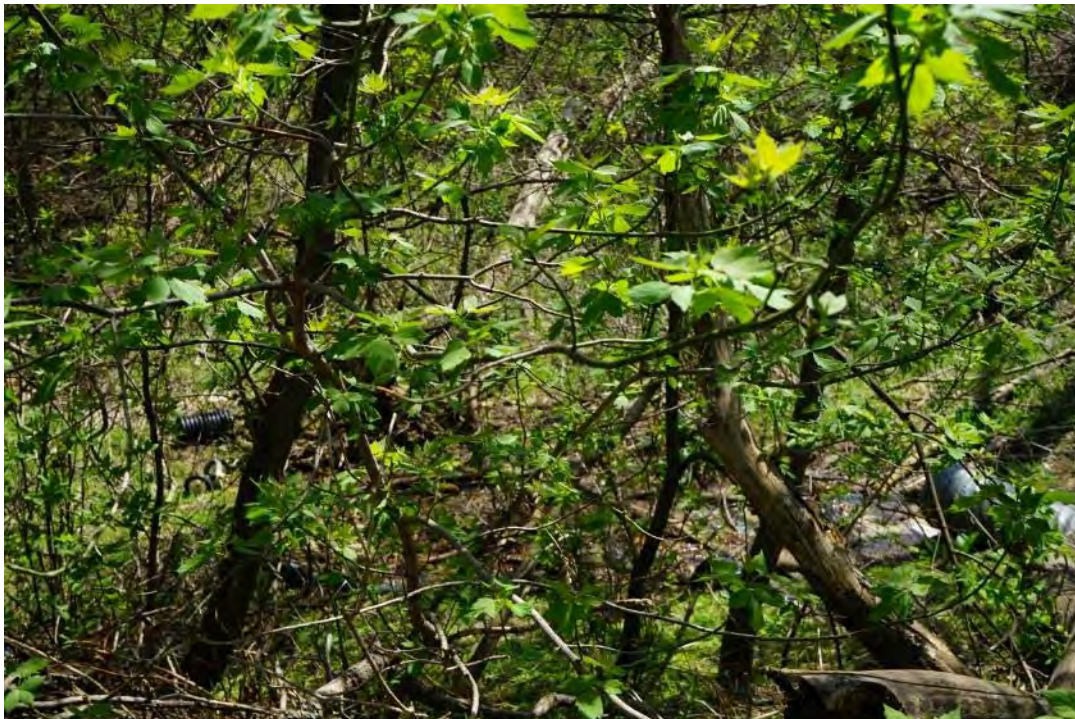
Photo 2: A ravine is located in the centre of the Site.

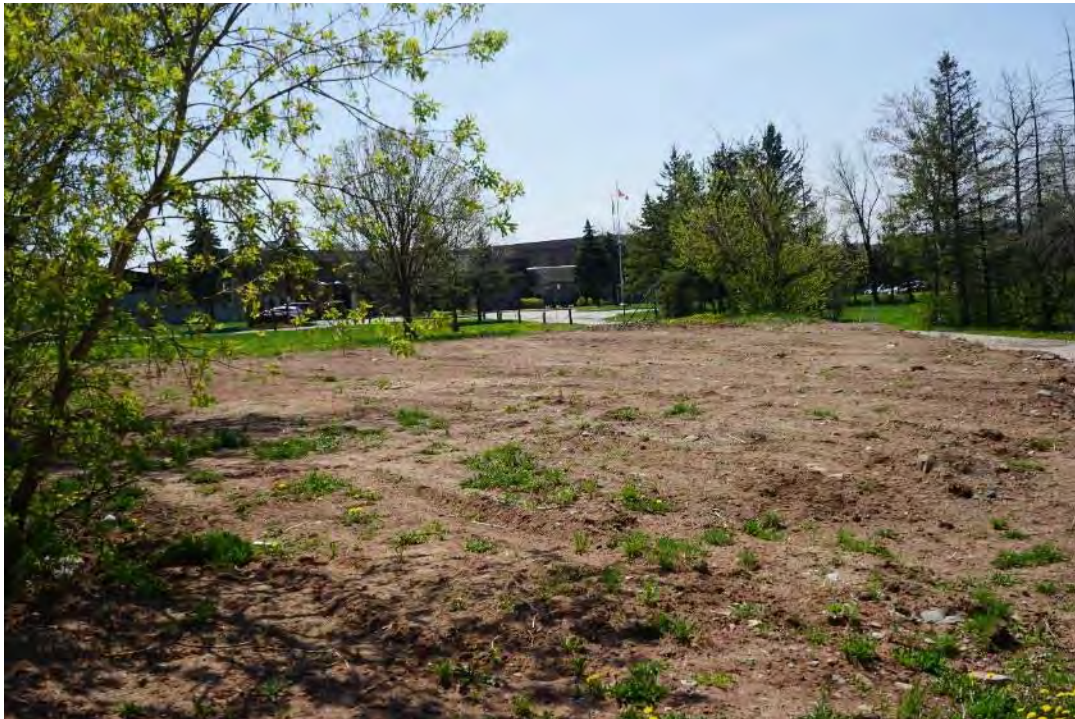
Photo 3: Former barn located on the western portion of the Site.

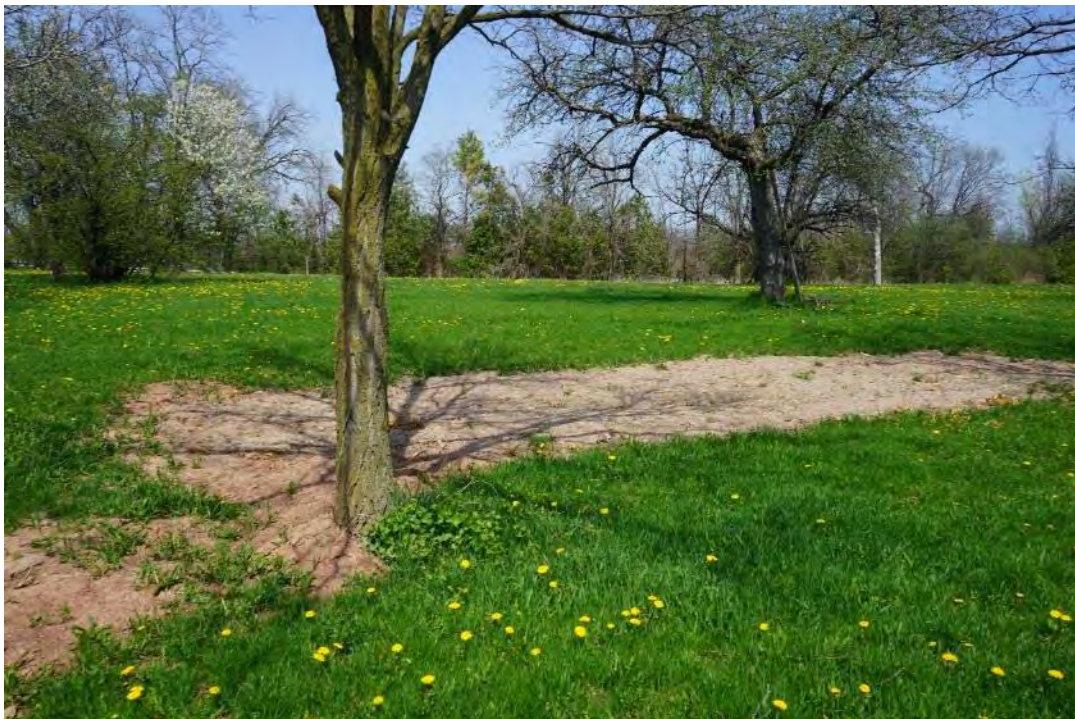
Photo 4: Former farm house footprint.

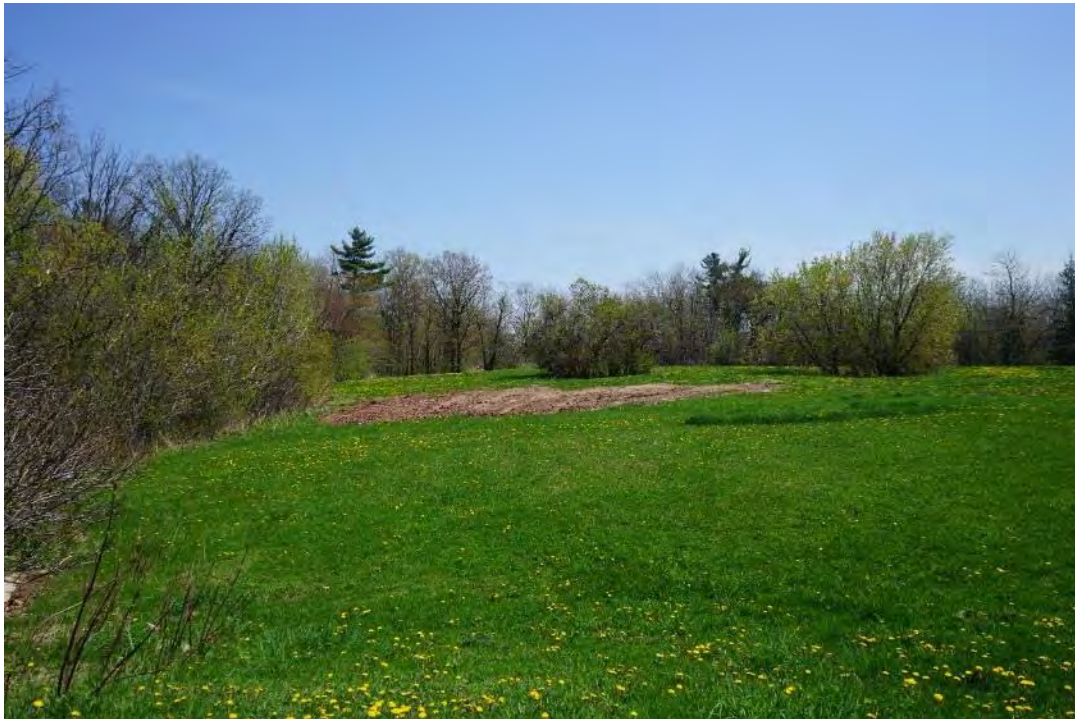
Photo 5: Fill material observed located on the southeastern portion of the Site.

Fill can be used to re-grade a property and to backfill excavations. Fill piles were observed at the location of the former barn and farm house, located on the western and northern portions of the Site, and a small number of fill piles were observed to the southeast of the Site. These fill piles were reportedly imported from the cemetery located southeast adjacent. The fill material is associated with PCA#30 - Importation of Fill Material of Unknown Quality.

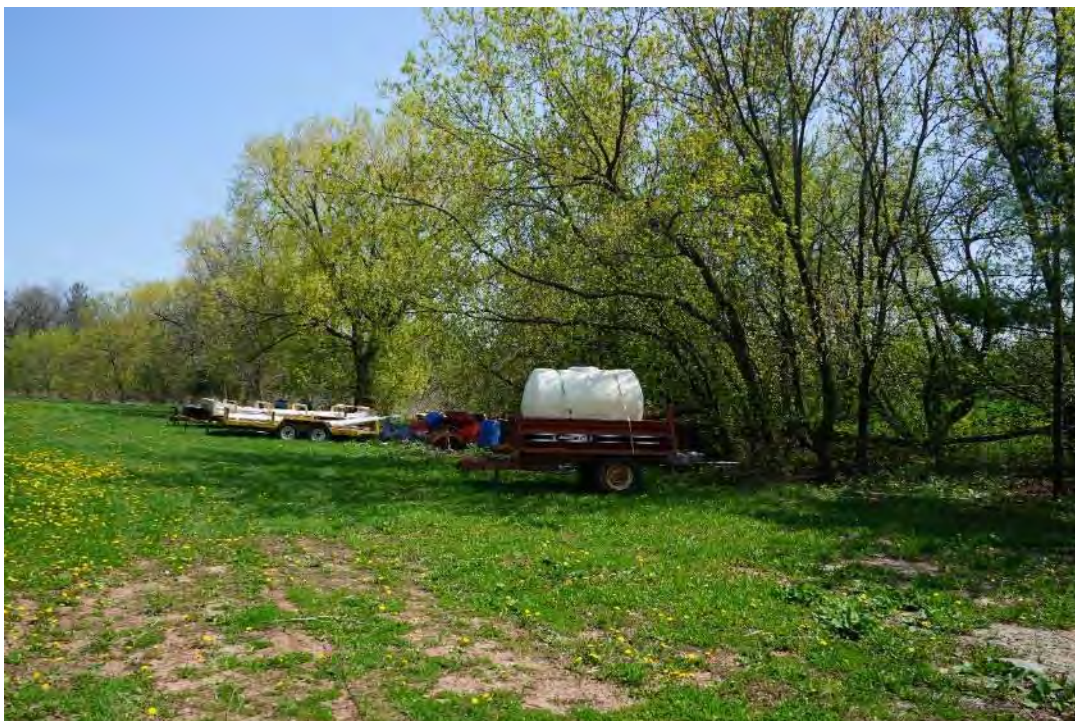
Photo 6: An AST observed on northern portion of the Site and was reportedly used for storage of pesticides.

The presence/absence and condition (if present) of ASTs at the Site was assessed during the Site reconnaissance. BIG did not observe the presence of any active ASTs (fill/vent pipes, access ports) at the time of the Site reconnaissance. One (1) AST was observed on the northern portion of the Site, near the ravine and was reportedly used for storage of pesticides and the tank is currently empty. Based on the

Site representative, the Site had a propane tank located to the north of the Site and was reportedly used for defrosting. The Site is associated with PCA#40 - Pesticides (including Herbicides, Fungicides and Anti-Fouling Agents) Manufacturing, Processing, Bulk Storage and Large-Scale Applications.
