# Wycroft Road Improvements from Bronte Road to Kerr Street

## Appendix J: Traffic Safety

# Road Safety Review

Prepared for Town of Oakville  
by IBI Group  
June 28, 2019

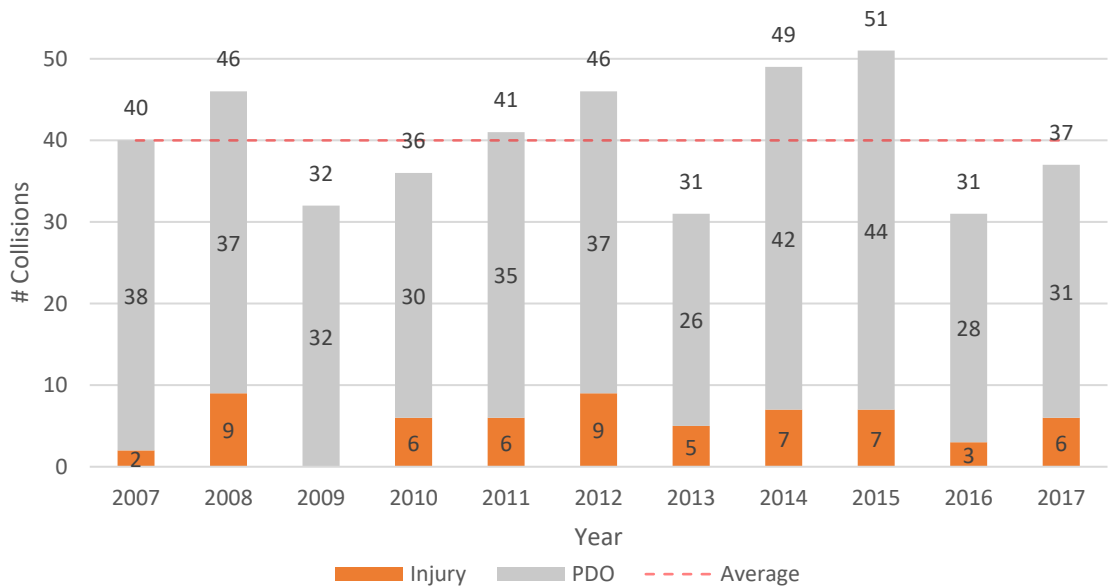
**Exhibit 3-1: Yearly Collision Frequency by Severity (2007-2017)**

Between 2007 and 2017, the total number of collisions occurring along Wyecroft Road ranged from 31 to 51 collisions per year. An average of 40 collisions occurred per year. Typically, collision frequency is expected to trend upwards over time, as traffic volumes generally increase over time. Collision frequency has remained relatively flat in the study area over the last 10 years, varying between 31 and 51 collisions per year.

The total number of collisions resulting in a non-fatal injury has also fluctuated slightly over the last 10 years, with between 0 and 9 injury collisions per year (0% to 20% of all collisions). Over the last 5 years (i.e., 2012-2017), the percentage of collisions resulting in an injury has remained comparatively consistent with an average rate of 14%. This is a low rate of injury collisions for an urban environment, which suggests that a high proportion of collisions along Wyecroft Road are occurring at low speeds, possibly under congested conditions.

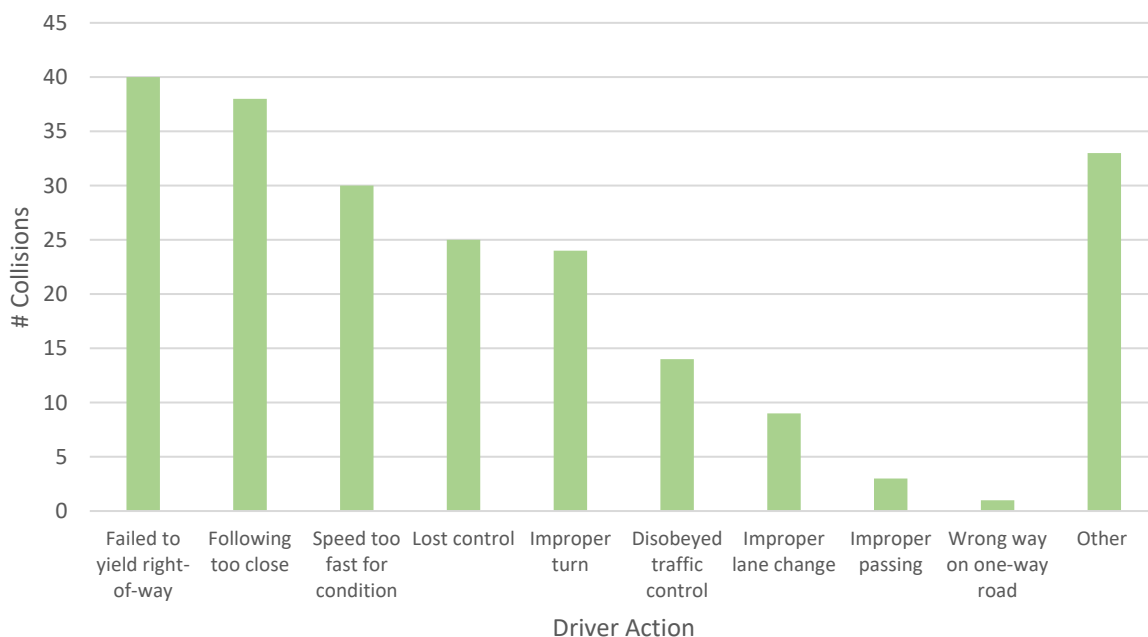
**Exhibit 3-4: Collision Breakdown by Driver Action (Excluding Driving Properly)**

The collision breakdown by driver action is illustrated in Exhibit 3.4. Dominant driver actions that resulted in a collision are drivers following too close, speed too fast for conditions, and failed to yield right-of-way. All three of these actions are associated with more aggressive driving behaviour.

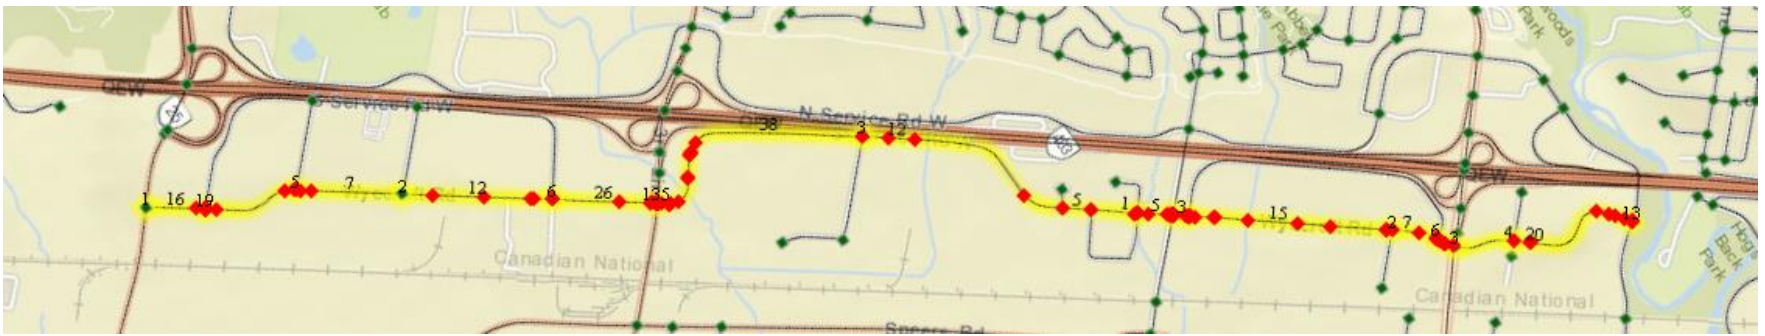
**Exhibit 3-7: Map of All Collisions (2007-2017)**

While Exhibit 3-6 illustrates which individual intersections or midblock segments have high collision frequency, some segments are longer than others, and those in close proximity to each other may have overlapping contributing factors. Exhibit 3-7 illustrates the prominent clusters of collisions along the Wycroft Road corridor.

Exhibit 3-7 shows a cluster of collisions in the segment approaching Dorval Drive. A disproportionately high number of collisions occurred in this segment, given the short segment length. Discussion regarding the segments' unique features and potential contributors to the high collision frequency is discussed in Section 3.5.

With the exclusion of Third Line, the portion of Wyecroft Road between Third Line and Cranberry Court accounts for 24% of all collisions that resulted in an injury. This is proportional to the relative size of the segment. However, the vast majority of the collisions occur along the 500 metre long reverse curve just east of Third Line, which is only 7% of the total corridor length. The concentration of collisions along the reverse curve is more clearly illustrated in the map in Exhibit 3-7 (Section 3.1).

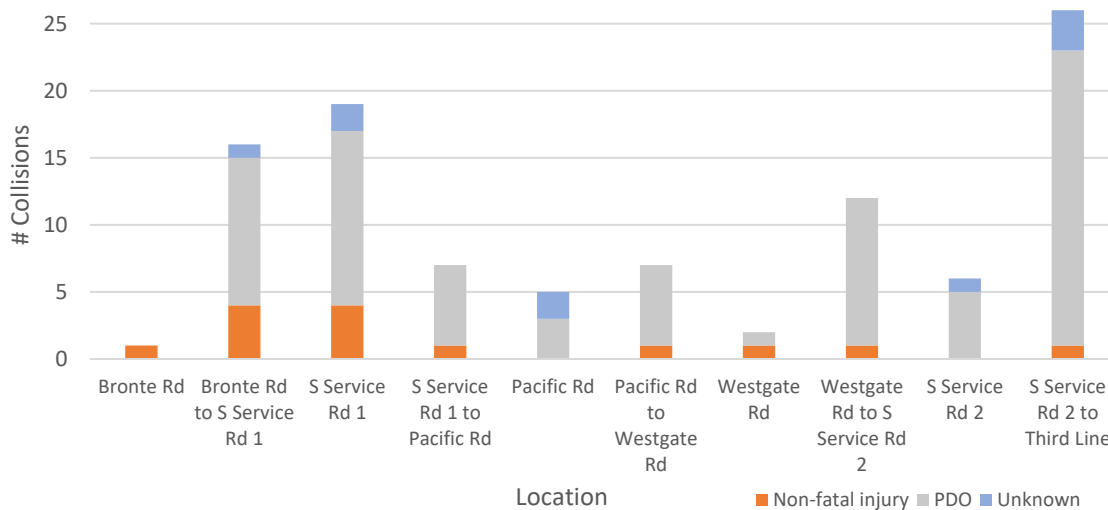
**Exhibit 3-8: All Collisions in the West Segment by Location and Severity**

The midblock segment between South Service Road 2 and Third Line has the highest proportion (26%) of collisions in the west segment. The majority of these collisions are rear-ends (35%) and sideswipe (23%), suggesting that the lane configuration change and congestion from the nearby intersection of Third Line may be contributing factors. The low injury rate (one (1) injury collision between 2007 and 2017) also suggests that these collisions are occurring under congested conditions, as low injury rates are typically associated with lower vehicle speeds.

The portion of Wyecroft Road between Bronte Road and South Service Road 1 – containing the midblock segment between Bronte Road and South Service Road 1 and the intersection of South Service Road 1 – also has a high frequency of collisions. Over the analysis period, 35% of all collisions, and 57%

of all collisions resulting in an injury, occurred in this short 240 metre segment. This is disproportionately high as this segment is comprised of only 11% of the length of the entire west segment. This indicates that there may be issues with drivers entering/exiting the driveways on the north side of Wycroft Road. Consideration to improving sightlines could be investigated in the road re-design.

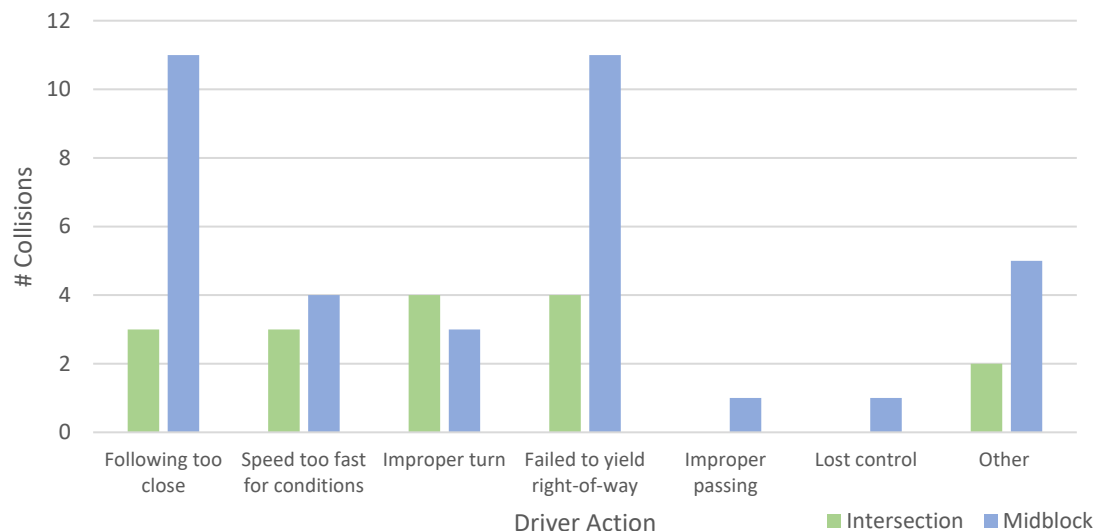
**Exhibit 3-11: Breakdown of All Collisions in the West Segment by Driver Action**

Exhibit 3-11 supports the earlier discussion that collisions result from the conflict between drivers travelling through the corridor (following too close, speed too fast for conditions) and drivers accessing the surrounding land use (improper turn, failed to yield right-of-way).

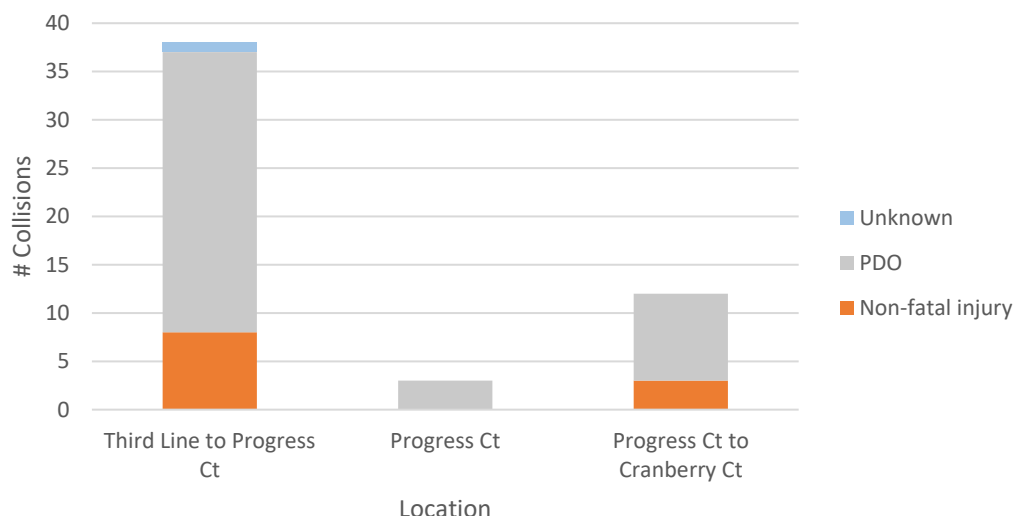
**Exhibit 3-15: All Collisions in the Middle Segment by Location and Severity**

For the analysis period, 72% of all collisions in the middle segment occurred immediately east of Third Line. 21% of those collisions resulted in an injury. A high percentage of the injury collisions had an initial impact type of Single Motor Vehicle (SMV) other, with an associated driver action of either the driver's speed is too fast for the conditions, or the driver lost control (Exhibit 3-16).

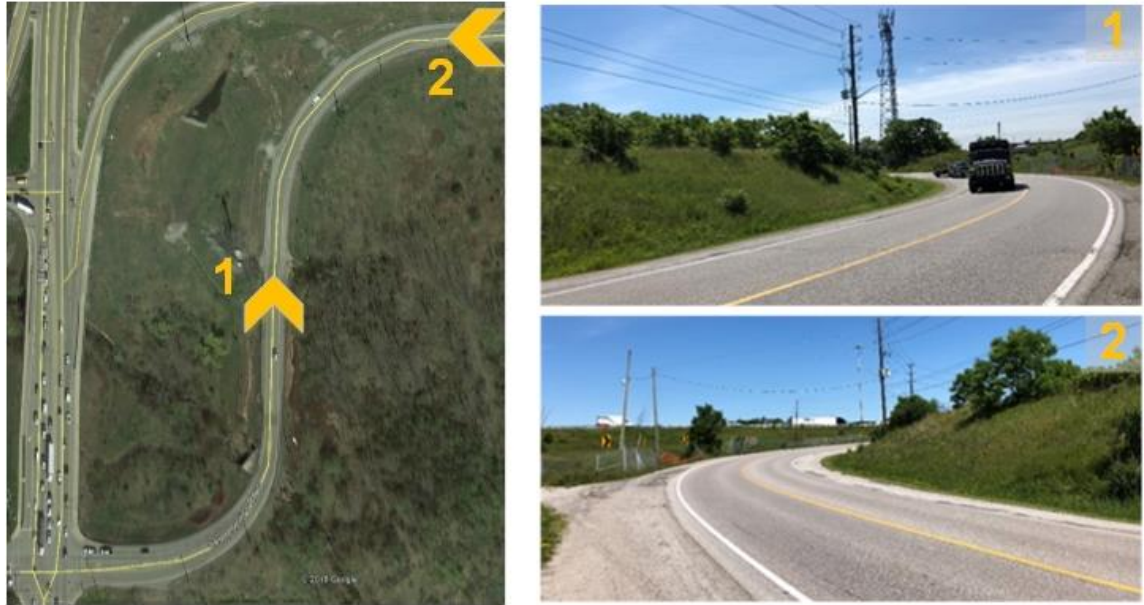
**Exhibit 3-17: Reverse Curve on South Service Road**

Furthermore, the majority of collisions with an initial impact type of SMV other occurred during adverse weather conditions (i.e., rain, snow, or fog). This supports the supposition that the sharp reverse curve east of Third Line is a significant contributing factor to safety concerns in this section. Design alternatives could explore alternative horizontal alignments for this reverse curve.

The reverse curve is illustrated in Exhibit 3-17.

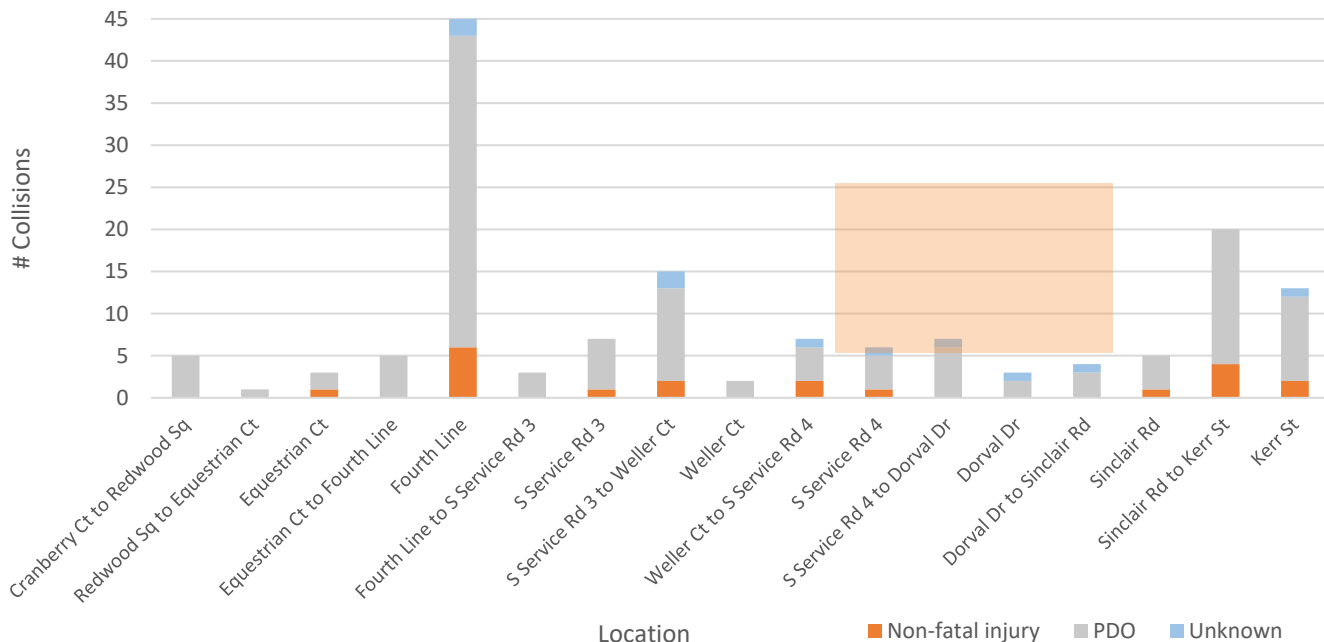
**Exhibit 3-21: Breakdown of All Collisions in the East Segment by Location and Severity**

Fourth Line has the highest concentration of collisions in this segment. The majority of collisions at this signalized intersection are rear-ends (53%) and angle (22%), which is expected for this type of intersection control. The majority of the rear-end collisions occurred in the eastbound or southbound directions. Collisions that resulted in an injury involved vehicles travelling westbound, indicating that operating speeds east of the intersection may be higher.

This portion of Wyecroft Road has one travel lane per direction with a two-way centre left-turn lane. The centre left-turn lane effectively separates turning vehicles from through vehicles, allowing the through vehicles to travel at higher speeds. The generally straight alignment provide clear sightlines to driveways, though this may lead to higher operating speeds. However, the higher operating speed increases the risk of collisions between turning vehicles and through vehicles, which may have contributed to the spike in collisions between South Service Road 3 and Weller Court (Exhibit 3-21).

Exhibit 3-21 also shows a higher concentration of collisions on the eastern portion of the corridor (between Sinclair Road and Kerr Street). Similar to the section just east of Third Line, there is a reverse curve between Sinclair Road and Kerr Street. The curve in this segment is not as extreme; however, there are multiple uncontrolled full-move driveways along the curve. Driveways located along a curve may have inadequate sightlines for the high operating speeds along Wyecroft Road. Factors affecting sightlines, such as daylight triangles, could be considered during roadway design.

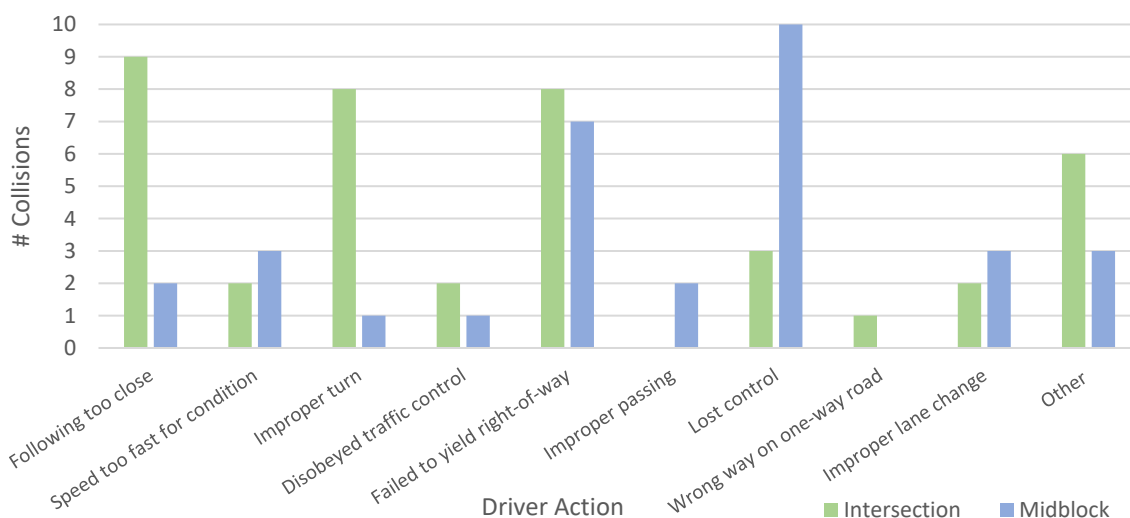
**Exhibit 3-24: Breakdown of All Collisions in the East Segment by Driver Action and Severity**

Similar to the west segment, failure to yield the right-of-way and following too close are dominant driver actions that resulted in a collision. This indicates that a prominent contributing factor may be the number of uncontrolled driveways (e.g. in the event a driver brakes unexpectedly to access a driveway, a collision is more likely to occur if the driver behind is following too closely). A high proportion (25%) of collisions are also a result of drivers losing control of their vehicles, and these collisions have a higher likelihood of resulting in an injury.

Approximately half of the injury collisions where drivers lost control occurred between South Service Road West and Weller Court. Higher operating speeds (85th percentile speeds of 64-66 km/hr) may be a contributing factor to collisions in this segment. The other half of the injury collisions occurred between Sinclair Road and Kerr Street, where the reverse curve with uncontrolled driveways may be the dominant contributing factor.
