# **Berta Point West Bank Shoreline Improvements**

## **Environmental Study Report**

**Shoreplan  
Engineering Limited**

**April 2022**

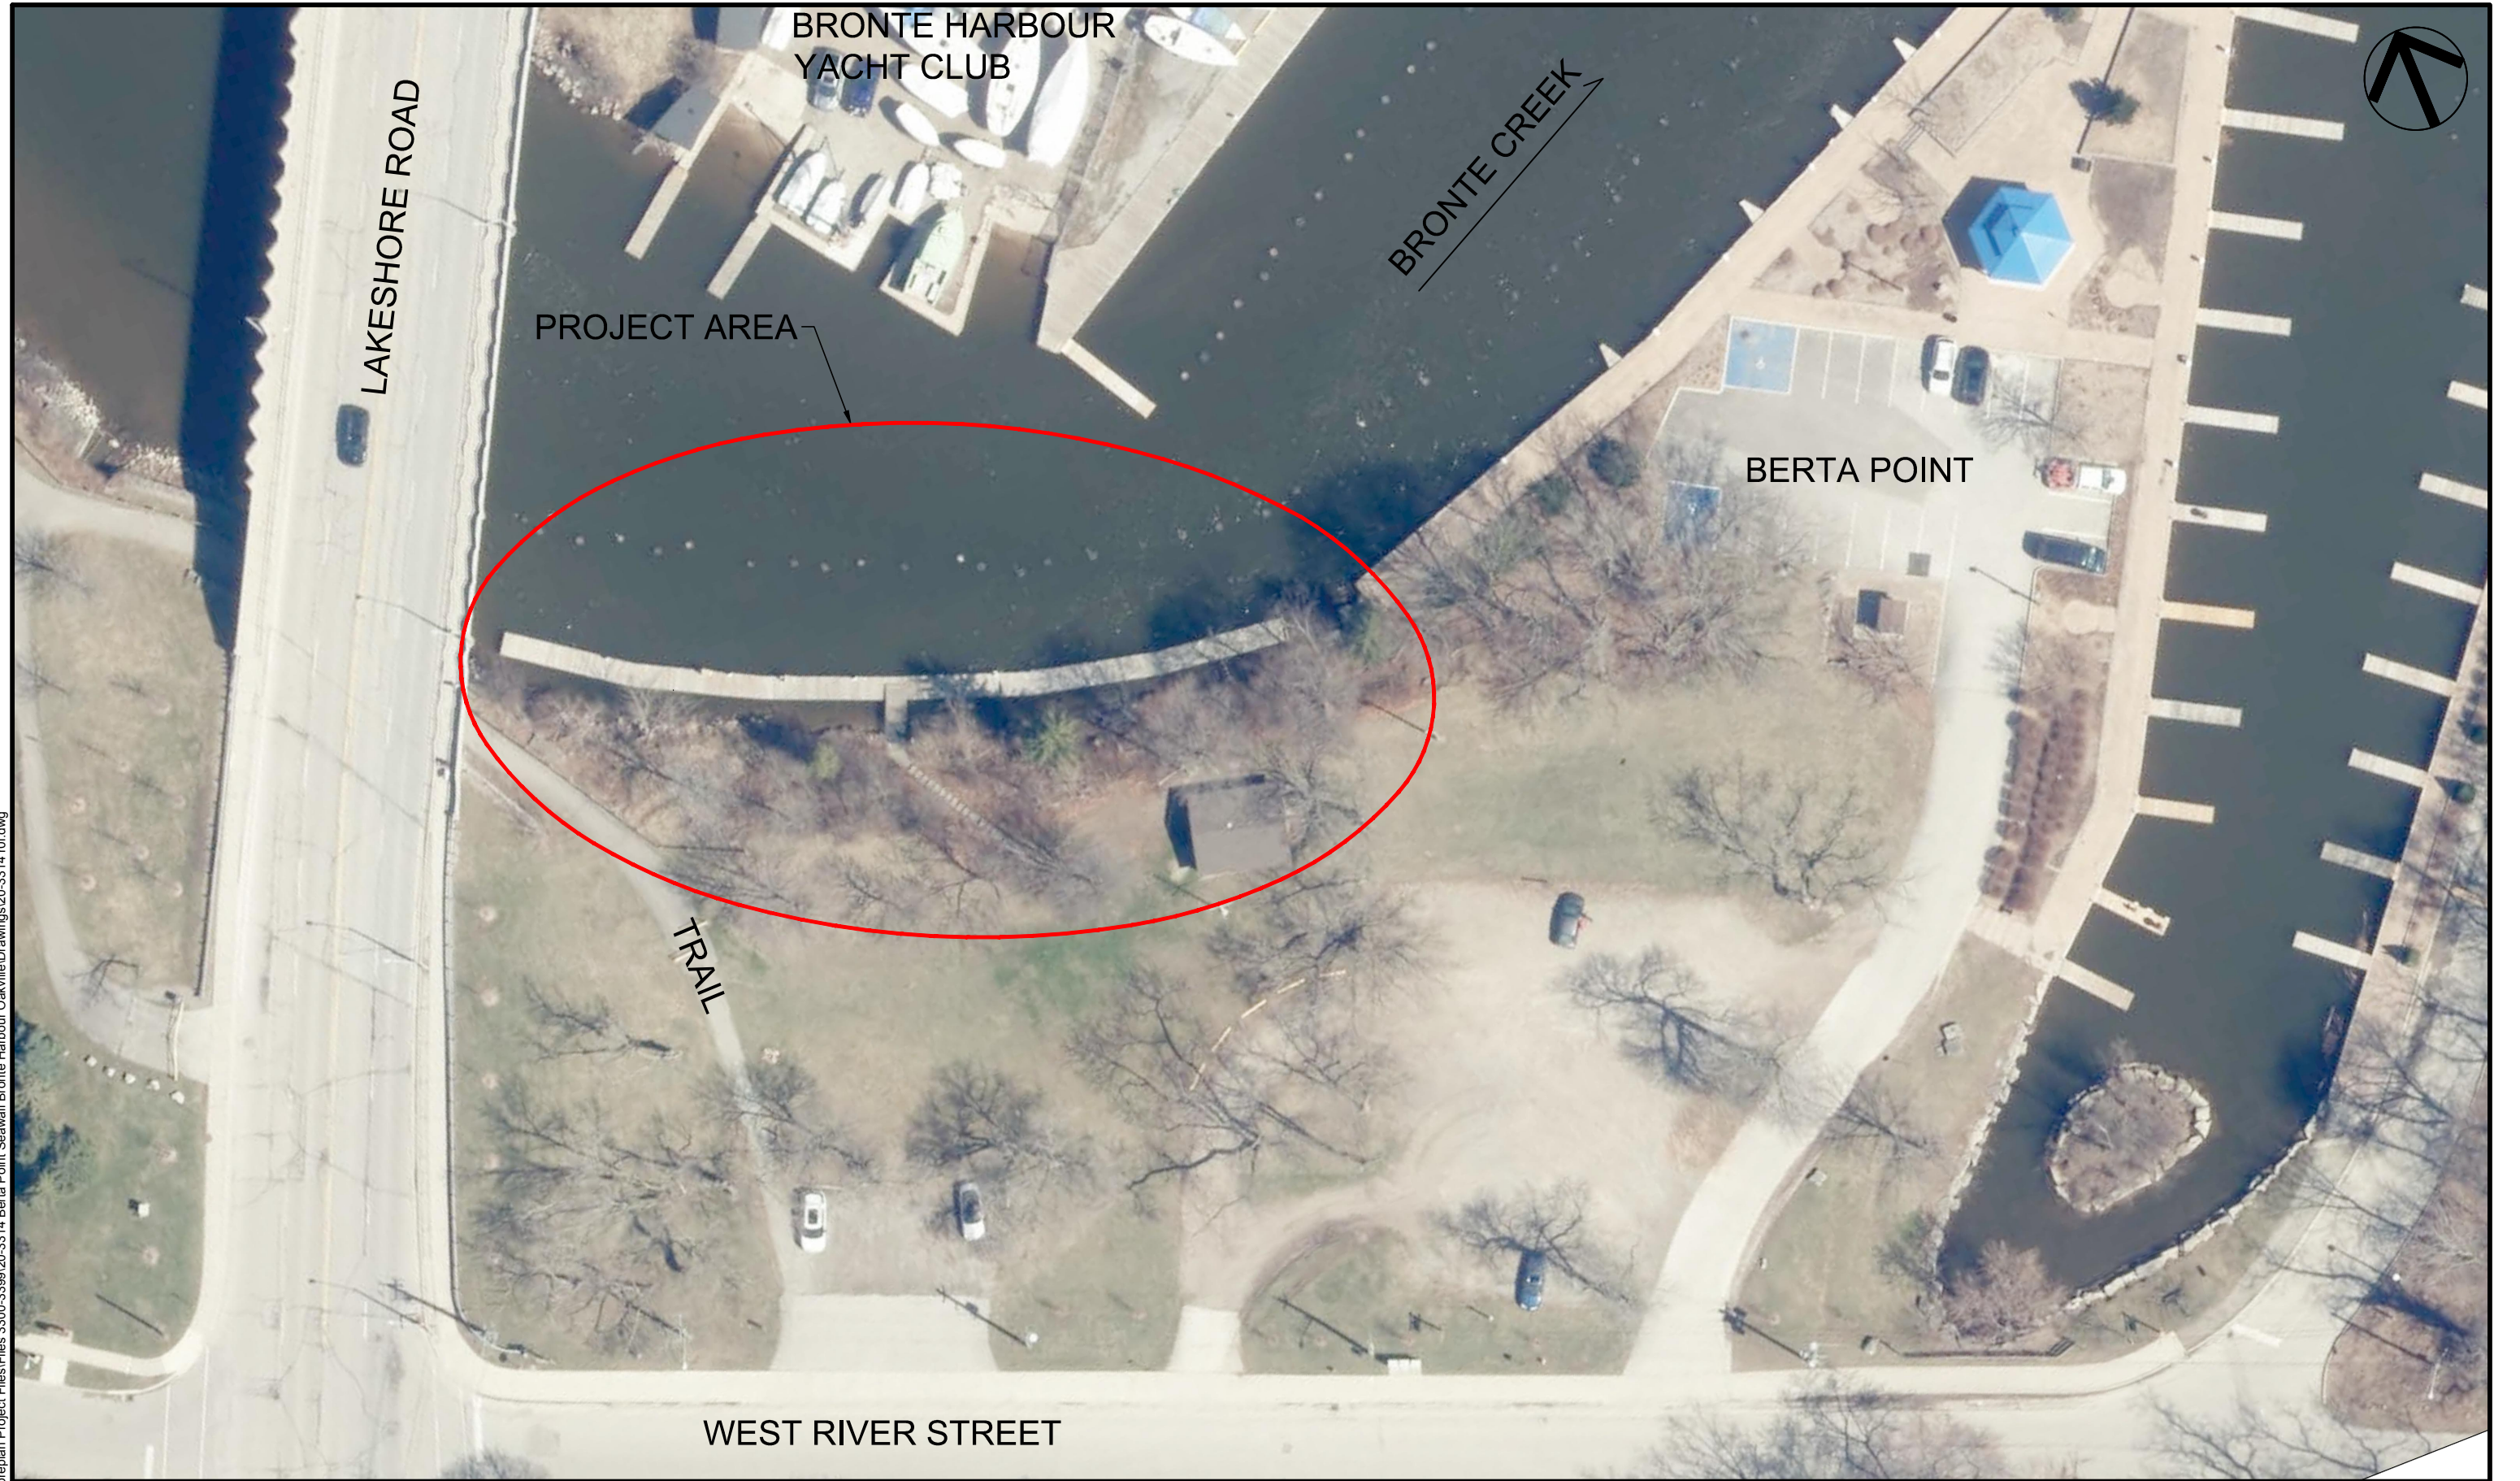
Figure 1  
 Berta Point West Bank Shoreline Improvements  
 Preferred Option - Rock Protection With Pile Supported Walkway Site Plan

Overall, Option 2 Rock Protection with Pile Supported Walkway, was found to be the preferred Alternative Solution based on the evaluation. Figure 1 shows the layout of the preferred option. Implementation of the preferred alternative solution will need to consider further design changes and modifications to optimize the project and gain acceptance by the reviewing agencies, park users, and residents of Oakville.

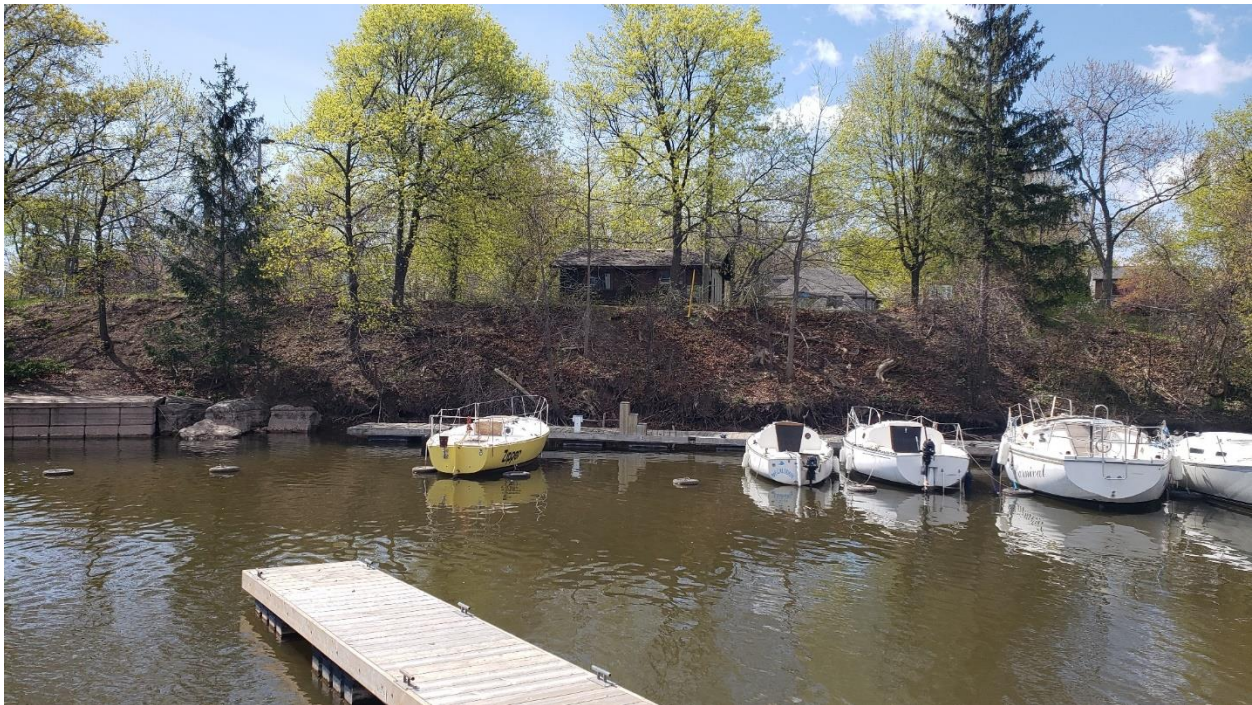
Photo 3.3: Project Area with Seasonal Floating Docks

The site is a public park that serves both local and regional functions. The site is along the shore of Bronte Creek and is in proximity to commercial areas to the east and residential areas to the west. It is used by residents who live near the park and the Bronte Inner Harbour area as well as recreational boaters who berth their vessels on the seasonal floating docks, shown in Photo 3.3 below.

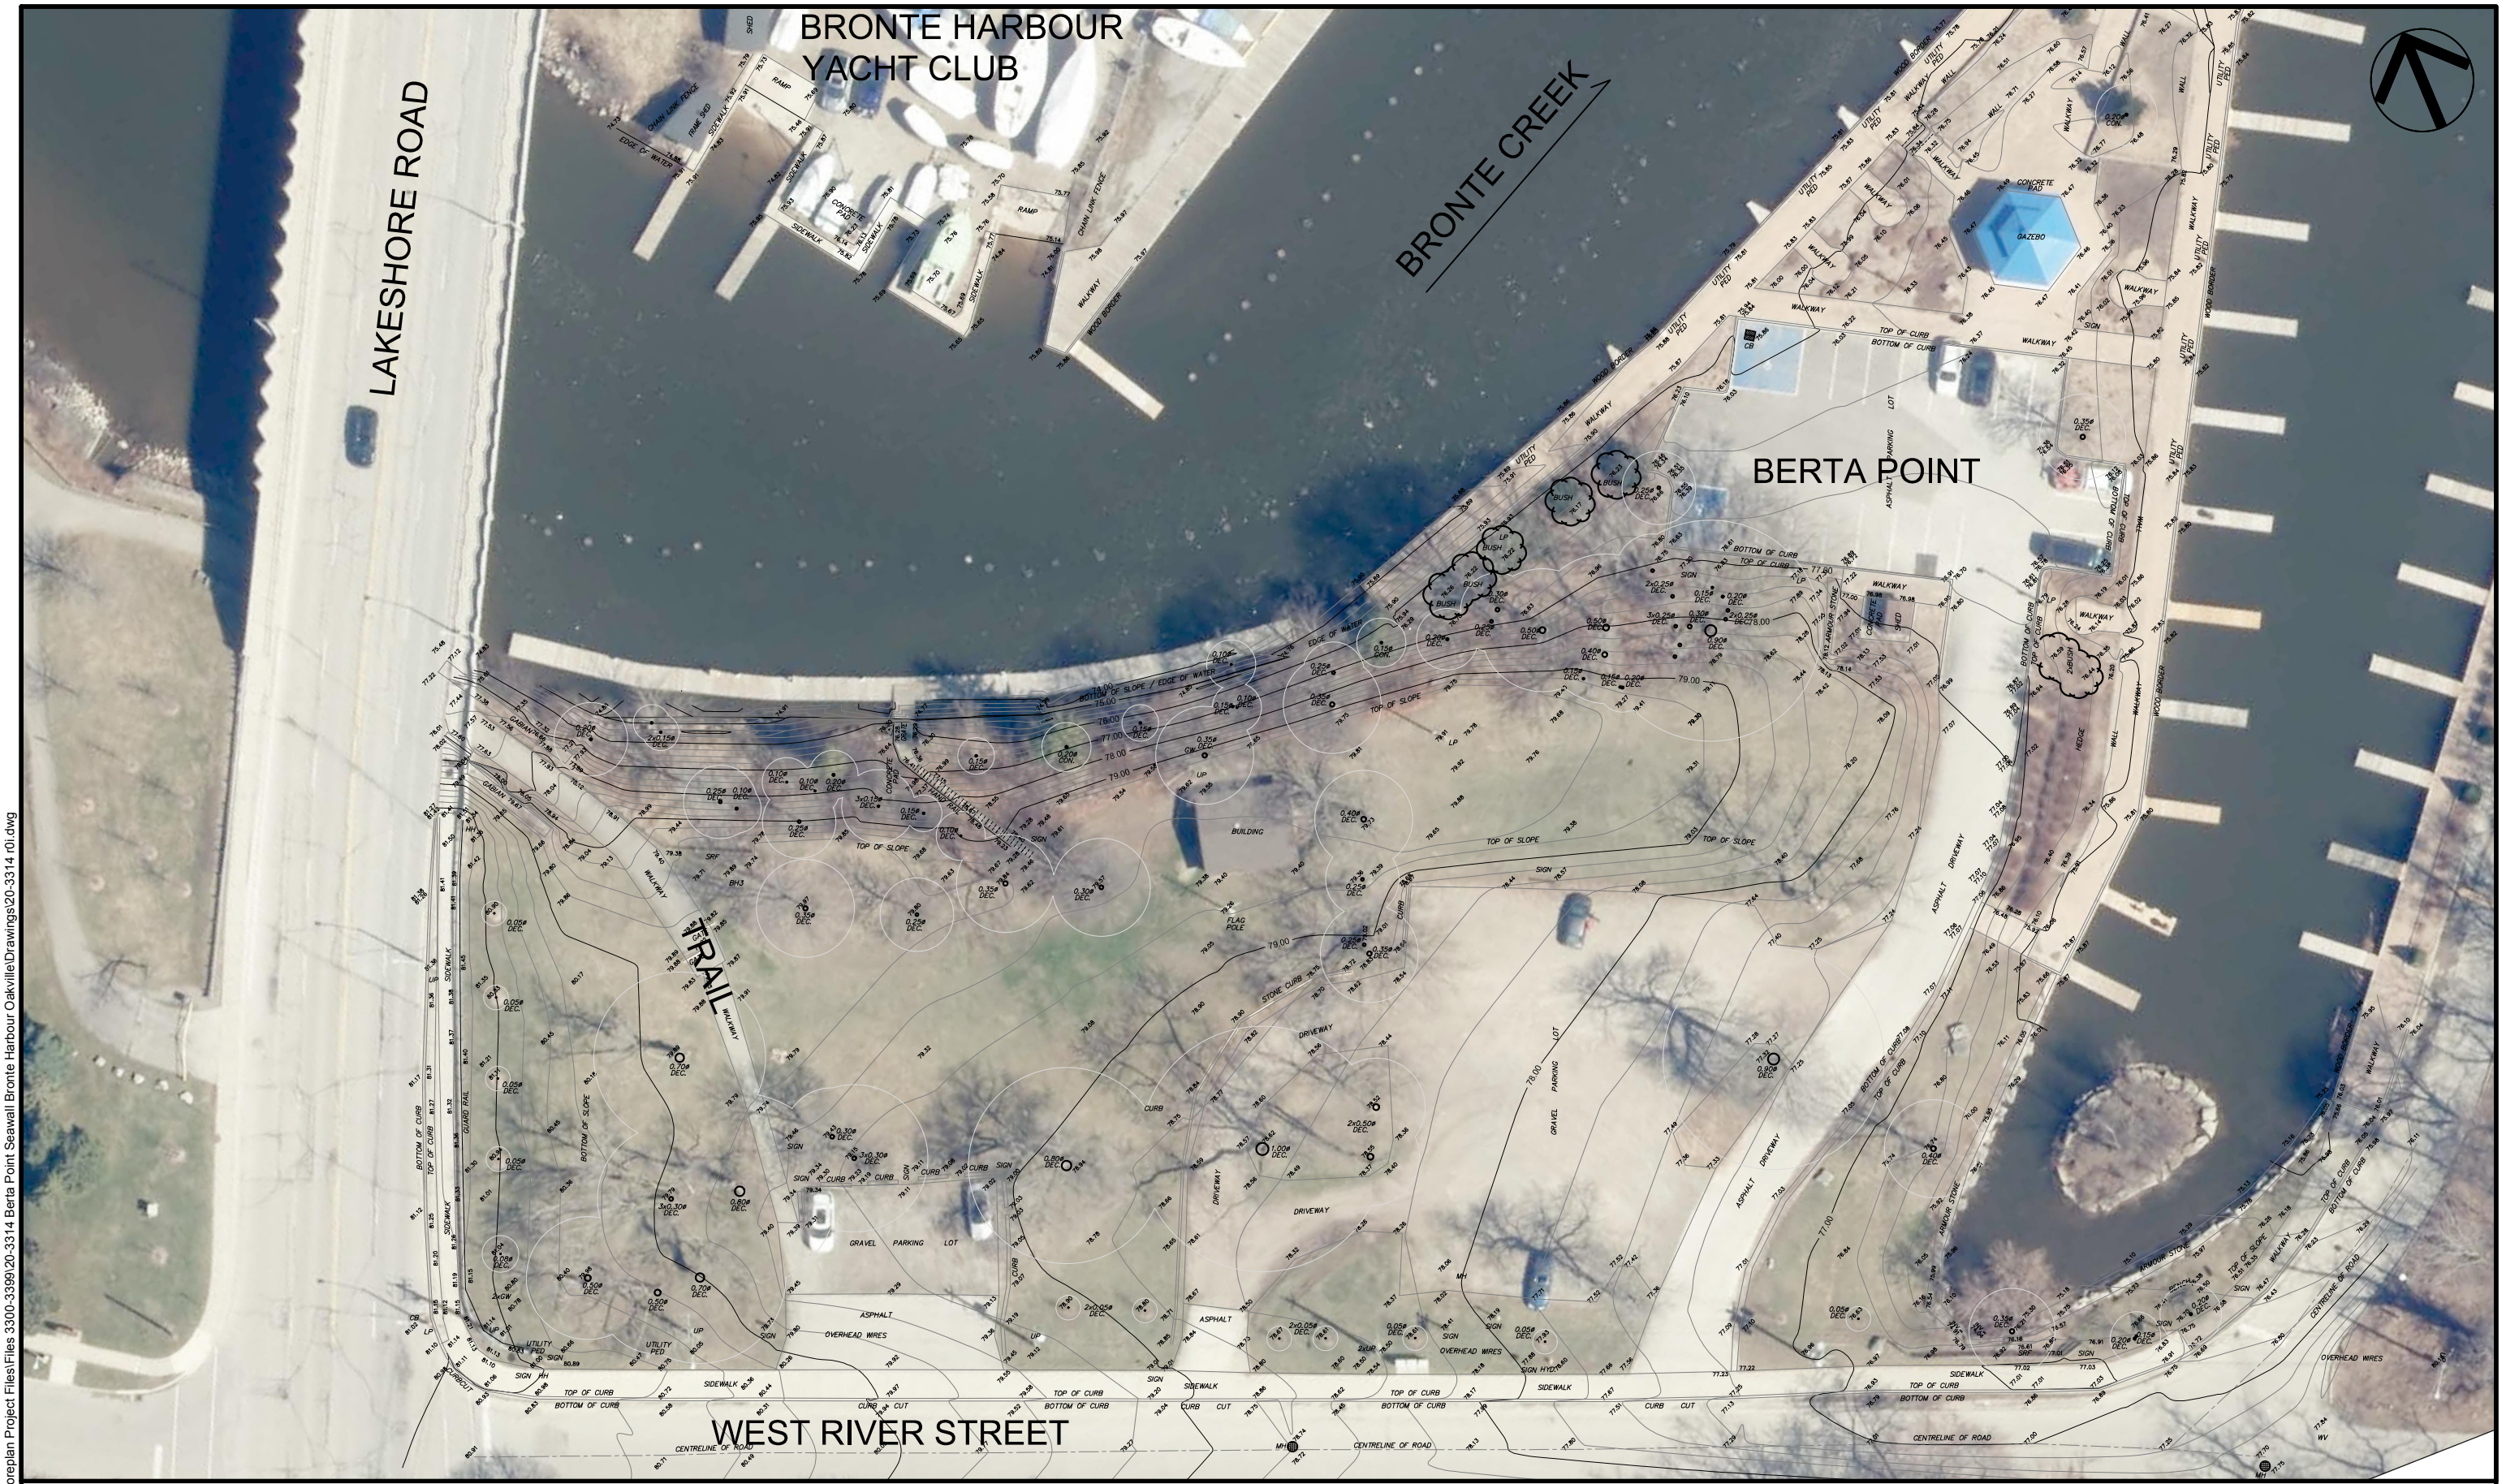
Figure 3.2  
 Berta Point West Bank Shoreline Improvements  
 Legal Survey with Supplemental Bathymetry

The parkland on the west, north, and south shores of Bronte Creek are owned by the Town of Oakville. The creek bottom along these shorelines and to where the creek outlets to Lake Ontario is also owned by the Town. Figure 3.2 shows a legal survey of the harbour with supplemental bathymetric data gathered by Shoreplan on November 19, 2021.

A Sonarmite and Trimble Geo 7X GPS unit were used for the survey. The soundings were referenced to the water level on the day and approximate time the survey was conducted. The water level at the Lake Ontario Burlington gauge was used to determine the water level at the site. The average water level on March 24th, 2021 was approximately 74.50 m International Great Lakes Datum 1985 (IGLD). Additional bathymetric data was collected by hand in the shallow nearshore on November 19, 2021. Figure 3.2 shows bathymetric contours based on the data collected in 2021.

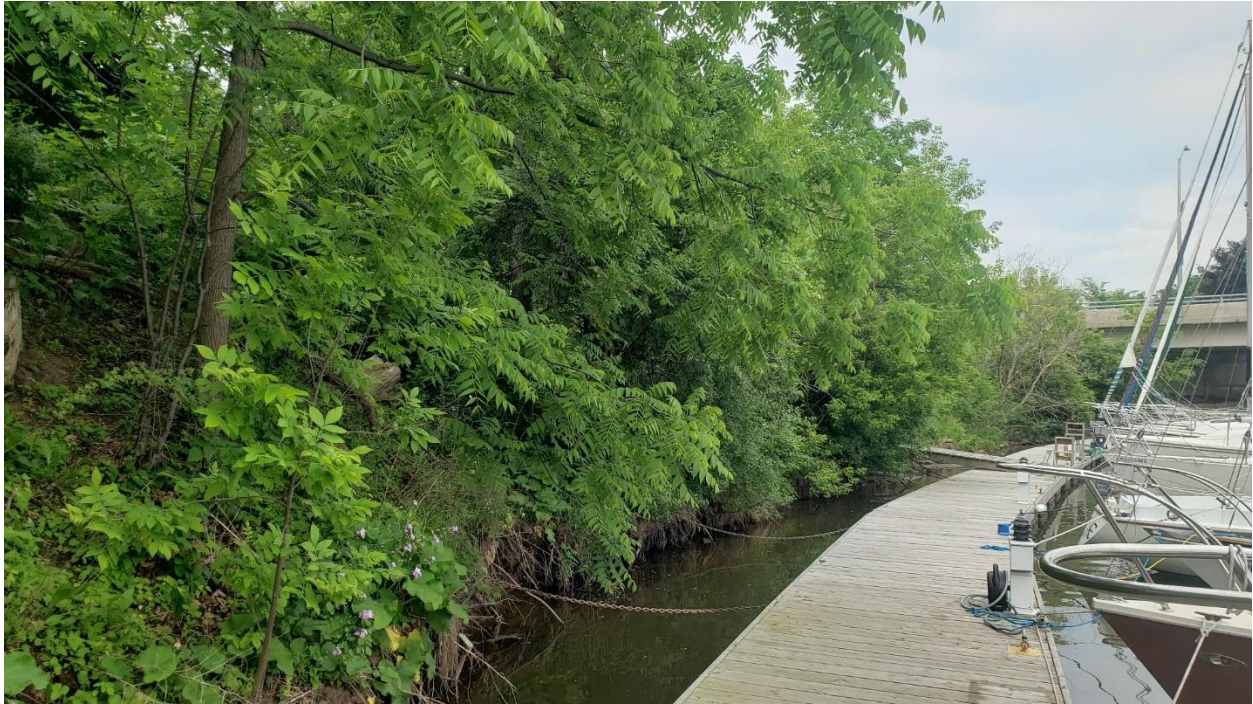
Photo 3.4: View of Bank with Vegetation

Berta Point is dominated by hardscaping features such as paved pathways, parking lots and park structures. The upper part of the park (south of Lakeshore Road and east of River Street) which is immediately adjacent to the project area has an informal gravel parking lot, walking trails, park buildings, manicured lawns, and some exotic and/or invasive vegetation species. The study area is likely used by mammals typical of such an urban setting such as foxes, racoons, squirrels, voles etc. However, this park is not considered to have significant terrestrial habitat The existing conditions at Berta Point can be seen in Photo 3.4, Photo 3.5, and Photo 3.6 below.

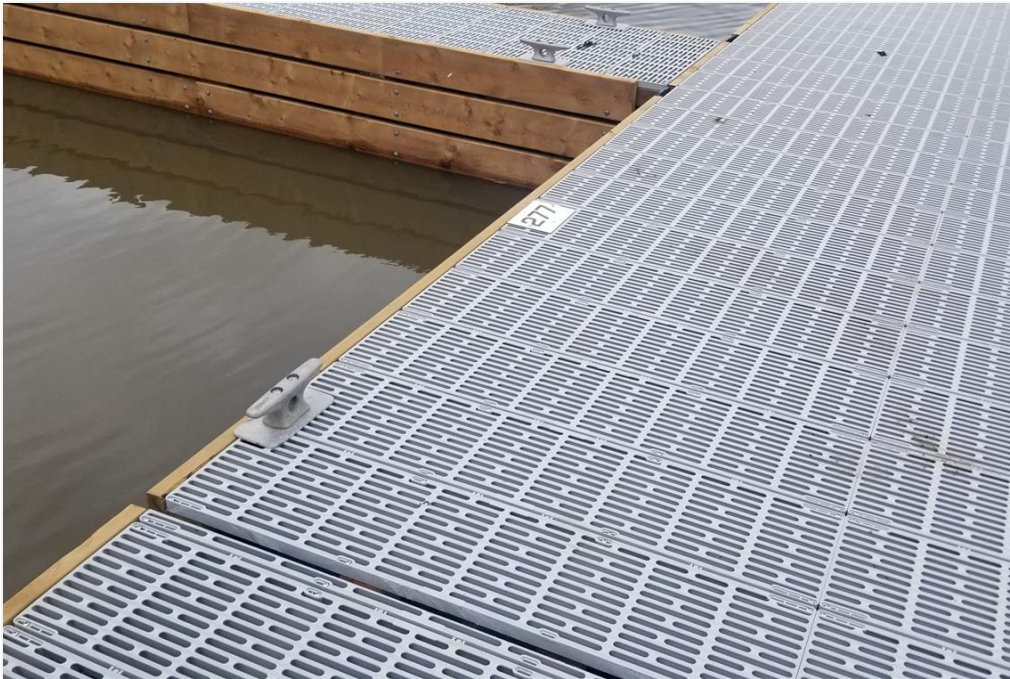
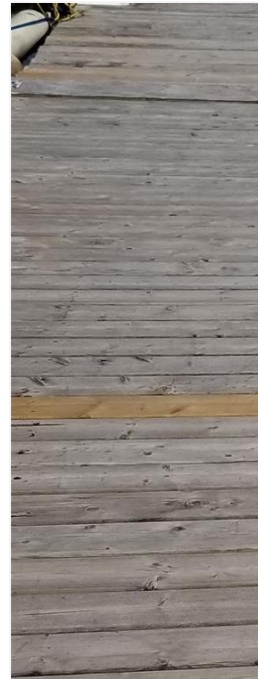
## Walkway features

- Galvanized steel grating
- Thruflow decking
- Marine power pedestal
