Arborist Report & Tree Preservation Plan

106 - 114 Robinson St & 71 Water Street
Oakville, ON

March 31, 2022

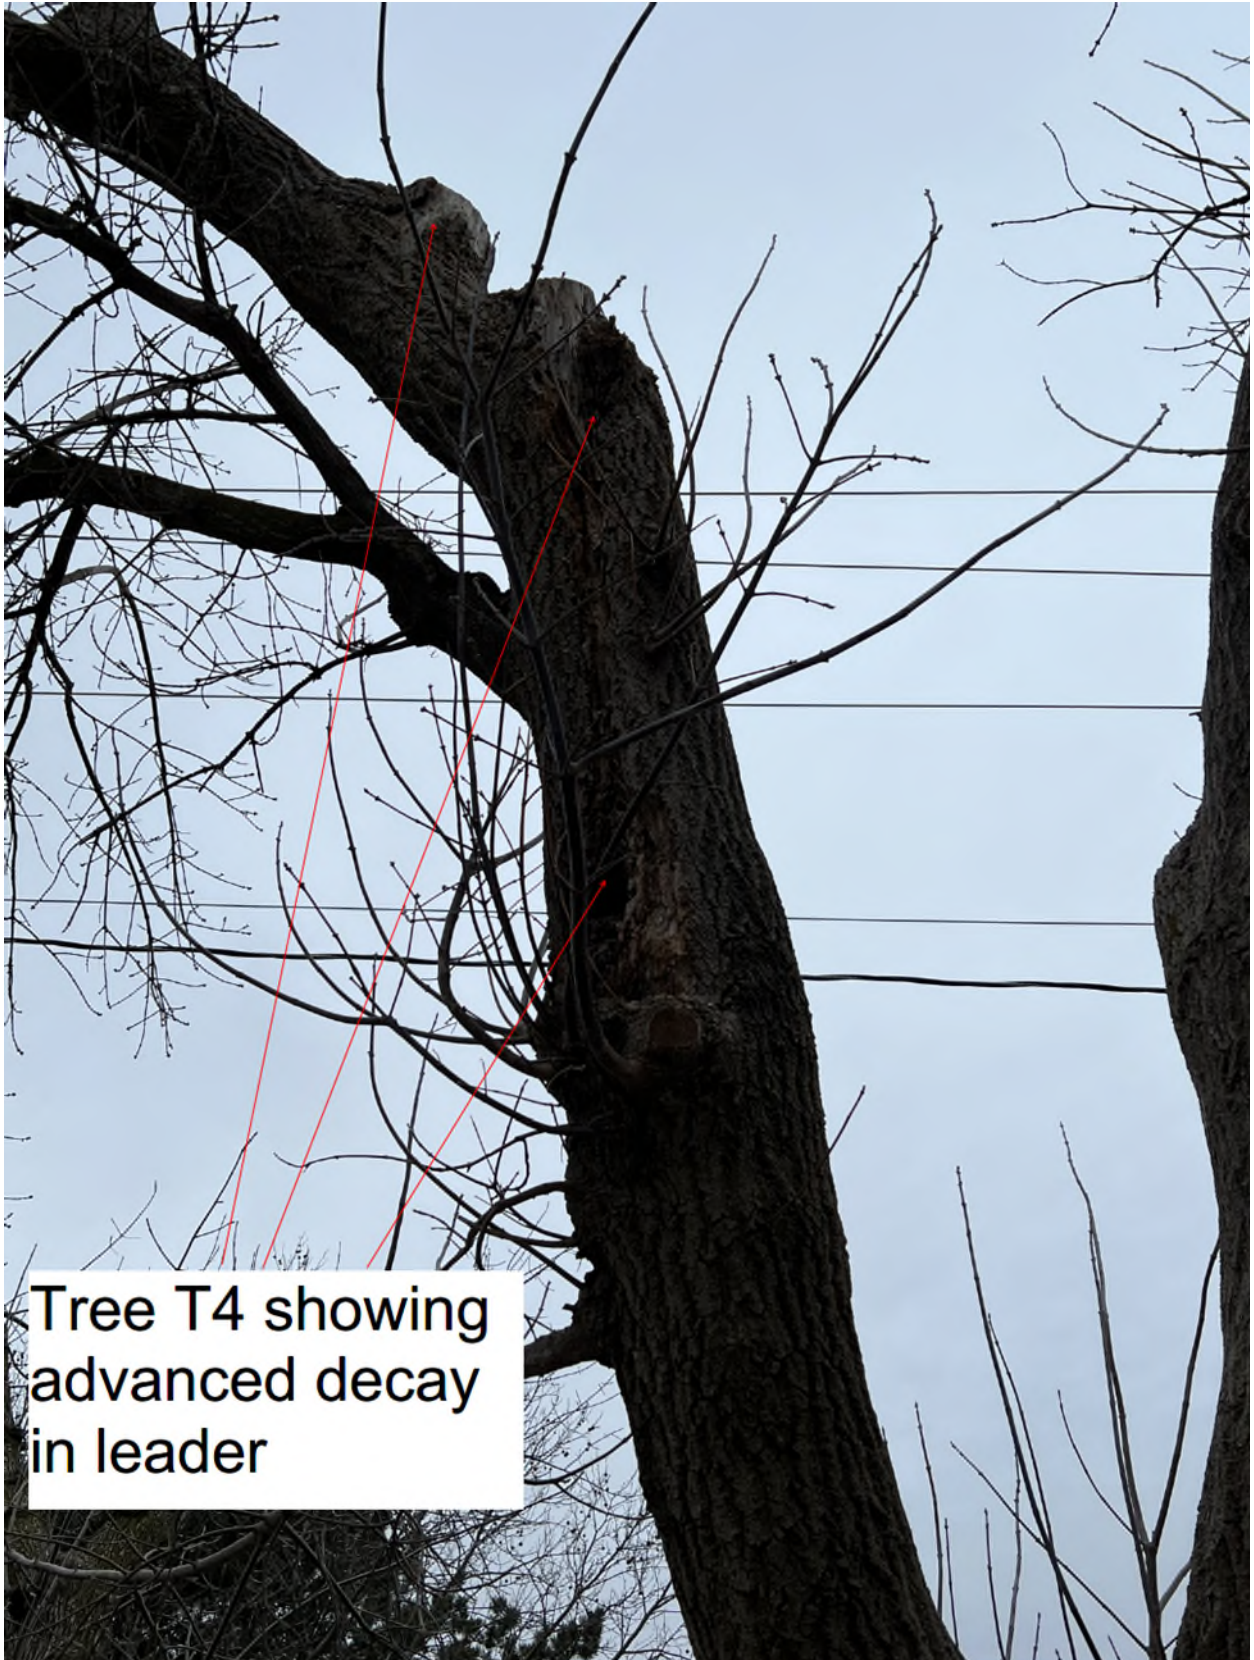
Photo #5:

**Tree T4 showing
advanced decay
in leader**

1. From the list above, trees no. T1-T4 are in conflict with the proposed development and as such require removal as a consequence of construction and/or landscaping.
2. Tree no. T3 is terminally infected with EAB, has been marked for removal, and is no longer listed in the Town of Oakville Street and Park Trees Inventory.
3. Tree no. T4 represents a potential hazard, is growing on a severe lean with advanced decay evident at the main union and throughout its leaders. This tree is not a suitable candidate for preservation and as such is recommended for removal regardless of this proposed development application.
4. Pursuant to the Town of Oakville Town Tree By-law, the client will submit a permit application to remove four (4) trees.
