**REPORT ON
PHASE TWO ENVIRONMENTAL SITE ASSESSMENT
50 SPEERS ROAD
OAKVILLE, ONTARIO**

**REPORT NO.: 5557-21-EB
REPORT DATE: JUNE 20, 2023**

**PREPARED FOR
HELBERG PROPERTIES LIMITED
SUBMISSION V2**

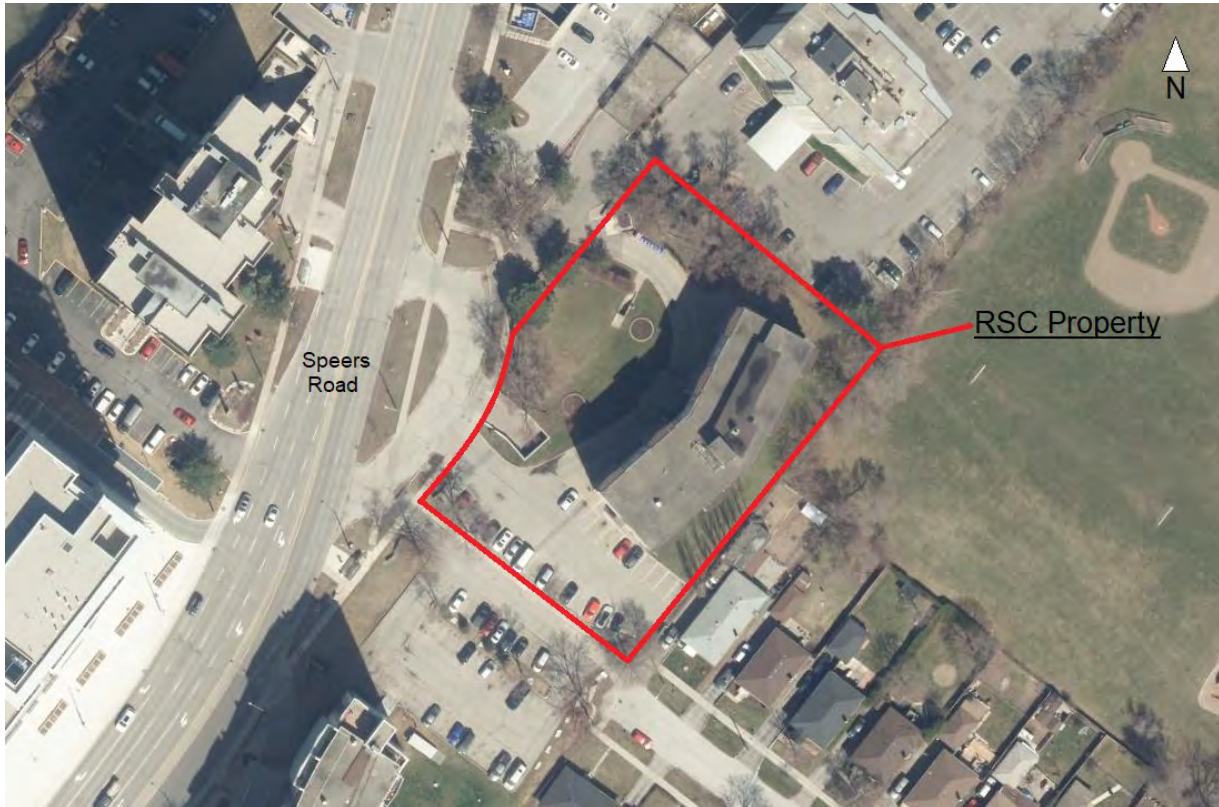
Image No. 1: 2019 Aerial photograph showing subject site
(Source: Oakville Interactive Map)

The layout of the Phase Two Property is presented in Image No. 1, below.

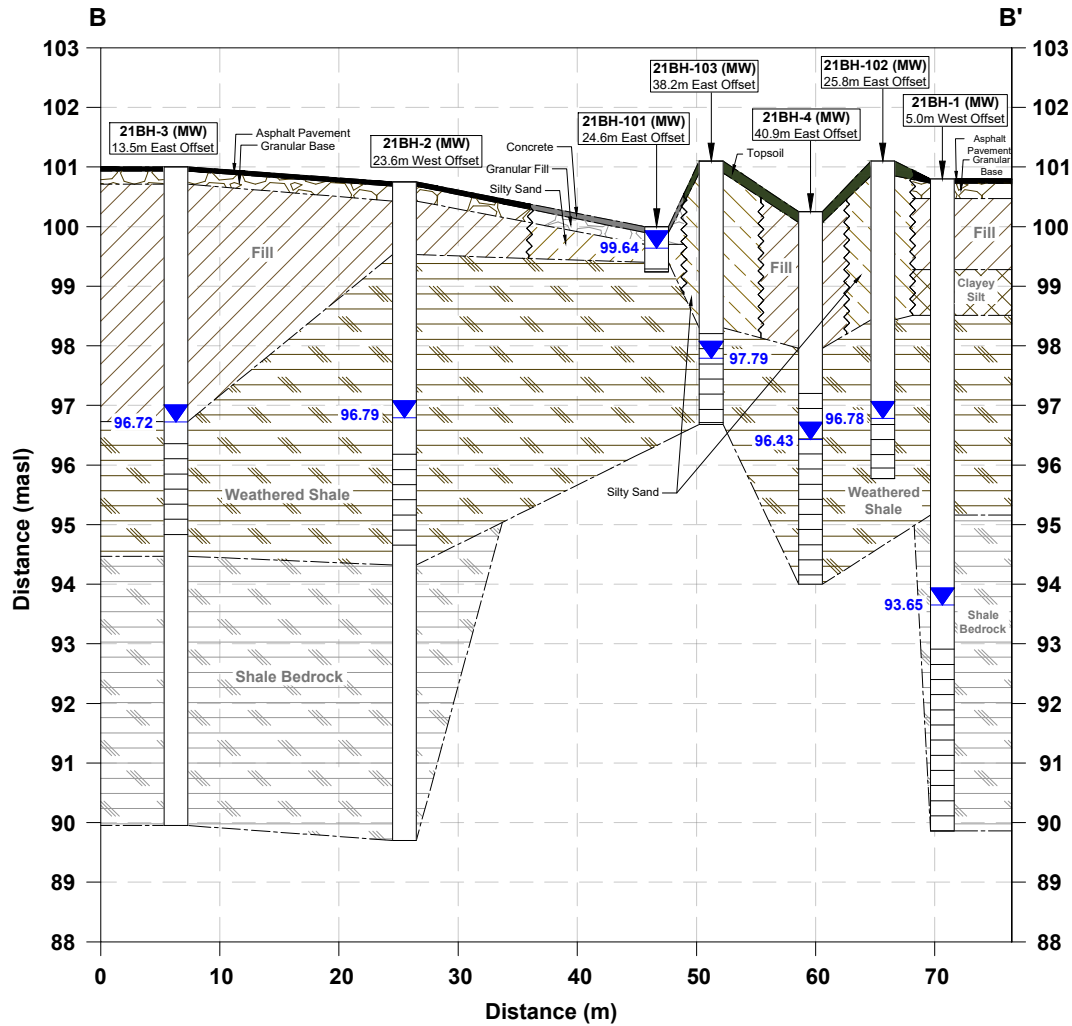
TITLE: Section B-B'	
LOCATION: 50 Speers Road, Oakville, Ontario	
PROJECT NO. 5557-23-EE	DATE: July 2023
FIGURE NO. 7

NOTES:
Vertical Exaggeration: 5x
