January 27, 2023 WE 22055

RE: 1075 North Service Road CH Floodplain Modelling Spill Issue

Conservation Halton Regulation Mapping

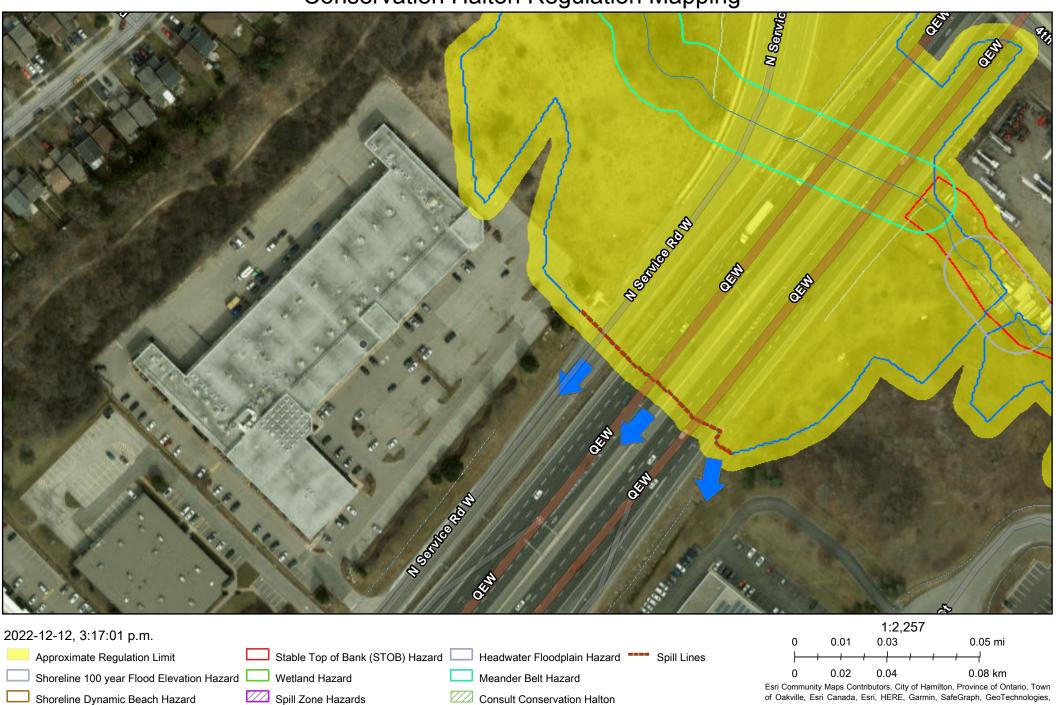
- There is existing flooding potential on the Subject Property as defined by the blue line on the CH figure. The floodplain touches the easterly boundary of the Subject Property but only impacts the existing parking lot area in a very minimal manner (noting that the yellow highlight is only a planning buffer on the actual hazard limit);

- A spill area has been defined as being present by the red dashed line crossing the North Service Road and the eastbound and west bound lanes of the QEW;

- 3 Spill direction is indicated by the blue arrows as located on the North Service Road as well as on the QEW, i.e. the spill arrows are not located on the Subject Property;

- The limits of the spill zone are within public rights-of-way and are not present on the Subject Property;
- Any spill that may occur would be minor in nature as it would only be generated by shallow floodwaters in the fringe areas of the creek;

- Should any spill occur, topography would suggest that the spill would be towards the QEW and not the North Service Road as the QEW is lower than the North Service Road, particularly the local ditch between the North Service Road and the QEW;

- Sound a spill occur along the North Service Road, such a spill would be constrained by the existing ditch system of the North Service Road and conveyed westerly without impacting the Subject Property; and,

8 In discussions with Ms. Alex Lenarduzzi, CH concurs with the conclusion that flows would be contained within the ditch systems and not impact the Subject Property.

As such, it is our professional opinion that there is no hazard present on the Subject Property. Any spill, should it occur, would be within public rights-of-way. If spill were to occur on the North Service Road, it would be contained within the ditch systems of the North Service Road and not impact the Subject Property.
