- **PHASE I ENVIRONMENTAL SITE ASSESSMENT**

**Part of Lot 10, Concession 1  
(North of Dundas St. E., east of Eighth Line)  
Oakville, ON**

HAM-00800615-A0

May 26, 2014

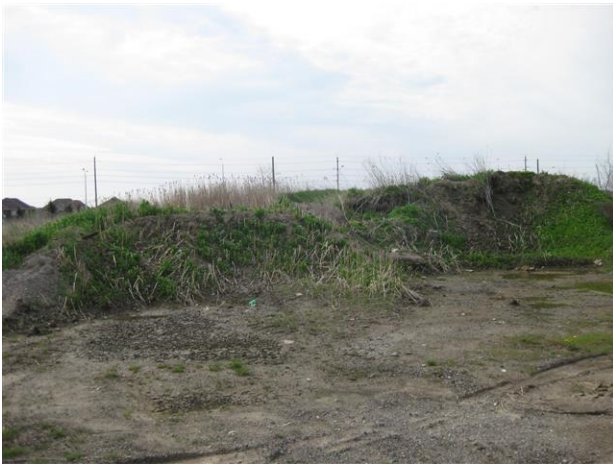
.Large stockpiles of soil partially covered in vegetation consisting of top soil and clay/silt were observed on the south portion of the Site. According to the Site representative, this material originates from on-Site.

Photo 1: View of stockpiles on the south portion of the Site (facing south).

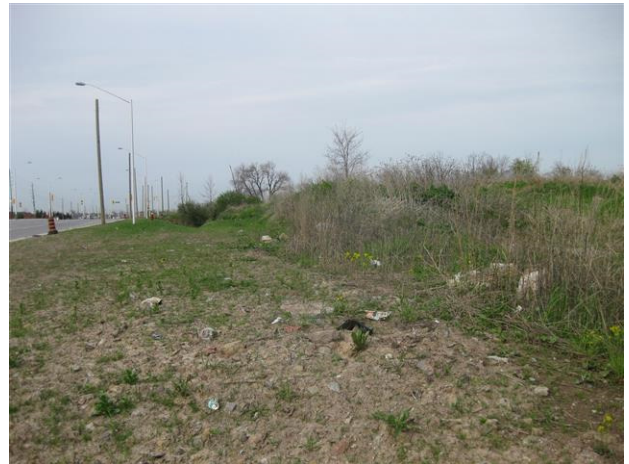
Photo 2: View of the road allowance (facing west).

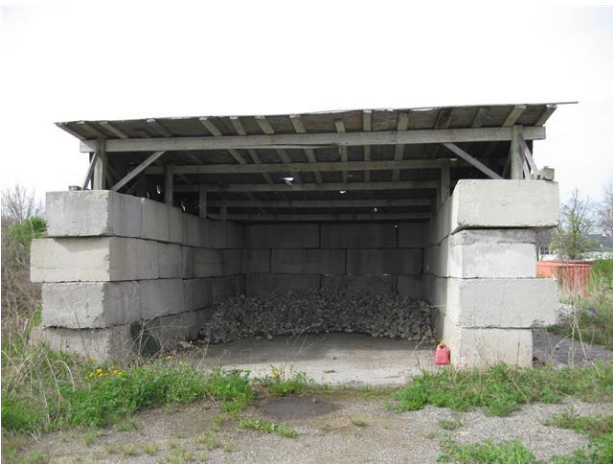
A minor oil stain was observed in front of the concrete structure (landscape material storage).

Photo 3: View of the concrete structure containing landscaping material.

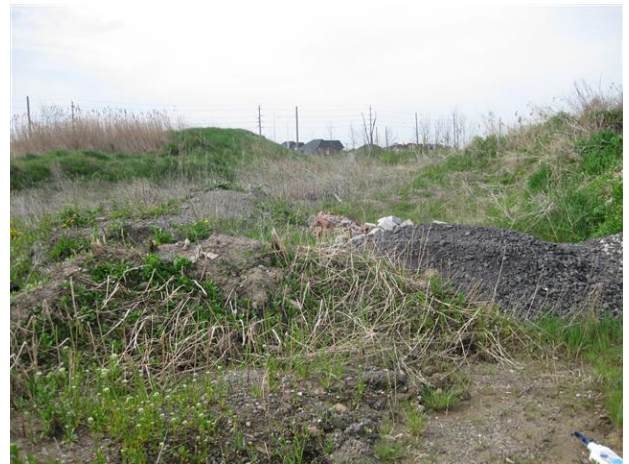
A few small piles of construction material / fill material were observed on the south portion of the Site. According to the Site representative, the material has been illegally dumped on the Site and will be removed prior to development.

Photo 4: View of the small fill piles on the south portion of the Site.

Issue Identified	Recommendation	Rationale
Presence of waste materials	Solid waste materials should be disposed off-Site to a licensed waste facility	To comply with waste management regulations

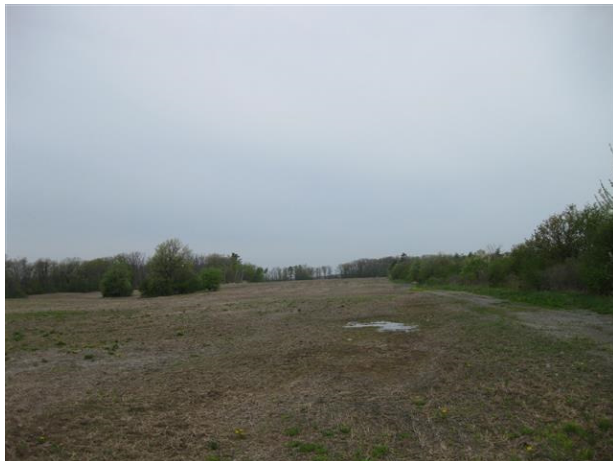
Photo 5: View of the north portion of the Site (agricultural land) (facing north).

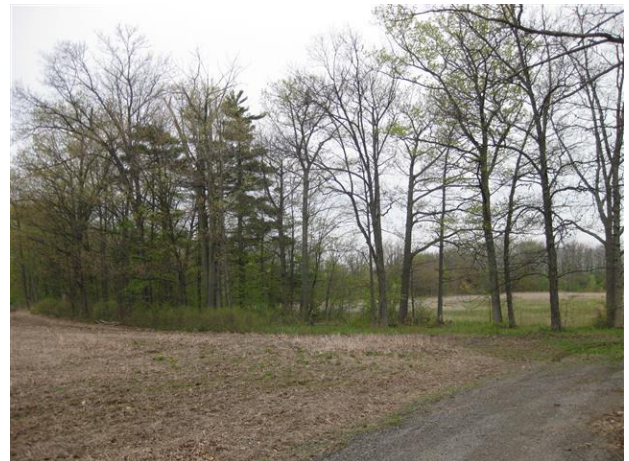
Photo 6: View of the eastern boundary of the Site (facing northeast).

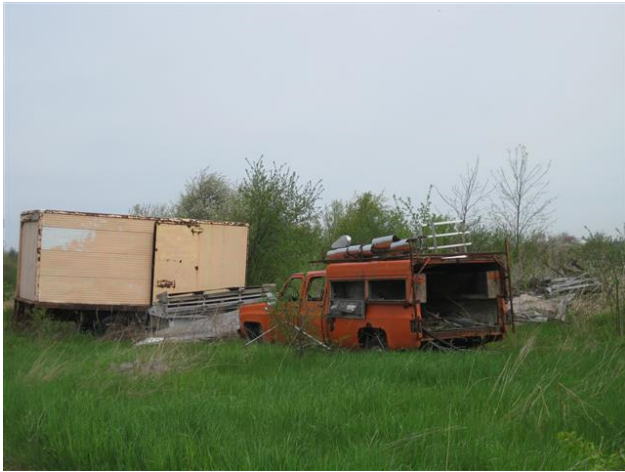
An abandoned truck was observed on the south portion of the Site.

Wooden planks were observed in the vicinity of the trailer and truck located along the eastern boundary of the Site.

Photo 7: View of storage container, truck and wooden skids on the southeast portion of the Site.

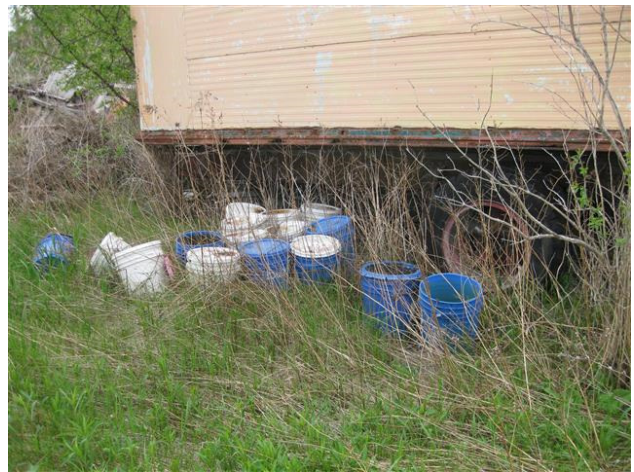
Several 20 L pails of “Durock” (Exterior Insulation Finish Systems- EIFS) were observed at the southeast portion of the Site in the vicinity of the storage container and abandoned truck. The contents of the pails were not known.

No evidence of spillage or leaks was noted from the pails at the time of the Site visit. No other significant chemical inventory, storage or evidence of chemical handling was observed or reported at the time of the Site visit.

Photo 8: View of 20 L containers in the vicinity of Trailer (refer to Section 5.1.4).

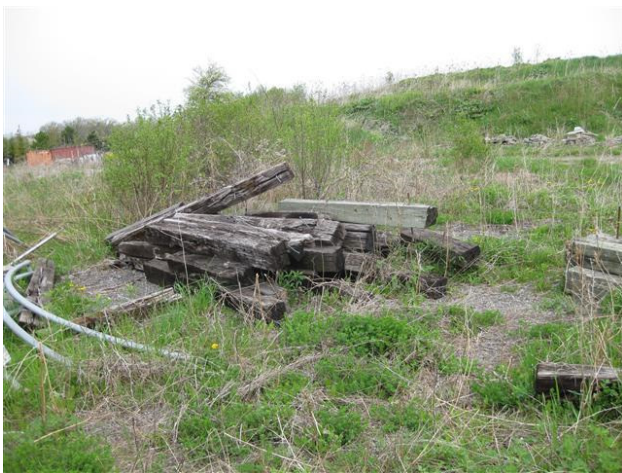
The south portion of the Site was previously occupied by a landscaping company. Landscaping rocks and paving slabs were observed on the south portion of the Site. Old railway ties and metal pieces were also observed. This waste material will be removed prior to development of the Site.

Photo 9: View of old railway ties on the south portion of the Site.

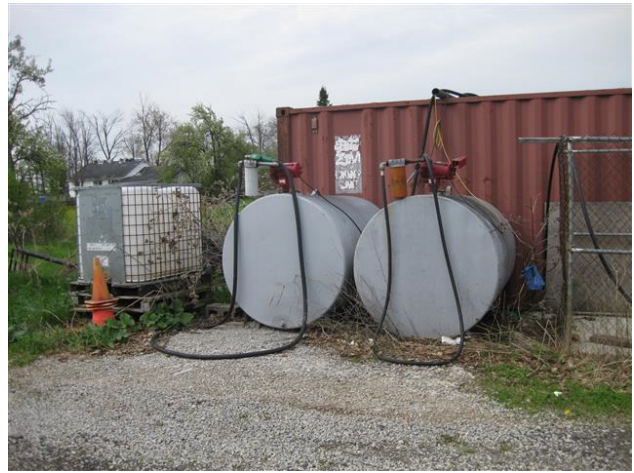
Two aboveground storage tanks were observed on the west adjacent property (west of the shed located at 3043 Dundas Street East. No evidence of spills or staining was observed on the gravel surface in the vicinity of the tanks at the time of the Site visit.

Photo 10: View of the aboveground storage tanks (ASTs) on the west adjacent property.
