**REPORT ON  
RESULTS OF PHASE 2  
SUBSURFACE ENVIRONMENTAL  
SITE ASSESSMENT  
349 DAVIS RD.  
OAKVILLE, ONTARIO**

Ref. No. G-04.0106  
March 2004

**RESULTS OF PHASE 2 SUBSURFACE  
ENVIRONMENTAL SITE ASSESSMENT  
349 DAVIS ROAD  
OAKVILLE, ONTARIO**

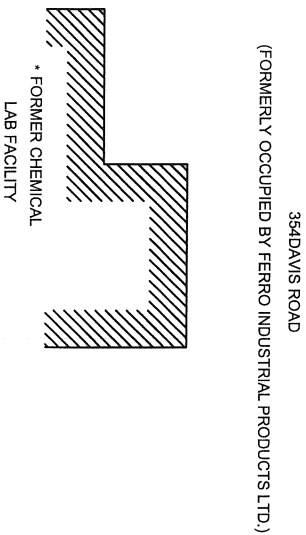
As indicated on the attached Figures No.1 and 2, a total of six (6) boreholes were distributed throughout the subject property, with two (2) boreholes near the southern property limit, two (2) boreholes along the eastern property limit, one borehole near the northern property limit, and a final borehole along the northern exterior wall of the existing structure. The boreholes along the eastern and southern property limits were placed in response to the findings of our Phase I ESA, which indicated that an underground storage tank had recently been removed from 359 Davis Road, and that an unapproved hazardous landfill site is present to the immediate south of the subject property (354 Davis Road, formerly occupied by Ferro Industrial Products). It should be

BOREHOLE WITH WATER MONITORING WELL  
BOREHOLE

\* THE LOCATIONS OF THESE FORMER FEATURES ARE HIGHLY APPROXIMATE AND HAVE BEEN ESTIMATED FROM FIRE INSURANCE MAPS AND ANECDOTAL INFORMATION

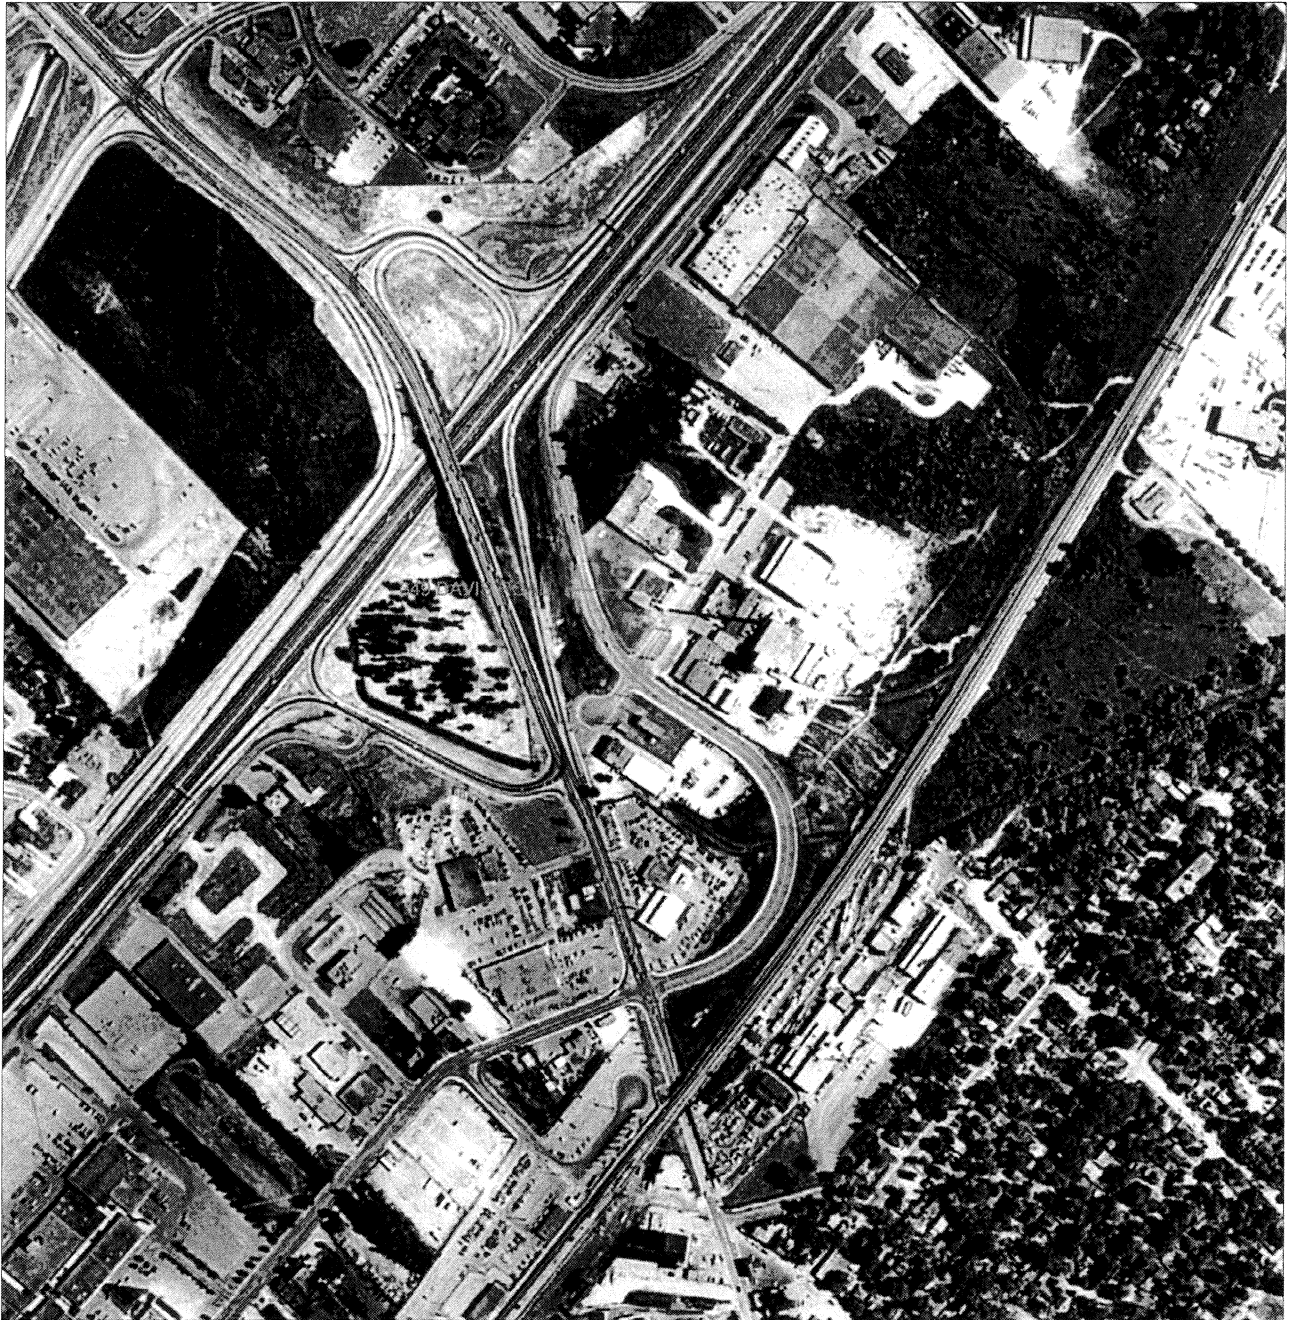
349 DAVIS ROAD  
AERIAL PHOTOGRAPH FROM 1978

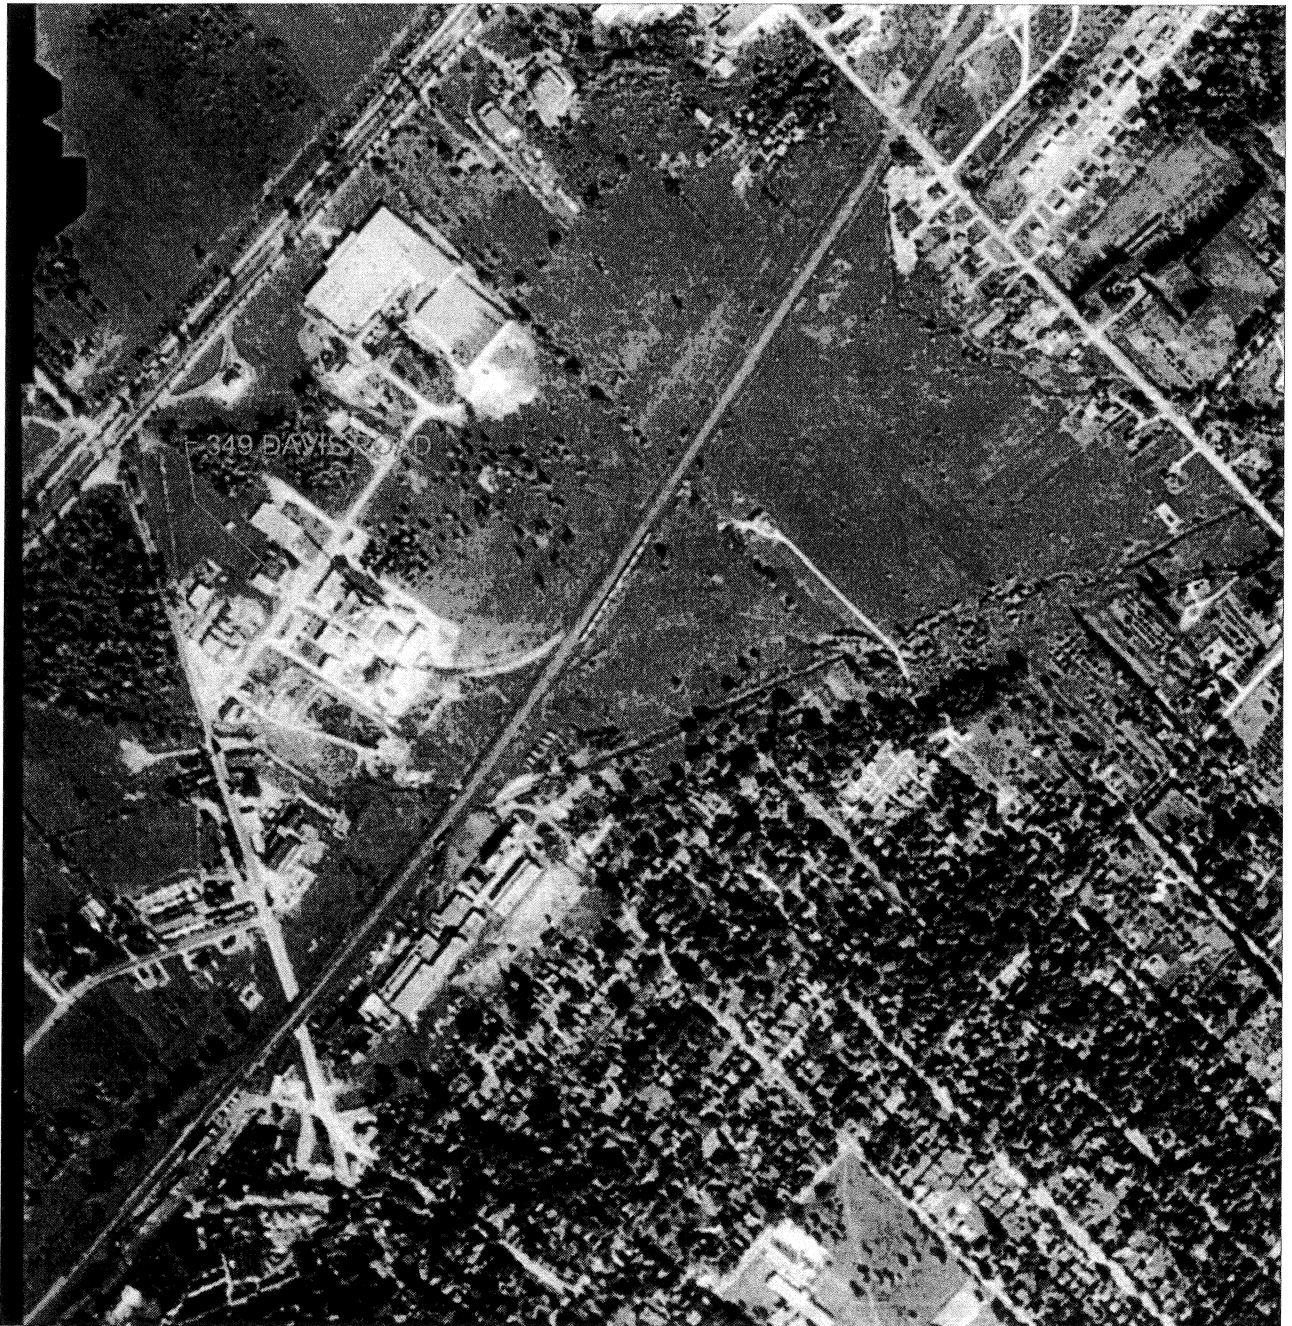
349 DAVIS ROAD  
AERIAL PHOTOGRAPH FROM 1954
