1
TI-1
TREE INVENTORY, PROTECTION, AND REMOVALS PLAN
SCALE: 1:300

STAMP	DATE JANUARY 2026
	DRAWN BY NV
ISSUED FOR OPA ONLY NOT FOR CONSTRUCTION	PLAN SCALE 1:300
All drawings and specifications are instruments of service and will remain the property of MHBC Planning and must be returned at the completion of the work. This drawing shall not be used for construction purposes unless the drawings are marked 'Issued for Construction' and the professional seal is signed and dated by the landscape architect.	FILE NO. 20375F
PROJECT 1493 6TH LINE OAKVILLE, ONTARIO	CHECKED BY N.M.
FILE NAME TREE INVENTORY, PROTECTION, AND REMOVALS	OTHER
	DWG NO. TI-1

DRAWN BY NV
	PLAN SCALE -
	FILE NO. 20375F
	CHECKED BY N.M.
OTHER	
PROJECT 1493 6TH LINE OAKVILLE, ONTARIO	
FILE NAME TREE INVENTORY, PROTECTION, AND REMOVALS	DWG NO. TI-2

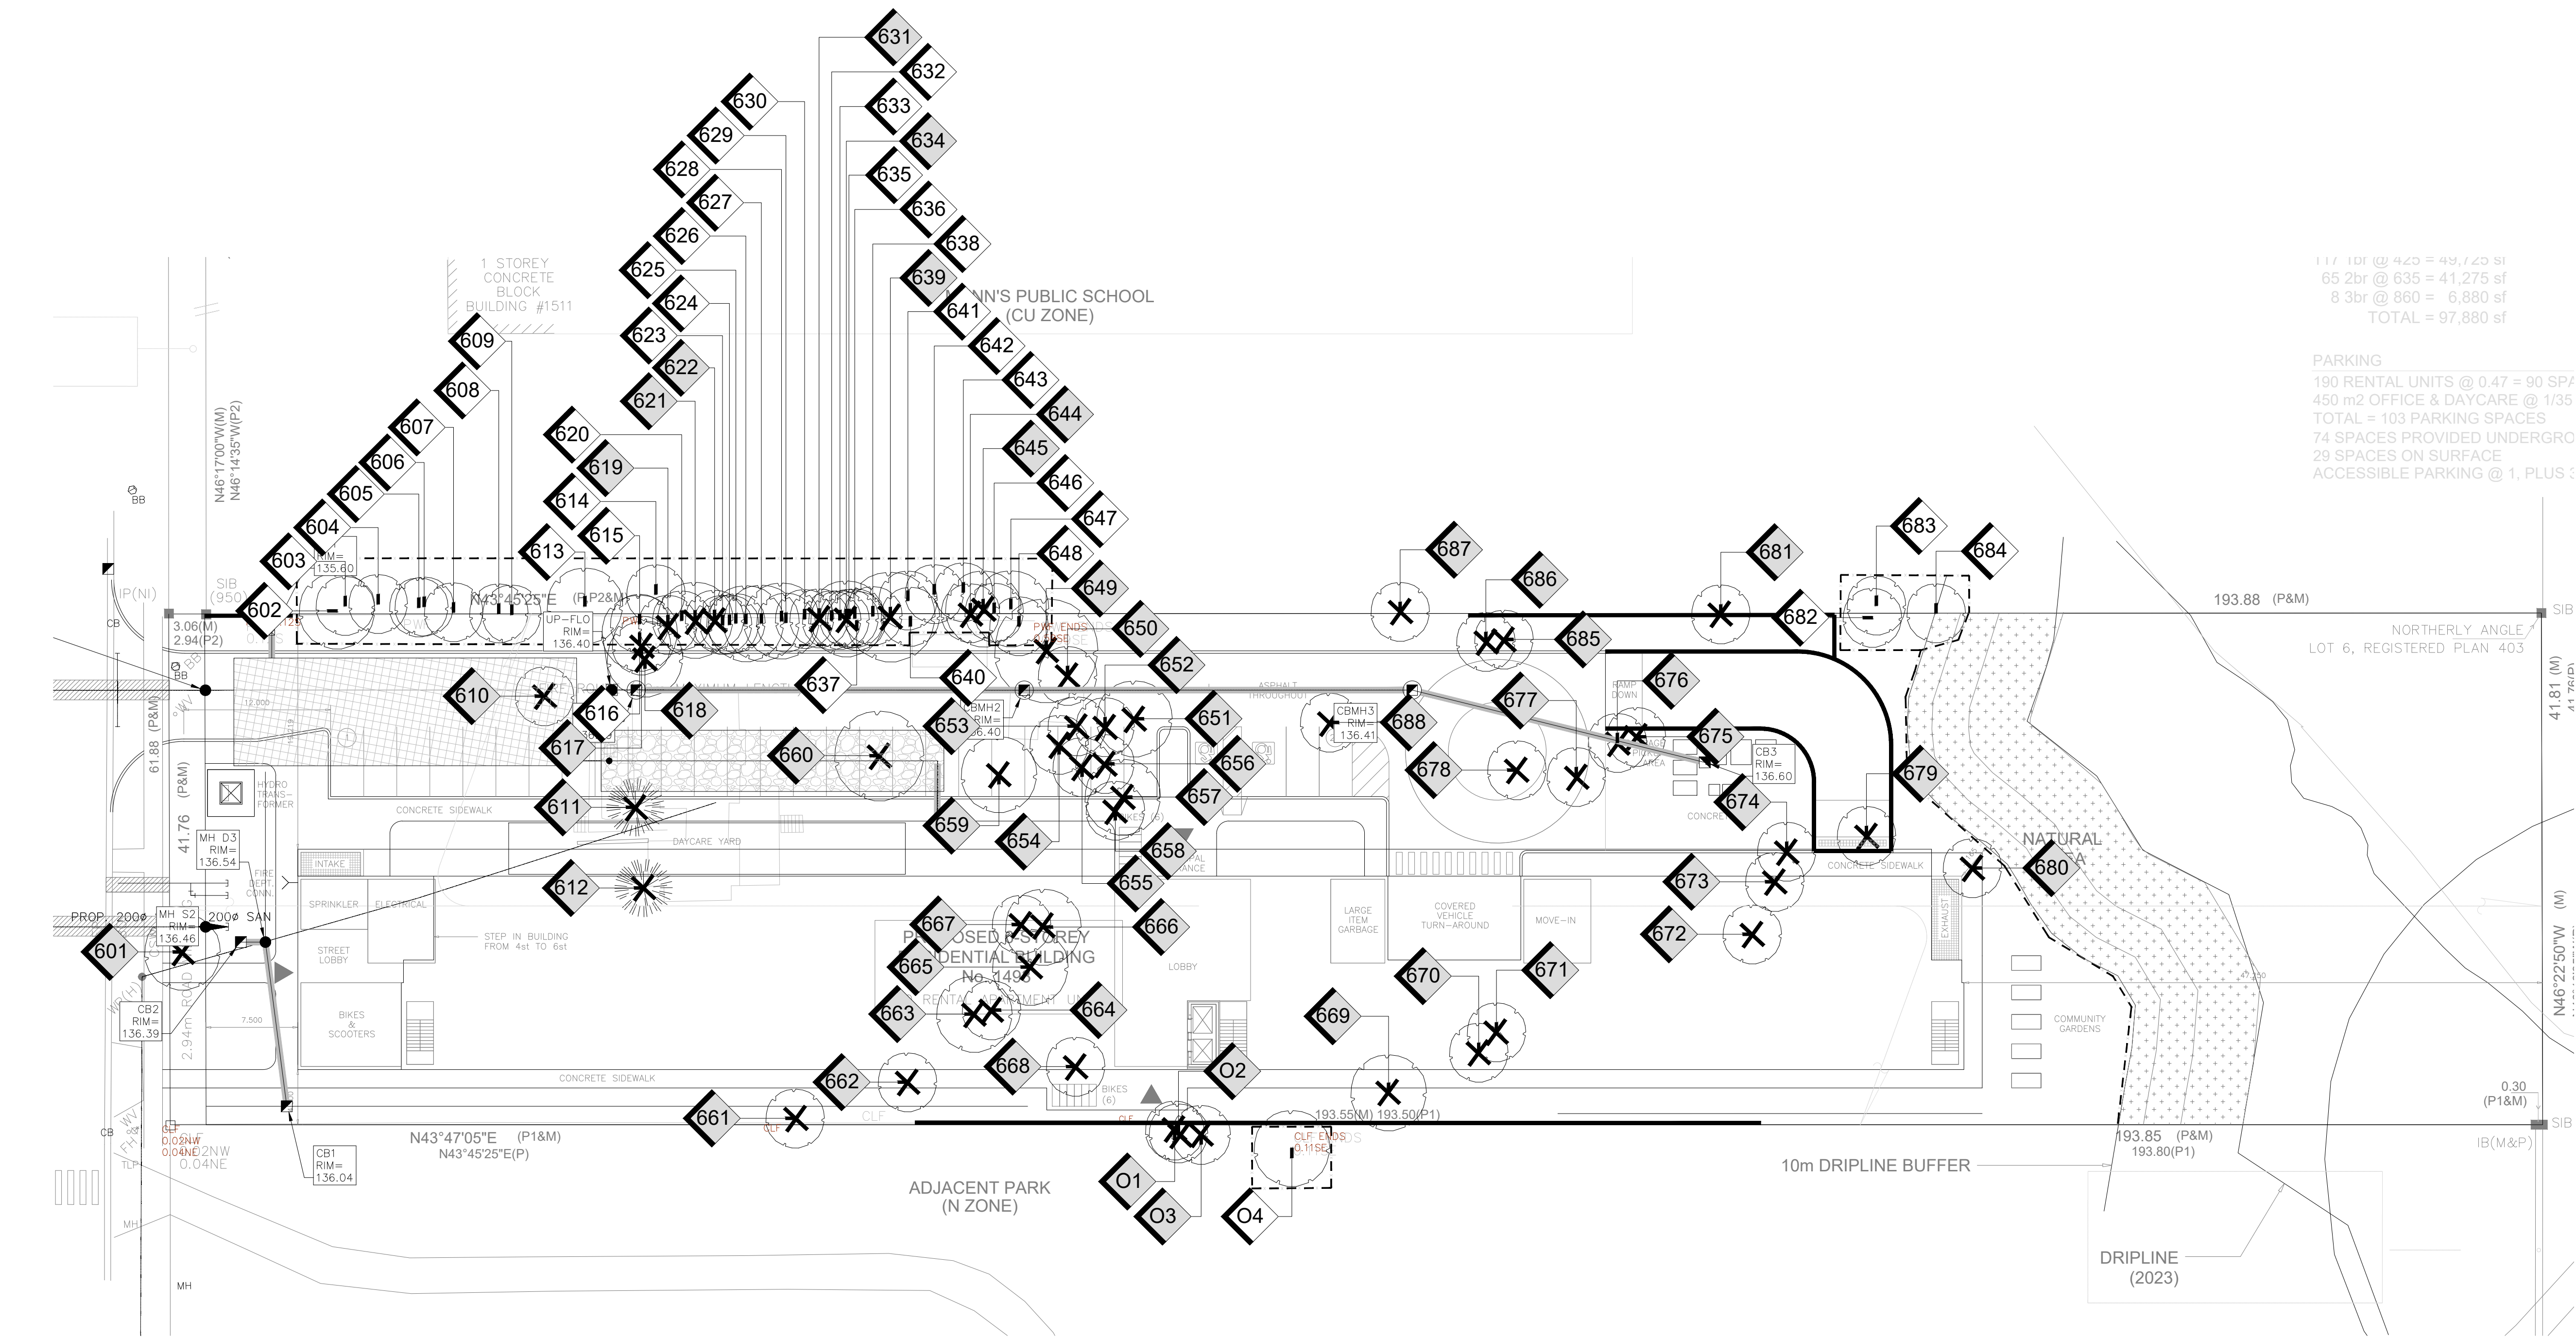
- EXISTING DECIDUOUS TREE TO REMAIN
- EXISTING DECIDUOUS TREE TO BE REMOVED (REFER TO ARBORIST REPORT)
- EXISTING CONIFEROUS TREE TO BE REMOVED (REFER TO ARBORIST REPORT)
- TREE IDENTIFICATION KEY (TREES TO BE RETAINED)
- TREE IDENTIFICATION KEY (TREES TO BE REMOVED)
- TREE PROTECTION FENCING PER TOWN OF OAKVILLE STANDARDS

- The tree inventory includes assessment of trees >10cm DBH. The trees have been assessed based on species, size and condition.
 - The contractor shall check and verify all existing and proposed grading and conditions on the project and immediately report any discrepancies to the consultant before proceeding with any removals.

Tree No.	Owner	Common Name	Botanical Name	DBH (CM)	Min. TPZ Radius (M)	Cond.	Structure	Canopy Diameter (M)	Comments	Recommendation
601	Private	Norway Maple	Acer platanoides	37	3.0	F/P	P	12	Minor deadwood throughout, imbalanced canopy, growing in overhead wires, main leader is dead at top, heavily pruned previously	Remove due to construction
602	Neighbour/ Boundary	Siberian Elm	Ulmus pumila	36	3.0	F	F	8	Multi-stem, growing through wire fence	Retain
603	Neighbour	Norway Maple	Acer platanoides	26	2.4	F	F	7	Growing through wire fence, minor deadwood throughout	Retain
604	Neighbour	Norway Maple	Acer platanoides	27	2.4	F	F	9		Retain
605	Neighbour	Norway Maple	Acer platanoides	30	2.4	F	F	8		Retain
606	Neighbour	Norway Maple	Acer platanoides	23	2.4	F	F	6	Mild lean away from subject site, imbalanced canopy with majority of limbs on northern side of tree	Retain
607	Neighbour/ Boundary	Norway Maple	Acer platanoides	17	2.4	F	F	8	Growing through wire fence	Retain

608	Neighbour/ Boundary	Norway Maple	Acer platanoides	29	2.4	F/P	F/P	14	3 stem at 0.8 metres, moderate deadwood throughout	Retain
609	Neighbour/ Boundary	Norway Maple	Acer platanoides	21	2.4	F	F	8	Elevated canopy	Retain
610	Private	Norway Maple	Acer platanoides	28	2.4	F/P	F/P	8	Moderate deadwood throughout, tree is in decline, mildew disease evident	Remove due to construction
611	Private	Cedar Sp.	Thuja Sp.	26	2.4	F	F	5		Remove due to construction
612	Private	Cedar Sp.	Thuja Sp.	27	2.4	F	F	6	Multi-stem	Remove due to construction
613	Neighbour	Norway Maple	Acer platanoides	33	3.0	F	F	16	3 stem at base, minor deadwood throughout	Retain
614	Neighbour	Norway Maple	Acer platanoides	18	2.4	F/P	F/P	8	Imbalanced canopy with majority of limbs on northern side of tree, cavity at 2.5 metres with signs of internal rot evident	Retain
615	Private	Siberian Elm	Ulmus pumila	27	2.4	F/P	F/P	4	Mild lean, elevated canopy, minor deadwood throughout	Retain

616	Private	Siberian Elm	Ulmus pumila	47	3.0	F	F	18	2 stem at 0.9 metres, one main limb with mild to moderate lean	Retain
617	Private	Norway Maple	Acer platanoides	20	2.4	F	F/P	9	Minor to moderate deadwood throughout, moderate lean	Remove due to construction
618	Private	Siberian Elm	Ulmus pumila	47	3.0	F	F	16	Minor deadwood throughout	Remove due to construction
619	Private	Siberian Elm	Ulmus pumila	27	2.4	D	-	-	Tree is 100% dead	Remove due to condition
620	Private	Siberian Elm	Ulmus pumila	23	2.4	F	F	5	Moderate lean away from subject site	Retain
621	Private	Siberian Elm	Ulmus pumila	33	3.0	P/D	P	4	2 stem at 1.3 metres, one stem dead, one stem 85% dead, significant deadwood throughout	Remove due to condition
622	Private	Siberian Elm	Ulmus pumila	18	2.4	P/D	P	2	Tree is 95% dead	Remove due to condition
623	Private	Norway Maple	Acer platanoides	21	2.4	F	F/P	7	Elevated canopy, moderate deadwood throughout	Retain

624	Private	Norway Maple	Acer platanoides	15	2.4	P	P	4	Significant deadwood throughout, tree is in decline	Retain
625	Private	Siberian Elm	Ulmus pumila	30	2.4	F	F	8	2 stem at 0.7 metres	Retain
626	Private	Siberian Elm	Ulmus pumila	46	3.0	F	F	10	Moderate lean away from subject site	Retain
627	Private	Siberian Elm	Ulmus pumila	34	3.0	F	F/P	8	One stem previously cut at 1.2 metres, moderate lean away from subject site, multiple bows throughout	Retain
628	Private	Siberian Elm	Ulmus pumila	31	3.0	F	F	10	Minor to moderate deadwood throughout	Retain
629	Private	Norway Maple	Acer platanoides	15	2.4	F	F/P	8	Moderate deadwood throughout	Retain
630	Private	Siberian Elm	Ulmus pumila	21	2.4	F	F	5	Moderate lean away from subject site	Retain
631	Private	Siberian Elm	Ulmus pumila	24	2.4	D	-	-	Tree is 100% dead	Remove due to condition
632	Private	Norway Maple	Acer platanoides	21	2.4	F/P	F/P	6	Moderate to significant deadwood throughout, elevated canopy	Retain

633	Private	Siberian Elm	Ulmus pumila	39	3.0	F	F	10	2 stem at base, smaller stem with significant lean into subject site	Retain
634	Private	Siberian Elm	Ulmus pumila	17	2.4	D	P		Tree is 98% dead, significant deadwood throughout	Remove due to condition
635	Private	Norway Maple	Acer platanoides	18	2.4	F	F/P	7	Moderate deadwood throughout, elevated canopy	Retain
636	Private	Siberian Elm	Ulmus pumila	29	2.4	F/P	P	10	2 stem at 1.1 metres, one of two stems is dead	Retain
637	Private	Norway Maple	Acer platanoides	20	2.4	F	F	7	Minor deadwood throughout, mild lean into subject site	Retain
638	Private/ Boundary	Siberian Elm	Ulmus pumila	51	3.6	F	F	15		Retain
639	Private	Siberian Elm	Ulmus pumila	19	2.4	D	-	-	Tree is 100% dead	Remove due to condition
640	Private	Siberian Elm	Ulmus pumila	22	2.4	P/D	P	4	2 stem at 0.5 metres, one stem dead	Retain
641	Neighbour	Norway Maple	Acer platanoides	21	2.4	F	F/P	8	Moderate deadwood throughout, moderate lean away from subject site	Retain

642	Neighbour	Norway Maple	Acer platanoides	18	2.4	F	F	9	Minor deadwood throughout	Retain
643	Neighbour	Norway Maple	Acer platanoides	26	2.4	F	F	11	Minor deadwood throughout	Retain
644	Neighbour/ Boundary	Siberian Elm	Ulmus pumila	24	2.4	D	-	-	Tree is 100% dead	Remove due to condition
645	Neighbour	Siberian Elm	Ulmus pumila	44	3.0	D	-	-	Tree is 100% dead	Remove due to condition
646	Neighbour/ Boundary	Siberian Elm	Ulmus pumila	27	2.4	F	P	6	Significant bow at 7.0 metres into subject site	Retain
647	Neighbour	Norway Maple	Acer platanoides	43	3.0	F	F	15	Minor deadwood throughout	Retain
648	Private	Norway Maple	Acer platanoides	20	2.4	F	F	6		Retain
649	Private	Siberian Elm	Ulmus pumila	69	4.2	F	F	23	Minor deadwood throughout	Remove due to construction
650	Private	Siberian Elm	Ulmus pumila	25	2.4	F	F	9		Remove due to construction

651	Private	Norway Maple	Acer platanoides	35	3.0	F	F	17		Remove due to construction
652	Private	Norway Maple	Acer platanoides	17	2.4	F	F	6	Minor deadwood throughout	Remove due to construction
653	Private	Norway Maple	Acer platanoides	16	2.4	P	P	6	Moderate to significant deadwood throughout, signs of internal rot, tree is in decline	Remove due to construction
654	Private	Norway Maple	Acer platanoides	21	2.4	F	F	9	Minor deadwood throughout	Remove due to construction
655	Private	Norway Maple	Acer platanoides	17	2.4	F/P	F/P	6	Bow at base, suckers from 2 - 7 metres, minor deadwood throughout, elevated canopy	Remove due to construction
656	Private	Norway Maple	Acer platanoides	21	2.4	F	F	8		Remove due to construction
657	Private	Norway Maple	Acer platanoides	37	3.0	P	F/P	13	Cavity on south side of tree at 2.0 metres with evident internal rot, mild lean, minor deadwood throughout	Remove due to construction

658	Private	Norway Maple	Acer platanoides	27	2.4	F	F	14	Mild lean	Remove due to construction
659	Private	Norway Maple	Acer platanoides	32	3.0	F	F	12	Minor deadwood throughout	Remove due to construction
660	Private	Silver Maple	Acer saccharinum	60	3.6	F/P	F	14	Moderate deadwood throughout	Remove due to construction
661	Private	Norway Maple	Acer platanoides	18	2.4	P	P	3	Top of tree is dead, suckers throughout	Remove due to condition
662	Private	Basswood	Tilia americana	22	2.4	F	F	5	Minor deadwood throughout	Remove due to construction
663	Private	Norway Maple	Acer platanoides	50	3.0	F/P	P	8	Significant wound at 5.0 metres, suckers throughout, internal rot evident	Remove due to construction
664	Private	Elm Sp.	Ulmus Sp.	18	2.4	D	-	-	Tree is 100% dead	Remove due to construction
665	Private	Norway Maple	Acer platanoides	32	3.0	F	F	16	2 stem at 0.8 metres	Remove due to construction
666	Private	Norway Maple	Acer platanoides	33	3.0	F	F	14	Minor deadwood throughout	Remove due to construction

667	Private	Norway Maple	Acer platanoides	23	2.4	F	F	11	Mile lean, minor deadwood throughout	Remove due to construction
668	Private	Elm Sp.	Ulmus Sp.	19	2.4	F	F	10	2 stem at 0.4 metres, vertical cavity from 1 - 3 metres on southern stem	Remove due to construction
669	Private	Norway Maple	Acer platanoides	33	3.0	F/G	F	8		Remove due to construction
670	Private	Cherry Sp.	Prunus Sp.	24	2.4	F/P	F	5	Minor deadwood throughout	Remove due to construction
671	Private	Norway Maple	Acer platanoides	27	2.4	F	F	9	Minor deadwood throughout	Remove due to construction
672	Private	Cherry Sp.	Prunus Sp.	29	2.4	F/P	F	7	Moderate deadwood throughout	Remove due to construction
673	Private	Cherry Sp.	Prunus Sp.	24	2.4	F/P	F	8	Moderate deadwood throughout	Remove due to construction
674	Private	Cherry Sp.	Prunus Sp.	22	2.4	F/P	F	7	Minor deadwood throughout	Remove due to construction
675	Private	Elm Sp.	Ulmus Sp.	25	2.4	D	-	-	Tree is 100% dead	Remove due to construction

676	Private	Cherry Sp.	Prunus Sp.	20	2.4	F	F	5	Minor deadwood throughout	Remove due to construction
677	Private	Elm Sp.	Ulmus Sp.	19	2.4	P/D	P	2	Significant deadwood throughout, tree is 95% dead	Remove due to construction
678	Private	Norway Maple	Acer platanoides	29	2.4	F	F	8		Remove due to construction
679	Private	Common Buckthorn	Rhamnus cathartica	18	2.4	F/P	F/P	4	Moderate deadwood throughout	Remove due to construction
680	Private	Cherry Sp.	Prunus Sp.	28	2.4	F	F	7		Remove due to construction
681	Boundary	Norway Maple	Acer platanoides	25	2.4	F	F	9	Mild lean away from subject site, minor deadwood throughout	Remove due to construction
682	Private	Norway Maple	Acer platanoides	17	2.4	F	F	4		Retain
683	Neighbour	Norway Maple	Acer platanoides	20	2.4	F	F/P	6	Vertical wound from base to 3.0 metres callousing over, minor deadwood throughout	Retain
684	Boundary	Norway Maple	Acer platanoides	27	2.4	F	F	8	Minor deadwood throughout	Retain

685	Private	Common Buckthorn	Rhamnus cathartica	19	2.4	P	P	8	Significant deadwood throughout	Remove due to construction
686	Private	Common Buckthorn	Rhamnus cathartica	17	2.4	F/P	F/P	7	Moderate to significant lean, moderate deadwood throughout	Remove due to construction
687	Neighbour/ Boundary	Norway Maple	Acer platanoides	28	2.4	F	F	8		Remove due to construction
688	Private	Norway Maple	Acer platanoides	26	2.4	F	F	8		Remove due to construction
O1	Municipal Parkland	Norway Maple	Acer platanoides	24	2.4	F	F	12	Growing through chain link fence	Remove due to retaining wall construction
O2	Municipal Parkland	Norway Maple	Acer platanoides	19	2.4	F	F/P	13	2 stem at base, minor deadwood throughout, contorted stems	Remove due to retaining wall construction
O3	Municipal Parkland	Manitoba Maple	Acer negundo	28	2.4	F	F	9	Bow in trunk, minor deadwood throughout	Remove due to retaining wall construction
O4	Municipal Parkland	Common Buckthorn	Rhamnus cathartica	32	3.0	P/D	P	10	Water shoots throughout, significant deadwood throughout, tree is 85% dead	Retain

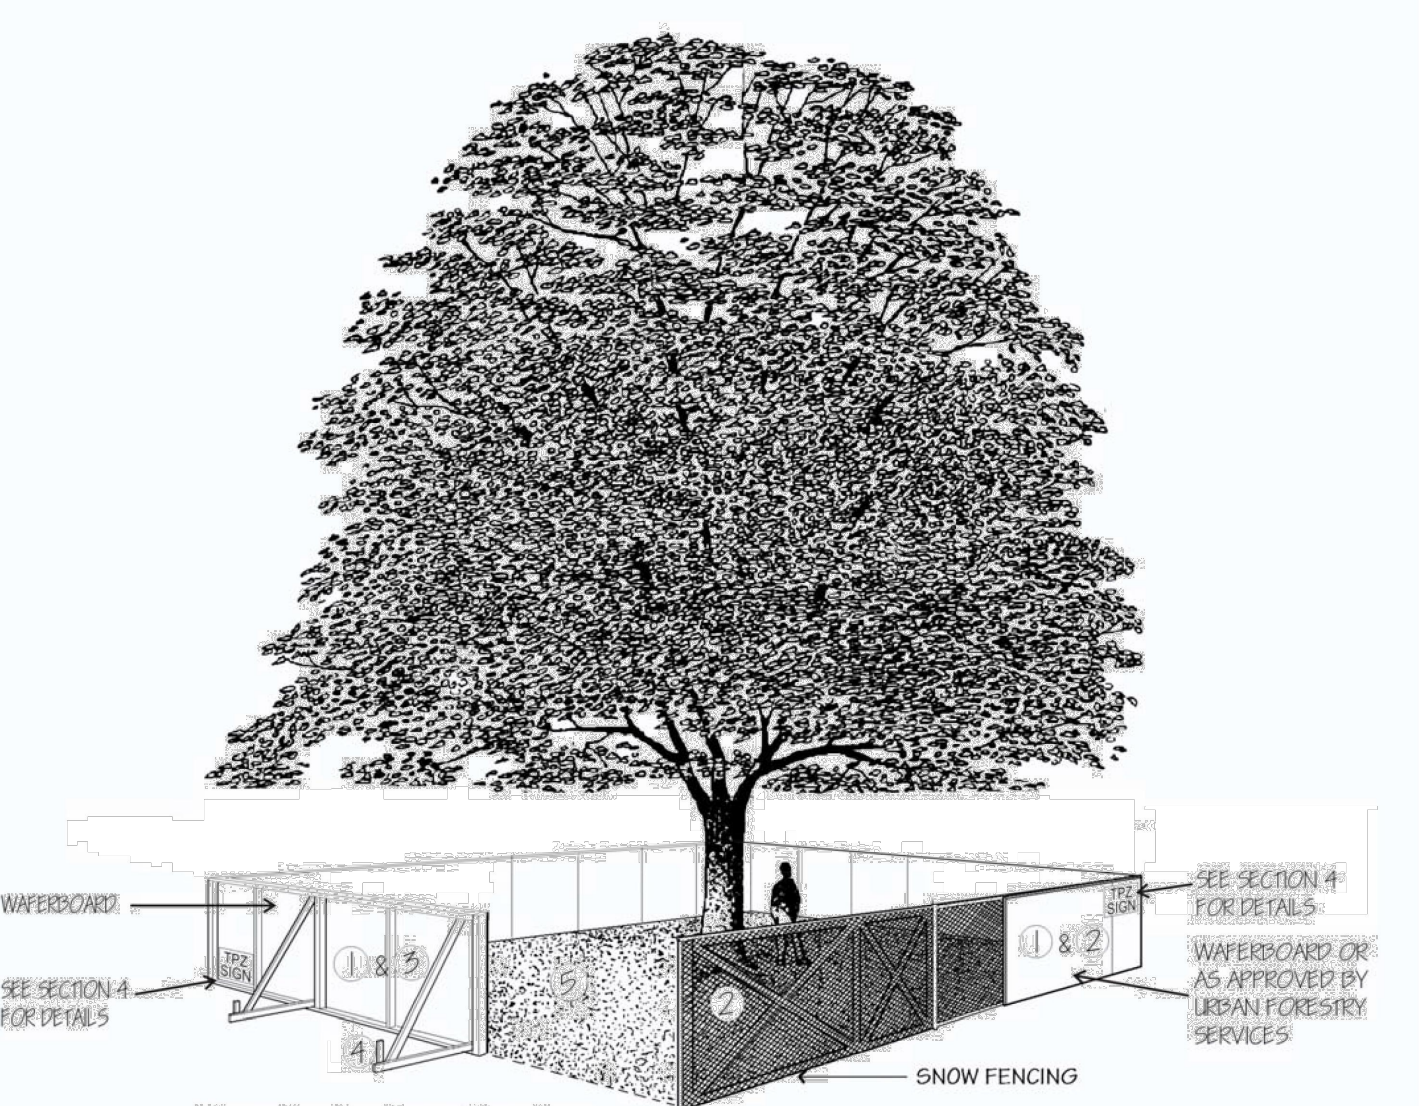
SCHEDULE 1 TREE PROTECTION BARRIER

Tree Protection Barriers

- Tree protection barriers must be 1.2m (4ft) high, waferboard hoarding or an equivalent approved by Urban Forestry Services.
- Tree protection barriers for trees situated on the Town road allowance where visibility must be maintained can be 1.2m (4ft.) high and consist of plastic web snow fencing on a wood frame made of 2"x 4"s .
- Where some excavate or fill has to be temporarily located near a tree protection barrier, plywood must be used to ensure no material enters the Tree Protection Zone.
- All supports and bracing should be outside the Tree Protection Zone. All such supports should minimize damaging roots outside the Tree Protection Barrier.
- No construction activity, grade changes, surface treatment or excavations of any kind is permitted within the Tree Protection Zone.
