## **PHASE TWO ENVIRONMENTAL SITE ASSESSMENT**

## **PROPOSED MIXED-USE DEVELOPMENT**

**2163 AND 2169 SIXTH LINE**

**Reference No. 1908-E077**

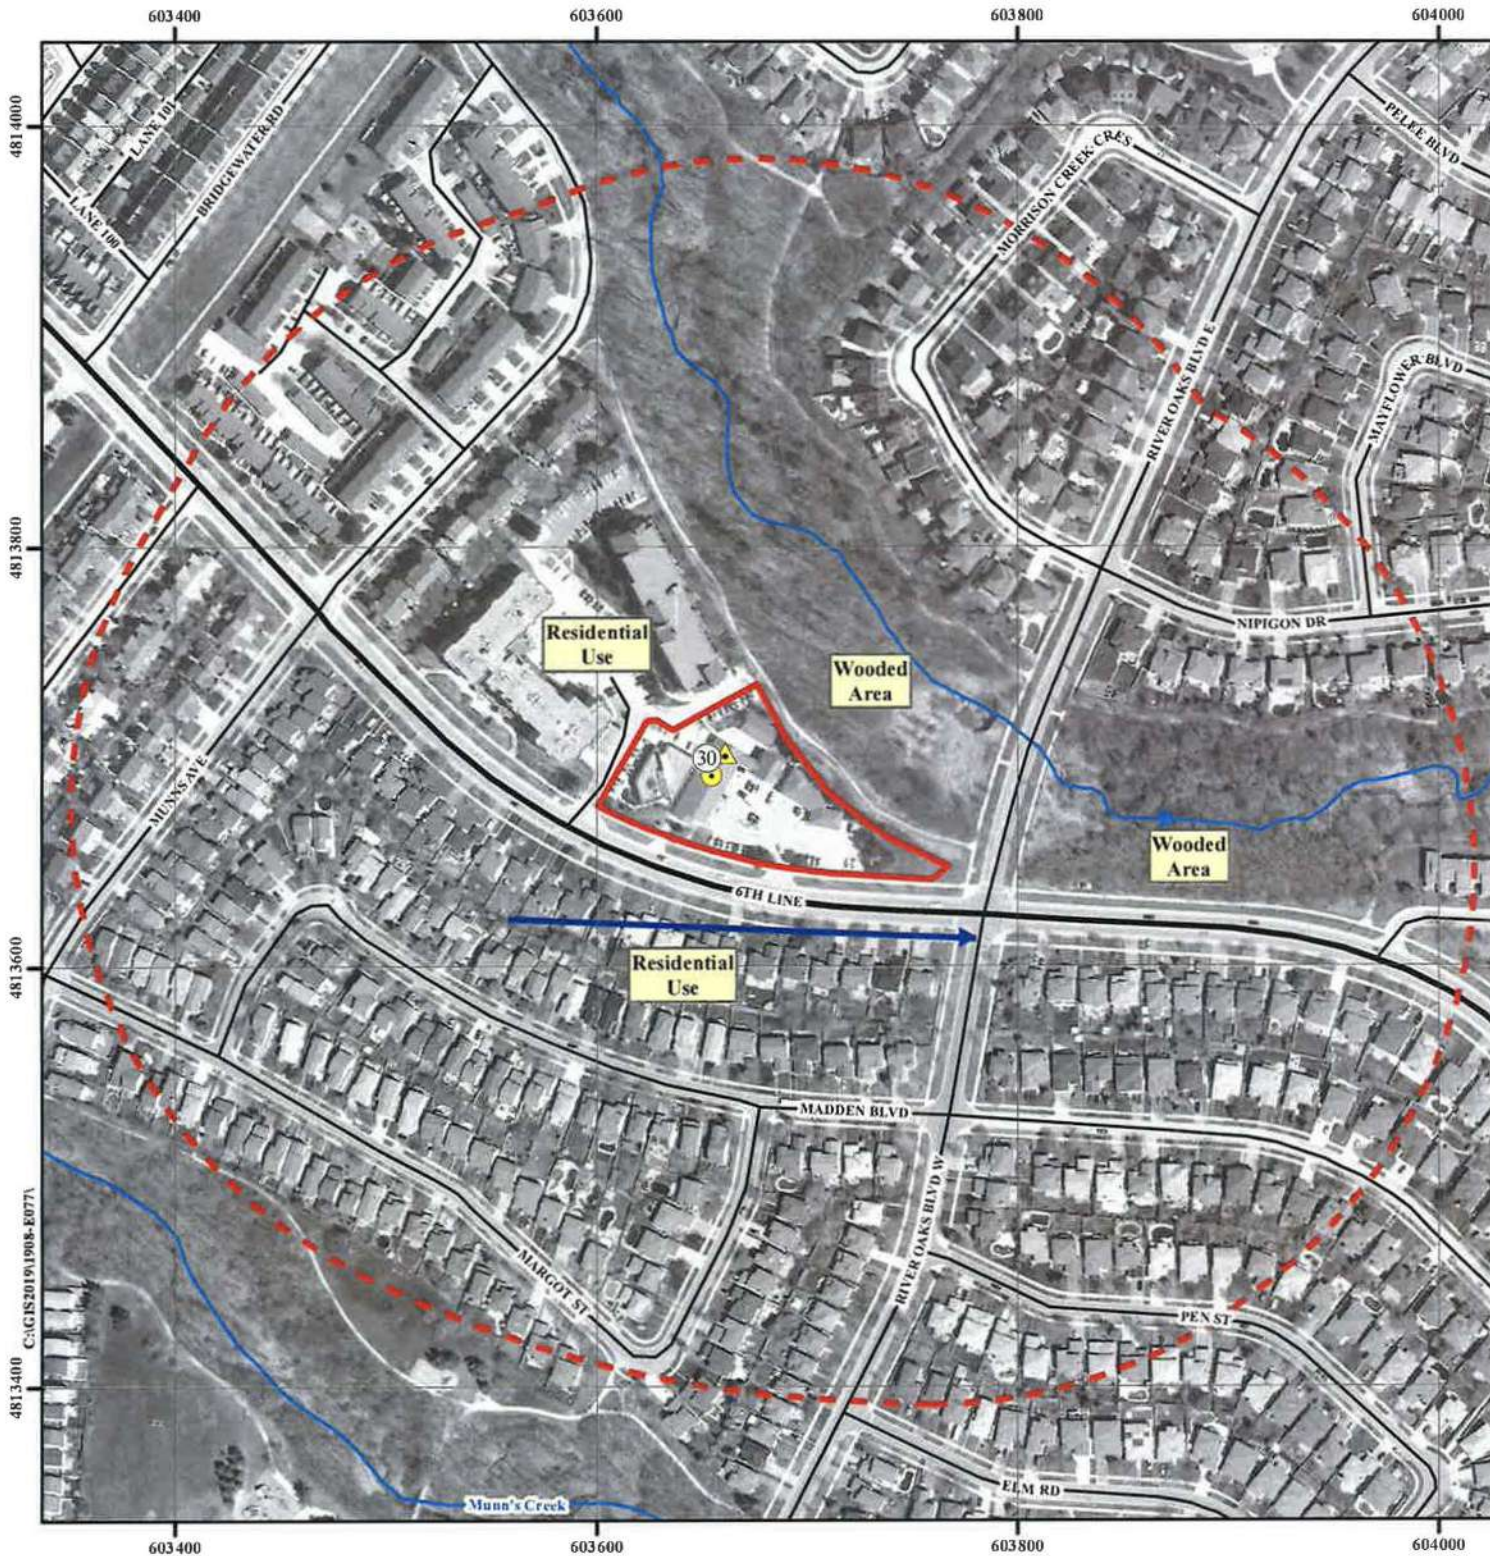
Drawing No. 1

- Subject Site
- Phase One Study Area
- Inferred Groundwater Flow Direction
- Watercourse
- Major Road
- Local Road
