**Phase Two Environmental Site
Assessment
358 Reynolds Street
Oakville, Ontario
Final Report**

October 25, 2021

Transmetro Limited

Stantec Consulting Ltd.
300W-675 Cochrane Drive
Markham ON L3R 0B8

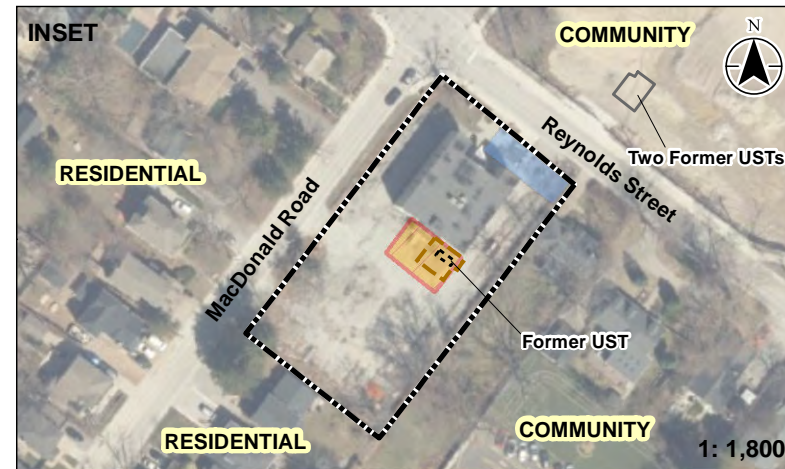
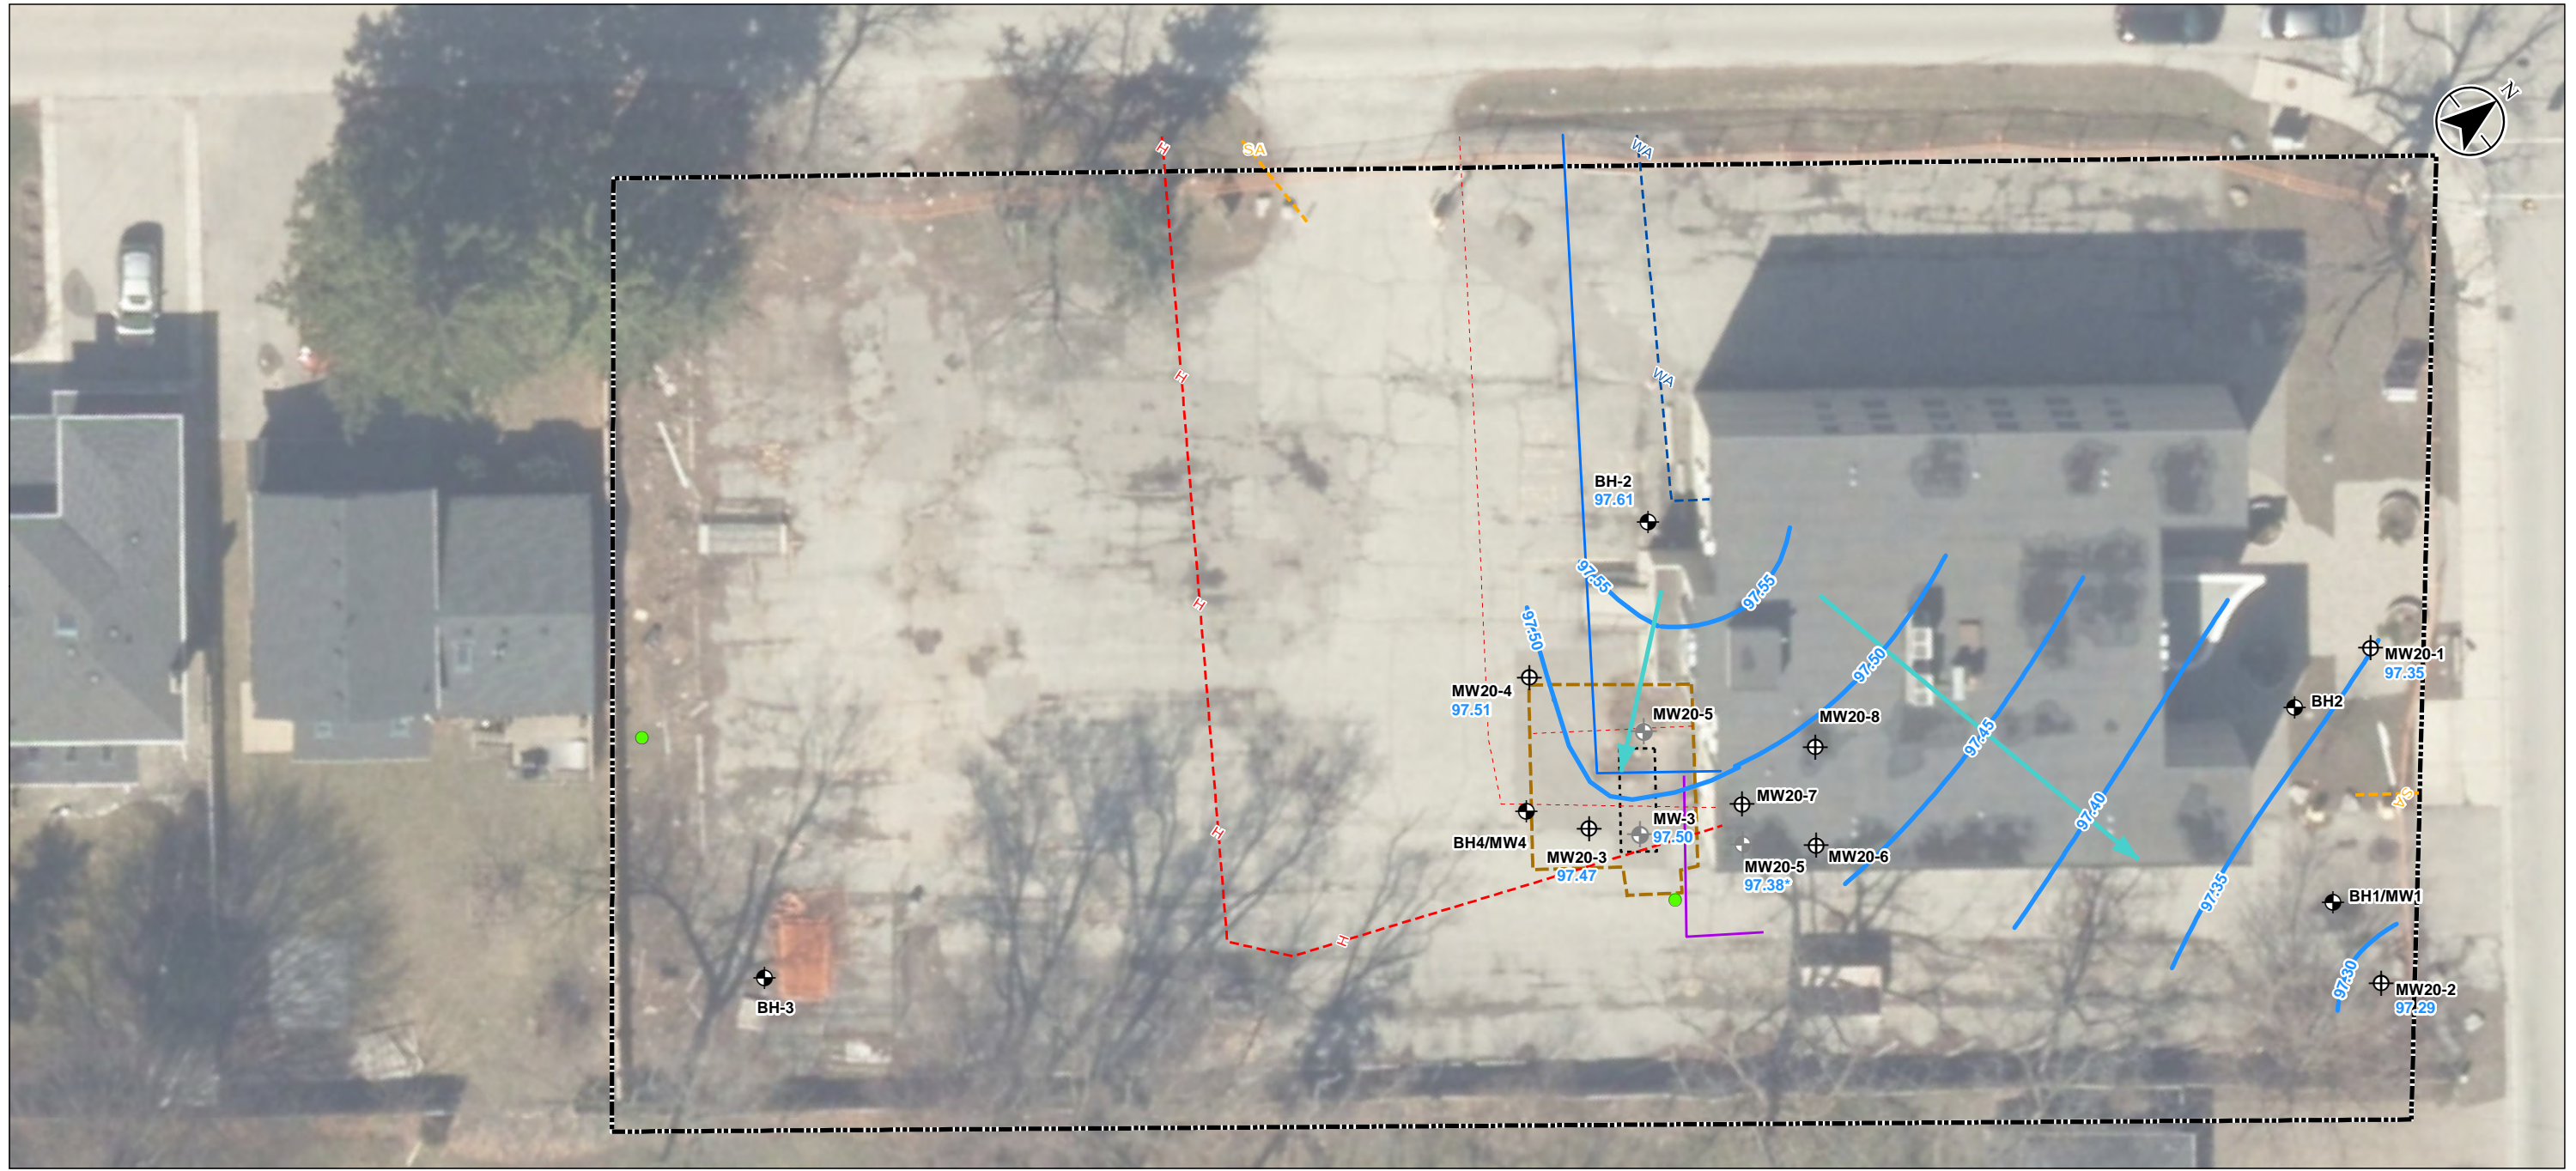
Based on the Phase Two ESA investigation, the interpreted ground water flow direction in the unconfined aquifer at the Phase Two Property is generally toward the east, with a southward/southeastward component in the central portion of the Site. Ground water levels were not measured in the southern and western portions of the Site and therefore flow direction in these areas cannot be confirmed. Ground water flow was inferred to be to the east in April 2020, however it should be noted that the water table in this area of the Site appears to be relatively flat based on the measurements taken in April of 2020, with a difference in ground water elevation of 0.04 m. Additionally, ground water level measurements in April 2020 were only collected from the southern portion of the site building and therefore the flow direction from this monitoring event is representative of this limited area of the Phase Two Property. Ground water levels are expected to vary seasonally and in response to individual precipitation events. The inferred ground water flow directions for January and April of 2020 are shown on **Figure Nos. 3a and 3b**.

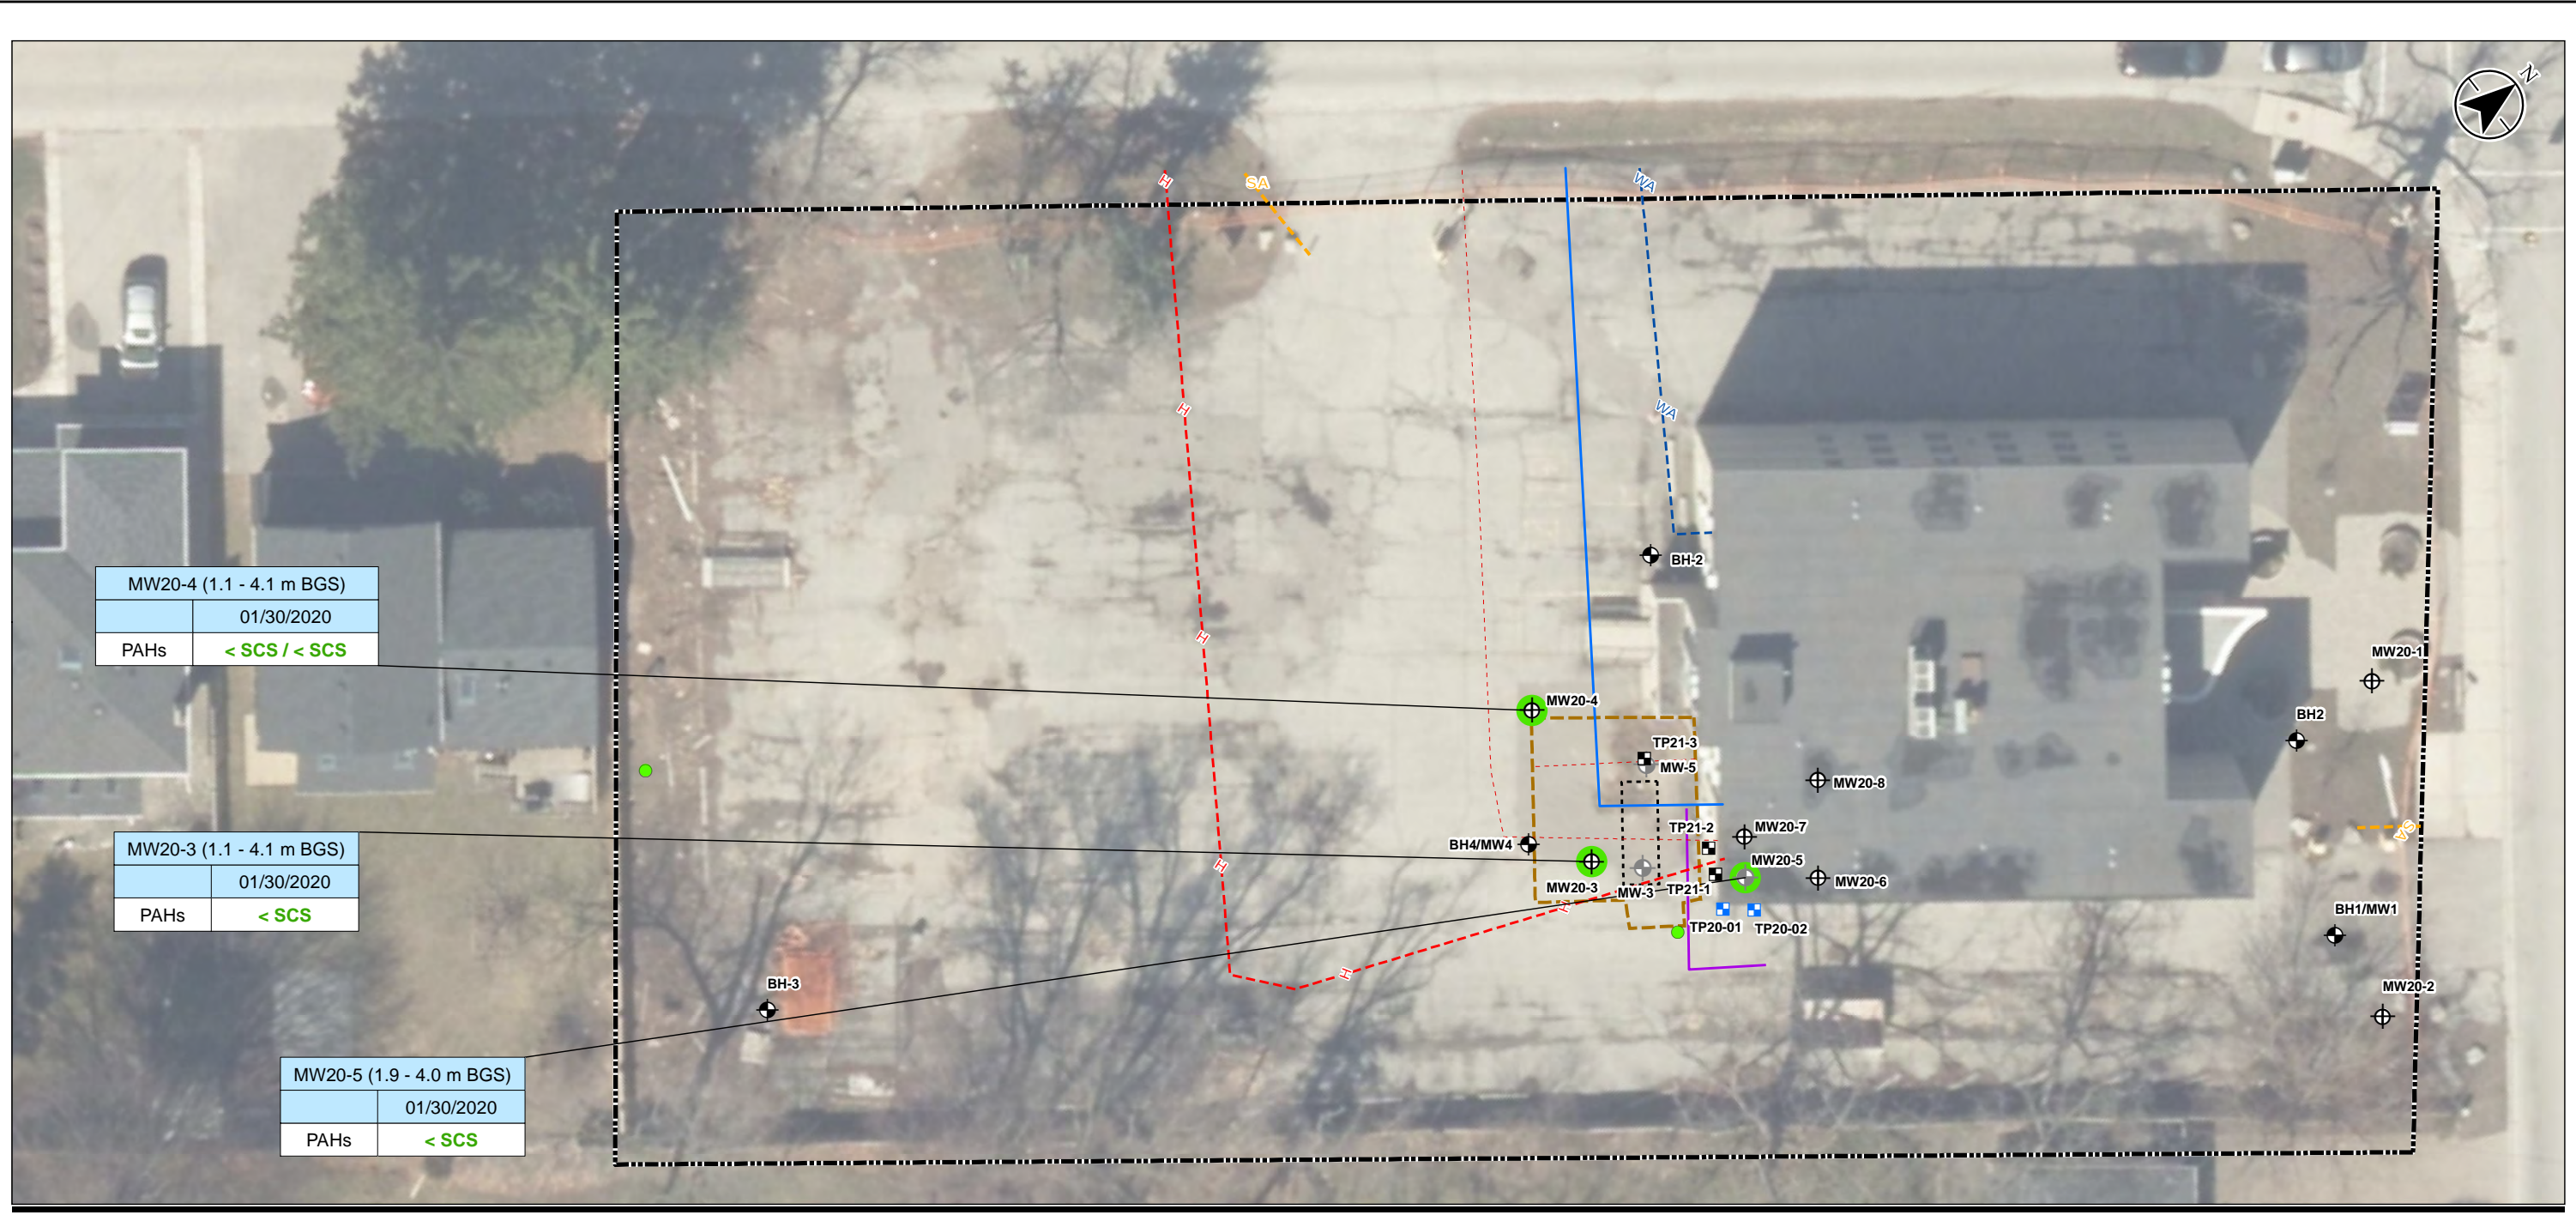
Figure No.: 5a
 Title: Summary of Ground Water Analytical Results - BTEX and PHCs

MW20-4 (1.1 - 4.1 m BGS)	
Screen Interval	01/30/2020
PAHs	< SCS / < SCS

MW20-3 (1.1 - 4.1 m BGS)	
Screen Interval	01/30/2020
PAHs	< SCS
