S2S PROJECT NO. 9550

PHASE ONE ENVIRONMENTAL SITE ASSESSMENT

**3043 SIXTH LINE
OAKVILLE, ONTARIO**

NOVEMBER 24, 2020

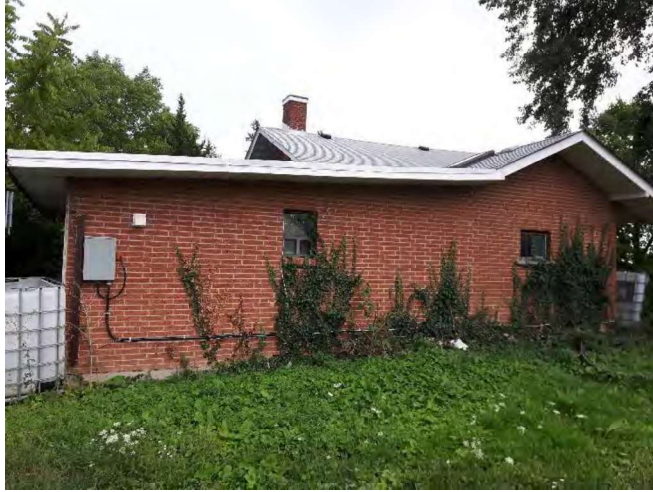
Photo 1: View of a portion of the northwest elevation of the Subject Building, looking southeast.

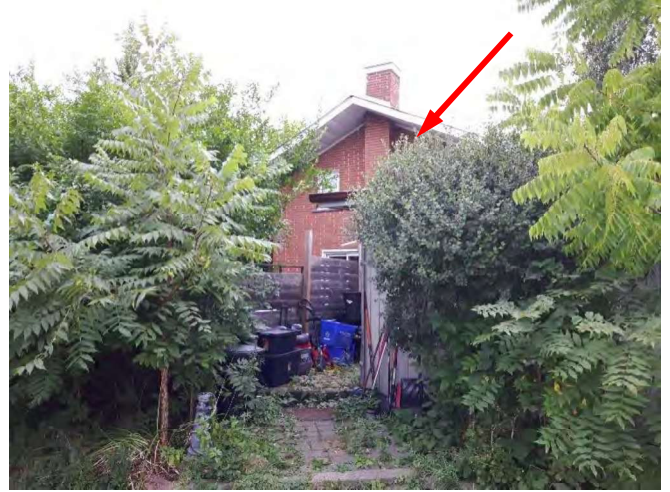
Photo 2: View of a portion of the northeast elevation (see arrow) of the Subject Building, looking southwest.

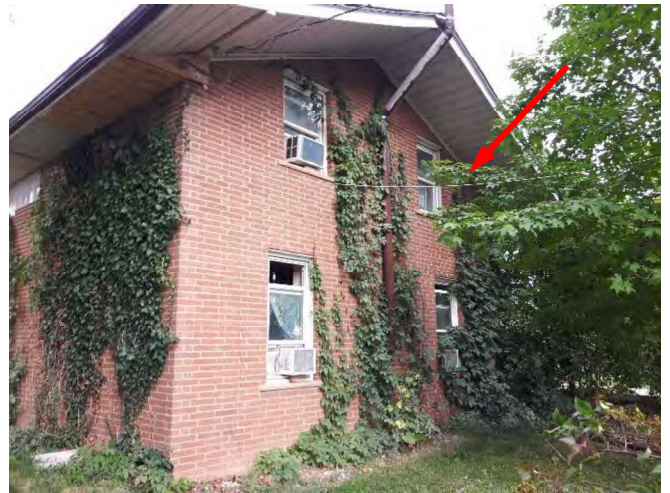
Photo 4: View of a portion of the southwest elevation (see arrow) of the Subject Building, looking southeast.

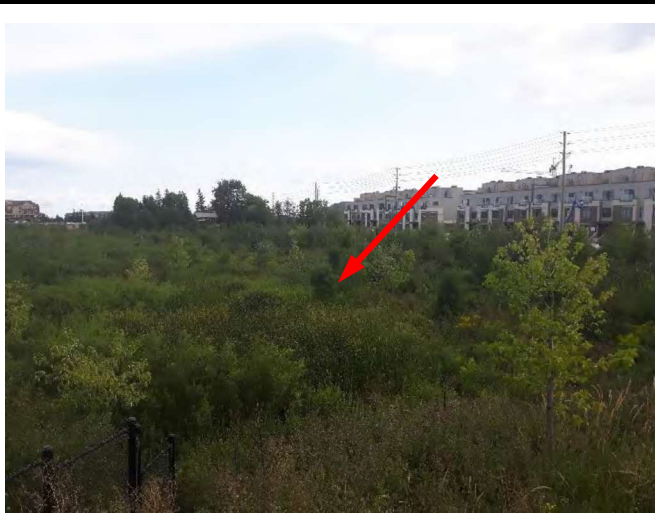
Photo 5: View of a portion of the adjacent agricultural/undeveloped property (see arrow), located to the northwest of the Phase One Property, looking southeast, from Sixteen Mile Drive.

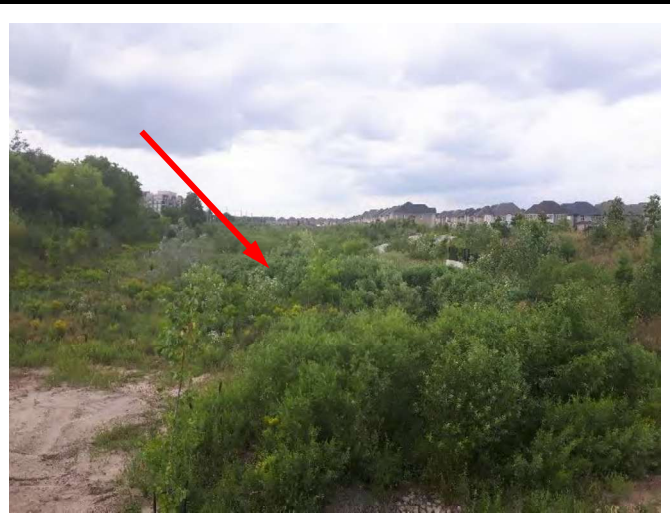
Photo 6: View of a portion of the adjacent agricultural/undeveloped property (see arrow), located to the northeast of the Phase One Property, looking north, from Dundas Street East.

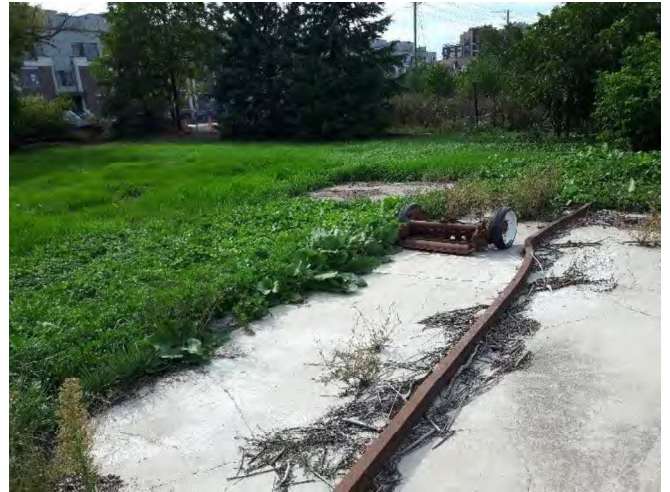
Photo 10: View of the north portion of the Phase One Property, the approximate location of the historical barn of the Phase One Property.

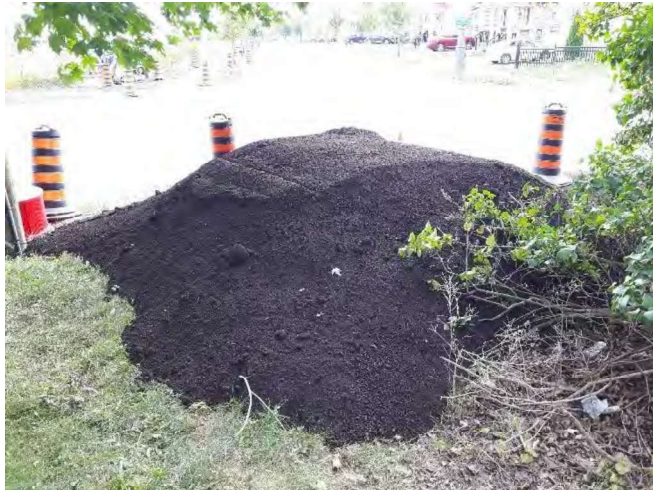
At the time of the site reconnaissance, fill materials in the form of imported topsoil were observed to be straddling the southeast and west property boundaries of the Phase One Property. Additionally, it appears that fill materials may have been applied at various locations when the Phase One Property was in the process of being developed (i.e., construction/development). It is possible that the unknown environmental quality of these fill materials represents an environmental concern to the Phase One Property.

Photo 11: View of fill material straddling a portion of the northwest property boundary of the Phase One Property.

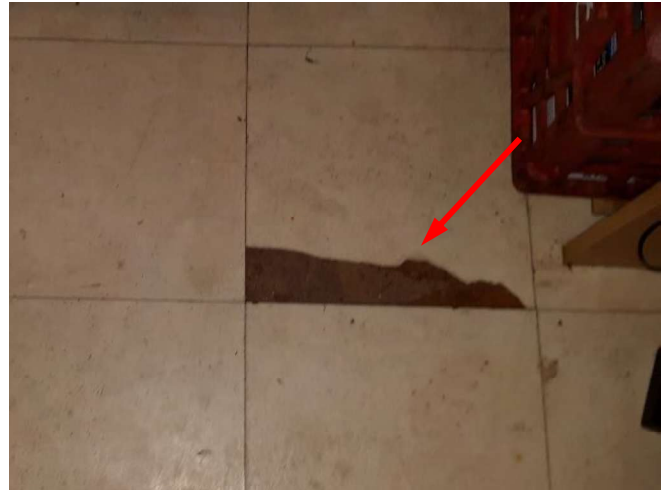
At the time of the site reconnaissance, the suspect ACM materials observed in the accessed areas were generally noted by S2S to be in fair to good condition. One damaged vinyl floor tile was observed in the kitchen of the Subject Building. It is recommended that this vinyl floor tile be repaired or replaced. Based on discussions with the site representative, an asbestos survey had not been completed for the Phase One Property in accordance with O. Reg. 278/05.

Photo 12: View of a damaged vinyl floor tile (see arrow) in the kitchen of the Subject Building.

In accordance with O. Reg. 278/05, an asbestos survey should be conducted on building(s) that are known or suspected to have ACMs and if asbestos is found to be present, an asbestos management plan should be implemented. Furthermore, where ACMs are in poor or deteriorated condition and

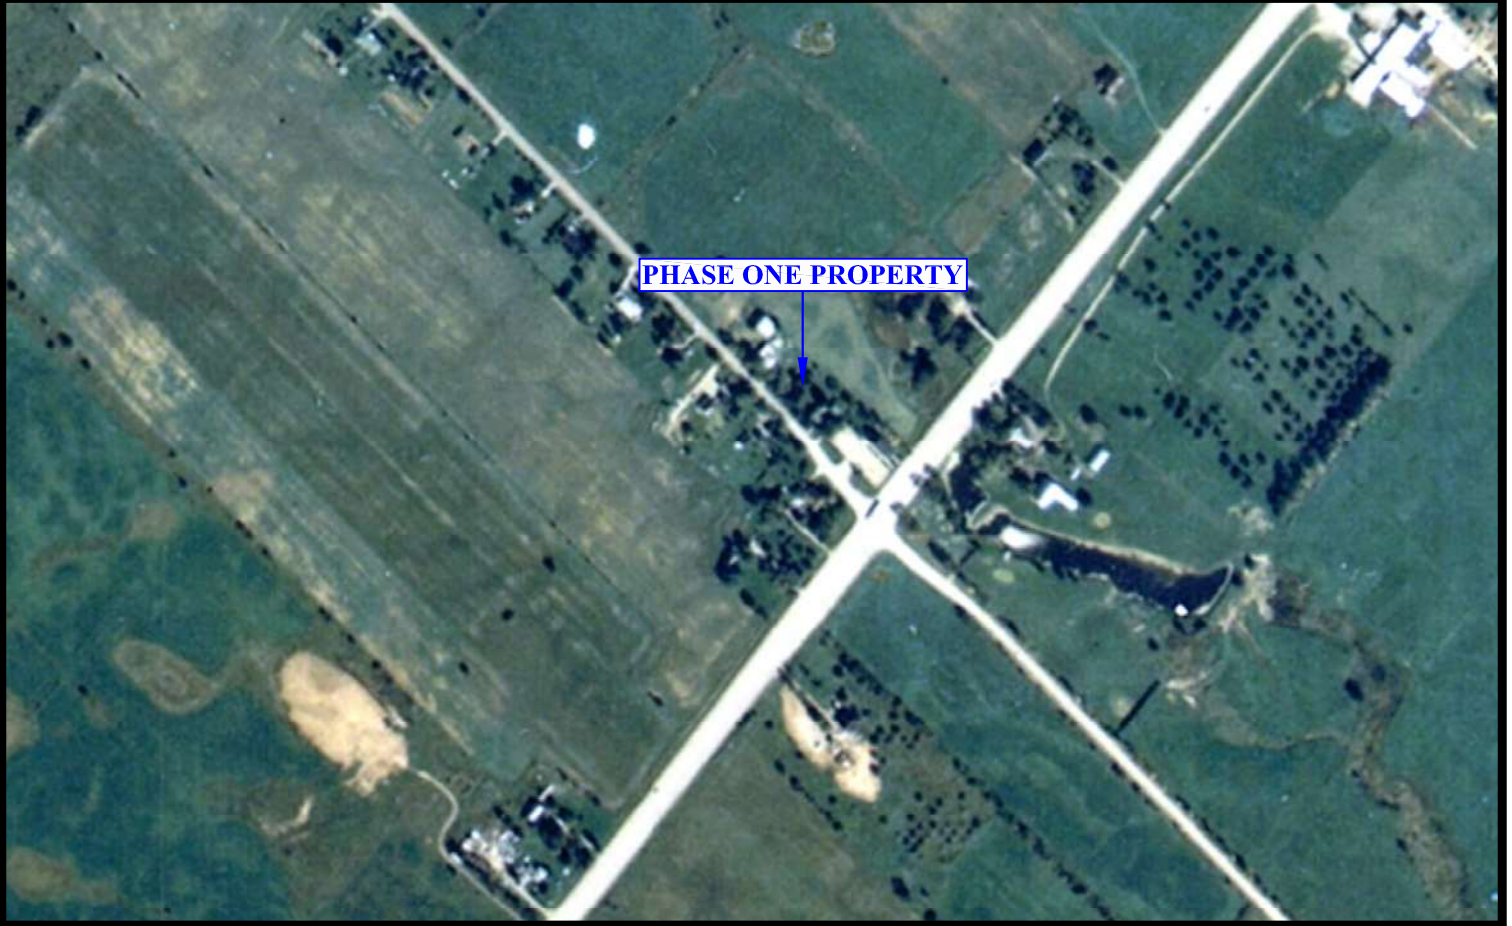
**AERIAL PHOTO SHOWING
PHASE ONE PROPERTY - 1985**

1985	Phase One Property:	The Phase One Property appeared to be occupied by the original, single-storey portion of the Subject Building and an inferred barn to the north of the Subject Building.
	Northwest:	The adjacent property located to the northwest of the Phase One Property appeared to be an agricultural property.
	Northeast:	The adjacent property located to the northeast of the Phase One Property appeared to be an agricultural property.
	Southeast:	The adjacent property located to the southeast of the Phase One Property appeared to be similar to that observed in the 2005 aerial photograph; however, the building further to the southeast was not observed.
	Southwest:	The immediate neighbouring properties located to the southwest (across Sixth Line) of the Phase One Property appeared to be similar to that observed in the 2005 aerial photograph.
1979	Phase One Property:	The Phase One Property appeared to be similar to that observed in the 1985 aerial photograph.

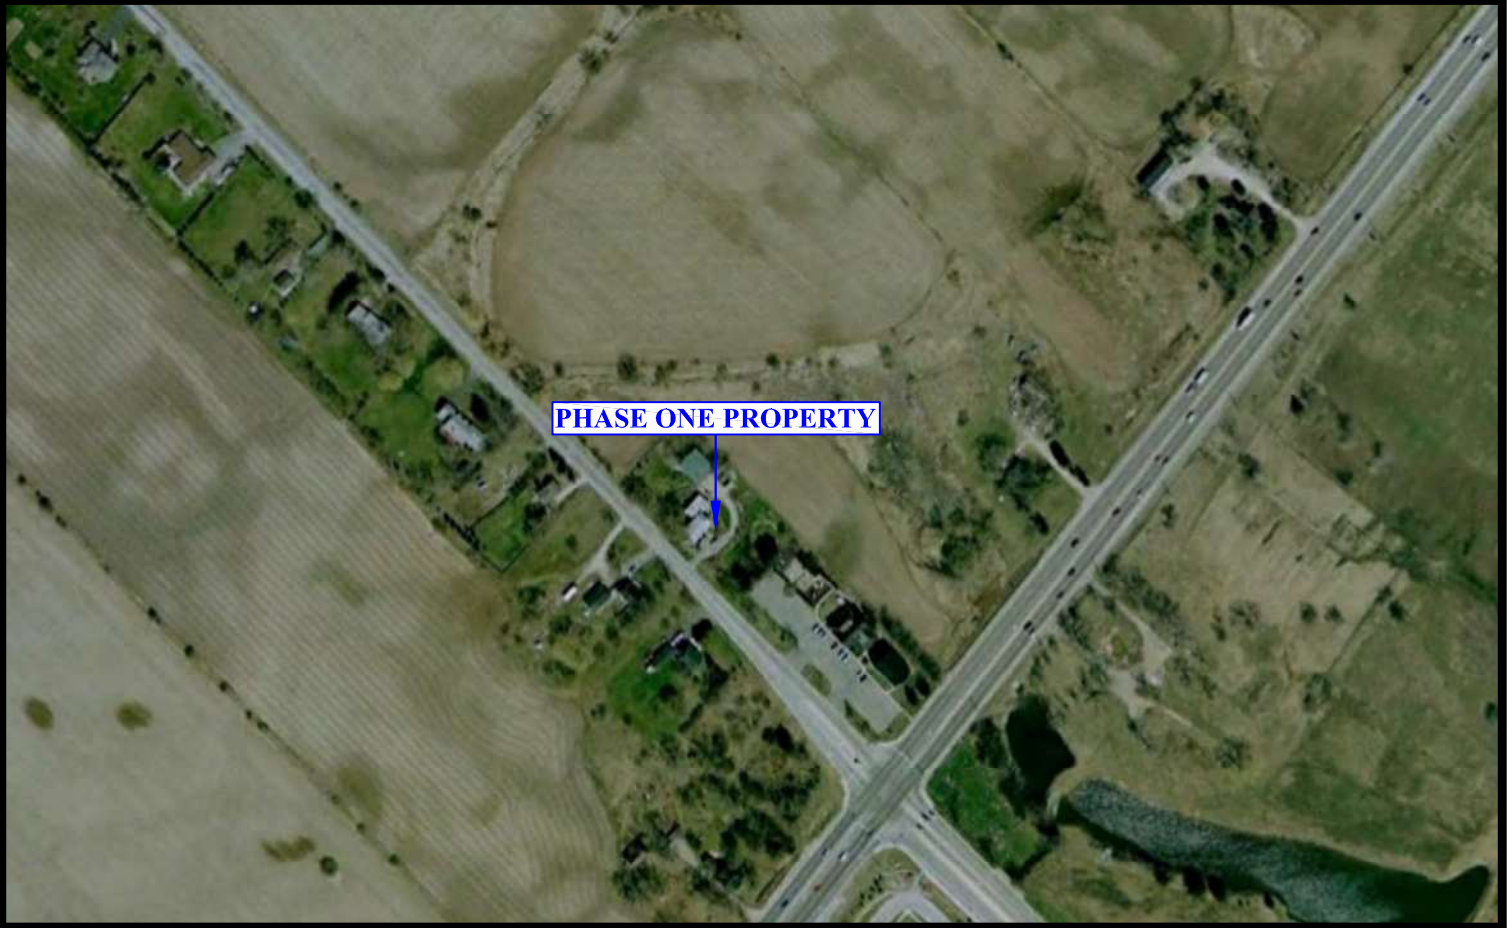
**AERIAL PHOTO SHOWING
PHASE ONE PROPERTY - 2005**

Year of Photograph	Findings for Phase One Property and Adjacent/Neighbouring Properties	
2005	Phase One Property:	The Phase One Property appeared to be developed with the current Subject Building and an inferred barn located to the north of the Subject Building.
	Northwest and Southeast:	The adjacent properties located to the northwest and southeast of the Phase One Property appeared to be similar to that observed in the 2018 aerial photograph.
	Northeast:	The adjacent property located to the northeast of the Phase One Property appeared to be similar to that observed in the 2018 aerial photograph; however, the manmade pond further to the northeast was not observed in this aerial photograph.
	Southwest:	The immediate neighbouring properties located to the southwest (across Sixth Line) of the Phase One Property appeared to be developed with two single-family residential dwellings. Furthermore, Kaitting Trail and the manmade drainage pond were not observed in this aerial photograph.
