THE REGIONAL MUNICIPALITY OF HALTON

1258 REBECCA STREET, OAKVILLE, ONTARIO PHASE ONE ENVIRONMENTAL SITE ASSESSMENT

September 30, 2021

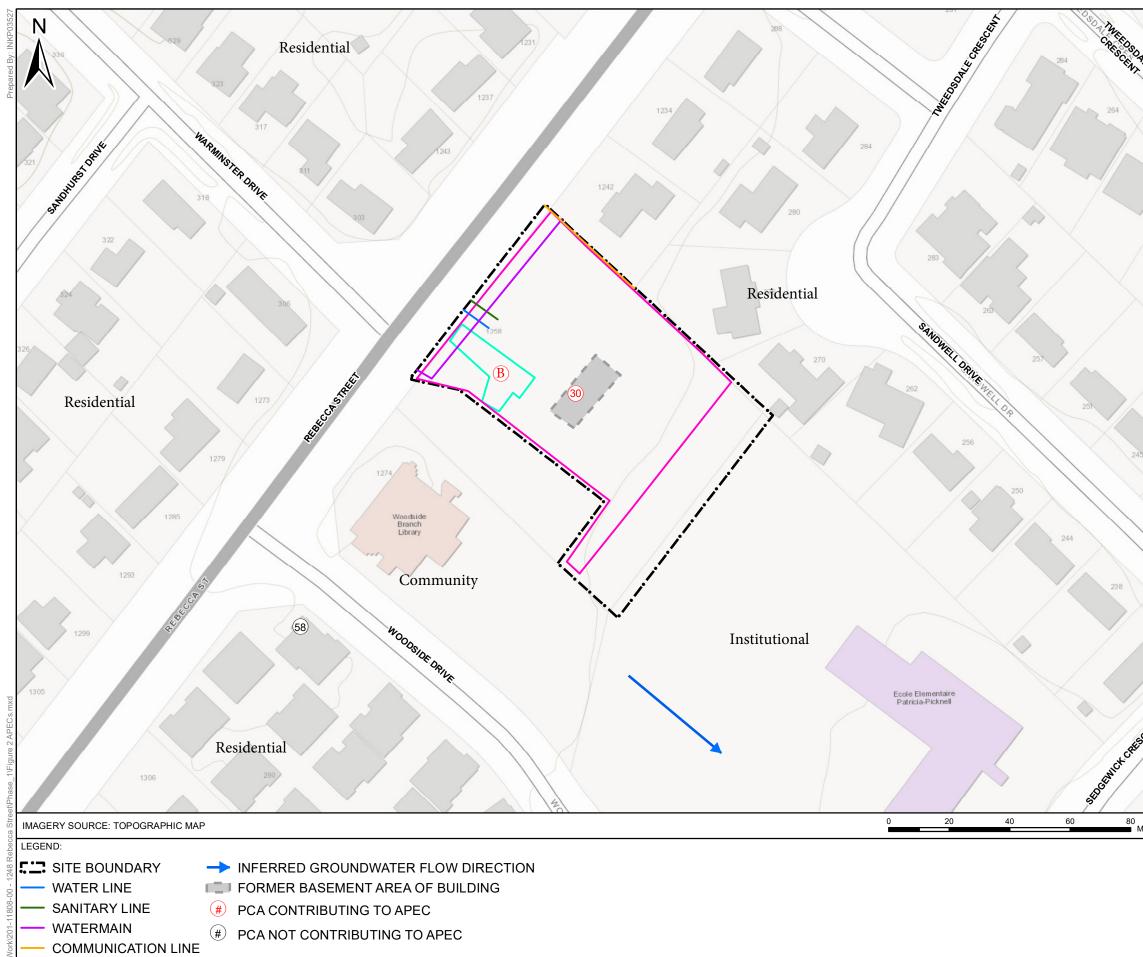
i. Adjacent Land Uses	Adjacent land uses at the time of the Site reconnaissance are illustrated on Figure 1, and were noted as follows:		
	North: Residential land uses.		
	South: A elementary school followed by residential land uses.		
	East: Residential land uses.		
	West: Community land uses as a public library, and ambulance station followed by residential.		
ii. Water Bodies	Fourteen Mile Creek is located approximately 240 m north of the Site and Lake Ontario is located approximately 650 m southeast of the Site. There is a drainage ditch located on the southern portion of the Site. It appears to be connected to culverts diverting surficial water.		
iii. Areas of Natural Significance	There were no areas of natural significance identified within the Phase One Study Area.		
iv. Potentially Contaminating Activity	During the site reconnaissance, the following PCAs were identified:Potential placement of fill within the former building envelope.

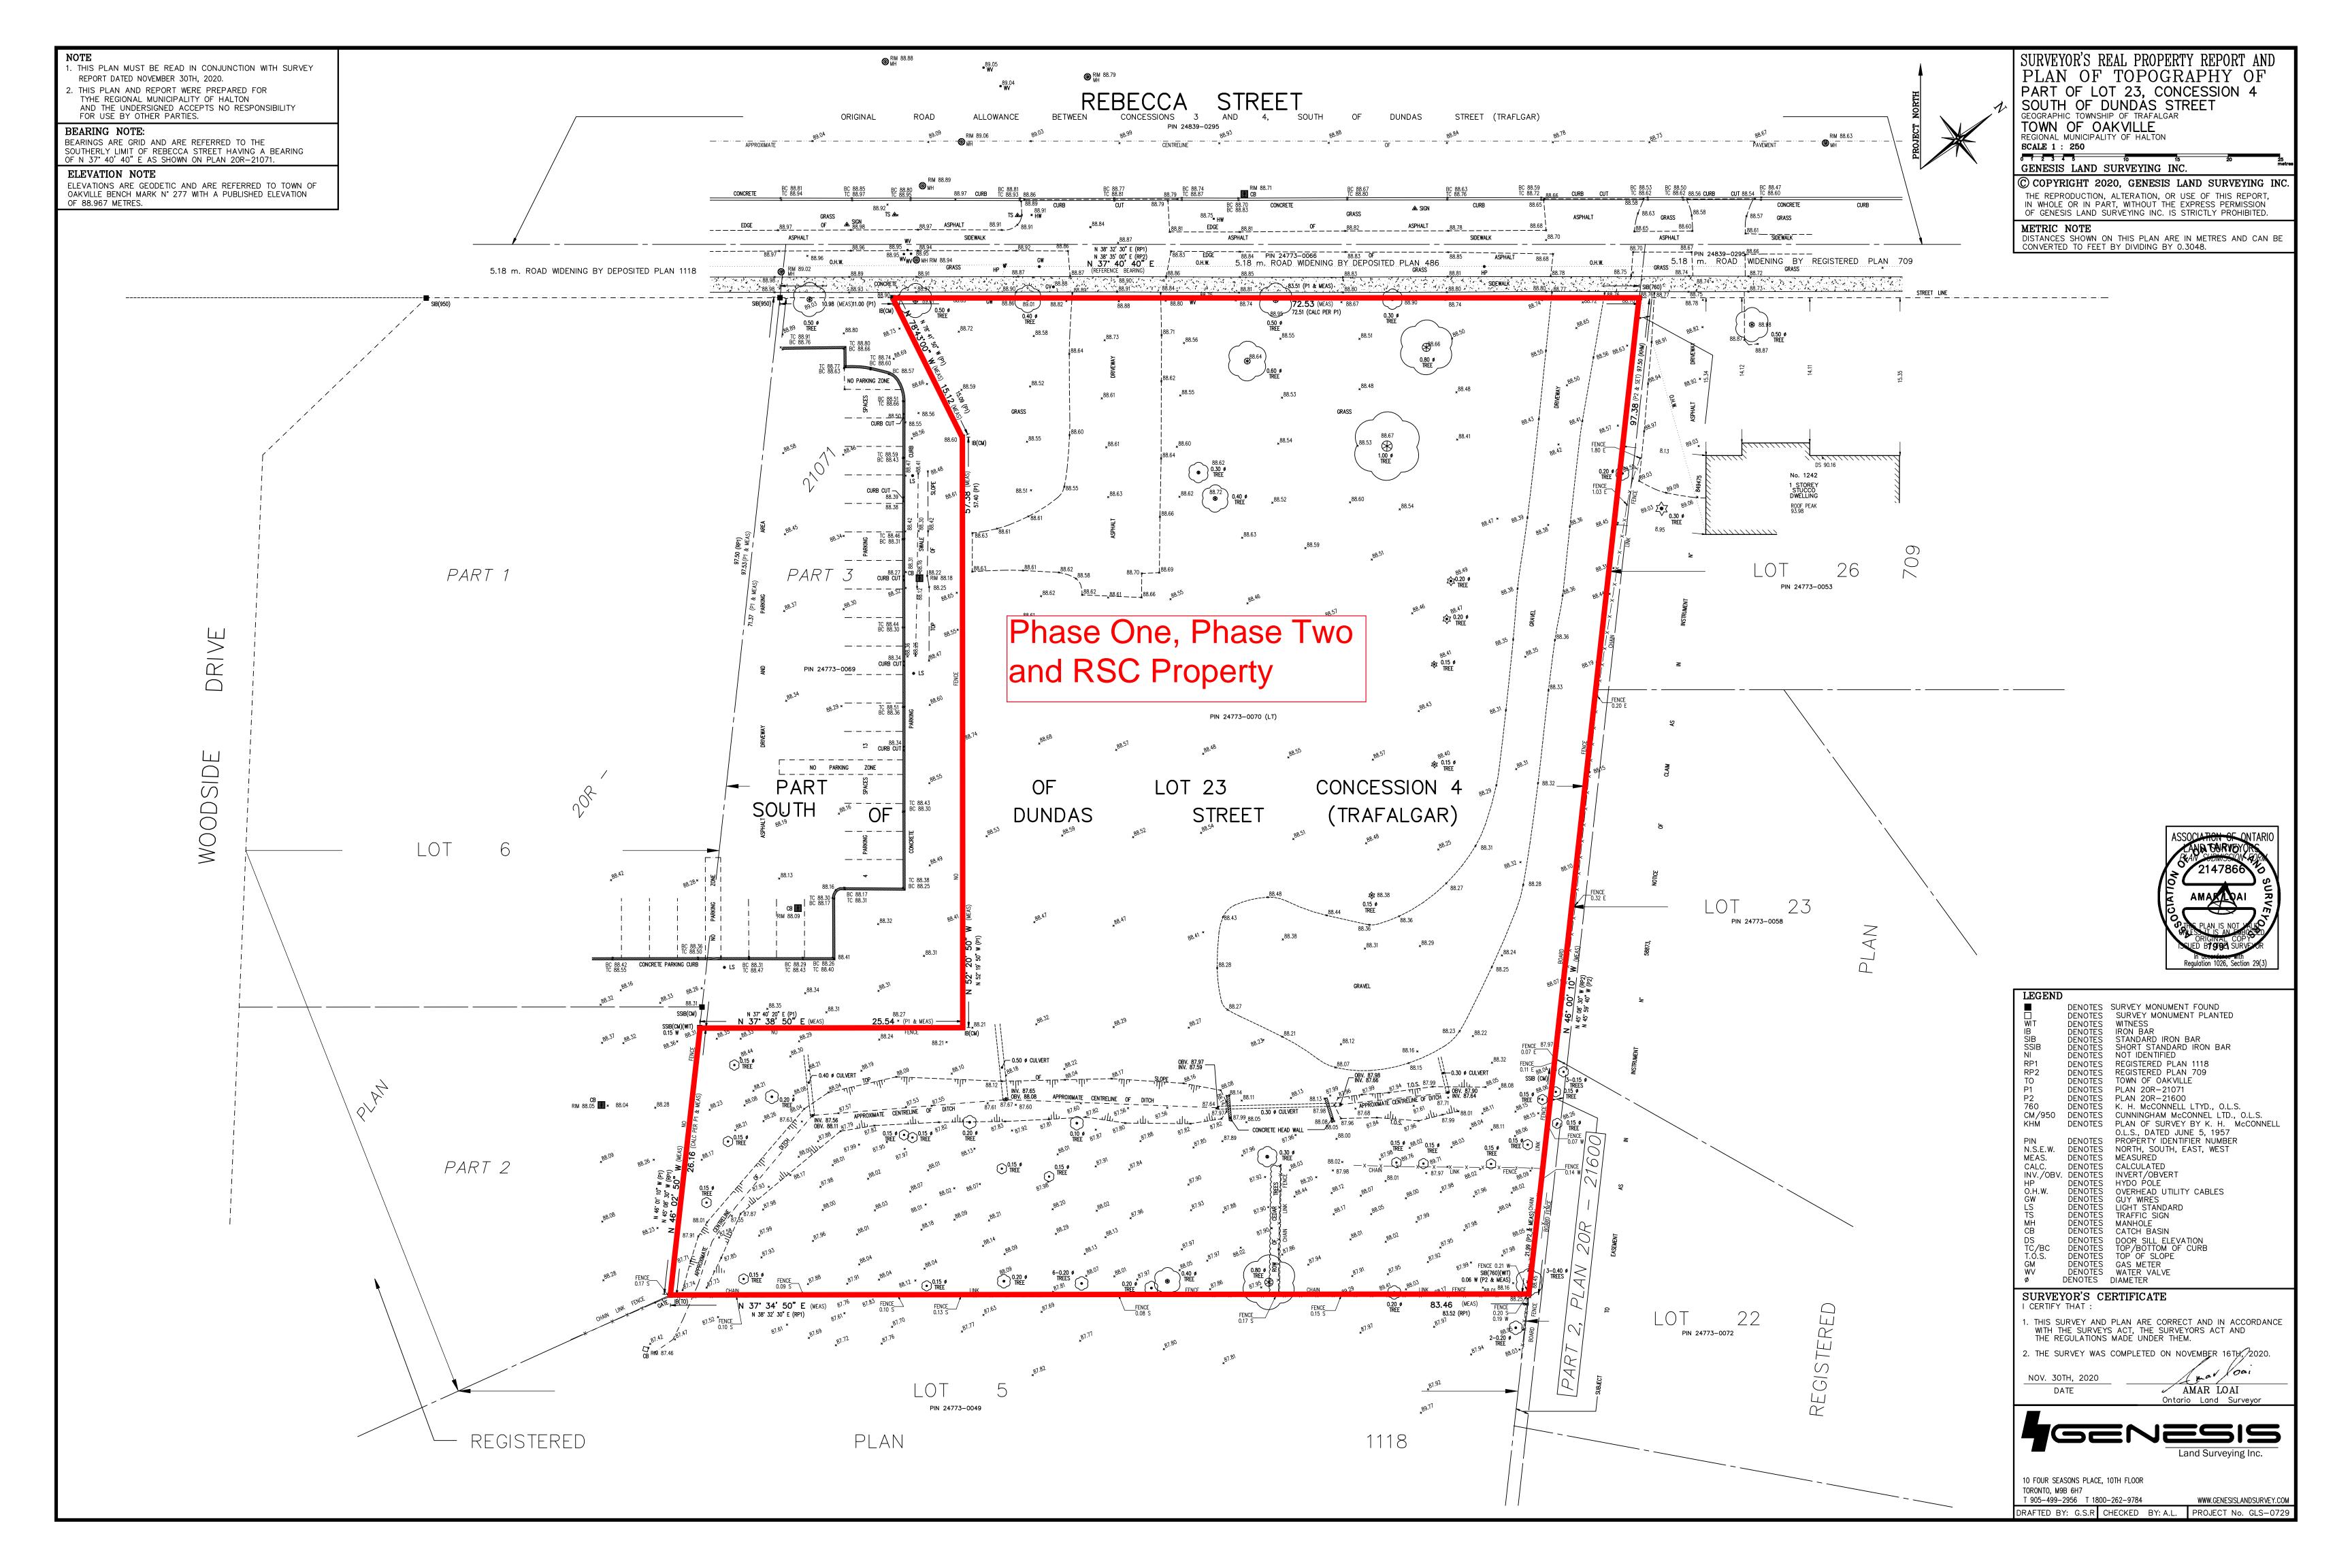
A PLAN OF SURVEY

- We have found easements or Rights-of-Way registered on tile.
- We have observed overhead utility cables along the front portions of the property.
