Re: GTR-23012833-B1 Phase One and Two Environmental Site Assessment Update
Neyagawa Boulevard, Oakville, Ontario

EXP Services Inc. (EXP) was retained by Sky Property Group Inc. to complete a Phase One and Two Environmental Site Assessment (ESA) Update at the above noted property in support of a Site Plan Approval from the Town of Oakville. For the purposes of this report, the terms "site" and "Phase One property" refer to the property on the northeast side of Neyagawa Boulevard, between Burnhamthorpe Road West and Highway 407, in Oakville Ontario. The property has no municipal address.

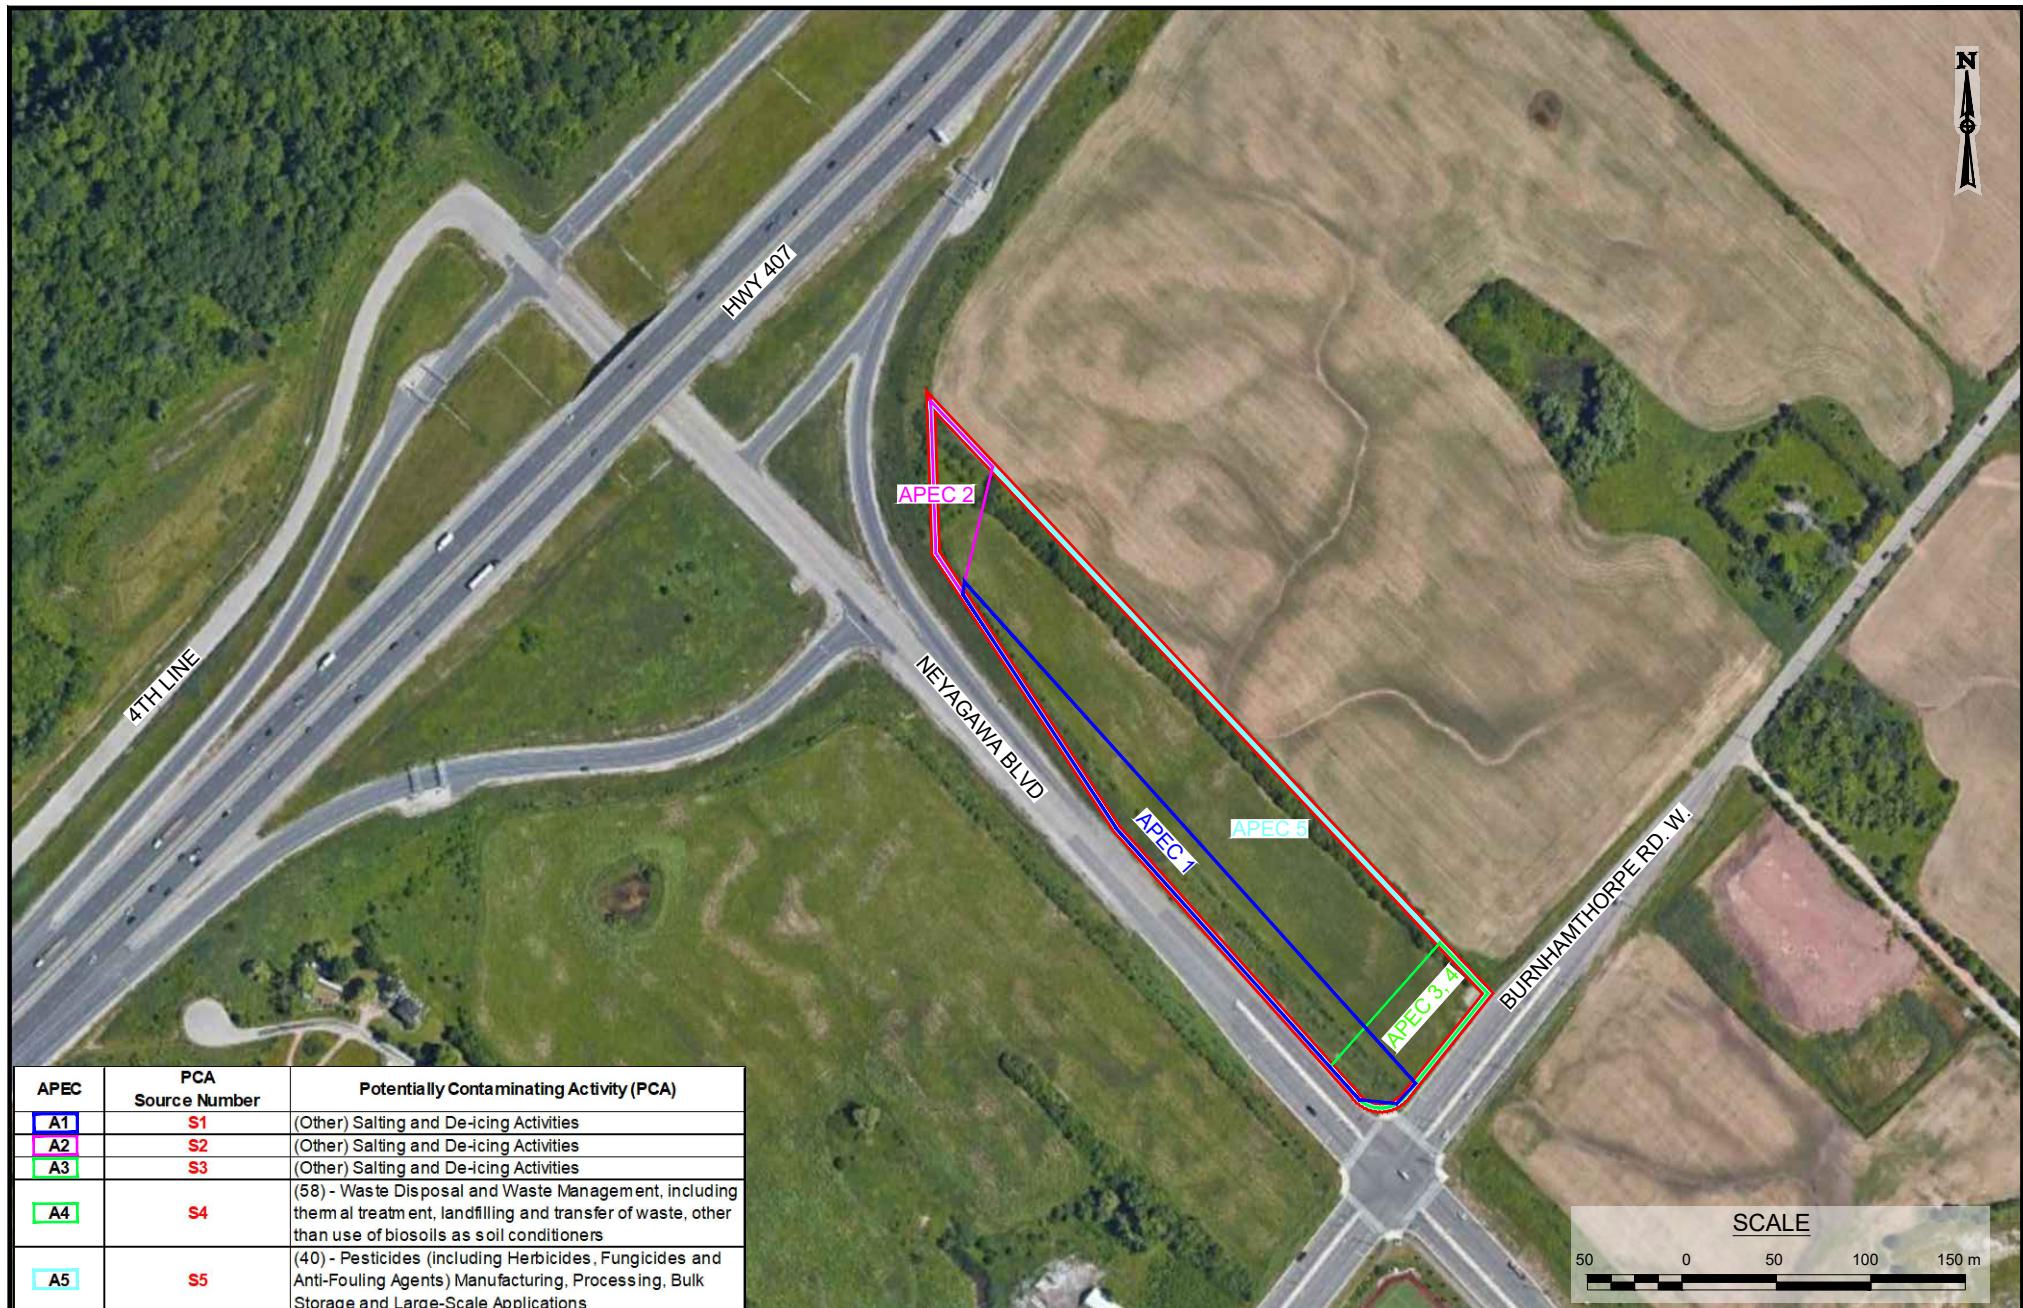
PROJECT NO.:	GTR-23012833-A0	DWN.:	K.G.
SCALE:	AS NOTED	CK:	A.C.
DATE:	NOVEMBER 2023	FIG. NO.:	4

APEC	PCA Source Number	Potentially Contaminating Activity (PCA)
A1	S1	(Other) Salting and De-icing Activities
A2	S2	(Other) Salting and De-icing Activities
A3	S3	(Other) Salting and De-icing Activities
A4	S4	(58) - Waste Disposal and Waste Management, including thermal treatment, landfilling and transfer of waste, other than use of biosolids as soil conditioners
A5	S5	(40) - Pesticides (Including Herbicides, Fungicides and Anti-Fouling Agents) Manufacturing, Processing, Bulk Storage and Large-Scale Applications

AREAS OF POTENTIAL ENVIRONMENTAL CONCERN
NEYAGAWA BOULEVARD,
OAKVILLE, ONTARIO

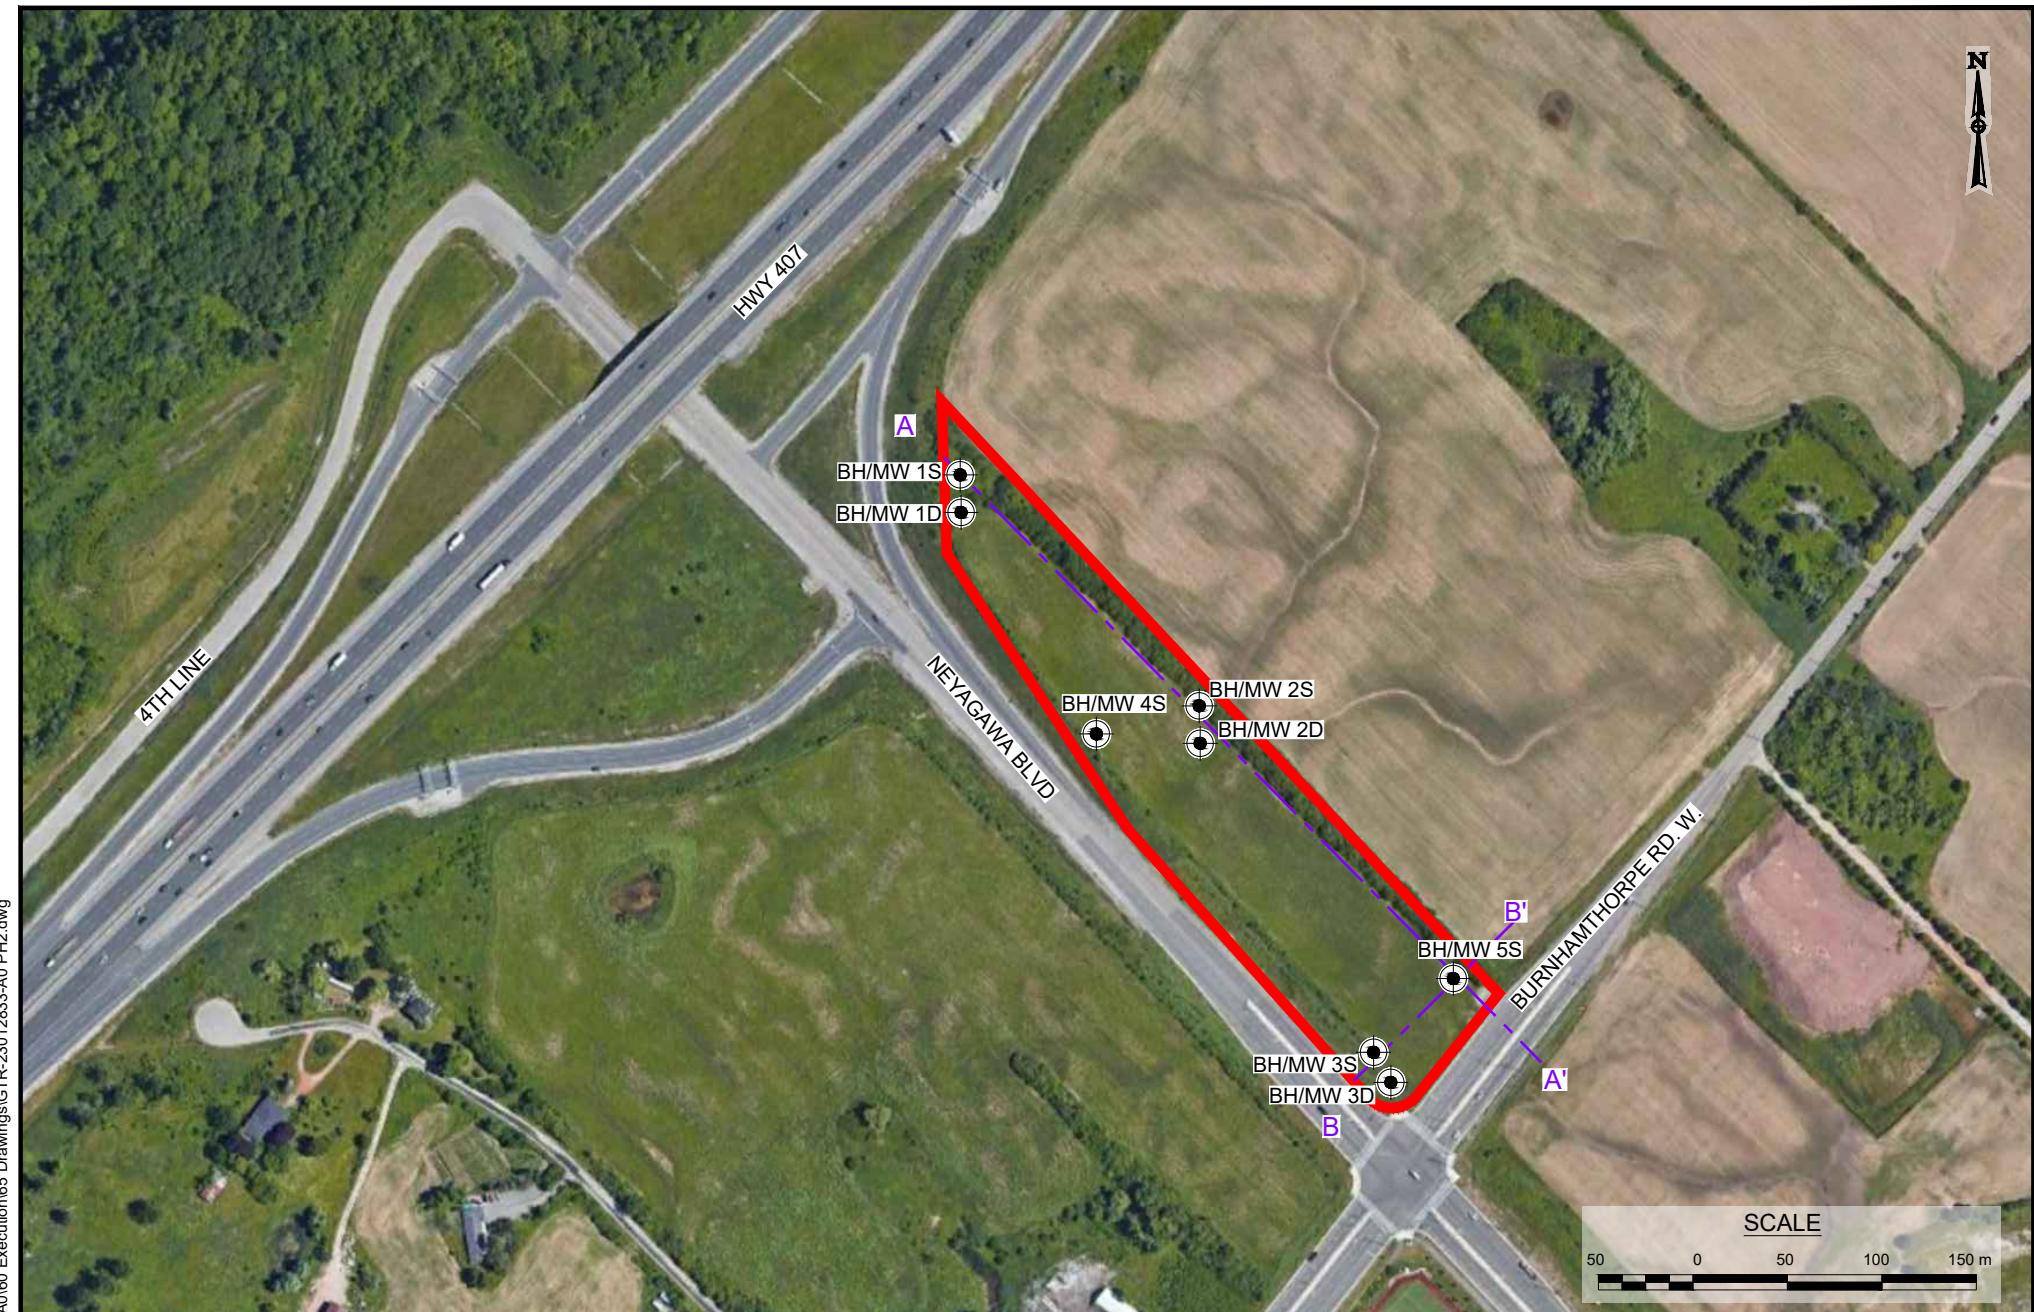
PROJECT NO.:	GTR-23012833-A0	DWN.:	K.G.
SCALE:	AS NOTED	CK:	A.C.
DATE:	NOVEMBER 2023	FIG. NO.:	5A

BOREHOLE/MONITORING
WELL LOCATION PLAN
AND CROSS SECTION PLAN
NEYAGAWA BOULEVARD,
OAKVILLE, ONTARIO

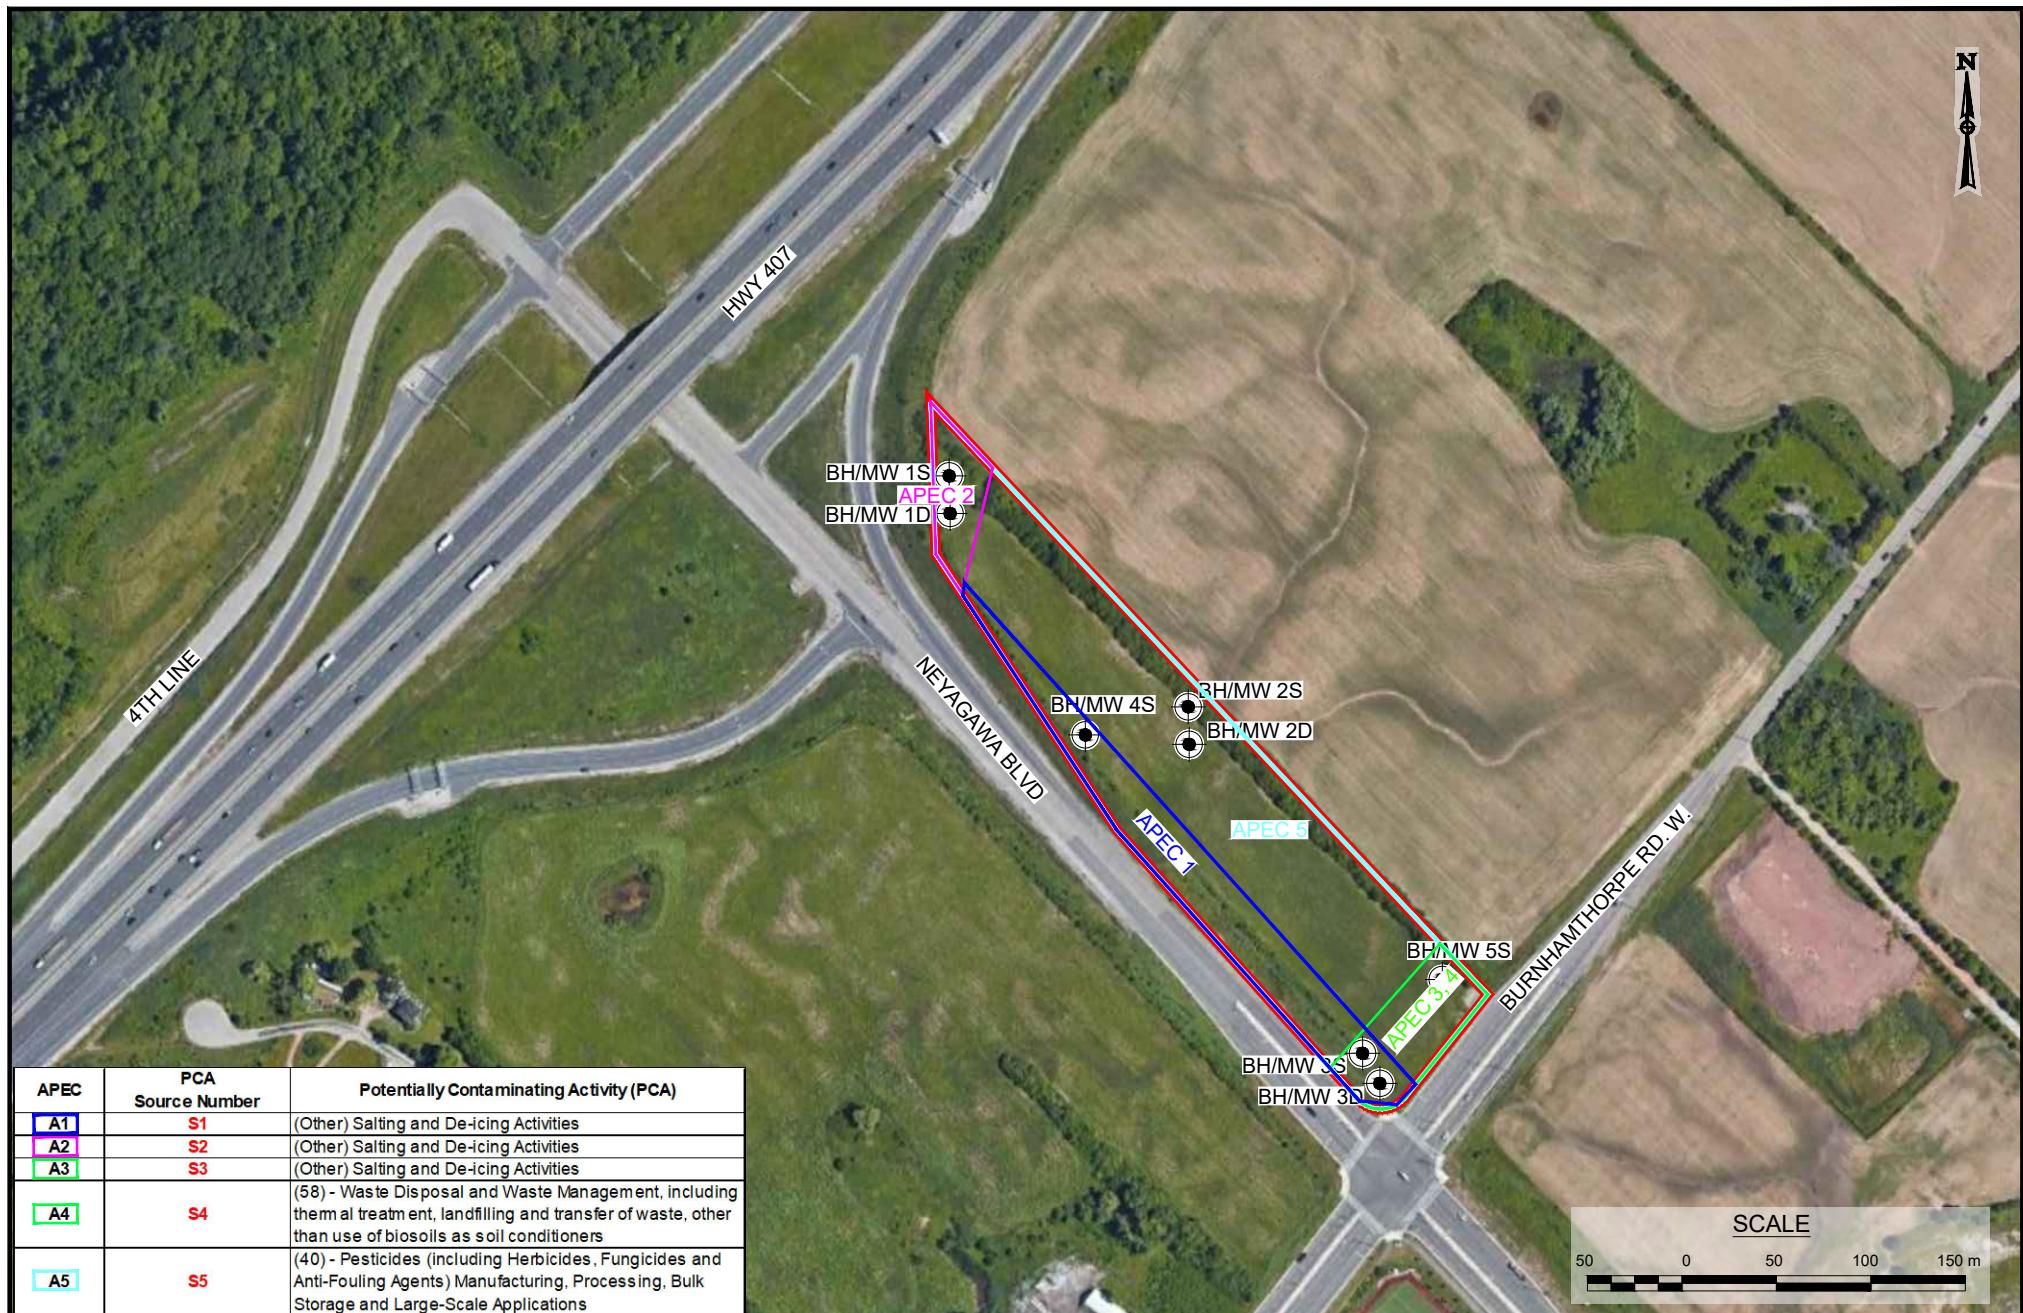
PROJECT NO.:	GTR-23012833-A0	DWN.:	K.G.
SCALE:	AS NOTED	CK:	A.C.
DATE:	NOVEMBER 2023	FIG. NO.:	5B

APEC	PCA Source Number	Potentially Contaminating Activity (PCA)
A1	S1	(Other) Salting and De-icing Activities
A2	S2	(Other) Salting and De-icing Activities
A3	S3	(Other) Salting and De-icing Activities
A4	S4	(58) - Waste Disposal and Waste Management, including thermal treatment, landfilling and transfer of waste, other than use of biosolids as soil conditioners
A5	S5	(40) - Pesticides (Including Herbicides, Fungicides and Anti-Fouling Agents) Manufacturing, Processing, Bulk Storage and Large-Scale Applications

BOREHOLE/MONITORING
WELL LOCATION PLAN
AND APEC
NEYAGAWA BOULEVARD,
OAKVILLE, ONTARIO

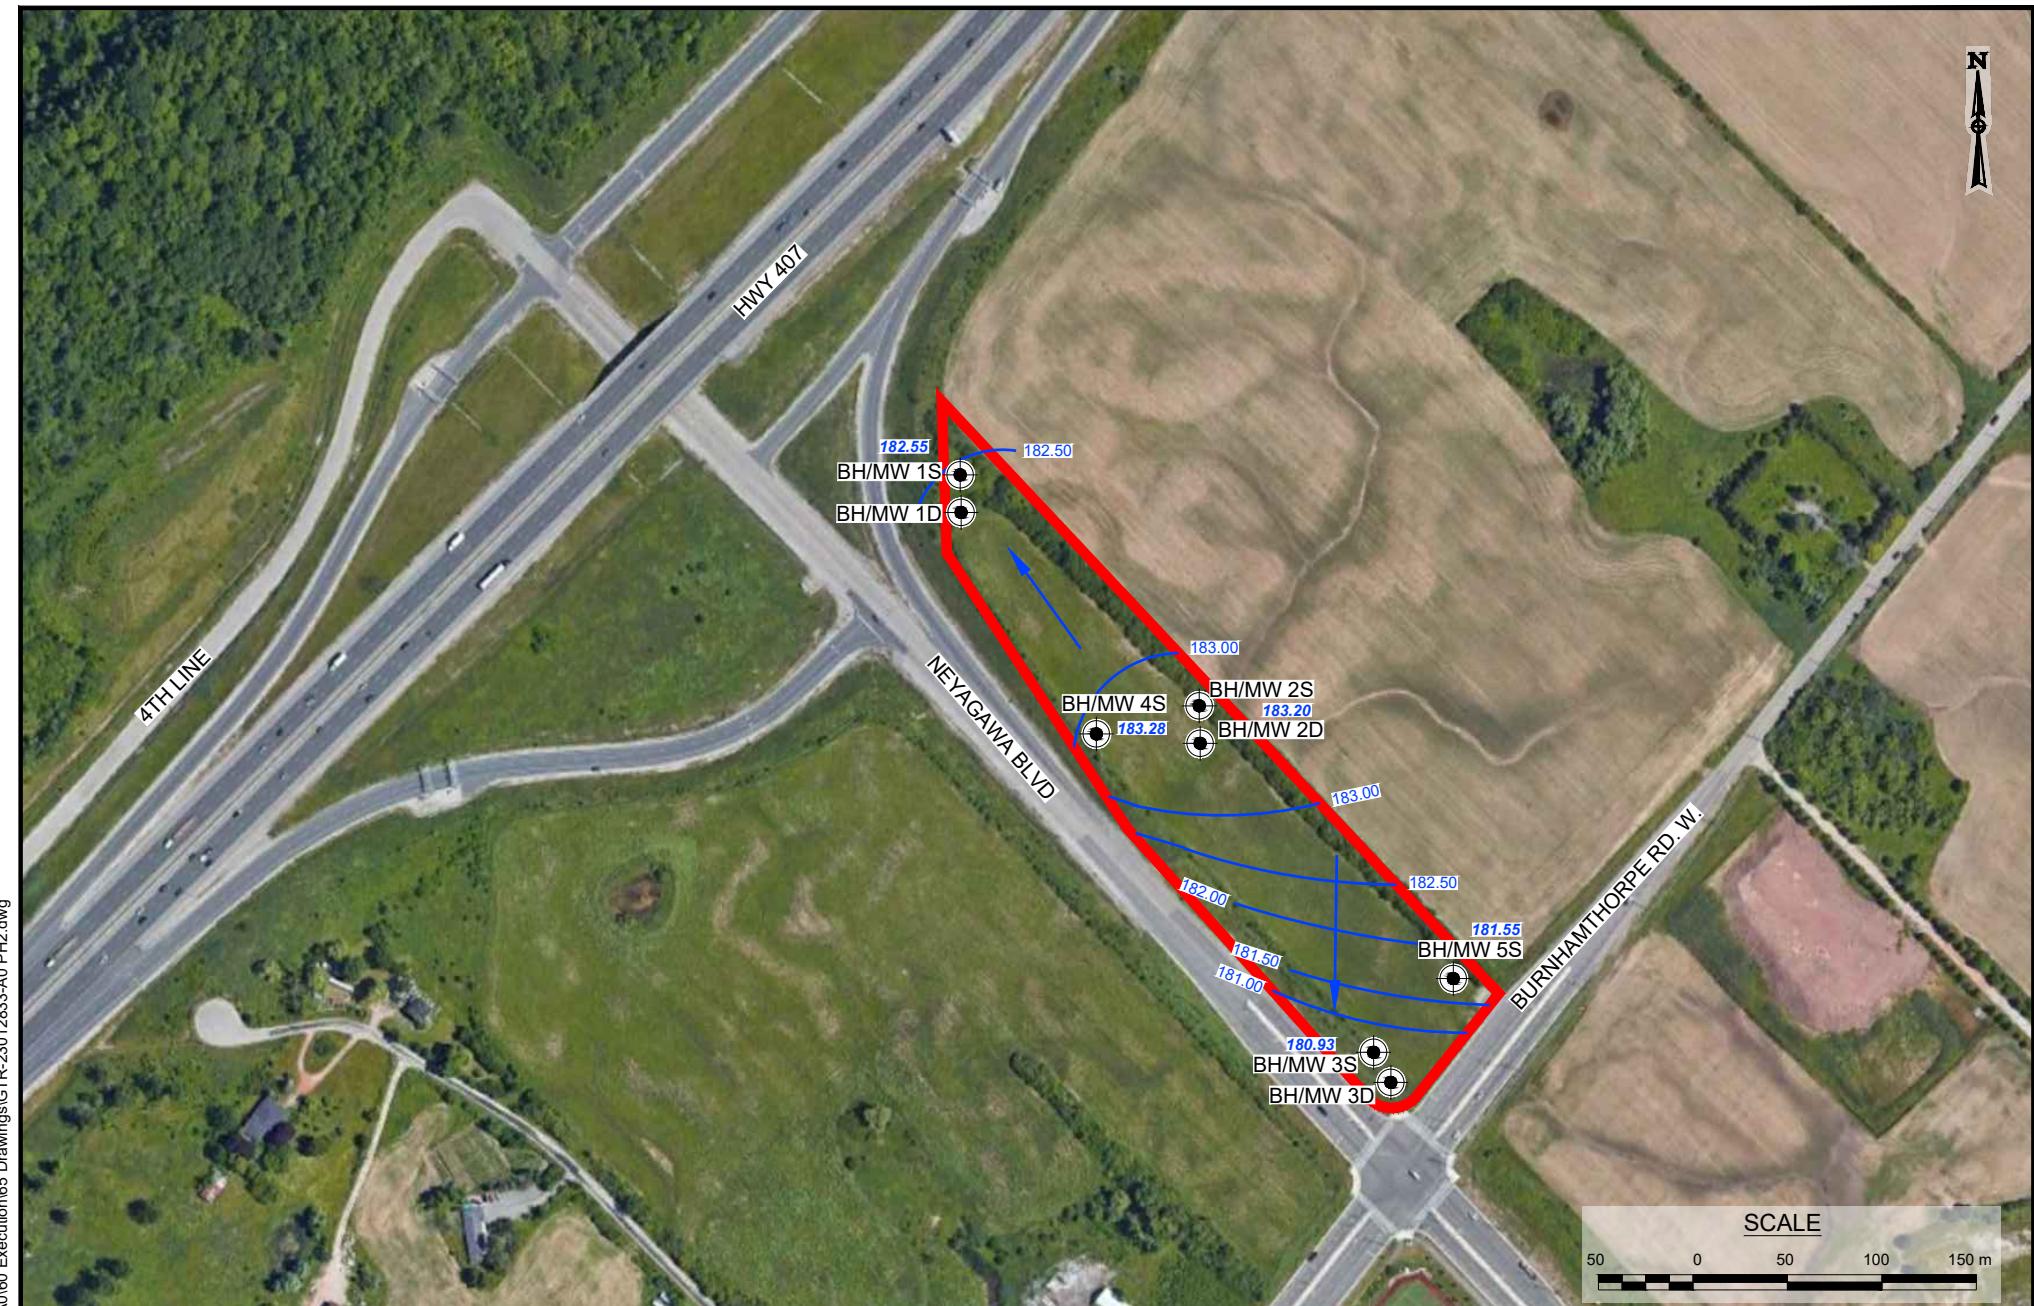
PROJECT NO.:	GTR-23012833-A0	DWN.:	K.G.
SCALE:	AS NOTED	CK:	A.C.
DATE:	NOVEMBER 2023	FIG. NO.:	6

TITLE AND LOCATION:
GROUNDWATER
CONTOUR PLAN
(NOVEMBER 2, 2023)
NEYAGAWA BOULEVARD,
OAKVILLE, ONTARIO

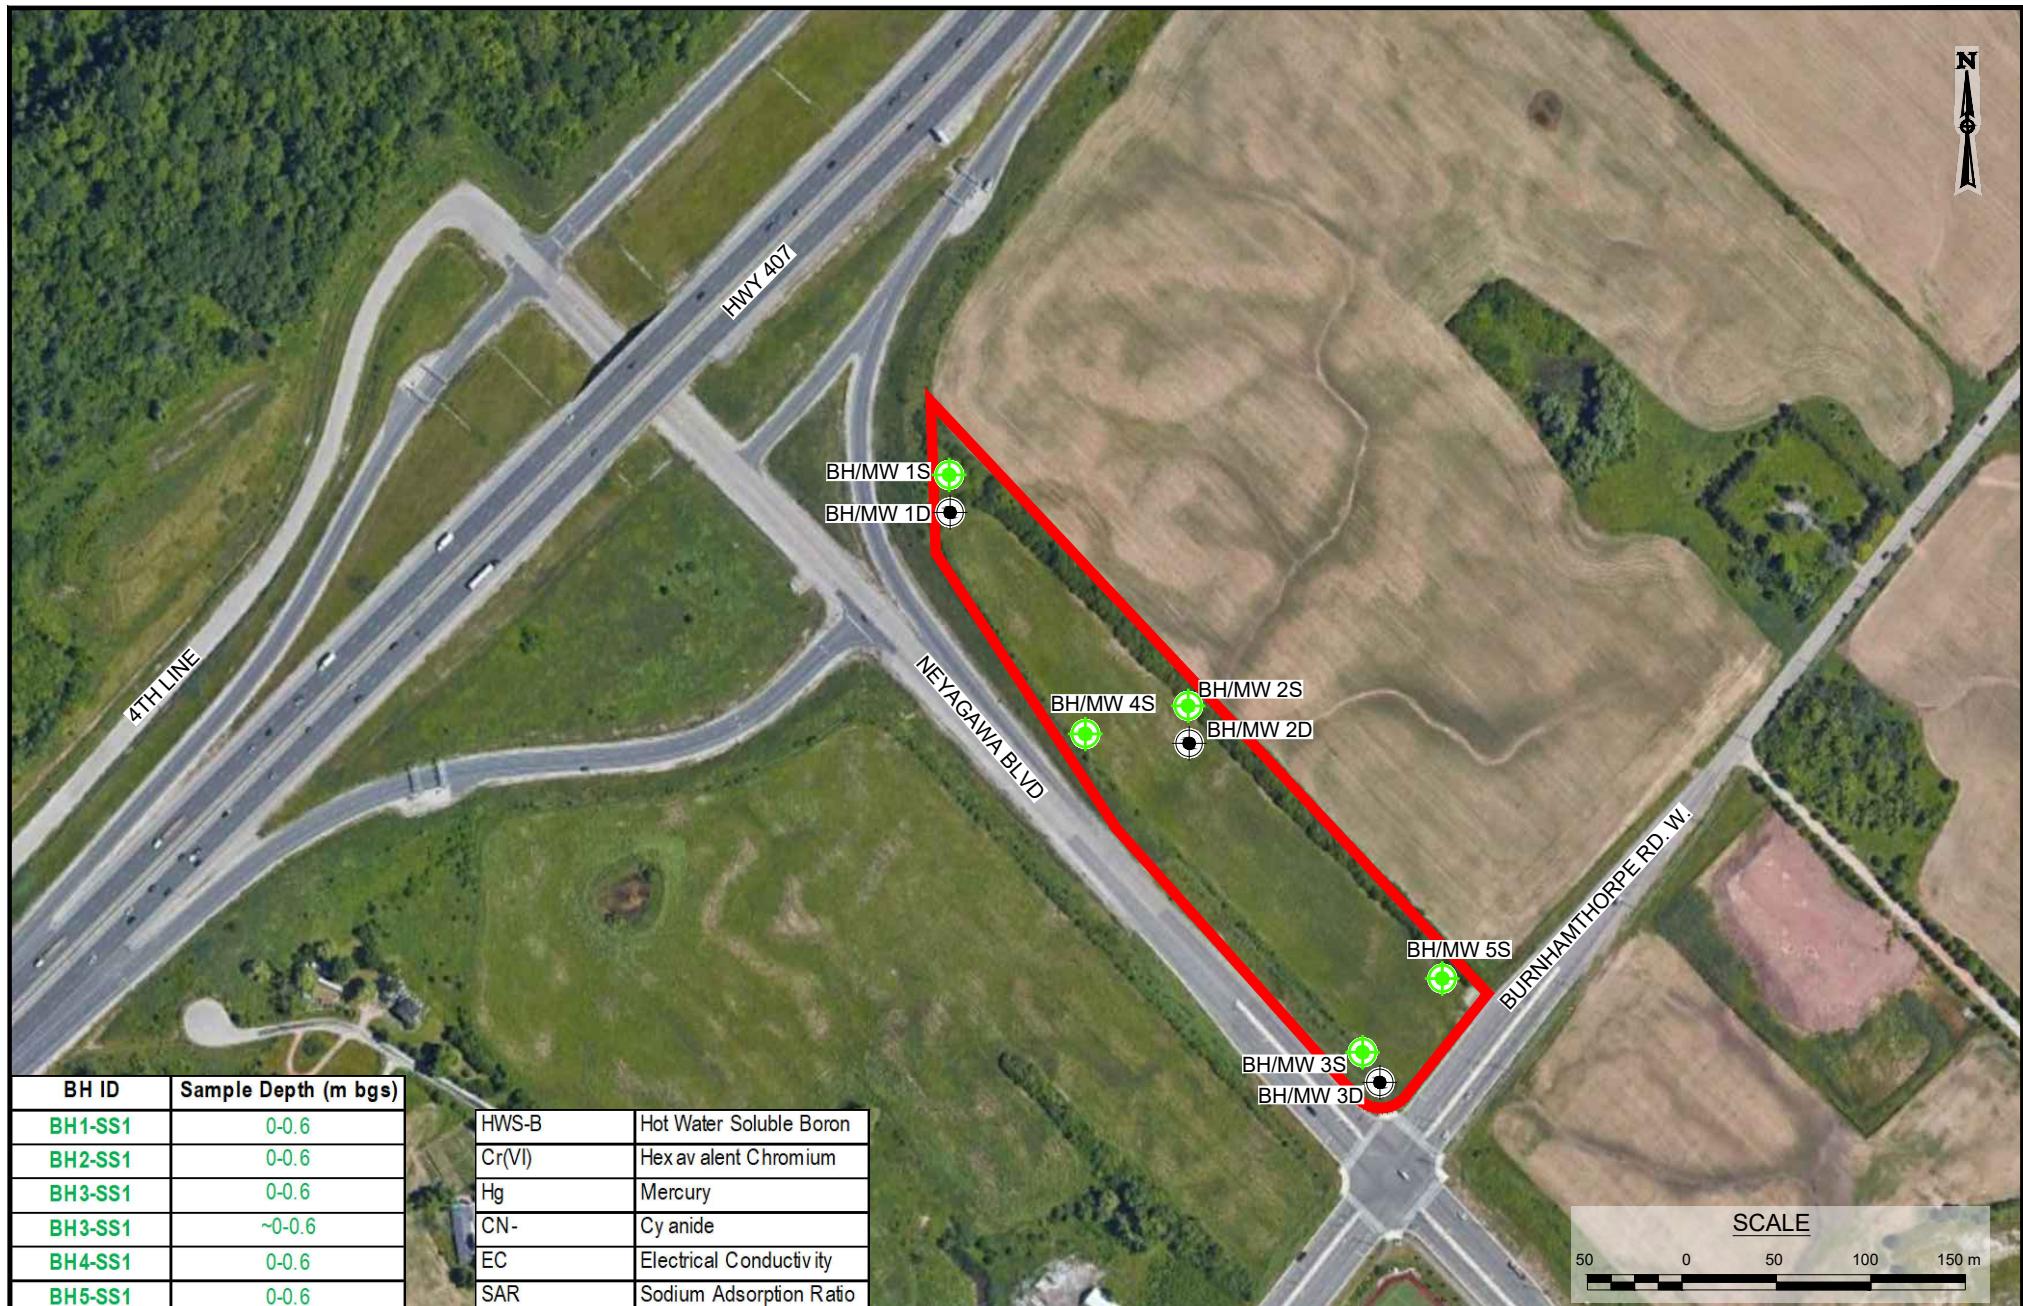
PROJECT NO.:	GTR-23012833-A0	DWN.:	K.G.
SCALE:	AS NOTED	CK:	A.C.
DATE:	NOVEMBER 2023	FIG. NO.:	7C

*STANDARDS SHOWN ARE FOR A RESIDENTIAL/PARKLAND/INSTITUTIONAL PROPERTY USE WITH FINE TEXTURED SOILS.
~ INDICATES FIELD DUPLICATE SAMPLE.
mbgs - METRES BELOW GROUND SURFACE.
ALL RESULTS IN UNITS OF $\mu\text{g/g}$, UNLESS OTHERWISE NOTED.

TITLE AND LOCATION:
SOIL ANALYTICAL RESULTS – METALS (INCLUDING HYDRIDE FORMING METALS) AND ORPs (Cr(VI), CN-, Hg, HWS-B, EC, SAR, pH)
NEYAGAWA BOULEVARD, OAKVILLE, ONTARIO

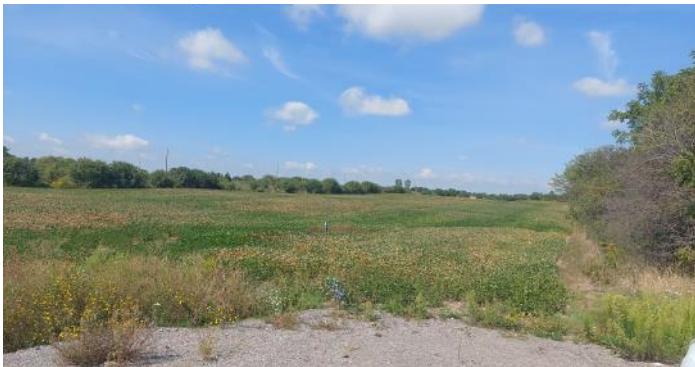
Photo 1: General view of the Site, looking northwest

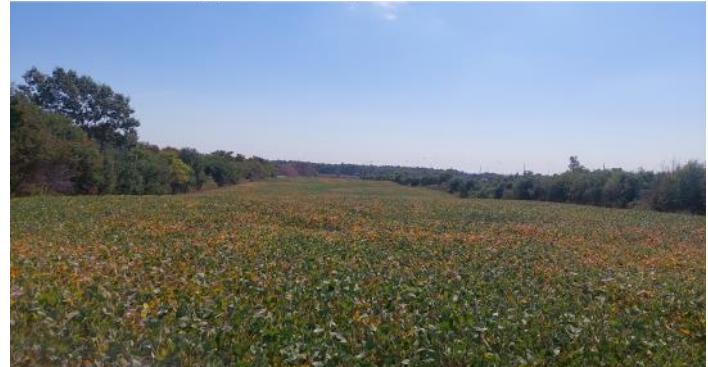
Photo 2: General view of the Site, looking southeast
