**Re: Phase Two Environmental Site Assessment Update
Proposed Residential Development
96 Chisholm Street
Town of Oakville**

DRAWINGS

REFERENCE NO. 1512-E088

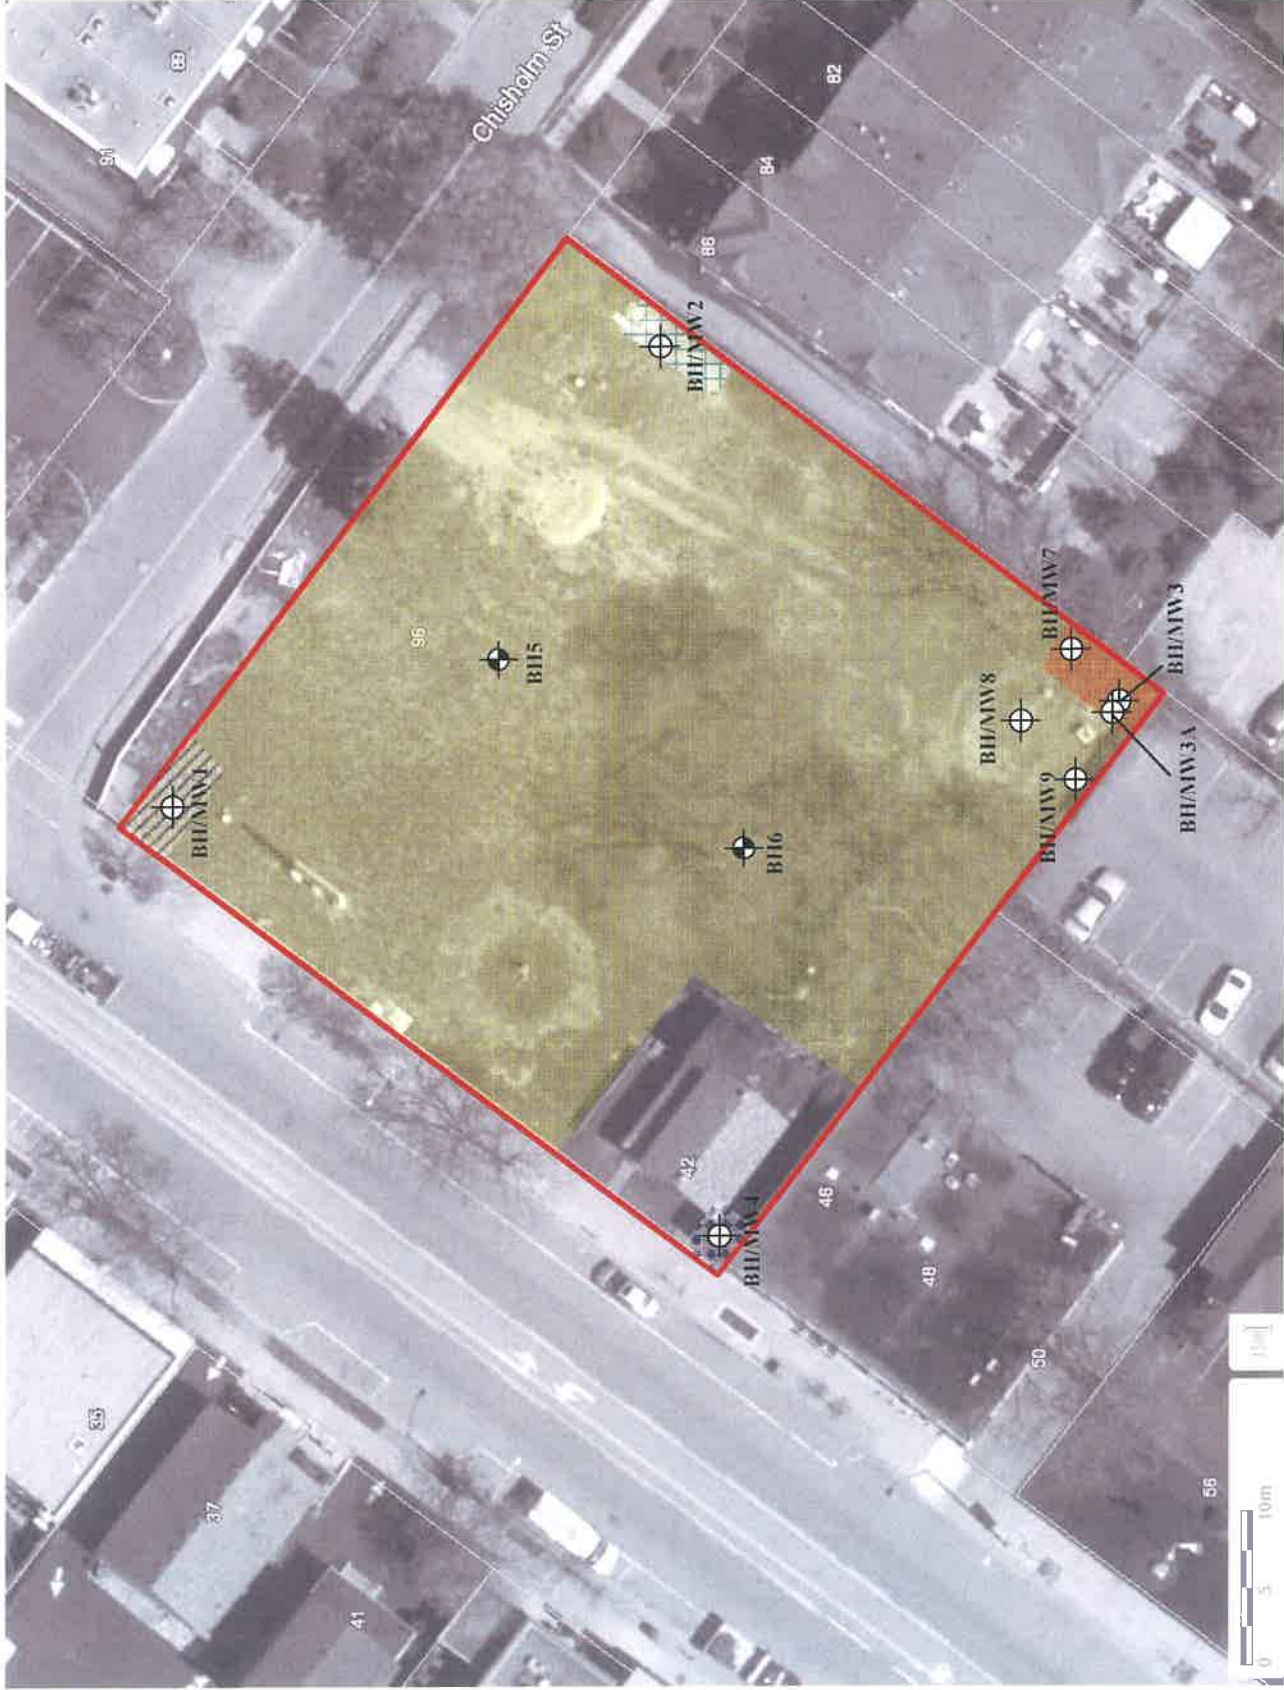
Drawing No. 2

Title:
Borehole and Monitoring Well
Locations Plan

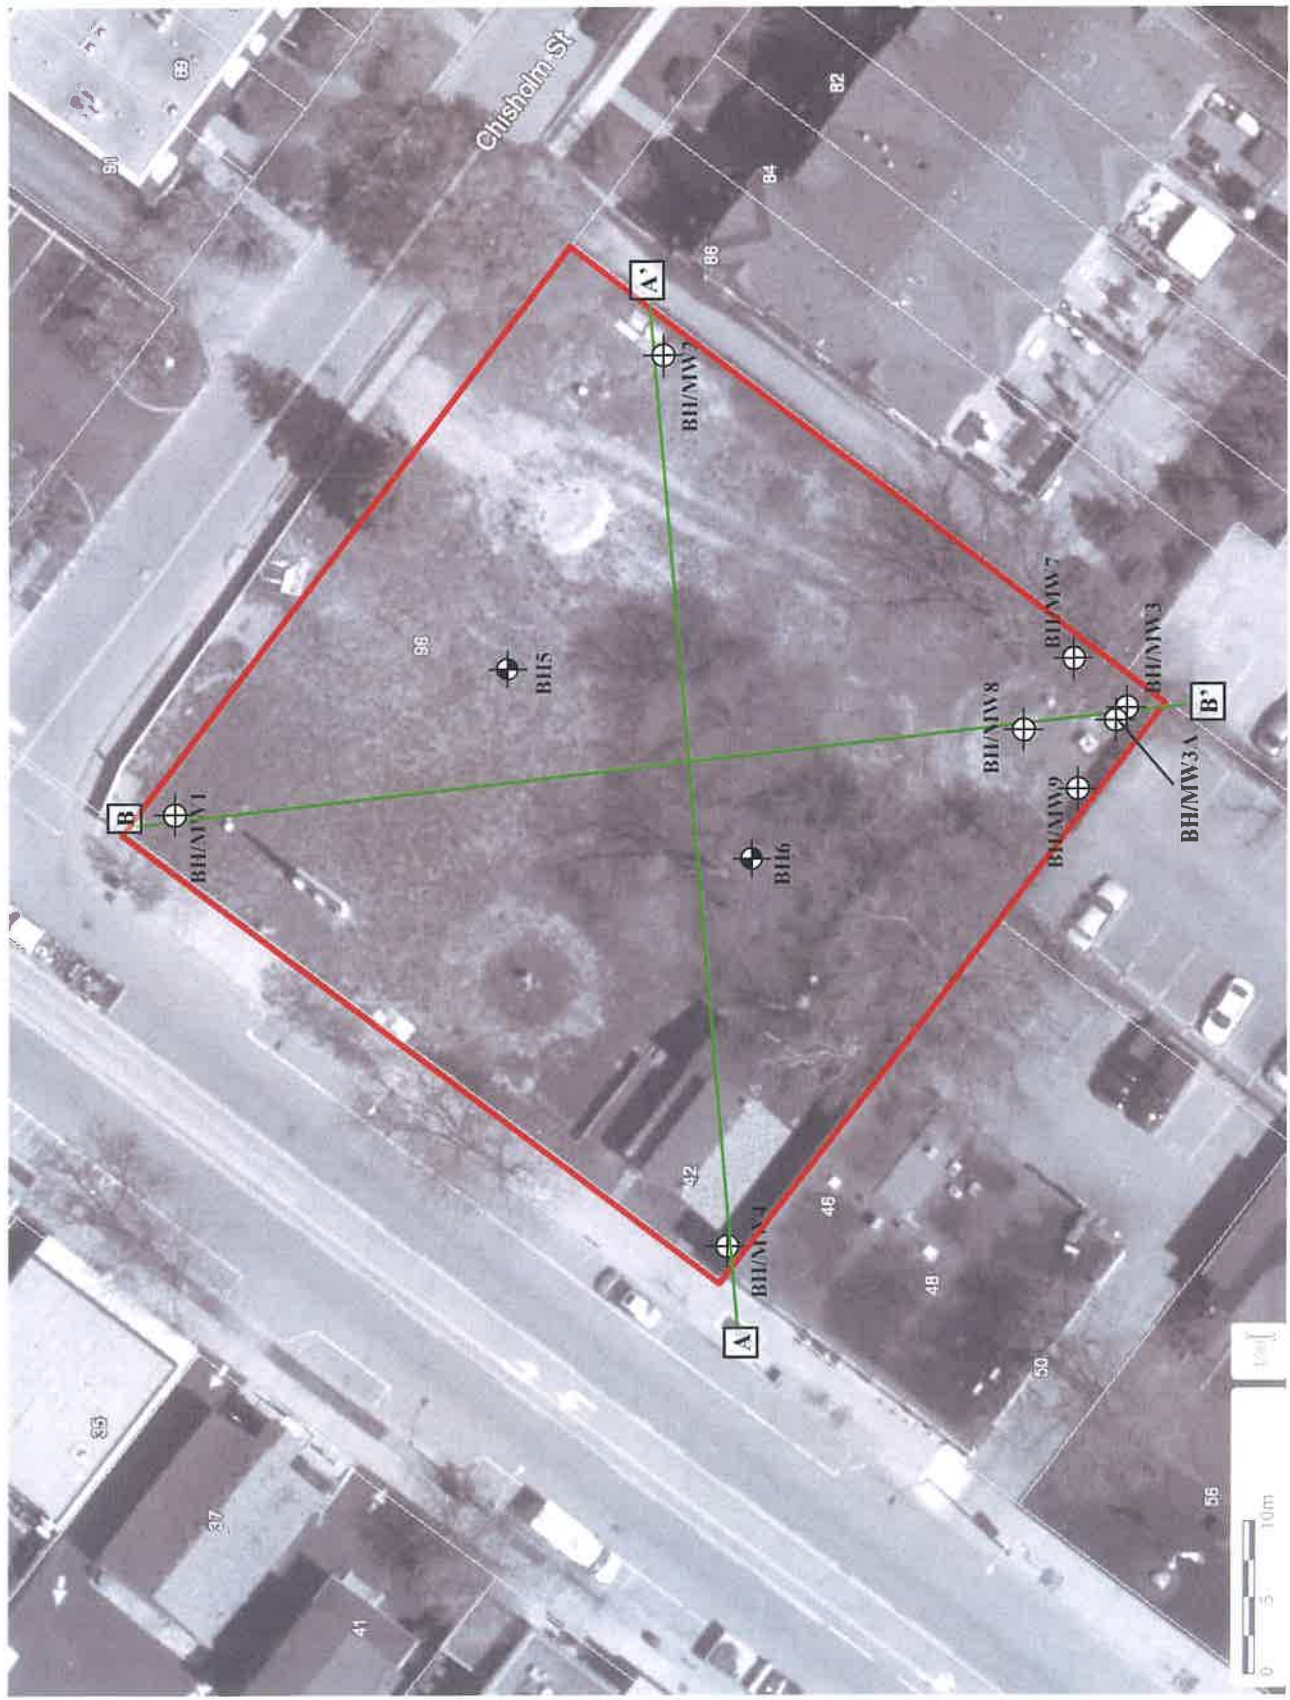
Reference No: 1512-E088	Date: October 30, 2017	Scale: V 1:200	Scale: II 1:1500	Drawing No. 4
----------------------------	---------------------------	-------------------	---------------------	------------------

SECTION A-A'

SECTION B-B'

Title: **Geological Cross-Sections A-A' and B-B'**

The drilling investigation for the Phase Two ESA consisted of advancing ten (10) boreholes to depths ranging from 1.4 mbgs to 7.6 mbgs at the subject site. The subsoil conditions at the borehole locations indicate, beneath the surface course of topsoil layer or sandy silt fill, the subject site is generally underlain by sandy silt and silty clay deposits at various depths and locations. No bedrock was encountered during the Phase Two ESA.

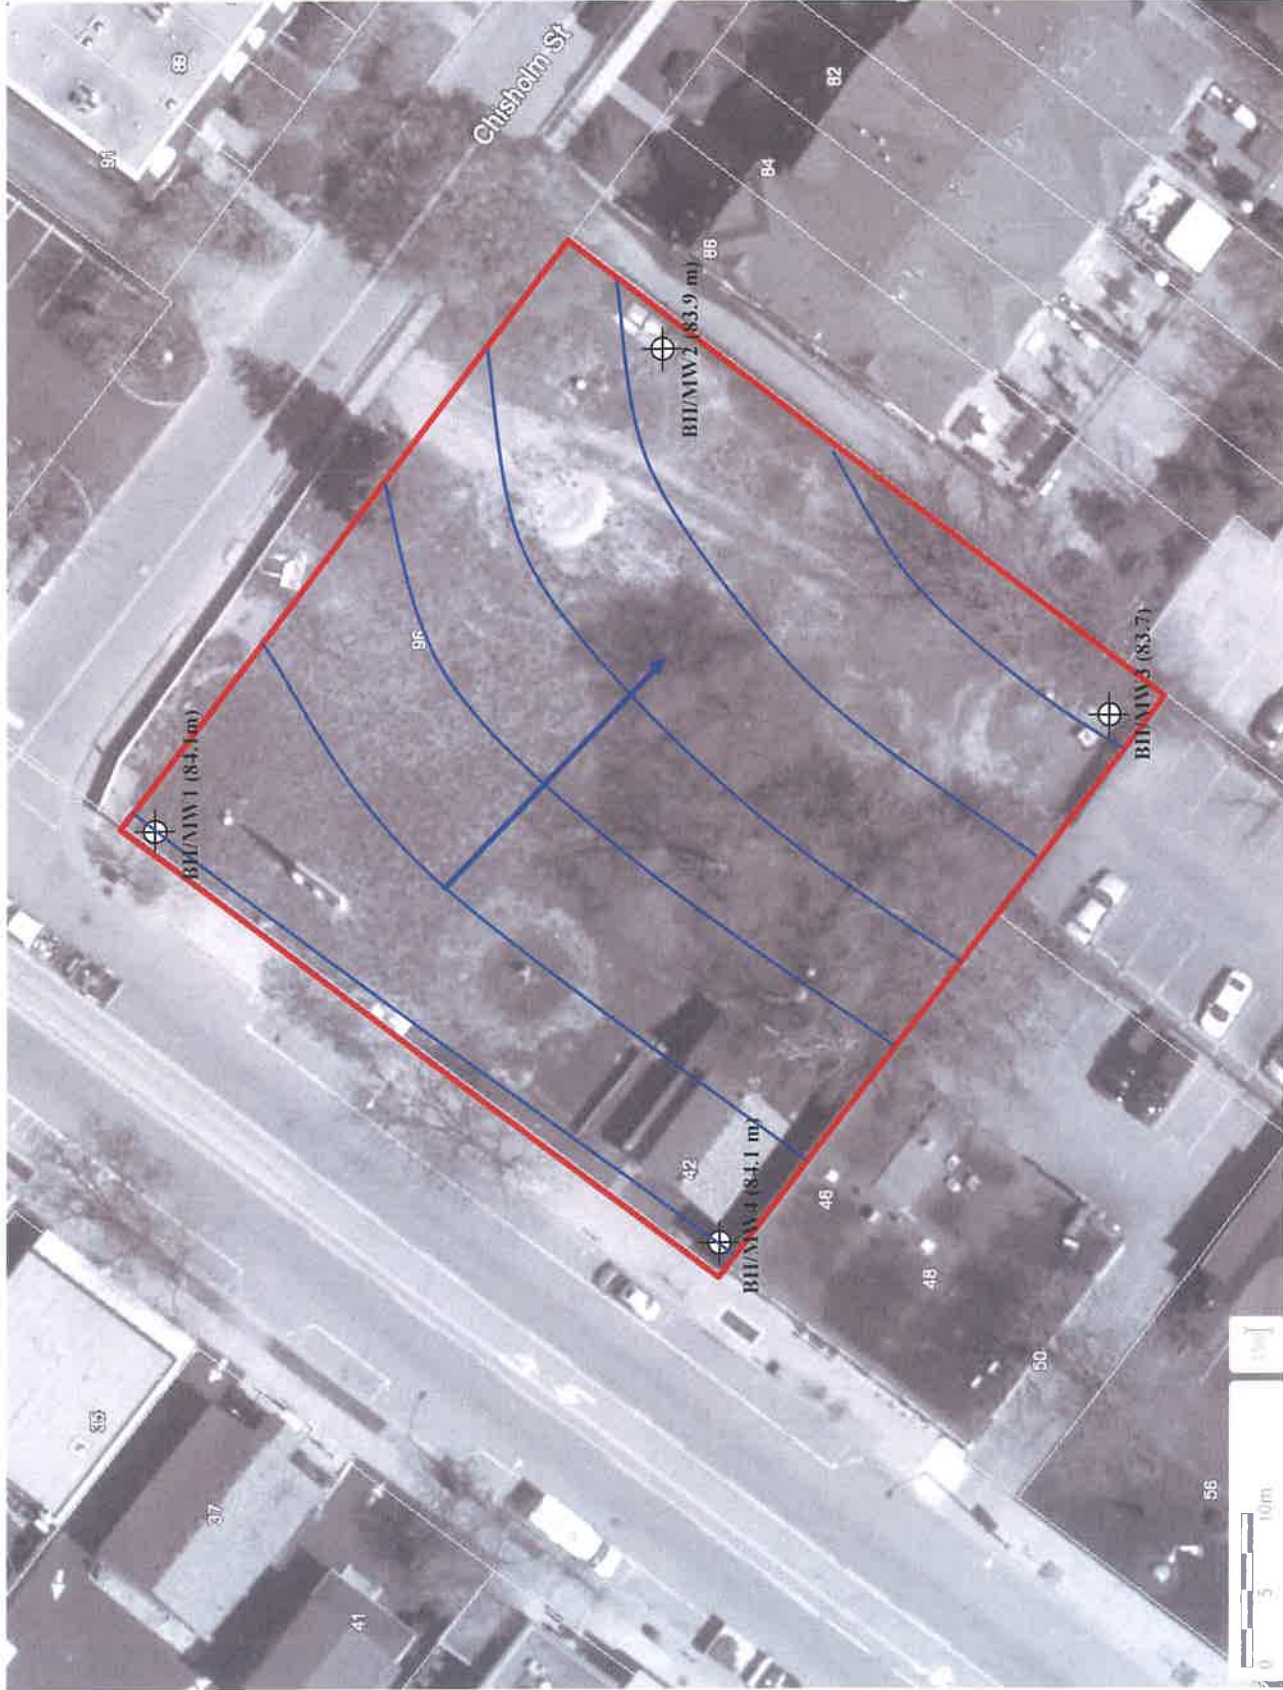
Title: Lateral Groundwater Delineation Plan
Project: Proposed Residential Development, 96 Chisholm Street, Town of Oakville
Reference No.: 1512-E088
Date: October 30, 2017
Scale: See Drawing
Drawing No.: 6

Monitoring Well ID	MW3	MW3A	MW9	MW7	MW8	MW3	Table 3 Standards
Depth (m)	1.4 – 3.7	6.1 – 7.6	1.6 – 4.6	1.6 – 4.6	1.6 – 4.6	1.4 – 3.7	
Trichloroethylene (TCE)	2.50	<0.2	<0.2	1.8	<0.2	0.57	17

Based on the review of the analytical results of the site investigation, the groundwater at BH/MW 3 location at a depth from 1.4mbgs to 4.4mbgs was found to contain contaminant TCE at a concentration of 350ug/l in excess of the Table 3 Standards of 17ug/l.
