**NOTE:**  
Vegetation inventory undertaken by Jeremy Jackson, Jackson Arboriculture Inc. ISA Certified Arborist (ON-1089A) on March 13, 2023.

**PROJECT**  
3005 Dundas Street West

**SHEET**  
Tree Protection Plan **L-1**

SHEET  
Tree Protection Plan L-2

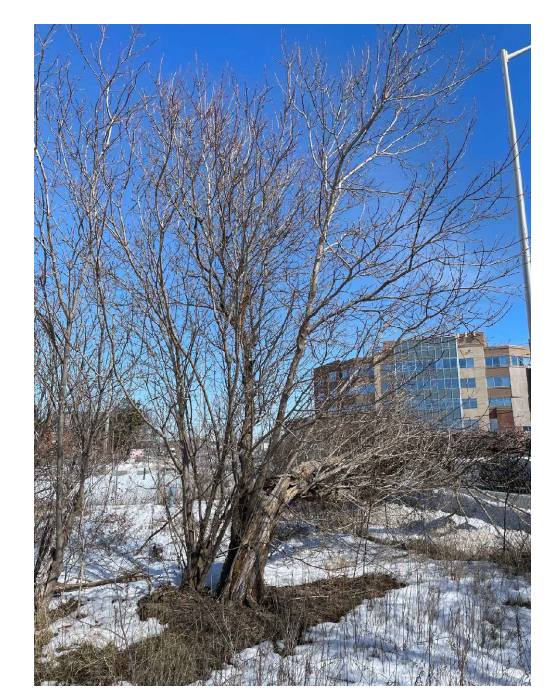
Tree #1

Tree #	Species (Common Name)	Species (Botanical Name)	DBH (cm)	Trunk Integrity	Crown Structure	Crown Vigor	mFZ	Dipline (m)	Crown Class	Comments	Potential Impacts from Construction	Ownership	Recommendation
1	Manitoba Maple	Acer negundo	16, 11	PF	F	F	2, 4	4	CD	Main stem failed	Conflicts with proposed building	Subject Property	Remove
2	Manitoba Maple	Acer negundo	22, 7, 8, 8	F	F	PF	2, 4	4	CD	Union at ground, 30% crown dieback, stem wound	Conflicts with proposed sidewalk	Subject Property	Remove
3	Manitoba Maple	Acer negundo	11, 7	P	P	P	2, 4	3	CD	Main stem failed	Conflicts with proposed building	Subject Property	Remove
4	Manitoba Maple	Acer negundo	70	P	P	P	4, 2	4	CD	Main stem failed at 2 m, hollow stem with heart rot	Conflicts with proposed building	Subject Property	Remove
5	Manitoba Maple	Acer negundo	56, 52	F	PF	PF	3, 6	5	D	Union at 1 m, stem wound, 30% crown dieback	Conflicts with proposed building	Subject Property	Remove

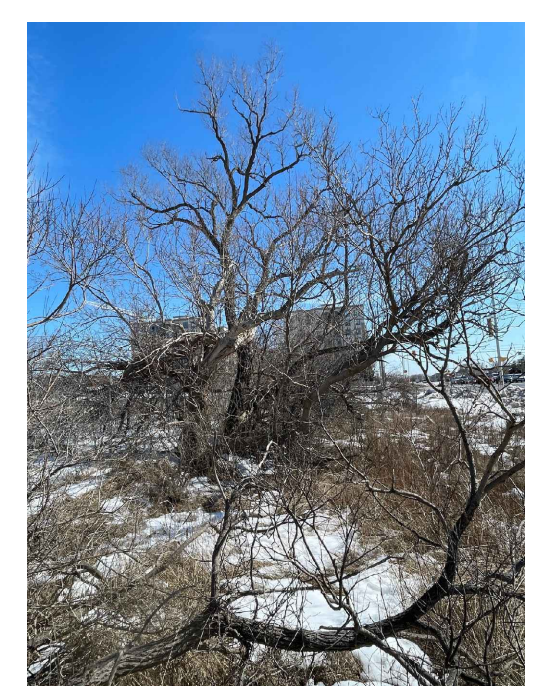
Tree #13

12	Willow species	Salix sp.	75	F	PF	PF	4, 8	9	CD	30% crown dieback	Conflicts with proposed building	Subject Property	Remove
13	Manitoba Maple	Acer negundo	69	P	P	P	4, 2	6	CD	50% crown dieback, broken branches, stem wound at flare with heart rot	Conflicts with proposed building	Subject Property	Remove
14	Willow species	Salix sp.	29	FG	F	F	2, 4	5	CD	20% crown dieback	Conflicts with proposed building	ROW	Remove
15	Willow species	Salix sp.	27, 39, 28, 20, 23, 21	F	FG	FG	3, 0	6	CD	Union at 0.4 m	Conflicts with proposed building	Subject Property	Remove
16	Pear species	Pyrus sp.	10	G	G	G	2, 4	2	CD	None	None	ROW	Remove
17	Eastern Cottonwood	Populus deltoides	16, 15, 18	F	FG	G	2, 4	4	CD	Union at ground	Conflicts with proposed building	Subject Property	Remove
18	Manitoba Maple	Acer negundo	13, 10, 9	F	FG	G	2, 4	4	CD	Union at ground	Conflicts with proposed building and internal walkway	Subject Property	Remove

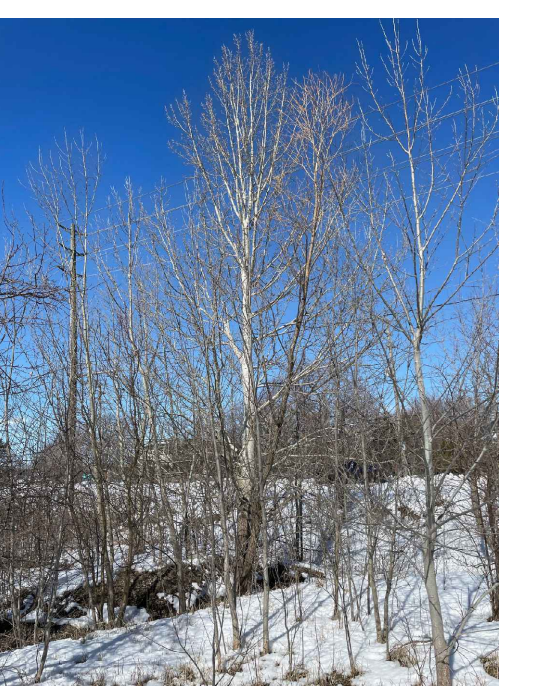
Trees #35-39

33	Manitoba Maple	Acer negundo	20, 15, 5	F	G	G	2, 4	4	CD	Union at 1.1 m	Conflict with proposed building	Subject Property	Remove
34	Apple species	Malus sp.	9, 10	F	FG	G	2, 4	3	I	Union at 0.2 m	Conflict with proposed building	Subject Property	Remove
35	White Poplar	Populus alba	11	G	G	G	2, 4	2	CD	Union at ground with included bark	Conflict with proposed building	Subject Property	Remove
36	White Poplar	Populus alba	11, 14	F	FG	G	2, 4	3	CD	Union at ground with included bark	Conflict with proposed building	Subject Property	Remove
37	White Poplar	Populus alba	10	G	G	G	2, 4	3	CD	Union at ground with included bark	Conflict with proposed building	Subject Property	Remove
38	White Poplar	Populus alba	10	G	G	G	2, 4	3	CD	Union at ground with included bark	Conflict with proposed building	Subject Property	Remove
39	White Poplar	Populus alba	36	G	G	G	3, 0	3	CD	Union at ground with included bark	Conflict with proposed building	Subject Property	Remove

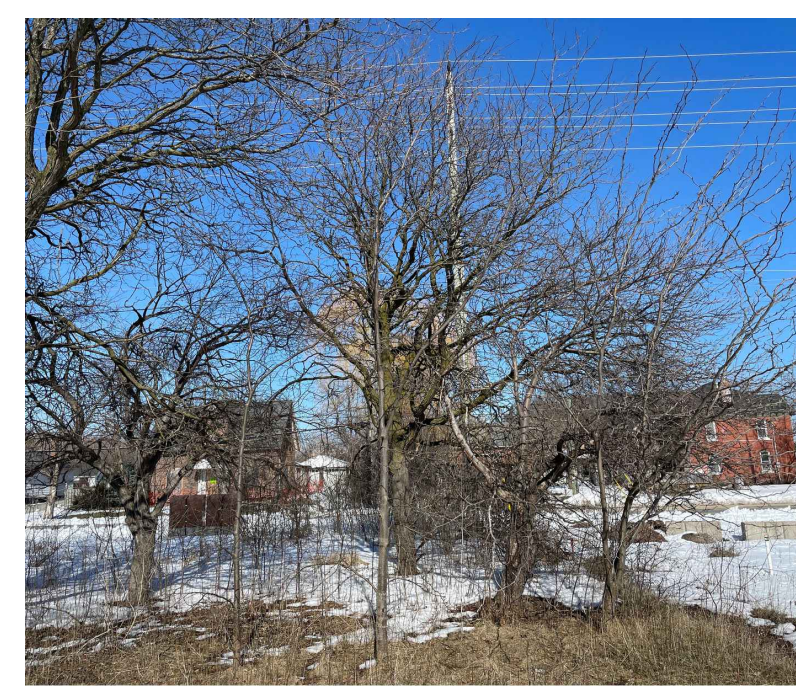
Trees #53-55

55	Apple species	Malus sp.	14, 22, 8	P	P	P	2, 4	3	I	Union at 0.5 m, 60% crown dieback	Conflict with proposed building	Subject Property	Remove
56	Eastern Cottonwood	Populus deltoides	13	G	G	G	2, 4	2	D	Union at ground	Conflict with proposed building	Subject Property	Remove
57	Siberian Elm	Ulmus pumila	13	G	G	G	2, 4	2	D	Union at ground	Conflict with proposed sidewalk	Subject Property	Remove
58	Willow species	Salix sp.	10	G	FG	G	2, 4	3	CD	Lean in crown	Conflict with proposed outdoor amenity area	Subject Property	Remove
59	Siberian Elm	Ulmus pumila	11	G	G	G	2, 4	2	D	Union at ground	Conflict with proposed outdoor amenity area	Subject Property	Remove
