# Updated Slope Stability Assessment

## Proposed Development

1260 & 1280 Dundas Street West, Oakville, ON

BIGC-ENV-185C

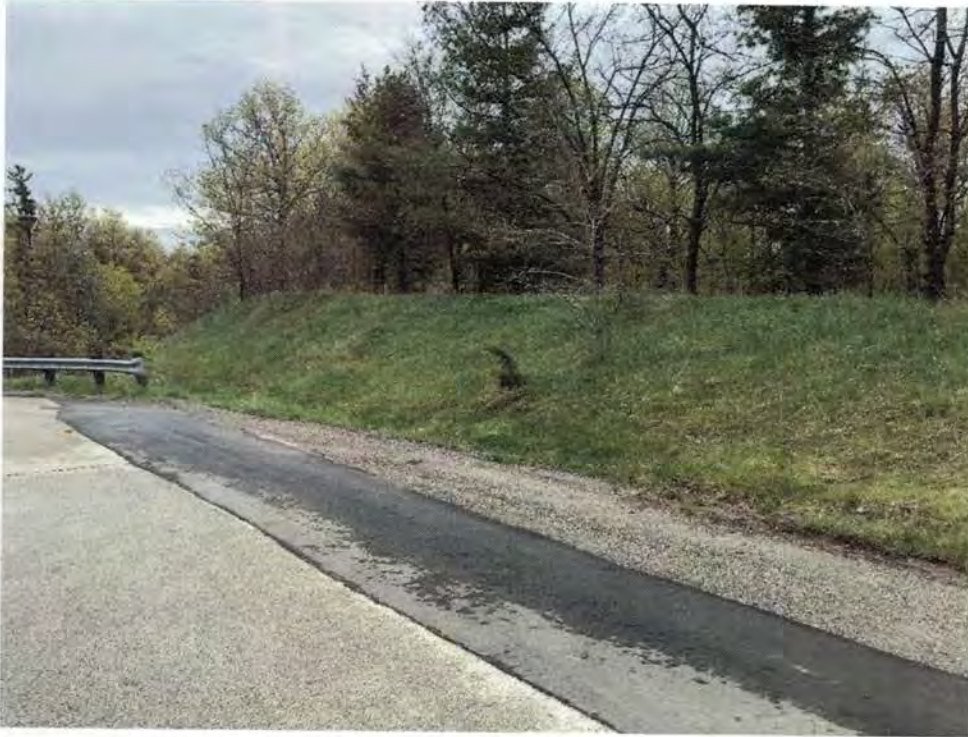
West Slope – Looking south, Cross Section C

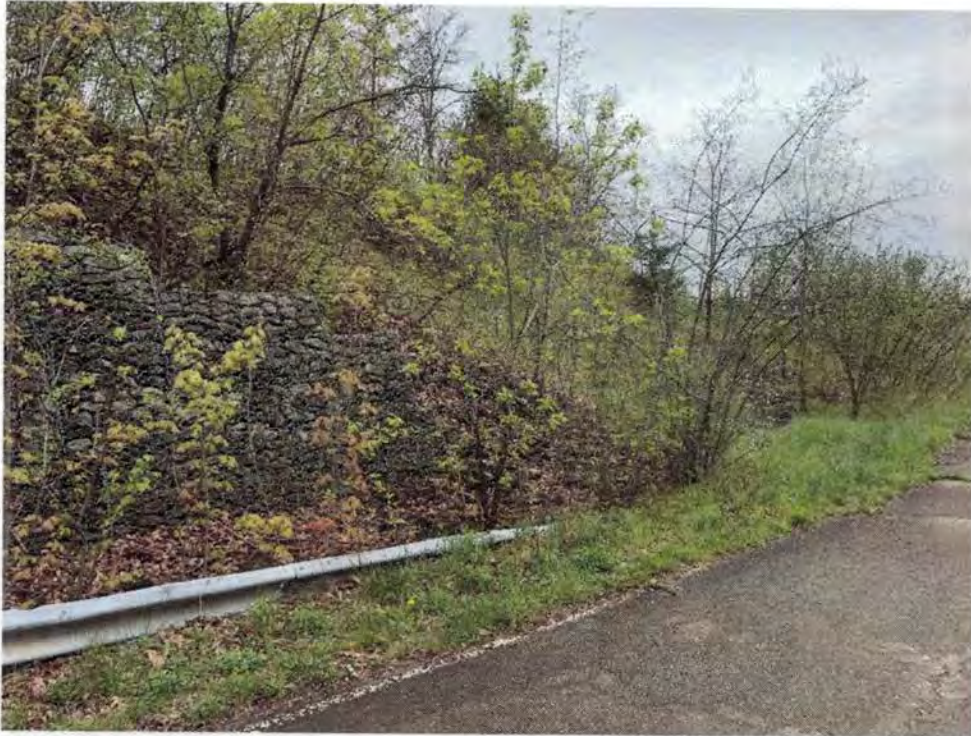
West Slope – Looking North, Gabion Retaining Wall

The West Valley Slope is located on the southwestern/western quadrant of the Site and west of Fourth Line Road and is a west/south facing slope. This slope wraps around towards Fourth Line Road at the south end. A drainage ditch with free-flowing surficial runoff was observed at the toe of the reviewed slope. Vegetation, including mature trees, young trees, small to large shrubs, and grass along the banks of the slope are growing vertical and upright indicating that the slope is generally stable. Only what is to be considered minor surface erosion was occasionally observed. At the area where the slope wraps around towards Fourth Line Road, an approximately 16 m wide gabion stone retaining wall is present.

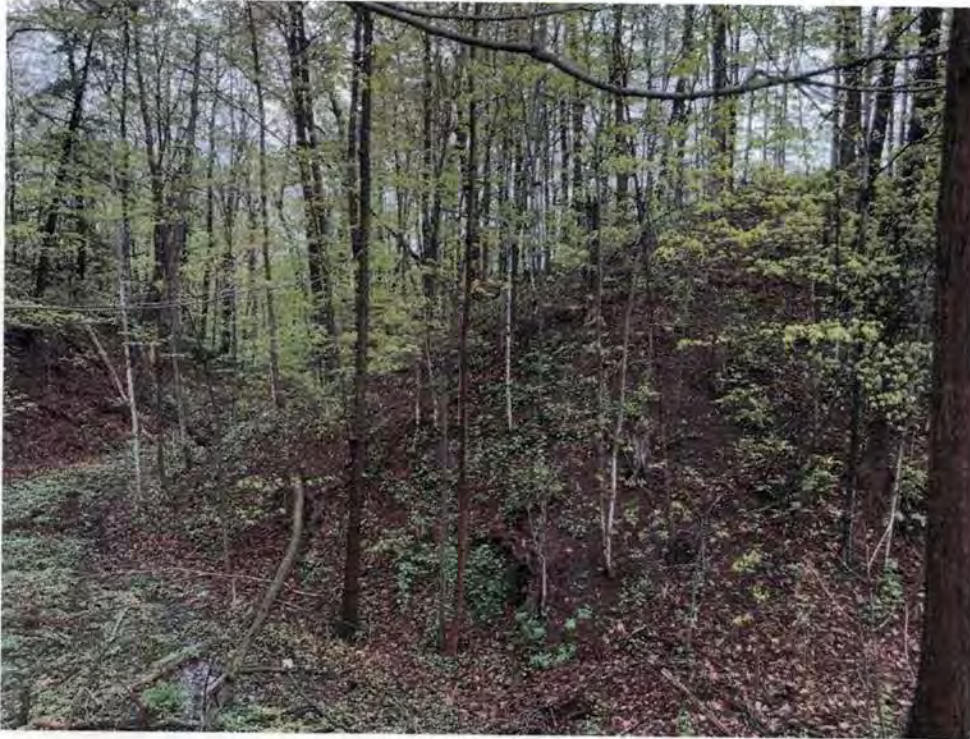
West Slope – Looking West, drainage flowing east toward Sixteen Mile Creek, Cross Section E

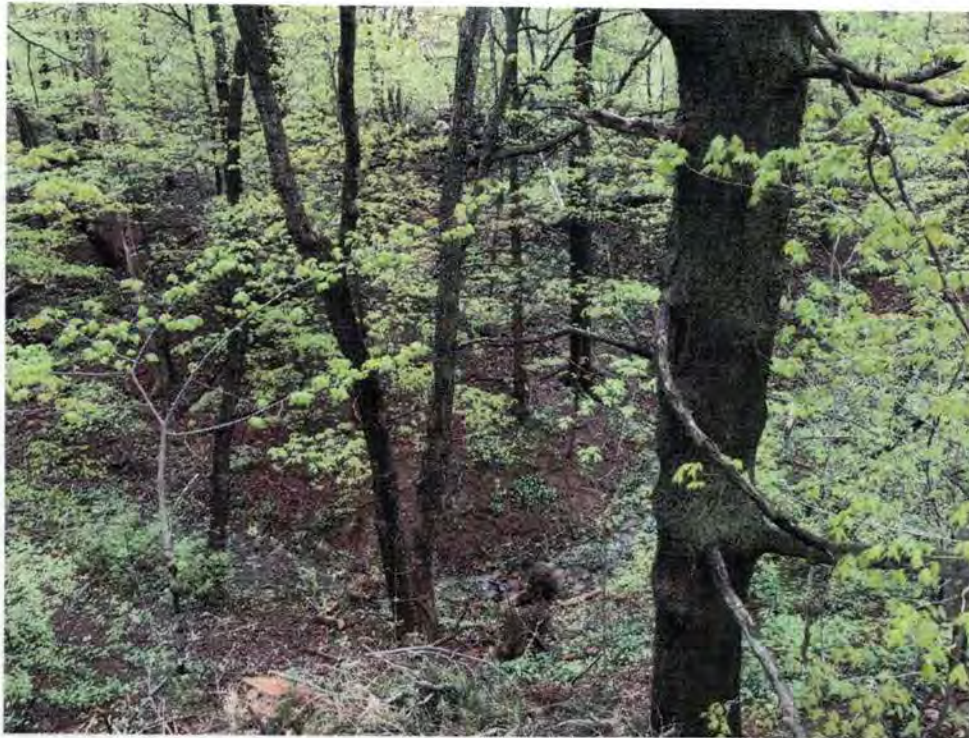
West Slope – Looking South, Cross Section E

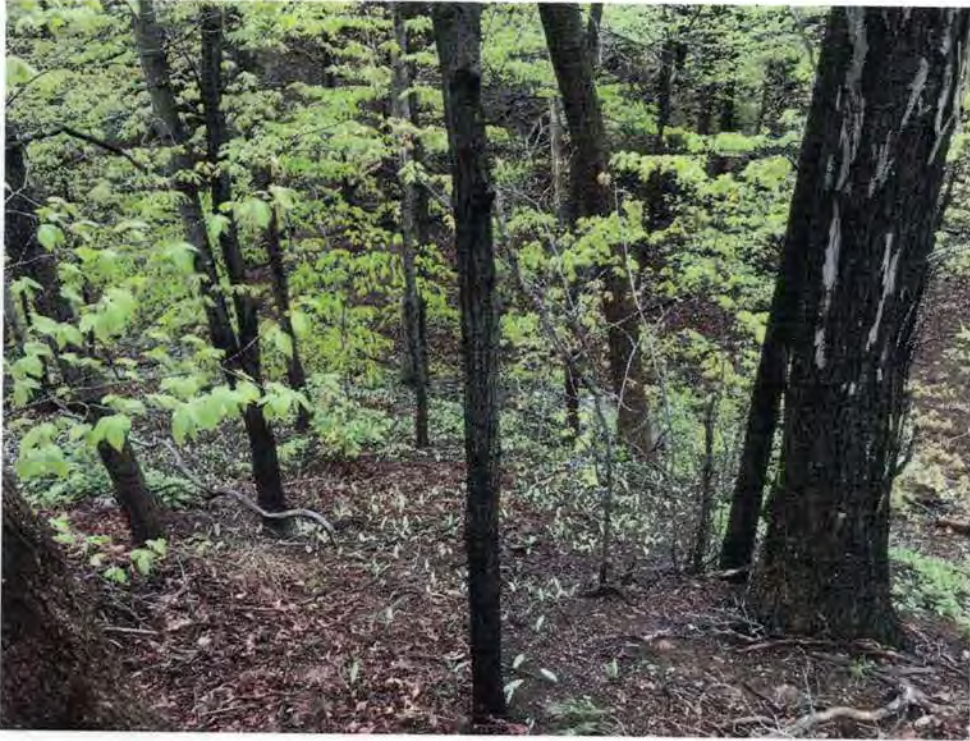
West Slope – Looking South, Cross Section D

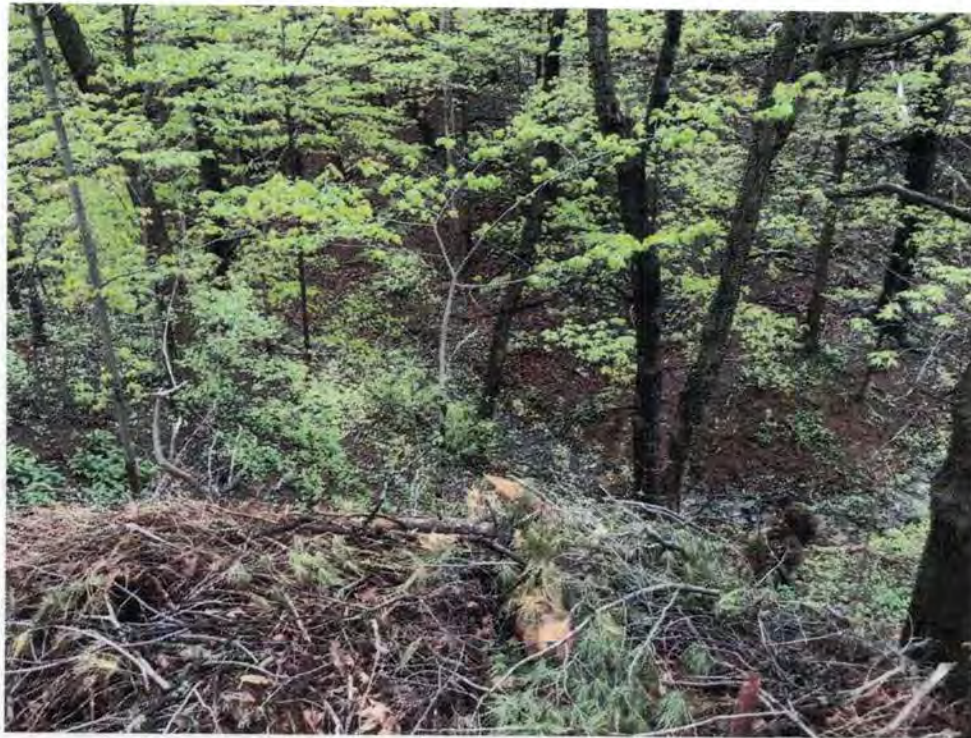
West Slope – Looking South, Cross Section D

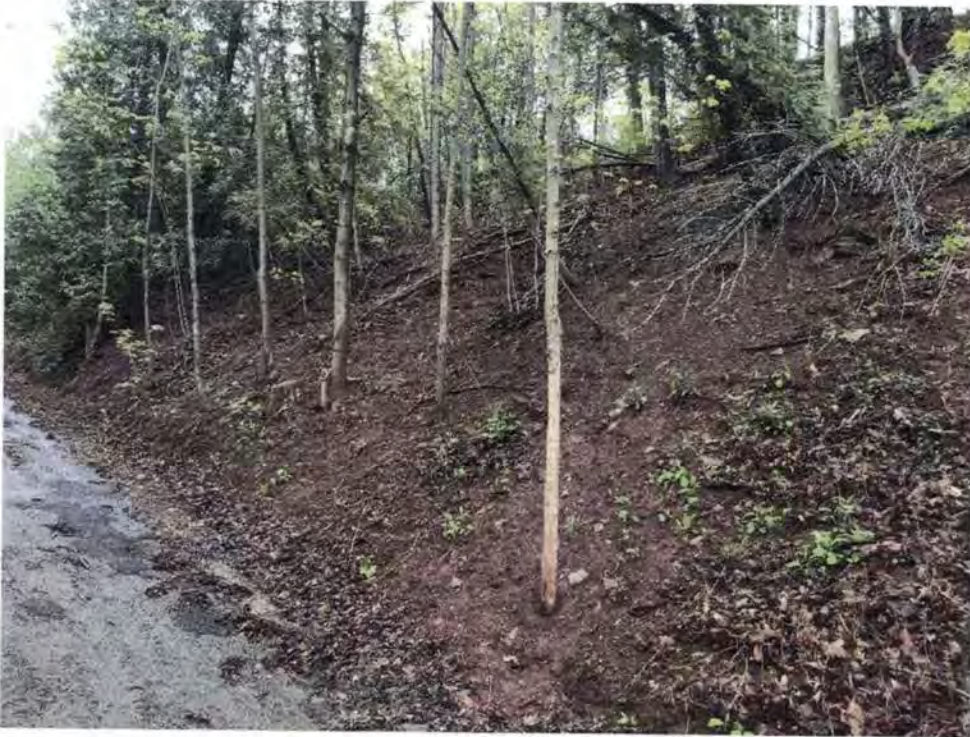
Sixteen Mile Creek Slope – Looking South, Cross Section C

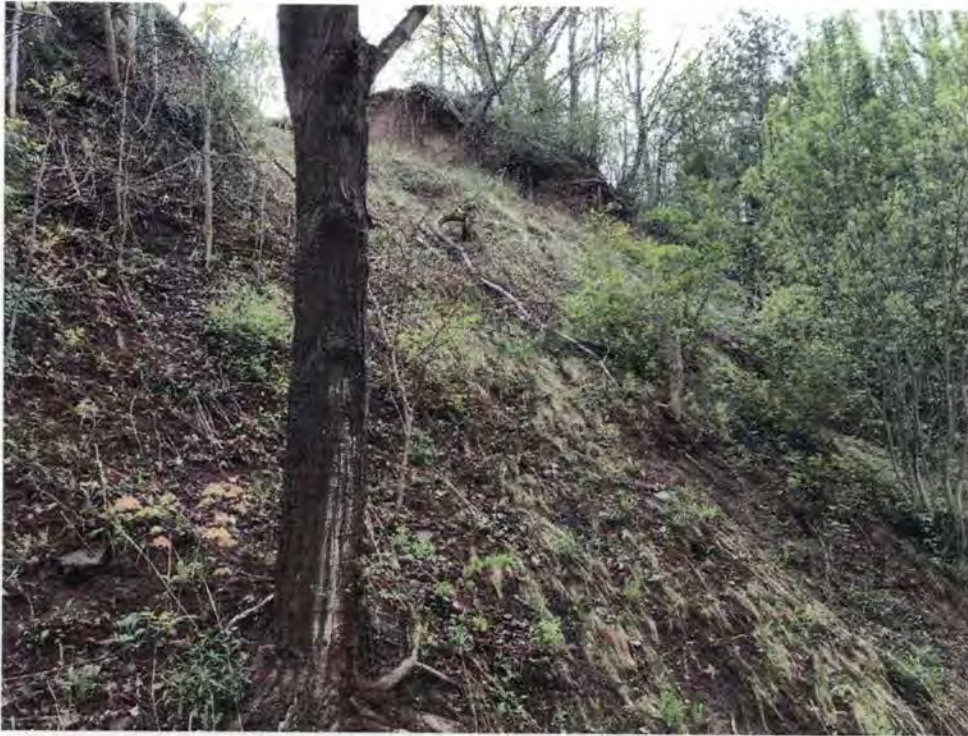
Sixteen Mile Creek Slope – Looking Northwest, Cross Section C

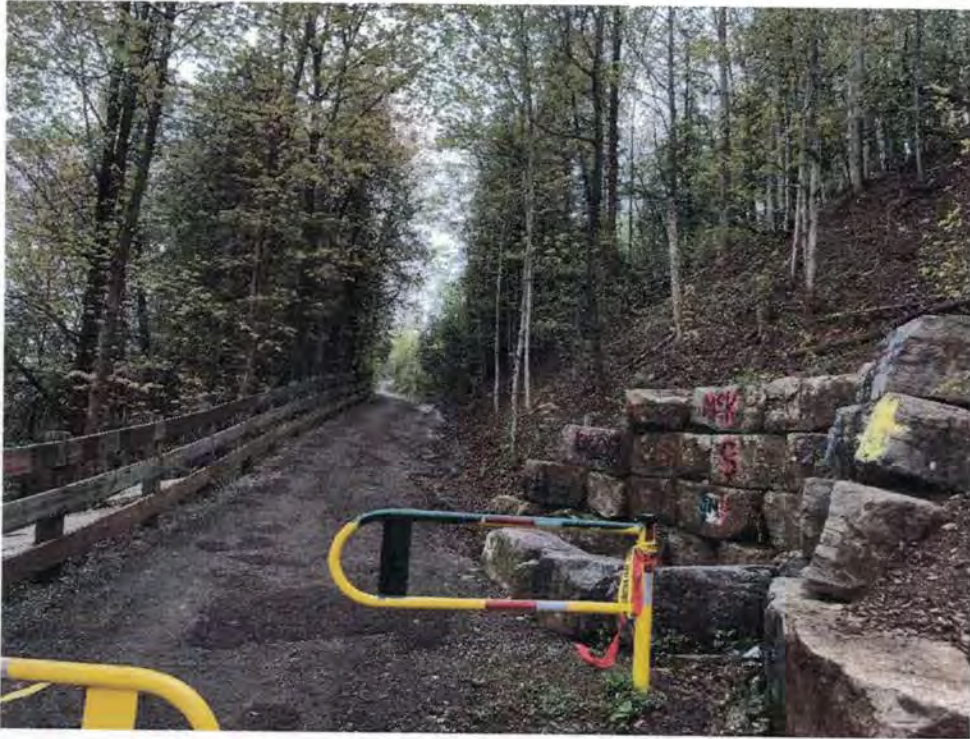
Sixteen Mile Creek Slope – Trail dividing the slope, looking Southeast

This northeast/east facing slope is divided into two sections by an asphalt paved walking path where approximately half the totality of the slope lies above the asphalt paved walking path, while one half lies below. Vegetation, including mature trees, young trees, small to large shrubs, and grass/shrubbery along the reviewed bank are growing vertical and upright indicating that the slope is generally stable. However, several surface erosion events of the slope in an eastward direction toward Sixteen Mile Creek were observed in the Upper half of the slope, i.e. above the asphalt paved walkway. In the areas where surface erosion was observed, only young trees and shrubs were observed to have fallen over due to the said erosion of the slope, while mature trees were upright and heavily rooted into the face of the slope. The widths of the observed erosion planes were in the order of 8 m to 16 m. The general locations of erosion areas are provided on the site plan (Drawing 1B). The observed surface erosion and other slope features are on the photographs provided in Appendix C.

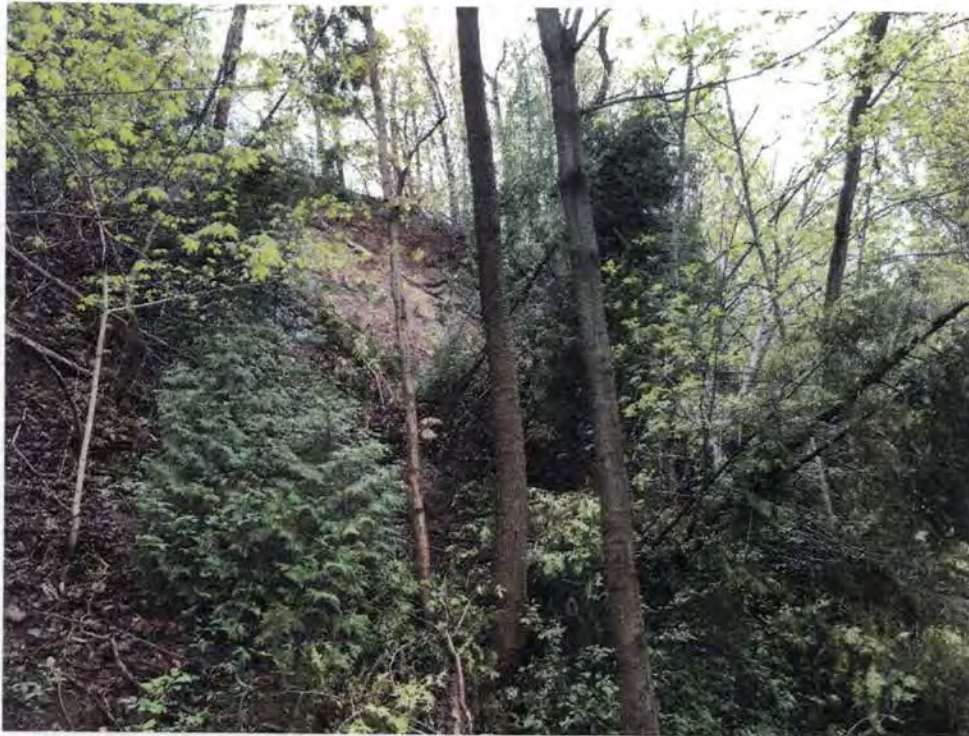
Sixteen Mile Creek Slope – Looking Northwest, slope overburden erosion, Cross Section B

Surface sloughing of this upper slope will occur in slopes steeper than 2.5H:1V when the surface becomes saturated and as observed in our site reconnaissance visit.

1. Sixteen Mile runs adjacent to the toe of the eastern slope however the start of the shale bedrock is much higher than the toe of the slope. Erosion at the toe of the subject slope is not considered to be a problem.
2. The vegetation on the existing slope surfaces must be preserved and must not be removed.
3. No additional surcharge can be applied in the area within 8 m from the top of the slope.
4. Building walls and footings must be at least 7 m away from the top of the existing slope. Footings must be founded below an imaginary 3 horizontal to 1 vertical line drawn up from the face of the slope at the bedrock surface (See Cross-Section Drawings 2 to 9).
5. Where erosion planes are present, slope treatment such as rip-wrap drainage and/or geogrid reinforcement and seeding of the slope surface is recommended.

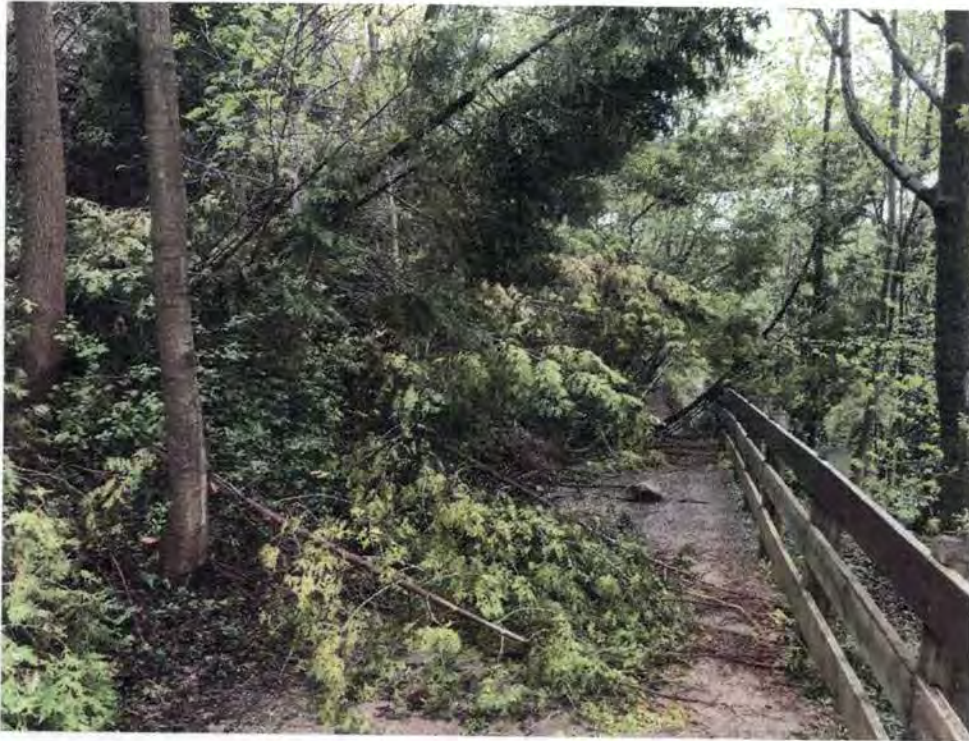
Sixteen Mile Creek Slope – Looking Southwest, slope overburden erosion impeding path, Cross Section B

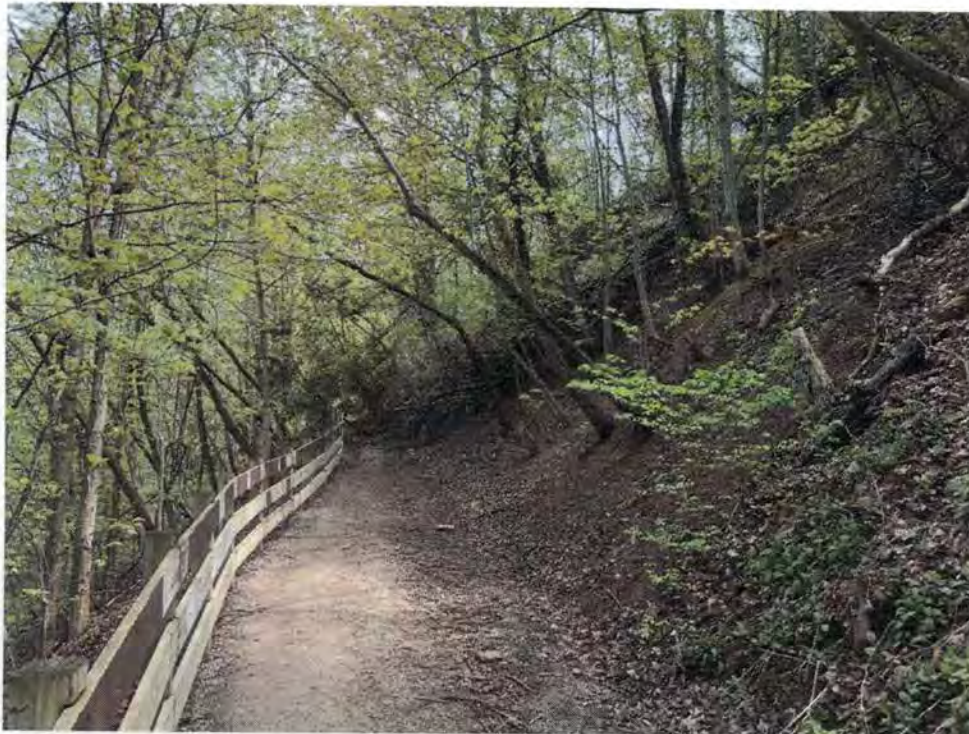
Sixteen Mile Creek Slope – Trail dividing the slope impeded by upper slope overburden erosion, looking South, Cross Section B

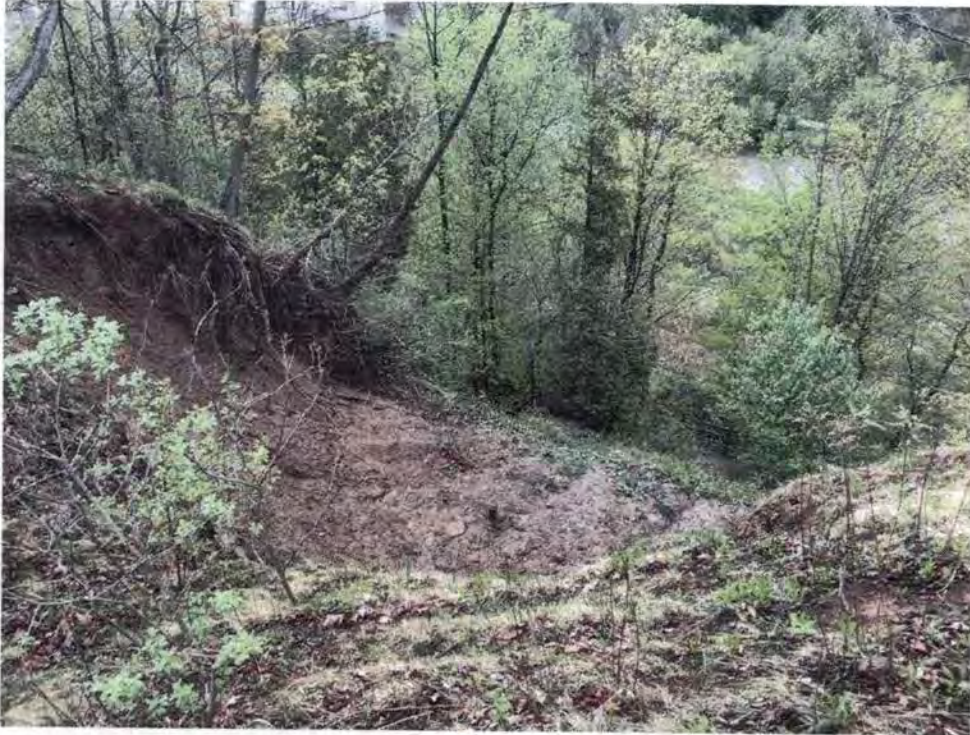
Sixteen Mile Creek Slope – Slope overburden erosion, looking East

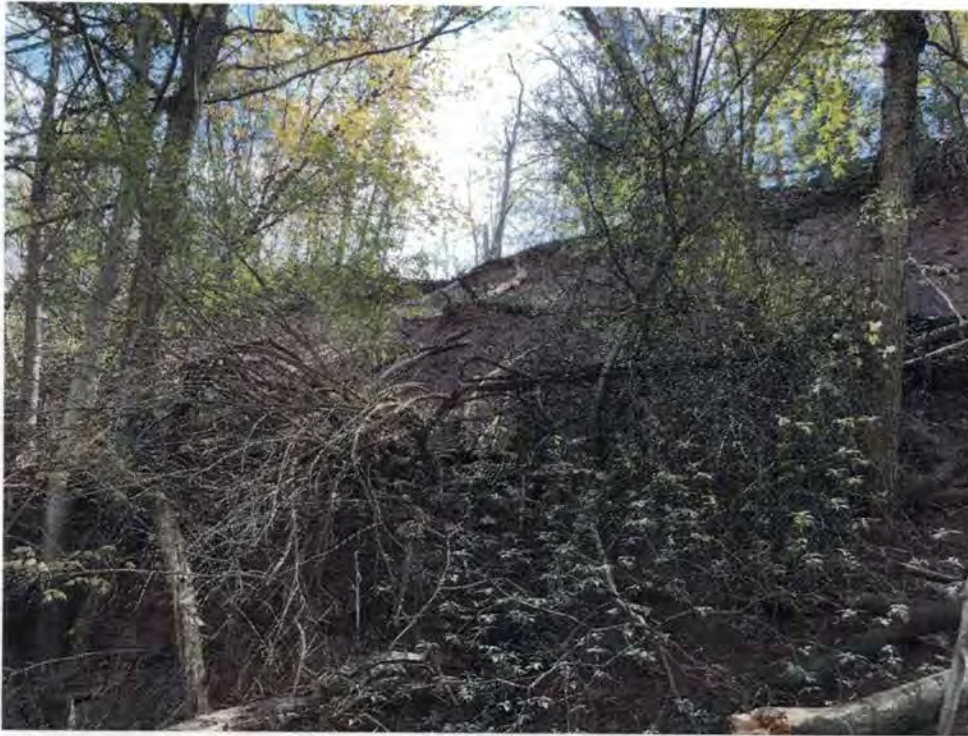
Sixteen Mile Creek Slope – Slope overburden erosion, looking West

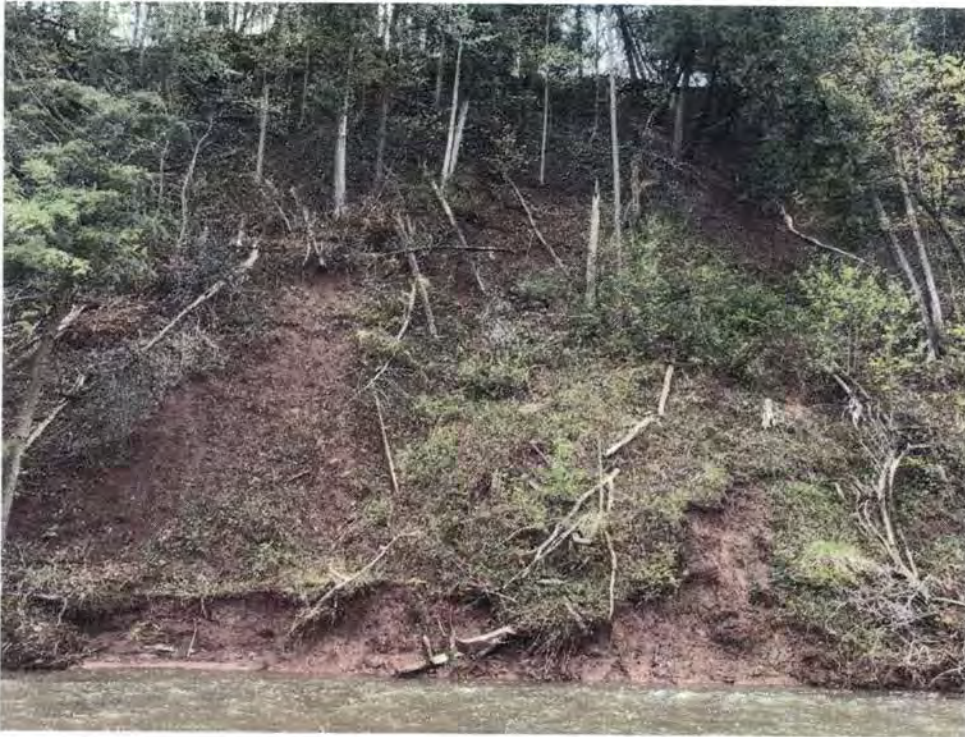
Gullies, or mild dips of the slope were observed in the half of the slope below the asphalt paved walking path and vegetation including mature trees, young trees, small to large shrubs, and grass were noted at the lower half of the slope. The vegetation was observed to be vertical and upright, with no evidence of movement of the slope, indicating the slope is generally stable. Sixteen Mile Creek is located adjacent of the toe of the slope. No signs of active toe erosion were noted along the toe of the slope.

Sixteen Mile Creek Slope – Toe of slope, looking West

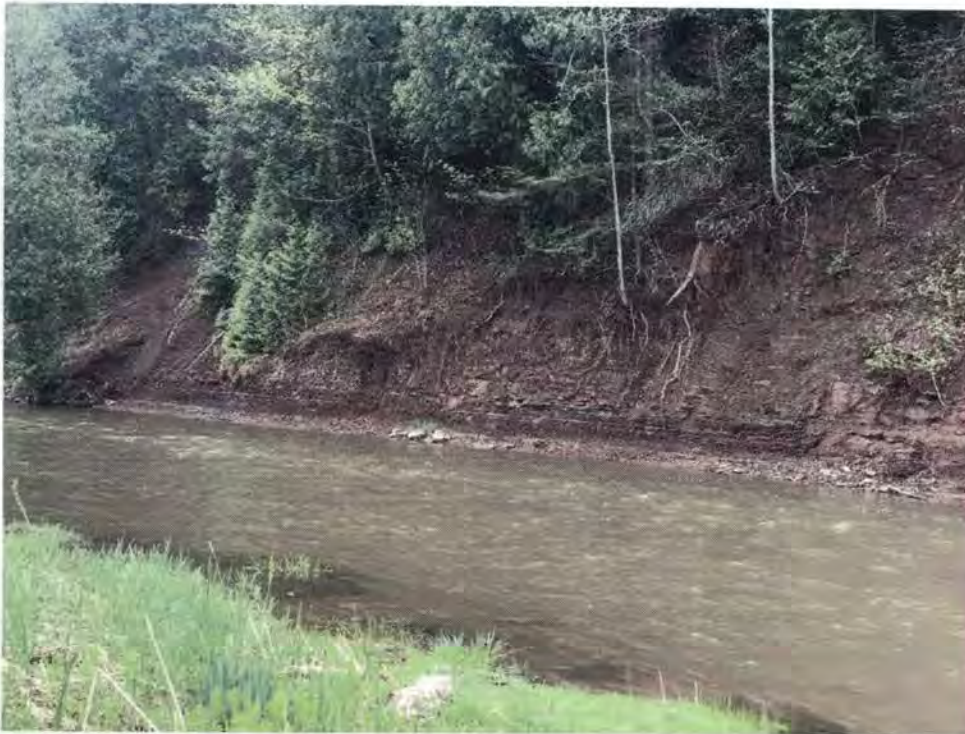
Sixteen Mile Creek Slope – Toe of slope, looking southwest, Cross Section C

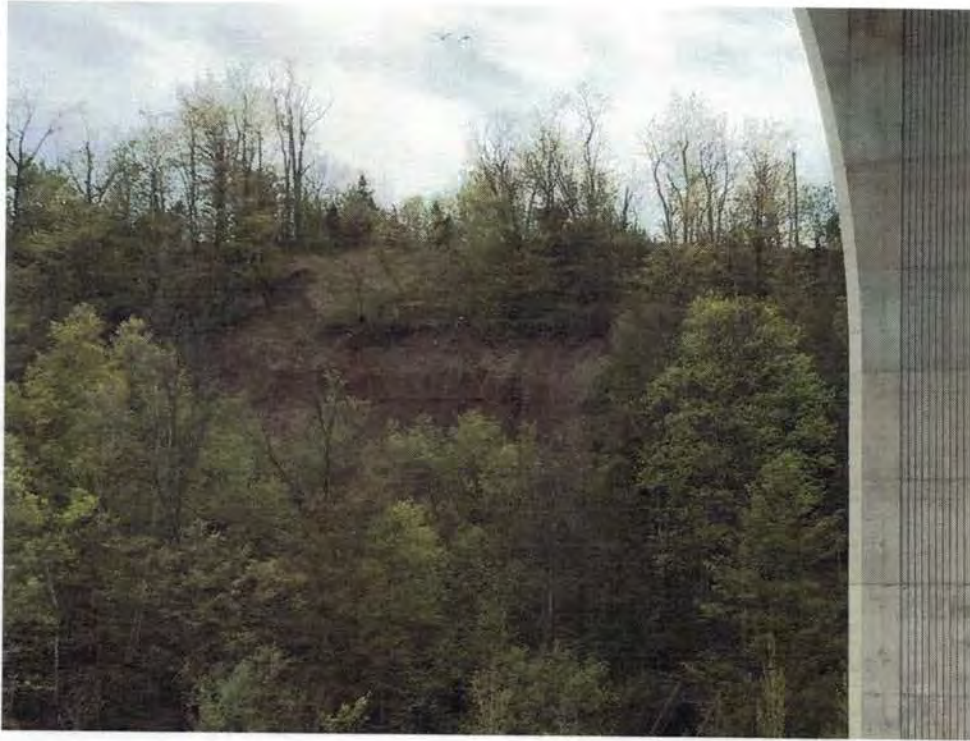
Sixteen Mile Creek Slope – Erosion of overburden on top of Queenston Shale, looking southwest, Cross Section A

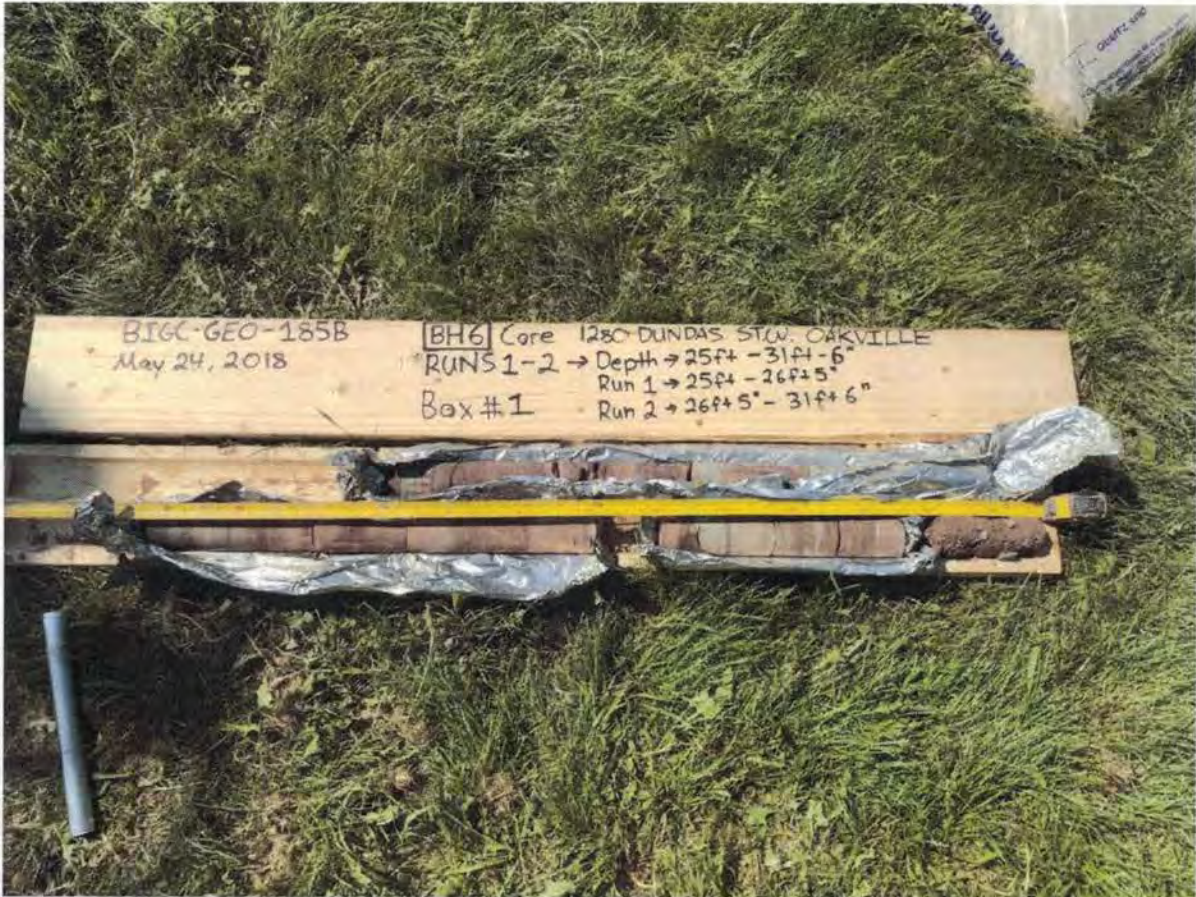
The rock can be penetrated by augering for various depths; however, the core recovery was very good. The rock quality was variable ranging from very poor to poor, i.e. Rock Quality Designation (RQD) of 22 % between 9.1 and 9.6 m depth at BH/MW3 to RQD of 40 % between 7.7 and 8.1 m depth at BH/MW6 to good to excellent quality, i.e. RQD ranging from 84 to 98 % in the lower levels of BH/MW2, BH/MW3 and BH/MW6. The red shale had interbedded grey shale layers, some horizontal fractures along planes, minimal vertical cracking, minimal vertical fractures and some interbedded clayey silt at 9.1 m in BH/MW6.

[BH6] Core 1280 DUNDAS ST. W. OAKVILLE  
RUNS 1-2 -> Depth -> 25ft - 31ft - 6"  
Run 1 -> 25ft - 26ft + 5"  
Box #1 Run 2 -> 26ft + 5" - 31ft + 6"

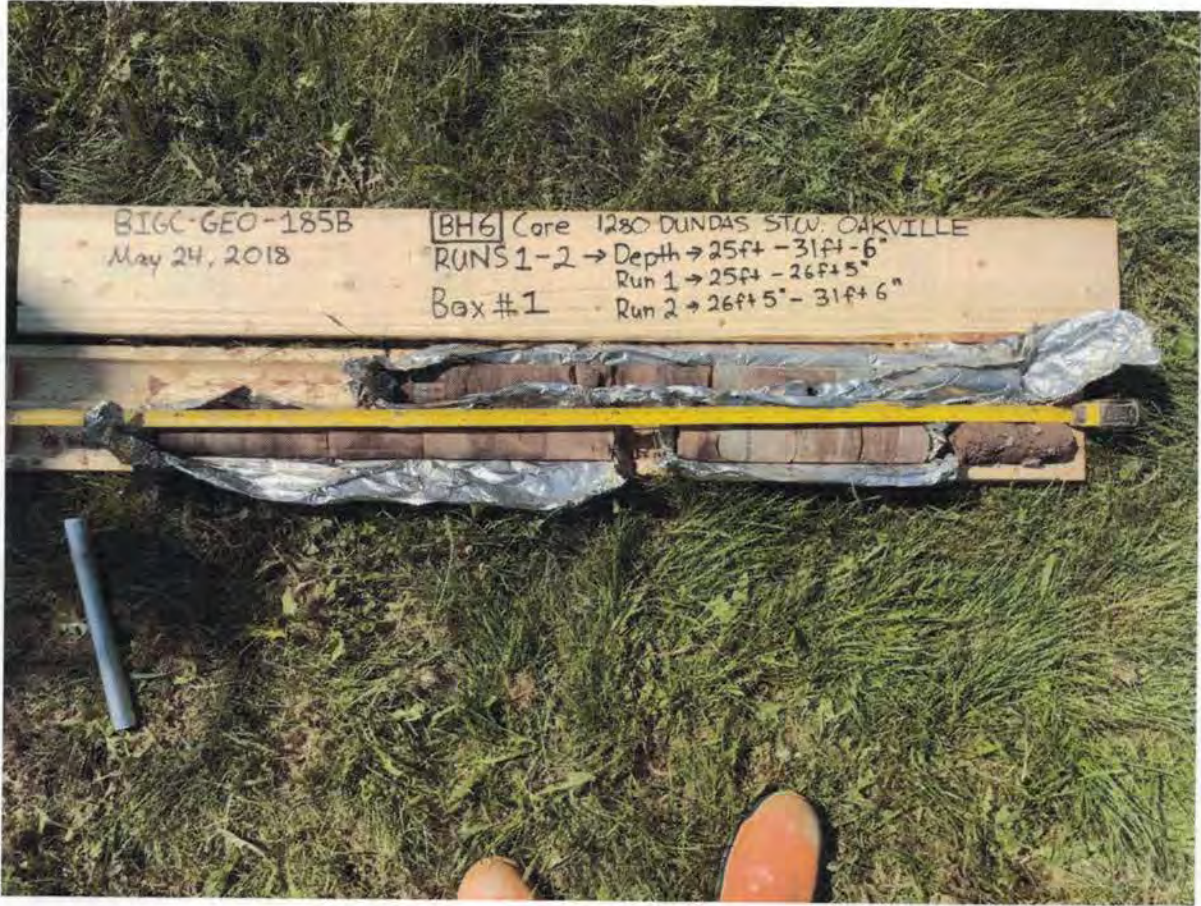
[BH6] Core 1280 DUNDAS STW. OAKVILLE  
RUNS 1-2 -> Depth -> 25ft - 31ft - 6"  
Run 1 -> 25ft - 26ft 5"  
Box #1 - Run 2 -> 26ft 5" - 31ft 6"

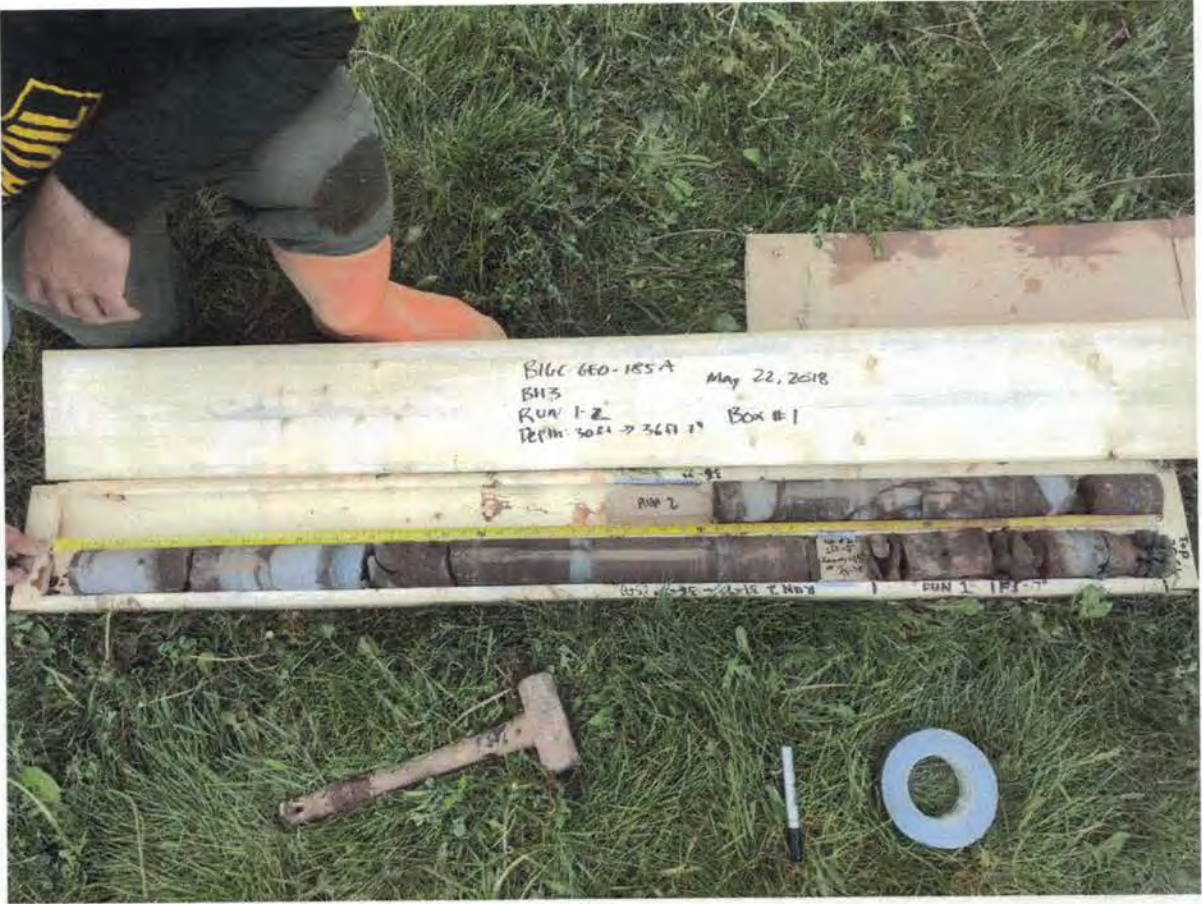
BGC 660-185A May 22, 2018  
BH3  
RUN 1-2 Box # 1  
Depth: 3021 -> 3671 ft
