Road Safety Performance Study (2017)

Road Safety Performance Assessment

**Lakeshore Road West
from Mississaga Street to Dorval Drive
Town of Oakville, Ontario**

**Author: Gerry Forbes, M.Eng, P.Eng, PTOE
President & Chief Engineer
Intus Road Safety Engineering Incorporated**

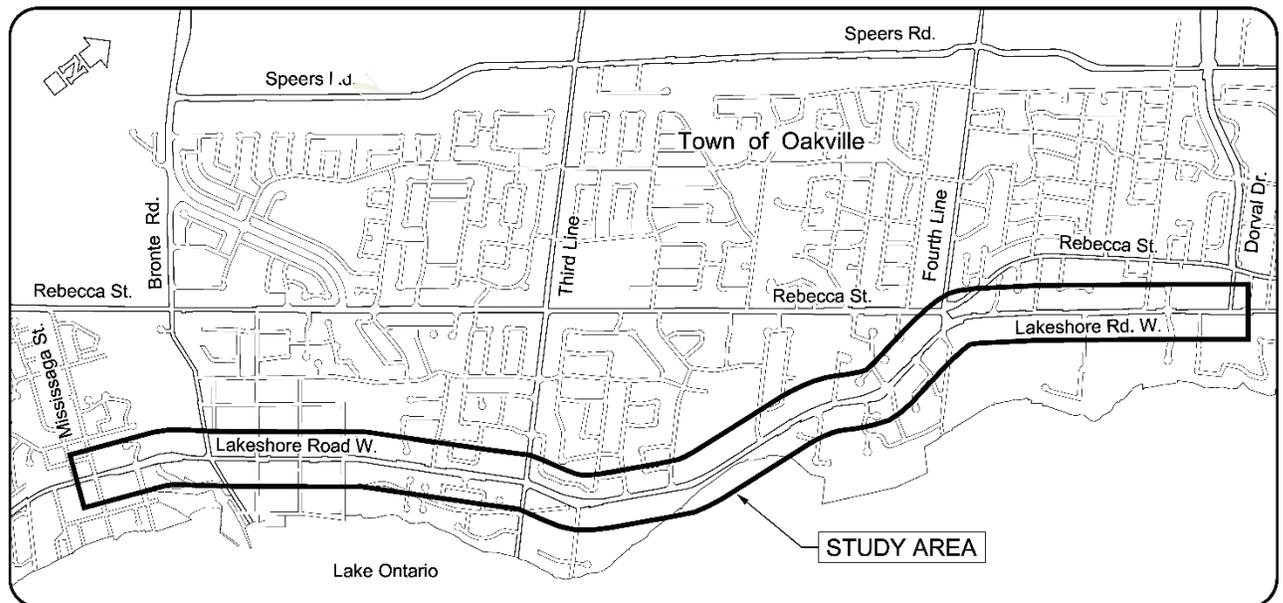
FIGURE 2: The Study Area

- 2.1 The section of Lakeshore Road West under study is shown in Figure 2. For the purposes of this study Lakeshore Road West is described as an east-west facility with crossing roads referred to as north-south streets.

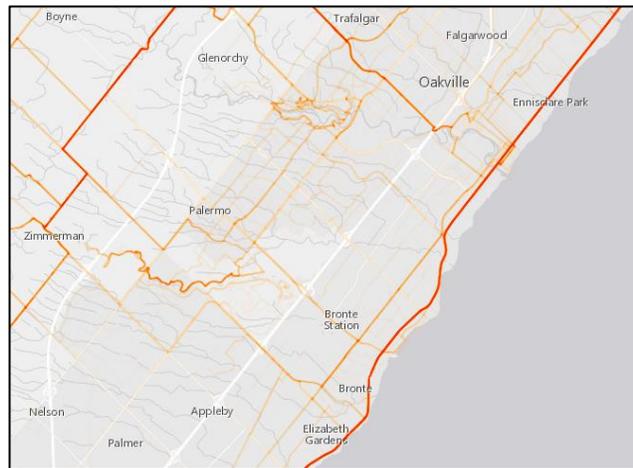
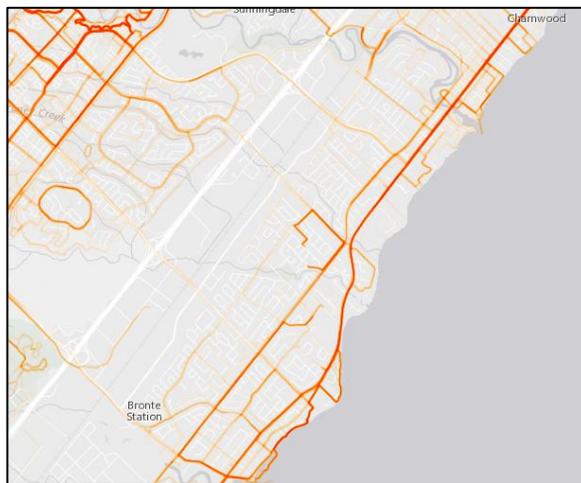
FIGURE 3: Cycling and Pedestrian Heat Maps³

- 2.9 The study area is a “peak use” cycling and pedestrian route based on available data (see Figure 3). These cycling and pedestrian heat maps show the heaviest travelled cycling and walking routes throughout Oakville based on 5,624 and 2,002 Strava² users registered in Oakville, respectively. Lakeshore Road West through the study area is the most heavily-used east-west cycling and walking facility south of the Queen Elizabeth Way.

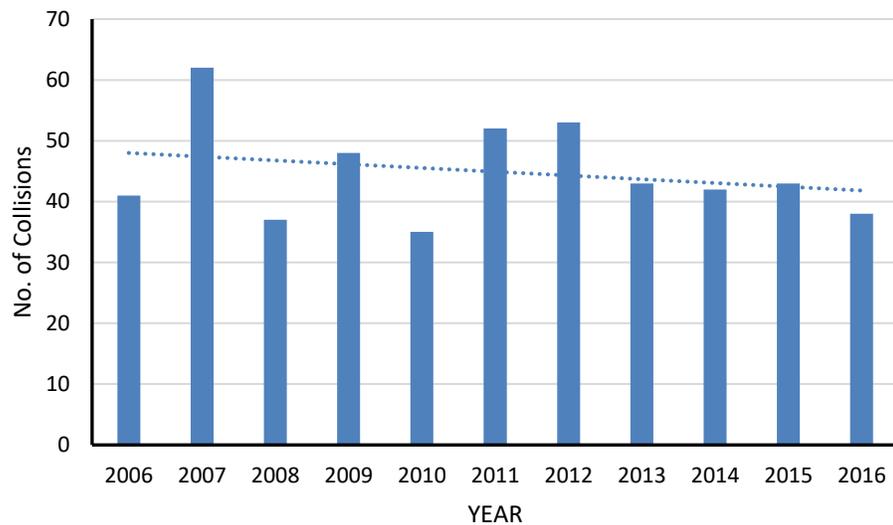
FIGURE 4: Annual Collision Frequency

- 3.2 According to municipal records, there were 494 collisions in the Lakeshore Road West study area during this period (see Figure 4), or an average of 44.9 collisions/year [40.1 : 49.7]⁴. There is a slight downward trend in the year-to-year collision data.

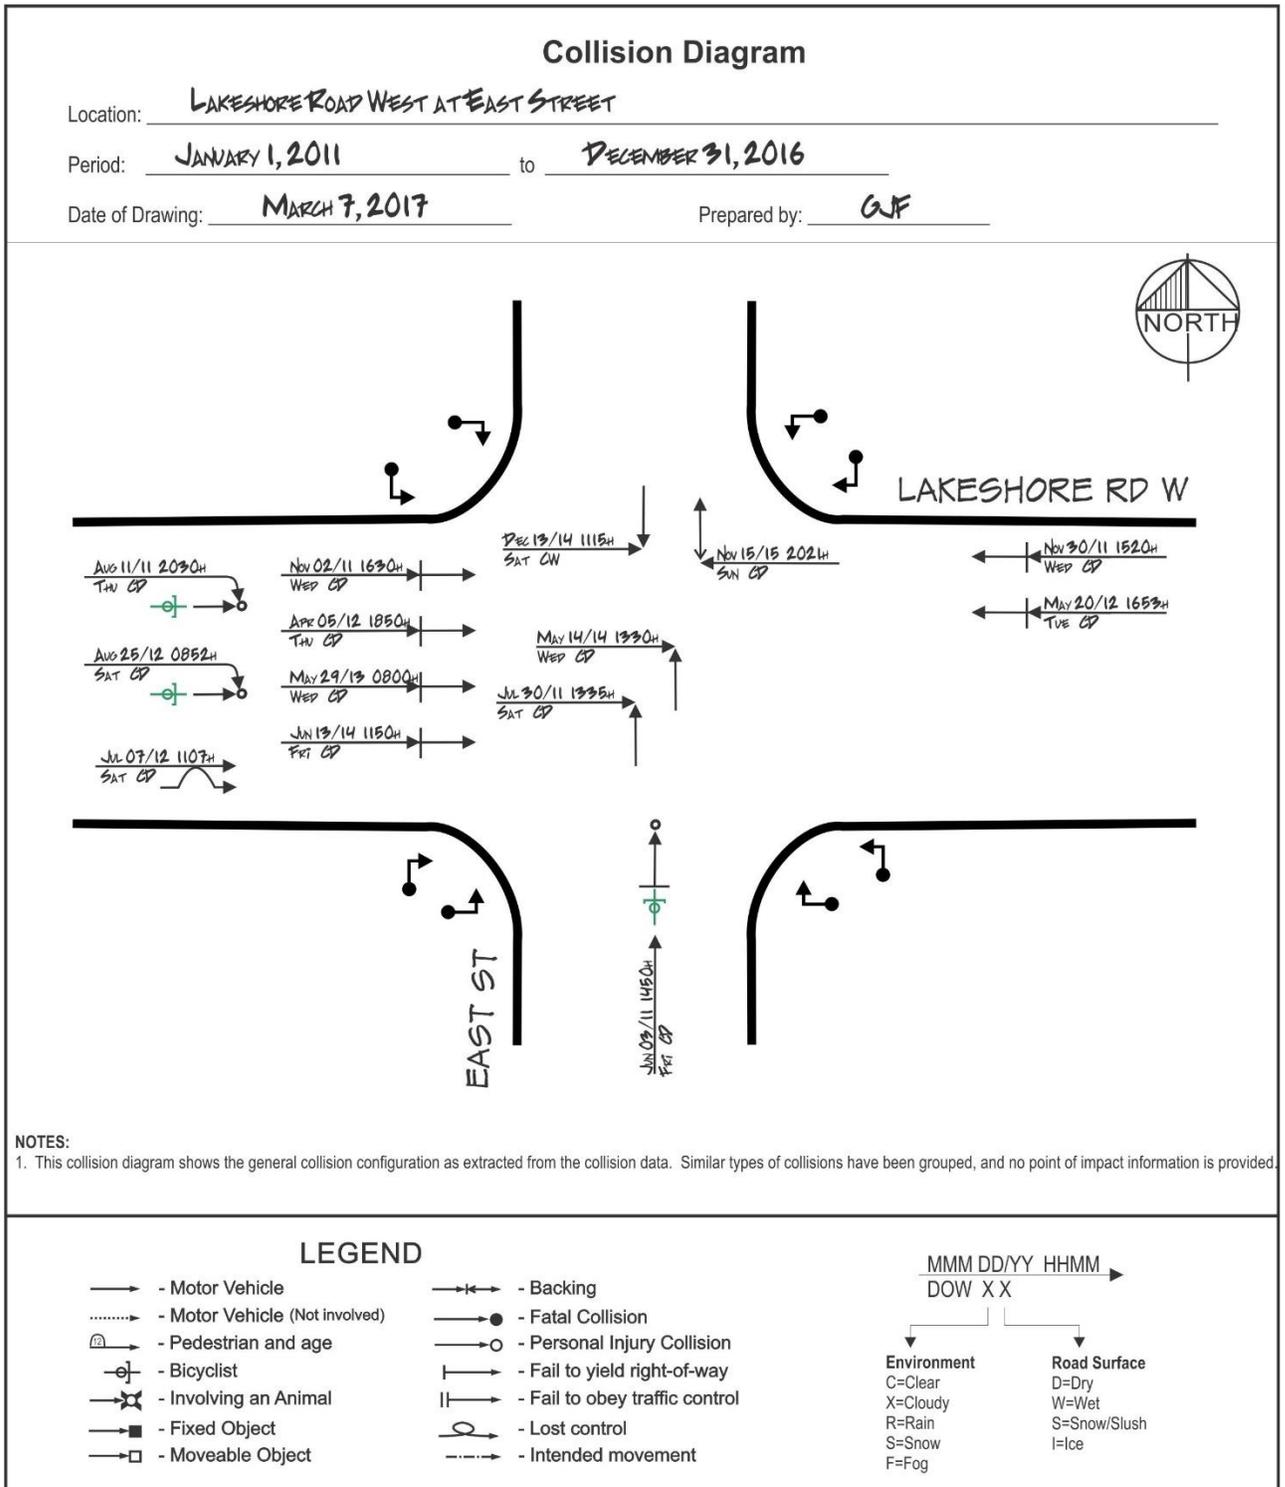
FIGURE 4: Collision Diagram for Lakeshore Road West at East Street

- 3.17.1 The collision diagram for the intersection of Lakeshore Road West at East Street is shown in Figure 4. There is a total of 14 collisions at this location. All of the collisions occurred during clear weather conditions and all but one collision occurred on dry roads.

- 3.17.3 It is noteworthy that 10 of the 14 collisions (71%) involved eastbound road users. Of those 10 collisions, four of the collisions were rear-end collisions, and three of the collisions were sideswipe collisions. None of the eastbound rear-end and sideswipe collisions were precipitated by poor weather or road conditions. There is also no particular day or time of the day that these eastbound collisions occur. Rear-end and sideswipe collisions in this type of setting are usually due to inter-user speed differentials that are precipitated from traffic congestion, poor signal timing, lack of exclusive turn lanes, accesses proximate to the intersection, and/or driver distraction.

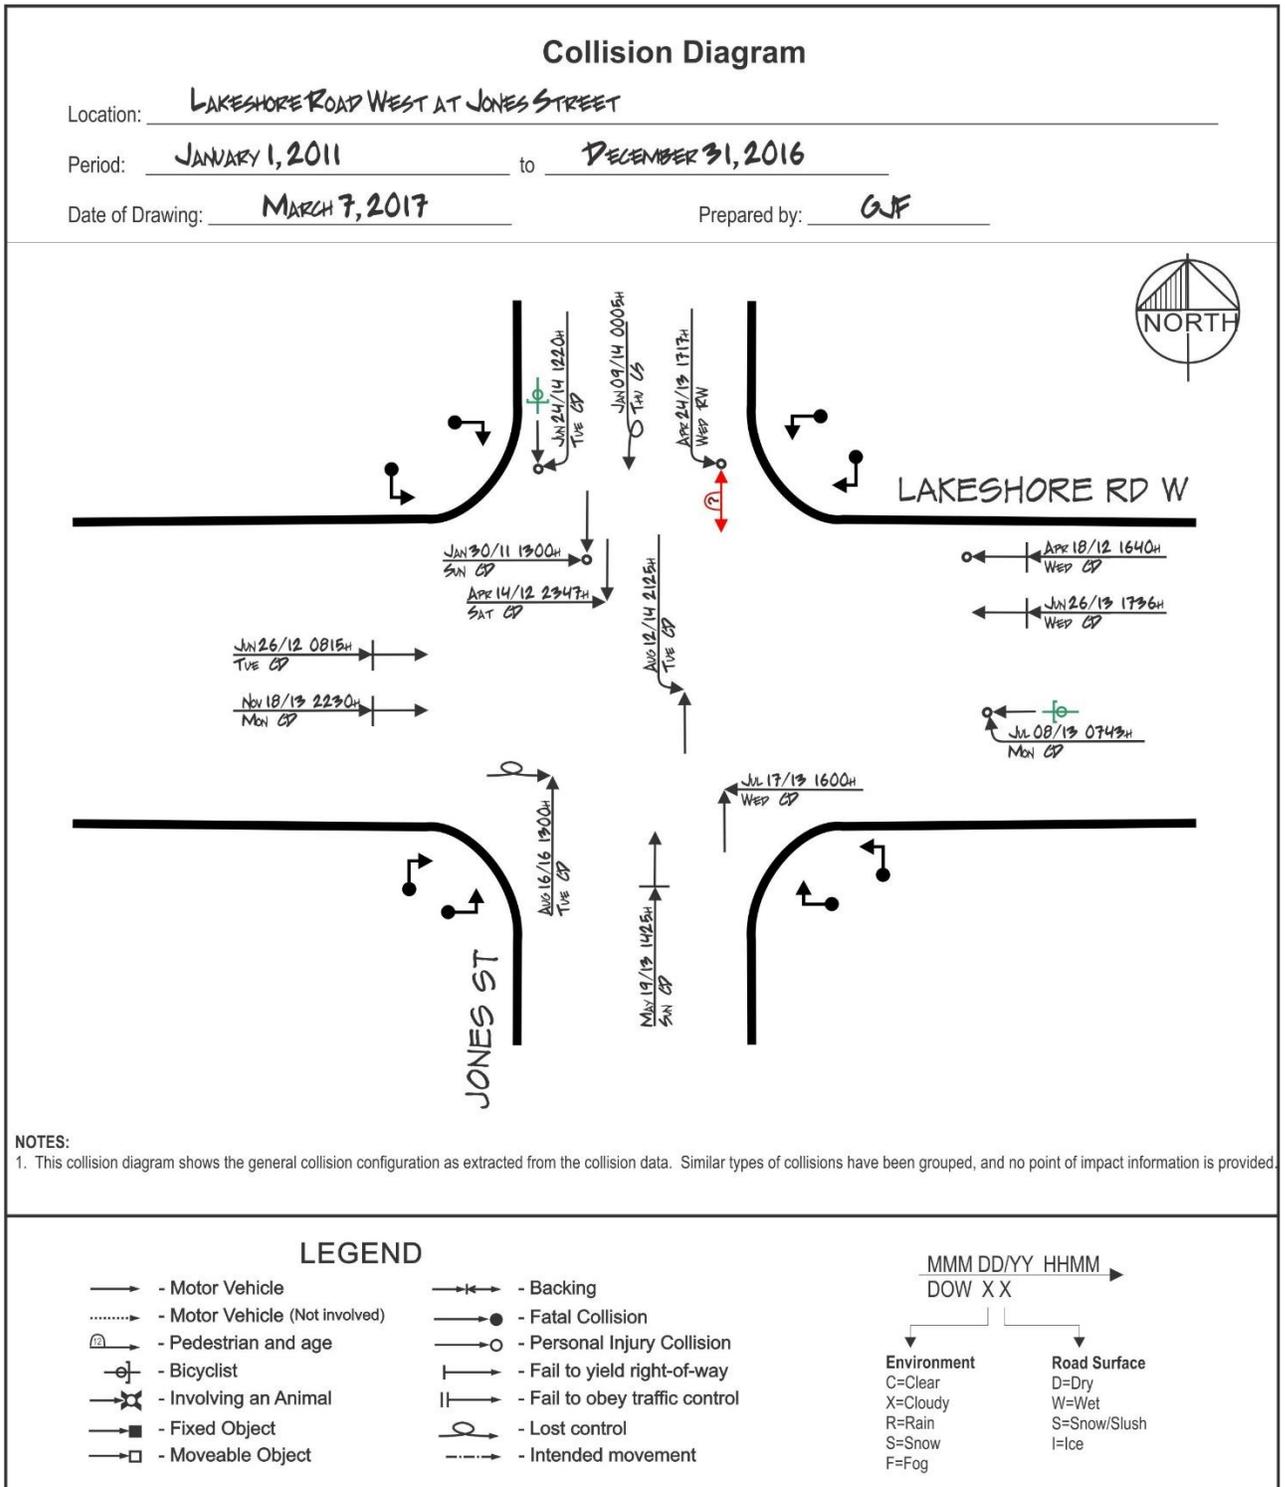
FIGURE 5: Collision Diagram for Lakeshore Road West at Jones Street

- 3.18.1 The collision diagram for the intersection of Lakeshore Road West at Jones Street is shown in Figure 5. There is a total of 14 collisions at this location⁹. All but one of the collisions occurred during clear weather conditions and all but two collisions occurred on dry roads.
- 3.18.2 Two of the 14 collisions (14%) involved a cyclist. One of the collisions involved a pedestrian. Five of the 14 collisions (36%) were injury collisions.

3.18.3 There were 27 road users involved in the 14 collisions. The initial direction of travel of the involved users, compared to the percentage of vehicles entering the intersection are shown in Table 4. North and south traffic is disproportionately involved in the collisions at this intersection, based on traffic volume entering.

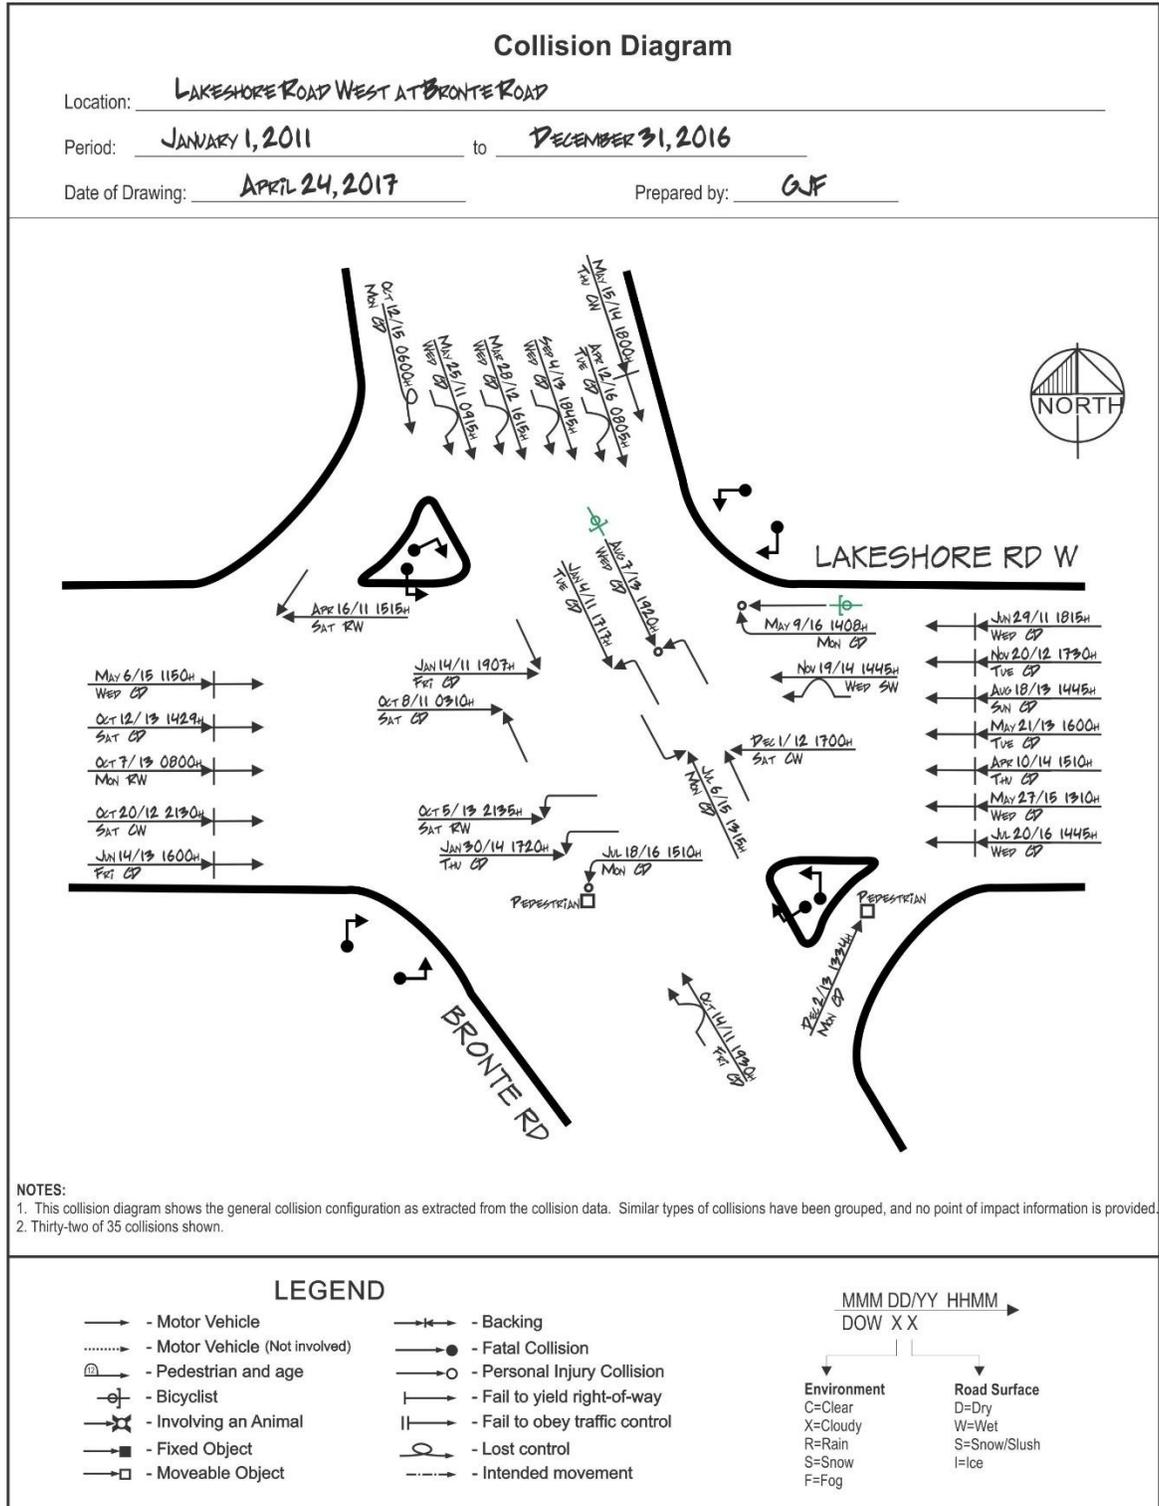
FIGURE 6: Collision Diagram for Lakeshore Road West at Bronte Road

3.19.2 Two of the 35 collisions (6%) involved a cyclist, and two of the collisions (6%) involved a pedestrian. Three of the four above-referenced collisions resulted in an injury, the severity of the remaining collision was reported as “other”.

3.19.3 Rear-end collisions is the most prevalent collision type, comprising 13 of the 35 (37%) collisions. All but one of the rear-end collisions occurred on Lakeshore Road West, with only three rear-end collisions occurring during wet road conditions. The next most prevalent collision types are sideswipe collisions (17%) and collisions involving a left-turning motorist (17%). The sideswipe collisions are primarily occurring on the north approach; the left-turning collisions exhibit no trend or pattern. Rear-end and sideswipe collisions in this type of setting are usually due to inter-user speed differentials that are precipitated from traffic congestion, poor signal timing, lack of exclusive turn lanes, accesses proximate to the intersection, and/or driver distraction.

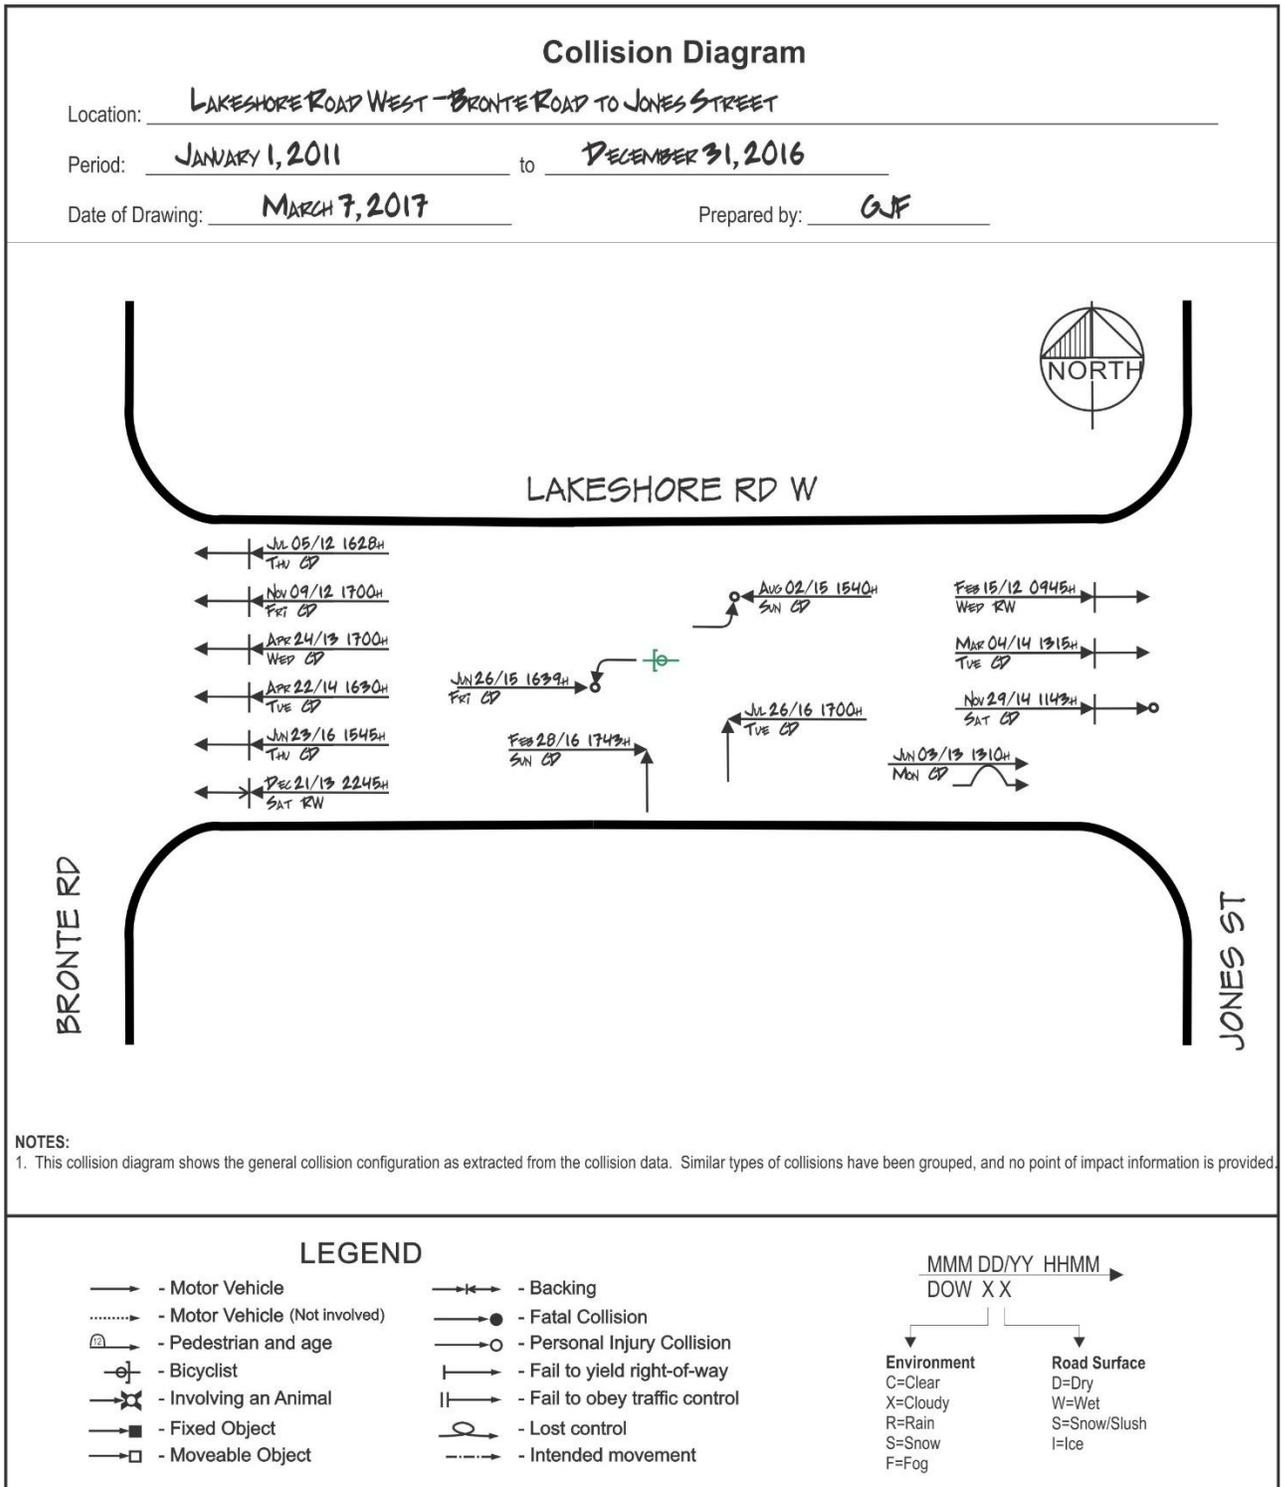
FIGURE 7: Collision Diagram for Lakeshore Road West from Bronte Road to Jones Street

- 3.20.1 The collision diagram for Lakeshore Road West from Bronte Road to Jones Street is shown in Figure 7. There is a total of 14 collisions at this location. Eighty-six percent of the collisions occurred during clear weather conditions and on dry roads.

- 3.20.3 Eight of the 14 collisions (57%) were rear-end collisions. Five of the rear-end collisions involved westbound vehicles; three of the rear-end collisions involved eastbound vehicles. Only two of the rear-end collision occurred on wet roads – indicating that road surface conditions were not a causative factor.

- 3.20.4 Half of the 14 collisions occurred on a weekday during the PM peak travel period.
- 3.20.5 Without specific information on the location of the collisions within this section of road it is impossible to determine the causes of the rear-end collisions. It is likely that these collisions are due to increase traffic congestion during the PM peak periods of travel.

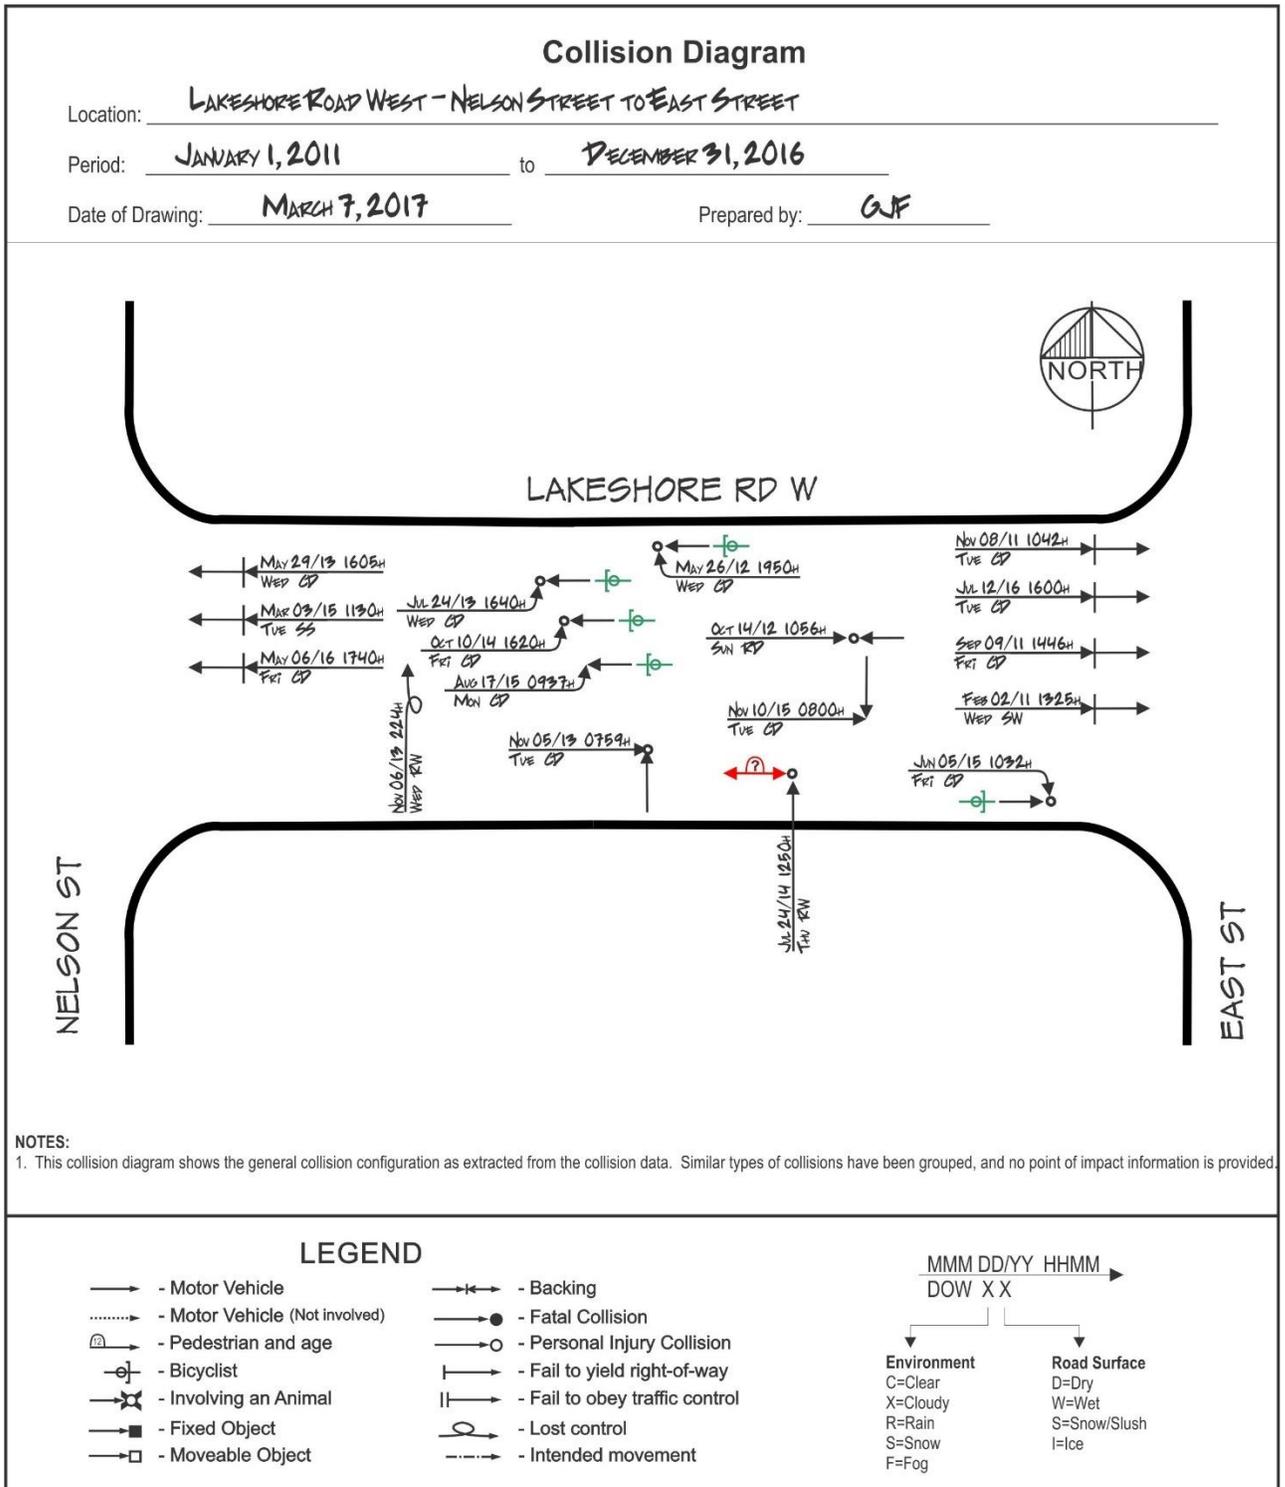
FIGURE 8: Collision Diagram for Lakeshore Road West from Nelson Street to East Street

- 3.21.1 The collision diagram for Lakeshore Road West from Nelson Street to East Street is shown in Figure 8. There is a total of 17 collisions at this location. Seventy-six percent of the collisions occurred during clear weather conditions, and 82% of the collisions happened on dry roads.

- 3.21.2 Five of the collisions (29%) involved a cyclist. All of the cyclist collisions resulted from a turning vehicle colliding with a cyclist who was travelling straight. Three of the collisions involved motorists turning left, and two of the collisions involved a motorist turning right. Four of the five (80%) of the cyclist collisions involved a westbound cyclist.

- 3.21.3 There was one pedestrian-involved collision during the study period. Half of the 14 collisions (50%) were injury collisions.
- 3.21.4 Seven of the 17 collisions (41%) were rear-end collisions. Four of the rear-end collisions involved westbound vehicles; three of the rear-end collisions involved eastbound vehicles. Only two of the rear-end collision occurred on wet or snowy roads – indicating that road surface conditions were not a causative factor. All of the rear-end collisions occurred on weekdays in either the mid-day or PM peak travel period.

3.21.5 Only one of the collisions occurred on a weekend. Seven of the 16 weekday collisions (44%) occurred mid-day (0900h to 1459h).

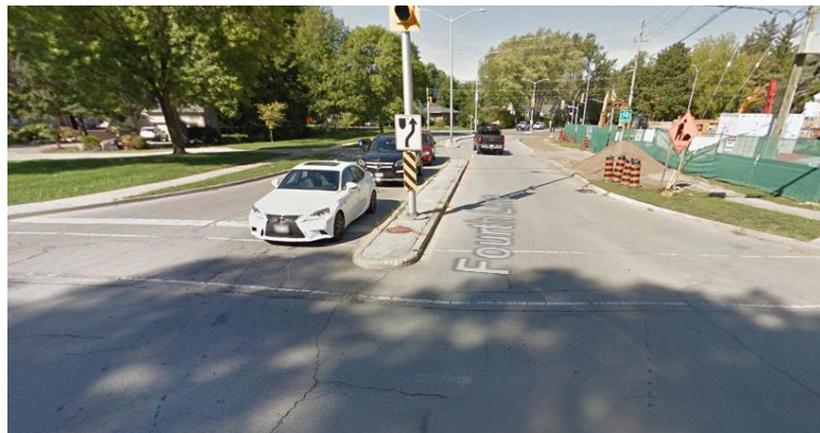
- The raised median island on Fourth Line at Lakeshore Road West extends into the north crosswalk, creating a trip hazard for visually-challenged pedestrians (Figure 10).

FIGURE 10: Raised Island Protruding in to the North Crosswalk at Fourth Line

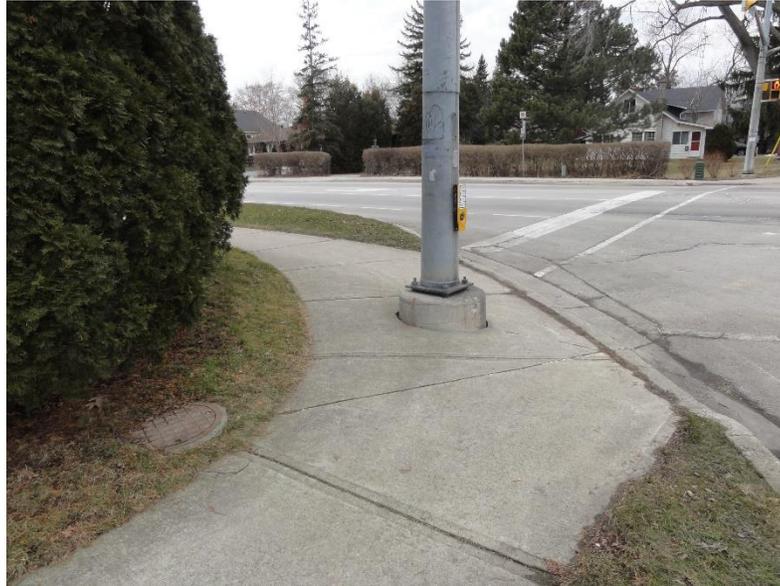
- One or more of the traffic signal poles at the intersection of Lakeshore Road West and Mississaga Street are located in the middle of the sidewalk, reducing the available sidewalk width to a dimension that will not accommodate a wheelchair (Figure 11).

FIGURE 11: Sidewalk Too Narrow for a Wheelchair at Mississaga Street

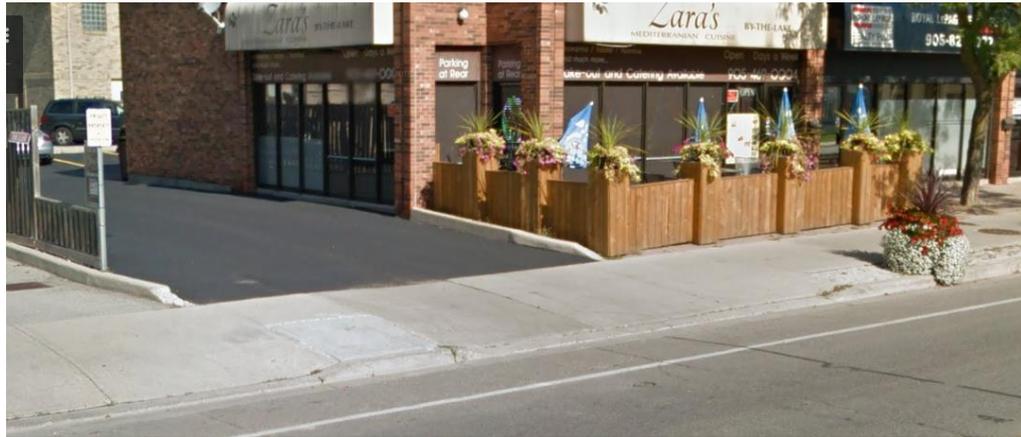
- The sidewalk through Bronte Village is continuous on both sides of the road, and the buildings fronting on Lakeshore Road West are set back to afford minimum visibility triangles at the interstitial driveways. The exception to the above is at 2347 Lakeshore Road West (Zara's By The Lake) where the fence surrounding the outside dining area directly abuts the sidewalk and the driveway (see Figure 12). At this location, the combination of the fence and the planters may create a visibility obstruction between pedestrians and motorists exiting the driveway.

FIGURE 12: Driveway Visibility Obstruction for Pedestrians

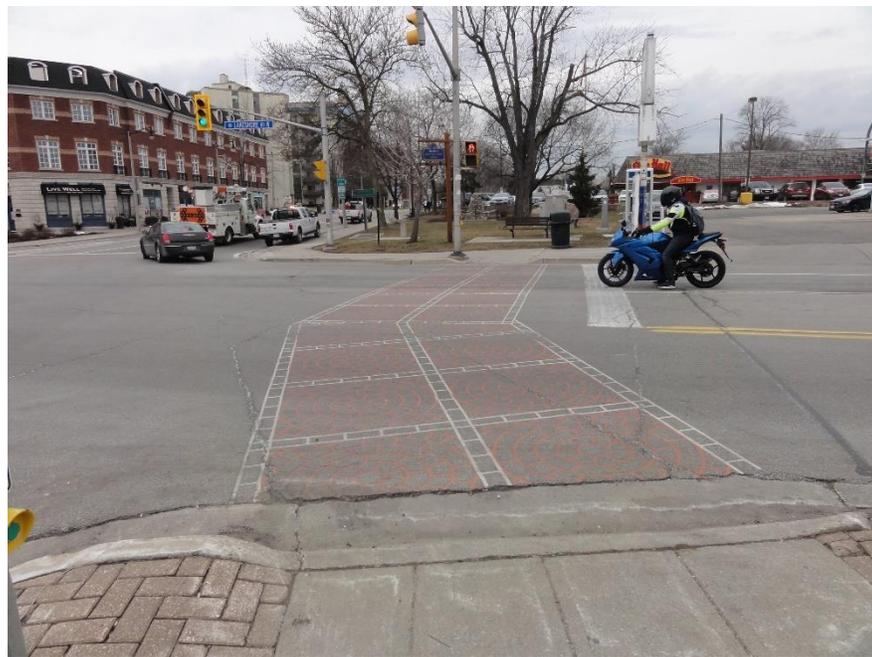
- The east crosswalk at the intersection of Bronte Road and Lakeshore Road West is not straight, creating a hazard for visually-challenged pedestrians who cannot detect the change in direction of the crosswalk (see Figure 13).

FIGURE 13: Bent Crosswalk at the Intersection of Lakeshore Road West and Bronte Road

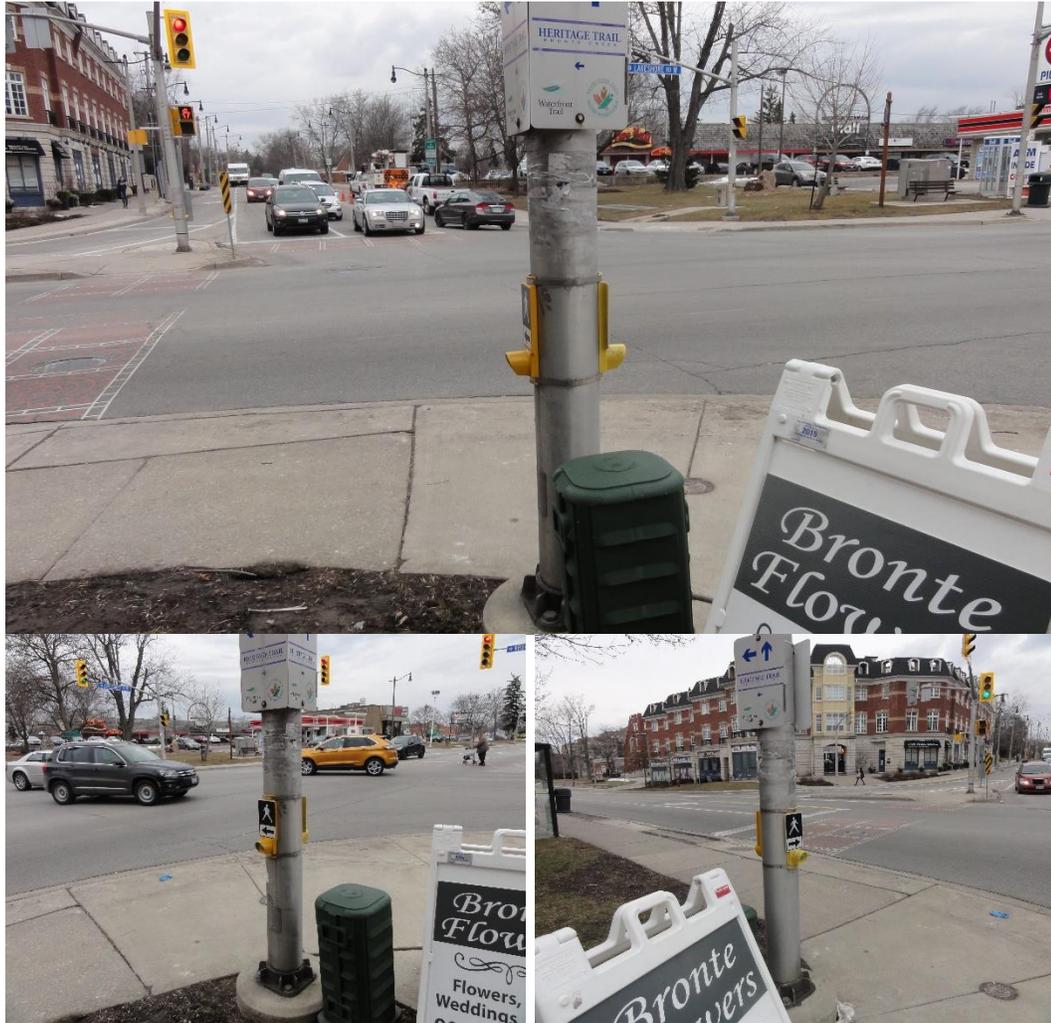
- By virtue of their placement, it is not clear which pedestrian pushbuttons activate which pedestrian signal heads at the southwest corner of Lakeshore Road West and Bronte Road (Figure 14). Both pushbuttons appear to activate the WALK signal for the west

crosswalk, despite one of these pushbuttons activating the WALK signal for the south crosswalk.

FIGURE 14: Confusing Placement of Pedestrian Pushbuttons

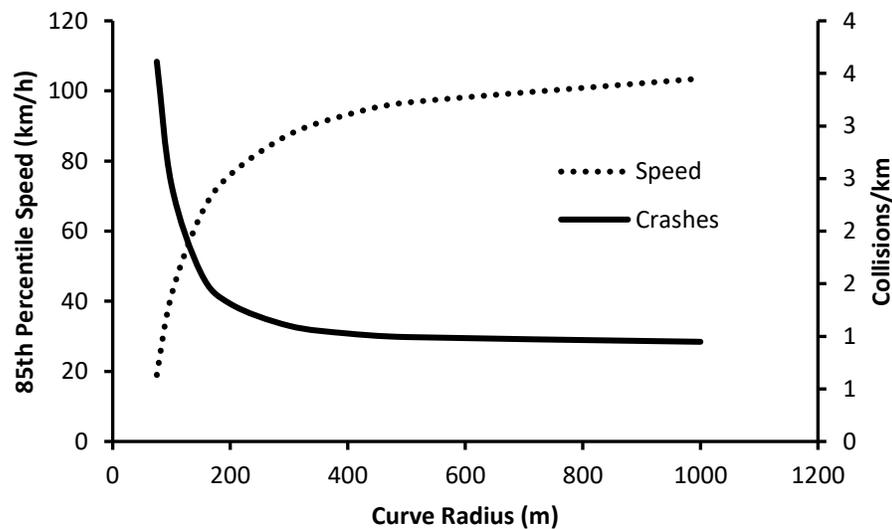
- 6.2.6 Having stated the above, a far more important consideration in selecting a revised horizontal alignment for Lakeshore Road West is that of alignment consistency. The actual “design speed” for each individual element is less important, from a safety perspective, than the relationship of the individual design speed to the design speed of the elements upstream and downstream of that element. The operating speeds that are expected to result from each horizontal alignment element should reduce operating speed variations along a route. For example, a low radius curve should not be placed at the end of a long tangent. The maximum difference between the design speeds and expected operating speeds of successive elements, should be ideally no more than 10 km/h different.

FIGURE 15: Relationship of Collision Risk to Horizontal Curve Radius

- 6.2.7 The operating speed of Lakeshore Road West west of East Street is 56 to 65 km/h under the current alignment. The revised alignment of Lakeshore Road West should be developed to be consistent with a proposed cross-section that will generally manage speeds to around 50 km/h through the entire study area. If a suitable speed prediction model can be found, then it is suggested that the preferred design of Lakeshore Road West be modelled to ensure that operating speeds and operating speed differentials are acceptably safe.

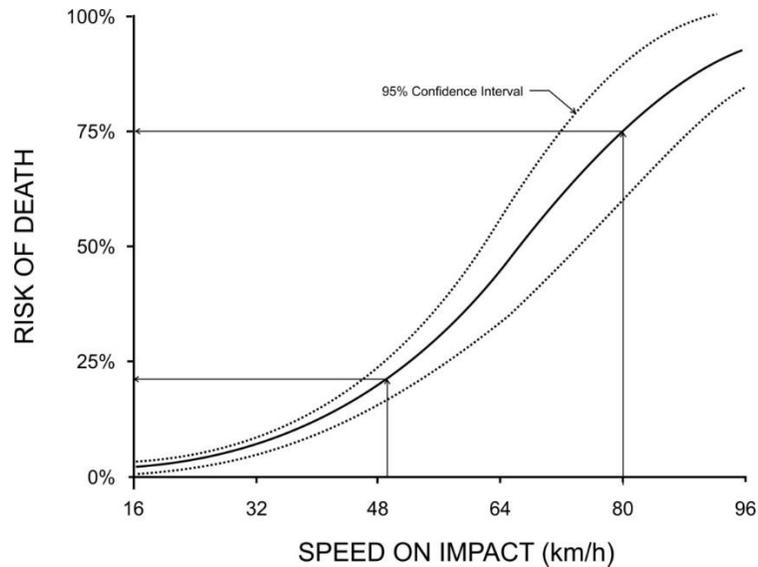
- 6.5.4 The probability of a pedestrian being fatally injured in a collision with a motor vehicle has been determined from field investigations of collisions, and is shown in Figure 16. Around 80% of pedestrians survive a car strike at a speed of 50 km/h, whereas only 25% survive at a strike at a speed of 80 km/h. Several studies have been conducted in this area, and many have found slightly different figures, but the trend is clear – lower impact speeds result in less severe collisions.

FIGURE 16: Pedestrian Survivability in a Collision
