Environmental Impact Study in Support of a Zoning By-law Amendment

**1280 Dundas St. W. and Fourth Line
Town of Oakville, Ontario**

September 2020

SLR Project No.: 209.40574.00000

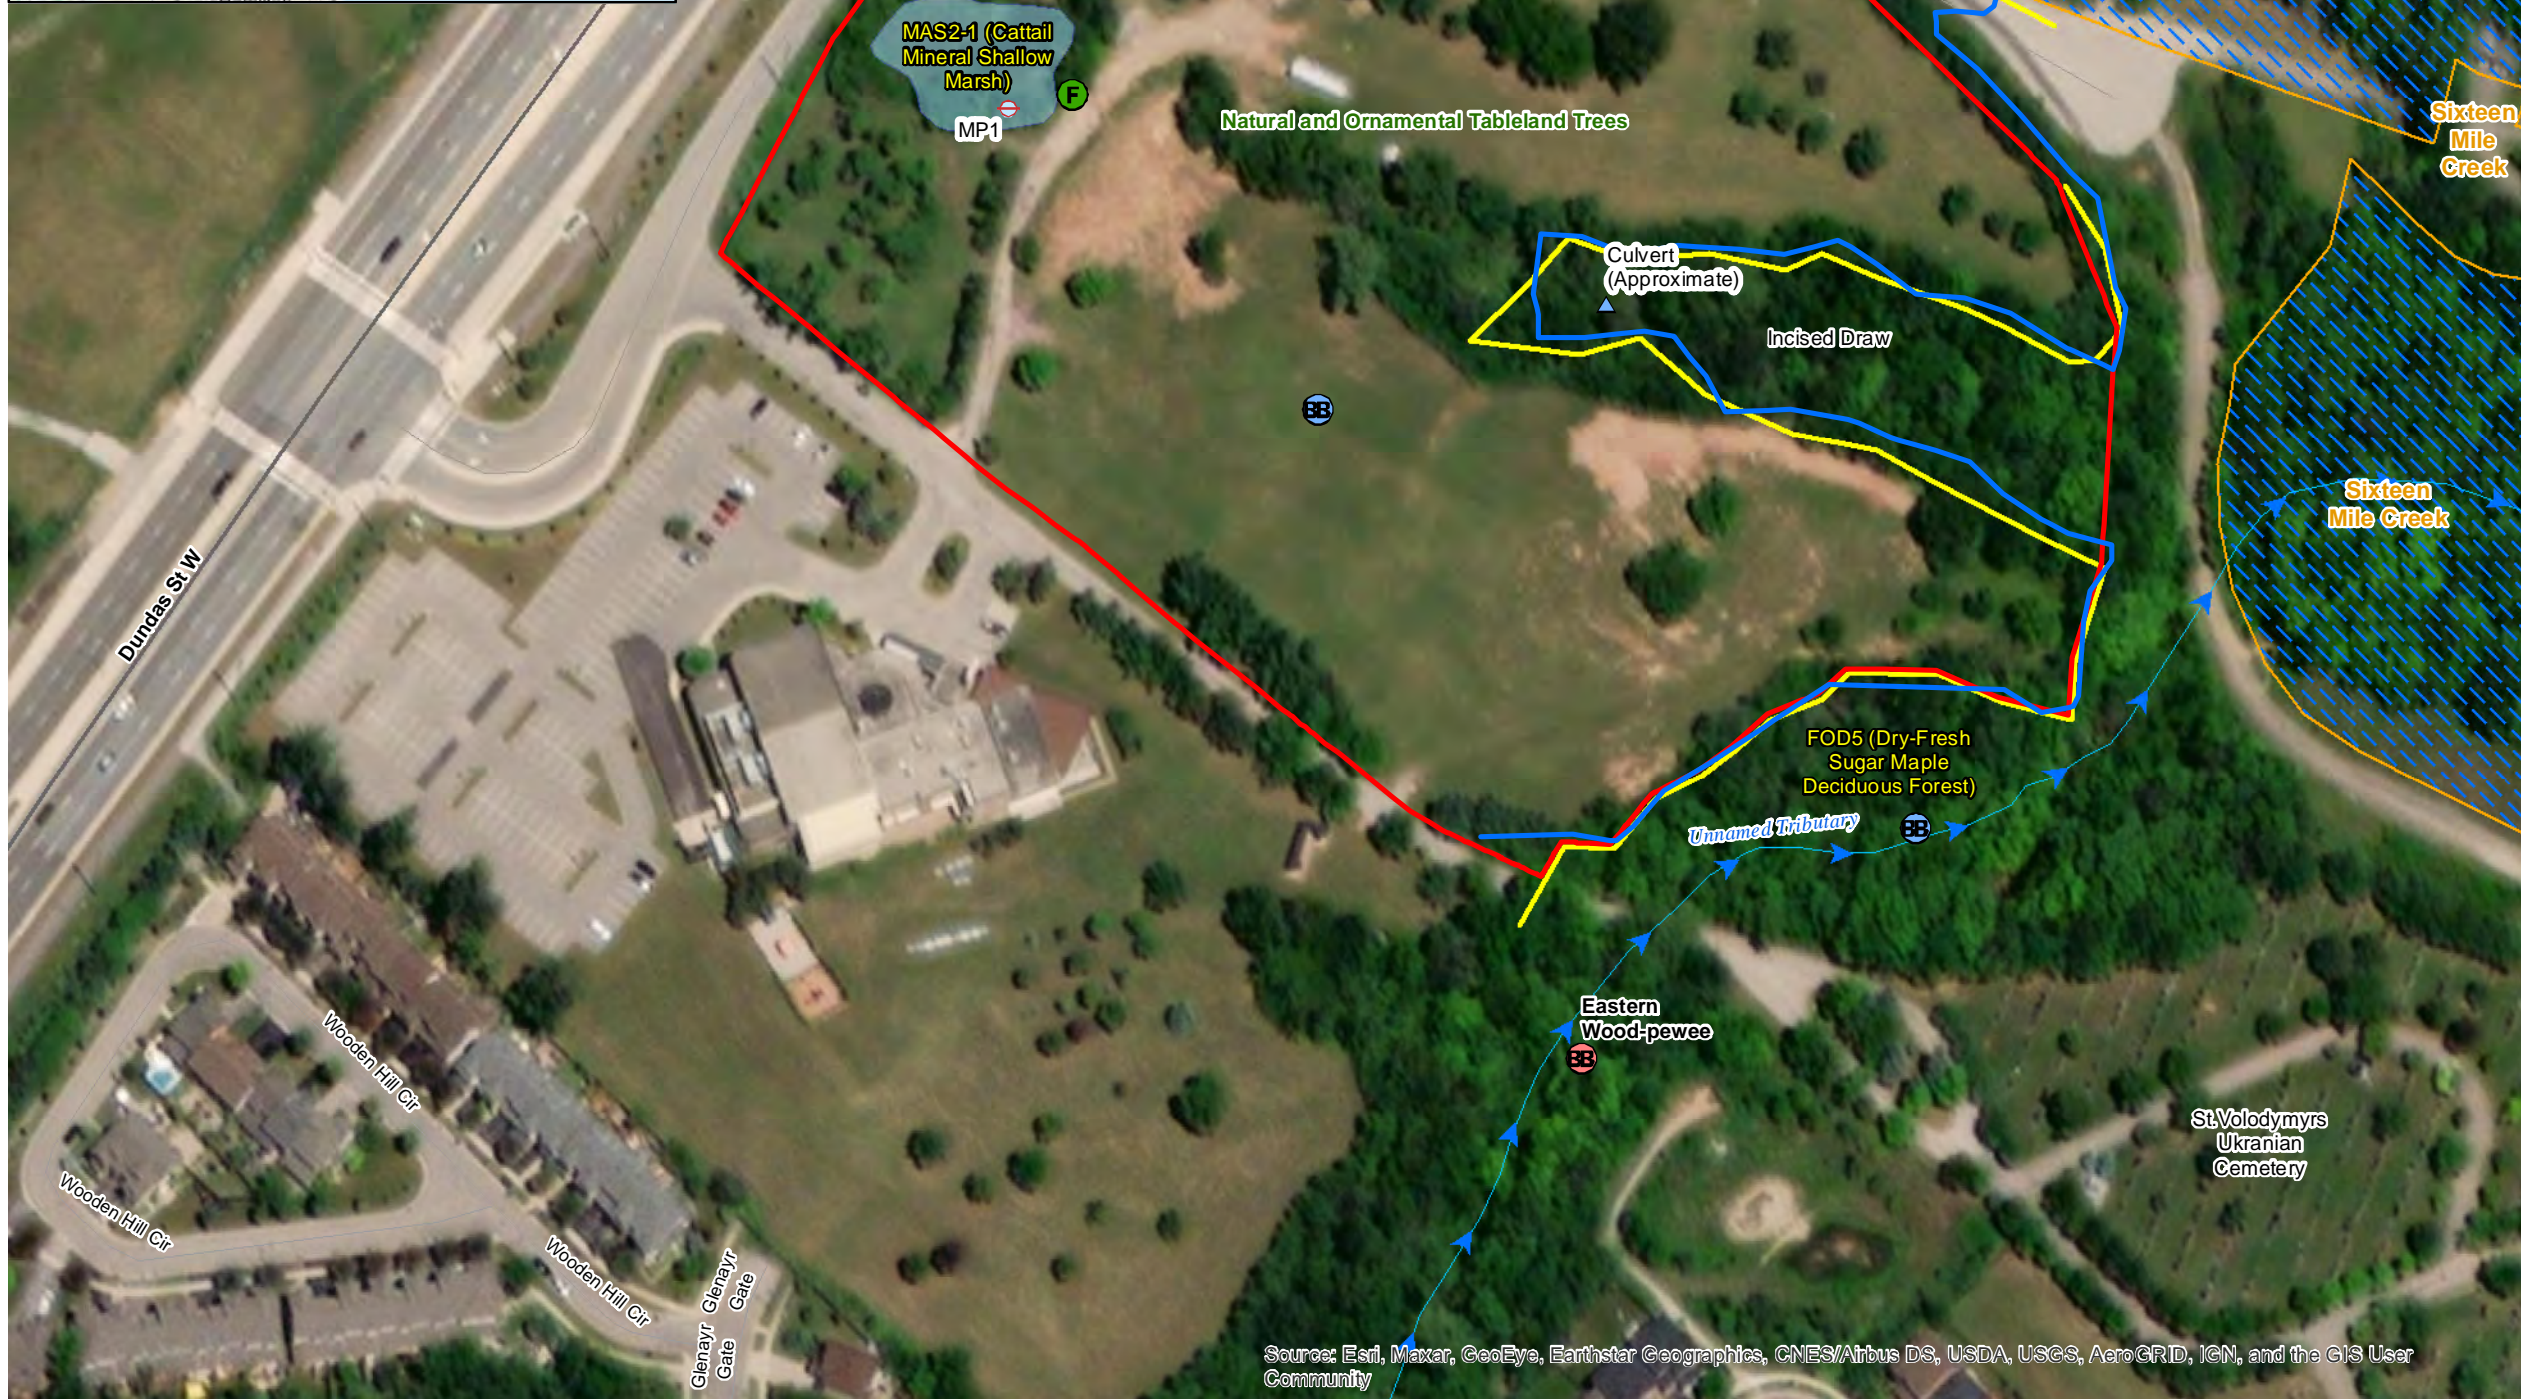
SITE LOCATION AND EXISTING CONDITIONS

This valley together with the unnamed tributary valley forming the east and southeast boundary of the Site and a portion of the incised draw feature are also identified as Valleylands and Floodplain on Schedule B and their treed portions are identified as Woodlands. Existing conditions are illustrated on **Figures 1**.
