**DATE** May 5, 2022**Project No.** 18112570**TO** 2652508 Ontario Limited, C/O Mara Micevic**CC****FROM** Ted Beadle, P.Eng.**EMAIL** tbeadle@golder.com**REVISED HAZARD LIMIT SETBACK ASSESSMENT TO SUPPORT RESIDENTIAL TOWER DEVELOPMENT  
(REVISION 1)  
627 LYONS LANE, OAKVILLE, ONTARIO**

PROJECT  
 REVISED HAZARD LIMIT ASSESSMENT TO SUPPORT  
 RESIDENTIAL TOWER DEVELOPMENT  
 627 LYONS LANE, OAKVILLE, ON

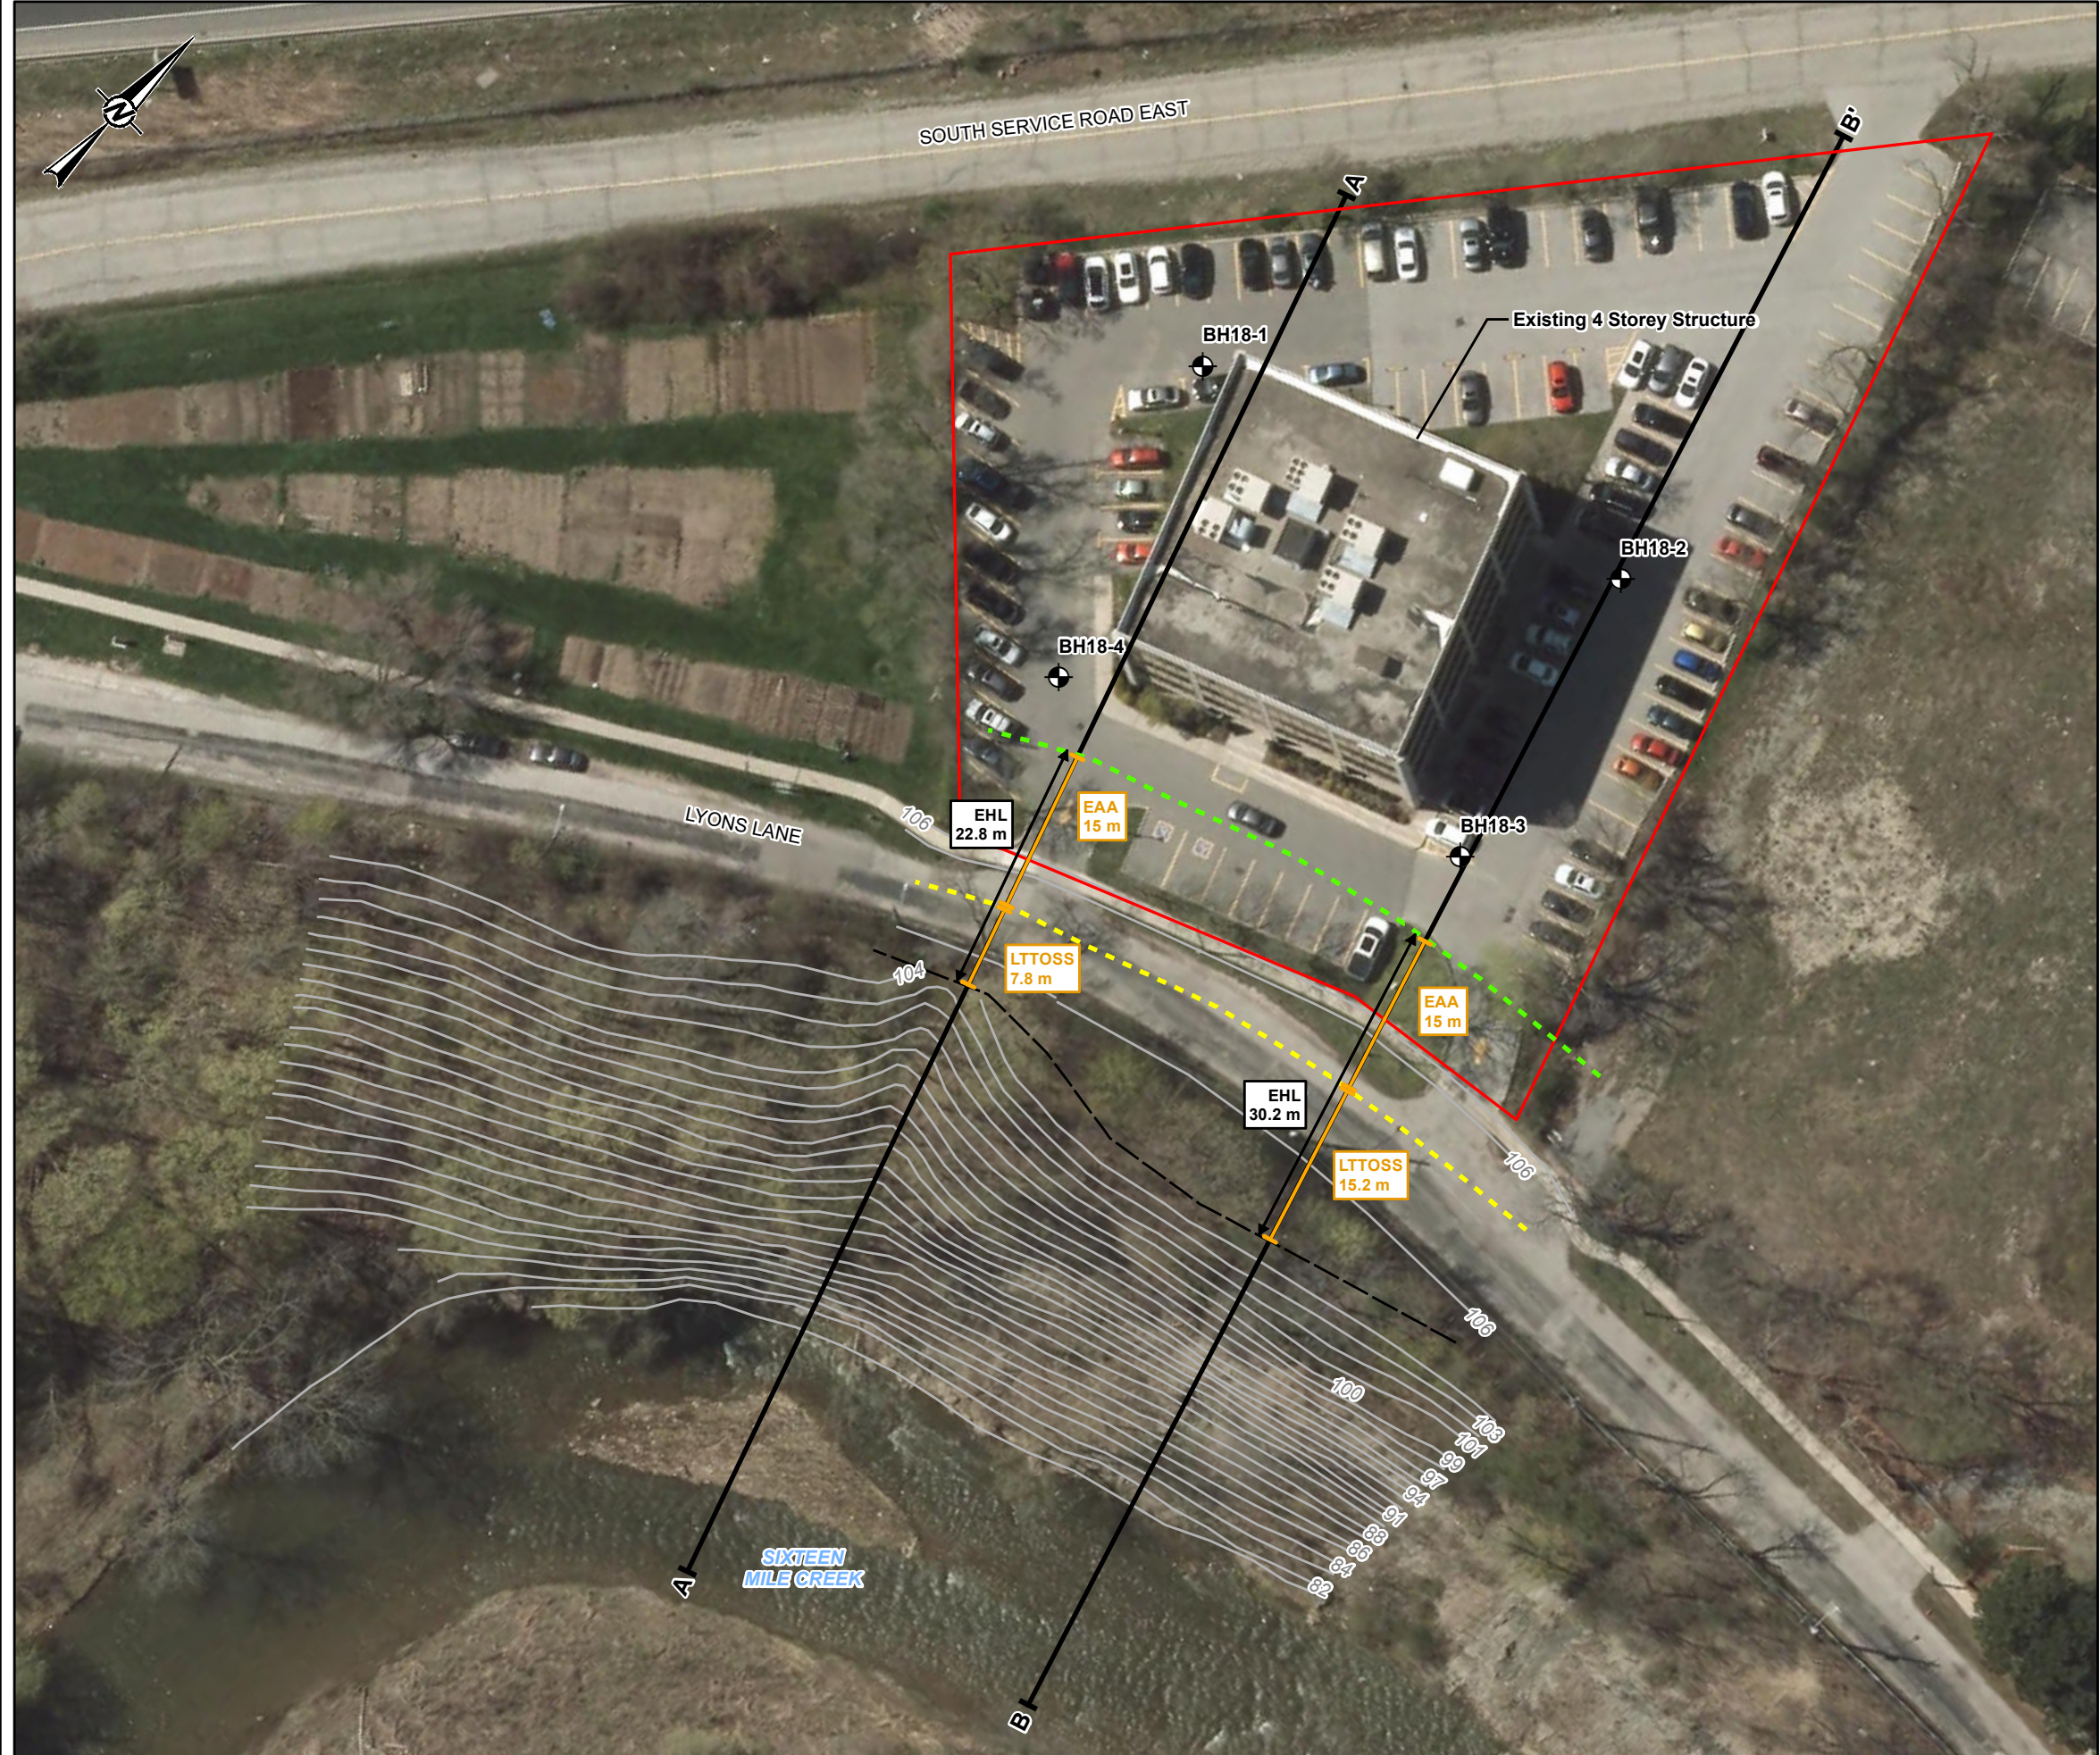
**TITLE**  
 BOREHOLE LOCATION PLAN

Based on representative cross-sections through the site (Section A-A’ and B-B’ on Figure 2), the creek bed is at approximately Elevation 79 m, the toe of slope at Elevation 81 m, and existing top of slope at approximately Elevation 106 m. Based on the results of Borehole BH18-1 and BH18-3 advanced during the January 2019 geotechnical investigation, shale bedrock is expected to be present along the creek bed and the majority of the valley slope. A site visit performed on December 17, 2018 confirmed the steep slope valley and edge of creek bed appear to consist of weathered shale bedrock at Section A-A’. An additional site visit and visual slope assessment

The valley slope geometry is generally consistent along the width of property at the tableland running parallel to the creek, thus, cross-sections A-A' and B-B' located near the east and west limits of the site were selected as representative sections (see Figure 2). The interpreted soil and bedrock stratigraphy was based on the results of the 2019 borehole investigation and are shown in Figure 3 and Figure 4. A stabilized groundwater level at Elevation 89 m was modelled at the building site and the creek water level was estimated to be at about Elevation 81 m based on the topography contours provided and visual observation of the creek relative to the toe of slope in September 2020. The geotechnical parameters used in the stability analysis are included in the 2019 geotechnical investigation report.

It is understood that an Erosion Access Allowance (EAA) of 15 m should be considered according to Conservation Halton guidelines. An Erosion Access Allowance (EAA) of 15 m is shown on Figures 3, 4 and 5.

The following table is a summary of the measured and calculated setback components along the typical Cross-Sections A-A' and B-B', resulting in the total geotechnical setback allowance or Erosion Hazard Limit referenced to the surveyed Top of Bank line as determined by Conservation Halton and shown on Figures 3, 4 and 5.

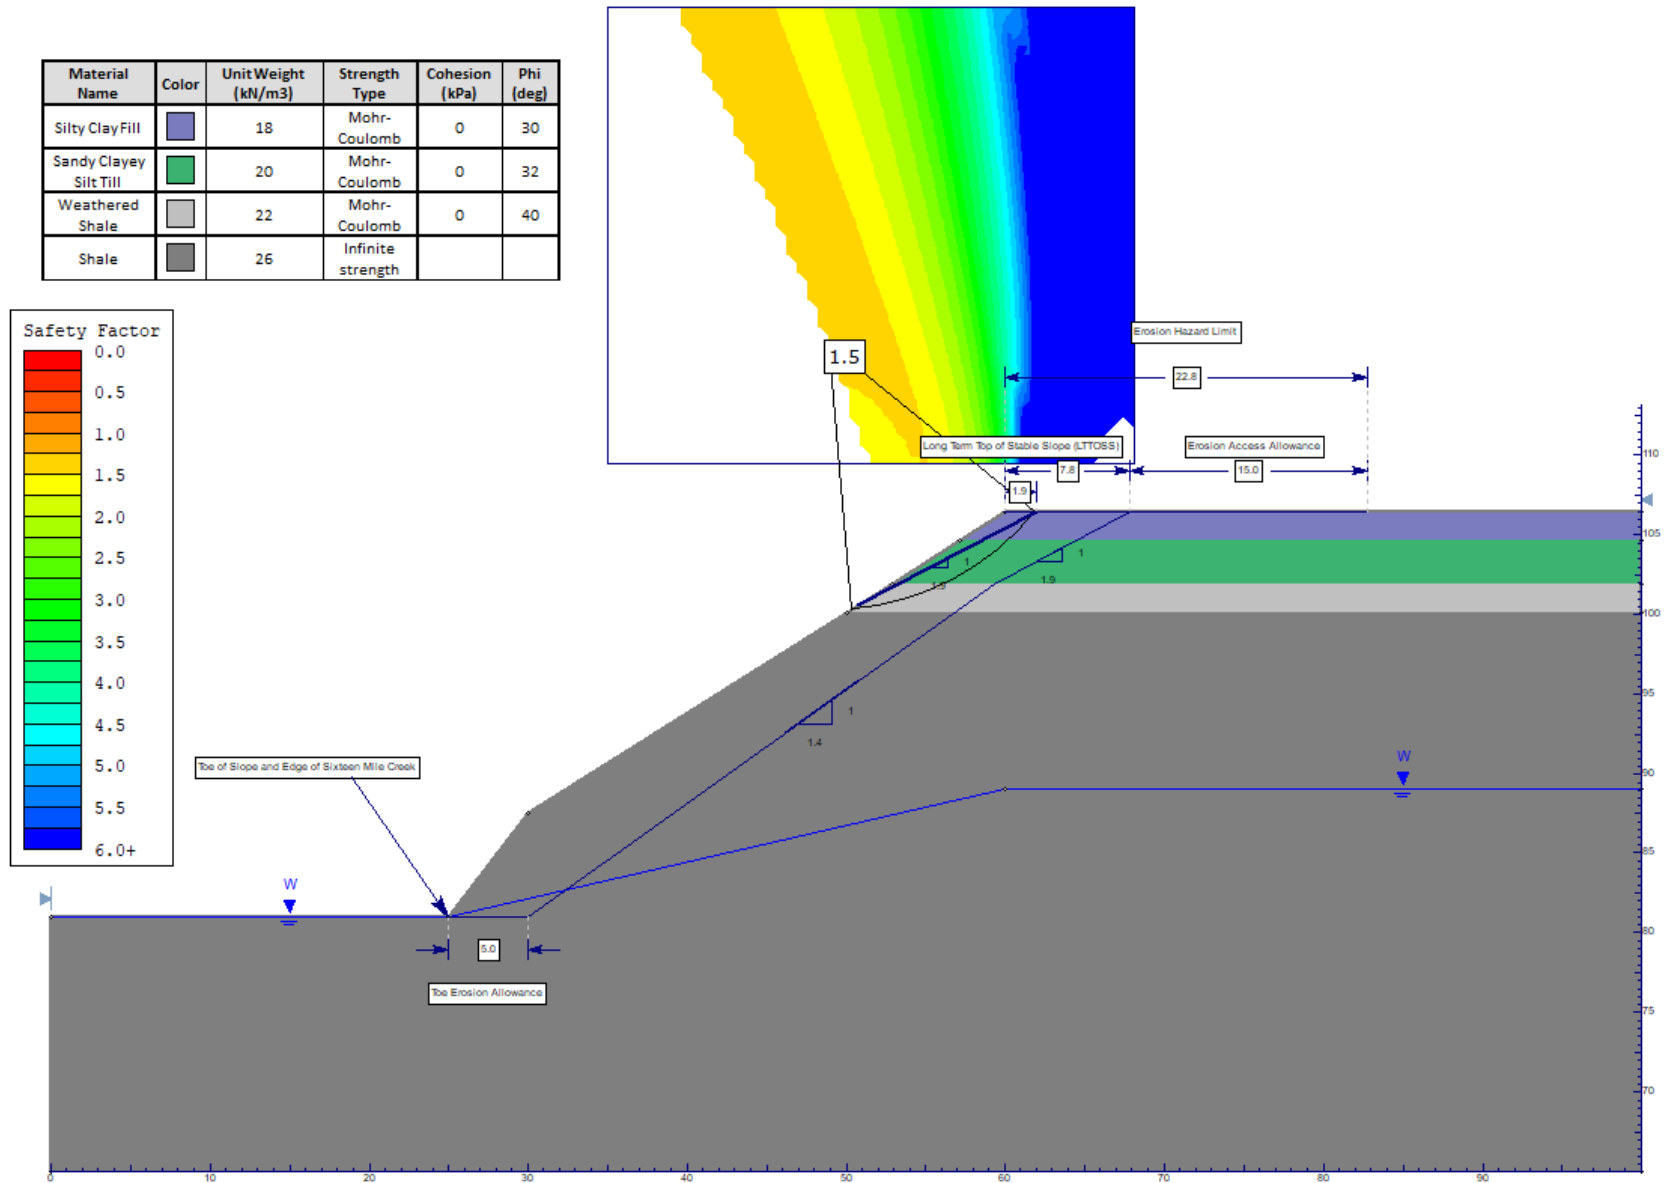
The results of the stability analysis for Sections A-A' and B-B' are shown on Figures 3 and 4 and indicate the setback where a minimum factor of safety equal to 1.5 is calculated against global instability for the long-term condition. Short-term (undrained) analysis was also carried out as a check; however, the long-term condition is considered to be more conservative and is more applicable to the proposed development. Therefore, the long-term condition is used to develop the top of stable slope. The long term top of stable slope (LTTOSS) is shown on Figure 2 and on the cross-sections in Figures 3, 4 and 5. Given that the slip surface passes through the overburden soils (above the more competent bedrock), a setback gradient line for the overburden soil was measured to be about 1.9H:1V and 2.0H:1V above the bedrock level for Section A-A' and B-B', respectively. As recommended by CH and consistent with the MNR Guide, a setback gradient line of 1.4H:1V was modelled for the bedrock and the corresponding LTTOSS limit for Section A-A' and B-B' is shown in profile on Figures 3, 4 and 5 accordingly. Referring to Figures 3, 4 and 5, the calculated LTTOSS is slightly further setback compared to the staked top of bank by Conservation Halton, thus, the LTTOSS line should be used for the stability component of the erosion hazard limit.
