PHASE I **ENVIRONMENTAL SITE** **ASSESSMENT**

1280 Dundas Street West, Oakville, Ontario

BIGC-GEO-185B

June 13, 2018

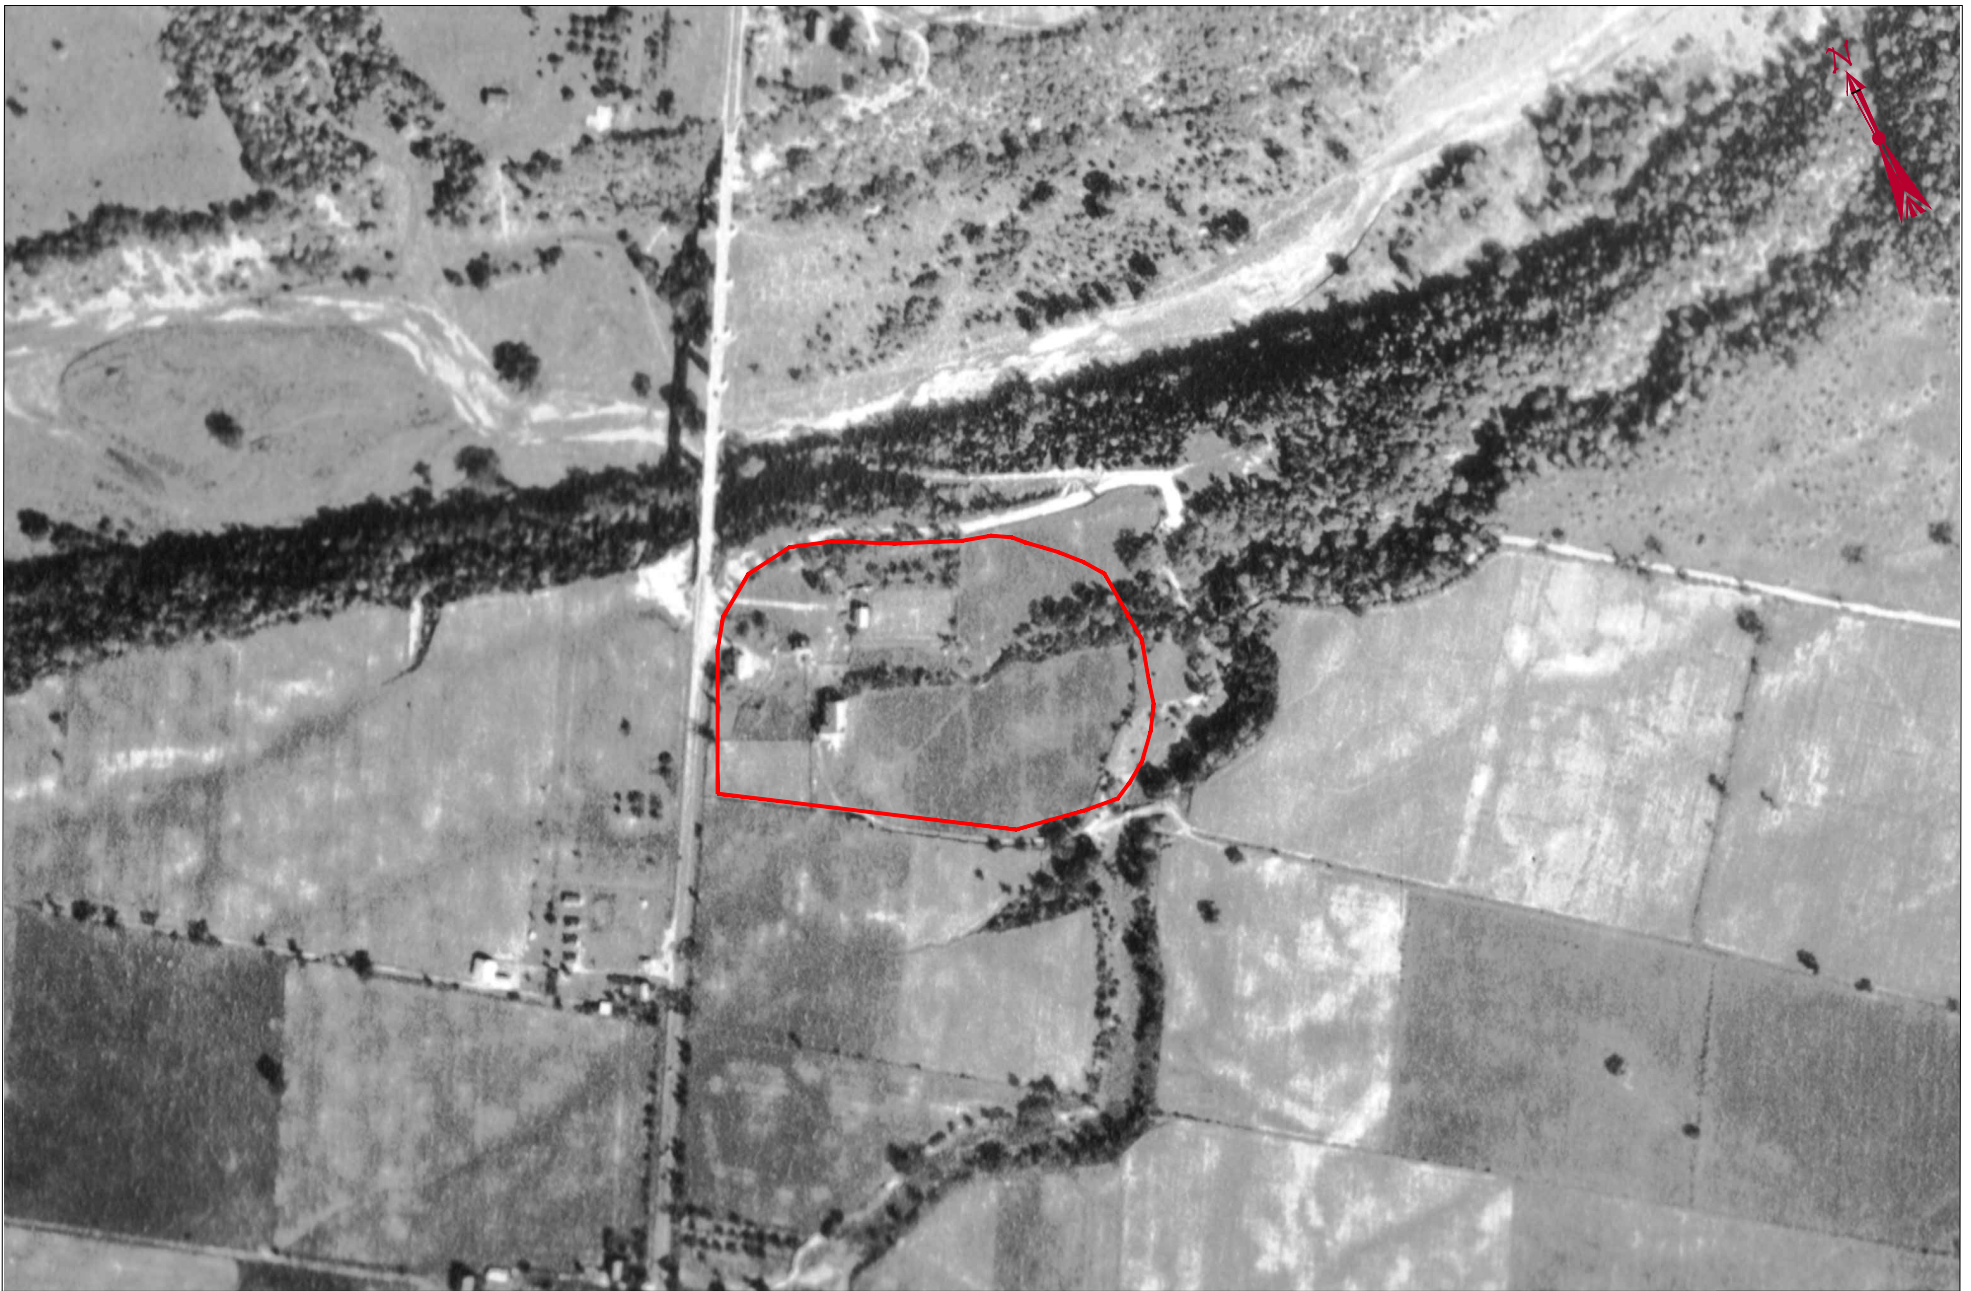
PROJECT NO. BIGC-GEO-185B	DWN. S.M.
SCALE NOT TO SCALE	CK. E.L.
DATE MAY 2018	FIG NO. F-2

IMAGERY SOURCED FROM LGI COPY SERVICES, DATED 1965

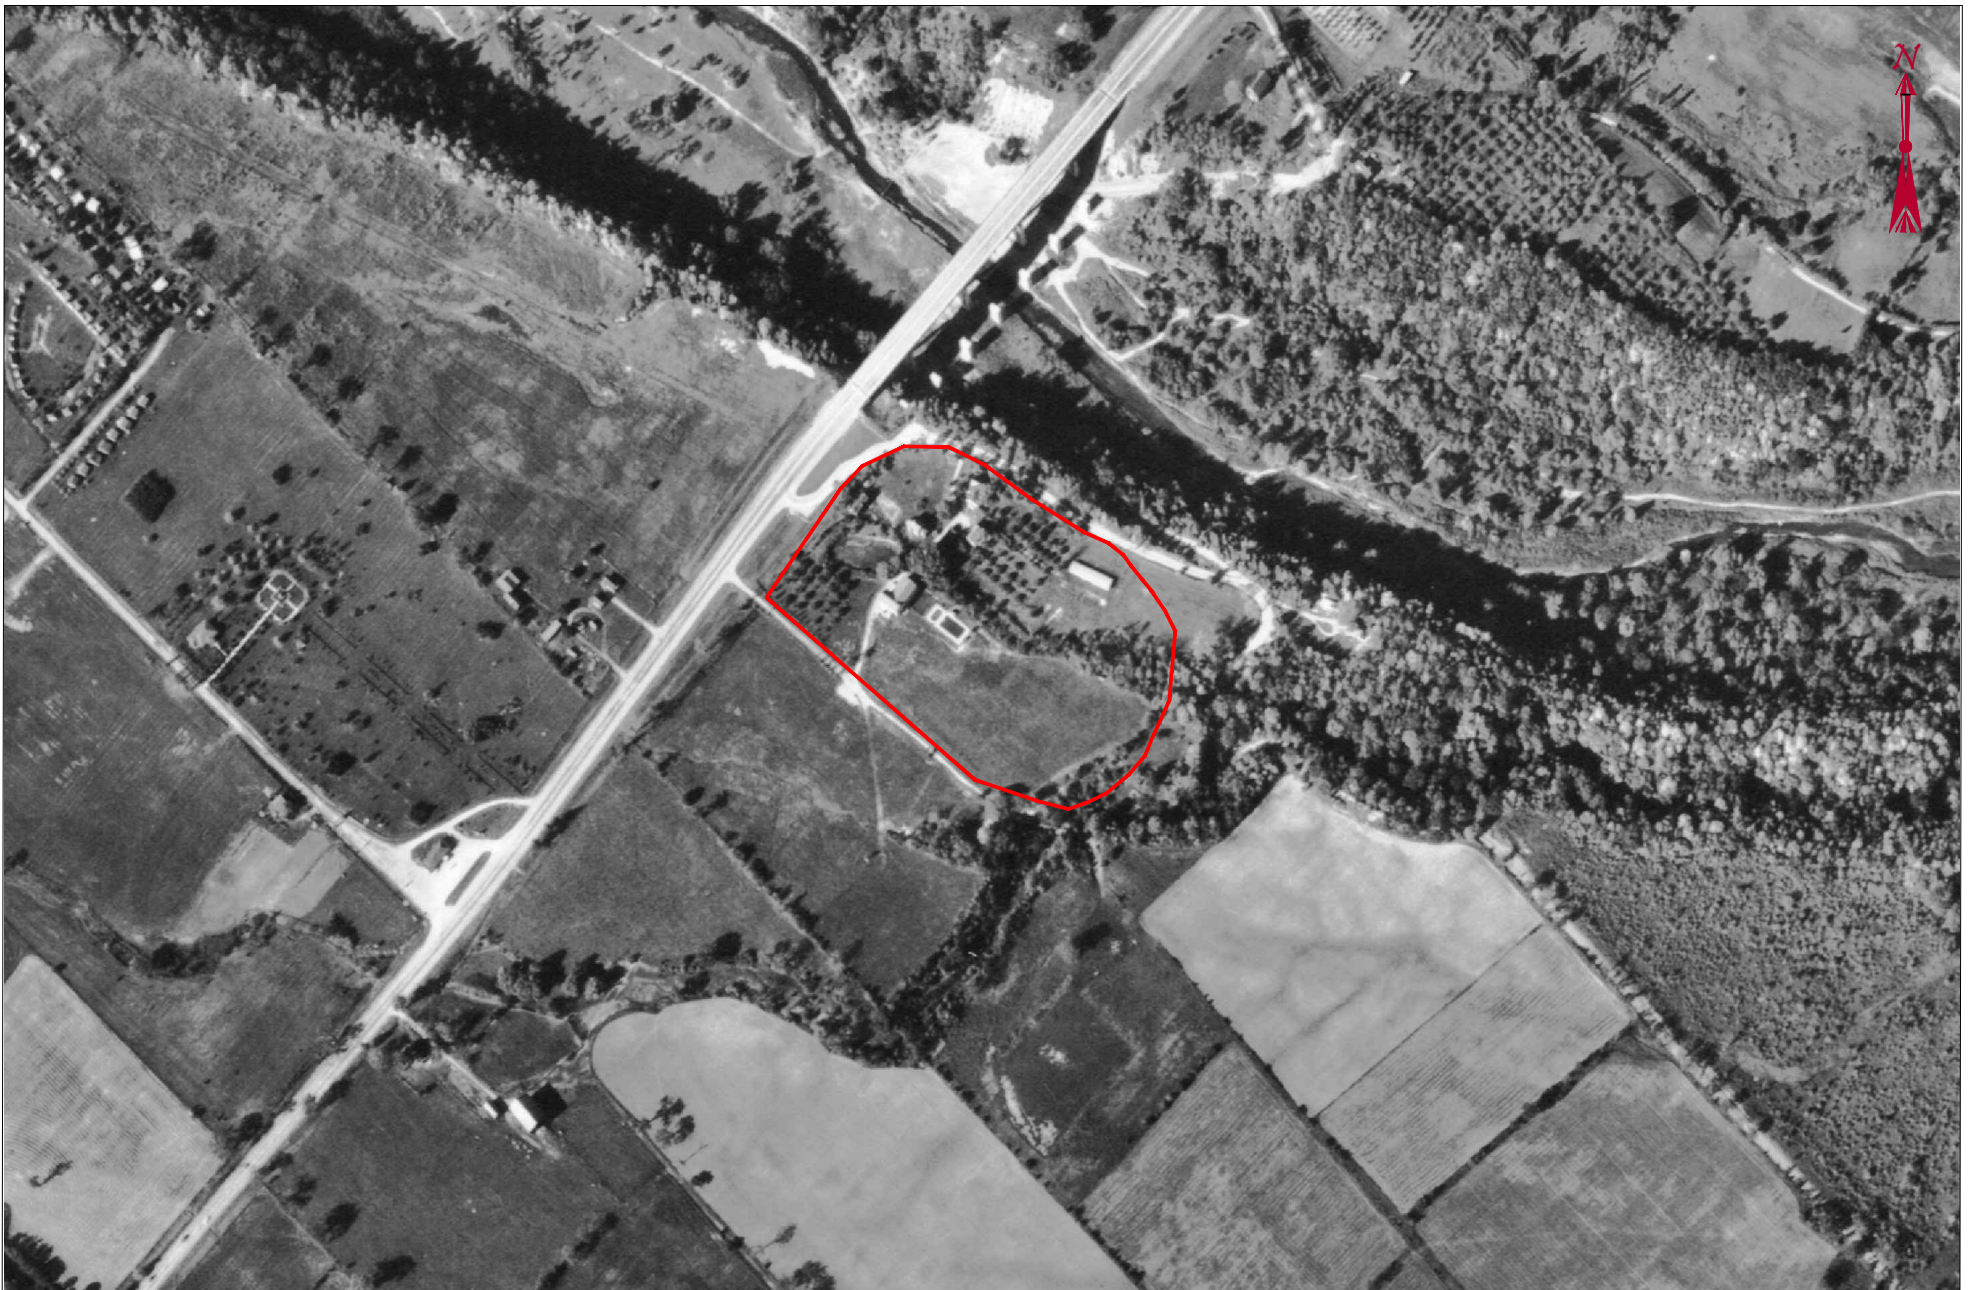
Aerial photographs dated 1934, 1965 and 1985 were obtained from LGI Copy Services Canada in order to review the development and land use history of the Site and the Phase I Study Area. An aerial photograph dated 1995 was obtained from Town of Oakville and aerial photographs dated 2005 and 2016 were obtained from Google Earth. BIG noted that at the time of this Phase I ESA, the 1934 aerial photograph was the earliest available photograph for the Site and Phase I Study Area. The aerial photographs were

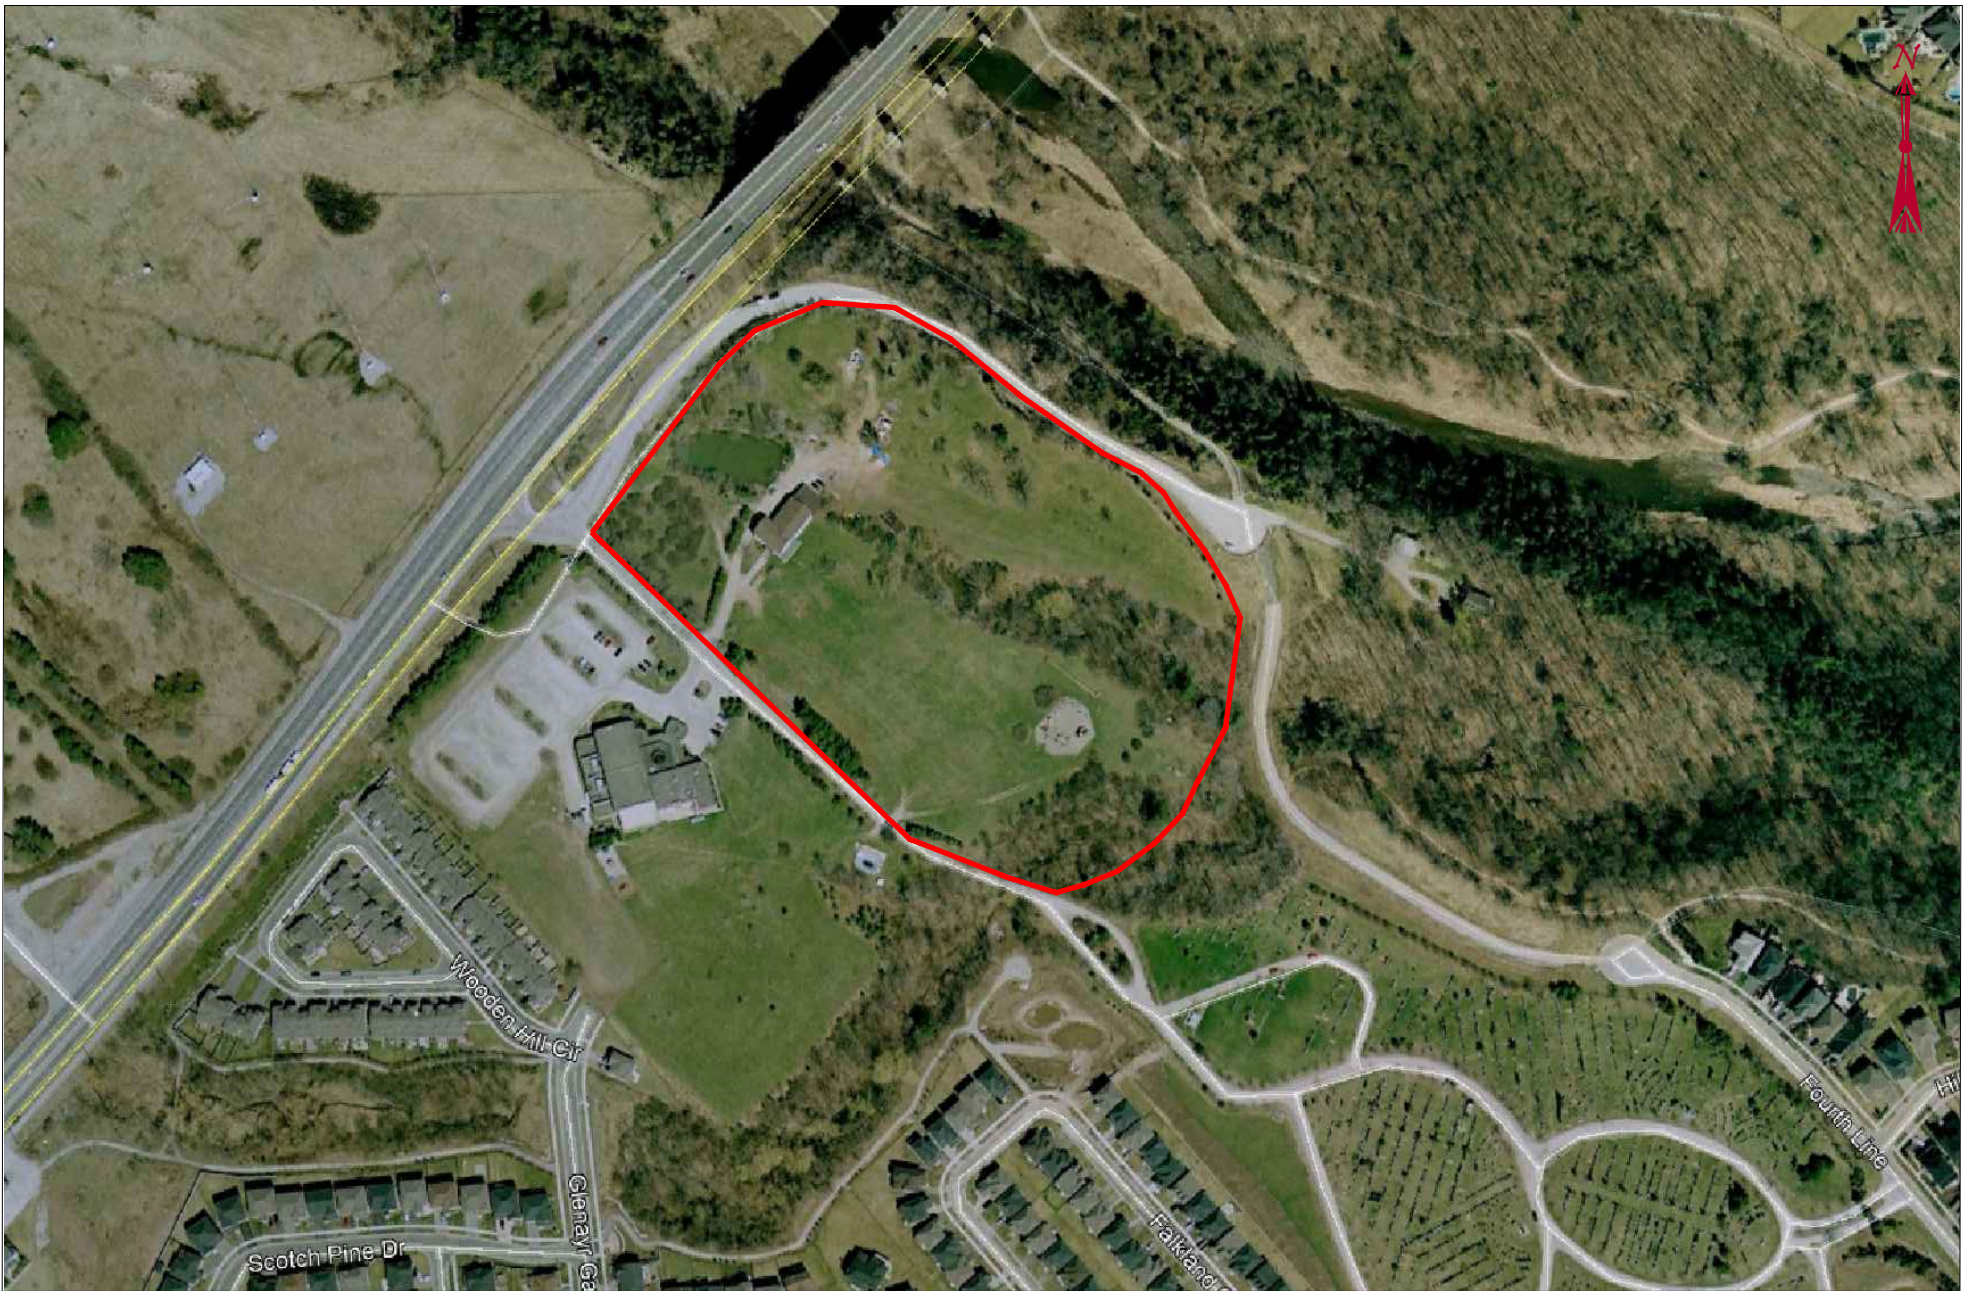
PROJECT NO. BIGC-GEO-185B	DWN. S.M.
SCALE NOT TO SCALE	CK. E.L.
DATE MAY 2018	FIG NO. F-5

IMAGERY SOURCED FROM GOOGLE EARTH ONLINE IMAGERY, DATED 2016

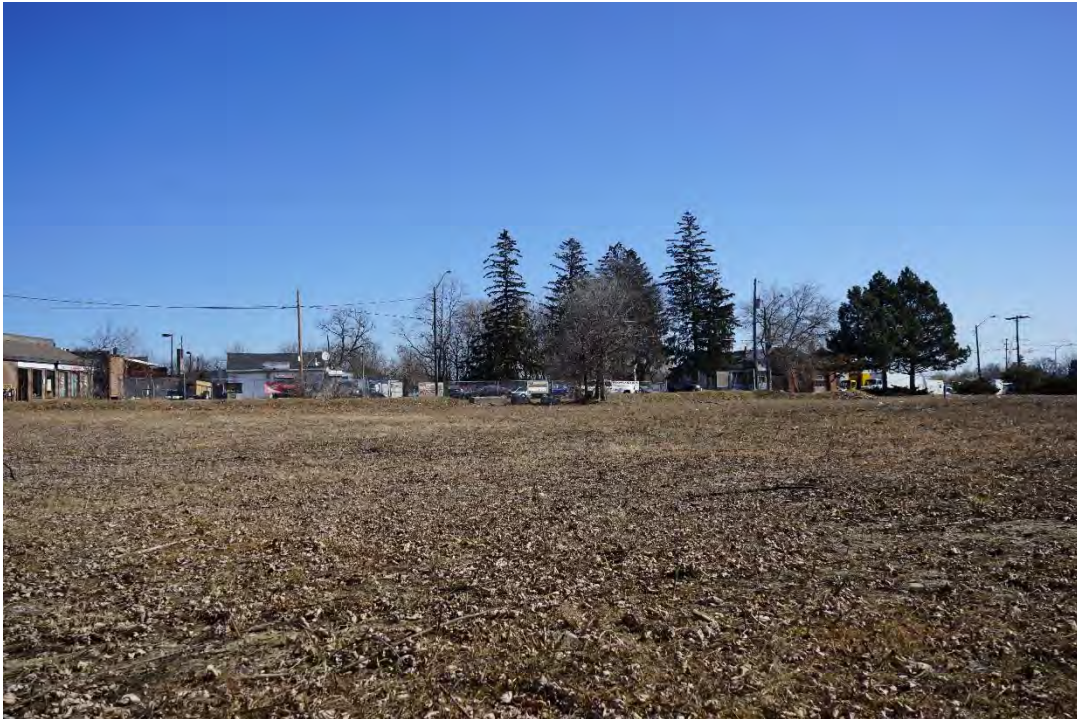
Photo 1: Frontage of the Site, facing northeast.

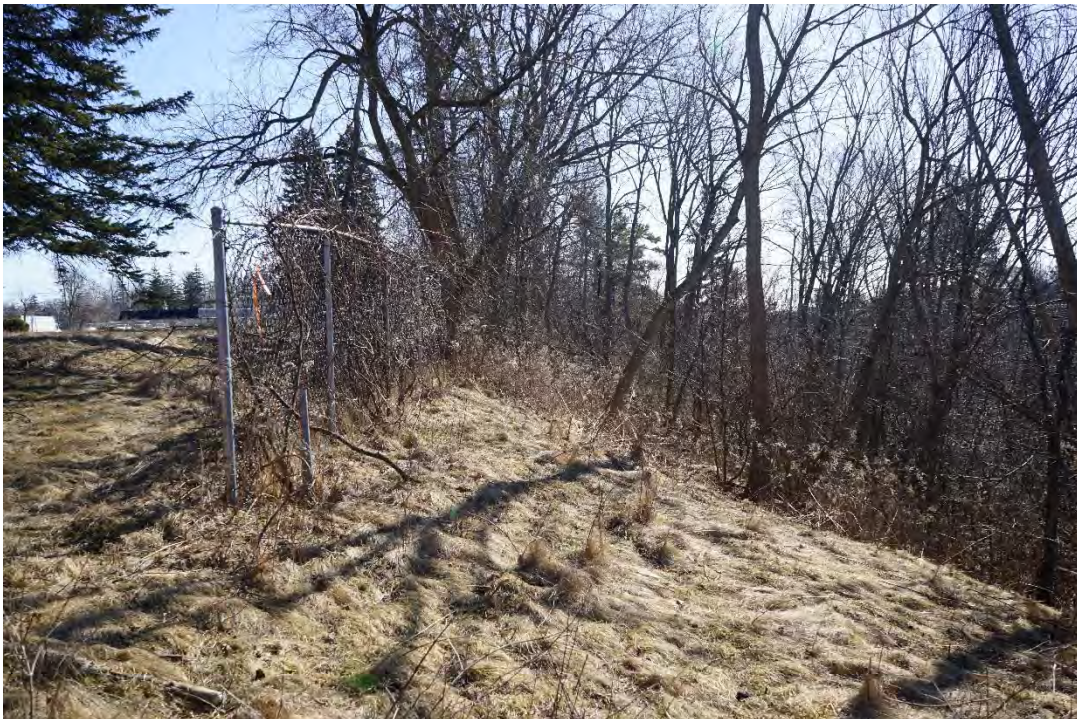
Photo 2: Southern Site boundary, facing east.
