Phase One Environmental Site Assessment

1493 Sixth Line, Oakville, Ontario

February 6, 2026
Trace Project No. 900-0494-01

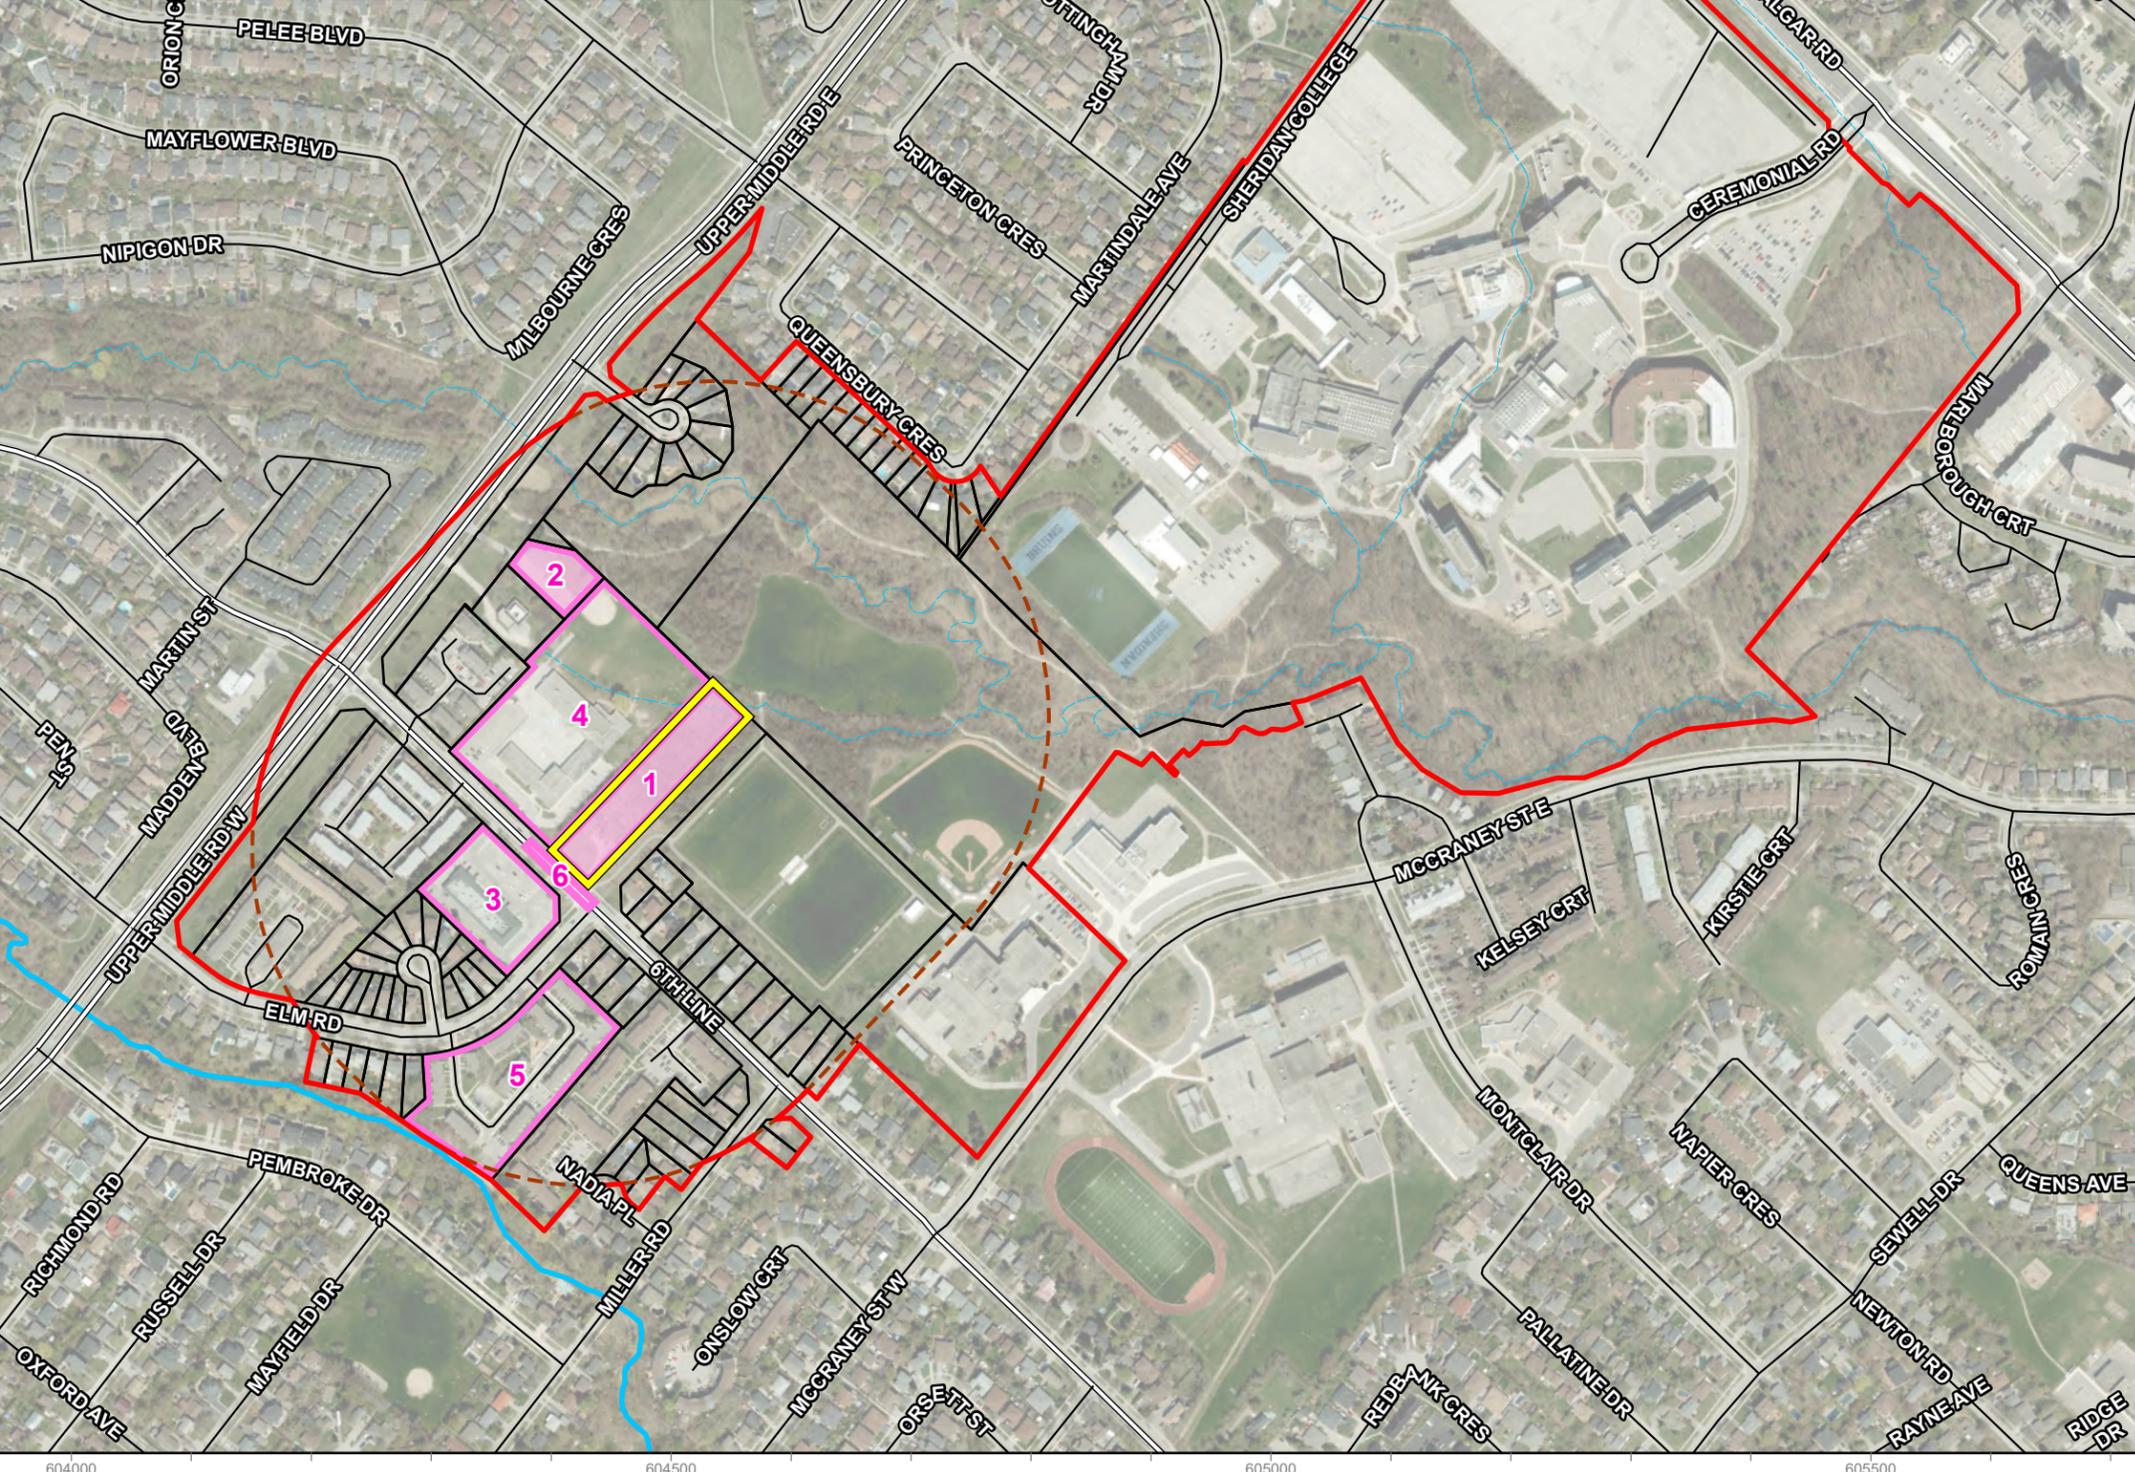
Potentially Contaminating Activities

PCA Address Number	Address	Potentially Contaminating Activity
1	1493 Sixth Line	#28 Gasoline and Associated Products Storage in Fixed Tanks
2	36 Upper Middle Road	#28 Gasoline and Associated Products Storage in Fixed Tanks
3	1500 Sixth Line	#37 Operation of Dry Cleaning Equipment (Where Chemicals Are Used)
4	1511 Sixth Line	#52 Storage, Maintenance, Fuelling and Repair of Equipment, Vehicles and Material Used to Maintain Transportation Systems
5	1478 and 1490 Elm Road	N/A - Spills
6	Sixth Line	#55 Transformer Manufacturing, Processing and Use N/A - Application of Road Salt for De-icing Purposes

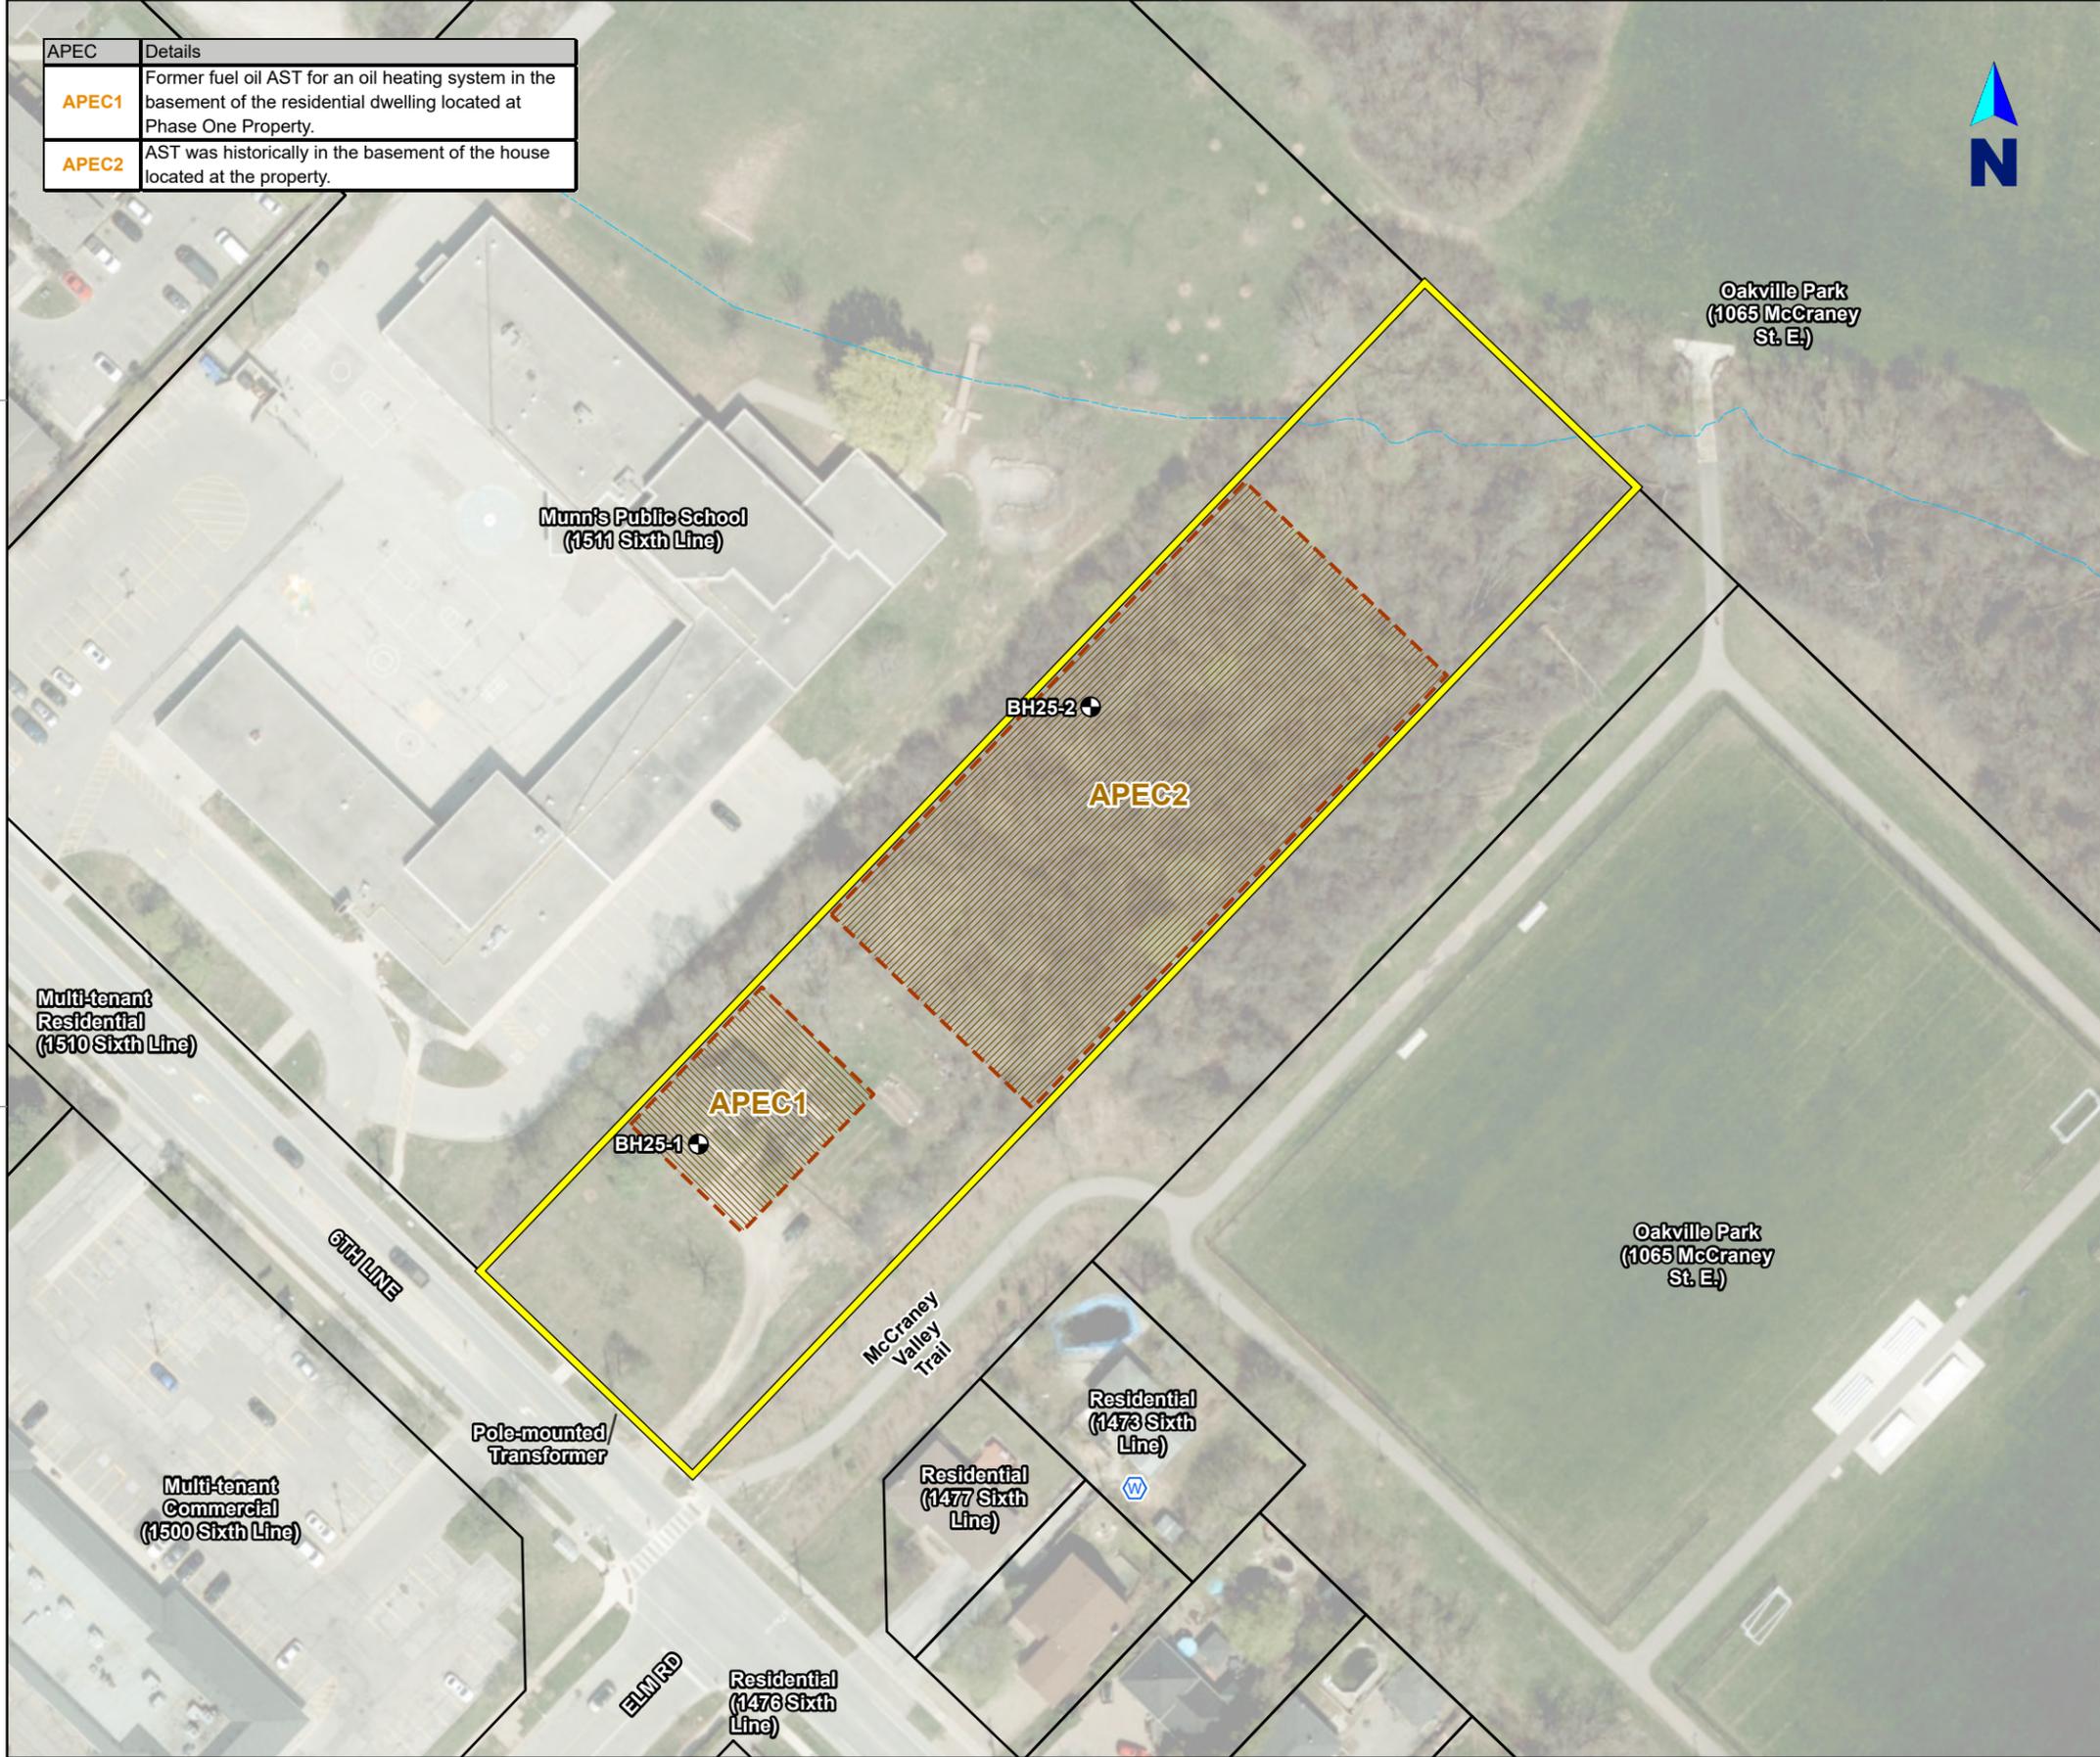
Areas of Potential Environmental Concern

APEC	Details
APEC1	Former fuel oil AST for an oil heating system in the basement of the residential dwelling located at Phase One Property.
APEC2	AST was historically in the basement of the house located at the property.

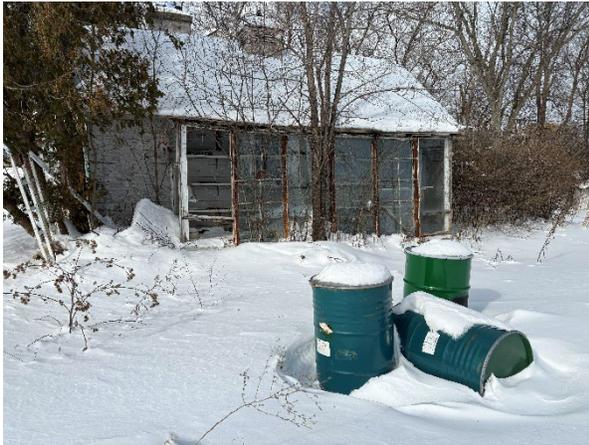
Photo 3: View of the east side of the residential dwelling at the Phase One Property, with empty drums (January 28, 2026).

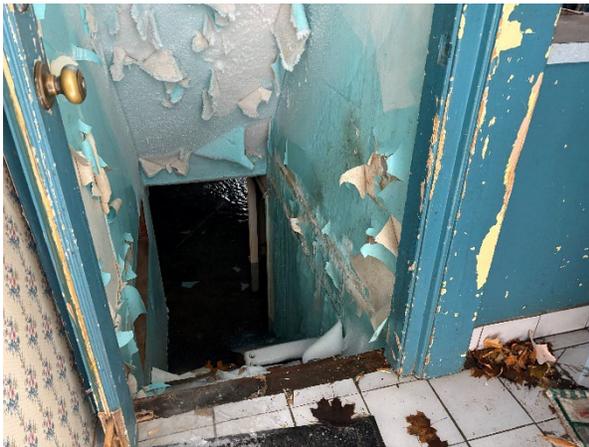
The basement of the residential dwelling was heavily flooded, with several feet of standing water visible. On the main floor, the kitchen sink was actively discharging water onto the floor, resulting in substantial overflow. This had caused ice to form across the kitchen, floor, cabinets, and surrounding surfaces.

Photo 7: View of flooding in the basement of the residential dwelling at the Phase One Property (January 28, 2026).

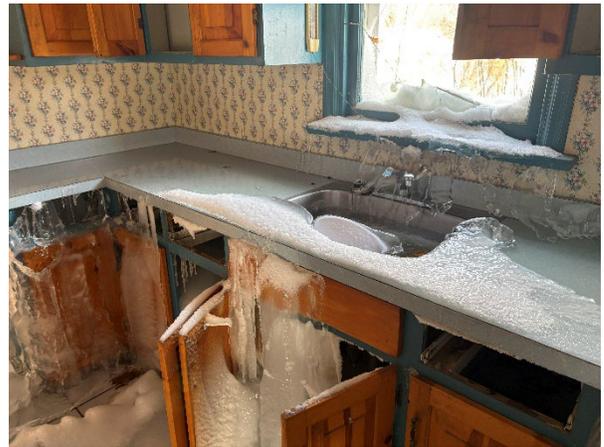
Photo 8: View of kitchen sink flooding at the residential dwelling at the Phase One Property (January 28, 2026).

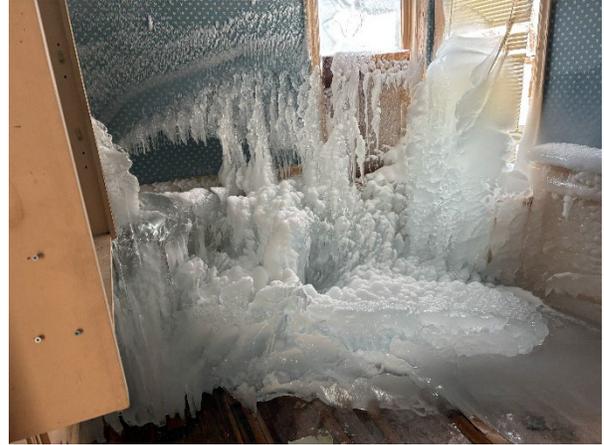
Photo 10: View of flooding in a room on the main floor of the residential dwelling at the Phase One Property (January 28, 2026).

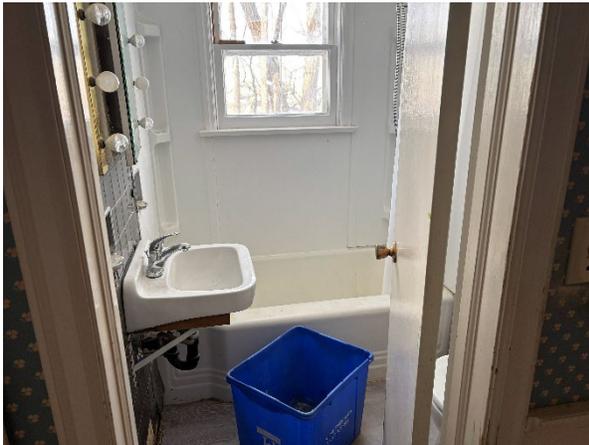
Additionally, a pipe near the main-floor bathroom was actively leaking, contributing to further water accumulation and ice formation on adjacent walls and flooring.

Photo 11: View of the bathroom on the main floor of the residential dwelling at the Phase One Property (January 28, 2026).

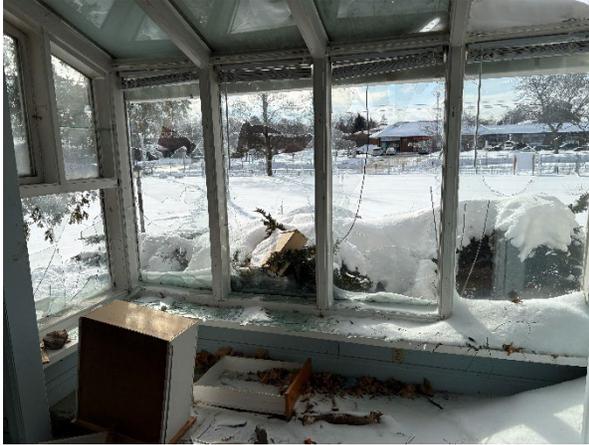
At the time of the site visit, the Phase One Property was developed with a vacant residential dwelling. Upon arrival, it was immediately apparent that the residential dwelling had sustained extensive damage. Multiple windows were broken and there was significant damage to the interior walls and flooring, consistent with signs of forced entry and/or vandalism.

Photo 13: View of damaged windows on the main floor of the residential dwelling at the Phase One Property (January 28, 2026).

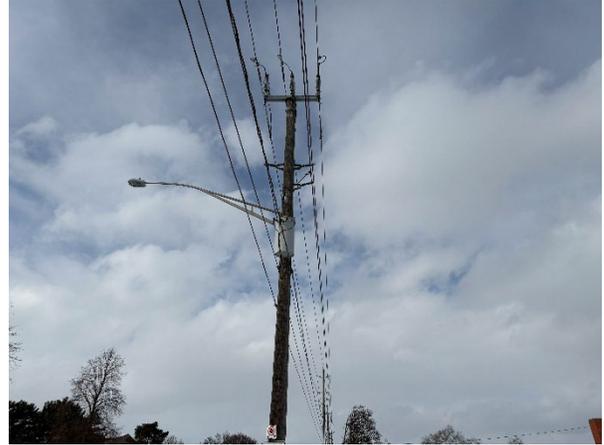
Electricity is supplied by Oakville Hydro Electricity via overhead wires to the residential dwelling. Transformers were observed on the utility poles located along Sixth Line, adjacent to the south. Natural gas supply is provided by Enbridge Gas via underground piping. The residential dwelling was historically heated with furnace oil following the use of coal for heating. Site personnel indicated that an oil-fired boiler was previously used to heat the residential dwelling and that fuel was historically stored in an AST situated in the basement. Reportedly, the AST had been removed prior to the Phase I ESA (RWDI, 2025). As a result of the flooding occurring in the basement at the time of the 2026 site visit, Trace personnel could not observe the boiler heating system.

Photo 18: View of the transformer on Sixth Line (January 28, 2026).
